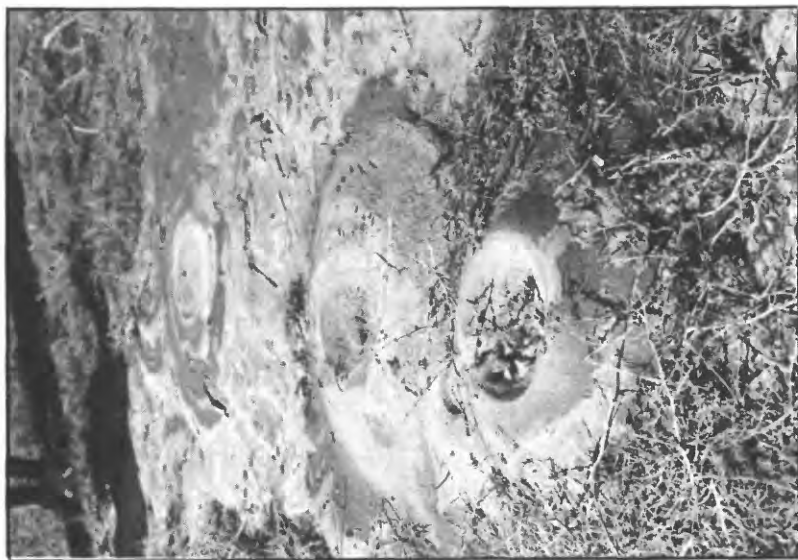
FIGURE 9.—Mud cones developed along fractures about one-eighth mile west of Kosmo. Utah earthquake.

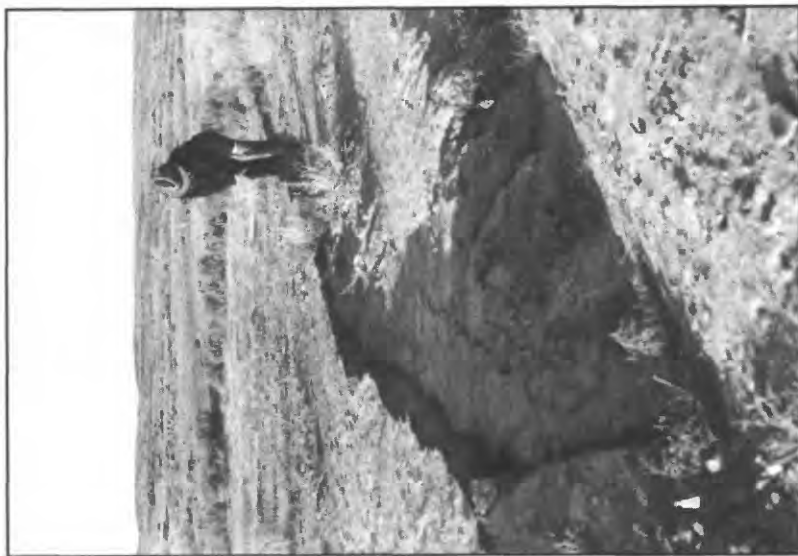
FIGURE 8.—Fault scarp north of Kosmo showing how opposite sides of scarp fit together. Utah earthquake.

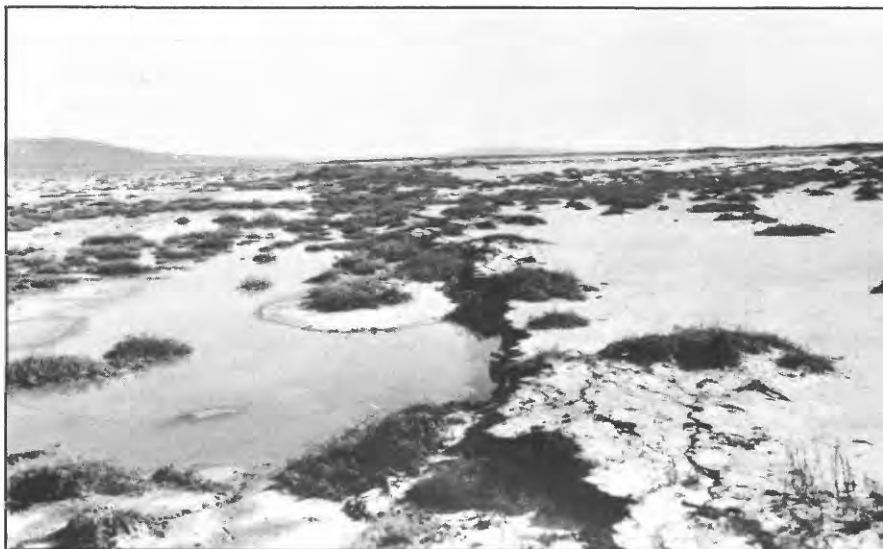
FIGURE 11.—Water issuing from fault on salt flat northeast of Kosmo. Utah earthquake.

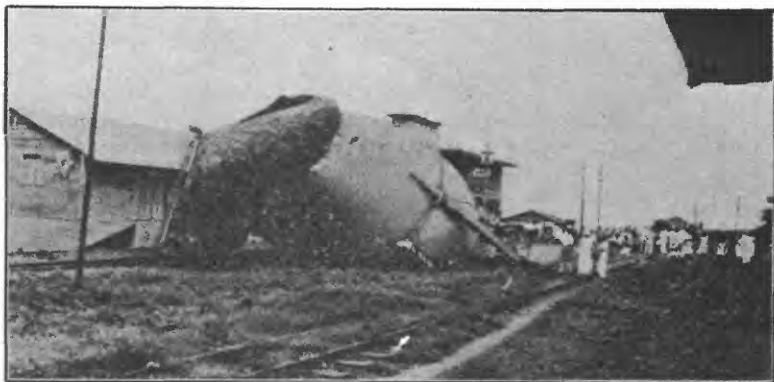
FIGURE 12.—Wrecked water tank. Puerto Armuelles yard. Panama earthquake.

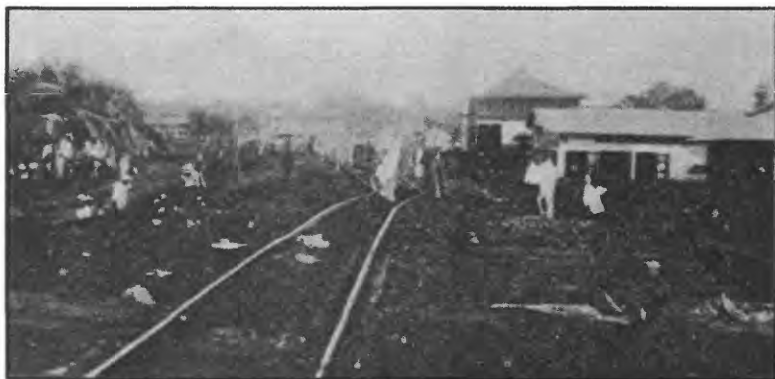
FIGURE 13.—Railroad track shifted out of alignment at Puerto Armuelles. Panama earthquake.

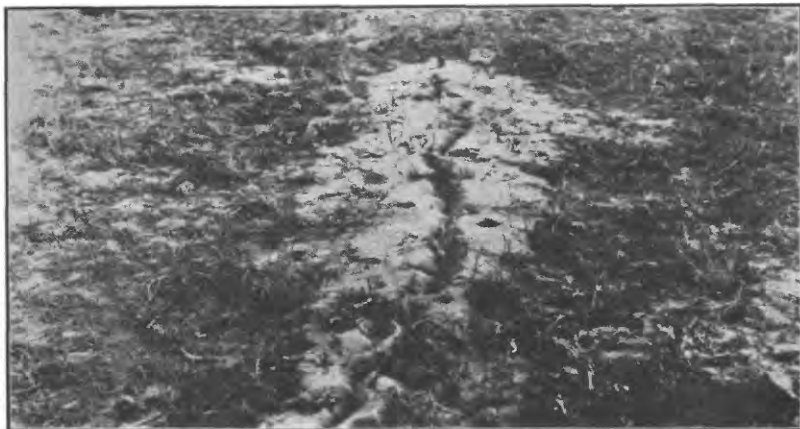
FIGURE 19.—Crack which spouted water and sand. Six miles northeast of Helena.
