UNITED STATES DEPARTMENT OF THE INTERIOR

GEOLOGICAL SURVEY

Stability of Slope Areas II and IV Below the Sherwood Uranium Mine,
Spokane Indian Reservation, Northeastern Washington

Open-File Report 85-438

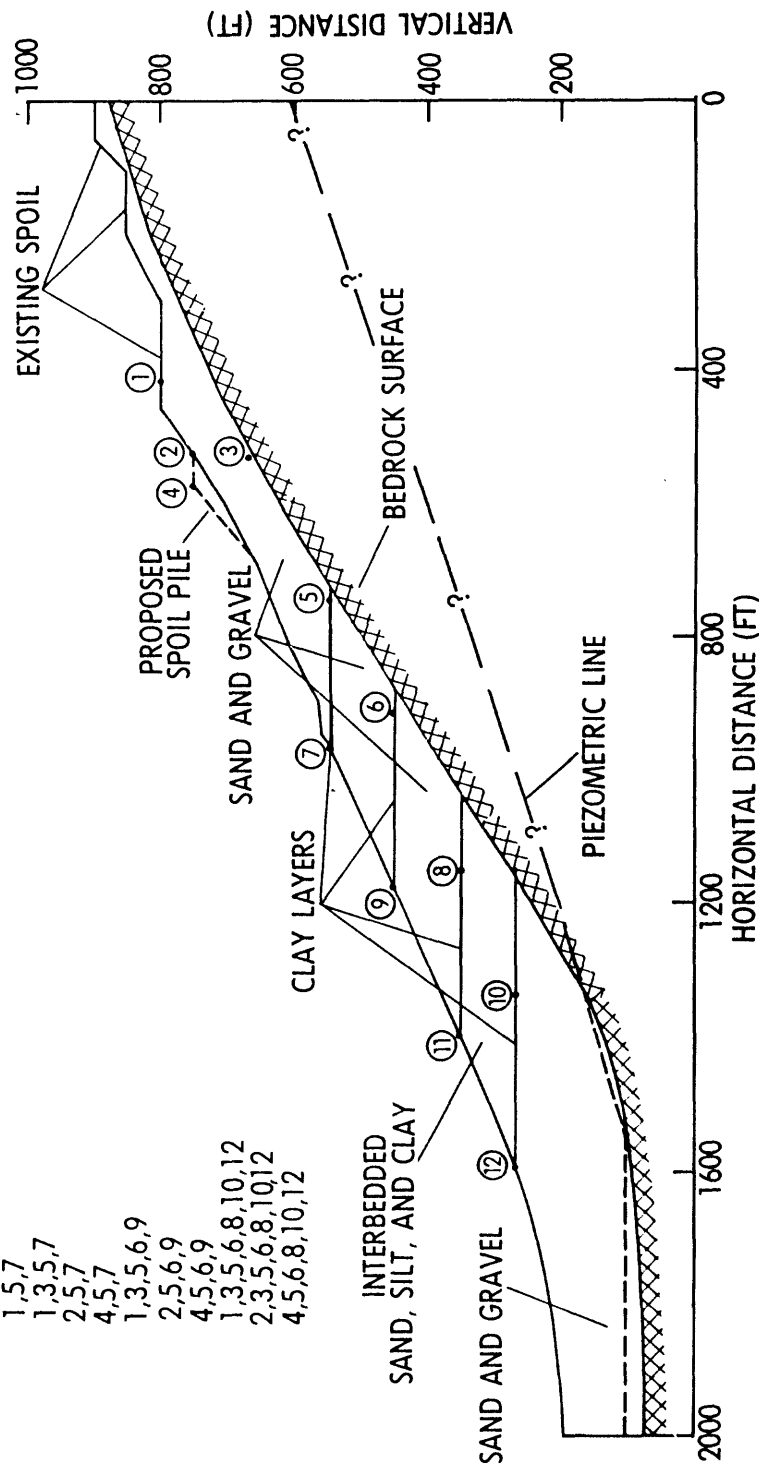
Figure 2.--Idealized cross section D-D' (plate 1, slope area II) showing the location of trial failure surfaces.

a depth of at least 100 ft. Above the 1650-ft elevation, the natural surficial slope material consists entirely of sand and subordinate gravel. The locations of clay layers shown in cross section D-D' (fig. 2) are based on actual clay-bed exposures found in slope area II or are inferred from exposures found in nearby slope areas. Slope area II is bounded by a large area of exposed bedrock to the southeast (slope area I) and to the northwest by the bedrock exposure of slope area III. Spoil piles presently load the top of slope area II, and additional spoil-pile loading is being considered, which would extend downslope to approximately the 1750-ft elevation, as shown in figure 2 (Gary Righittini, Western Nuclear Corp., written commun., 1984). Previous stability analyses for cross section A-A' of slope area II (pl. 1), using the Morgenstern-Price and sliding-wedge methods of analysis under existing slope conditions without additional spoil, yielded factors of safety ranging from 1.62 to 2.01 using peak shear-strength parameters and 1.55 to 1.86 using residual strength values (OFR 84-627). It was recommended in OFR 84-627 that the effects of additional spoil loading in slope area II be analyzed in advance, to determine the advisability of such additional loading.

Stability analyses were performed using the sliding-wedge method of analysis (OFR 84-627) in order to examine the effects of the proposed additional spoil-pile loading depicted in figure 2. The location of cross section D-D' is shown on plate 1. Material properties used in the analyses are listed in table 1; these properties are the same as those used in previous analyses described in OFR 84-627. The trial failure surfaces shown in figure 2 incorporate all or part of the proposed spoil in each analysis. In all cases, the base or lowermost segment of the trial failure surface is located in a clay layer. Correspondingly, the material properties of the clay were used for those trial failure-surface segments in each analysis. Stability-analysis results for cross section D-D' trial failure surfaces are presented in table 2.

As shown in table 2, some of the calculated factors of safety are below the recommended safe minimum values of 1.5, using peak strengths, or 1.3, using residual strengths (OFR 84-627). Trial failure surfaces A, C, and D, which have factors of safety below the recommended safe minimum values, involve the possible clay layer near elevation 1640; trial failure surface G with a calculated factor of safety of 1.27, using residual strength values, involves the possible clay layer near elevation 1550. As previously stated, these analyses are based on the assumption that the clay layers are continuous across slope area II. However, surface and subsurface field evidence is meager and, therefore, inconclusive. If the weak clay layer assumed present in a given analysis is in fact not present, the sliding wedge analysis is inappropriate for the problem and the factors of safety presented here are probably too low.

Trial failure surface	Locus of trial failure surface points (see fig. 2 for location)	Factor of safety	
		Based on peak shear strength	Based on residual shear strength
A	1,5,7	1.51	1.21
B	1,3,5,7	1.56	1.36
C	2,5,7	1.48	1.13
D	4,5,7	1.49	1.00
E	1,3,5,6,9	1.59	1.40
F	2,5,6,9	1.66	1.40
G	4,5,6,9	1.57	1.27
H	1,3,5,6,8,10,12	1.60	1.51
I	2,5,6,8,10,12	1.60	1.48
J	4,5,6,8,10,12	1.60	1.47

It is recommended that plans for additional spoil-pile loading in slope area II (fig. 2) be abandoned or postponed until it can be demonstrated by additional drilling and (or) other detailed field studies that clay layers found in nearby outcrops are not continuous across slope area II and that recalculated factors of safety resulting from stability analyses for different slope conditions are not lower than the recommended safe minimums.

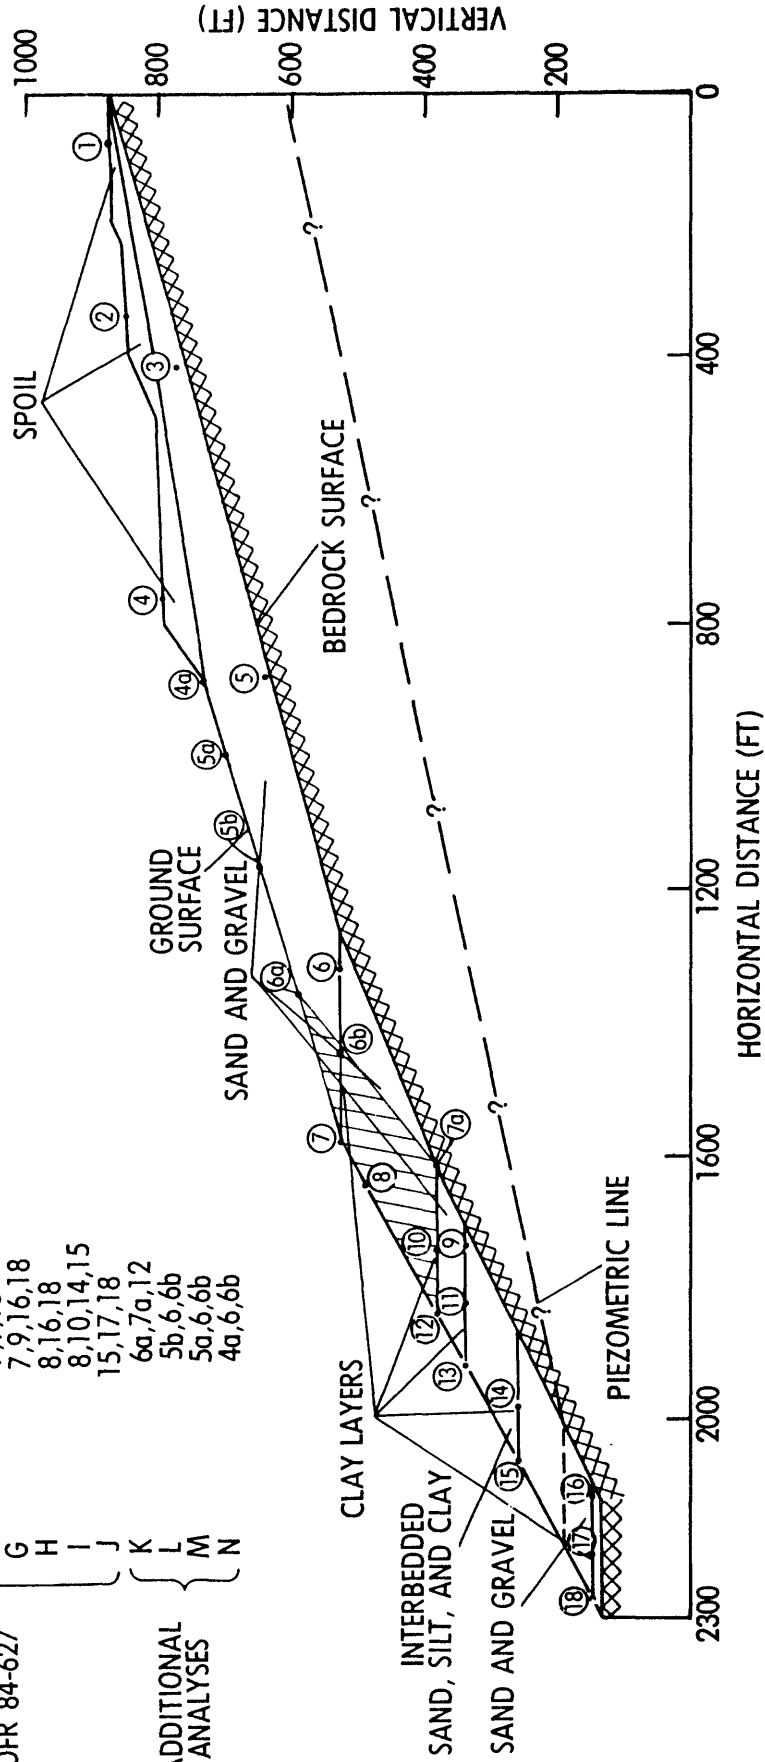
Previous stability analyses using the Morgenstern-Price and sliding-wedge methods of analysis revealed six trial failure surfaces in slope area IV with factors of safety lower than the recommended safe minimums (OFR 84-627). All of those surfaces are located in the lower part of the slope and involve clay beds actually cropping out on the slope or inferred to exist on the basis of clay outcrops found in nearby slopes at similar elevations. It was recommended in OFR 84-627 that slope area IV be routinely examined to identify any potential landslides that might result in retrogressive failures involving spoil material in the upper parts of the slope, and that additional slope stability analyses be performed to examine the effects of such retrogressive failures.

Additional stability analyses were performed to check the likelihood of retrogressive slope failure developing on the upper part of slope area IV due to failure of the lower part. The sliding-wedge method of analysis and appropriate shear strength parameters described in OFR 84-627 were used to obtain factors of safety. Material properties used in the analyses are shown in table 1. In order to examine the effects of support lost to the upper part of slope area IV due to a slope failure on the lower part, a wedge failure along trial failure surface 6a, 7a, 12 was assumed, resulting in removal of material in the hachured area shown in figure 3. The resulting surface geometry (6a, 6b, 7a, 12, in fig. 3) was then incorporated into the analyses of trial failure surfaces 5b, 6, 6b; 5a, 6, 6b; and 4a, 6, 6b, all involving the remaining part of the uppermost clay layer between points 6 and 6b. The results of these analyses are shown in table 3. As seen in table 3, of those trial failure surfaces involving the uppermost clay layer, only trial failure surface 5b, 6, 6b has a factor of safety (1.32 based on residual shear-strength parameters) approaching the safe minimum recommended in OFR 84-627 (1.30 based on residual parameters). The stability of the slope above the uppermost clay bed would be governed by the strength properties of sand, gravel and (or) spoil, and slope angles in excess of 35° to 37° would be required for instability as indicated by the infinite slope analyses of OFR 84-627. The existing natural slope above the uppermost clay bed is approximately 20° . The results shown in table 3 indicate that, under existing conditions, removal of support from the upper slope area due to failure(s) in the lower part probably would not result in retrogressive failures involving

Figure 3.--Idealized cross section B-B' (plate 1, slope area IV) showing the location of trial failure surfaces and hypothetical wedge failure resulting in removal of material in hachured area.

Trial failure surface	Locus of trial failure surface points (see fig. 3 for location)	Factor of safety	
		Based on peak shear strength	Based on residual shear strength
K	6a,7a,12	1.56	1.21
L	5b,6,6b	1.87	1.32
M	5a,6,6b	1.85	1.51
N	4a,6,6b	2.01	1.74

spoil material. Additional spoil-pile loading downslope of the existing piles, and above the trial failure surfaces considered in these analyses, would add to the shearing stresses and could reduce factors of safety below safe minimums. Any future plans for additional spoil-pile loading downslope of existing spoil into marginally stable areas will require detailed analyses. As previously mentioned, the actual location, extent, and orientation of clay beds used in the analyses are largely inferred on the basis of outcrops on adjacent slopes. Additional field work would be needed to verify their existence and to better ascertain their locations and orientations should more detailed analyses be required.

If money were no object, alternative B would be recommended in order to gain additional information on clay-bed locations which could be used to establish a surface survey and which would determine the credibility of the interpretations on which the stability analyses are based. However, in view of the relatively high cost of the drilling alternative and the absence of plans to add spoil downslope of existing spoil piles, the surface survey (Alternative C) appears to be a logical alternative that would, in the opinion of the authors, provide some protection against serious loss due to a massive slope failure with a measure of insurance against the uncertainties involved, at a relatively low cost.
