U.S. GEOLOGICAL SURVEY

**Preliminary Report**

**Investigations of the Central Chile**

**Earthquake of March 3, 1985**

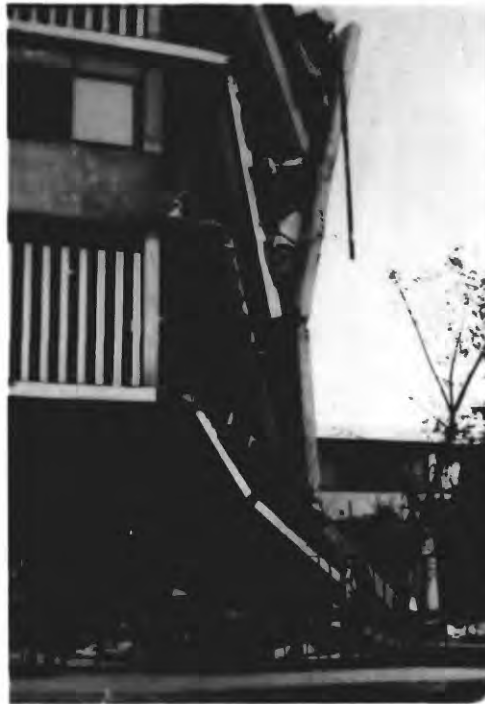
Figure 1.--Part of this building in Santiago collapsed. The building had soft first story. This building, one of several typical buildings in the same area, is the only one that did not perform well.

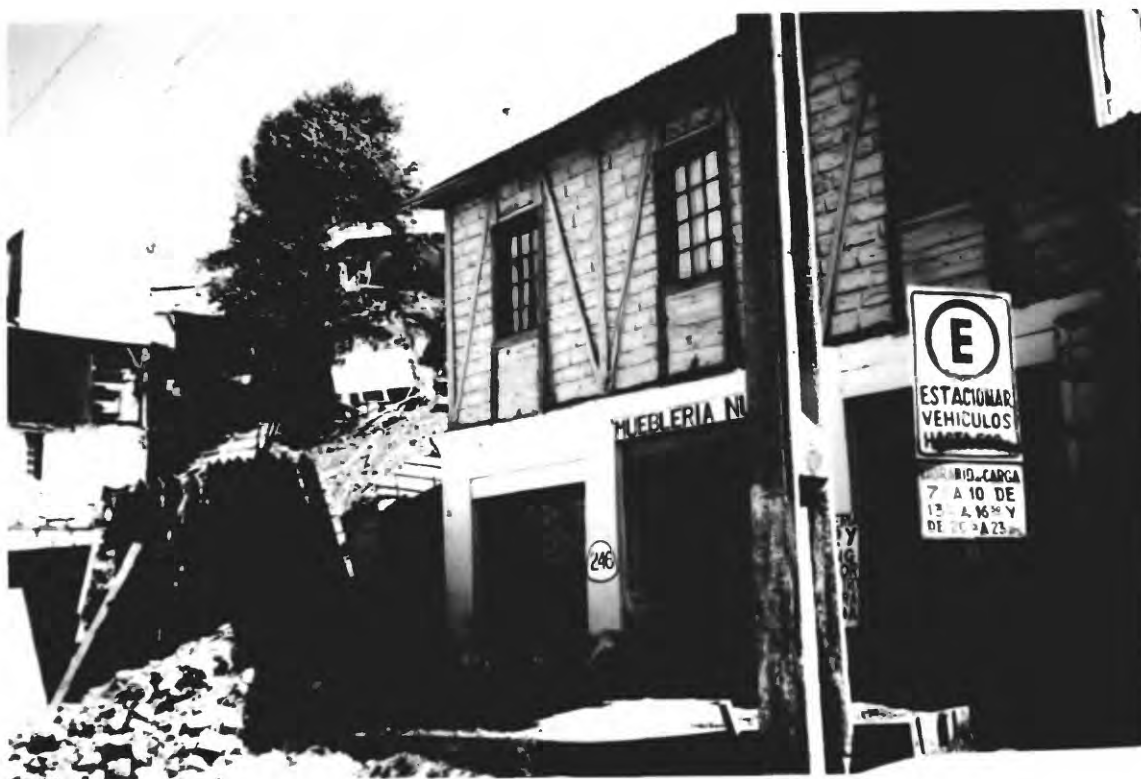
Figure 4.--A unique structure in downtown San Antonio. The first floor is reinforced concrete frame. The added on second floor is masonry reinforced with well braced timber. The building did not suffer any damage. Older adobe buildings adjacent to this building or behind it had completely collapsed.

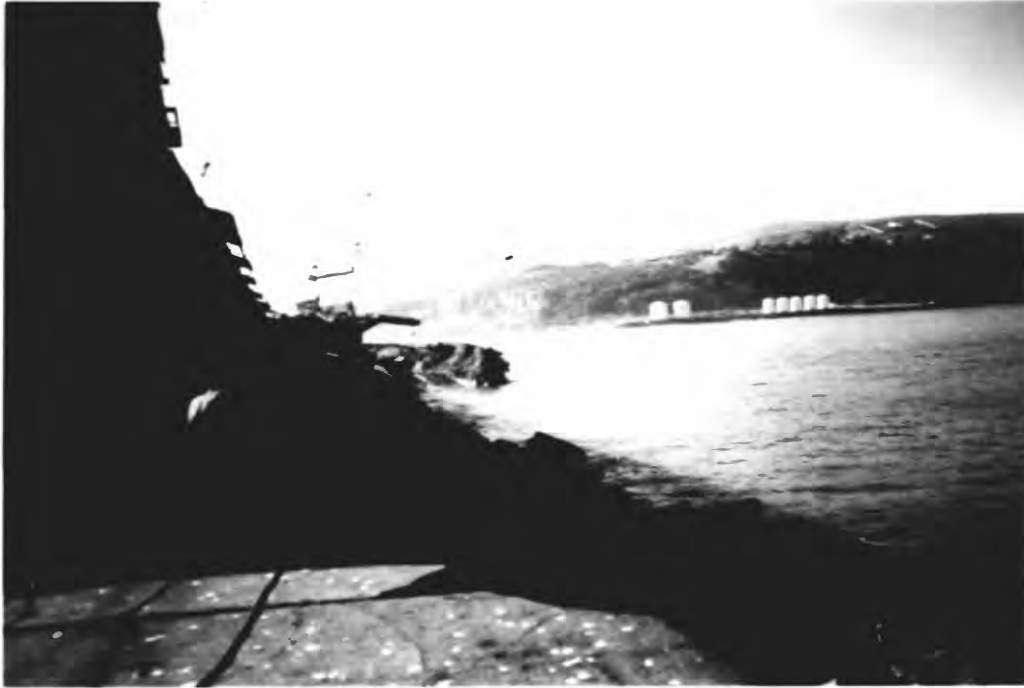
Figure 5.--The dock of San Antonio Harbor. All cranes either totally or partially tipped over. The unreinforced surface concrete was severely damaged as a result of liquefaction of the pumping of fill-sand underneath.

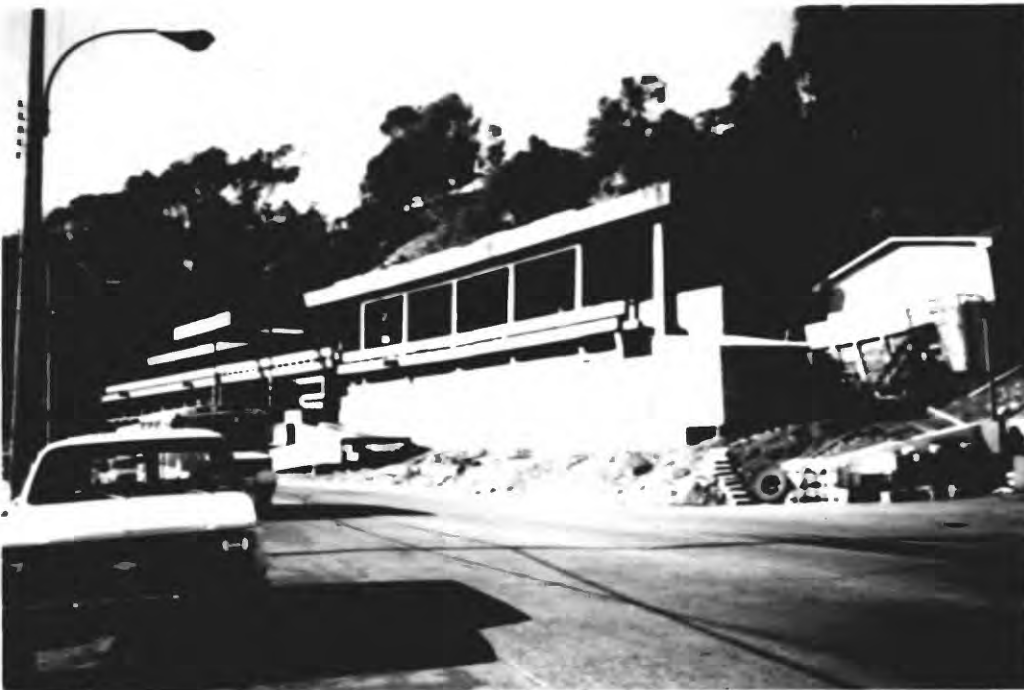
Figure 6.--A new reinforced concrete framed structure across from the San Antonio Harbor. Note the short columns between the tie beam (in the first floor) and the beam in the second story floor. These short columns were all damaged.

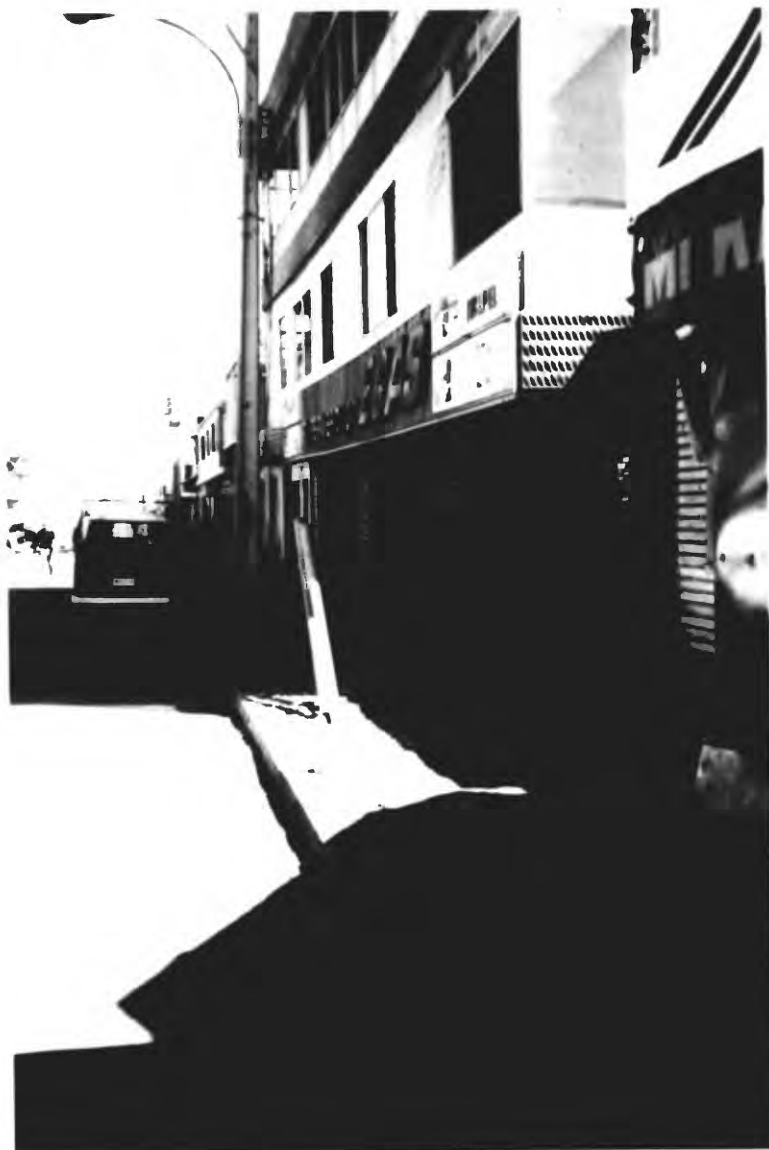
Figure 3.--The columns of the structure in San Antonio settled into the pavement due to liquefaction.

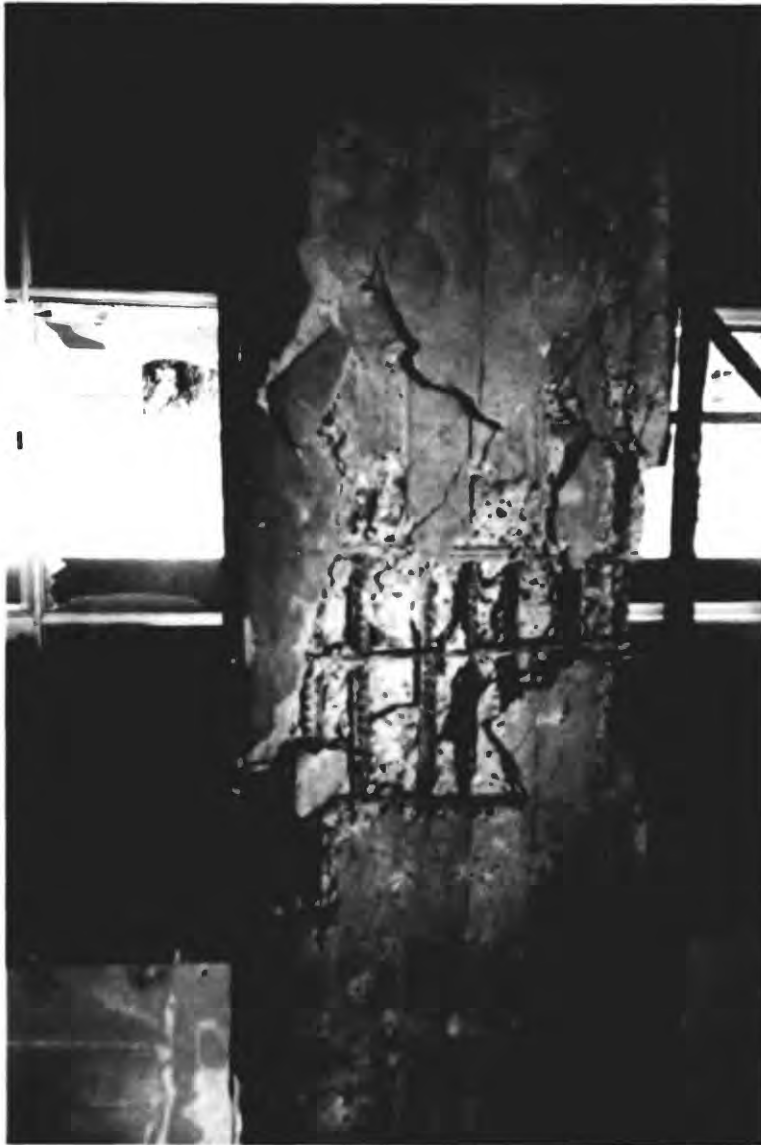
Figure 10.--Extensive spalling at the exterior and cracking in the confined concrete core of the column. The concrete quality appeared poor.

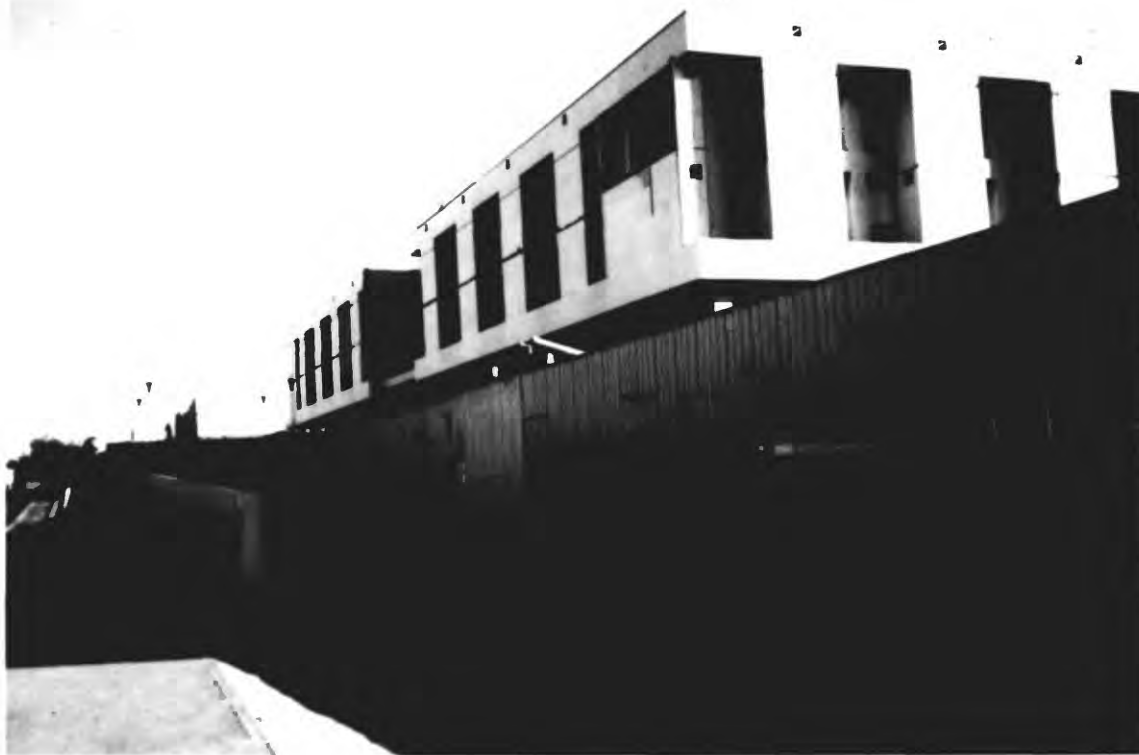
Figure 9.--Claudio Vicuña Hospital in San Antonio. The second story is the "soft story". The columns, particularly in one of the two blocks were damaged.

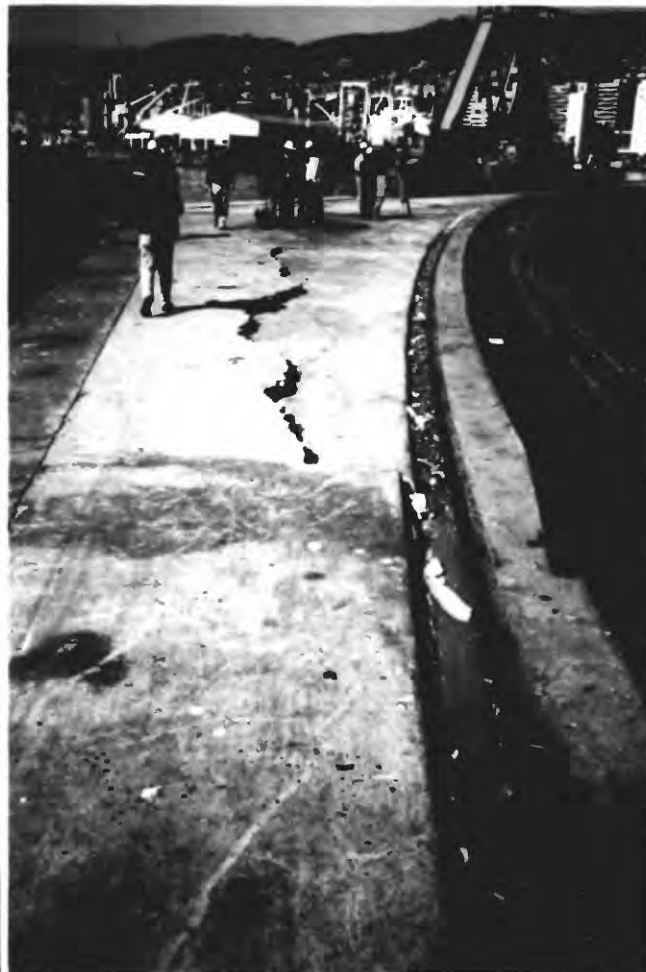
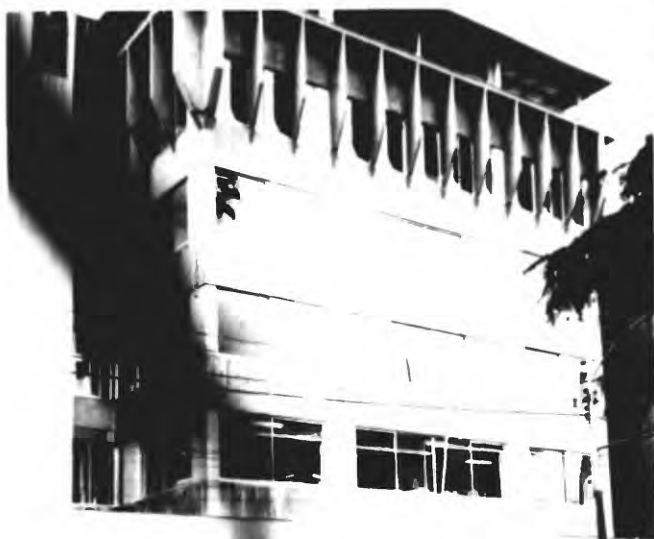
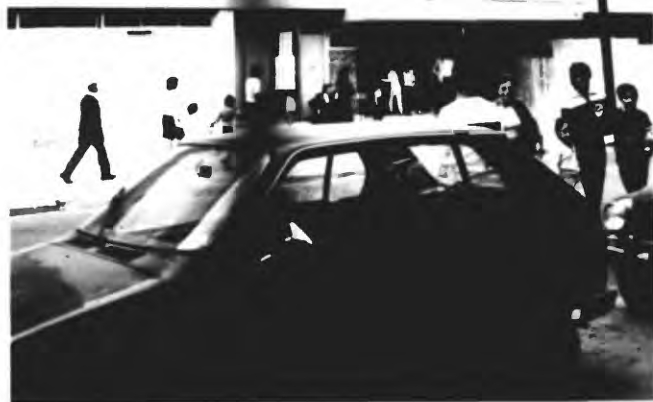
Figure 14.--Sermana Hospital in Valparaiso.  
Outside appearance does not reveal any  
distress; however, most of the divider  
panels inside the hospital were damaged  
or turned over. The concrete shear walls  
on the side were severely damaged, exhib-  
iting typical diagonal cracks.

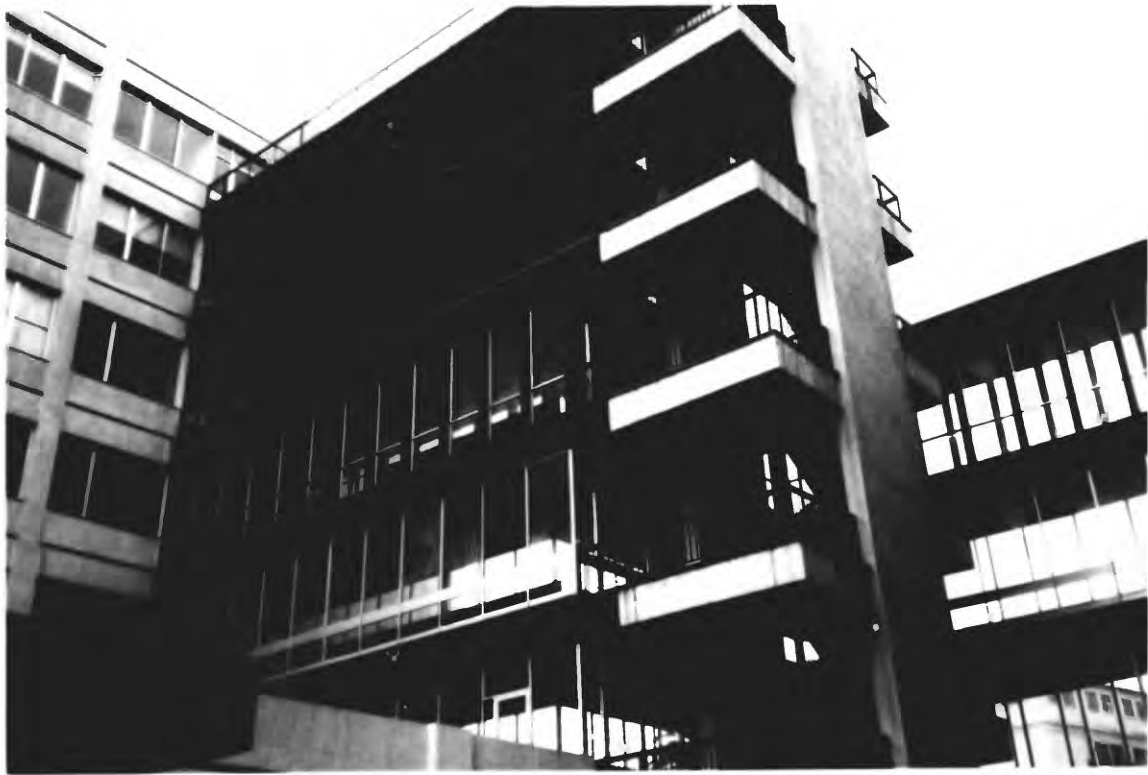
Figure 17a.--C. Van Buren Hospital in Valparaiso. There was no structural damage. However, the prefabricated infill panels separated from the frame elements in several locations. The operating room was damaged. The two blocks of this hospital is connected by a steel framed glass corridor.

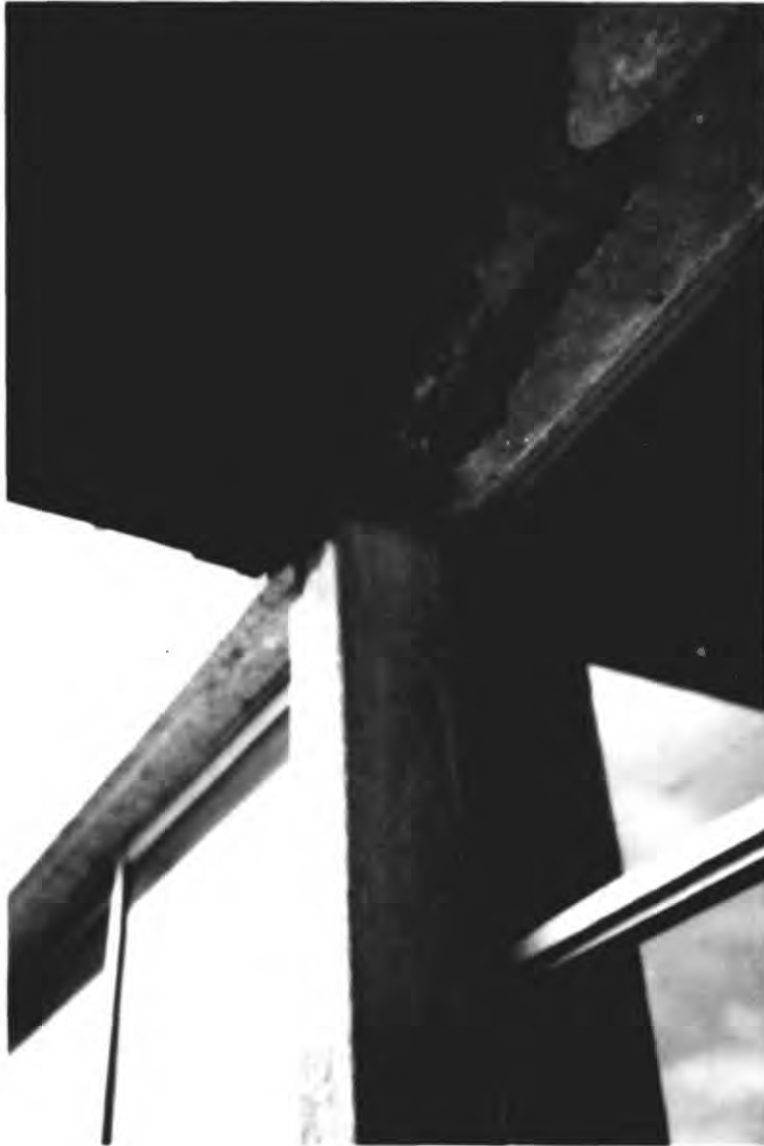
Figure 17b.--The bolts of the glass corridor structure attaching it to the concrete walls sheared off.

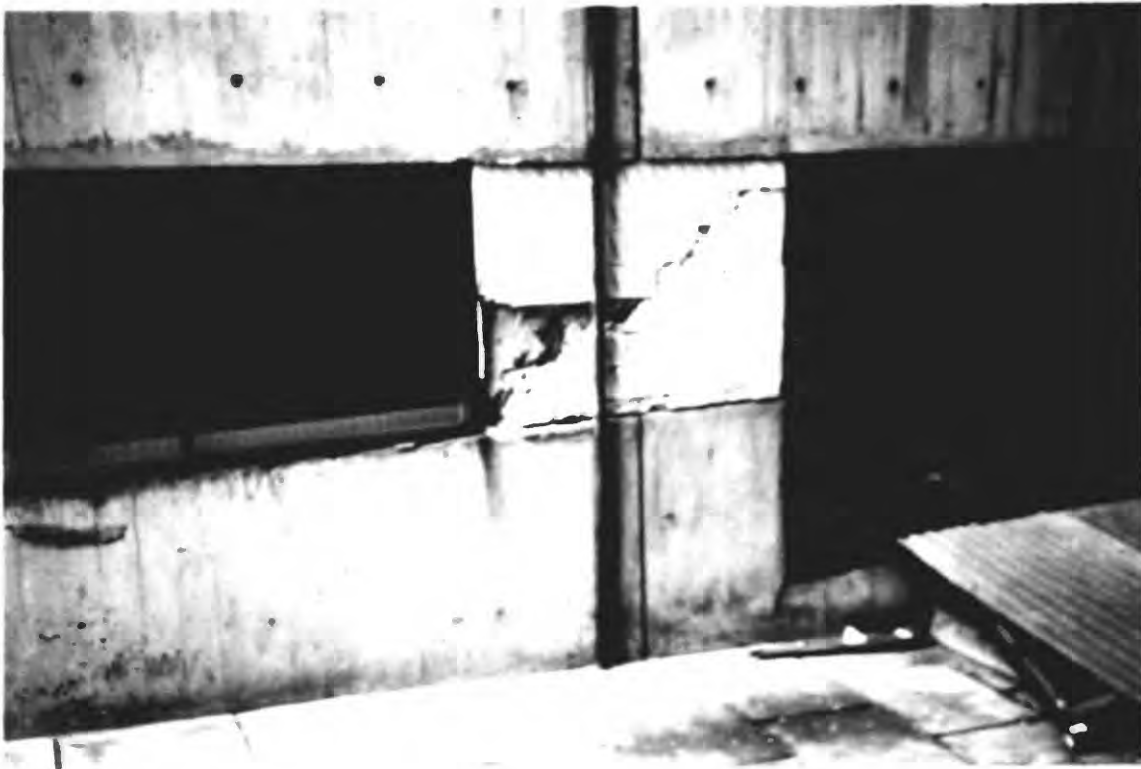
Figure 15.--Typical diagonal shear cracks developed in a short shear wall of the Sermana Hospital.

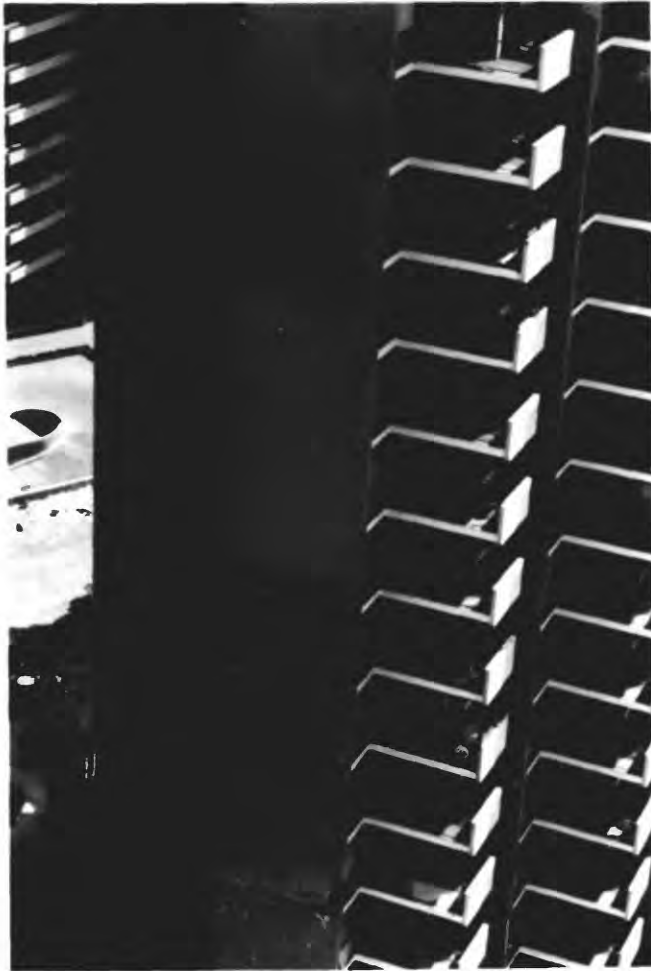
Figure 19.--Edificio Acapulco on San Martin Avenue - a modern structure on the beach of Viña del Mar. The shear walls were severely damaged and floor diaphragms cracked. This building was damaged also during the 1971 Chile earthquake.

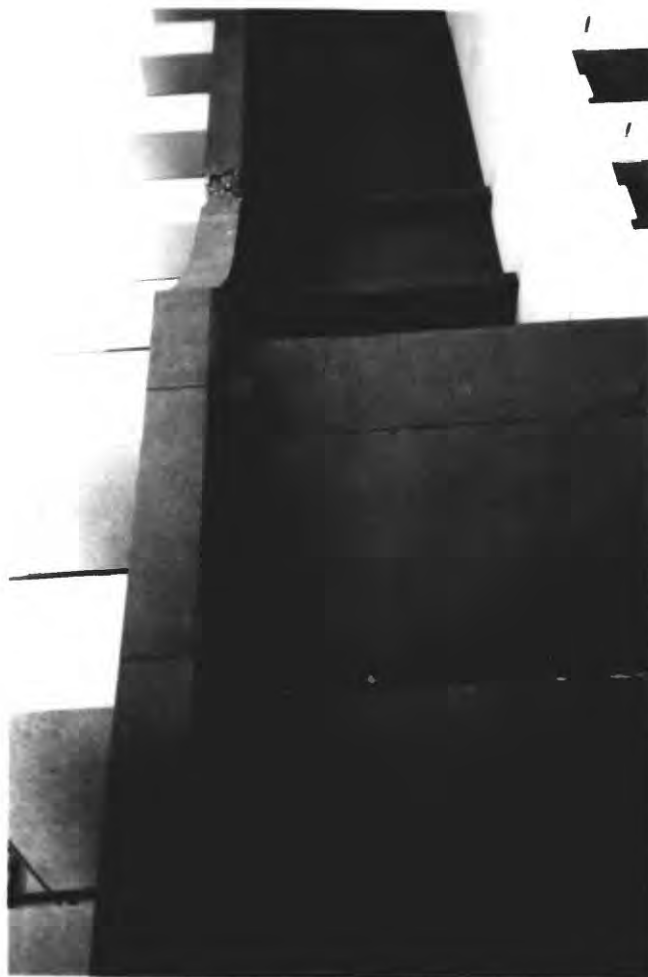
Figure 28.--Edificio Del Mar:  
minor structural damage in  
the exterior curved shear  
wall.

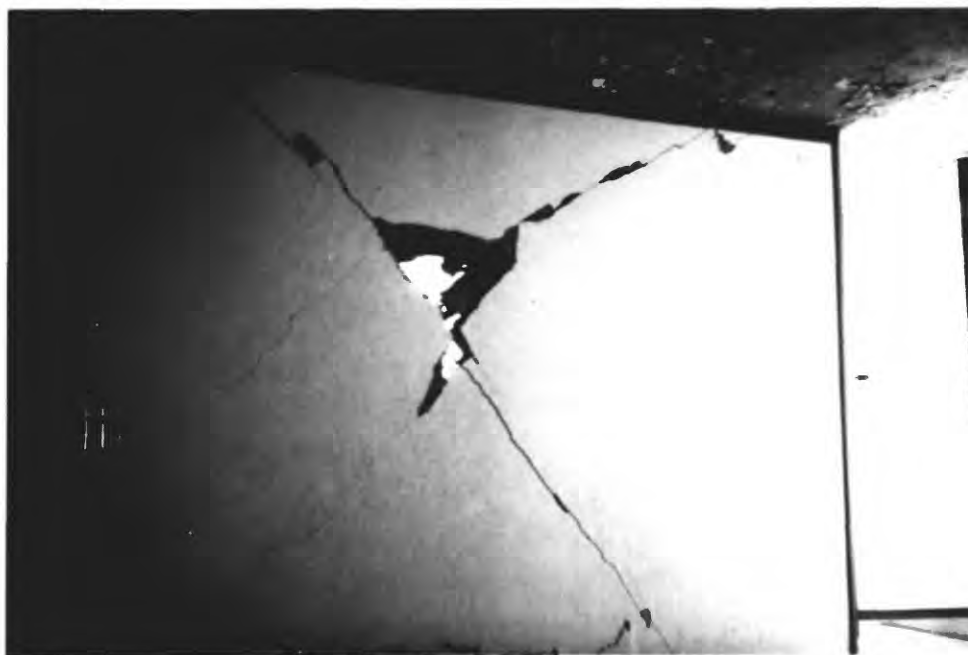
Figure 29.--Prefabricated brick panels of Edificio Del Mar cracked extensively,  
particularly in the top floors.

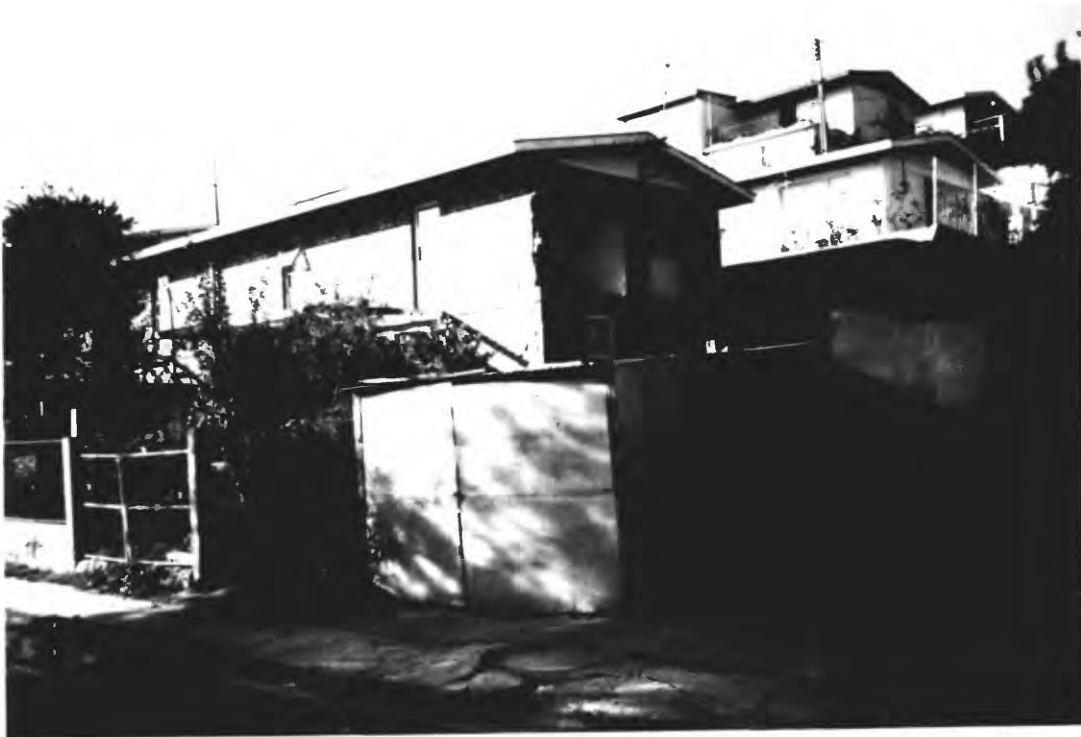
Figure 37.--One of the two Type A structures damaged. These structures are on a street next to a steep canyon.

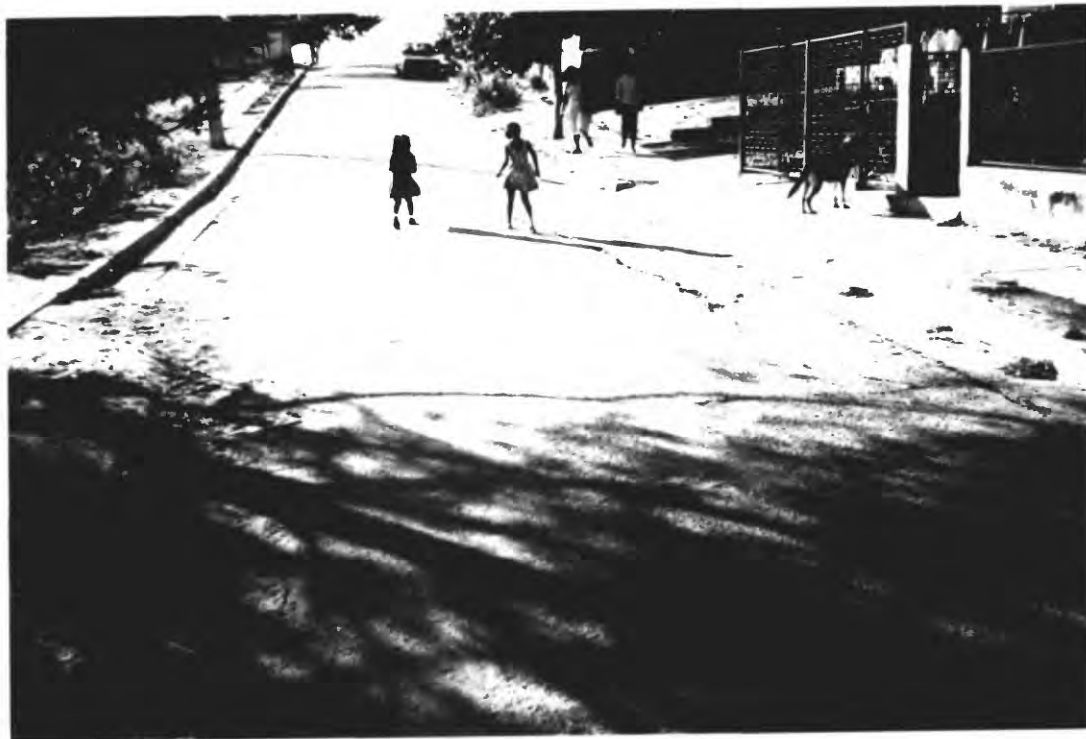
Figure 38.--The two damaged Type A structures are on this street which cracked extensively.

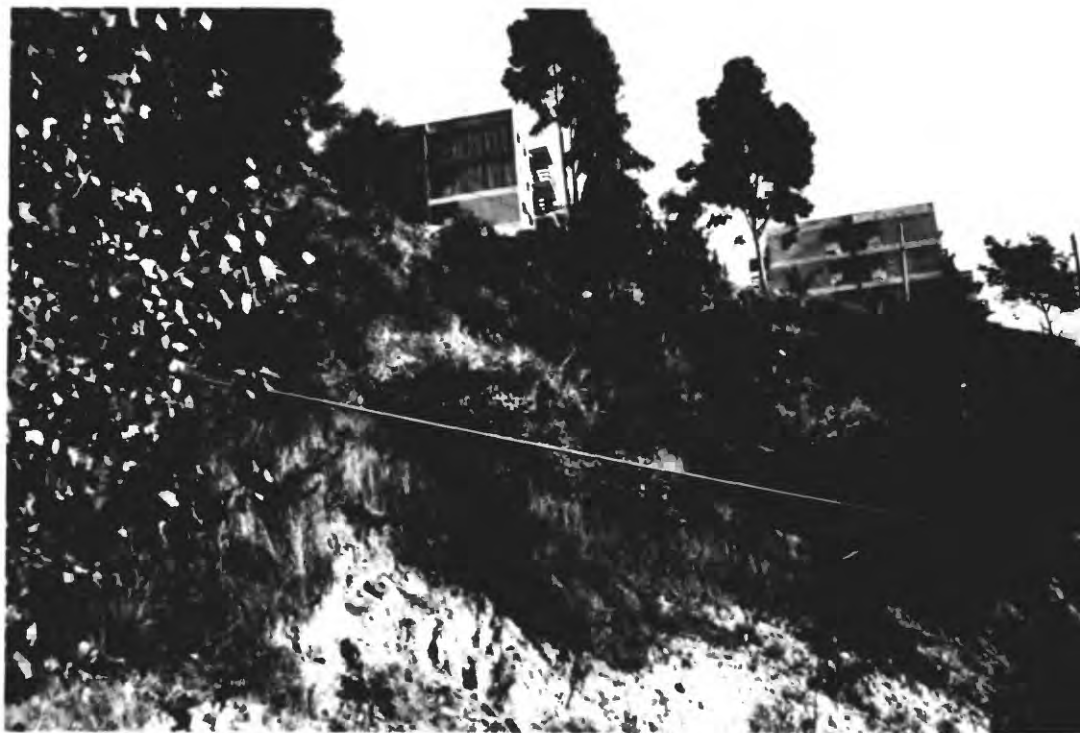
Figure 35.--These Type B structures (Isle Picton of Canal Beagle Subdivision) on top of one of the ridges next to entrance to the subdivision were severely damaged.

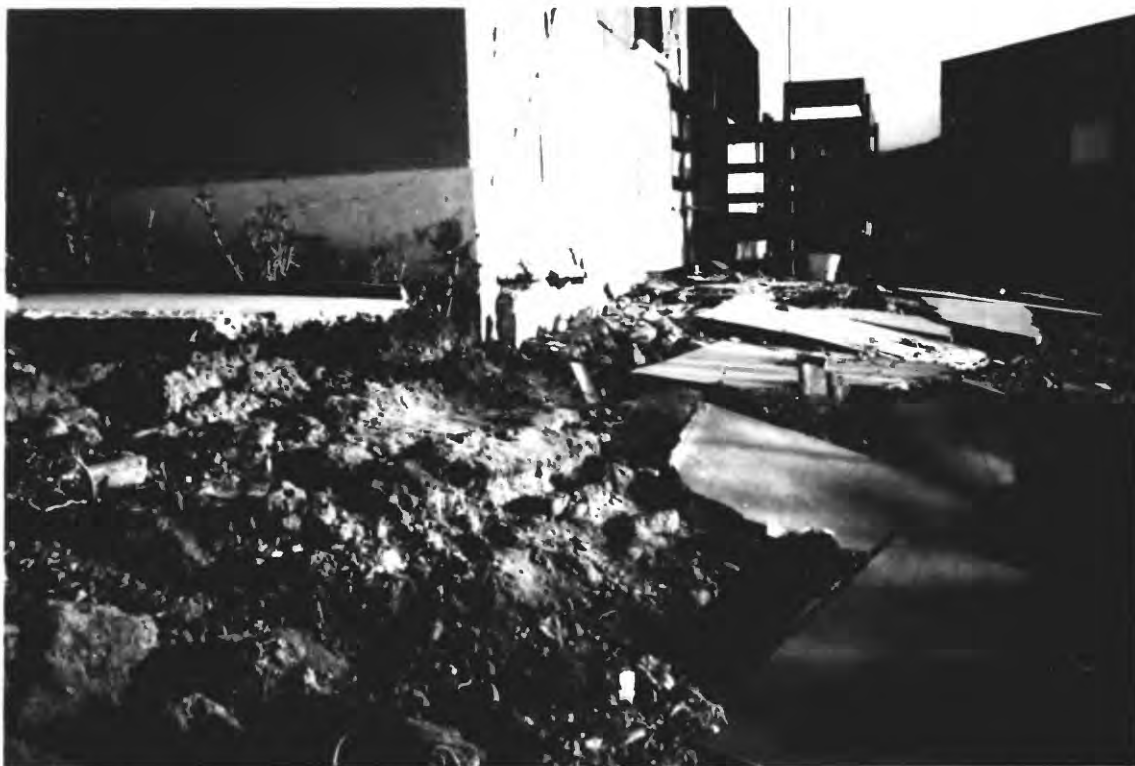
Figure 41.--Incipient slope failure caused the damages around and to the building of this Type B structure which was at the top of a steep slope of one of the ridges.

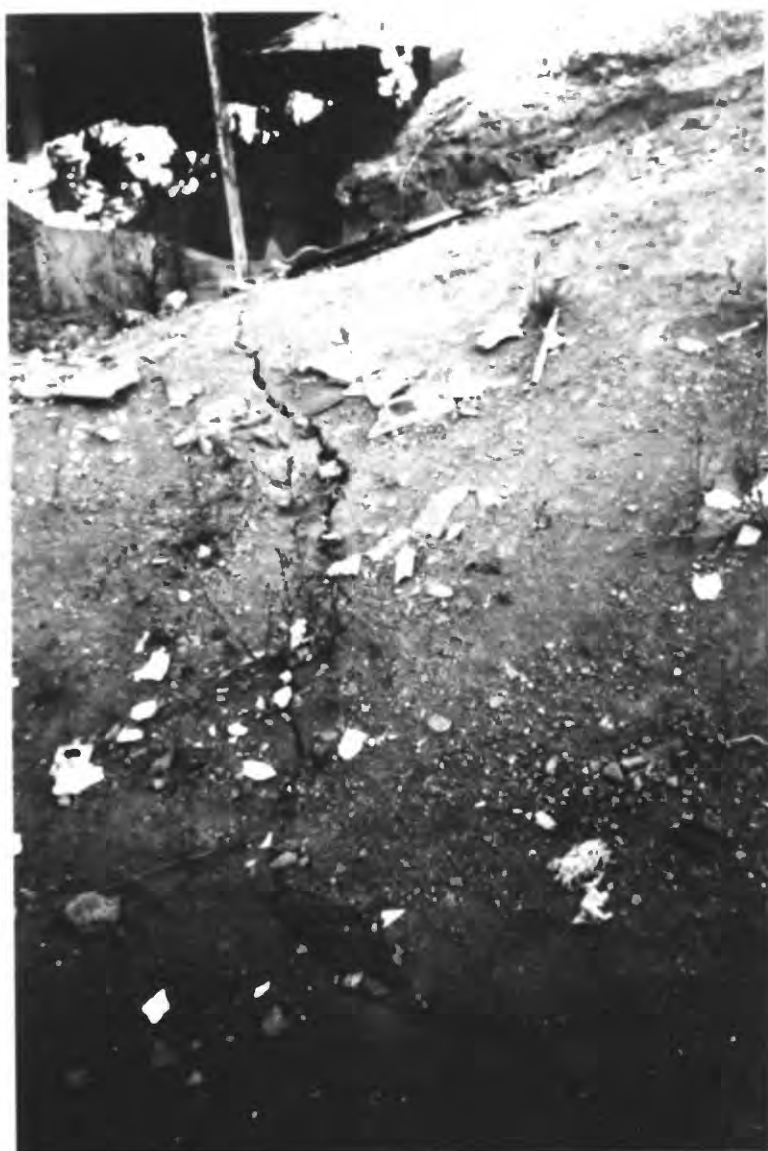
Figure 42.--Ground cracking started under the foundation of one of the Type C buildings. This crack could be followed down the slope through a retaining wall and around the perimeter of another Type C structure.

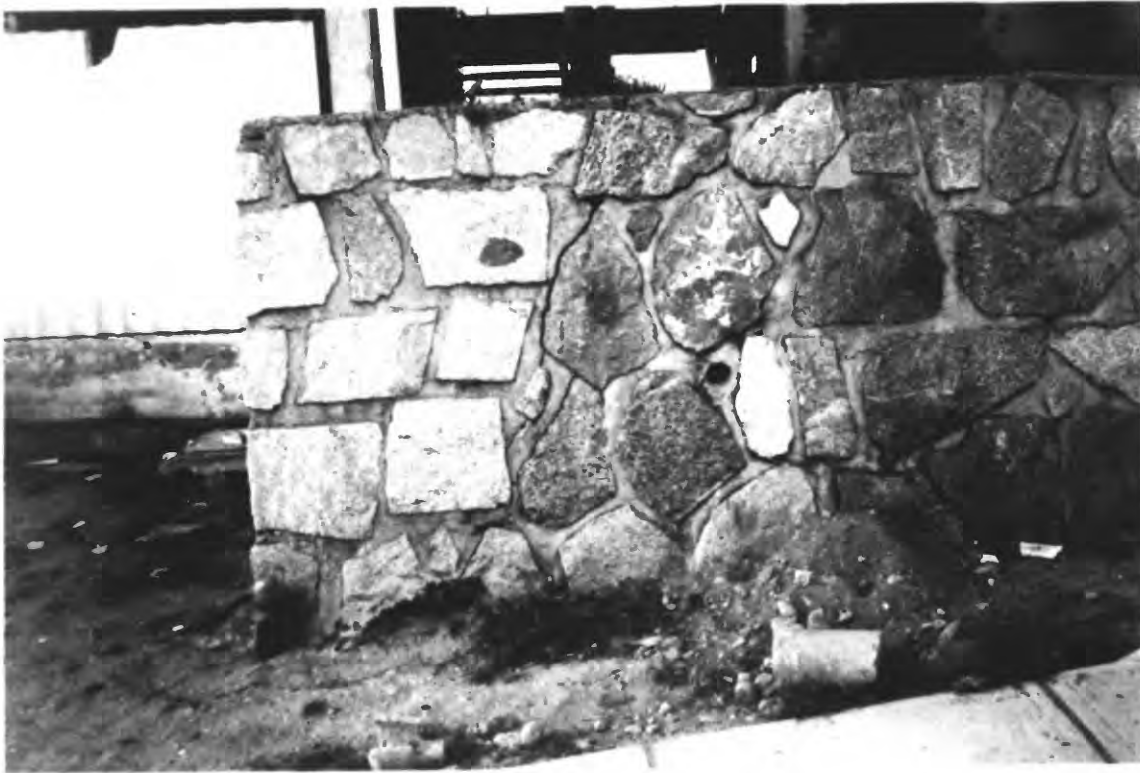
Figure 43.--A short retaining wall (cracked) in the vicinity of a Type B building (Isle Picton).

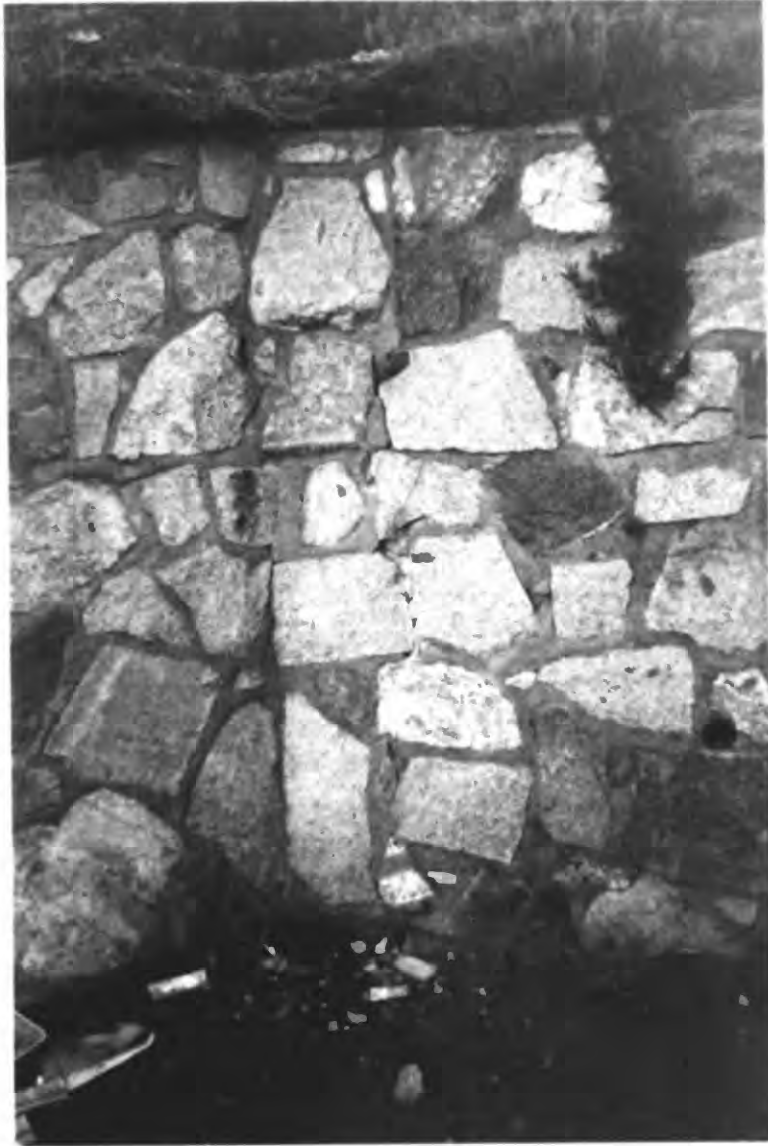
Figure 44.--A taller retaining wall cracked in the vicinity of two Type C buildings. These cracks extend from underneath the building above the retaining wall and follow down to the surrounding of the building below the retaining wall.

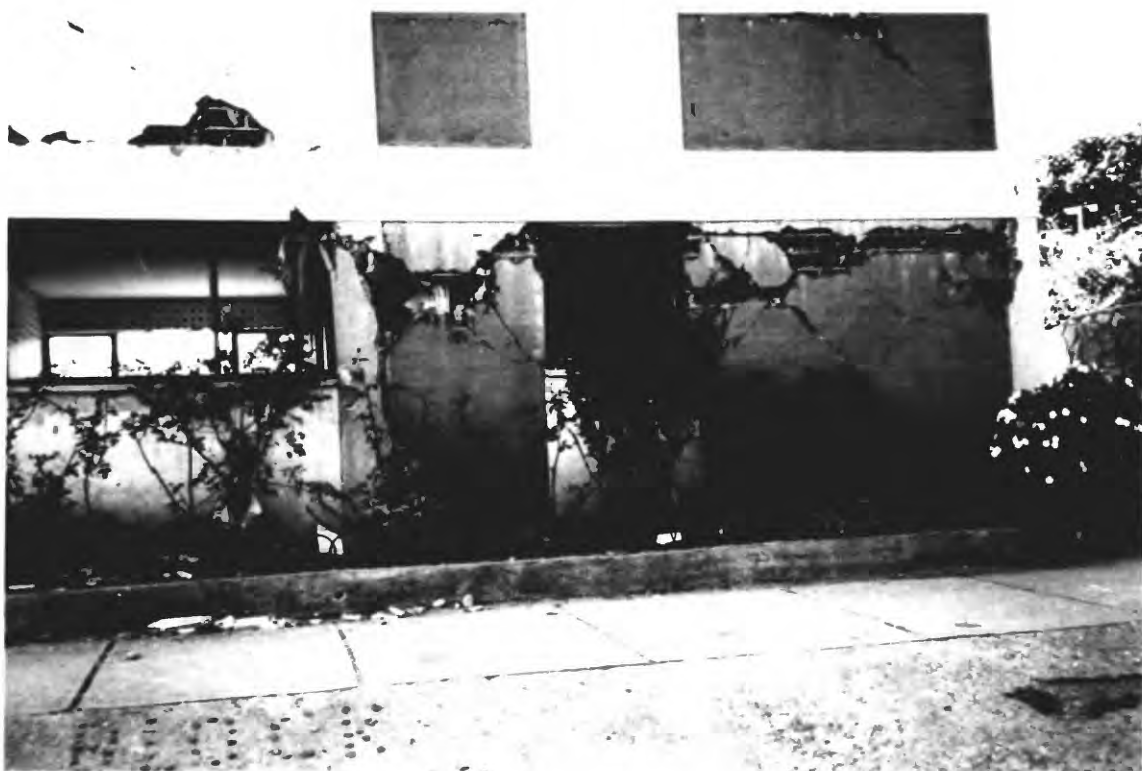
Figure 45.--Severely damaged Type B building. Note the damage to "short" column and brick infill wall.

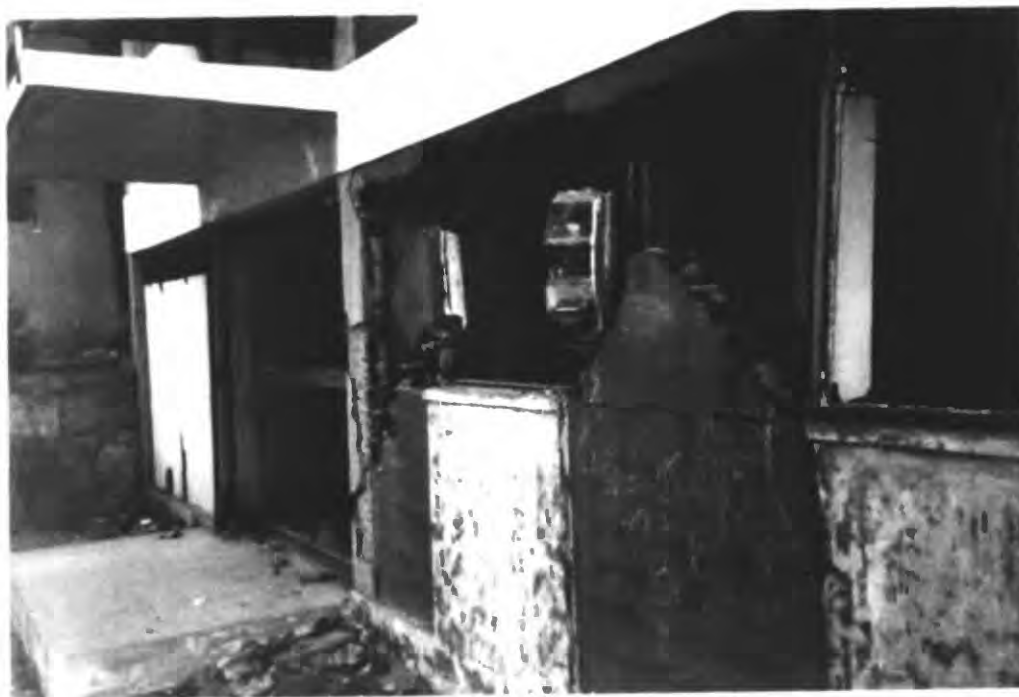
Figure 48.--Typical damages (diagonal shear cracks) in the brick infill walls.

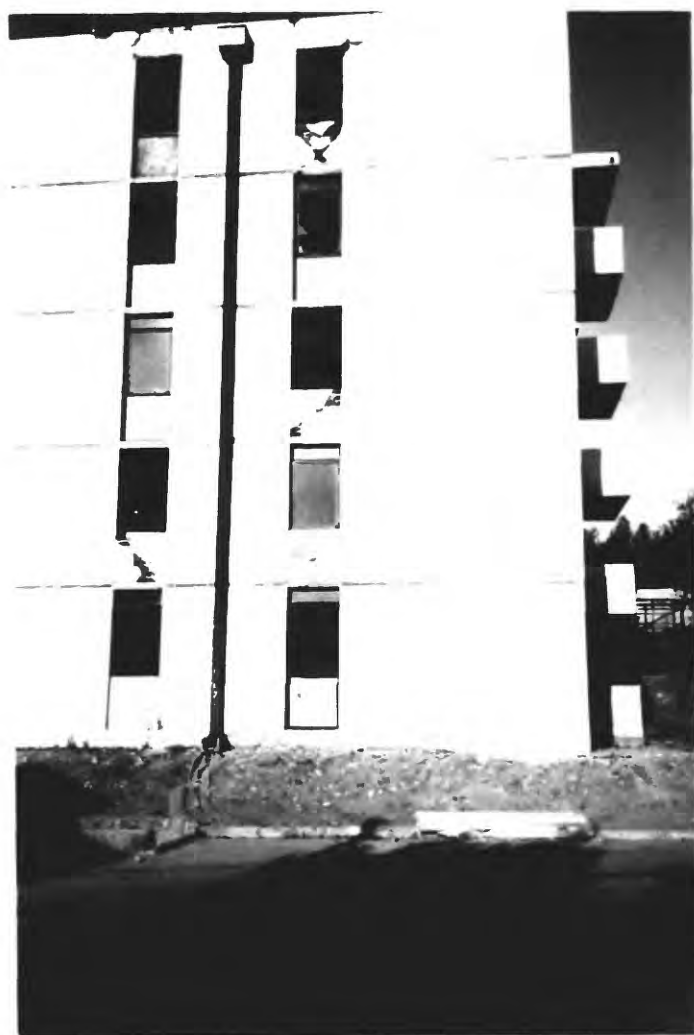
Figure 49.--Typical diagonal shear cracks in the infill walls that behaved as coupling beams (Type C buildings). These infill walls in window openings are not by design, but were installed by the owners of the apartment units.

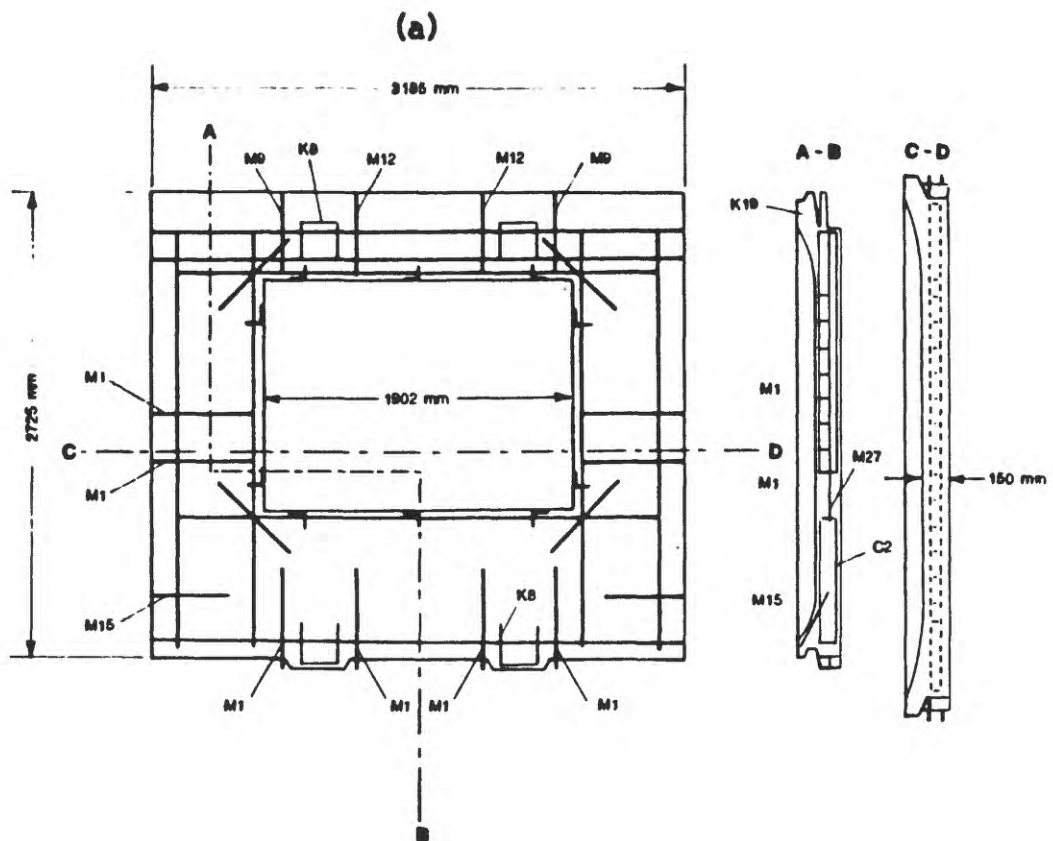
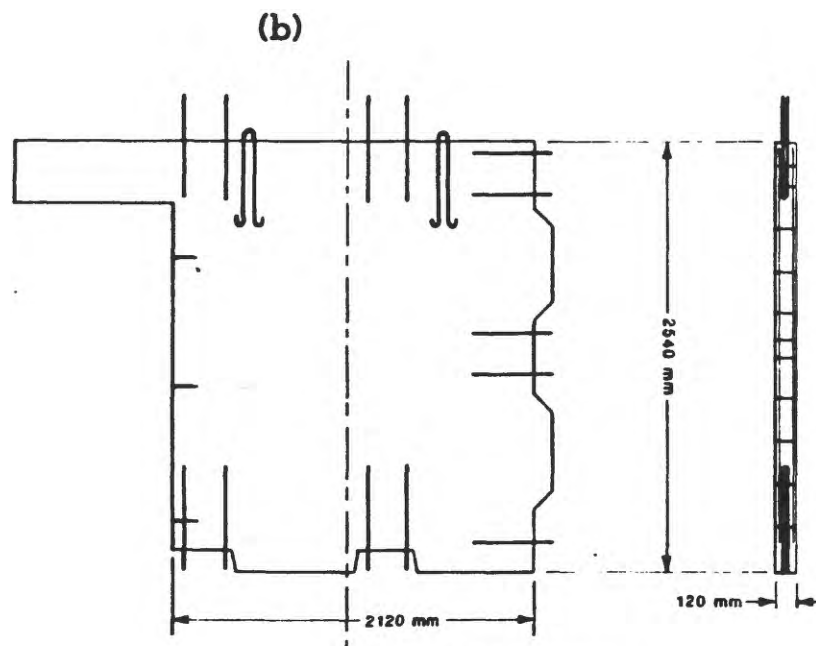
This panel had diagonal cracks  
in the 1st and 2nd levels
