Report of the Thistle Slide Committee

to State of Utah

Division of Water Rights

Open-File Report 86-505

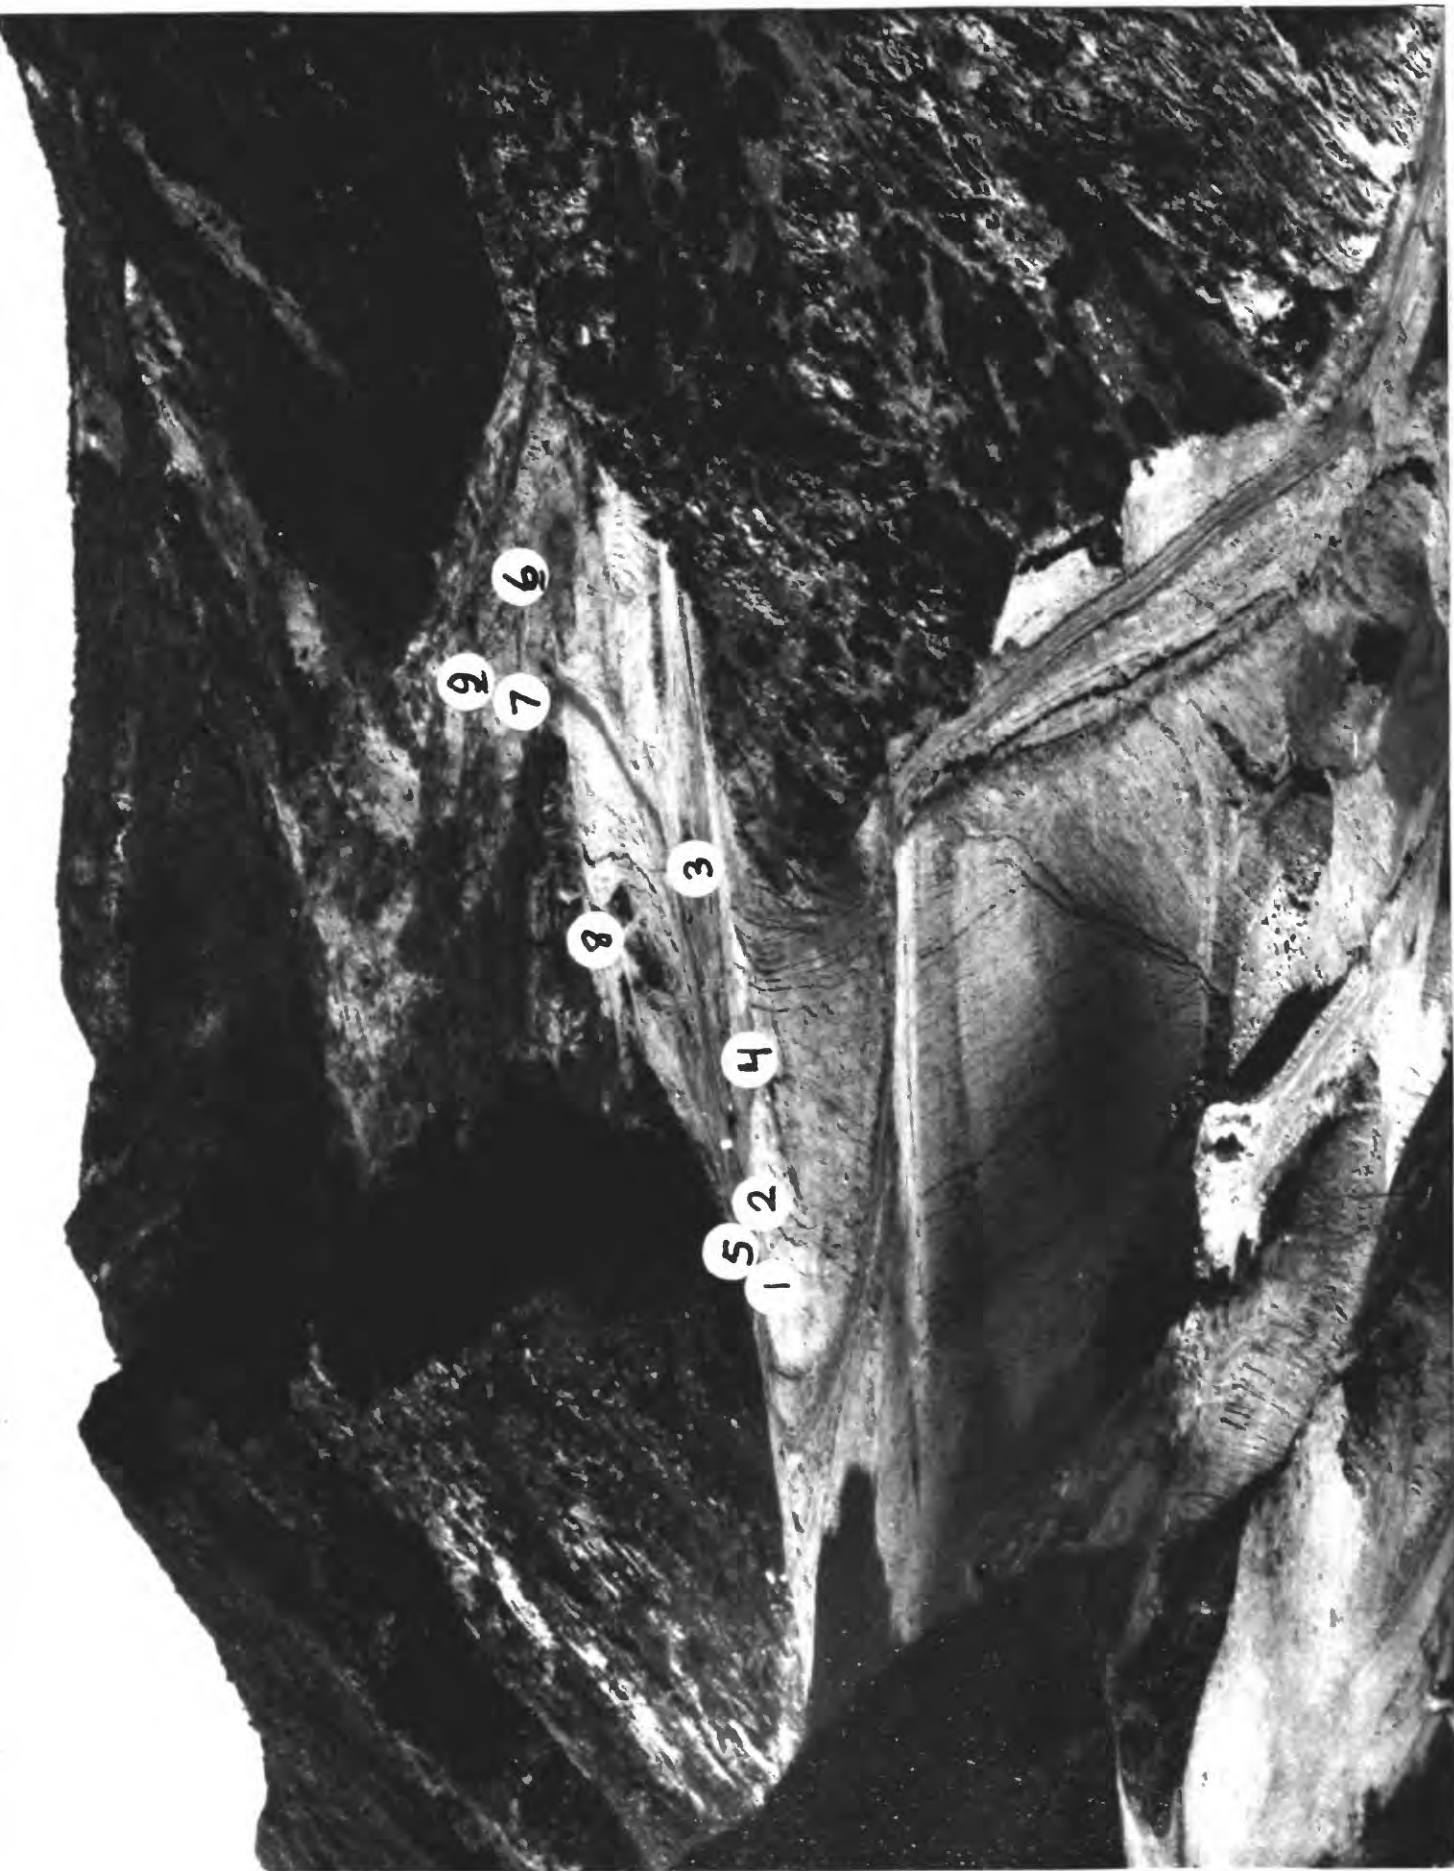
Figure 1 -- Oblique photograph of the 1983-Thistle landslide.
(Numbers are locations of recent boreholes)

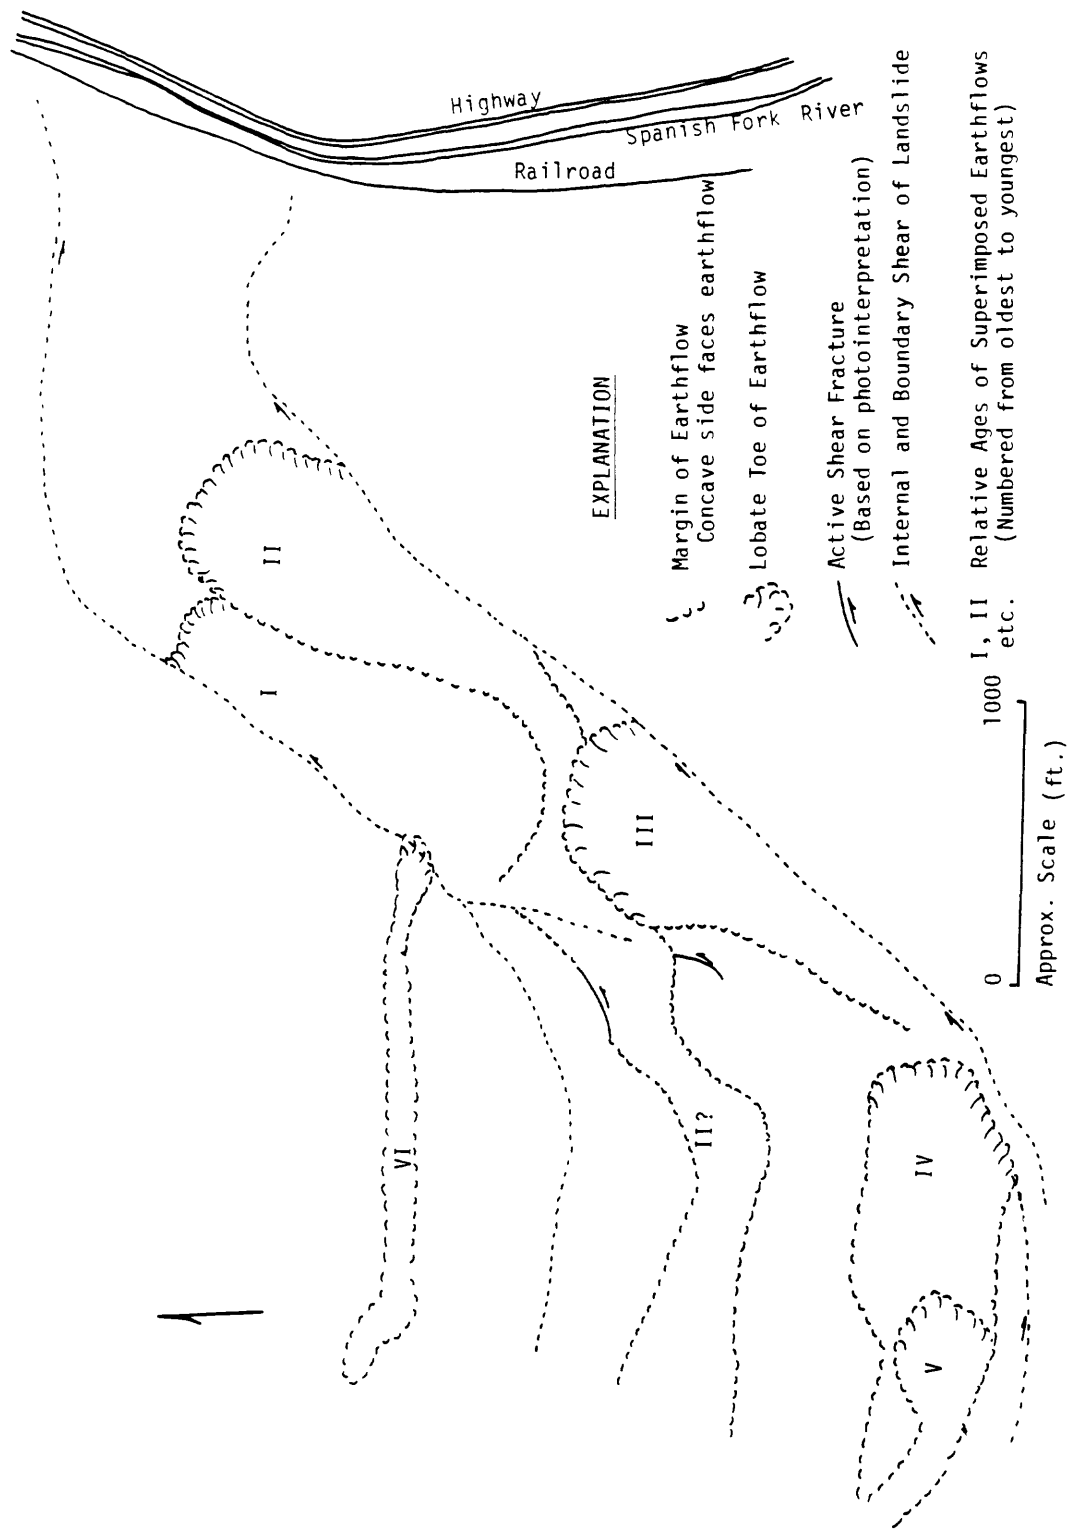
Figure 2 -- Map of the Pre-1983 outline of the Thistle landslide

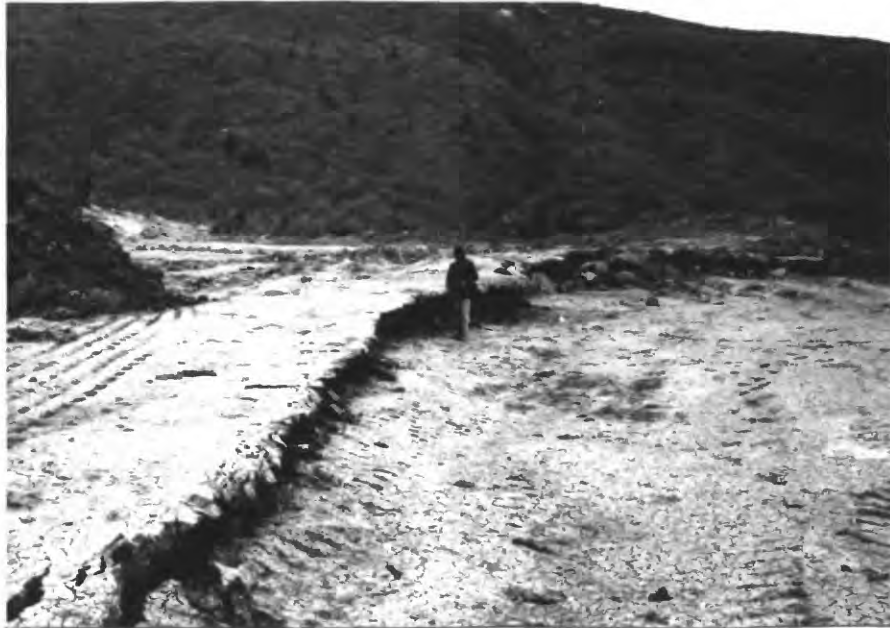
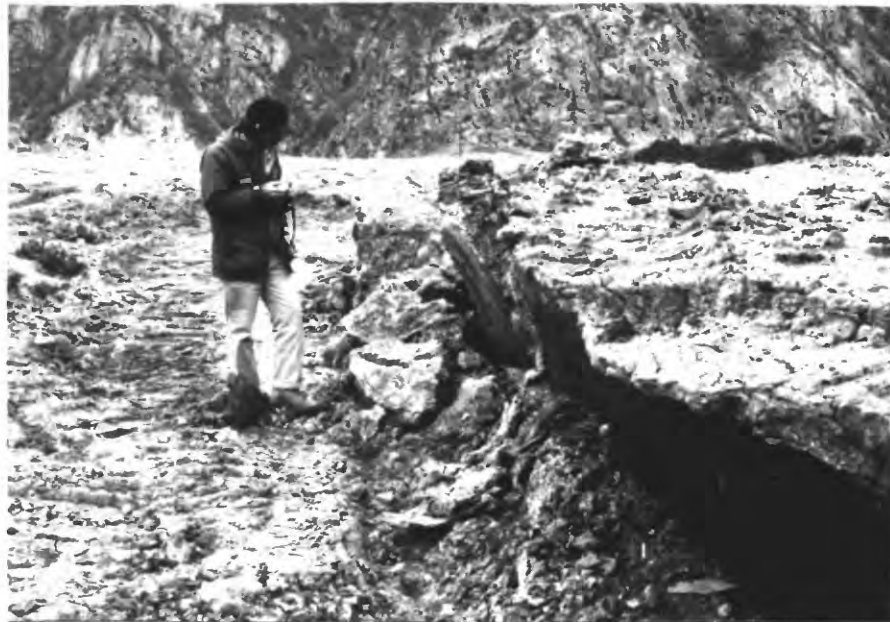
The areas containing thrust faults apparently migrated upslope as the elevation of the blockage increased. Thrusting apparently began in the canyon floor at the onset of rapid movement. Later, the thrust planes were visible well above the canyon floor on the downstream side of the blockage. By April 26, thrust planes were noted on the crest of the blockage by Committee member Patton. The thrusting propagated upslope as the buttressing effect of the blockage became more pronounced. Perhaps the last major thrust, photographed in late May, 1983 (fig. 3), was in the area of the bend.

Figure 3 -- Photographs of thrust plane intersecting surface of Thistle landslide. Large thrust formed in landslide debris in the area of the bend. (A) View looking toward the northwest flank. (B) View toward southeast showing detail on the thrust surface (Photograph taken in late May, 1983 by I. J. Witkind, USGS).

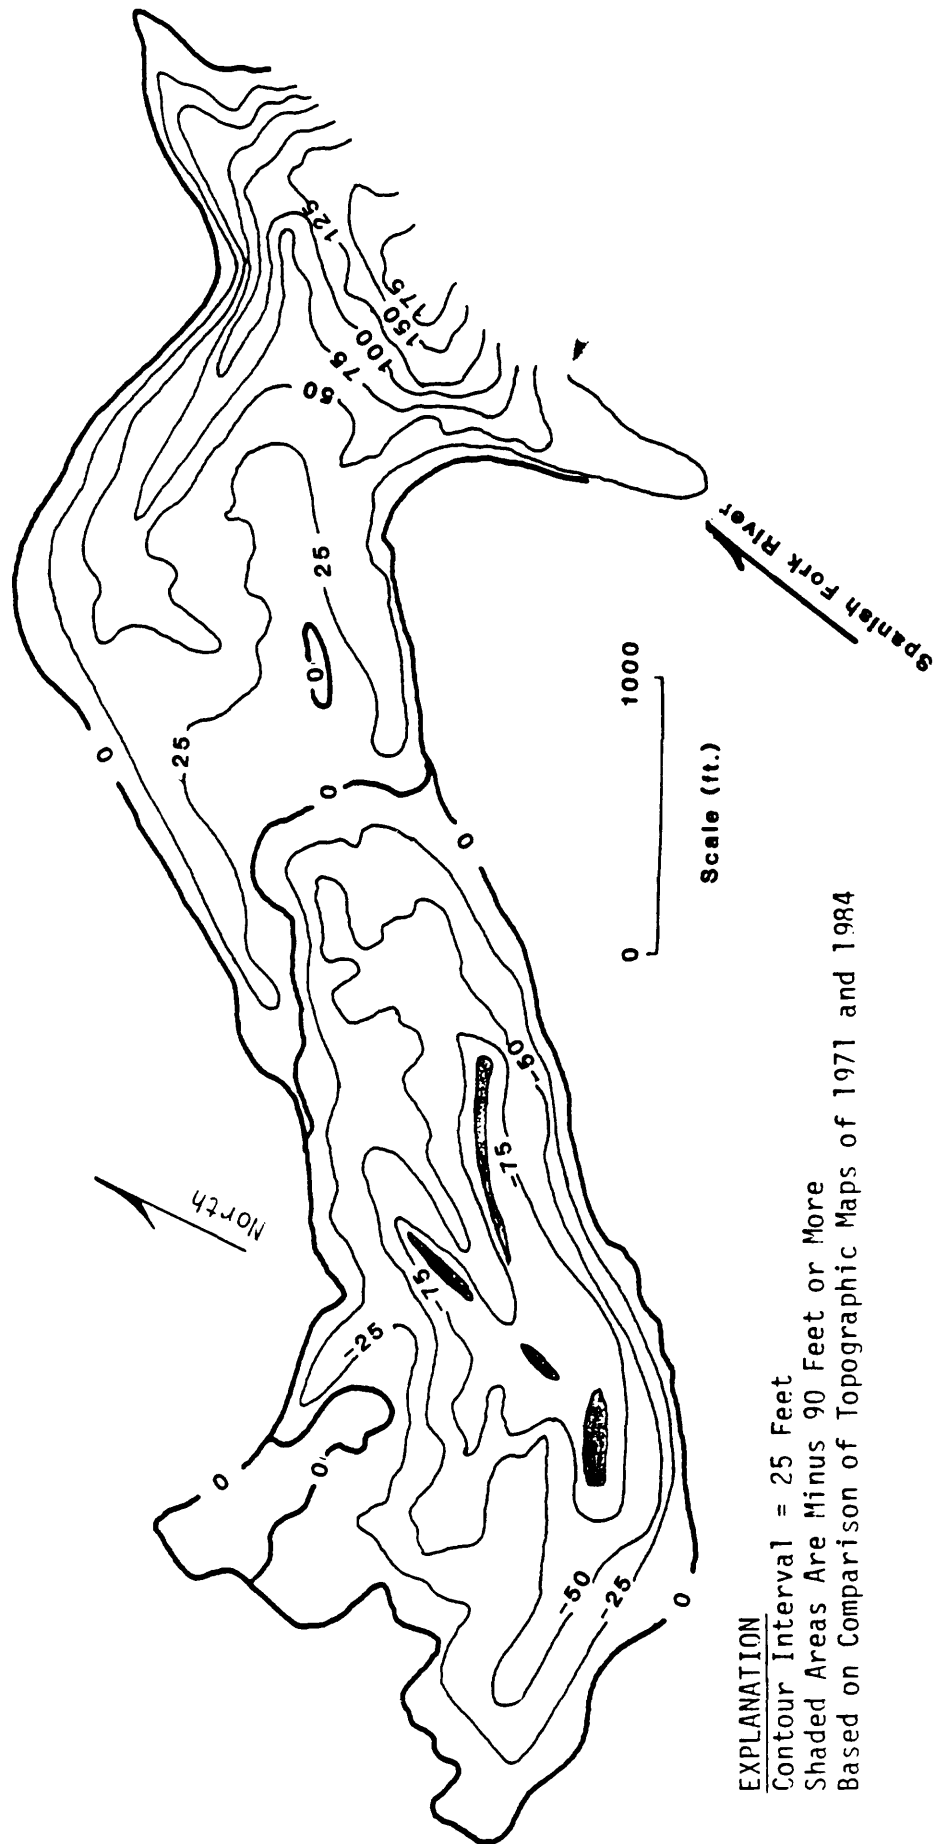
Another factor in the marked reduction in rate of displacement by early May was the loss of driving force at the upper part of the landslide. Displacements in excess of 500 ft resulted in a major redistribution of the landslide debris. For this study a map was prepared of the elevation changes of the ground surface that resulted from landslide movement. This map was made by subtracting the contours from the post-slide topography from the pre-slide topography. Figure 4 is the resulting contour map of the elevation changes. It shows an increase in the thickness of the landslide debris in the floor of the canyon in excess of 175 ft. There is an elevation increase for more than 2,000 ft up the slope from Spanish Fork River to a neutral line (zero contour). For about 4,000 ft above the neutral line, the landslide was depleted by the slide movements. More than 90 ft of material is missing in the areas shaded on figure 4.

Figure 4 -- Map of elevation changes caused by landslide movement

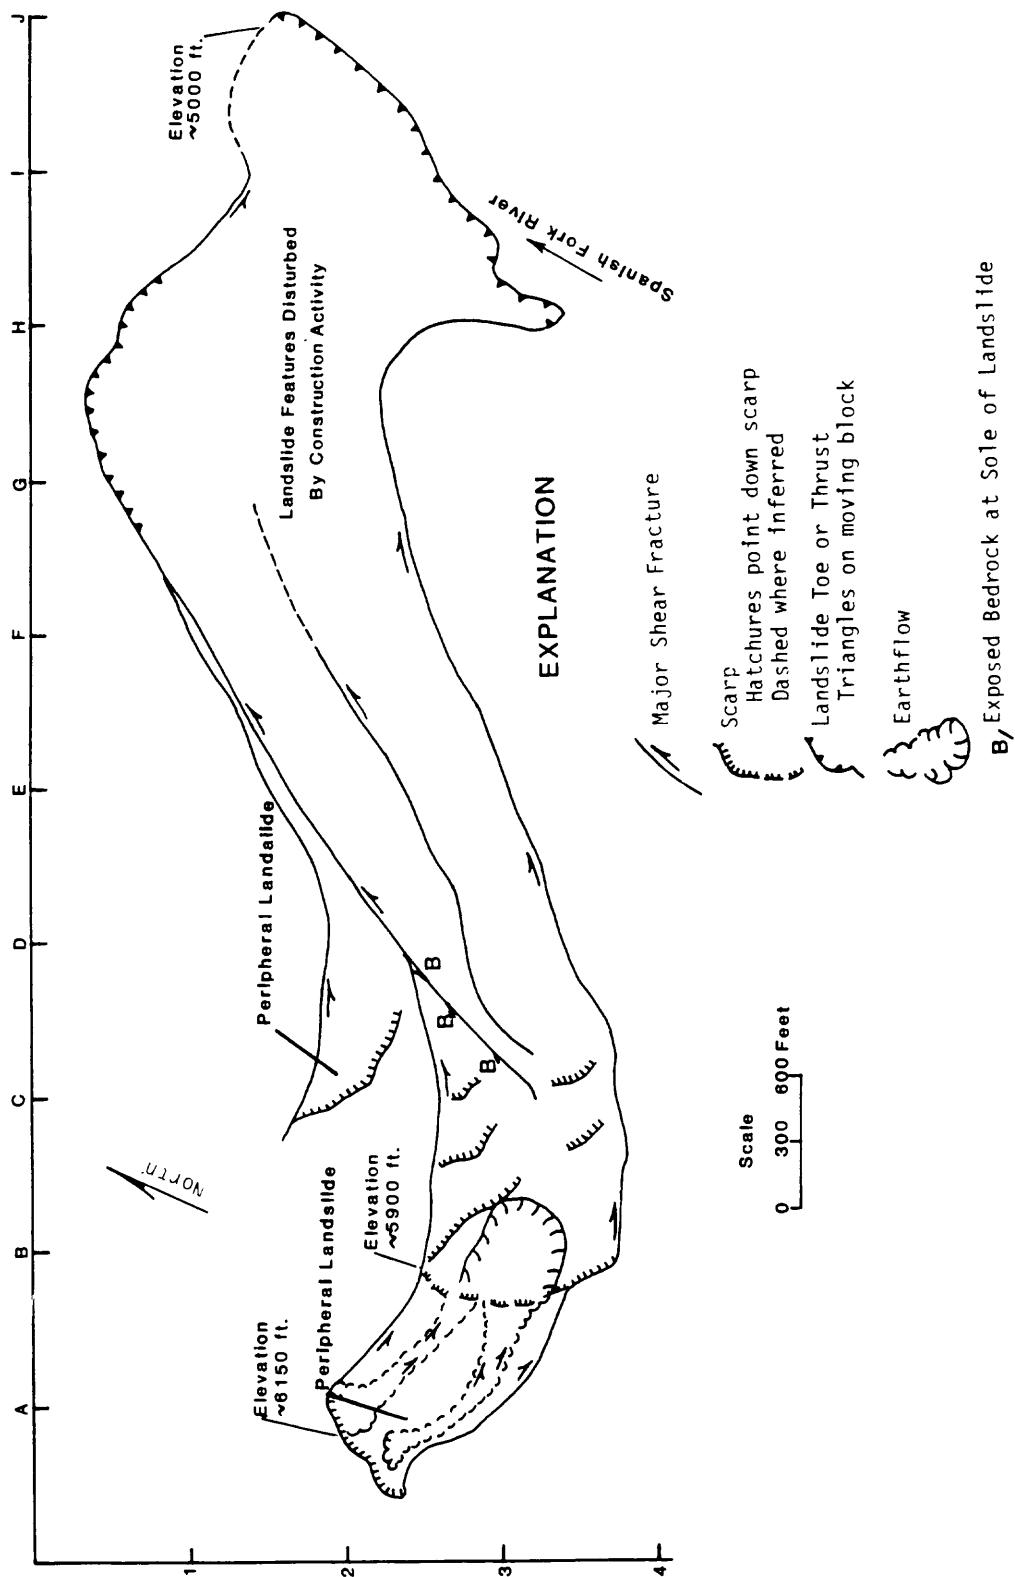
Figure 5 -- Simplified geologic map of the Thistle landslide

Along the northwest flank, near the head scarp at B-3 to C-3 (fig. 5), landslide debris was confined between the curving shear fracture in the center of the landslide, and the northwest flank of the landslide. There, the landslide moved as large slump blocks with both uphill- and downhill-facing scarps; some blocks were rotated slightly upslope. Displacements in this part of the landslide were apparently smaller than the rest of the main landslide.

confirm that the attitude of the underlying Ankareh Formation has controlled the movement of the landslide, and that the upper part of the landslide is depleted of material. The locations are shown as "B" on figure 5. At these locations, thin landslide debris rests on undisturbed Ankareh Formation, and the contact zone is slickensided and striated, and associated with soft, plastic clay layers. Locally, the failure zone appears as a clayey gouge about 1/4 to 2 in. thick. The slickensided surface plunged about 15° toward Spanish Fork Canyon.

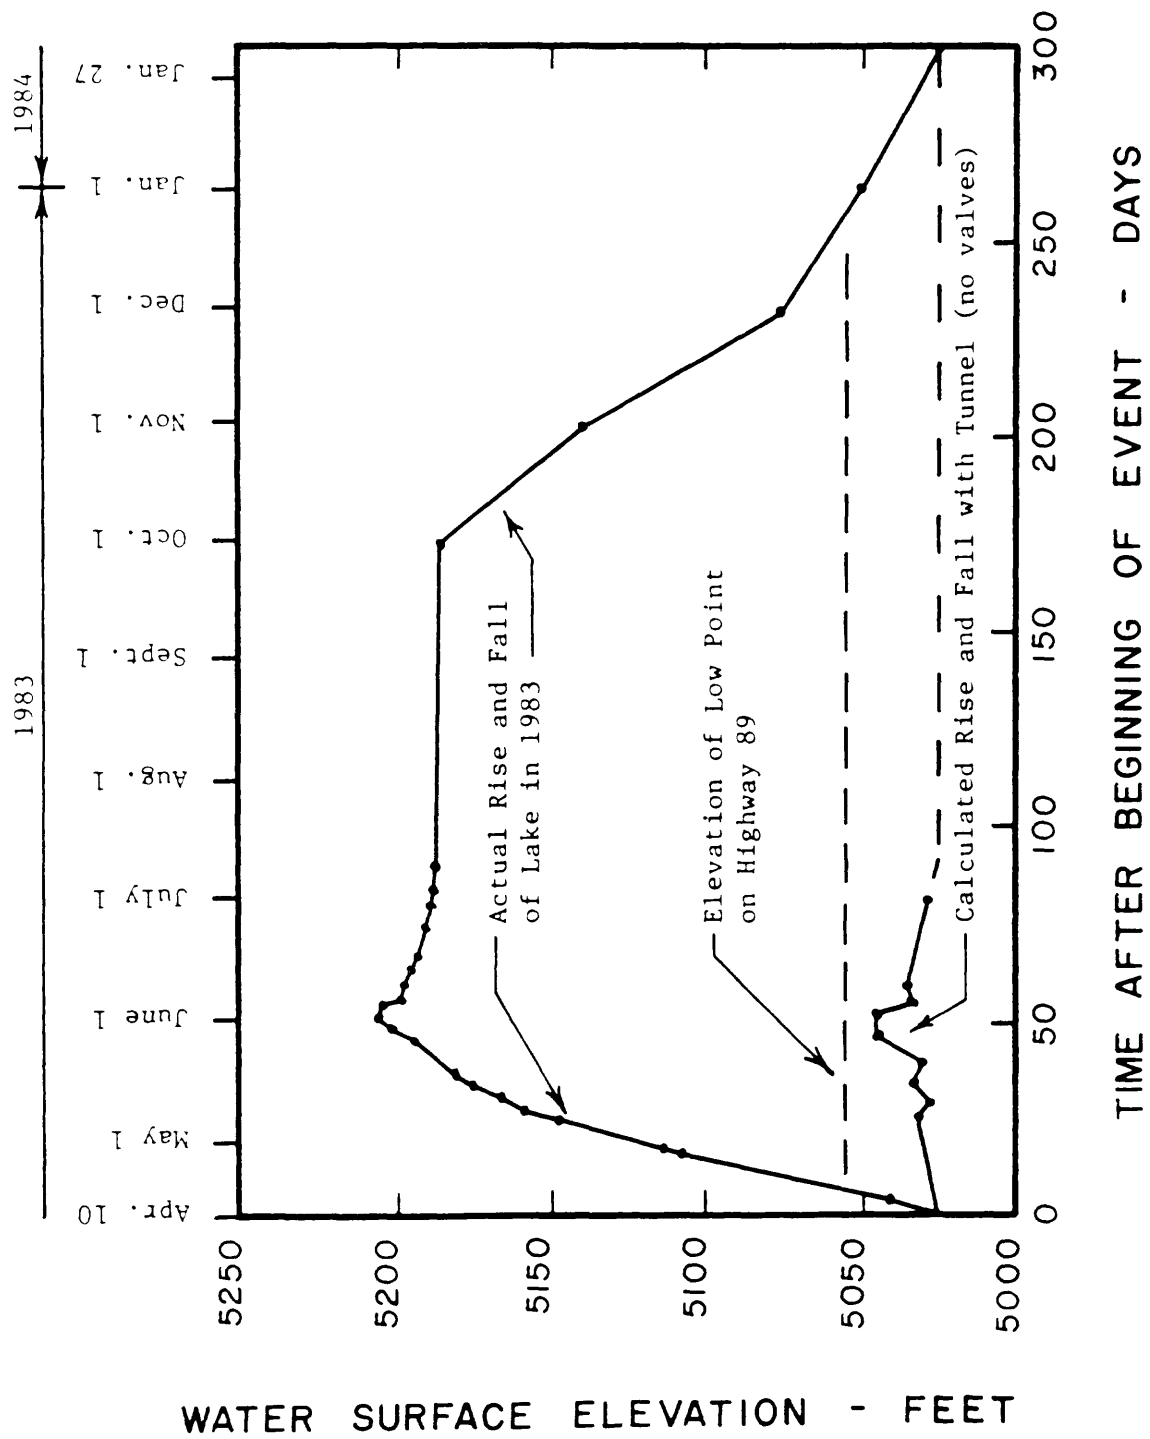
A calculated rise and fall of the lake is also shown in figure 6 for the condition that would exist if the 1983 inflow to the lake was experienced under the present conditions; that is, with the low-level tunnel open and no regulating valves in place. In this case, the lake level would rise to elevation 5,045, 10 ft below the low point on Highway 89, and would return to normal after 90 days.

Figure 6 -- Rise and fall of Thistle lake

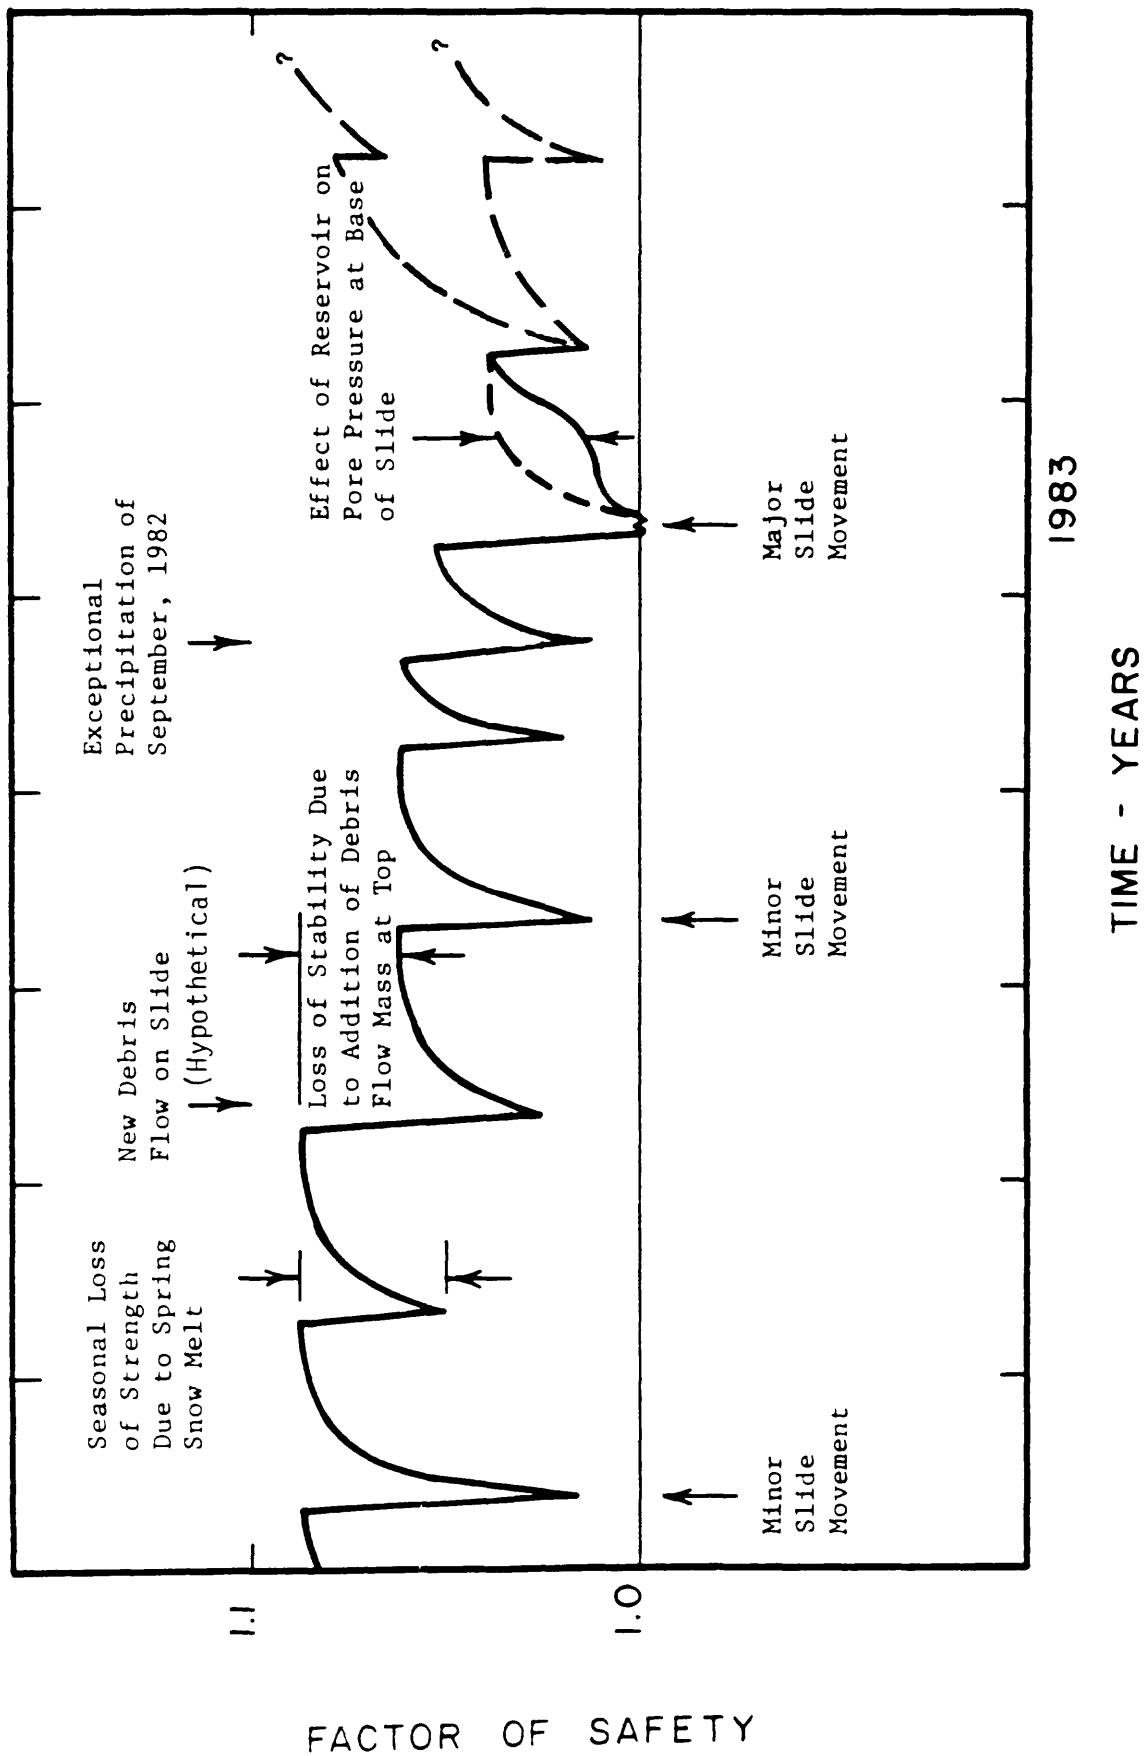
In summary, the Thistle landslide has existed in a meta-stable condition for many years as an old slide comprised of clay-rich debris. A significant long-term detrimental effect was the periodic addition of earthflows and shallow landslides to the upper portions of the main slide mass. Probably less significant were events at the toe of the slide. These include erosion, dredging, and railroad construction and maintenance. The triggering action was most likely the direct and indirect effects of the spring snowmelt of 1983 superimposed on the remnant effects of the exceptionally heavy rainfall of late September, 1982. The result was that the overall factor of safety of the slide reached a low value (on the order of 1.0), which had not been achieved for hundreds or more years. The rising lake level behind the slide probably contributed to the duration of the period of pronounced slide instability in April and May, 1983.

Figure 7 -- Schematic representation of variation of factor of safety with time

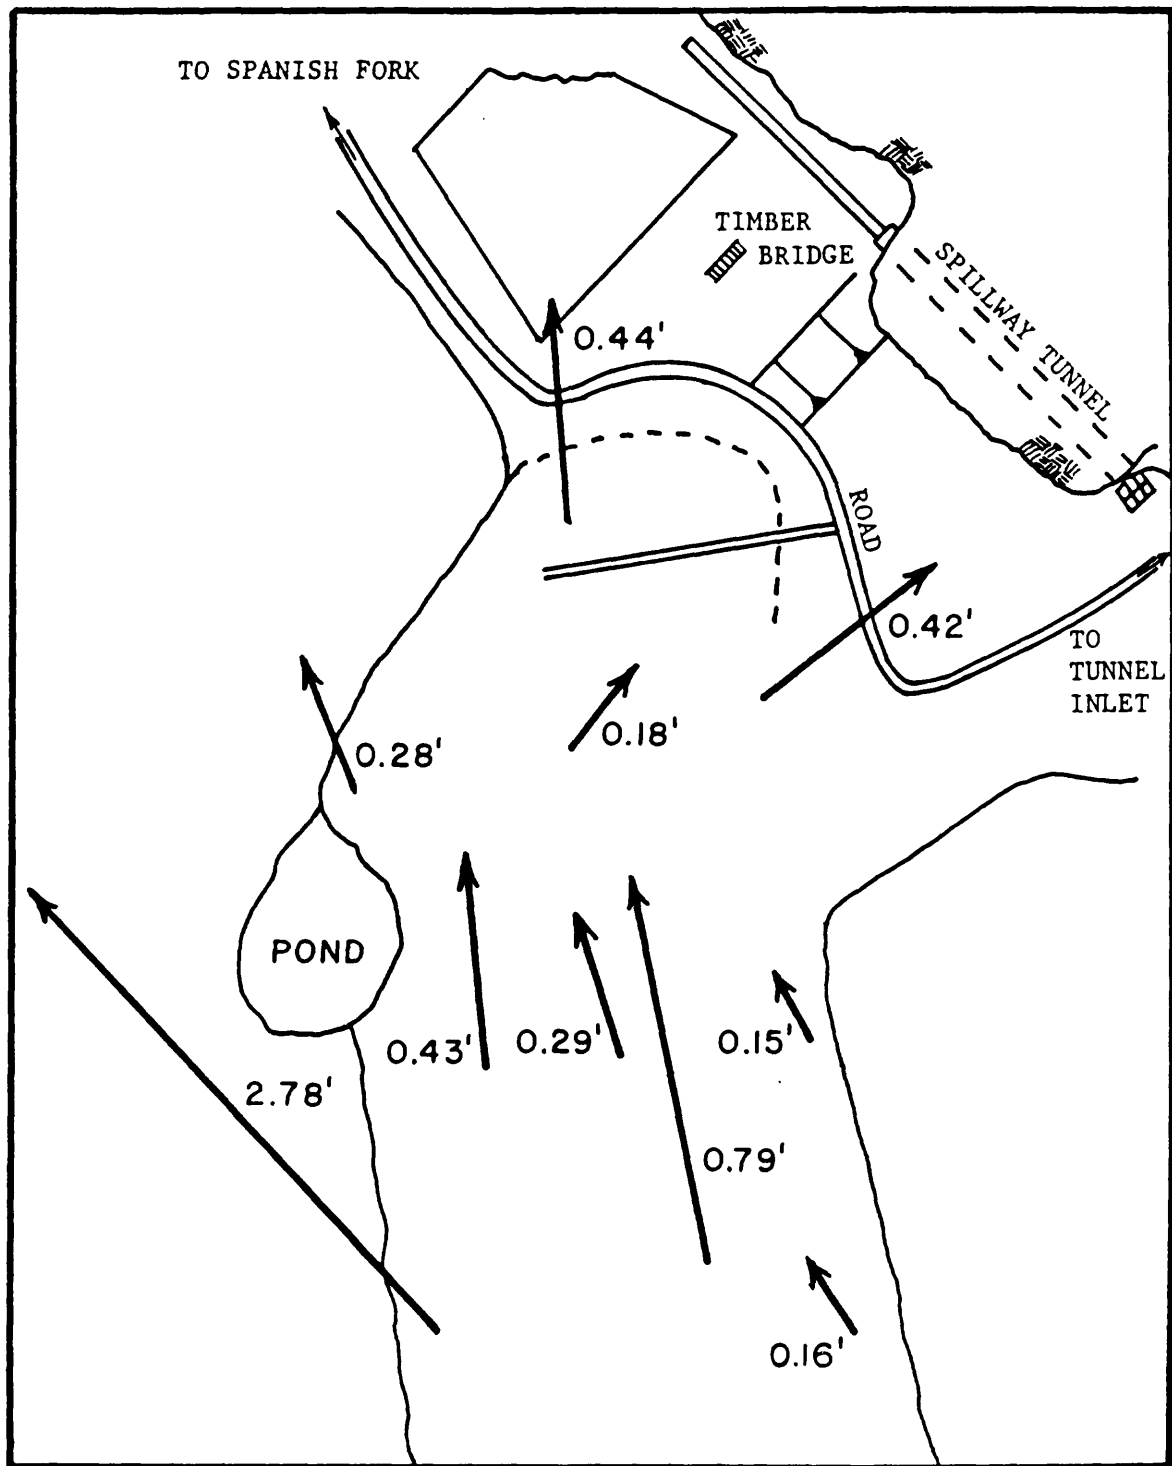
Figure 8 -- Map of measured surface movements from March 19, 1984 to August 14, 1985
