UNITED STATES DEPARTMENT OF THE INTERIOR

GEOLOGICAL SURVEY

SOME SLOPE MOVEMENT PROBLEMS IN WINDSOR COUNTY,

VERMONT, 1984

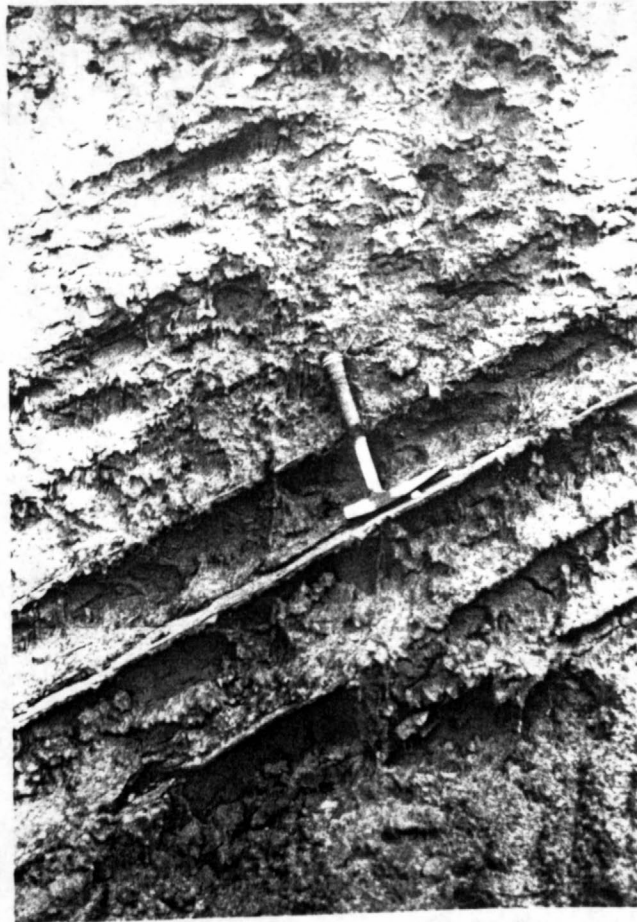
Some of the rhythmite deposits no longer show their original horizontal bedding (Fig. 3). These materials were deposited on or around stagnant ice blocks. As the ice melted, the depositional units collapsed, an example occurs at the North Springfield Reservoir. Most of these rhythmites dip toward the failure face.

Figure 3. Glacial Lake Hitchcock rhythmite deposit at the North Springfield flood control reservoir. The deposit is dipping to the west (left side of photo), and has several calcite-cemented sand layers (hammer rests on one of these).

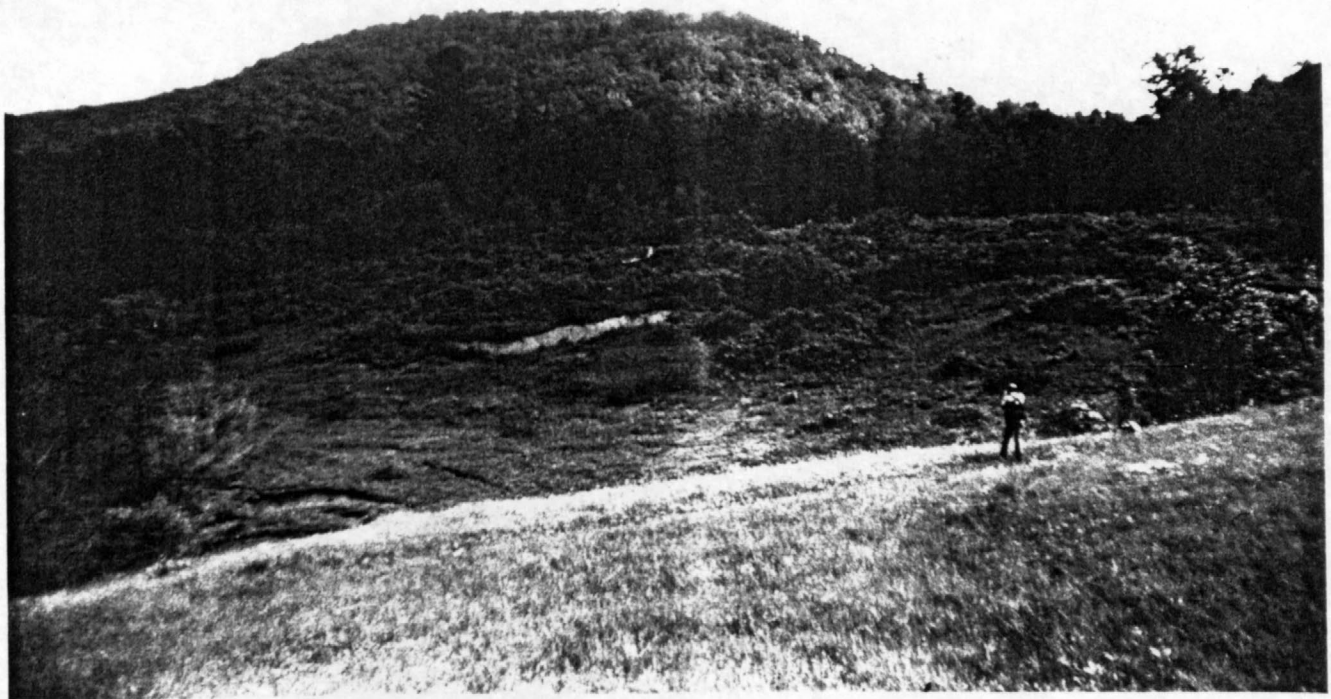
A slide located on the northeast valley wall of the reservoir (Fig. 6), near the North Hartland dam emergency spillway was an example of the slump-earth flows encountered. This slope movement occurred in the spring of 1984 along the face of a terrace that formed the northeast valley wall. An unnamed stream flows southwestward into the reservoir from the west flank of Miller Hill (loc. 20, Fig. 1 and Fig. 5A) along the base of the terrace. The toe of the failure temporarily blocked the stream, but by eroding the toe, the stream has reoccupied its original channel.

The east side of the failure mass, right side of Fig. 6 just out of view, had numerous en echelon transverse tension gashes with small vertical displacements. The west side of the mass was bounded by an irregular, curving scarp, and one or more lateral shear planes. Except for some tension cracks, the central portion of the slope movement had a relatively smooth upper surface.

The lateral tension cracks seen in the left foreground of Figure 6 resulted from an increase in friction on the basal shear surface of the failure as the fluidized substrate pinched out, placing the basal shear surface in direct contact with the sole of the slide mass. This caused drag on the sole of the slide mass pulling it apart (extension) as shown in Figure 8. Drag on the basal shear surface in the headscarp area generated tension crack openings (tensile stress) normal to the direction of movement during sliding as shown at T in figure 7. The entire upper surface of the slide mass has undergone some extension in the direction of movement. Hummocks and lobes of slide material formed the distal part of the toe of this earth flow. Tension cracks were also found throughout the toe area.

Figure 6. View of slope movement on the northeast wall of the North Hartland flood control reservoir west of the spillway. The headscarp is in the center. Tension cracks on the mid section of the flow can be seen on the lower left. The shrubs on the lower left were mud coated due to high water during reservoir flooding. The smooth area in the foreground is the edge of a grass covered hill on the southeast side of the unnamed stream valley from which the photo was taken.

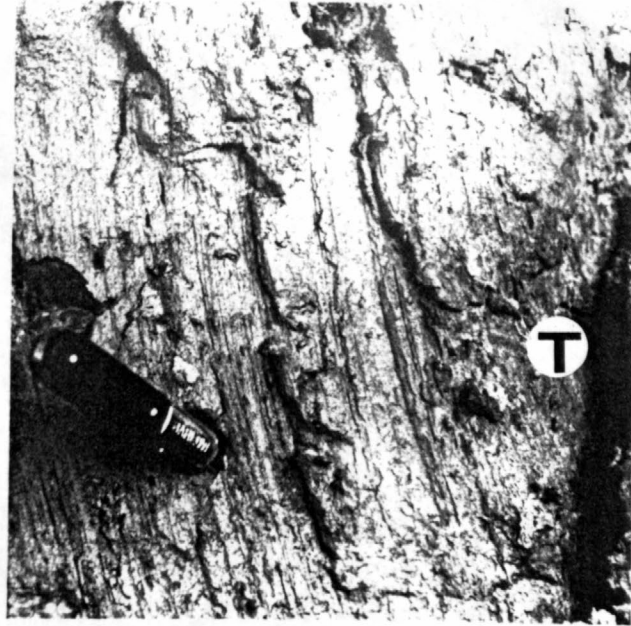
The slope failure had a differential elevation of 110 feet (33.5 m) from head scarp to the toe at the unnamed stream level. The toe of the failure was stopped by the stream channel referred to above just before reaching the lake. The failure length was about 580 feet (176.8 m) from the head scarp to the toe along the axis of sliding, and was 475 feet wide (144.78 m), normal to the axis. The upper boundary of this failure was marked by two undulating scarps. The two scarps (main and minor) had vertical offsets of 2.5 feet (0.76 m) each and horizontal tension openings of 4 to 9 inches (10.16 to 22.86 cm). The slope angle of the scarps ranged from 50° to 62° (119-188%). Slickensides were observed on clay-smeared fresh scarps in July 1984 (Fig. 7), but they were gradually eroded by subsequent rainstorms.

Figure 7. Photo showing slickensides on a clay-smeared head scarp surface of the slump-earth flow on the northeast valley wall of the North Hartland reservoir. T is the location of a horizontal tension crack.

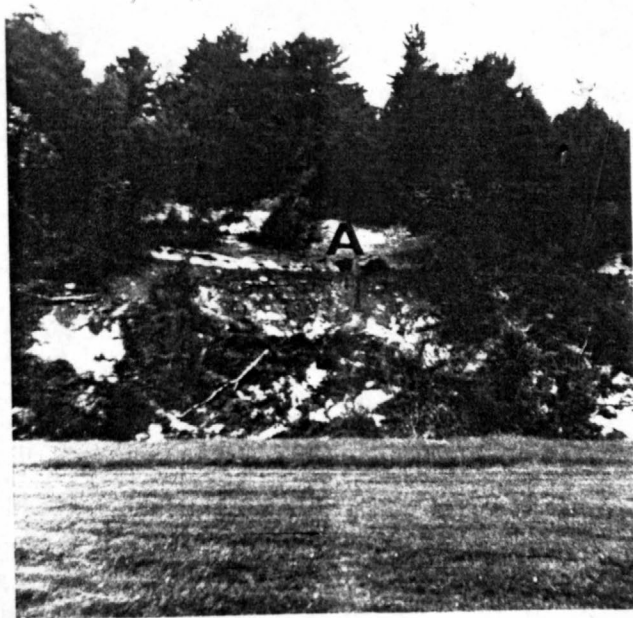
The slope failed as an earth flow, which was partially fed by water from the confined sand layer as well as from the saturated colluvium (Fig. 4). The material involved in the failure included the colluvial cover along the slope face as well as some of the rhythmite sequence. It moved as a rapid fluid earth flow across a stream channel and was stopped by the parking lot embankment (see foreground of Fig. 9). The failure removed

Figure 9. A view of part of the southwest valley wall of North Hartland reservoir showing piping cavities (A) in a sand layer confined between two rhythmite sequences. These cavities are up to 3.9 feet (1.2 m) in diameter.

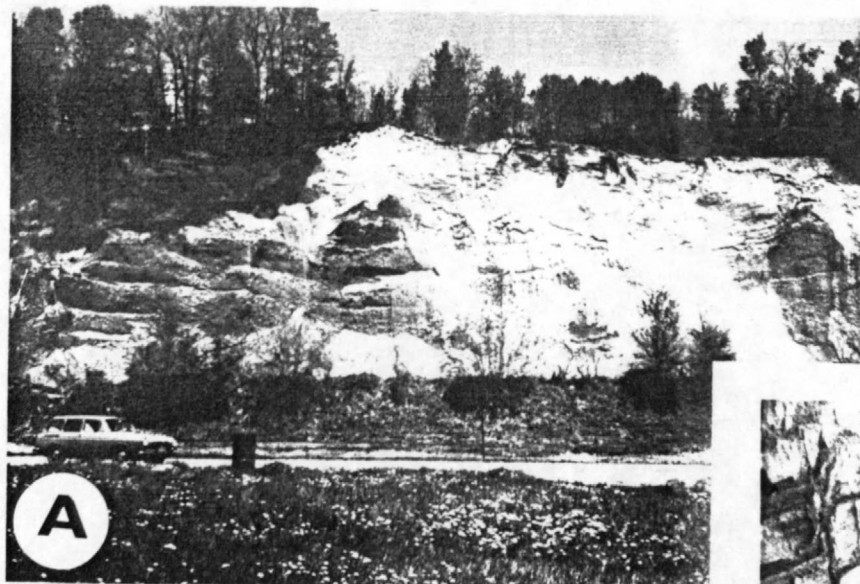
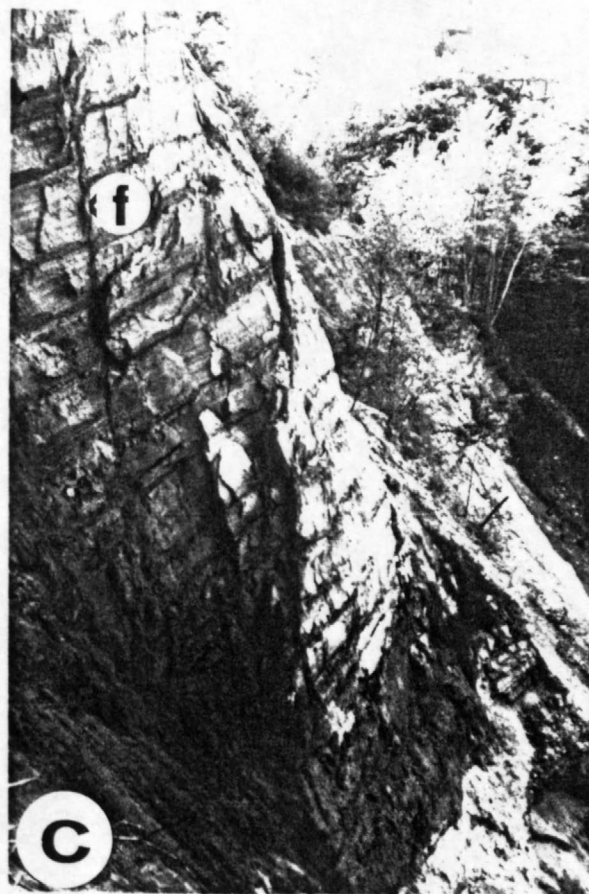
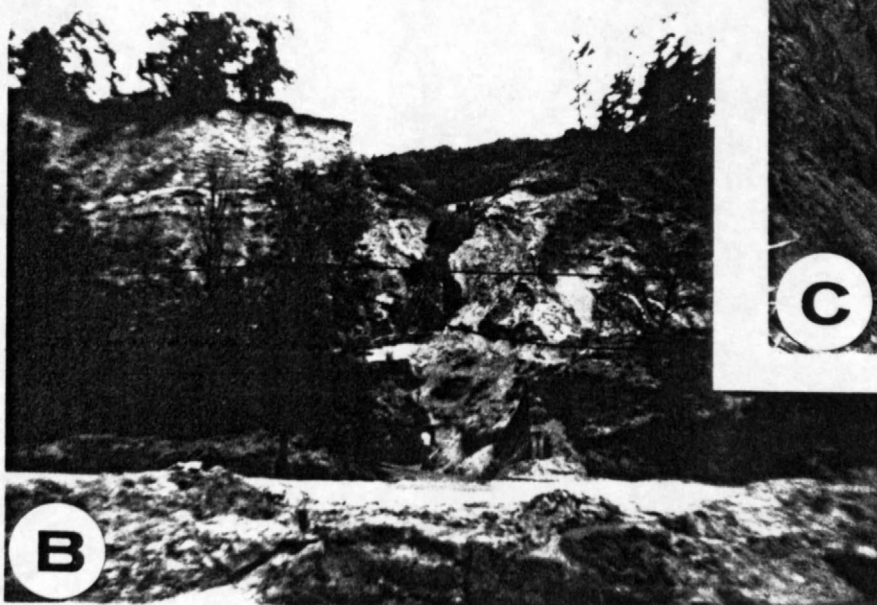
The rhythmically bedded units at Sharon are glacial Lake Hitchcock bottom sediments. The rhythmite units have a slight dip to the east and are displaced by reverse faults (Fig. 16B) which dip steeply to the west.

Figure 16. A view of the landslide site north of Sharon, Vt. on route 14. This photo shows how the site looked as a borrow pit facing Route 14 before the failure (A). The breach channel developed during failure is seen left of center in scene (B). The fault (at f in C) is one of several reverse faults exposed at this site. Photo (A) through the courtesy of Charles A. Ratte'.

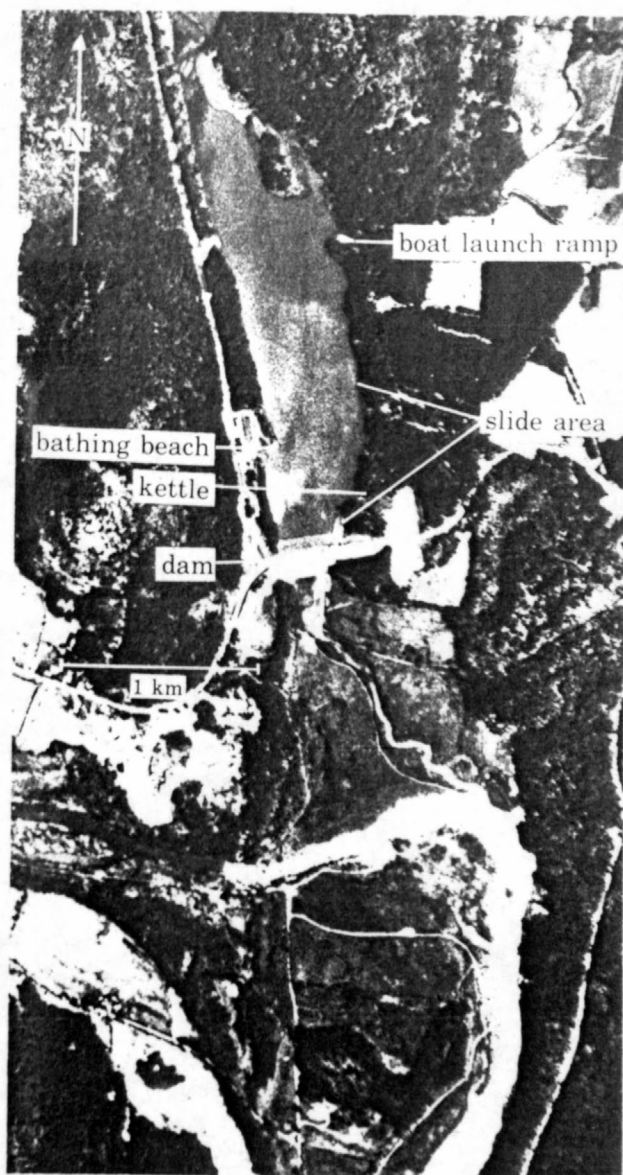
Figure 17. Enlarged portion of an aerial photograph of Stoughton Pond showing the location of slide areas on the east shore. (Photograph courtesy AeroGraphics Corp., Bohemia, N.Y.).

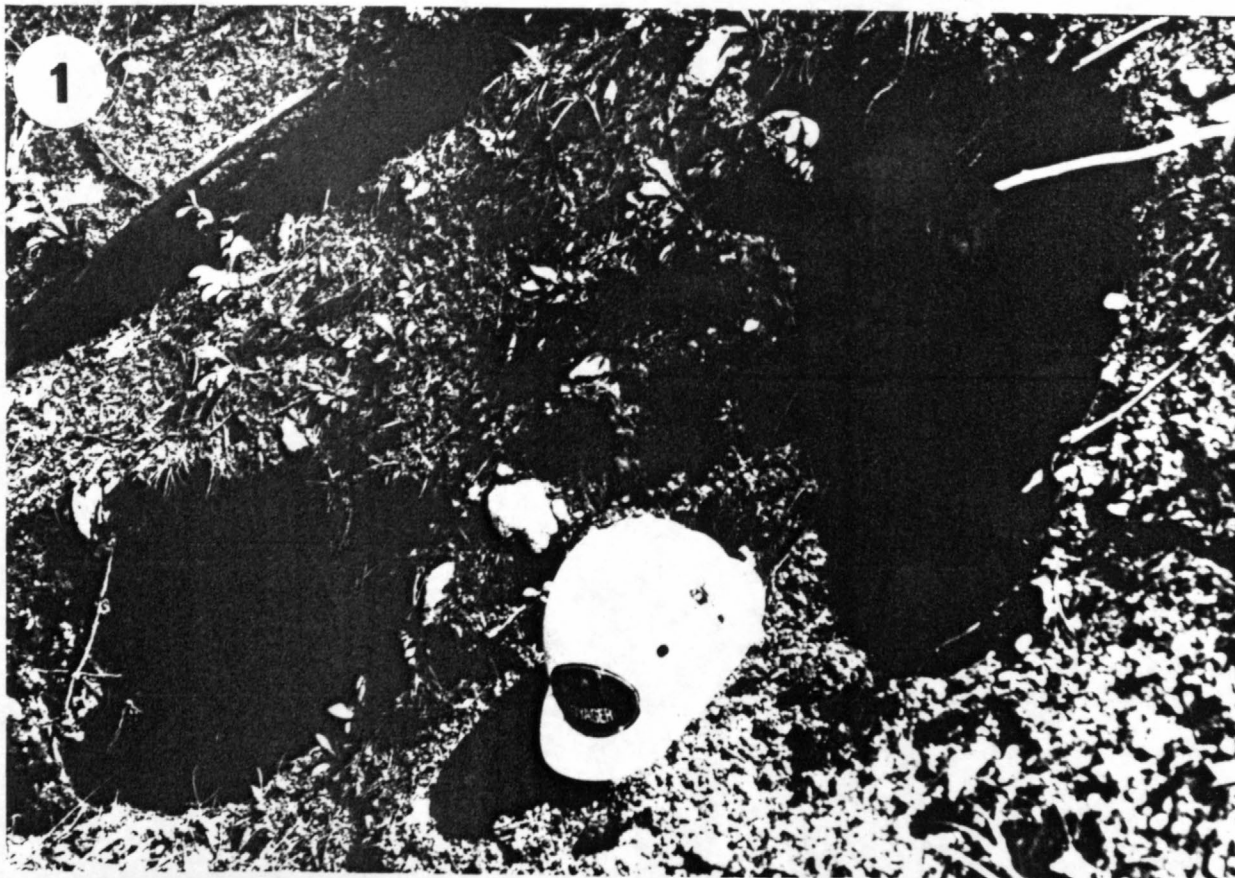
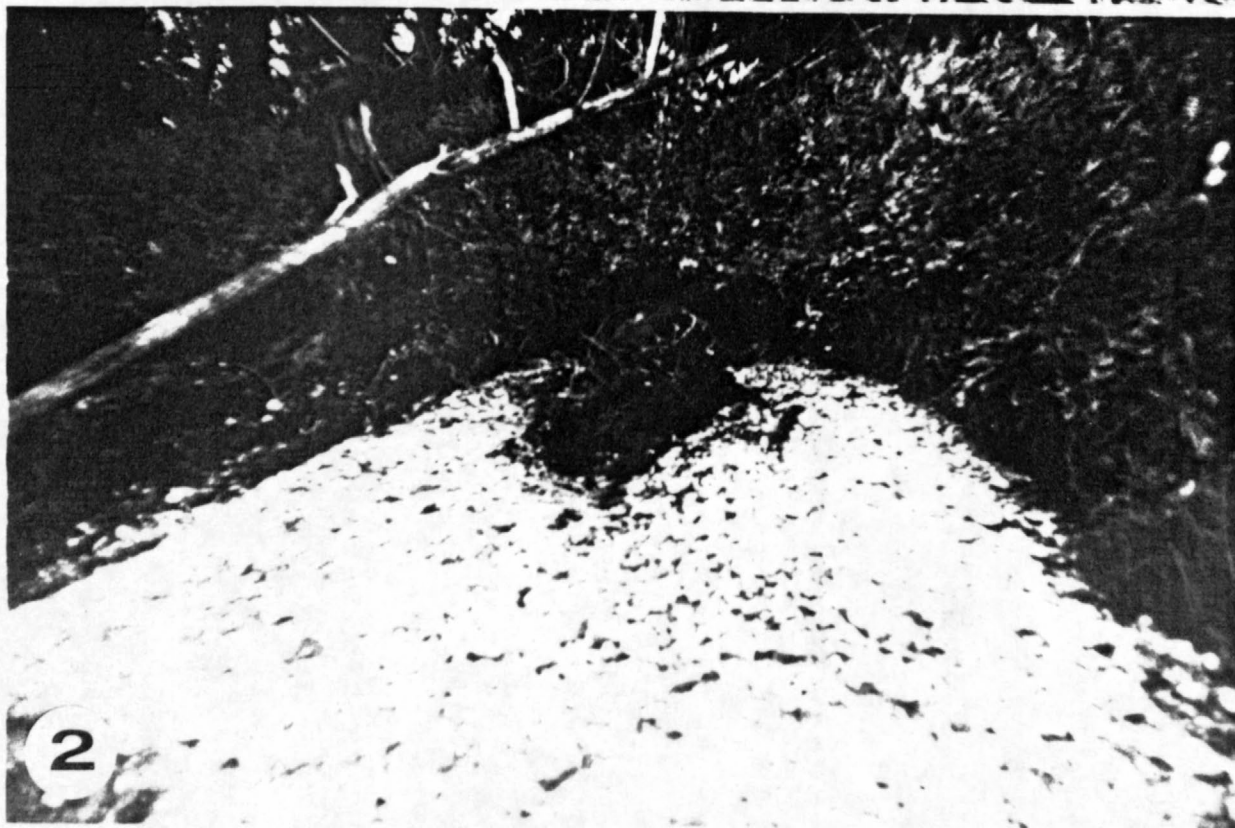
Sand and gravel deltas have built up along the pond's east shore slope near normal pool level, below where these pipes exit the slope (Fig. 19). Below pond water level off the mouth of these pipe-flow deltas, subaqueous pits were seen. These were obviously excavated by bottom scour of a high velocity slurry composed of water, sand, and gravel concentrated on the lake bottom at the locations of the pipe exits.

Figure 19. Photographs illustrating piping failures in the east slope of Stoughton Pond, an impoundment on the North Branch Black River. (1) Collapse pits over pipes--hardhat gives scale. (2) Outflow delta deposits from mouth of a pipe at pond level.
