The Influence of Hydraulics
on Boat Trajectories and Boating Accidents
on the Colorado River,
Grand Canyon, Arizona

Margie Marley

Open-File Report 87-576

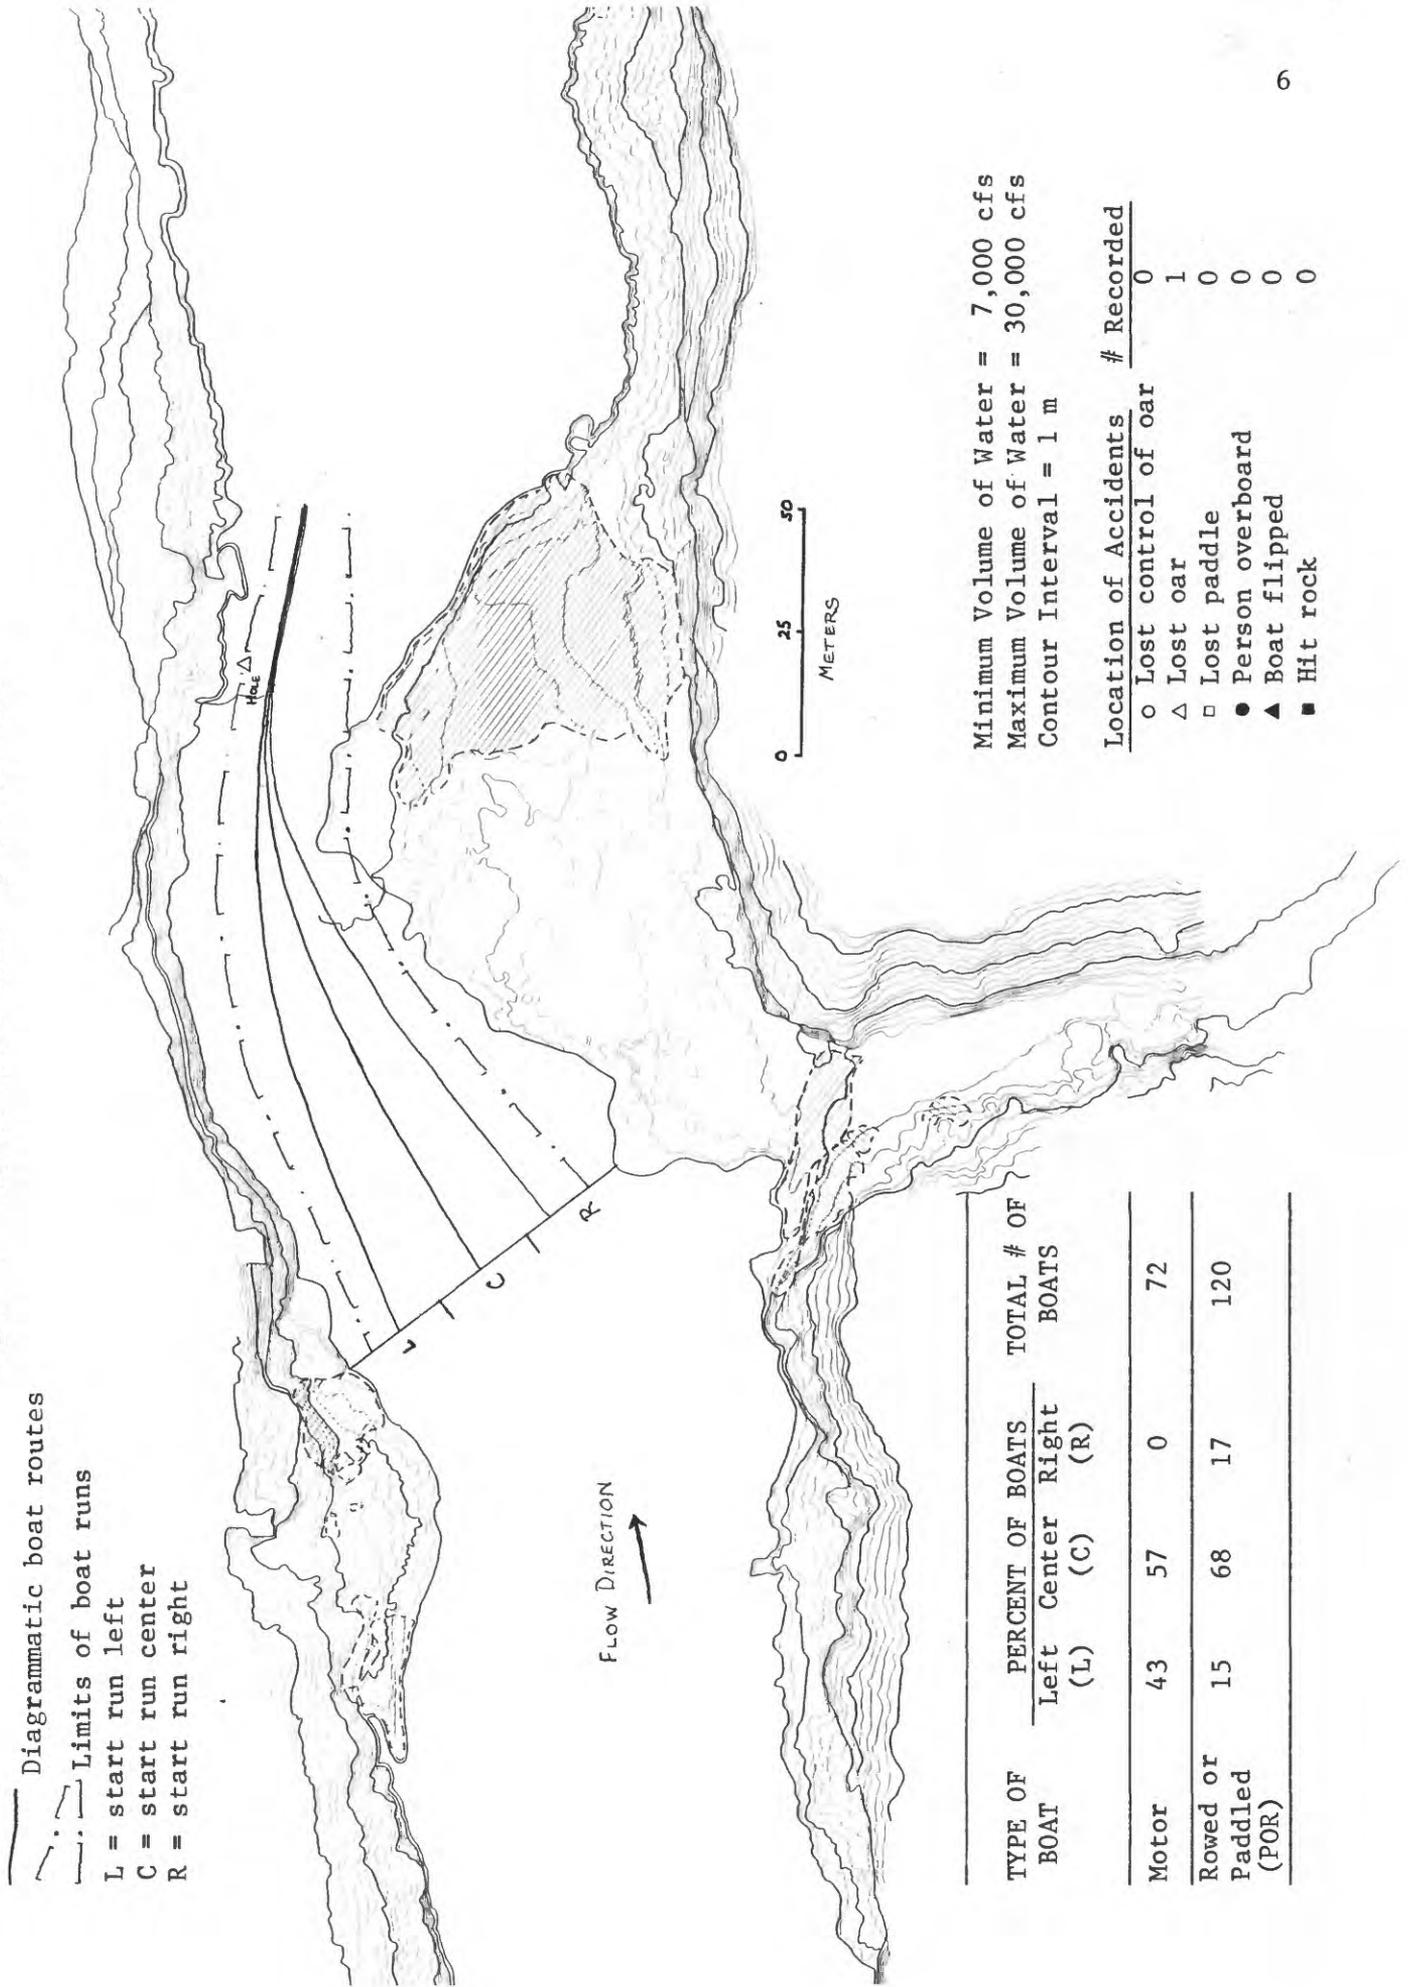
Figure 2. Map of House Rock Rapids with Data

House Rock Rapids (figure 2) has a large debris fan on river right and a sheer wall on the left. The geometry of the river constriction as it curves around the fan causes the river to flow towards the left wall. This curvature of the flow towards the wall is greater at low discharges (<10,000 cfs) when the debris fan is not covered with water and the channel is narrow than at high discharges, when the debris fan becomes submerged so that the water surface widens and the space available for boats on the right side of the river increases.

The major hydraulic hazard in the rapid is a hole at the bottom of the rapid (located by the triangle on figure 2 that indicates the loss of an oar in one accident). The observers wrote that the hole at the bottom of the rapid appeared to be largest when the flow was approximately 10,000 cfs. Upstream of this large hole there is another hole which had a "crest" pushing away from the wall. In the only accident observed, one POR boat went through the lower hole and lost an oar. Although boats started at the top of the rapid along a broad band from far right to far left (along the line labeled L, C, R on figure 2), boat trajectories converged in the left-center of the channel just above and to the right of the bottom hole (this is particularly true at low discharges where the trajectories are strongly bunched toward the left side of the river). None of the motorboats started on the right side of the channel, and only 15% of the rowed boats started on the left side of the channel.

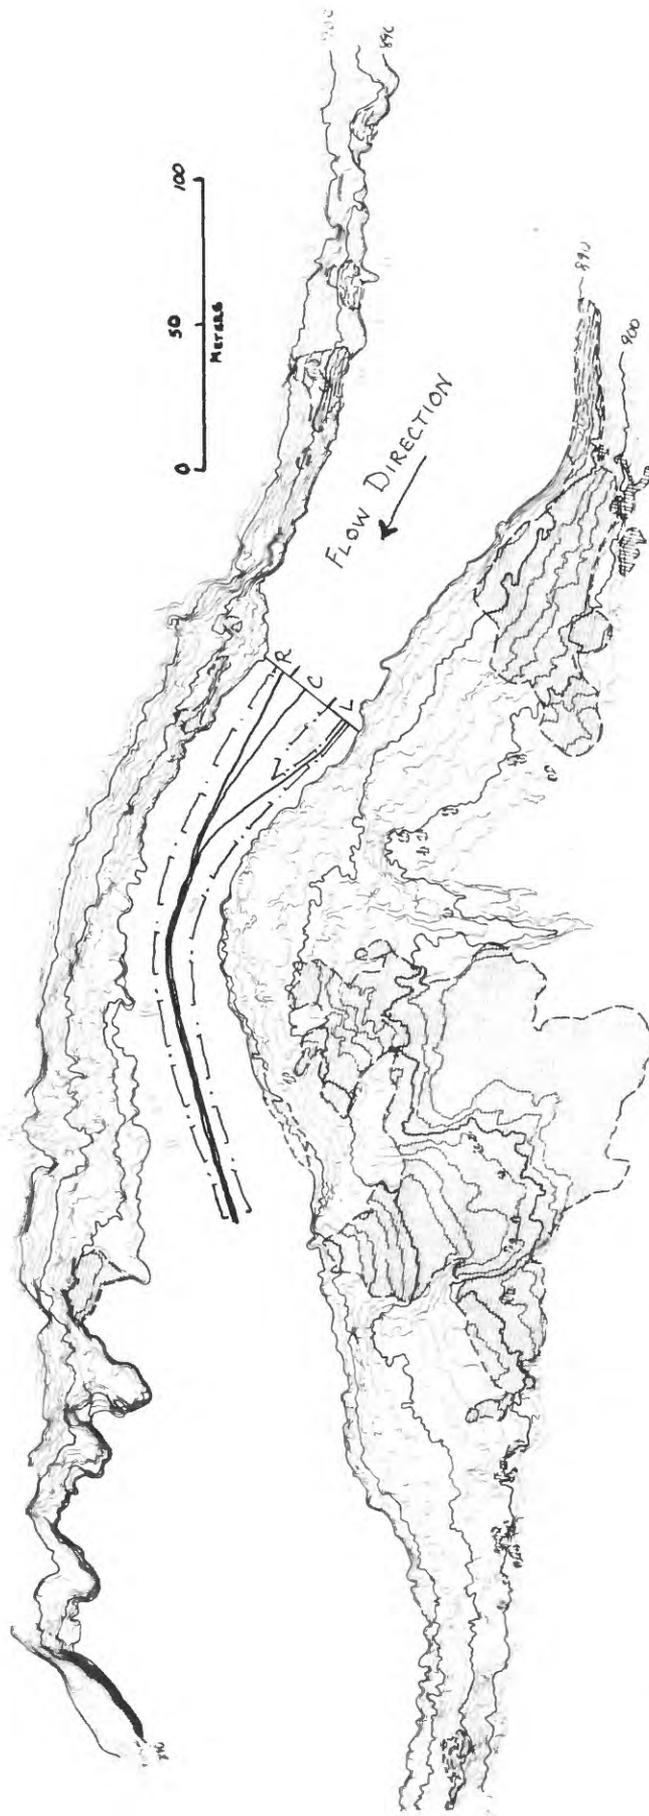
Figure 3. Map of Twenty-four and One Half Mile Rapids with Data

Twenty-four and One Half Mile Rapids (figure 3) has a prominent rock at the top left of the rapid that precludes entry on the left at discharges less than 11,000 cfs. Only 6% of the POR boats and no motorboats took this route. Three boats ran the left side when the discharge was 11,000 cfs and went over the barely submerged rock. The remaining four boats that entered left ran the rapid at 16,000 cfs and went left of the rock. The center and right entrances merge as there is no obstacle to separate them. 92% of the motorboats and 82% of the POR boats went down the center. No accidents were reported at any location in the rapid.

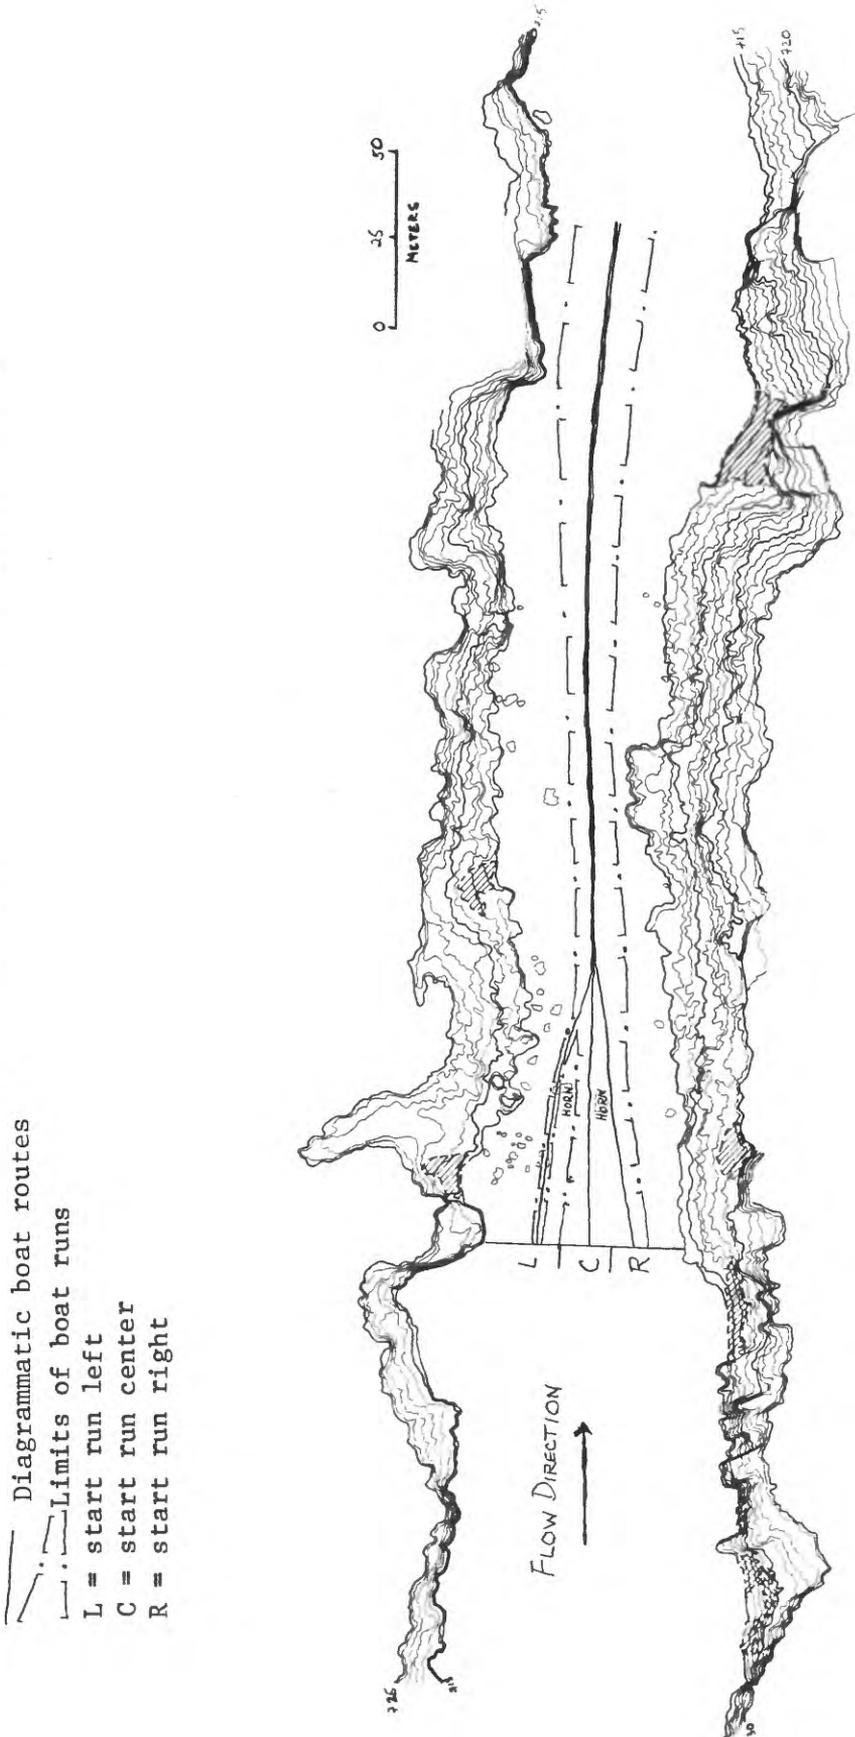
Figure 5. Map of Horn Creek Rapids with Data

Horn Creek Rapids (figure 5) was observed for only six days for reasons mentioned above. At Horn Creek Rapids, the canyon is straight and narrow. Two large submerged rocks form the "horns" at the top of the rapid. No boats went over the rock on the left, but some went over the rock to the right. During the observation period, the discharge never dropped below 17,000 cfs. No accidents were observed. However, accidents at Horn Creek are more frequent at water levels less than 10,000 cfs (Brown and Hahn-O'Neill, 1987). The beginning of the boat trajectories are similar to those at Twenty-four and One Half Mile Rapids; the left route is separate from the center and right runs which are continuous across the top. 84% POR boats and 87% motorboats took the center run.

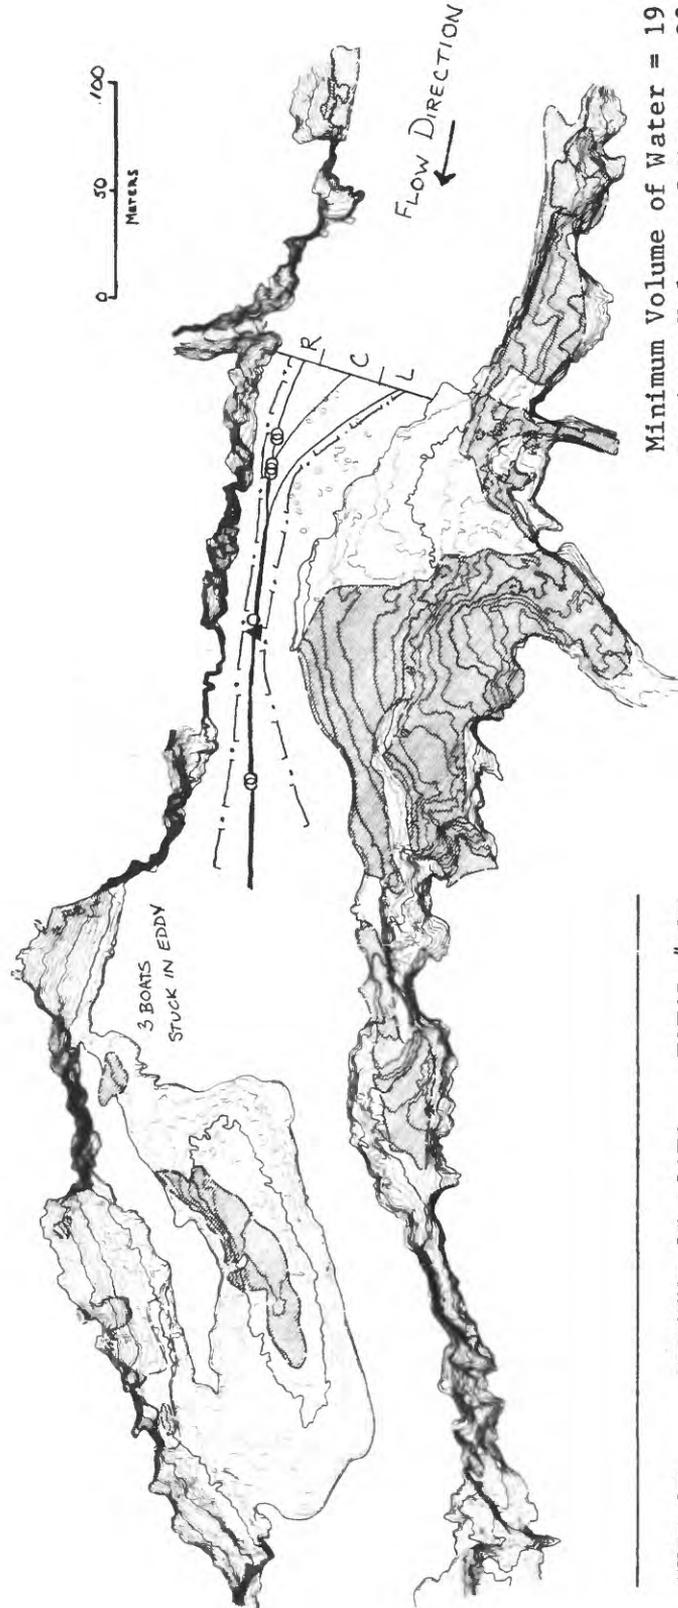
Figure 6. Map of Granite Rapids with Data

Granite Rapids (figure 6) has a sheer wall on the right (looking downstream) and a large debris fan on the left. The topography at Granite is similar to that at House Rock, but larger in scale. The current is constricted by the debris fan and the sheer wall. Boats starting left are moved swiftly towards the right. The boat trajectories in Granite meet in the convergent part of the rapid; the trajectories in House Rock meet in the divergent part of the rapid. As at House Rock, no motorboats took the run adjacent to the debris fan due to the shallow water (right at House Rock, and left at Granite).

Granite has very large waves in the main current against the wall, and the accidents occurred in these waves. Nine accidents were reported; in eight of these control of an oar was lost. This rapid had the second largest number of accidents reported, but only one of them was serious. In the serious accident a small (13.5 ft) boat flipped. Granite has a large and strong eddy on the bottom right. Three boats were noted as being "stuck" in it (there was no mention of how many times they recirculated). No other rapid observed had any notes about boats being stuck in eddies.

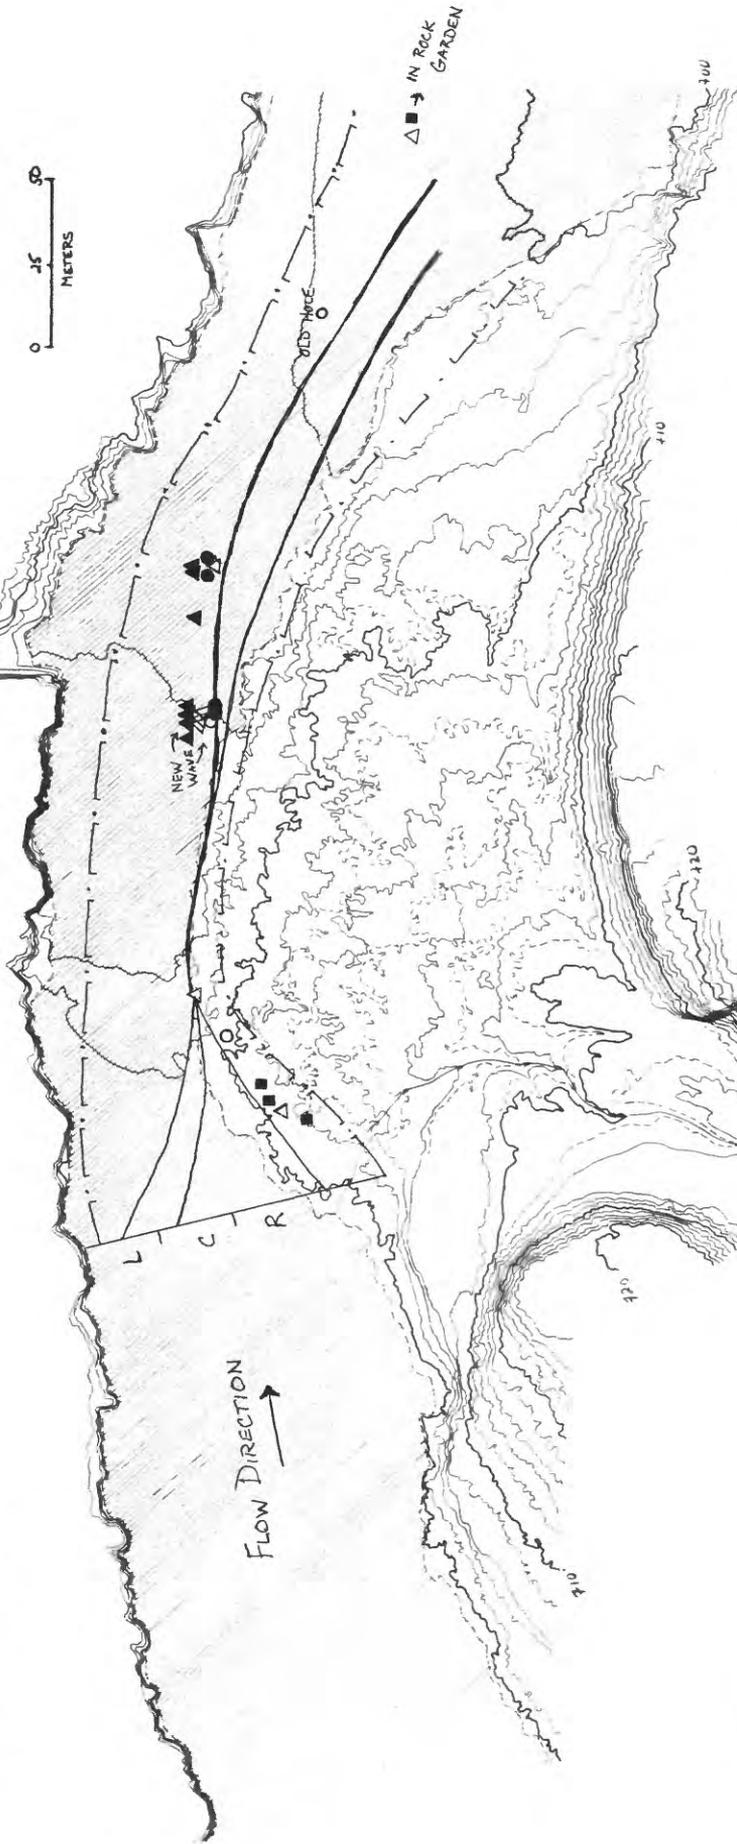
Figure 7. Map of Crystal Rapids with Data

Crystal Rapids (figure 7) had the largest number of and most serious accidents. Reported accidents on the observer forms include seven flips, four people overboard, five lost oars, two broken oars, three lost control of oar, and four hit rocks. The majority of these accidents are located in and near the "new wave" formed in 1983 (see location on figure 7).

78% of all POR boats entered Crystal on the right during the observation period. These boats started right and stayed right. The center run was used by 26 (21%) POR boats; two boats stayed in the center and 24 cut to the right. One (1%) POR boat started left and stayed far left. Only 32% of the motorboats started on the right side of the rapid. The remainder of the motorboats started left (13%) or mid-channel (55%) and cut (under power) to the right at the top of the rapid.

This left-to-right maneuver is a good example of the maneuverability available to a motorboat but not to a POR boat. A POR boat can not run the right side of Crystal by starting left because they lack the power to cut quickly across the current. Motorboats can do so because the boat under power builds momentum as it cuts across the tongue. This momentum keeps the boat on the right side of the rapid once it reaches the right side. 60% of the motorboats starting center or left made it to the right of the new wave. The POR boats that started in the center and cut to the right were not as successful as the motorboats; only 7 of the twenty-six POR boats (30%) attempting this maneuver went right of the new wave (the remainder went through it).

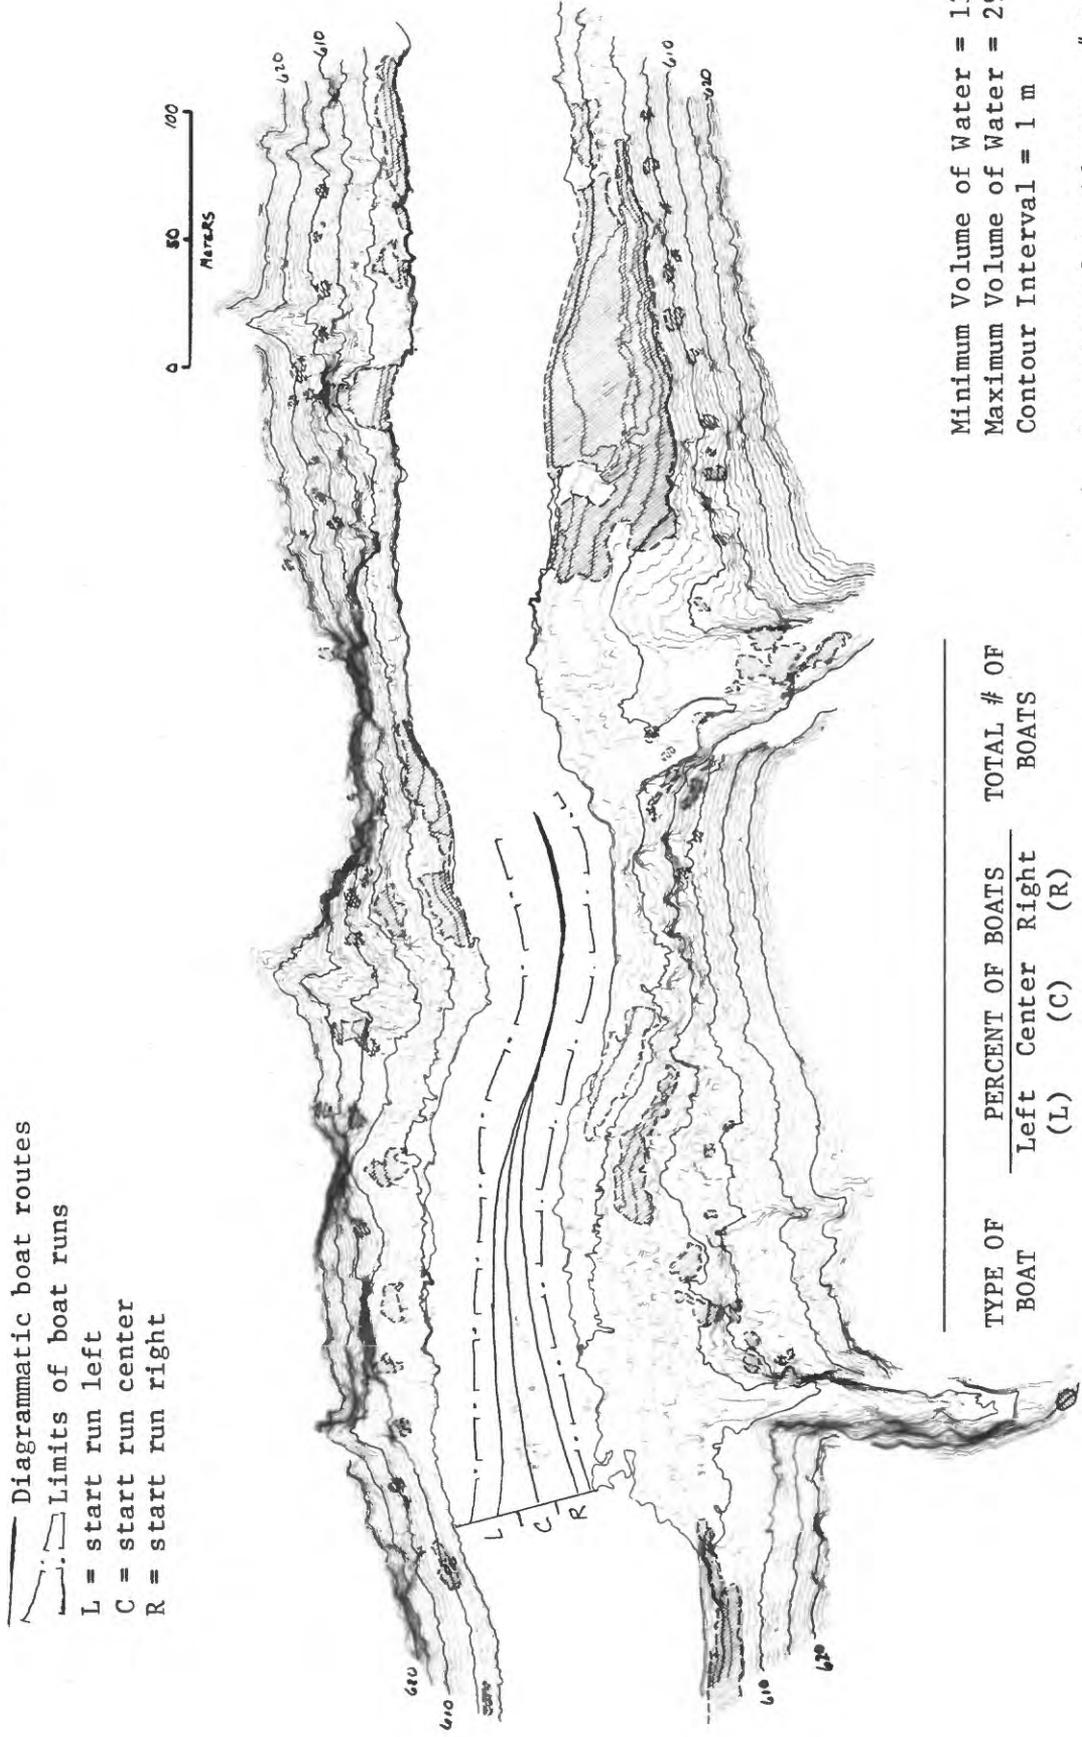
Figure 8. Map of Deubendorff Rapids with Data

Deubendorff Rapids (figure 8) is a very rocky rapid at low water. There are many rocks exposed in the center of the rapid at its head. 26% of all POR boats were described as taking the center run (the discharge exceeded 13,000 cfs during the entire observation period). 96% of all motorboats took the left run, but only 53% of POR boats went left. The water levels observed (13,000 to 29,000 cfs) allowed variety in the runs taken by POR boats, whereas motorboats stayed to the left. (The observers commented that the fluctuations in water levels made it difficult to correlate boat runs using the topographic base with a shoreline of 5,000 cfs shown on the form.) No accidents were recorded.

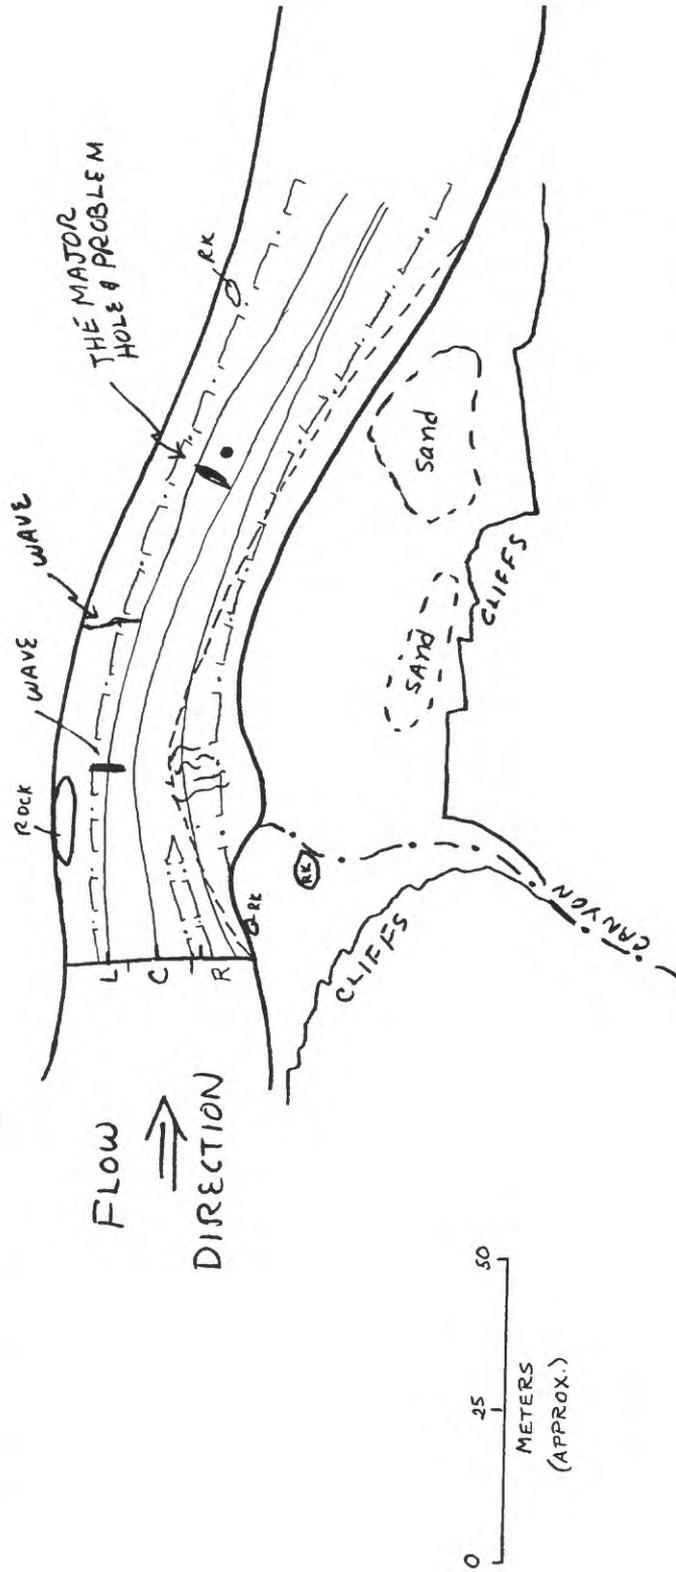
Figure 9. Map of Upset Rapids with Data

A sketch of **Upset Rapids** (figure 9) was drawn from an aerial photo with a water level of 5,000 cfs². A large rock located at the top right of the rapid separates the center run from the right run. The right run becomes non-existent at a medium flow (the lowest water observed). The majority of boats took the center run. The only accident recorded at Upset was a person overboard. This incident appears to have been the result of going through a large hole at the bottom of the rapid.

2. The observers must have thought the form showed a higher water level than 5,000 cfs because they sketched a narrower channel on the form to represent low water (their estimate of the low water shoreline is shown as a dashed line in Figure 9). The flows they saw never dropped below 5,000 cfs. The low water shore they drew in is probably for a flow of about 12,000 cfs as this is the lowest flow they witnessed. The original shore on the form is interpreted as the highest observed shore (30,000 cfs). The volunteers drew boat paths relative to the new shore that they made and did not draw boat runs above the original shore.

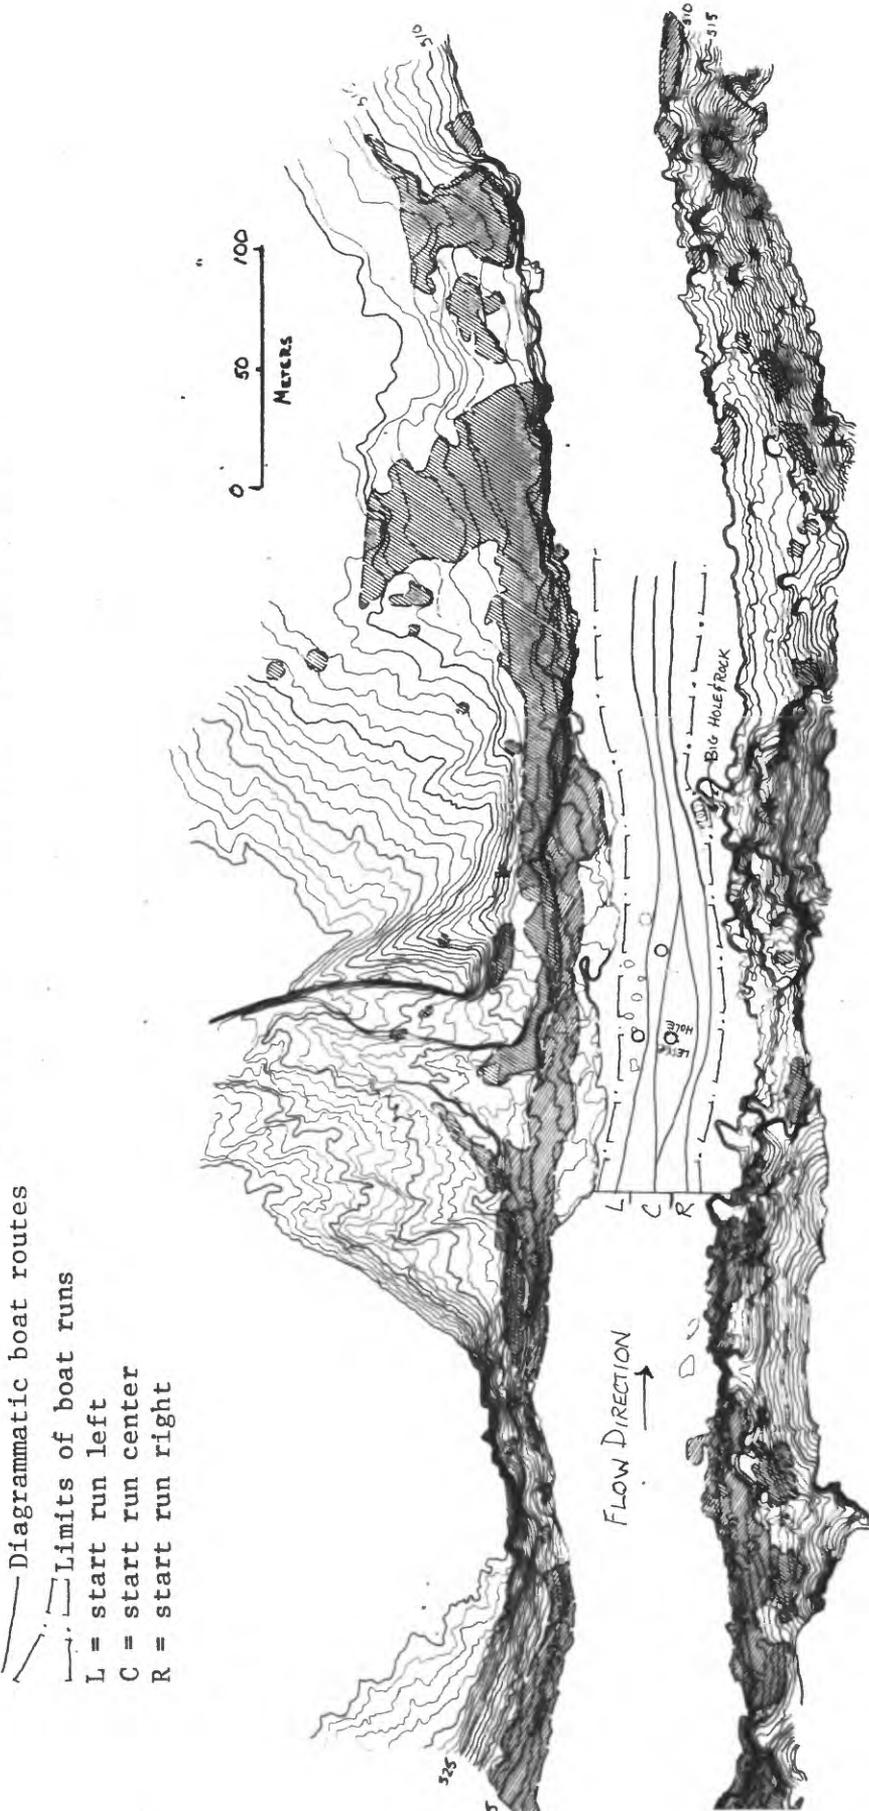
Figure 10. Map of Lava Falls Rapids with Data

Lava Falls Rapids (figure 10) has a large hole in the center top called the "ledge hole." Only 10% of the motorboats and 11% of the POR boats ran the center (just to the right or left of the ledge hole or through it). 64% of the POR boats took the left run and 78% of the motorboats took the right run. The left run, which crosses the debris fan from Prospect Creek is rocky at low and medium water levels. Approximately 45% of the POR boats went left at flows between 15,000 and 20,000 cfs and 97% went left above 20,000 cfs. No motorboats went left when the water level was below 29,000 cfs; 42% went left above 29,000 cfs.

The observers recorded the locations for accidents (figure 10); these sites are related to strong hydraulic features. However, the nature of the accidents was not documented.

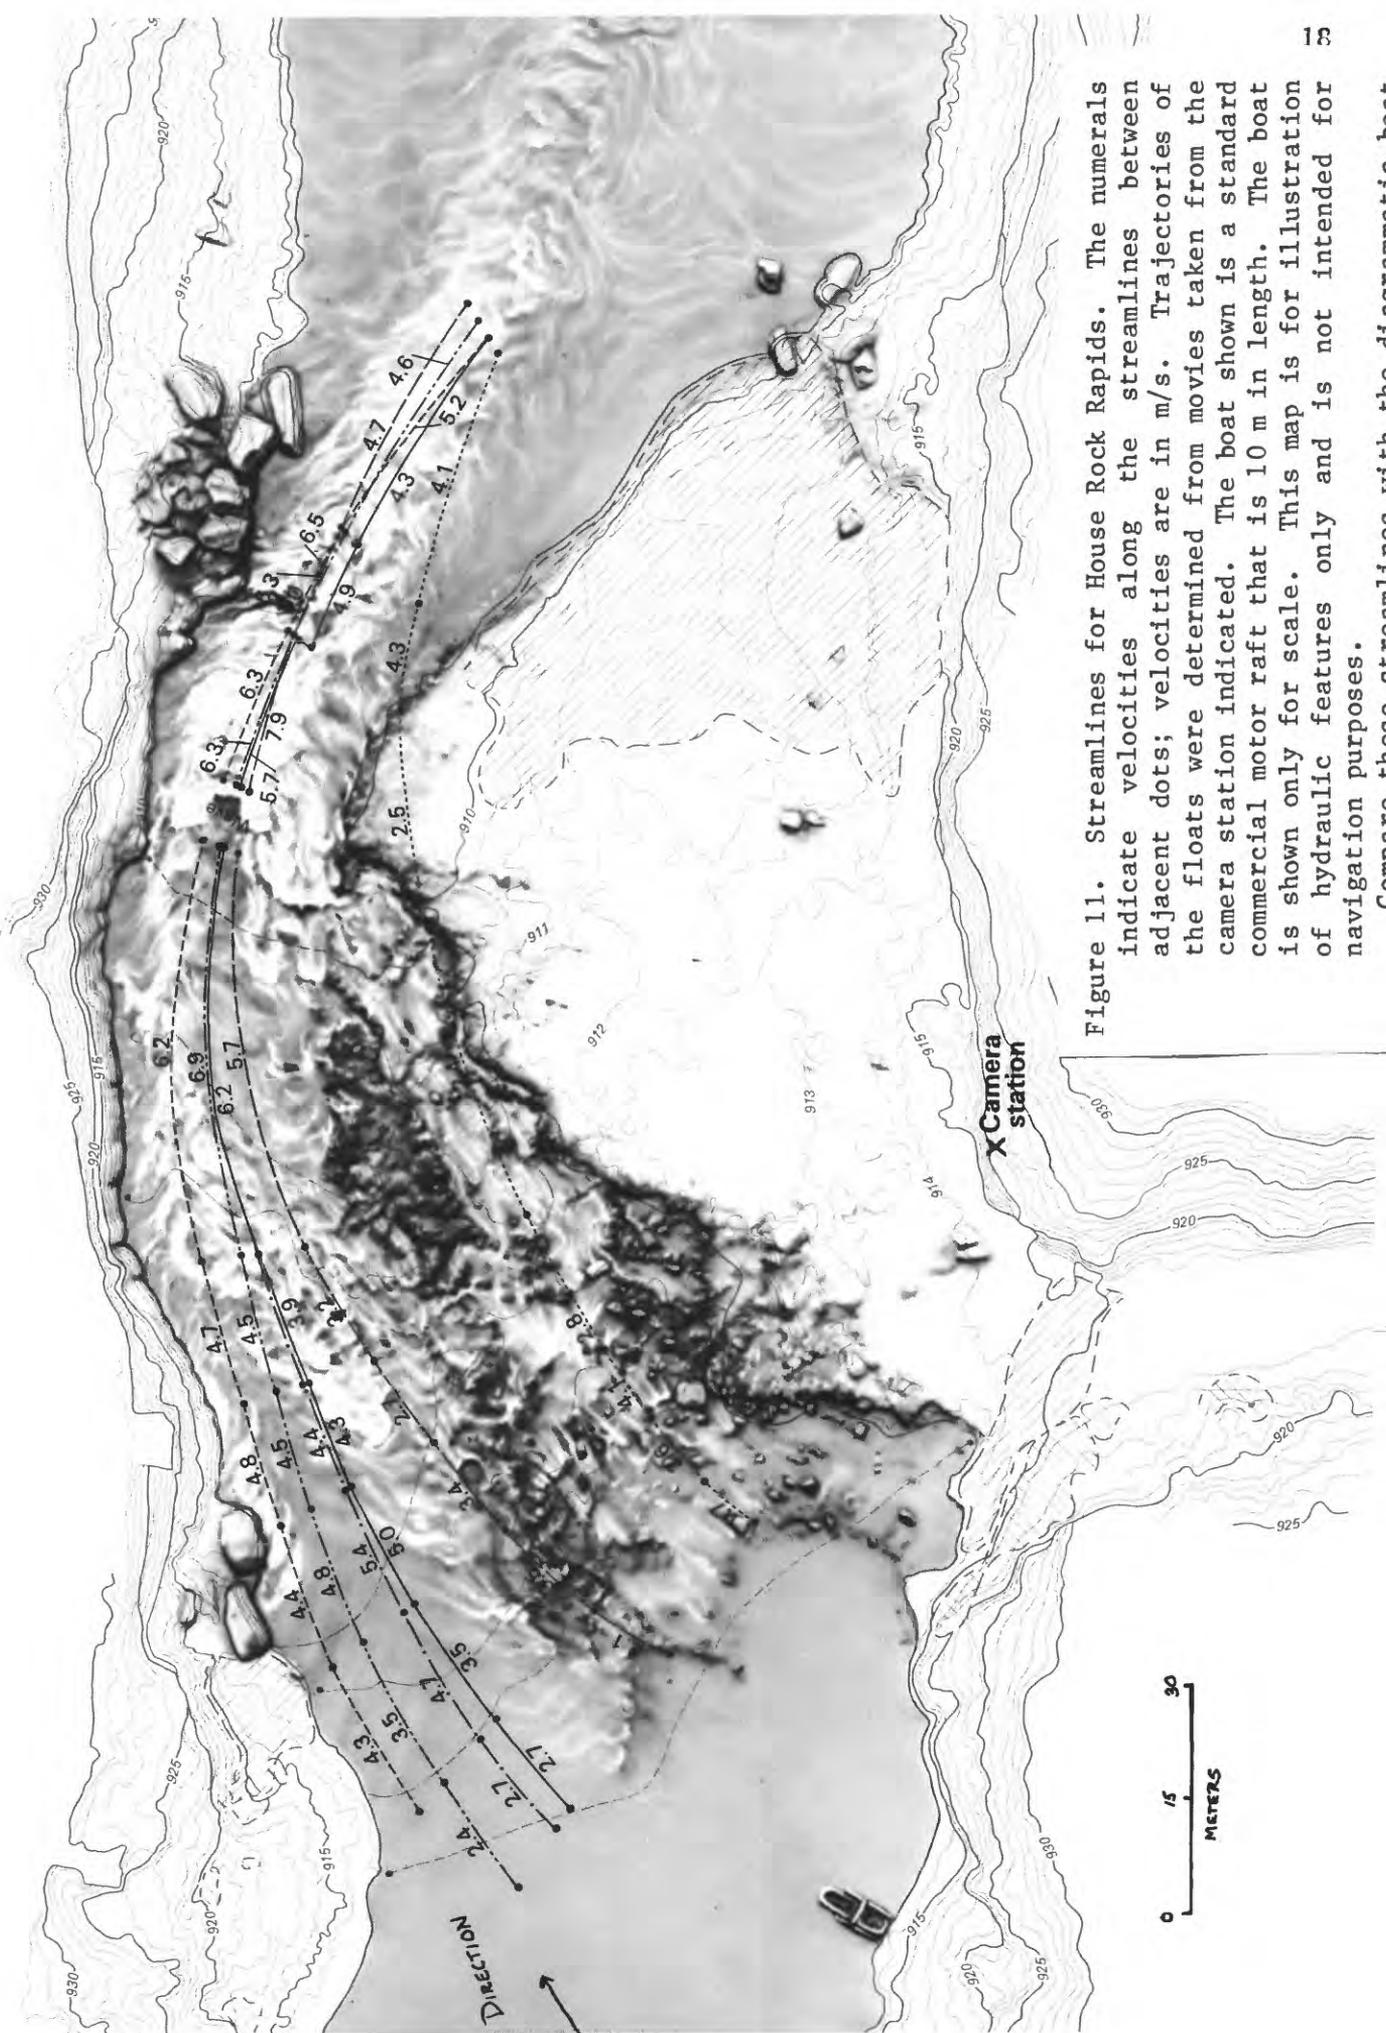
On the other hand, POR boats are much more strictly committed to a course determined by the streamline upon which they enter the rapid. This can be seen by comparing the trajectories of POR boats in House Rock Rapids (figure 2), with the trajectories of floats (i.e., streamlines) in House Rock (figure 11, from Kieffer, 1987). In this case the rowed boats and floats were both swept into the most constricted part of the river. The rowed boats had enough maneuverability to stay to the right of the large hole in the constriction, typically deviating from the streamlines by less than five meters.

Figure 11. Streamlines for House Rock Rapids. The numerals indicate velocities along the streamlines between adjacent dots; velocities are in m/s. Trajectories of the floats were determined from movies taken from the camera station indicated. The boat shown is a standard commercial motor raft that is 10 m in length. The boat is shown only for scale. This map is for illustration of hydraulic features only and is not intended for navigation purposes.
