**Preliminary Evaluation of Structures:
Whittier Narrows Earthquake of October 1, 1987**

OPEN-FILE REPORT 87-621

October 1987

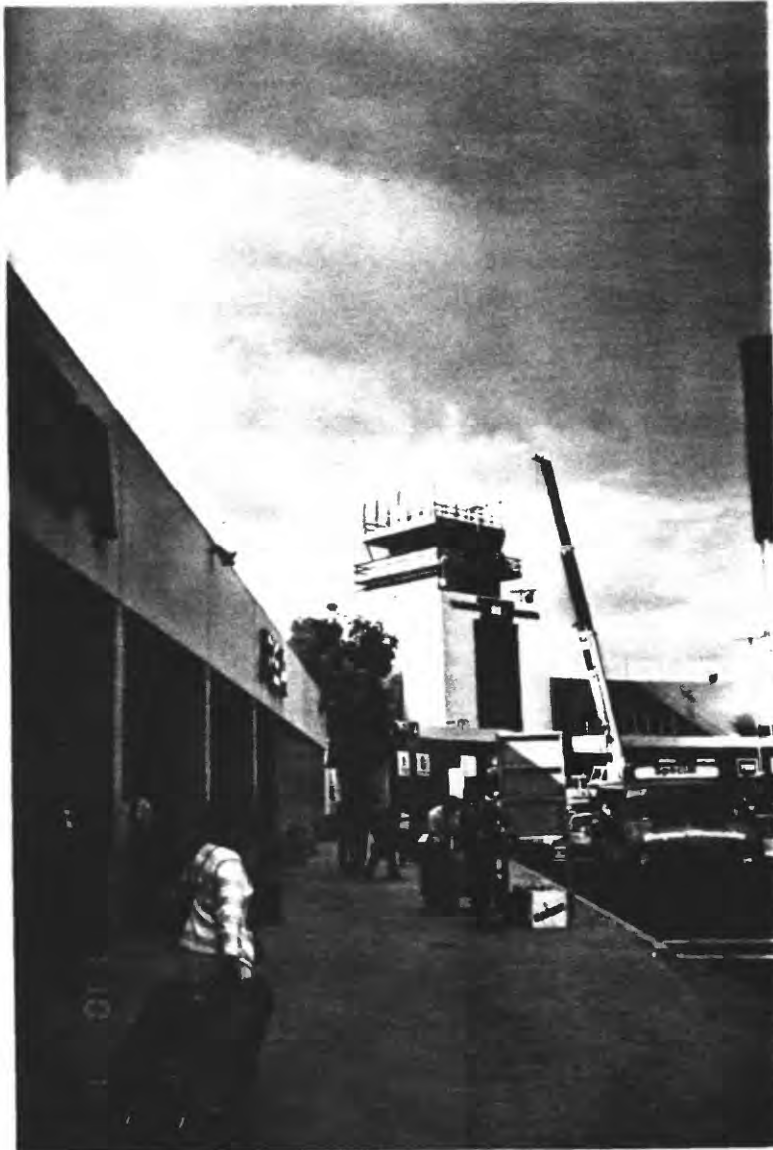
Most of the windows in the airport control tower were broken and for this reason the airport was closed for more than one hour after the earthquake. No other damage was observed at this airport. A general view of the tower is seen in Figure 2.

Figure 2. Control tower of Burbank Airport. The glasses were broken and as a result the airport was closed for approximately two hours.

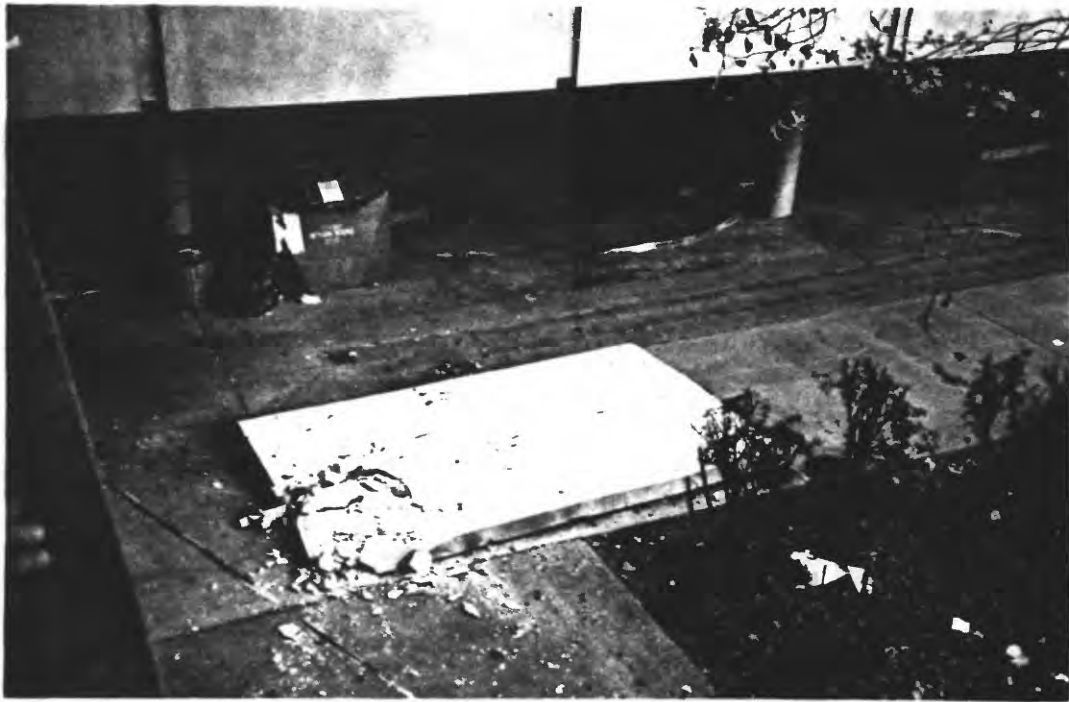
Primary attention on the campus is focused on a large, two-story parking garage where one of the heavy, second-story architectural panels fell on a passing student during the main shock, causing her death. The fallen panel is shown in Figure 4. The anchors of the panel to the reinforced concrete spandrel beam appeared to be very shallow and broke away from the concrete during the shaking (see Figure 5). Structural damage in the garage was small, with only minor spalling of concrete observed at the intersections of columns or shear walls with the floor system. Furthermore, several poorly-anchored utility pipe hangers were sheared off from the cast-in-place portion of the ceiling slab (Figure 6).

Figure 4. Precast side panel previously “anchored” to the cast-in-place spandrel beam of the garage. The panel caused the death of one student.

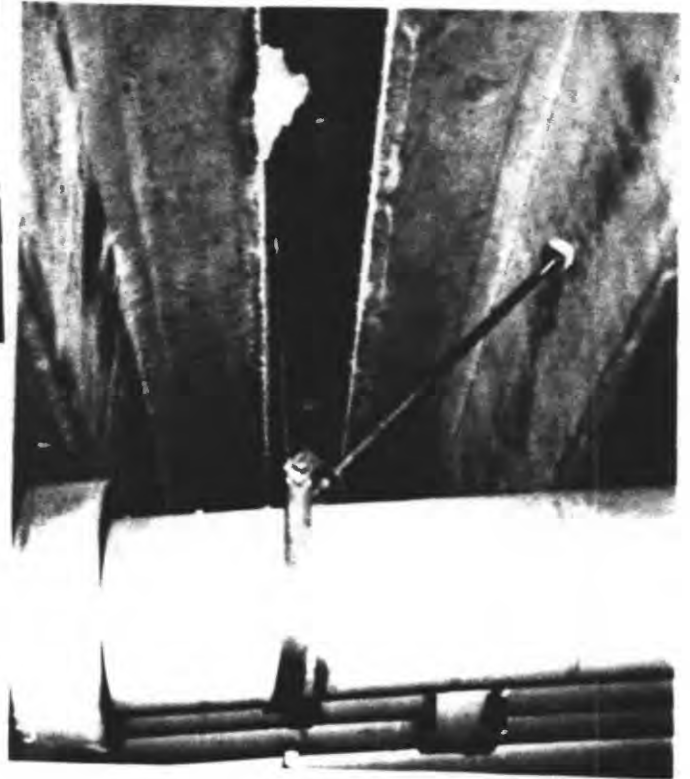
Figure 6. Utility pipe anchors sheared off from the cast-in-place portion of the ceiling slab.

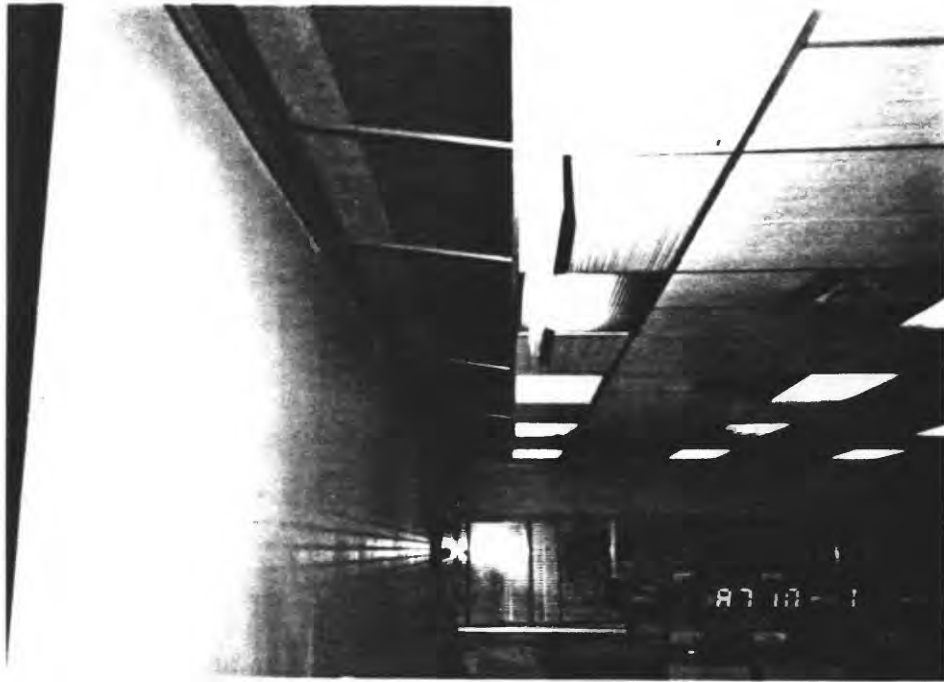
Another building with considerable damage is Salazar Hall. Most of the classrooms had severe ceiling damage, with rather heavy hanging ceiling panels spread all over the rooms (Figure 7). There were clearly visible shear cracks in interior walls and considerable cracking and spalling of concrete in some of the exterior architectural columns (Figure 8).

Figure 7. Hanging ceilings in most of the classrooms of the Salazar Building were severely damaged.

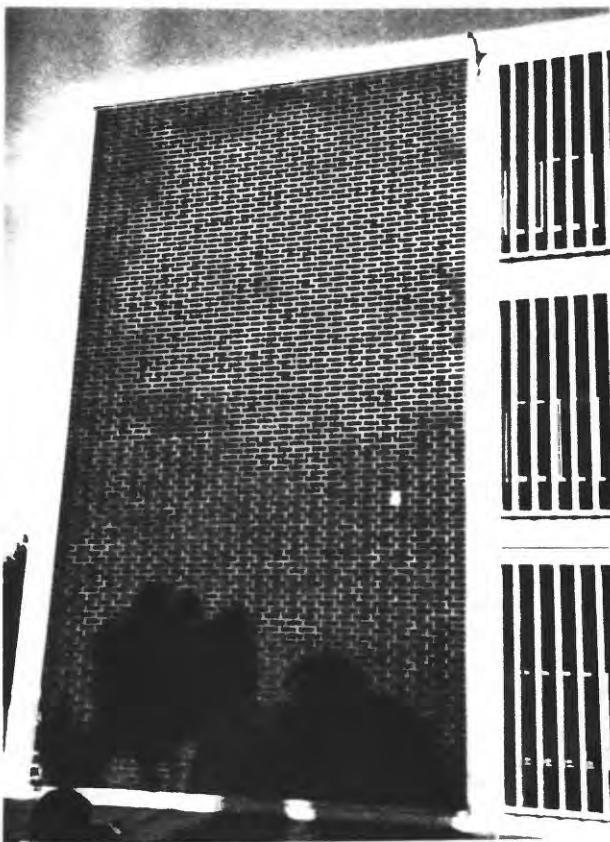
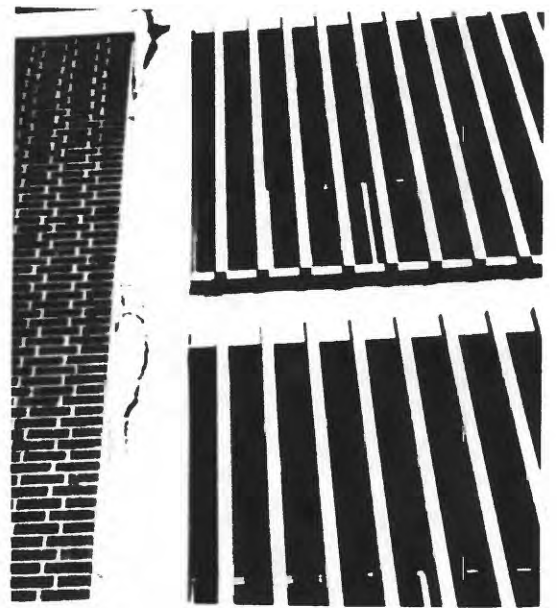
Figure 8. Exterior architectural columns cracked and spalled (Salazar Building).

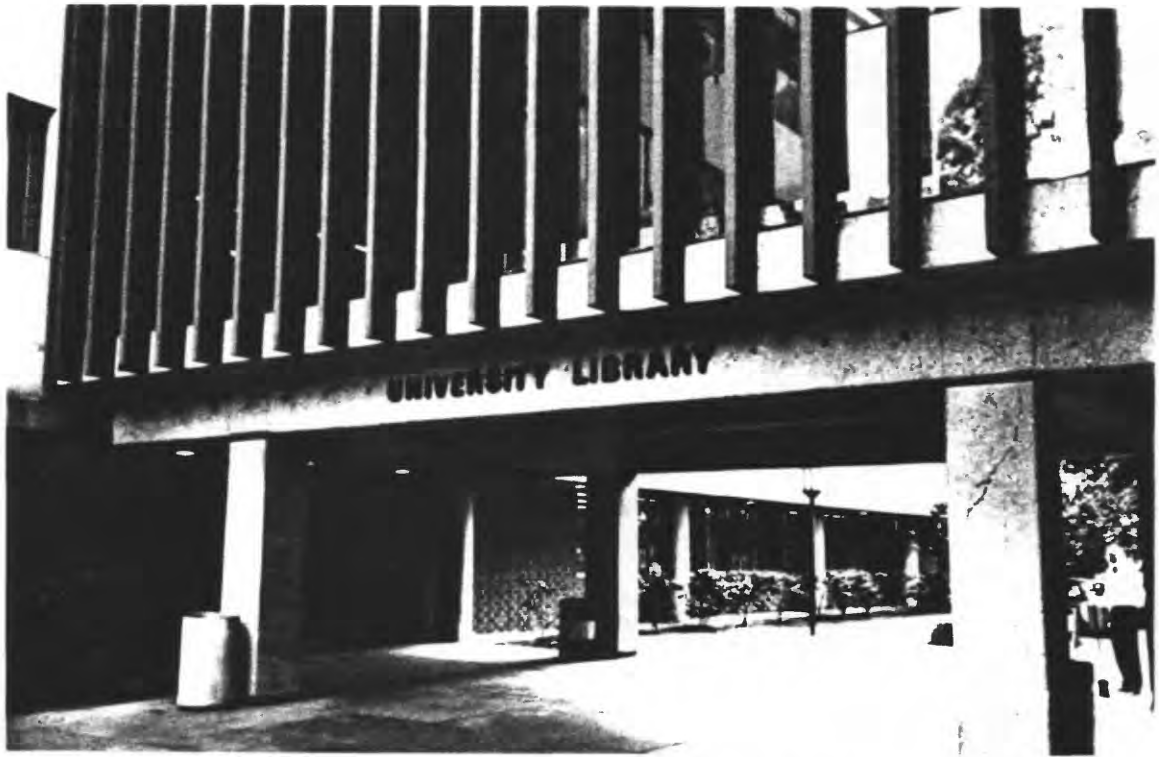
Structural damage was evident in the walkway between the two wings of the Kennedy Library (Figure 9). All four support columns (two per axis) in the first story had shear cracks, ranging from light to rather severe. Typical cracks in two of the columns are seen in Figure 10. The walkway building was separated from the two library wings through flexible joints (covered over 2"–3" gaps) and may have pounded against the wings, since the glass panels at the two ends of the walkway building were shattered on all stories.

Figure 9. Walkway between two wings of the Kennedy Library. Windows broken. Columns cracked.

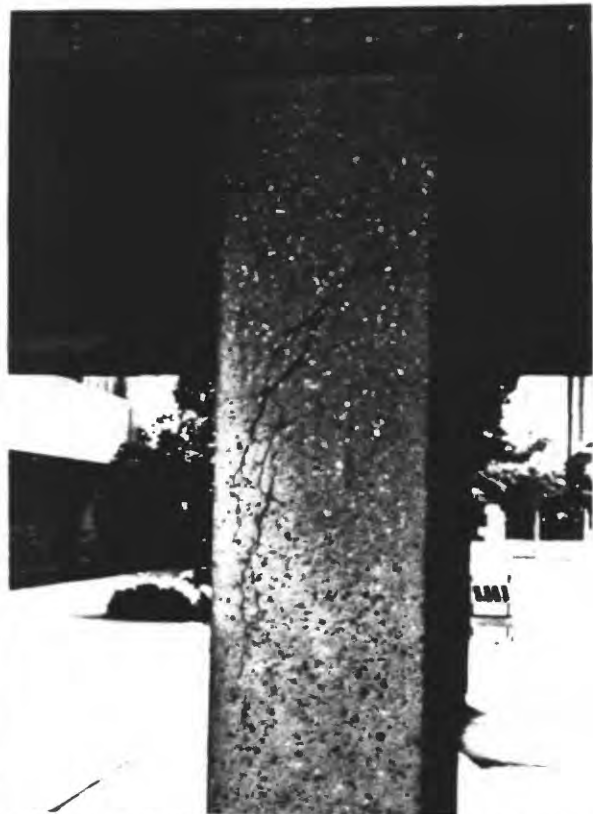
Figure 10. Shear cracks in two of the four columns of the walkway between the wings of the Kennedy Library.

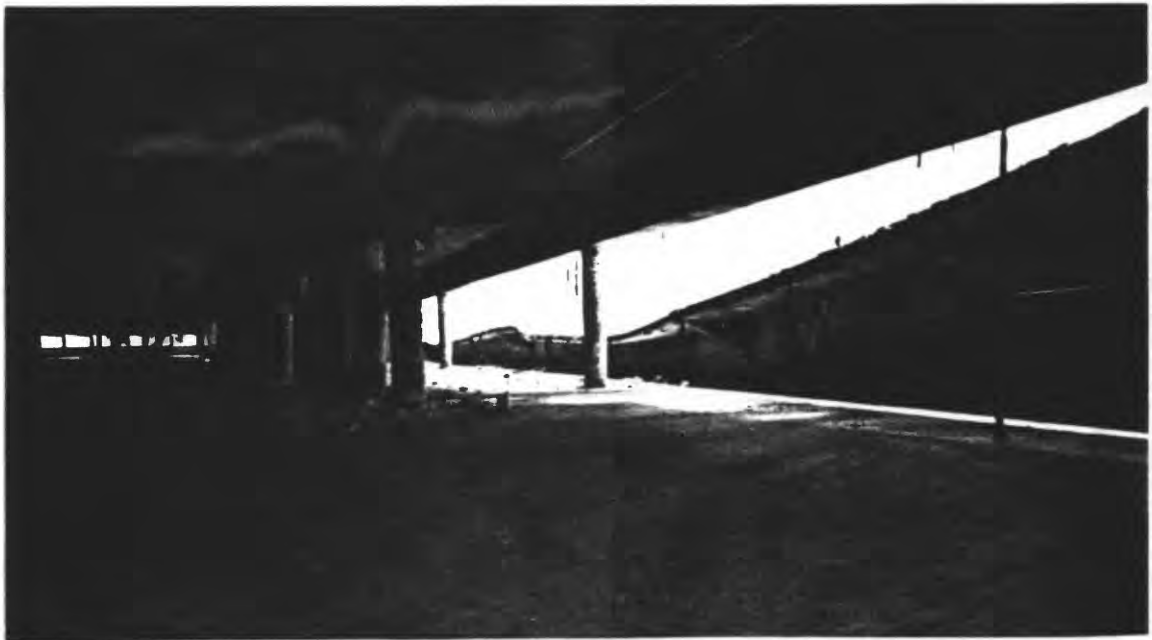
This large, two-level cast-in-place reinforced concrete structure was in part collapsed and in part very severely damaged and close to collapse. This garage, built around 1965, presents illustrative examples of design problems that should be avoided according to the present state of knowledge and modern seismic design criteria. A general view of the garage

Figure 12. Partially collapsed section of the May Company Parking Garage.

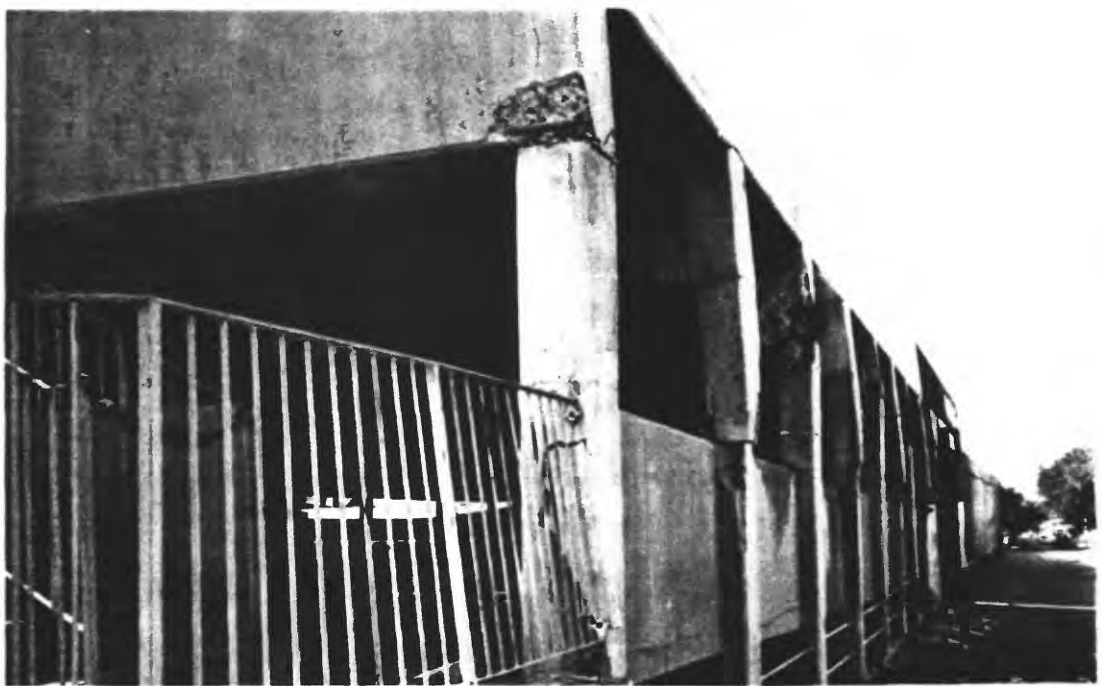
1. Very stiff exterior panels as well as deep webs of T-beams created “short columns” all around the perimeter of the building (Figure 13).
2. The 16×16 in. exterior columns were not designed for the high shear forces created by the short-column effect. The stirrups of the surveyed exterior columns were undeformed #2 bars spaced 12 inches or further apart (Figure 14).

Figure 13. Stiff exterior panels and deep webs of T-beams created "short column" effect all around the perimeter of the May Company garage building.

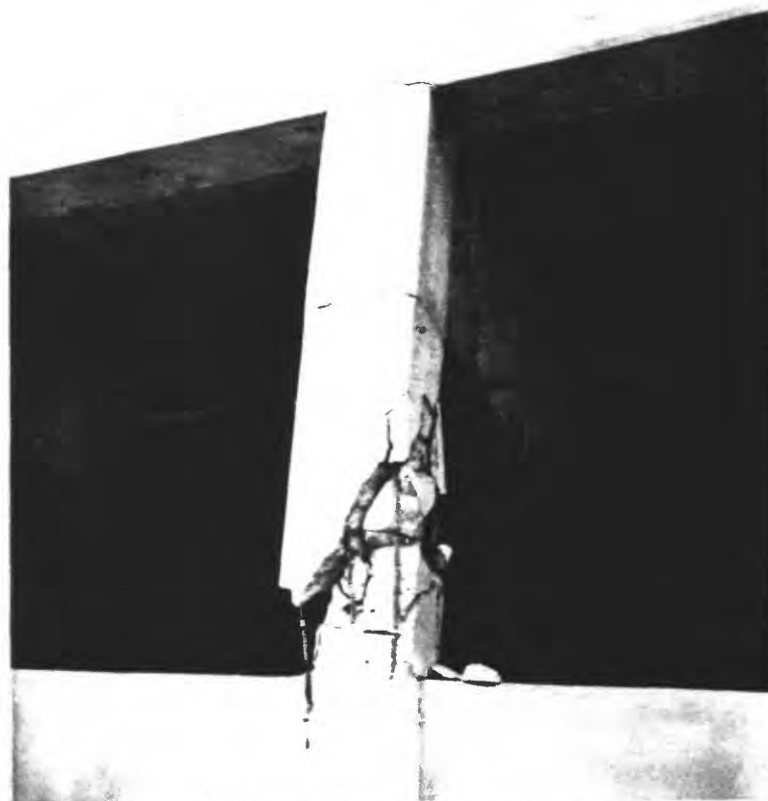
Figure 14. Shear reinforcement of exterior columns were insufficient (#2 undeformed bars spaced 12 inches or further apart). Note buckling of longitudinal bars.

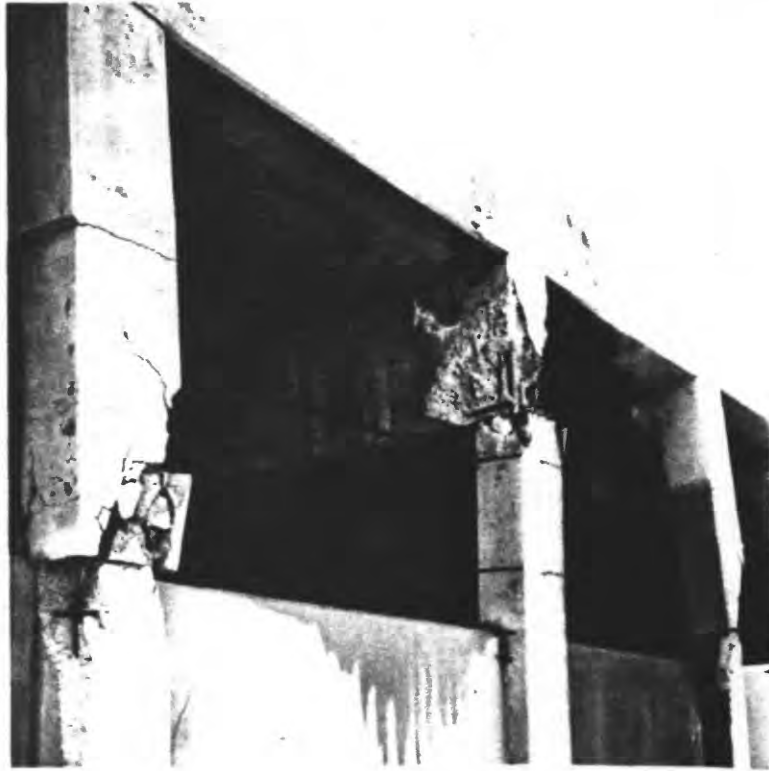
3. The joint detailing did not permit much moment transfer between the deep floor beams and the small exterior columns. The joints were not confined and the bottom bars of the beam were cut at the exterior column faces, preventing the development of positive moment at the joints (Figure 15a). In one column, a longitudinal bar was left outside the ties (Figure 15b).

Figure 15a. Beam column joints unconfined. Bottom longitudinal bar of the girder cut.

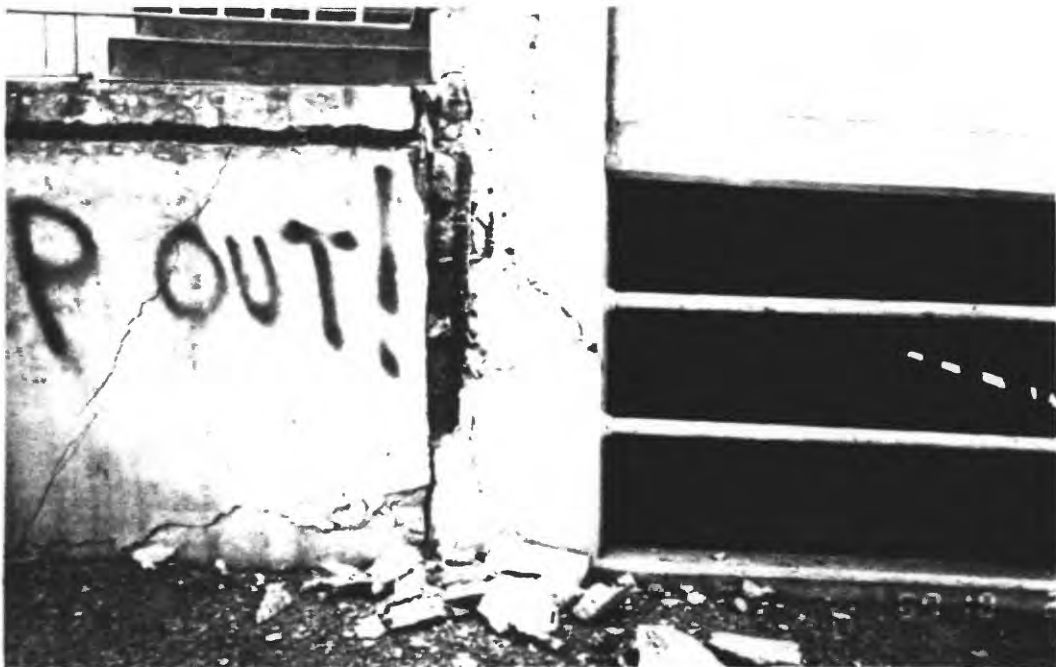
Figure 15b. Longitudinal bar in this column was left outside the ties.

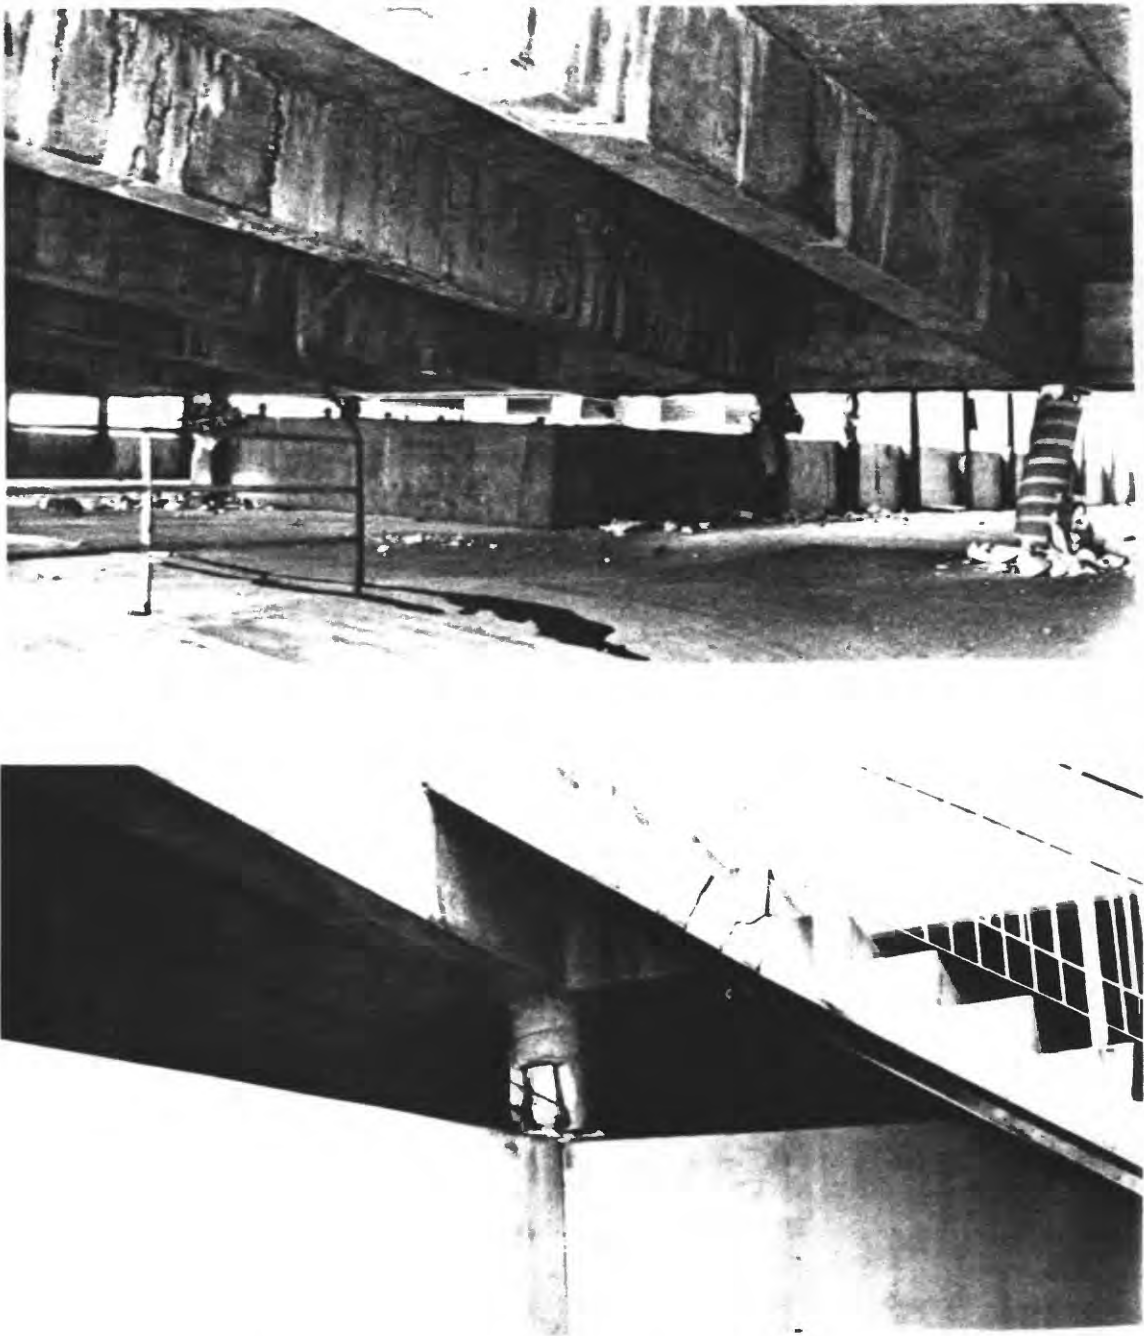
4. Bond between concrete and rebars was very poor.
5. Several of the interior circular columns had collapsed or were badly damaged and were barely able to support the heavy floor system (Figure 16).

Figure 16. Interior circular columns collapsed and barely supported the heavy floor system.

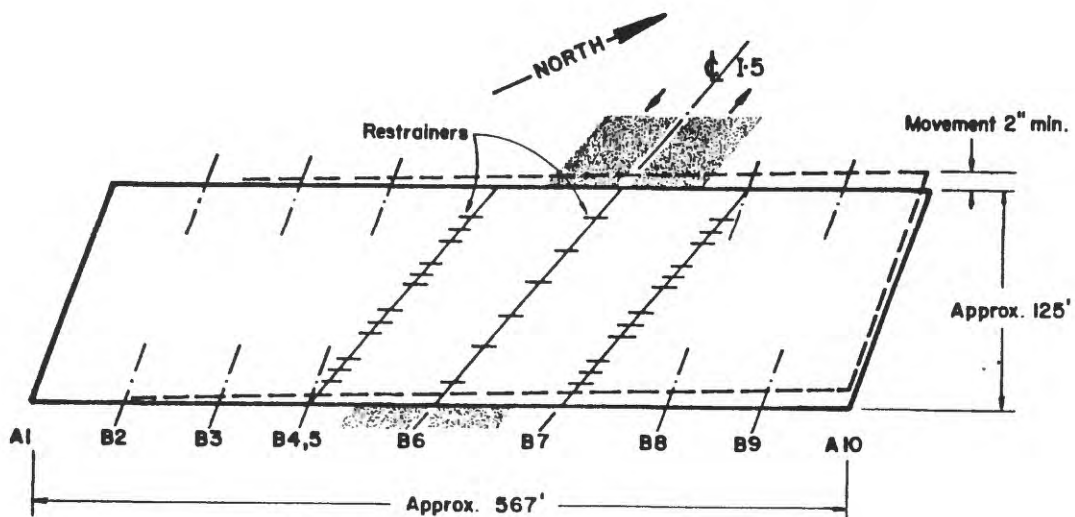
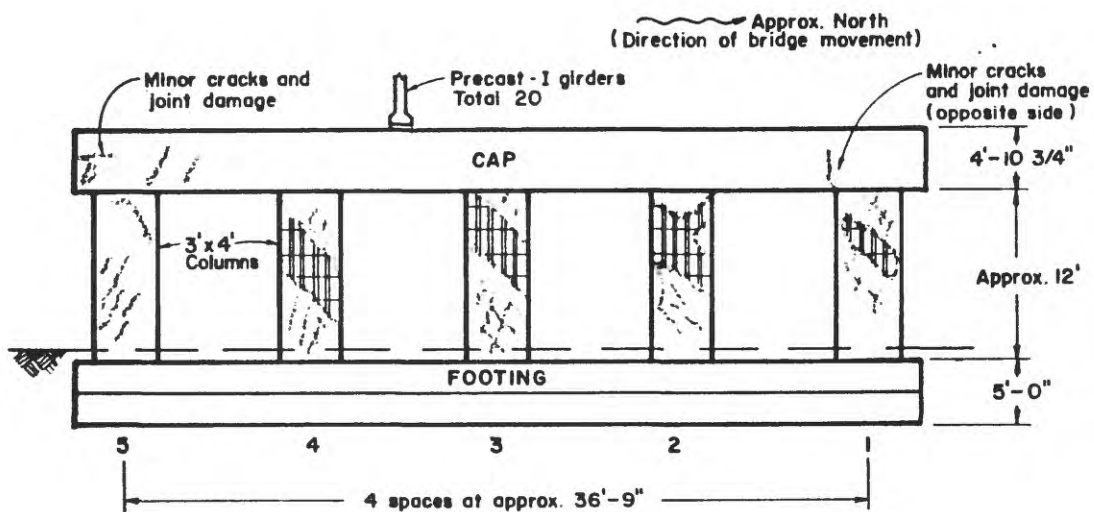
Severe structural damage was observed in the columns of an interior bent of the I-605 overpass. The overpass, constructed in 1964, is skewed and has 8 bents with five columns each (Figure 17) (J. Gates, 1987, private commun.). Figure 17 also shows the dimensions of the structure, the pattern of shear cracks and the restrainers implemented in 1981 (Klein and Mellon, 1987). Severe damage was found only in the one bent between the north- and south-bound lanes of I-5, the other bents appeared to have little or no damage. The damage consisted of shear cracking that was relatively light at the northernmost column and increased significantly in the columns further south.

Figure 17. I-605 overpass over I-5 severely damaged during the main shock. General sketch of the skewed deck and the shear crack pattern of bent #6 are shown (adapted from Klein and Mellon, 1987).

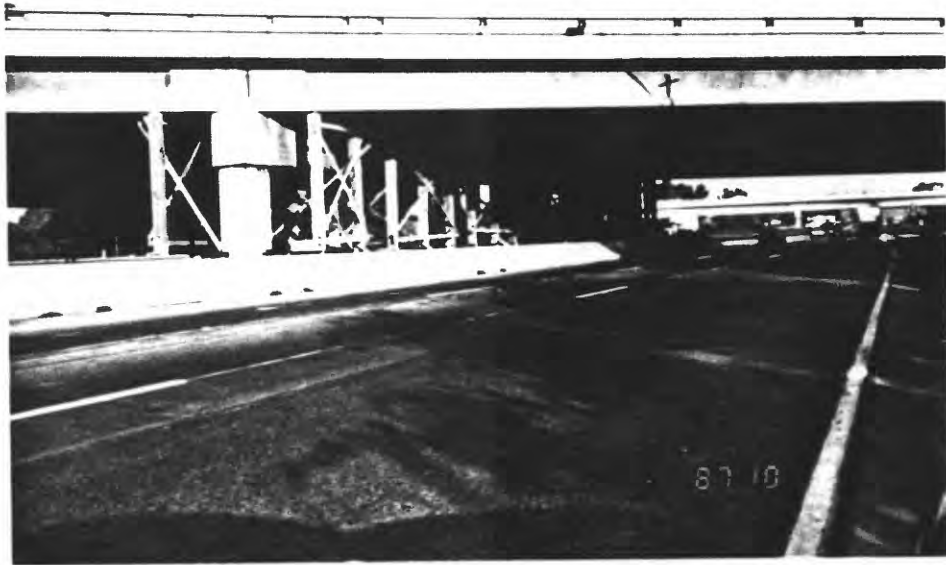
Figure 19. Temporary timber bracing and shoring to provide extra support to the I-605 overpass deck. The I-605/I-5 interchange was opened to traffic 24 hours after the main shock.

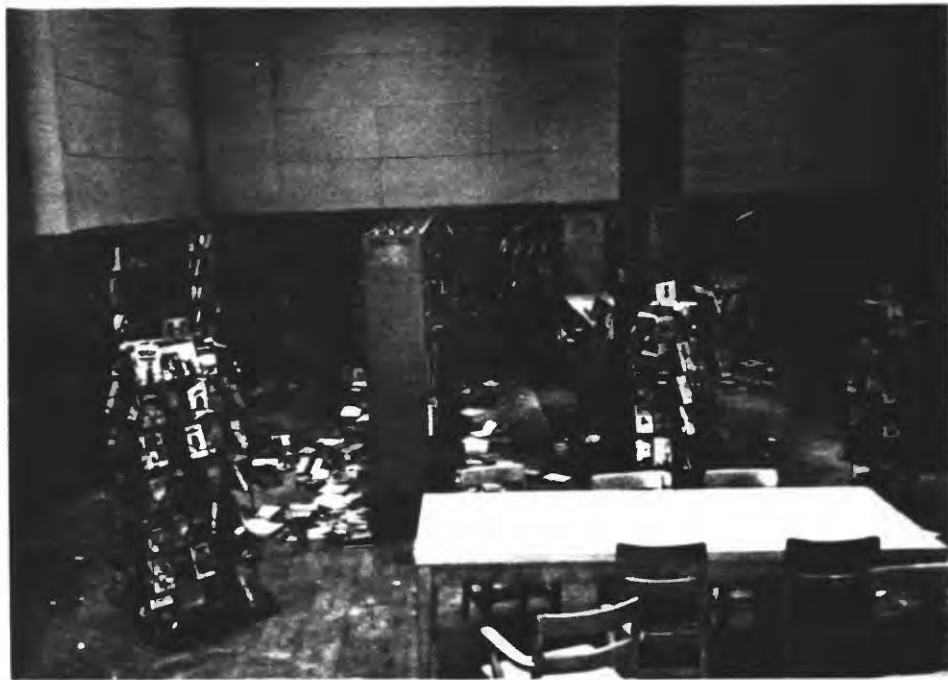
The auditorium, the administration building and the library of the school suffered minor damage. Books fell from well-anchored bookshelves in the library (Figure 20); some walls in the corridors of the administration building had small cracks; very light non-structural damage occurred in the large open auditorium.

Figure 20. The bookshelves in Whittier High School Library were anchored properly—none overturned. Only the books fell.

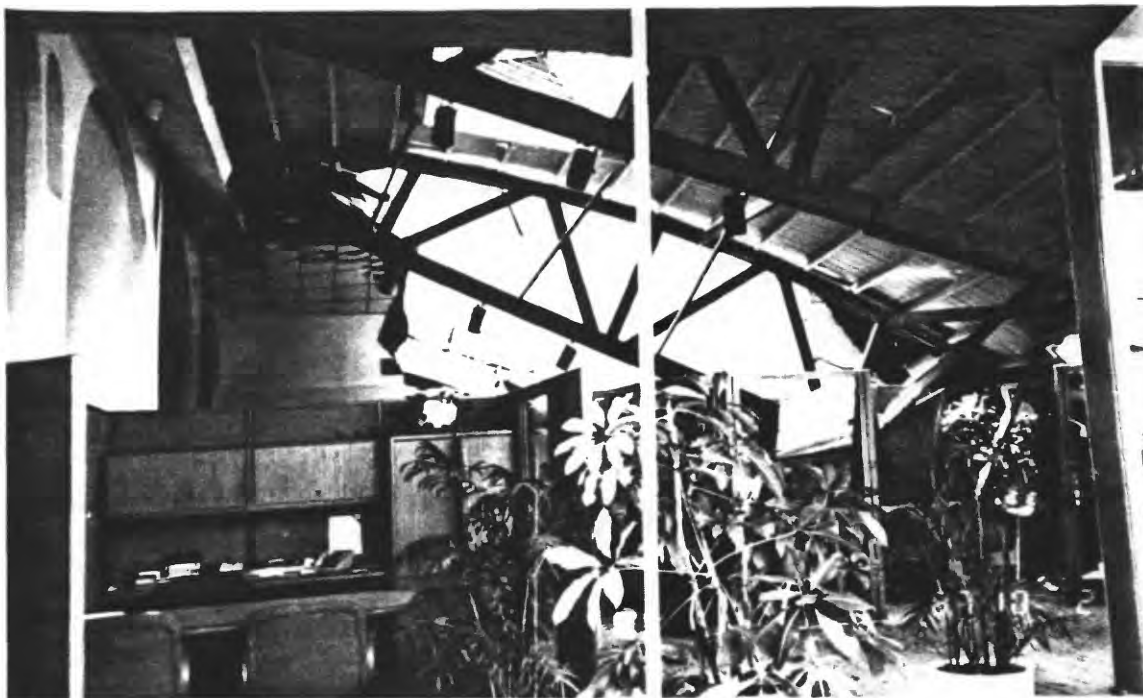
the cases observed by the field team, the damage occurred in buildings where the walls were not tied together properly. Perhaps the only surprise was that more collapses had not occurred, considering the relatively heavy ground shaking and the poor condition of many of the unreinforced masonry buildings. Although other cases may have existed, we saw only one building in the uptown Whittier area that could be considered a complete collapse. In this case the supporting wall of the roof trusses was sufficiently damaged to cause a cave-in of the roof trusses (Figure 21).

Figure 21. The supporting wall of the roof truss sufficiently damaged to cause a cave-in of the roof trusses.

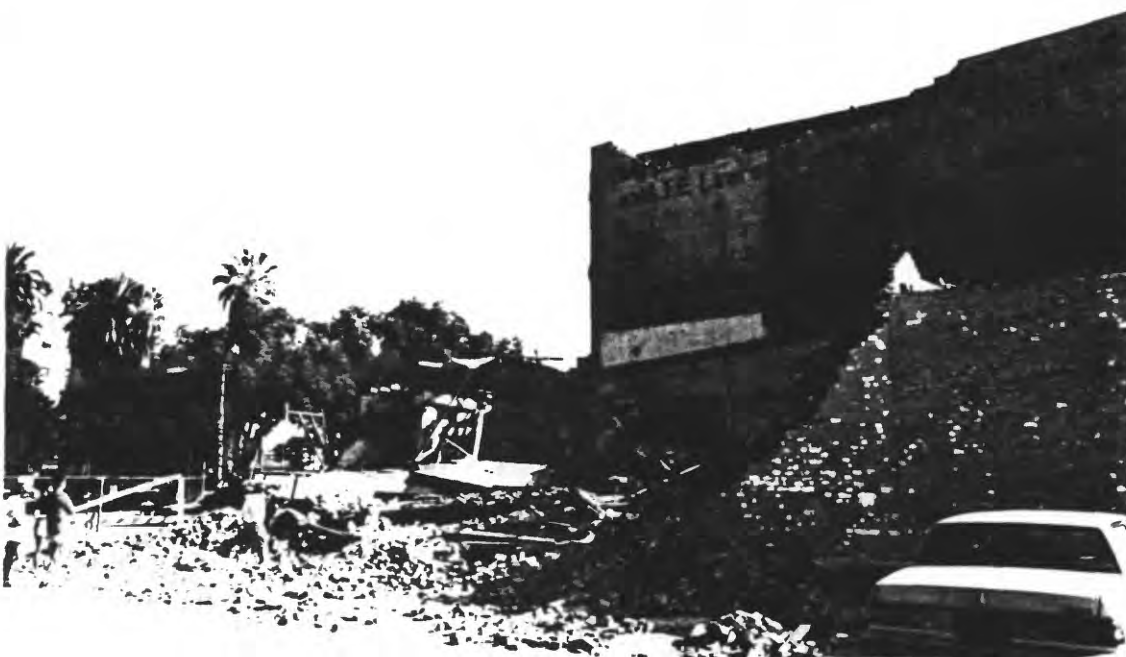
A complete collapse of an unreinforced masonry building occurred in Pasadena at the corner of Green and Fair Oaks (Figure 22). Again, this collapse is no surprise as engineers had pointed out the poor condition of this building in the past. Next to this collapsed building, another building that was being retrofitted suffered no significant damage (Figure 23), except that the upper part of the back wall fell onto the collapsed structure (seen in Figure 22).

Figure 22. Collapsed unreinforced masonry building in Pasadena (corner of Green and Fair Oaks). The building in the background (next figure) was being retrofitted and the top part of the back wall fell onto the collapsed structure.

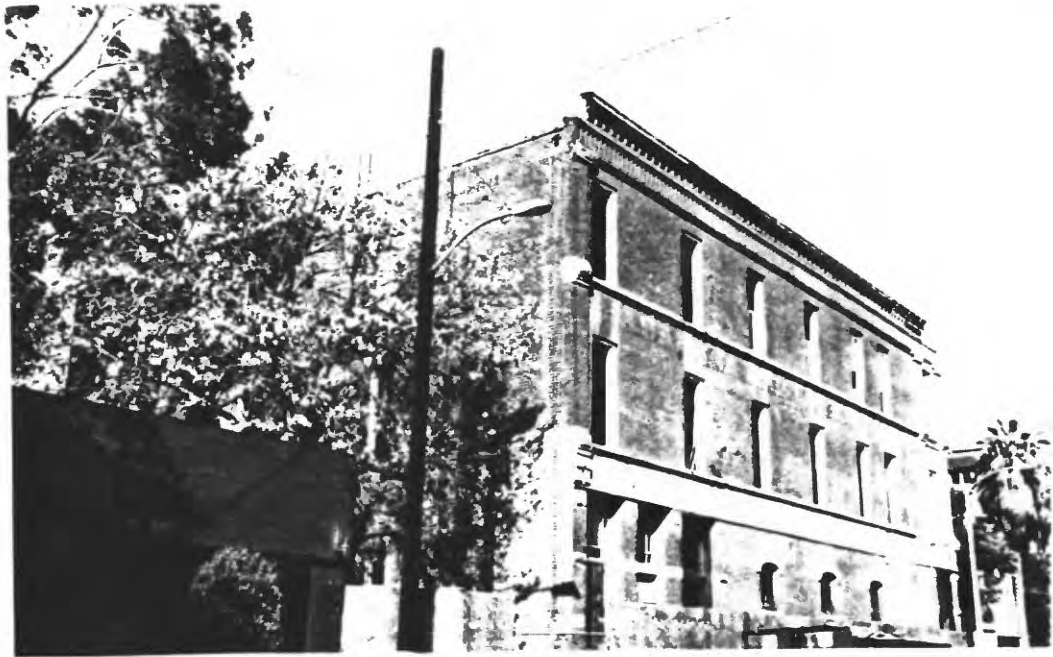
Figure 23. Next to the collapsed building (previous figure), this unreinforced masonry building, being retrofitted, did not exhibit significant damage other than the top part of the back wall.

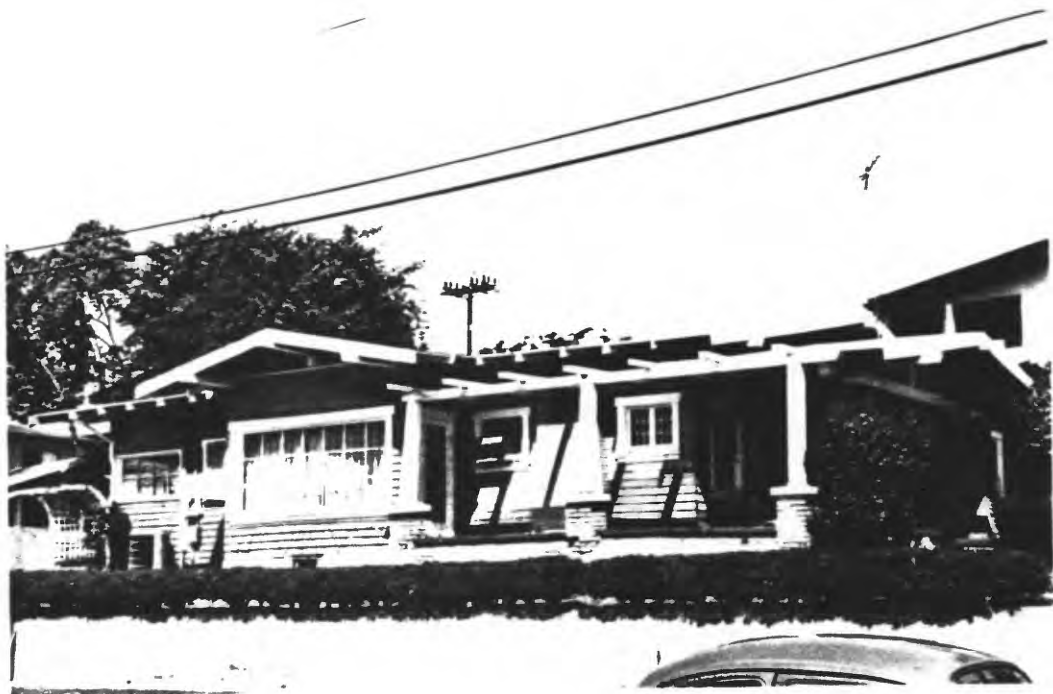
Damage to residential housing was evident in the hills of north Whittier, particularly around Beverly Boulevard. Timber houses fared rather well, with damage limited primarily to collapsed or cracked chimneys (Figure 24) and distorted porches and garage doors. In some of the masonry houses the damage was severe and of the type shown in Figure 25.

Figure 24. Collapsed chimney of a timber house in Whittier.

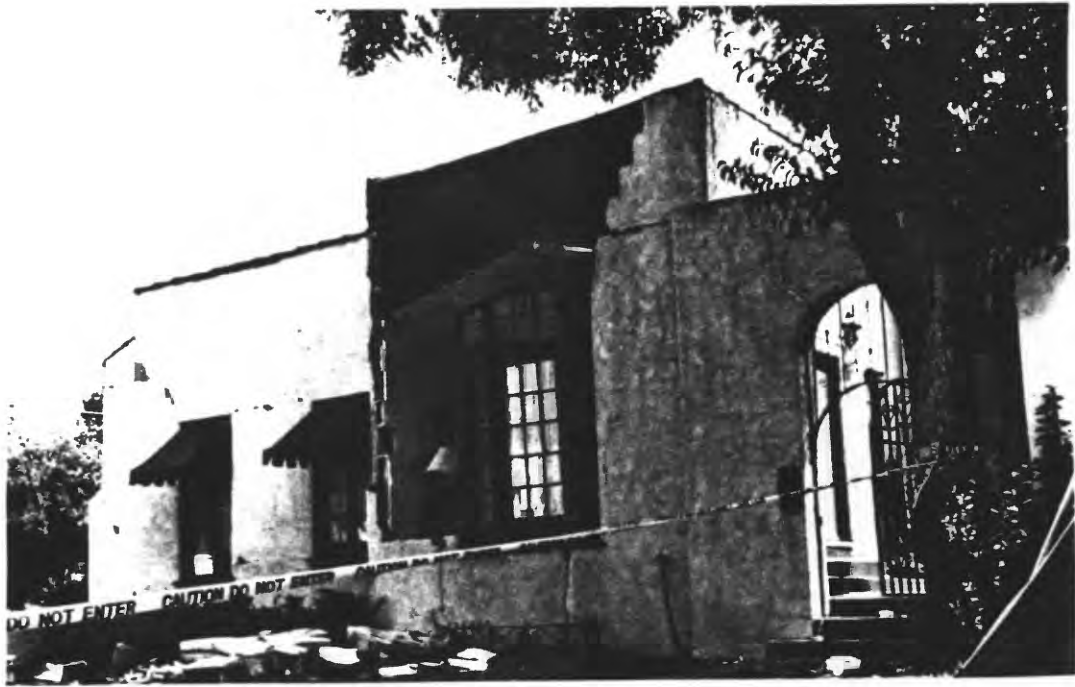
Figure 25. Partial front wall of this residence in Whittier collapsed.

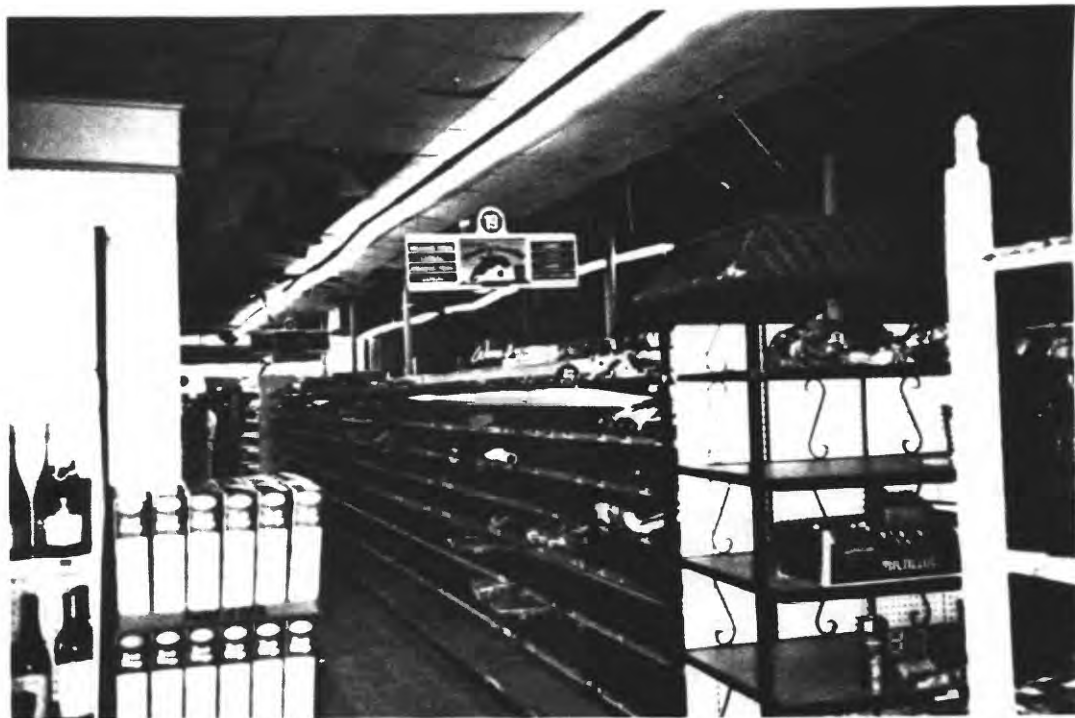
Nonstructural damage was evident in most places that were subjected to severe ground shaking. Most observers very commonly saw fallen ceiling panels (*e.g.*, California State University at Los Angeles, Lucky store in Whittier), damage to shelved goods (library at Whittier High School, Lucky store), cracks in infill walls and between infill walls and framing, shattered glass, and deformations around expansion joints. A view from the Lucky store in Whittier is seen in Figure 26.

Figure 26. A view of the Lucky store in Whittier. The hanging ceiling damaged and groceries displaced from the shelves.
