U.S. Department of the Interior
Geological Survey

**Vibration Investigation of the Museum Building at
White Sands National Monument, New Mexico**

Open-File Report
88-544

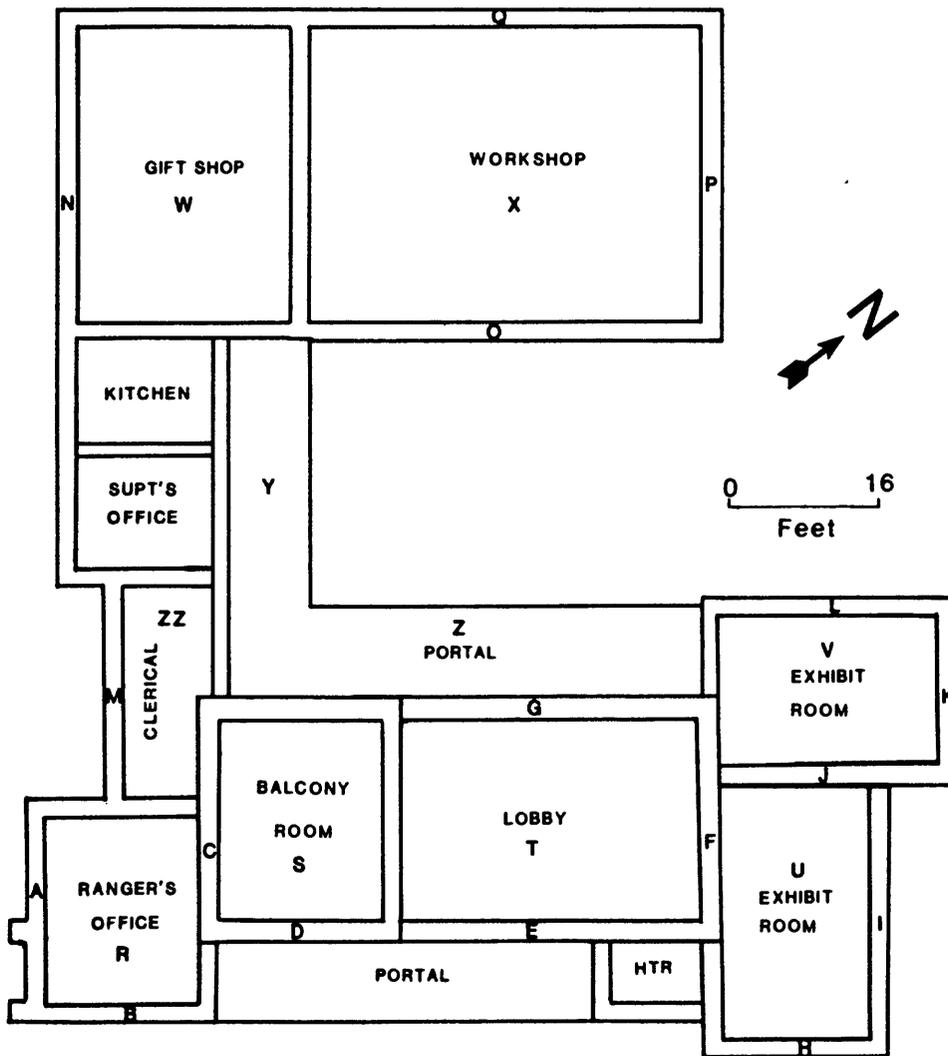
Fig. 2. (A) White Sands National Monument Museum and Administration Building, front view (Southeast elevation). (B) plan view showing wall and roof identifiers and locations of long-term instruments.

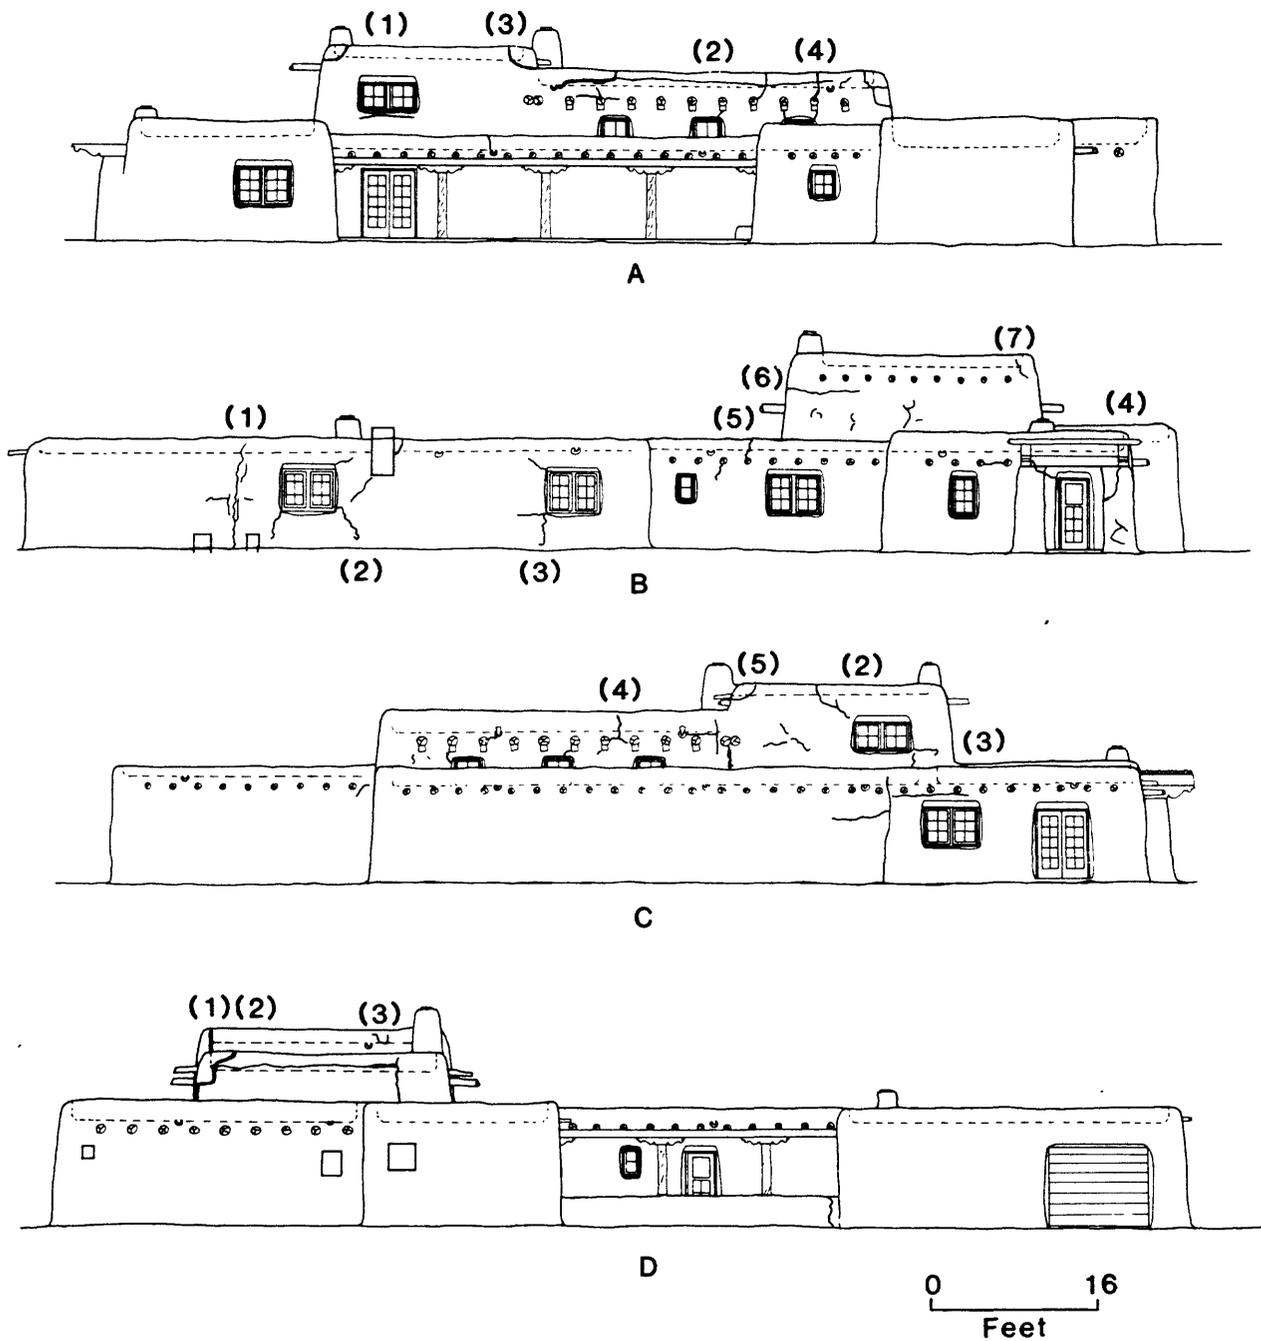
A visual inventory and photographs were taken of all wall cracking to document the damage for current and future studies. The more apparent cracking is shown in figures 3 A, B, C and D. The cracking which passes or extends through the gunnite covering and into or through the adobe material is in areas where dissimilar materials (adobe, concrete block, wood) are joined (fig. 3 B-1); at or near window-mounted air-conditioner supports (figs. 3 B-2-3 and C-3); at window and door headers (figs. 3 A-1-2, B-2-4, C-2); and at viga-parapet-roof junctions (figs. 3 A-3-4, B-5-6-7, C-4-5, D-1-2-3). All of these places are typical areas of stress concentration resulting from the load-bearing elements of the construction or from the addition of elements such as air conditioners and vents. The basic construction elements concentrate the stress but generally, the actual initiation of cracking is probably from differential settlement, thermal expansion-contraction, moisture expansion-contraction, vibration, or a combination of all of these sources.

The extent of cracking was used to assign a damage scale to the building. The measurement or scaling the degree of damage to the building was necessarily subjective and was done according to the methods developed during the Chaco Canyon, Hovenweep, and Paguate studies which gave a basic frame of reference (King et al. 1985, King et al. 1986, King et al. 1987). The damage scale derived from those studies range from a degree of 1 (which consists of light visible cosmetic cracking) to a degree of 5 (which has visible structural damage as cracking, movement or distortion present on interior and exterior walls which are wider or greater than 12 mm and longer than 10 cm in length) (table 1). The extensive cracking shown in figure 3 A on the parapet walls has a maximum cracking that is 2 to 8 mm wide and up to 25 cm in length. The average cracking generally falls into the range of degree of 3 to 4. No apparent visible evidence was found to indicate that the damage was caused by differential settlement or by thermal effects (except in the areas of adobe and concrete block wall junctions). It is suspected that moisture, although not a primary cause of the damage, could have accelerated the damage once the initial crack was formed.

Fig. 3. Elevation views of the Museum and Administration building showing the prominent visible wall cracks. Small numbers identify cracks discussed in text. (A) Southeast elevation, front, (B) Southwest elevation, back, (C) Northwest elevation, back, (D) Northeast elevation.

The areas of major cracking shown in figures 3A-3, 4, 3B-6, 3C-5, and 3D-1, 2 and 3 are at probable structurally-weak locations at the junction of the parapets and the vigas. There were no strong indicators that differential settlement or major thermal-moisture changes are the cause of this particular area of damage. The cause of cracking is probably a combination of a junction of material difference (wood, adobe, gunnite), a structural design that incorporates vigas which help concentrate the stress in an area of low support (the parapets), and the continuous roof diaphragming and wall shaking. If a new covering is put on the outside of the lobby walls, the parapets should be re-engineered and rebuilt to better absorb the stress induced by the vigas. The cracking near the windows on side B (fig. 3) 2 and 3 are probably due to the increased stress from the window mounted air conditioners. The air conditioners on side D which are independently supported away from the structure have caused no damage to the building. The cracking present at B-4 is probably due to a change of stress due to the removal of the vigas and colonnades which supported a portal that has been removed; this area should stabilize over a period of time. The major cracking at B-1 is due to the joint of dissimilar (thermally different) materials (cement block and adobe). An elastic-type material will be needed for rehabilitation of this section since either adobe or cement-gunnite will continue to crack due to the difference in the thermal expansion rates. It is probable that all the cracking in these areas of weakness has been accelerated by induced vibrations.

We would recommend the 2 mm/sec level for the structures at White Sands National Monument. If this is adopted, then the normal take-off pattern used by the nearby airport would be acceptable, but the low-flying helicopters and low-flying, high-speed jet aircraft flying within a few thousand feet of the structures would not be acceptable. Also, additional road construction or heavy earth-tamping should not be nearer than approximately 200 feet of the main museum building. This vibration level is recommended only for historic, irreplaceable adobe-masonry structures or for those structures that may have irreplaceable mud-adobe artifacts within.

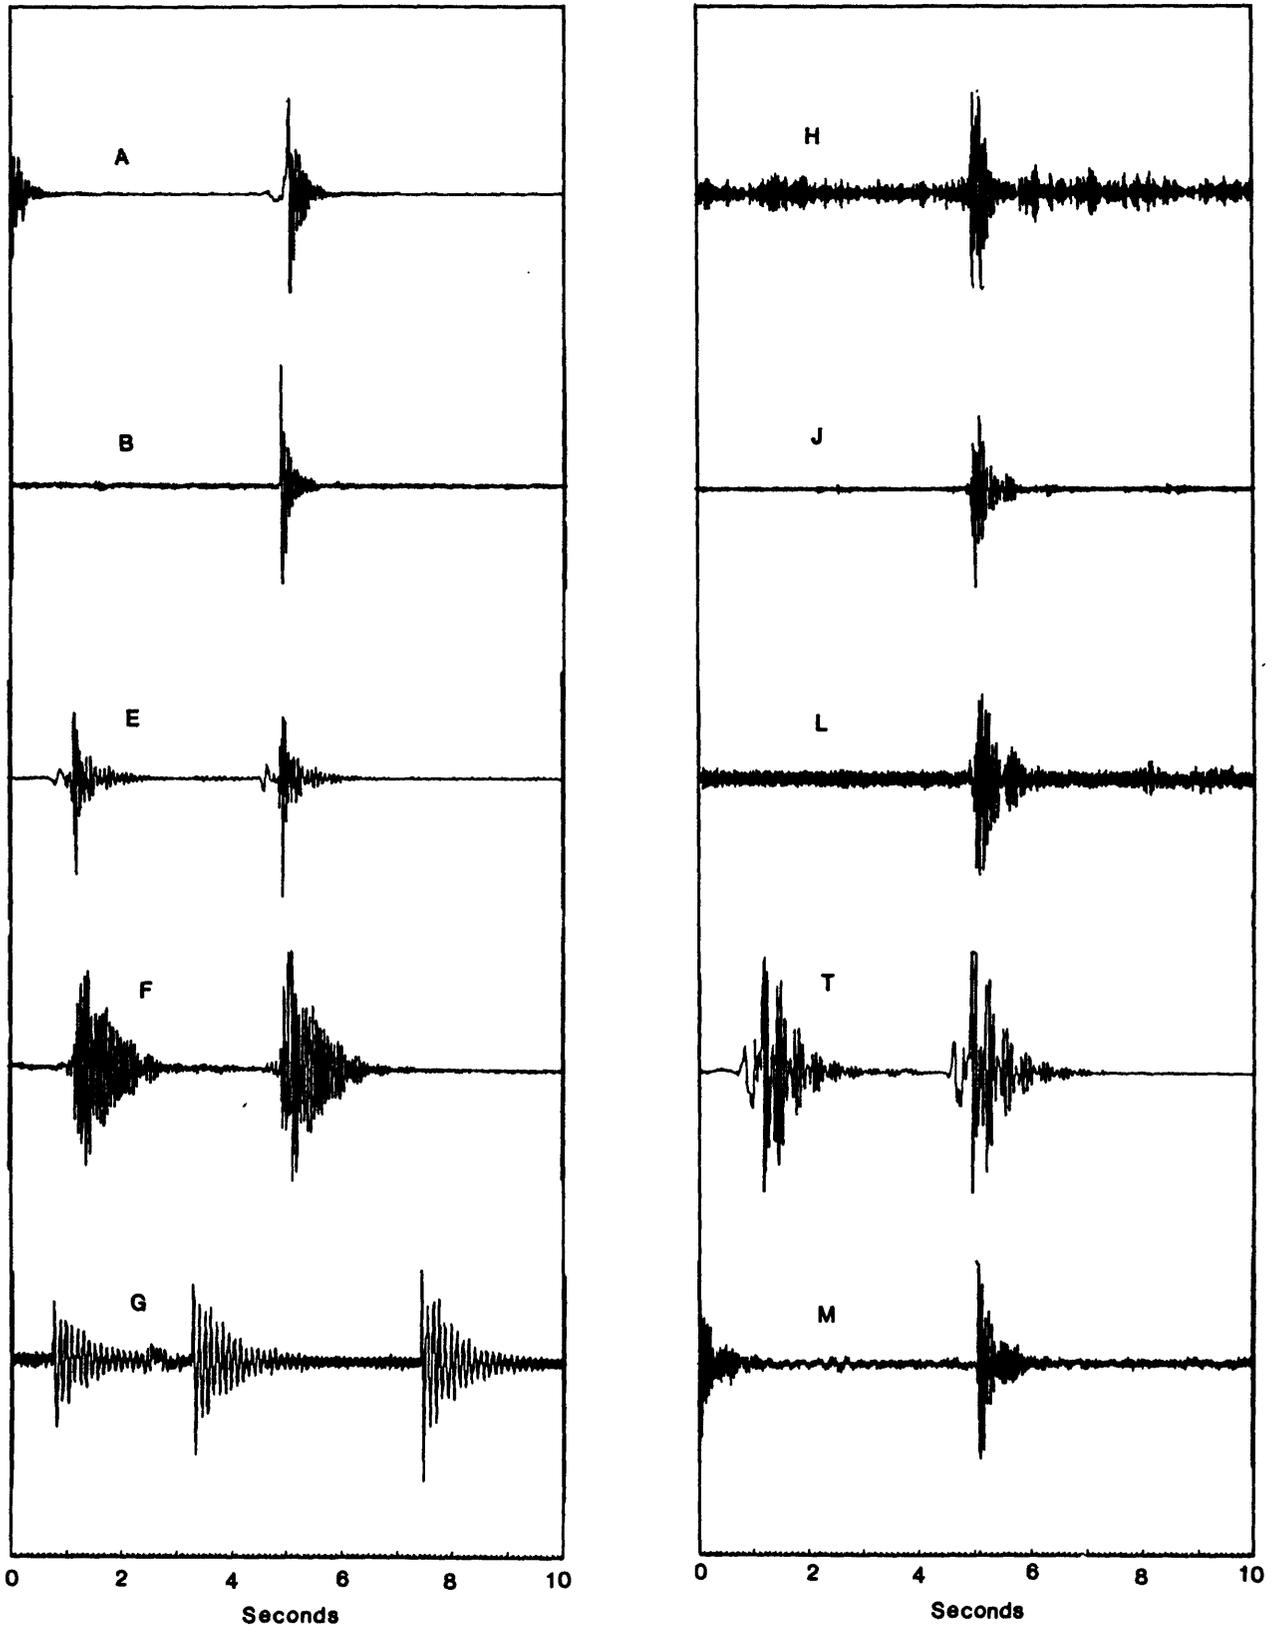
The records of the induced vibrations were analyzed to determine the response of the walls and roofs. Vibration time histories of some of the tests are shown on figure 4.

Fig. 4. Examples of wall and roof vibration velocity time histories from wall tests. Amplitudes are normalized to display space. Letters refer to wall identifiers shown on Fig. 2. "T" is the lobby roof.

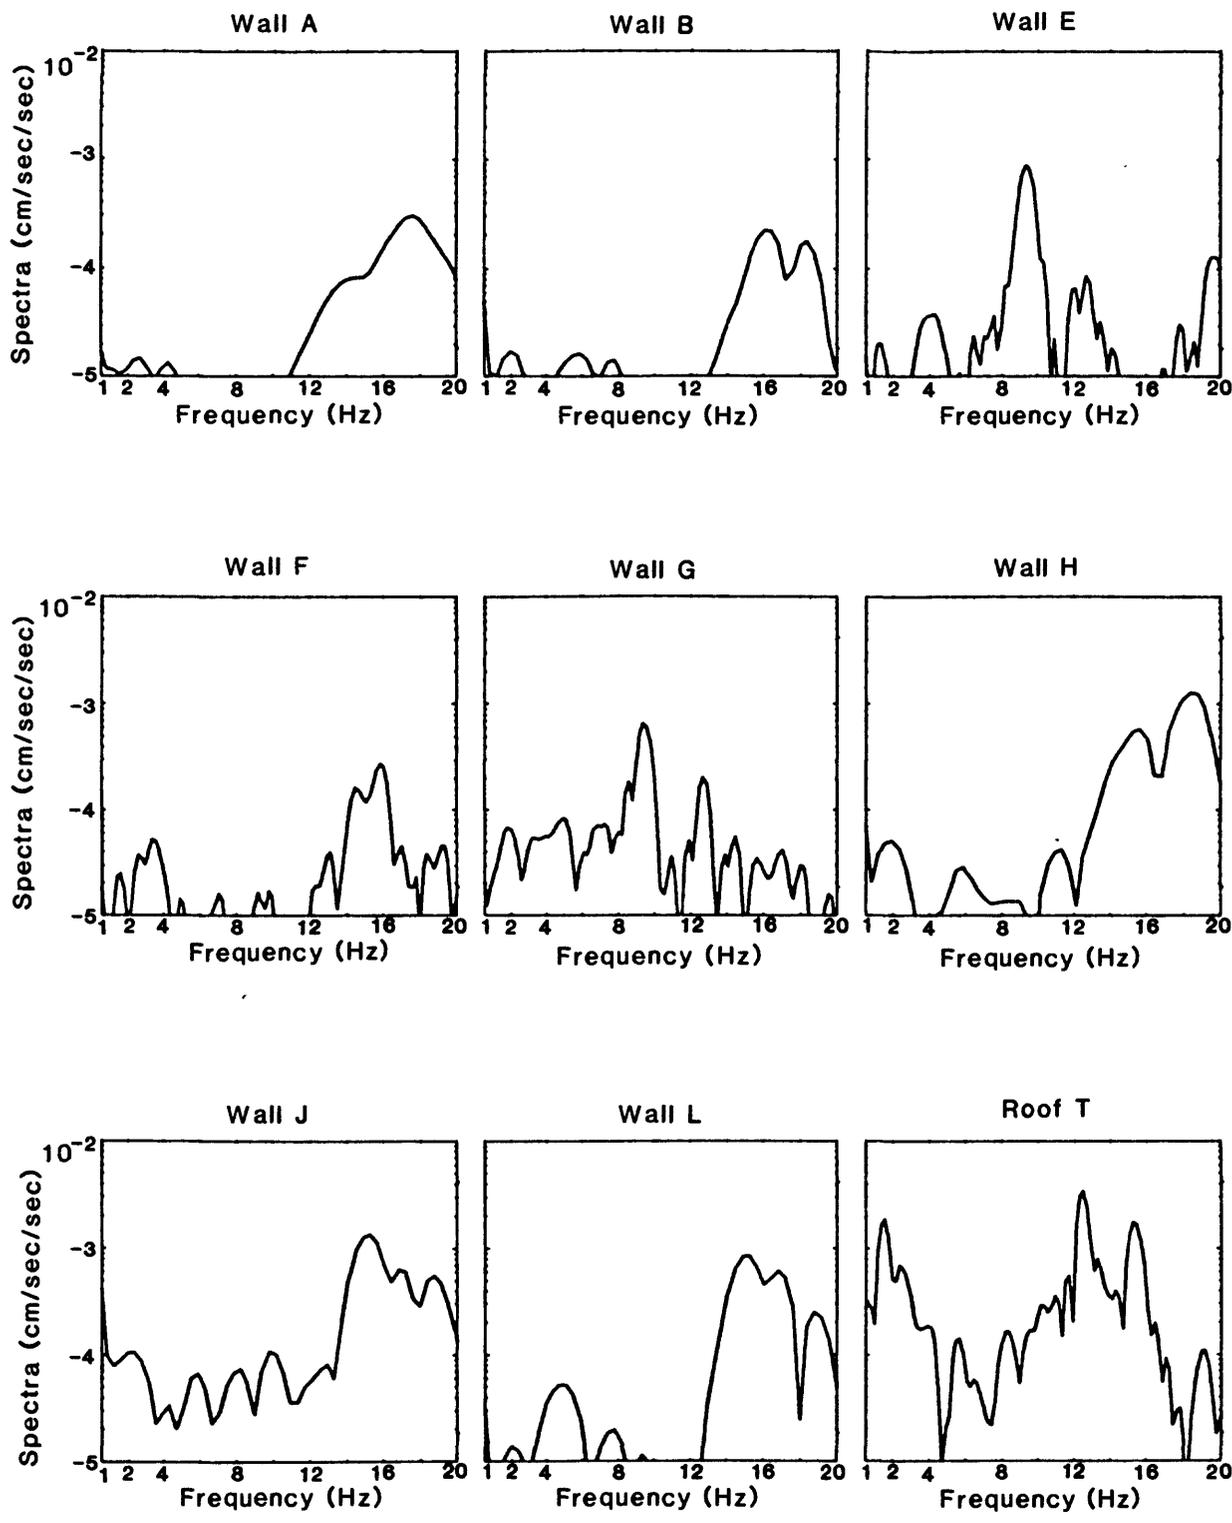
The peak frequency determined from the spectrum derived from the wall test data was considered to be the frequency to which the wall was most sensitive (fig. 5 and table 2). Many of the secondary peaks derived by the spectral analysis as shown in figure 5 are either harmonics of the natural frequency of the wall, or induced motions from adjacent walls/roof, or secondary torsional motions. The wall-roof vibrational frequency of most concern ranged from approximately 9 to 22 Hz (table 2).

where b is the percent critical damping and X_n is the velocity amplitude for the nth cycle of motion. The percent of critical damping for the walls and roofs ranged from 2 percent to 5 percent of critical. The natural frequencies of the roofs (figs. 5 J, L and T) are within the same general frequency range as the walls but, in general, have lower damping coefficients (Table 2). These frequencies and damping values are generally comparable to those found in one-to-two story structures (King and Algermissen, 1985, King and others, 1986). It is interesting to note that the vibration frequencies of the roofs (due to diaphragming motion) is similar to the walls but the damping of the roof structure is slightly lower for the diaphragming motion. In general, the roof beams (vigas) are approximately the same length as the walls are high, which accounts for the similar natural frequencies. But the roofs do not have the additional support (and added stiffness) from bearing walls, braces and foundations which explains the difference in the damping between the roofs and the walls.

Fig. 5. Examples of spectra (FFT) derived from the time histories of the vibration tests. The spectra show the predominant peaks at the wall's natural frequencies.

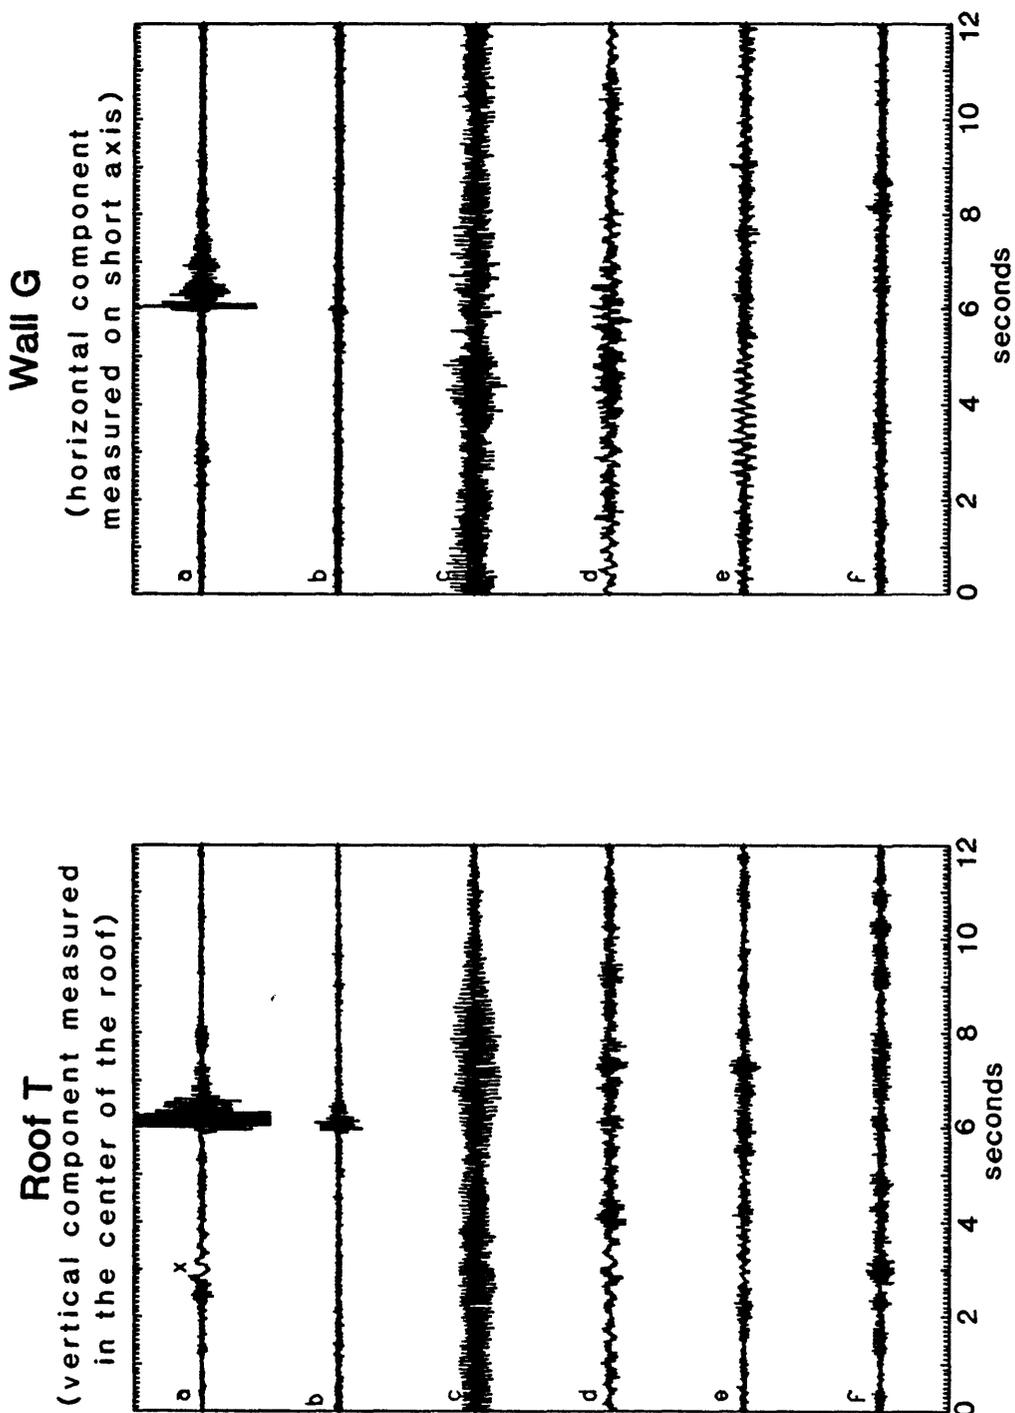
Fig. 6. Examples of vibration velocity time histories from and instrument located on a roof (T), and a wall (G). The vibrations were induced by specific and identifiable events (visual observations): (A) low-flying, high speed jet aircraft (F-15?) within 3,000 ft. of the museum. (B) High flying, high-speed jet aircraft (F15?) higher than 3,000 ft. over the museum. (C) Helicopter flying within 3,000 ft. of the museum. (D,E) Pairs of F15's(?) flying in the normal take-off pattern. (F) Vibrations induced by a semi-trailer truck on the interstate adjacent to the building traveling at approximately 60 mph. (x) Ground coupled acoustic waves arriving before the acoustic signals traveling a direct path to the building. All amplitudes normalized to (A).

higher level than the vibrations from heavy vehicles but considerably lower than the vibrations induced by the helicopters and the single high speed jet aircraft. It was apparent that the take-off pattern of the aircraft was such as to avoid overflights of the National Park structures. The helicopter and the single high-speed jet aircraft were not in the take-off pattern and were at a near over-flight attitude to the structures and therefore, were closer to the buildings by several thousand feet. This project was not designed to test the broad scope of acoustic effects; therefore, the true azimuth and distances to the aircraft and parameters of the aircraft (weight and speed) could not be accurately documented, but the general altitudes and distances were visually estimated, with estimates shown in figure 6.

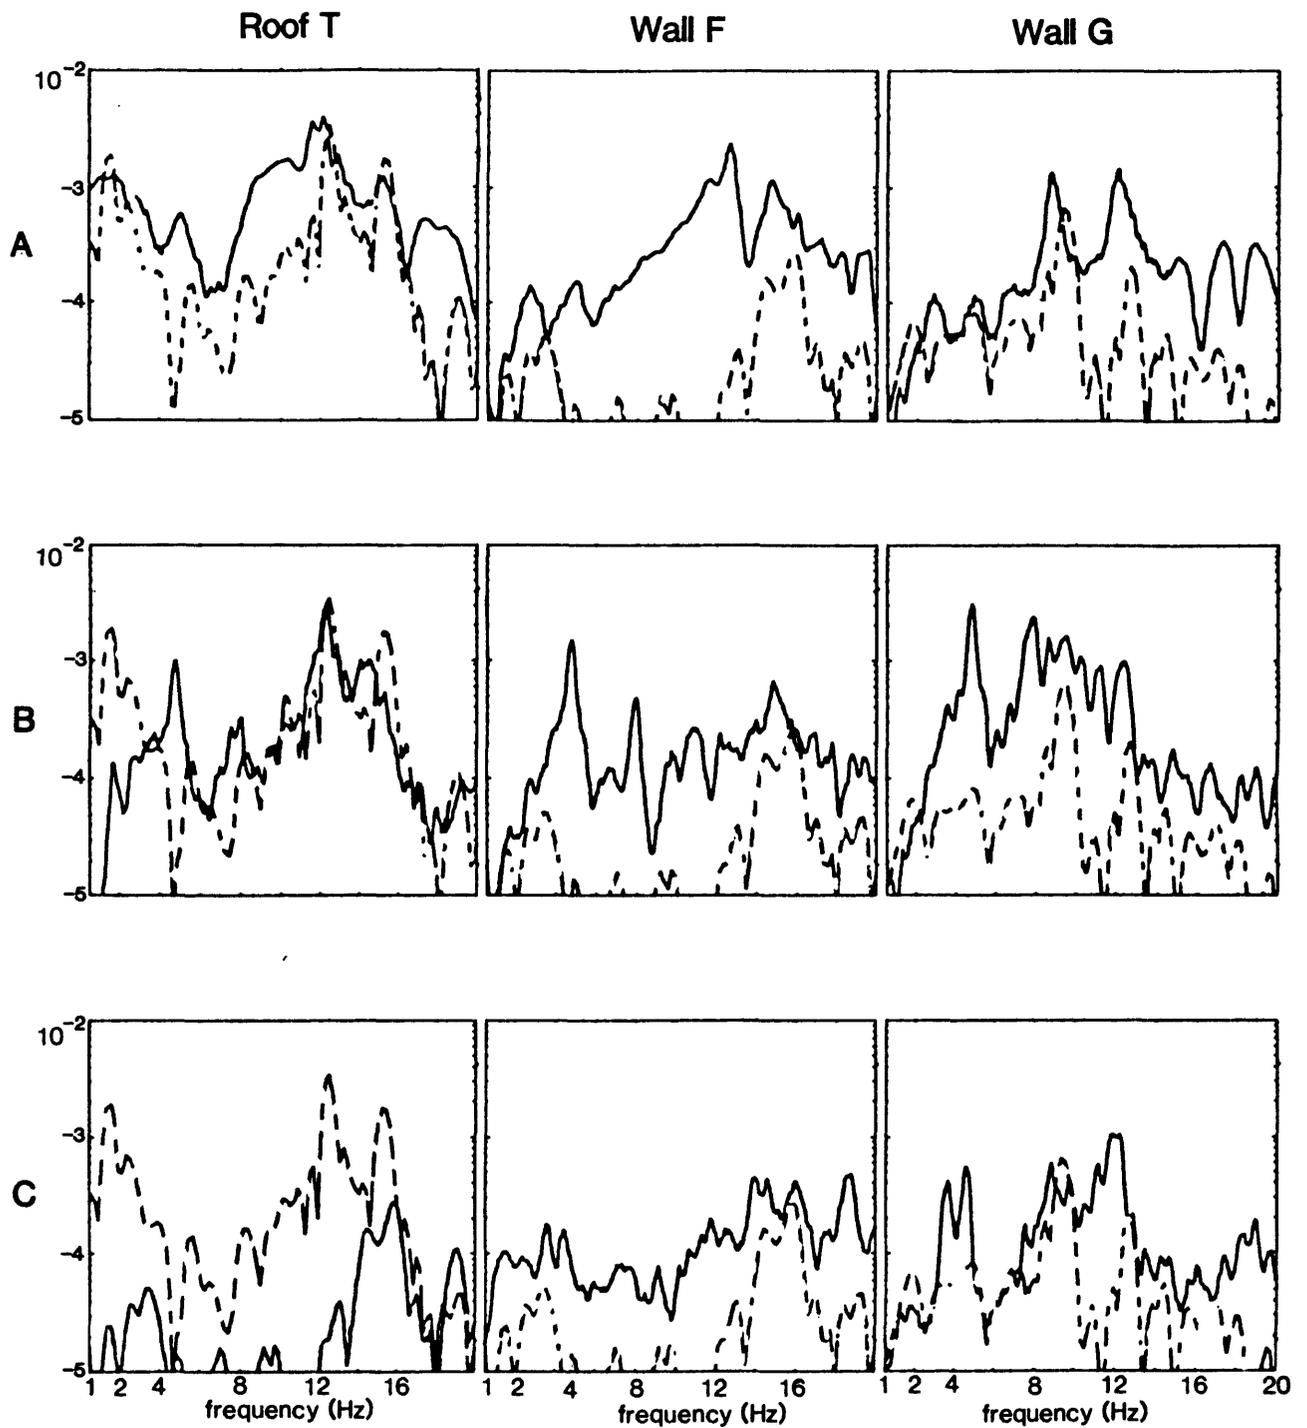
The spectra derived from the event data from induced sources, such as aircraft and vehicular traffic, were compared to the wall-testing data. The comparisons of event spectra with the wall test spectra show that the wall tests do accurately indicate those frequencies which will be excited and amplified by the structural elements during induced vibrations to the structure (fig. 7). The tests indicate the general energy level increase (and in what frequency band) that is introduced to the structure from external ground motion sources.

Fig. 7. Comparisons of the spectra derived from the wall tests (dotted lines) and the identified events (solid lines) on a roof(T) and two walls (F and G): (A) Low-flying, high-speed jet aircraft. (B) Pair of jet aircraft (F15's?) on normal take-off pattern. (C) Semi-trailer truck on the interstate highway. Amplitudes normalized to display space.

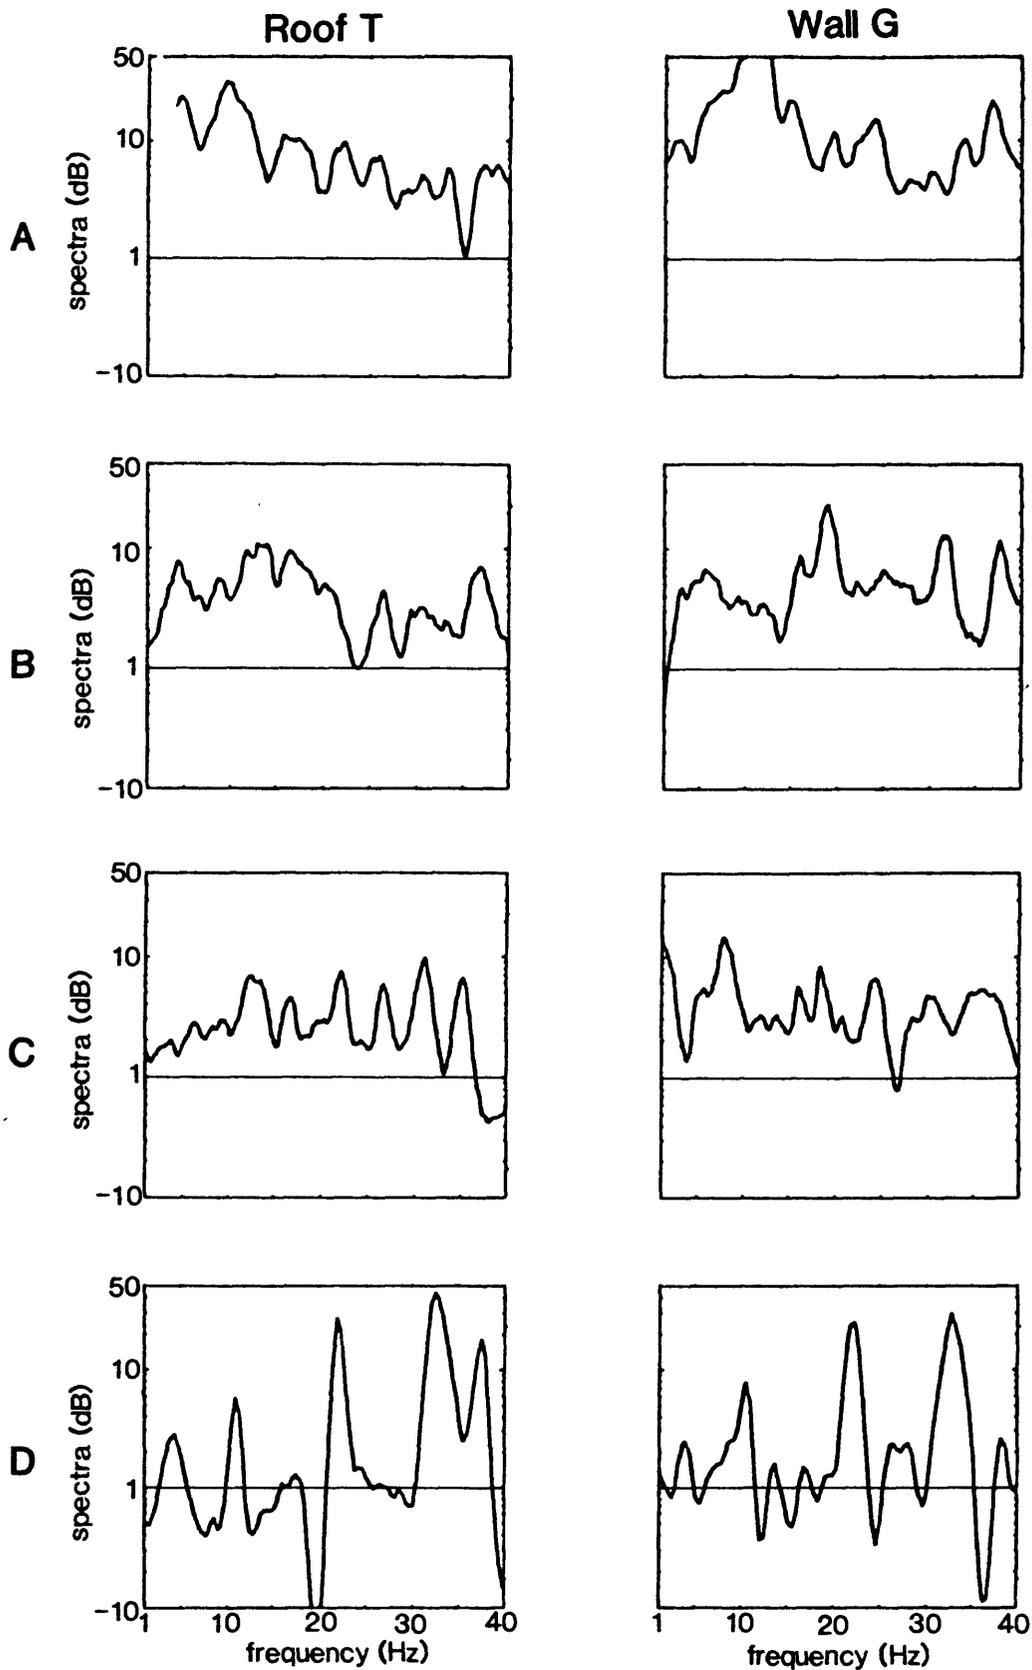
The event data from the induced sources were compared to the ambient vibration background of the structures. A similar time duration of ambient vibrations measured at the same positions on the building were transformed into velocity spectra. The ambient vibration durations for analysis were selected from seismic records at a time position of either approximately 5 to 10 seconds pre-event or 60 to 100 seconds post-event. The spectra of the ambient background was divided into the spectra of the induced sources as: $CF(f) = SS(f)/AS(f)$ where f = frequency in Hz, CF = comparison factor, SS = Source spectrum. AS = ambient or general background spectrum. These analyses indicate the general frequencies and intensity levels induced from several sources as compared to the ambient vibrations at that time. The heavy traffic on the highway and aircraft in the take-off pattern induced a general level of vibration in the structure wall and roof approximately 2 to 8 times the ambient level across the 1- to 40-Hz frequency band. The induced vibrations from the low flying, high-speed jet aircraft and the helicopter introduced the highest contrasts to the vibration ambient background level (fig. 8). These results are similar to those shown by the peak amplitudes on the vibration time histories. The high-speed, low-flying jet aircraft introduced a general vibration level to the building that was 10 times the ambient background with some selected frequencies as high as 60 times the ambient background level of that particular time period. The vibrations from the helicopter induced a narrow frequency band; that is, the induced frequency spectral width was less than the induced frequencies from the other sources. The helicopter induced peak vibrations at 10.5, 21.5, and 32 Hz frequencies. These selected frequencies induced motions in the roof and wall that were approximately 30 to 40 times higher than the ambient levels.

Fig. 8. Spectral ratios obtained by dividing the spectra derived from ambient vibrations and the vibrations induced by a specific event on roof T and wall G (Fig. 2): (A) Low-flying, high-speed jet aircraft. (B) Pair of jet aircraft flying in normal take-off pattern. (C) Semi-trailer truck on the interstate highway. (D) Helicopter.

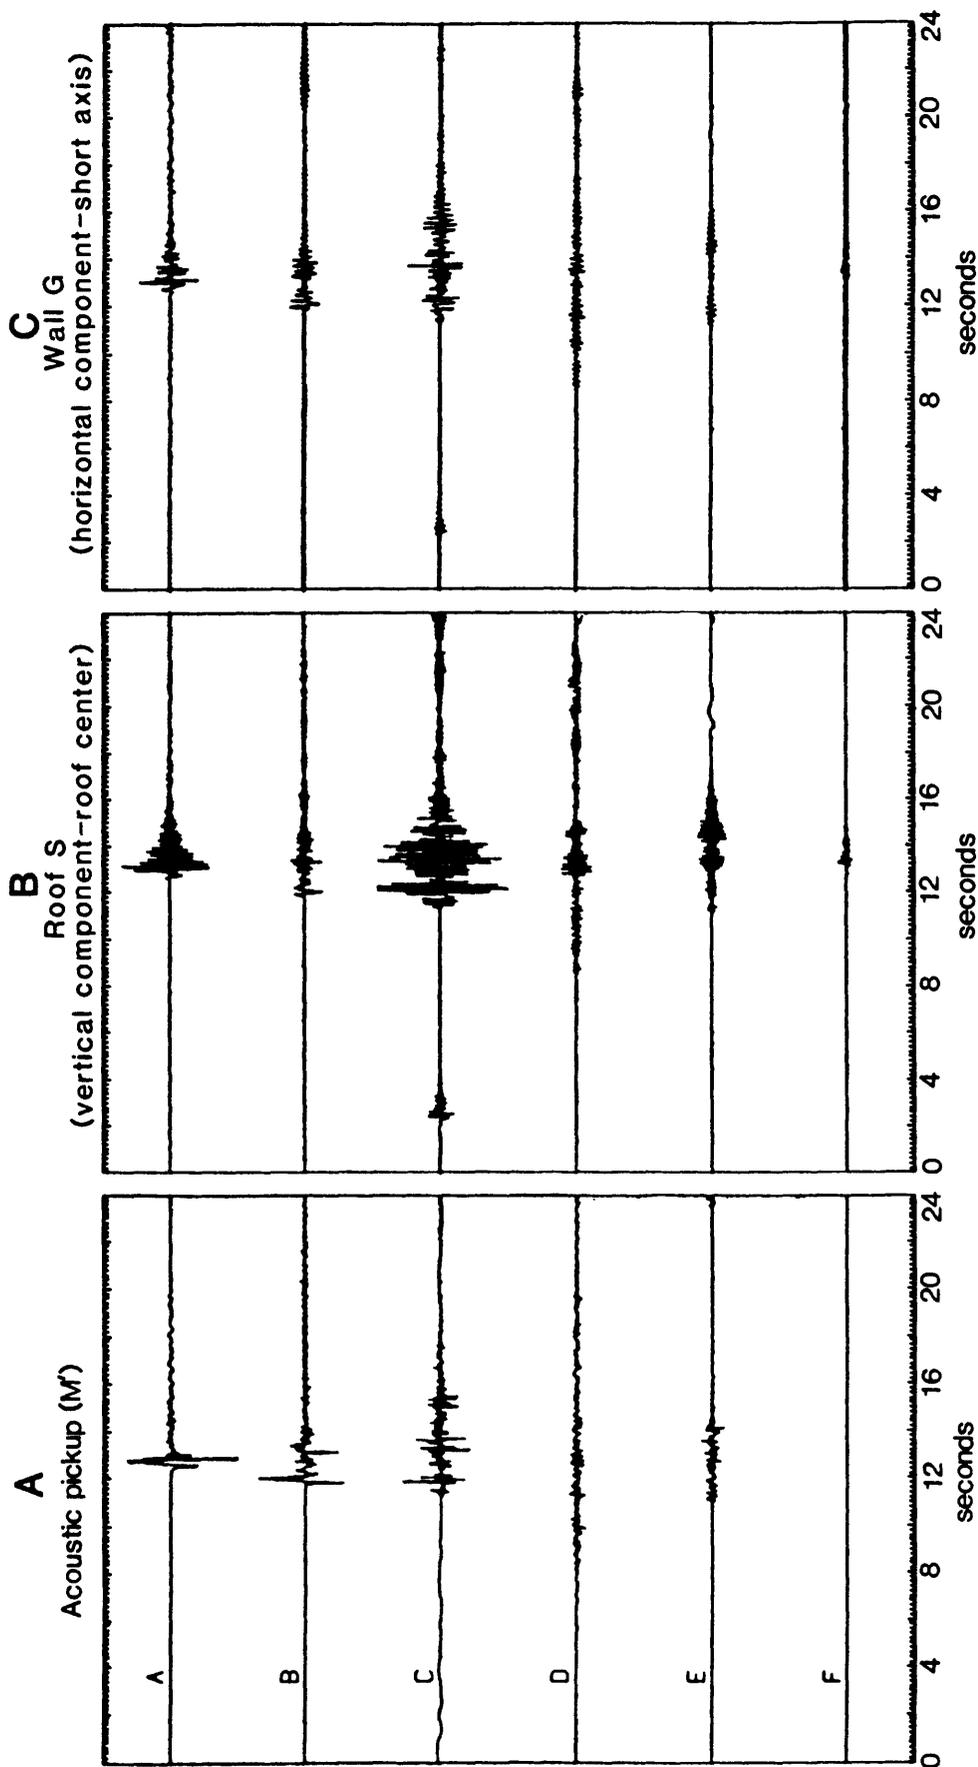
several other 24-hour periods had 50 or more events which were at or above the triggering level. Examples of the vibration time histories are shown in figure 9. Events A and C (fig. 9) are examples of the maximum motions recorded during this period. The peak vibration value for event A is 1.8 mm/sec and for C is 2.6 mm/sec (fig. 9). Comparison of the frequency signatures from the recorded vibrations indicates that events A, B, and C (fig. 9) were induced by low-flying, high-speed jet aircraft; however, this assumption is based only on vibration time-history and spectral comparisons from the project data and not from visual verification. The vibrational time histories shown in figure 9 indicate the range of recordings. The amplitudes have been normalized to the maximum size event (A & C) for ease of visual comparison. This method makes the relative amplitude of the smallest event (F) seem undetectable but, in reality, it is at the 0.1mm/sec level. Approximately 80 percent of the events were similar to events D and E which are probably routine flights in the Alamogordo Air Force base airport take-off pattern. Adequate quantitative analysis could not be made from the acoustical data since only one transducer was used as a detection and identification device; however, the point detection data indicate that the maximum overpressures were probably in the 0.001 lb/in² range.

Fig. 9. Examples of the maximum and minimum vibration time histories recorded during the unmanned observation period. Events were not visually identified. (A) Acoustic time history near location M (Fig. 2). (B) Vibration time histories of roof S. (C) Vibration time histories of wall G. Amplitudes are normalized to event a. All events triggered by the acoustic transducer.
