DEPARTMENT OF THE INTERIOR
UNITED STATES GEOLOGICAL SURVEY

HIGHWAY DAMAGE RELATED TO FAULTS NEAR PIERRE, SOUTH DAKOTA

Open-File Report 88-674

Highway Damage Related to Faults Near Pierre, South Dakota

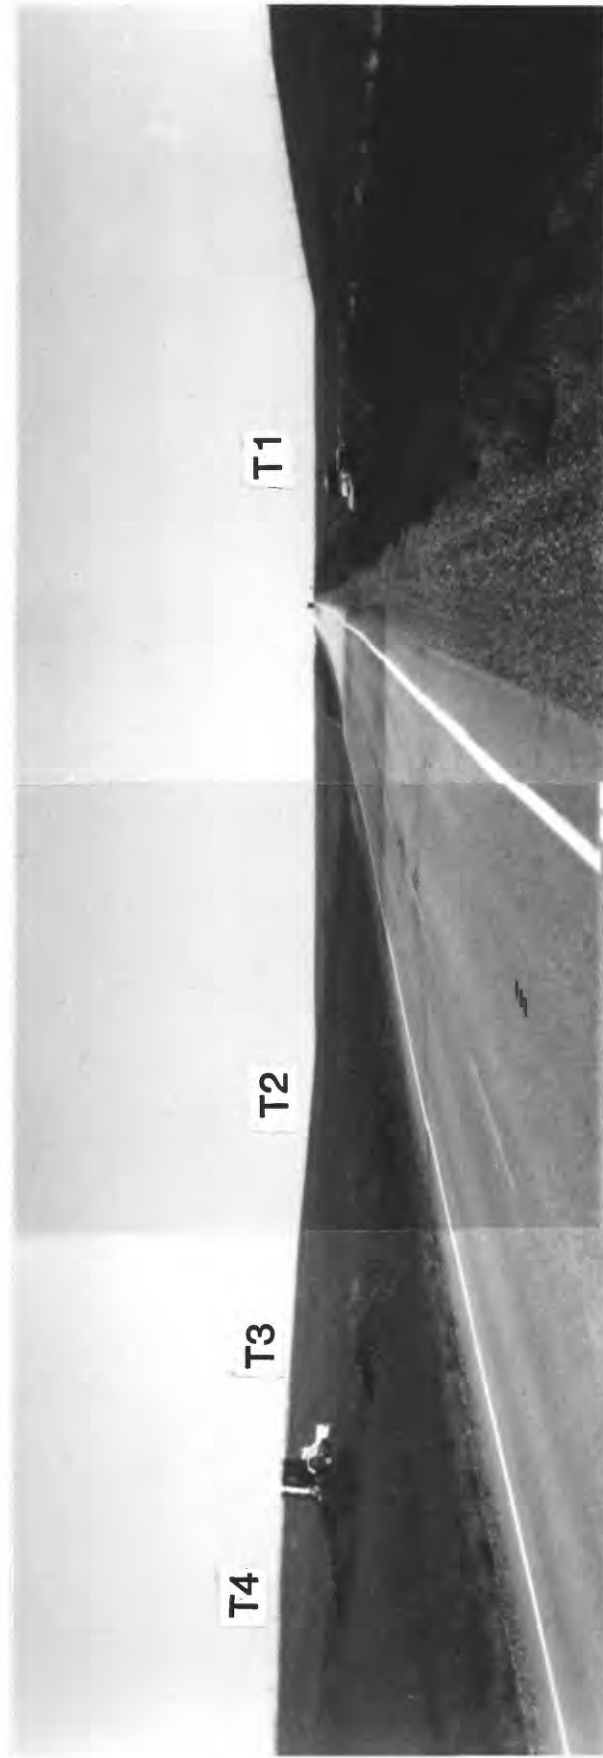
For this study, two sites (sites H1 and H2; fig. 1) were investigated where highways have been damaged by faulting. At site H1, the pavement on a new section of U.S. Highway 14 has been deforming since 1983. The highway pavement, adjacent ground, and nearby fence posts are being displaced. The fault that has caused this deformation has an average apparent dip of 52° E. with a strike of N. 30° W., and shows reverse separation. Because the fault plane has an irregular surface, an apparent dip was determined for each of the four trenches. This was done graphically by plotting the point where the fault entered the trench floor and the point where the fault intercepted the top of the trench. Then the angle between the top of the trench and the line connecting the top and bottom of the fault, representing an apparent dip, was measured. The resulting measurements for the four trenches were averaged to give the average apparent dip.

The cause of failure at site H1 is believed to be the result of swelling clays comprising the gouge reacting to moisture (Vern Bump, oral commun., 1986). This moisture, believed to be infiltration of meteoric water from

FIGURE 4. Photograph of site H1, looking east along U.S. Highway 14.
Trenches are labeled T1-T4.

To prevent or slow down fault-related, rebound-induced movement at site H1, a drain system placed within the south borrow ditch parallel to the highway and sloping away from the road should allow a rapid draining of surface water infiltration away from the weather fractured shale and fault breccia zone. This should minimize the wetting and drying cycle effects and prevent further ponding under the highway, thus reducing disintegration of the shale into a swelling clay-size fraction that would allow "easier" rebound movement by reduction of friction along the fault plane. D.D. Eberl (oral commun., 1988) recommends adding a gypsum layer under the highway. The layer would provide calcium ions to exchange with the sodium ions of the swelling clays of the shale, gouge, and breccia to reduce clay expansion and perhaps disintegration due to cyclic wetting and drying. Another consideration is to allow the rebound to stabilize after excavation and then to fill in the

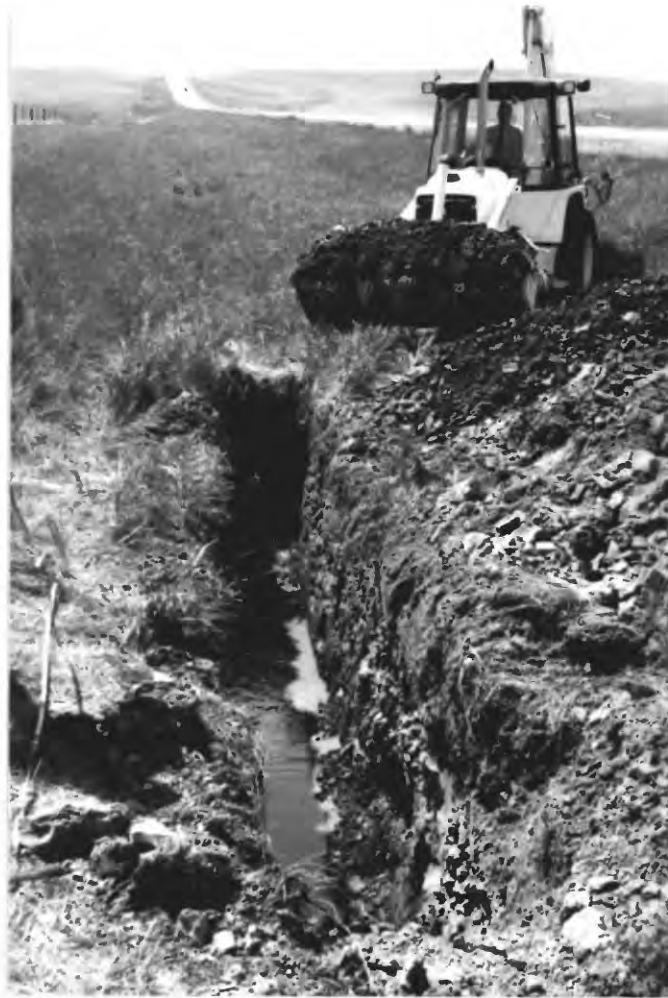
Trench dampness increased downslope from T4 to T1 (figs. 5-8). For instance, after 6 hours, T1 had as much as 2 in. of standing water along its length (fig. 5). The water was observed to be flowing from the shale fractures within 3 ft of the trench floor and possibly up through the floor. This latter source of water could not be verified due to amount of debris and water covering the floor. T2 also had 2 in. of water, but covering only a few feet of its length at the east end of the trench (fig. 6). The walls of T1 and T2 appeared to become wetter with depth. The other trenches (T3, fig. 7; and T4, fig. 8) were drier; that is, no water covered the floors and the walls were not as wet. Cross sections of all the trenches are presented in figures 9, 10, 11, and 12.

FIGURE 5. View looking west along trench T1 in borrow ditch on south side of U.S. Highway 14. Length of trench is 27 ft. Height of west wall is 6 ft. Water depth in trench is as much as 2 in.

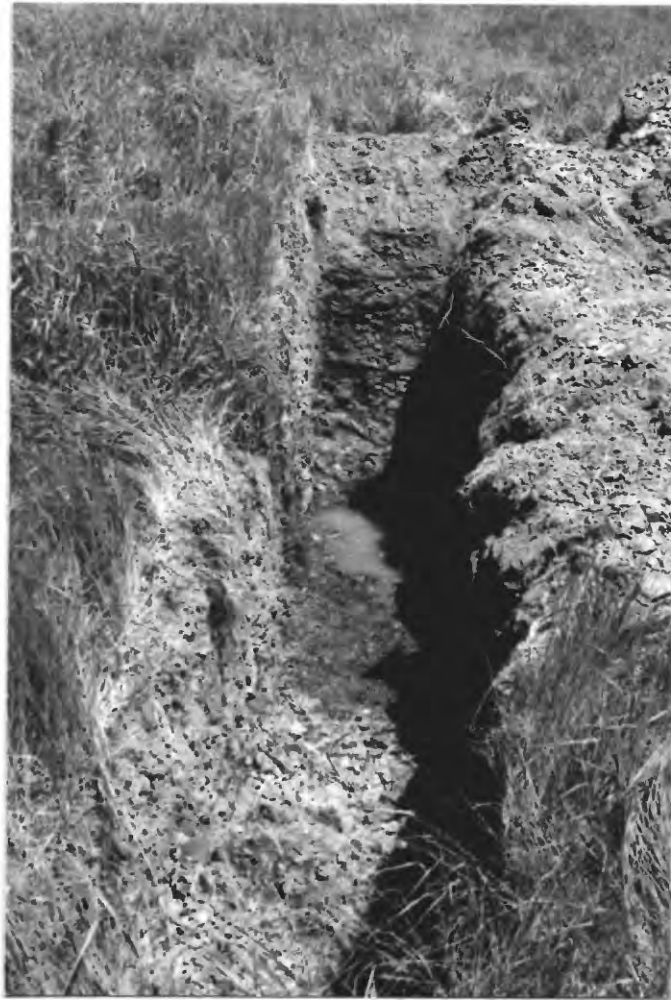
FIGURE 6. View looking east along trench T2 in borrow ditch on north side of U.S. Highway 14. Length of trench is 23.5 ft. Depth of trench varies from 3 to 5 ft. Maximum water depth is about 2 in.

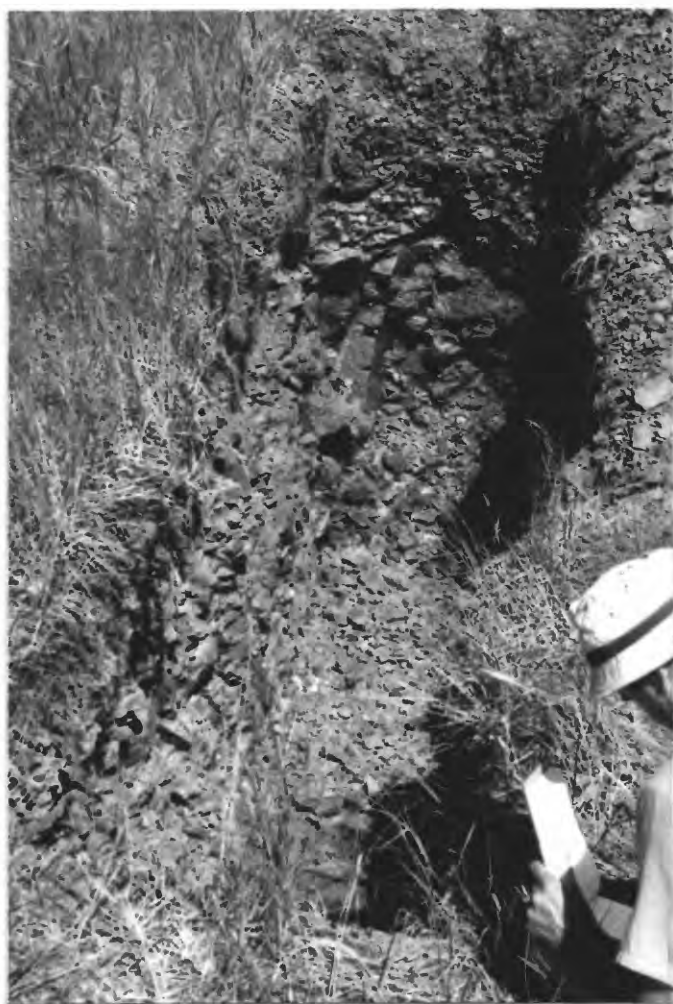
FIGURE 7. View looking east along trench T3 less than 40 ft uphill from trench T2 on north side of U.S. Highway 14. Trench length is 16 ft. Depth of trench is about 5 ft.

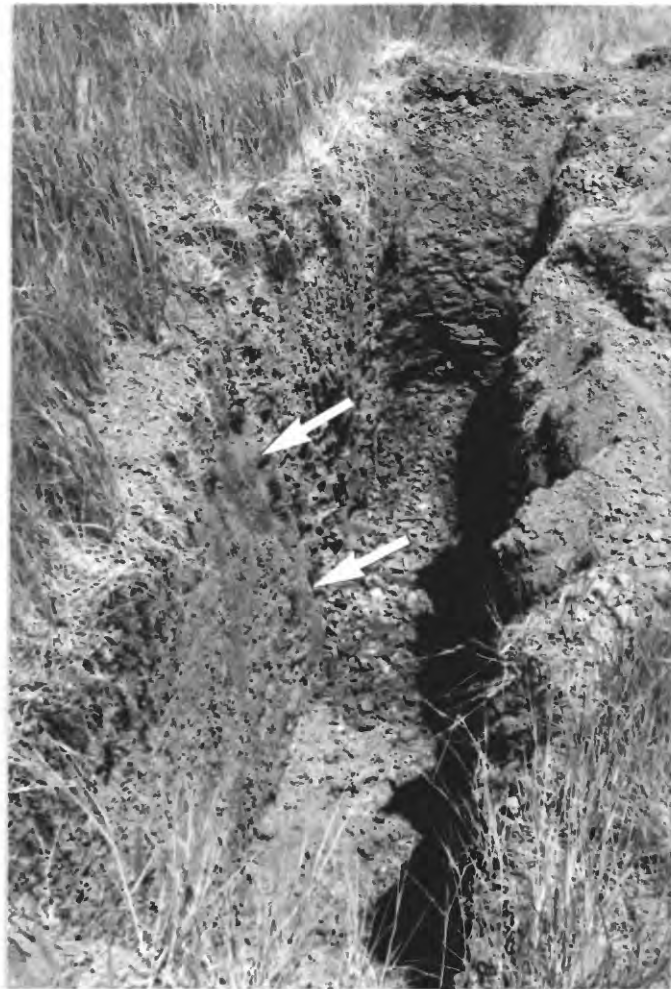
FIGURE 8. View looking east along trench T4 less than 30 ft uphill from trench T3 on north side of U.S. Highway 14. Trench length is 23 ft with depth of about 5 ft. Arrows point to location of fault plane. Note colluvial appearance of weathered in situ shale on west side of fault as compared to "fresher-appearing" shale to east of fault.

Comparison of shale-fragment size differences appeared more noticeable in T4 than in the other trenches. When first observed from outside trench T4, the shale to the west of the fault resembled a thick layer of colluvium (fig. 8). But upon close inspection, it was found to be an in situ weathered shale (regolith), having shale fragments less than 3 in. Shale on the east side of the fault was damper and had larger shale fragments (mostly greater than 3 in.). In contrast, the lower trenches did not have a noticeable difference in shale-fragment size or weathering characteristics on either side of the fault. The lower 2 ft of T1, however, had the largest fragment sizes (as much as 2 ft in maximum diameter). The size-fraction contrast in trench T4 is a result of reverse movement along the fault that has brought fresher underlying shale on the east side of the fault into contact with the more weathered shale on the west side of the fault.

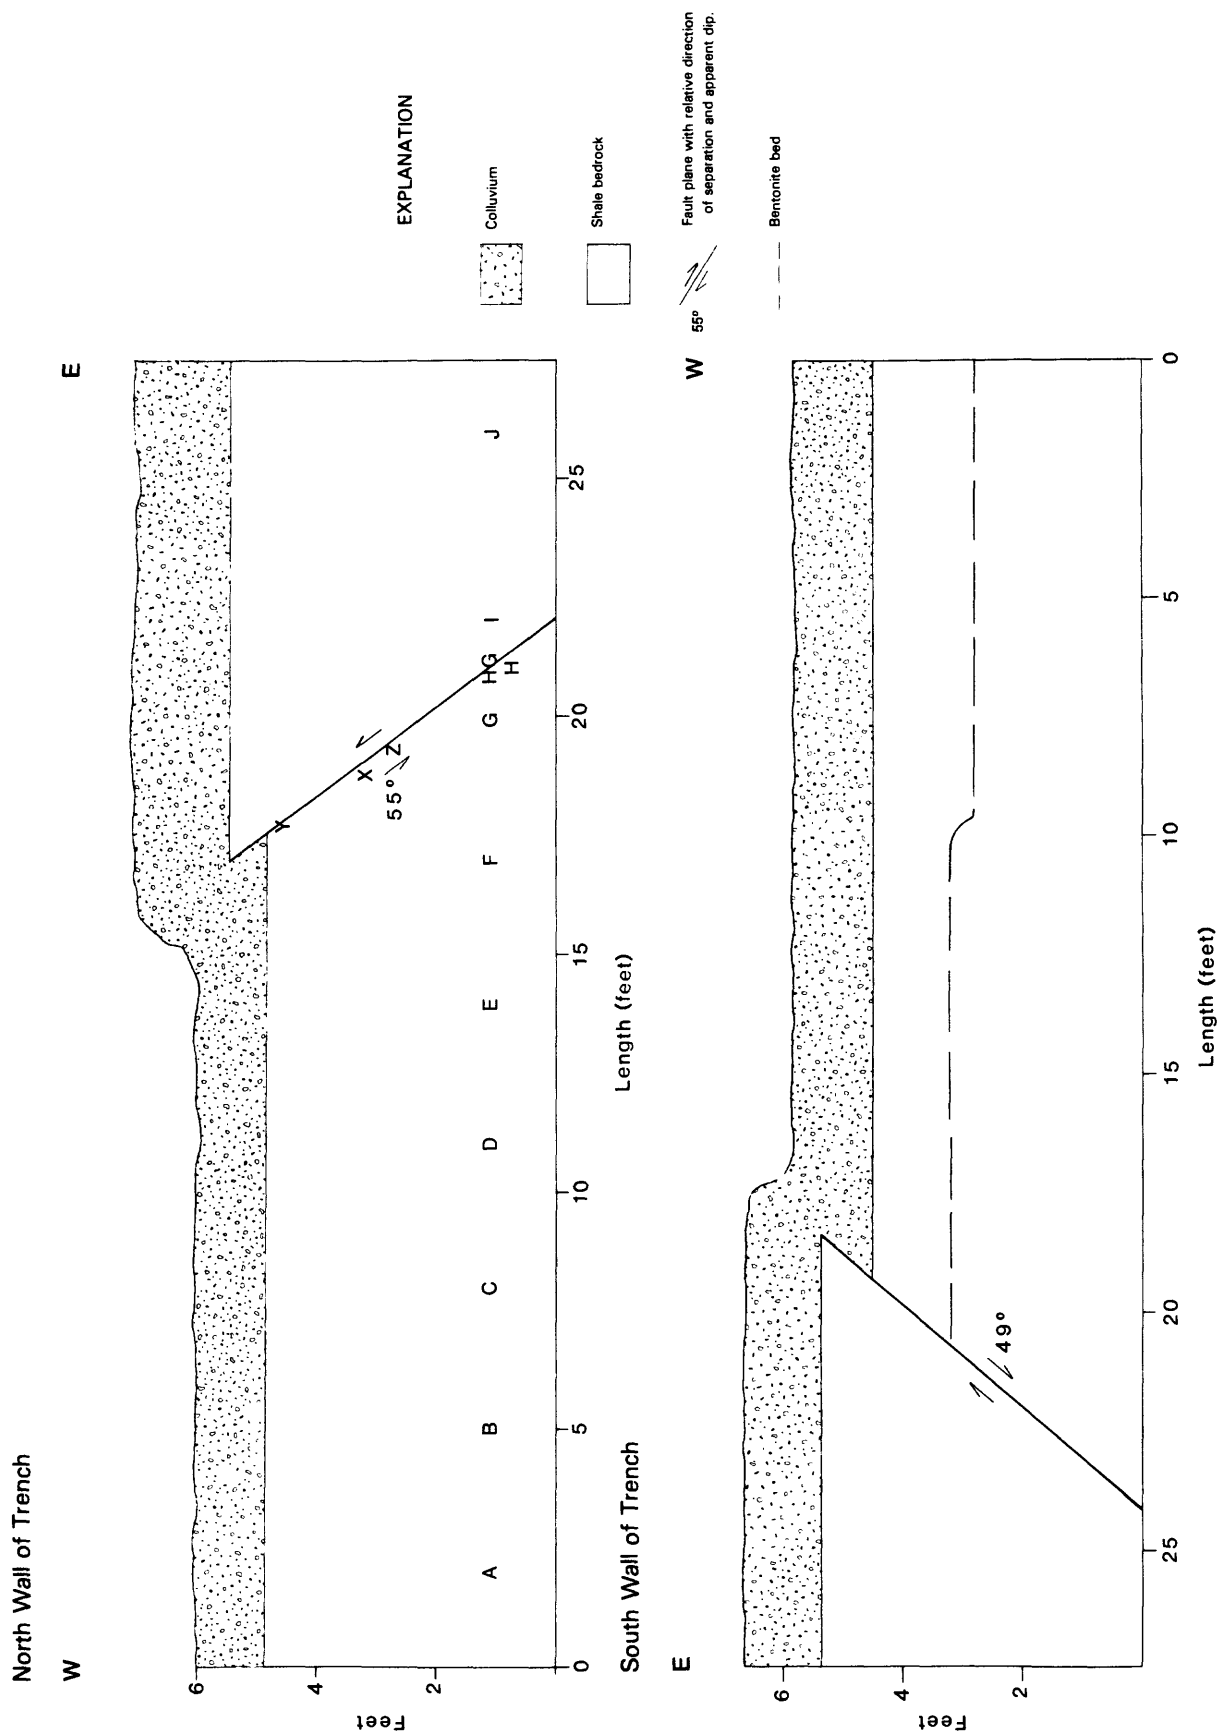
To better understand the physical properties of the shale and fault gouge at H1, shale samples were collected from west to east across the fault in trench T1 in order to perform the following analyses: X-ray clay mineralogy, moisture content, natural bulk density, and Atterberg limits. Samples were collected along the north trench wall 15 in. above the trench floor, at 2-3-ft intervals (fig. 9). Results of the analyses are presented in table 2. Detailed X-ray clay mineralogy analyses are presented in Appendix 1.

FIGURE 9. Schematic profile of trench T1 at site H1 (figs. 1 and 5) along south side of U.S. Highway 14. Letters indicate positions of selected samples collected for analysis (table 4; app. 1).

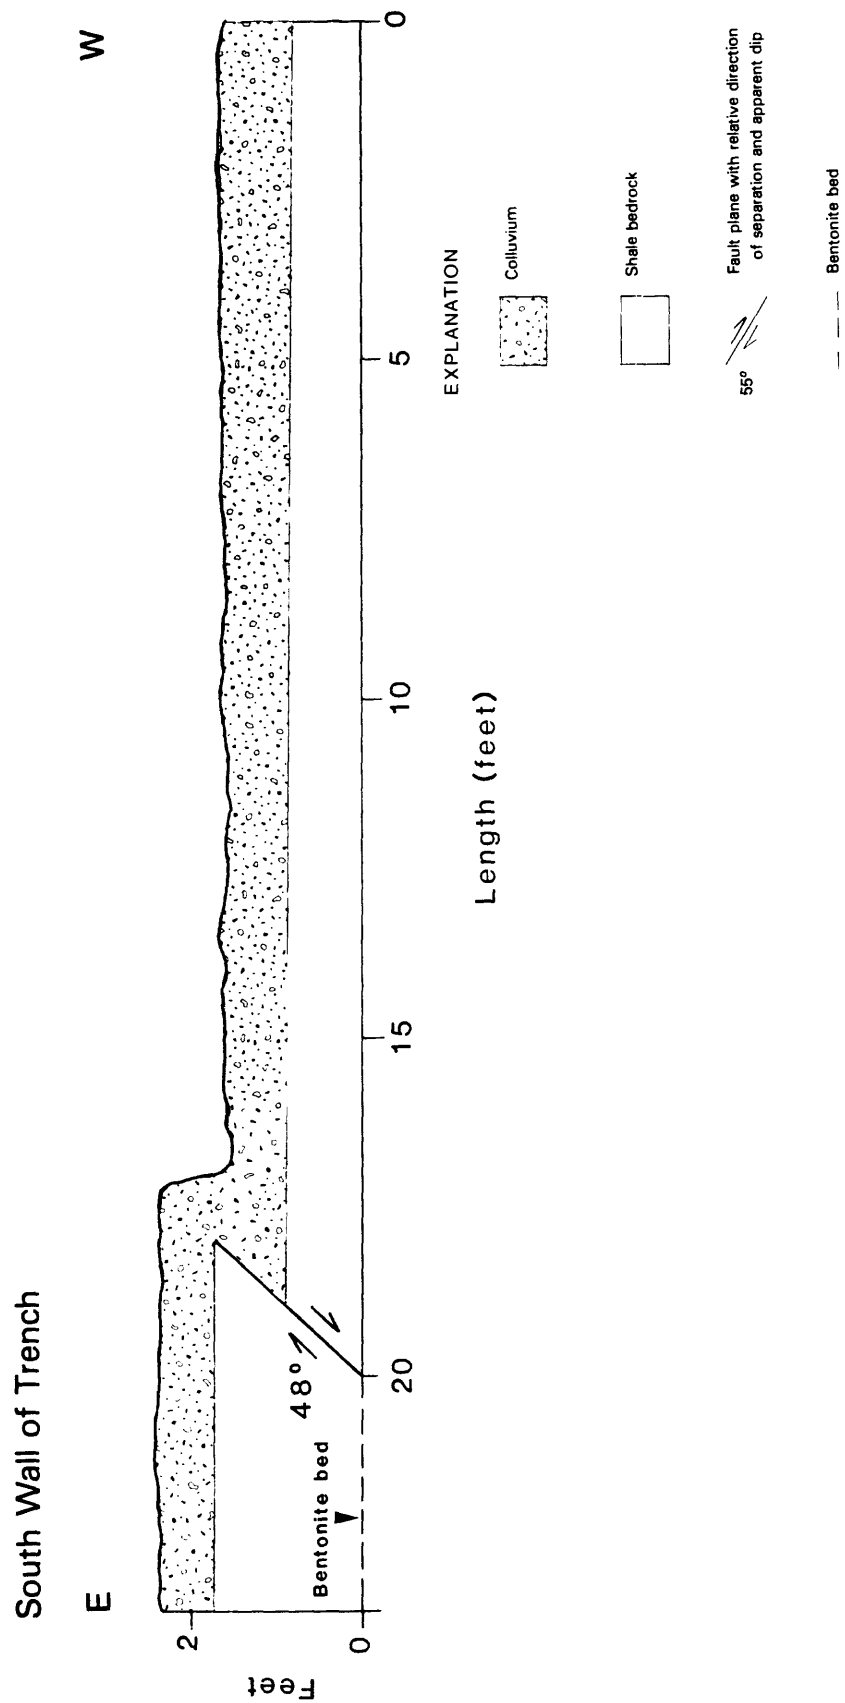
FIGURE 10. Schematic profile of trench T2 at site H1 (figs. 1 and 6) along north side of U.S. Highway 14.

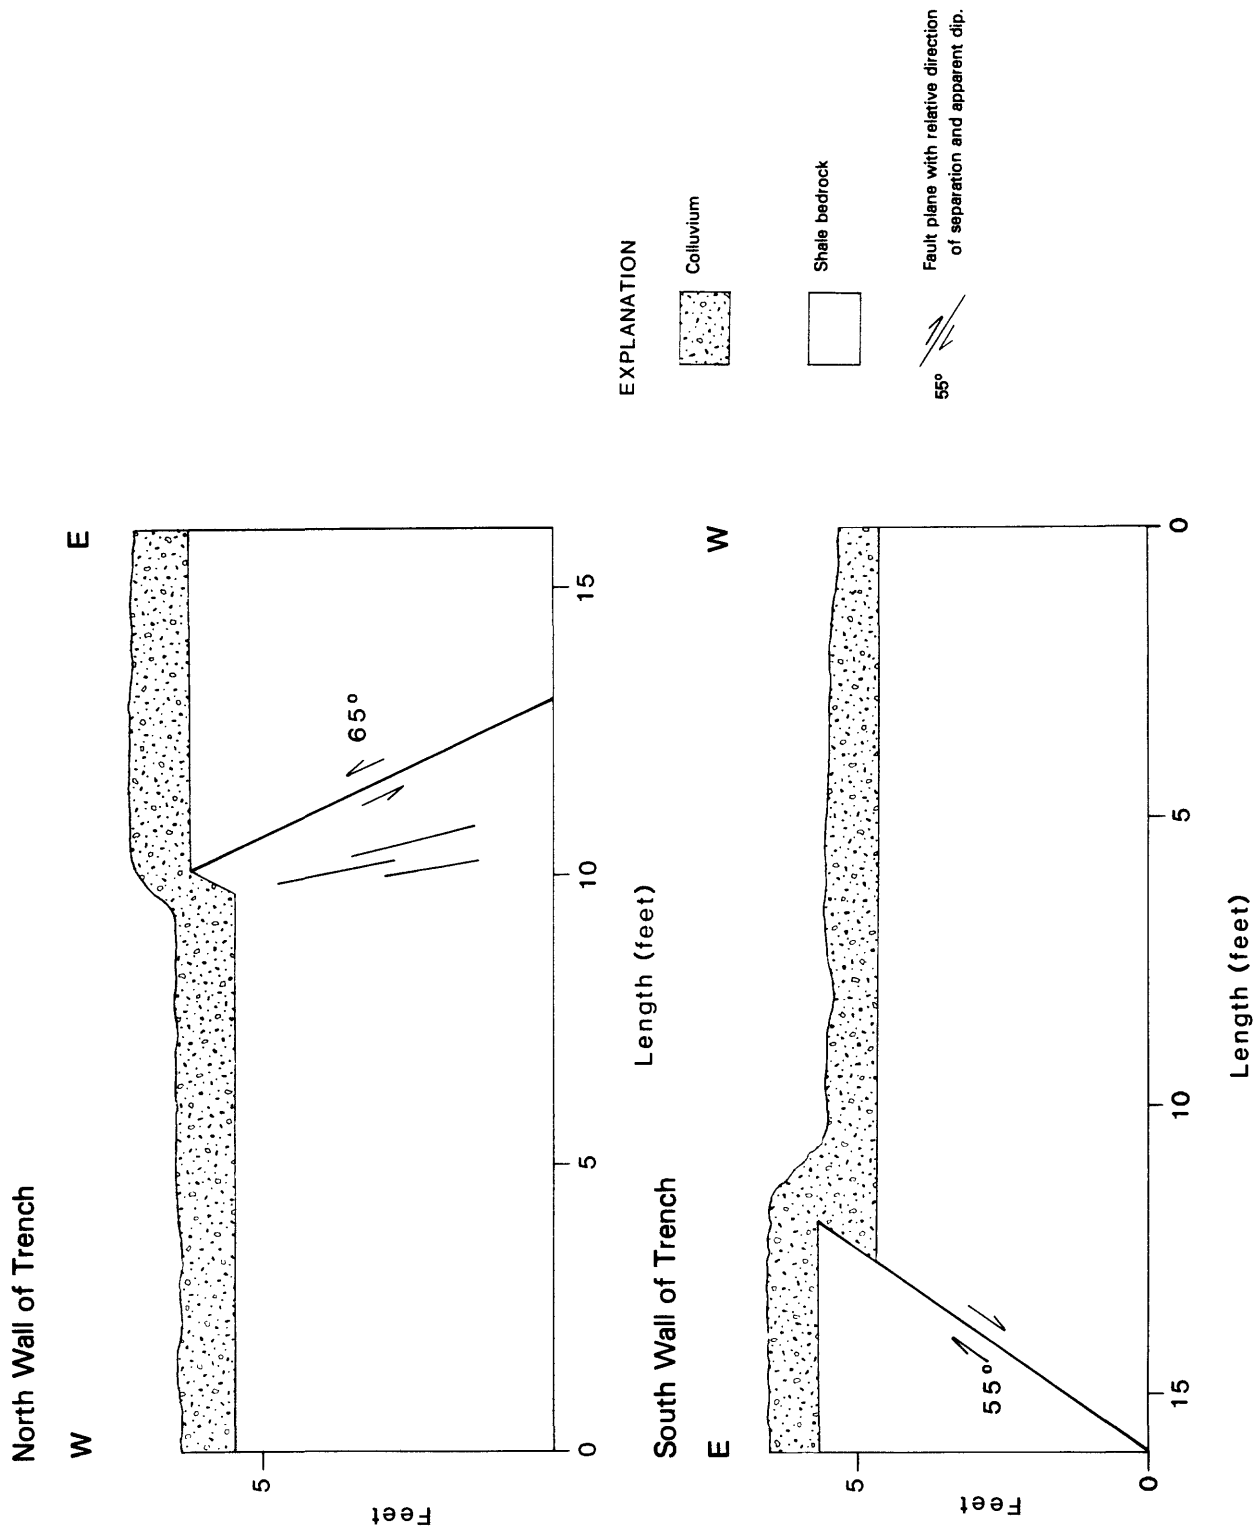
FIGURE 11. Schematic profile of trench T3 at site H1 (figs. 1 and 7) less than 40 ft uphill from trench T2 on north side of U.S. Highway 14.

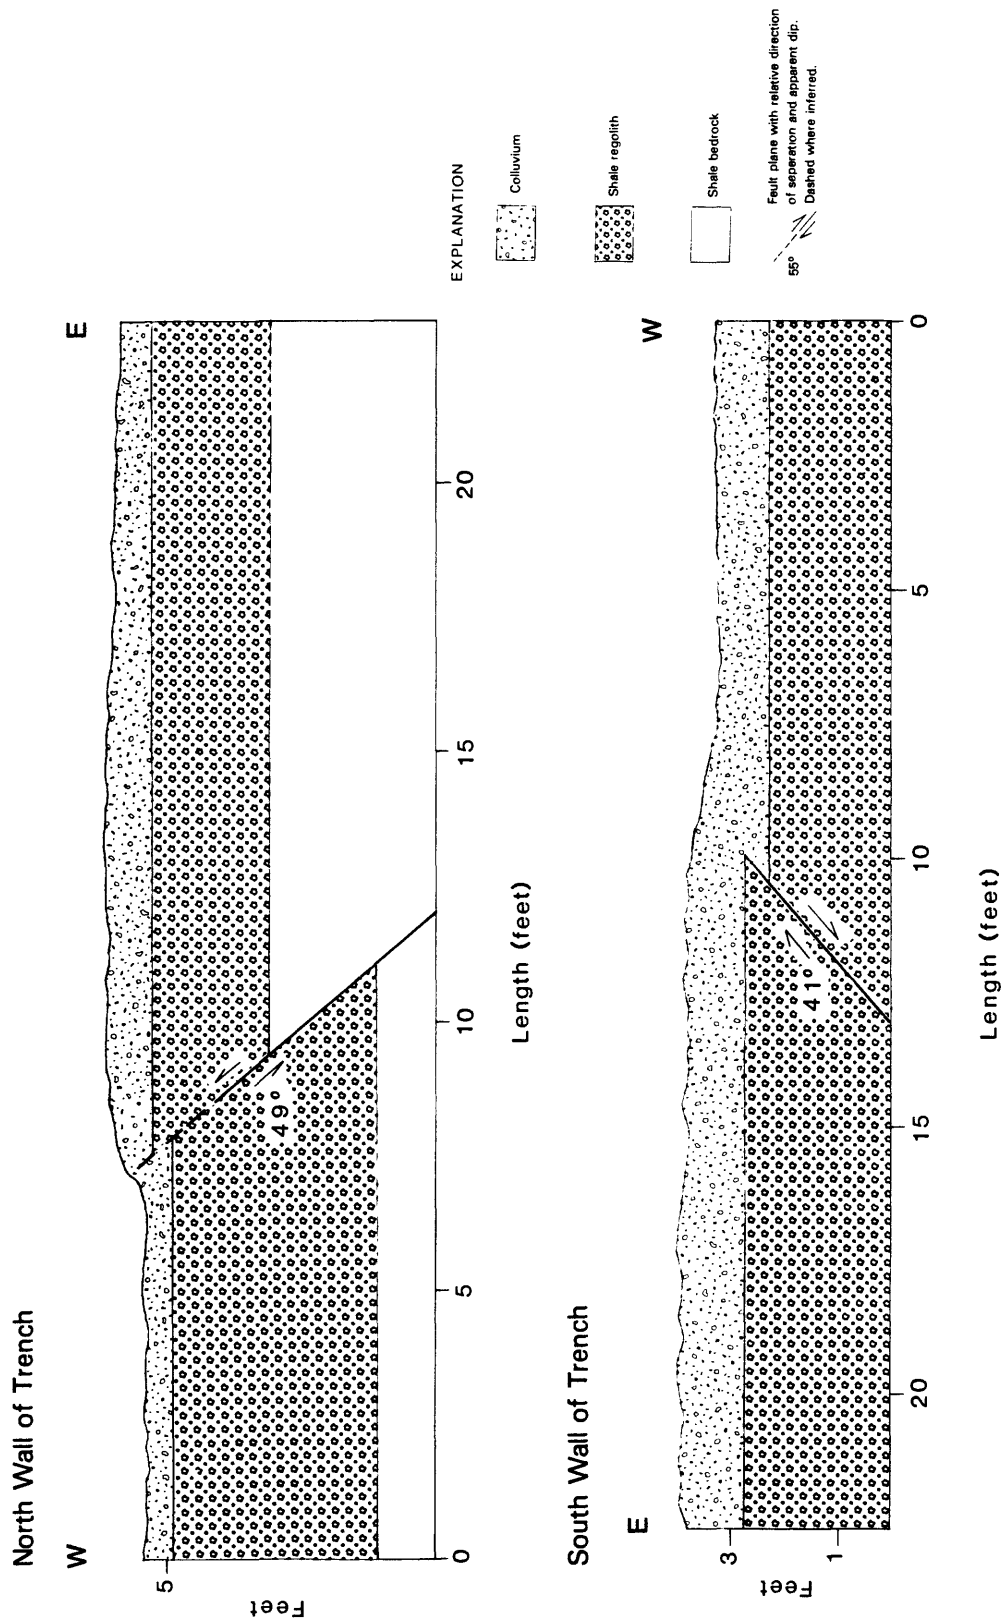
FIGURE 12. Schematic profile of trench T4 at site H1 (figs. 1 and 8) less than 30 ft uphill from trench T3 on north side of U.S. Highway 14.

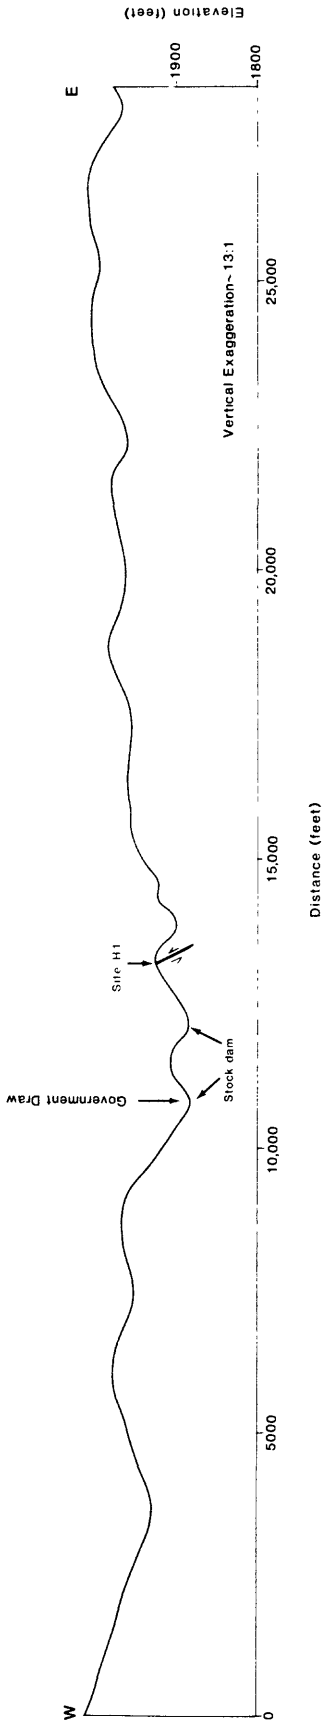
The permeability of the Pierre Shale matrix has been calculated to be 10^{-13} m/s (Nichols and others, 1986), a value too small to allow rapid water migration through the shale matrix to accumulate on the floors of trenches T1 and T2 within a few hours. However, on the basis of the moisture differences in the trenches, as well as the precipitates (iron oxide and gypsum) on the shale-fracture surfaces and in the gouge, water migration is dominated by downward movement through the shale-fracture system. Water ponds in the downthrown side of the fault under the southern borrow ditch of the road. Although the fault is located on a hill, it is positioned in a general topographic low (fig. 13). In this area, ground water flowing through the fractured bedrock from higher elevations is probably contributing more water to the fault zone than is derived from the immediately adjacent hill(s). It was also found that a nearby stock pond in Government Draw and its tributary east of and lower than site H1 (figs. 13 and 14) remained full even during the severe summer drought of 1988. This is in contrast with other stock ponds within the study area that were very low or dry, suggesting that this dam on Government Draw is filled mainly by ground water traversing a fracture system rather than surface runoff.

FIGURE 13. Topographic profile demonstrating that site H1 and nearby stock dam are located in a topographic low.

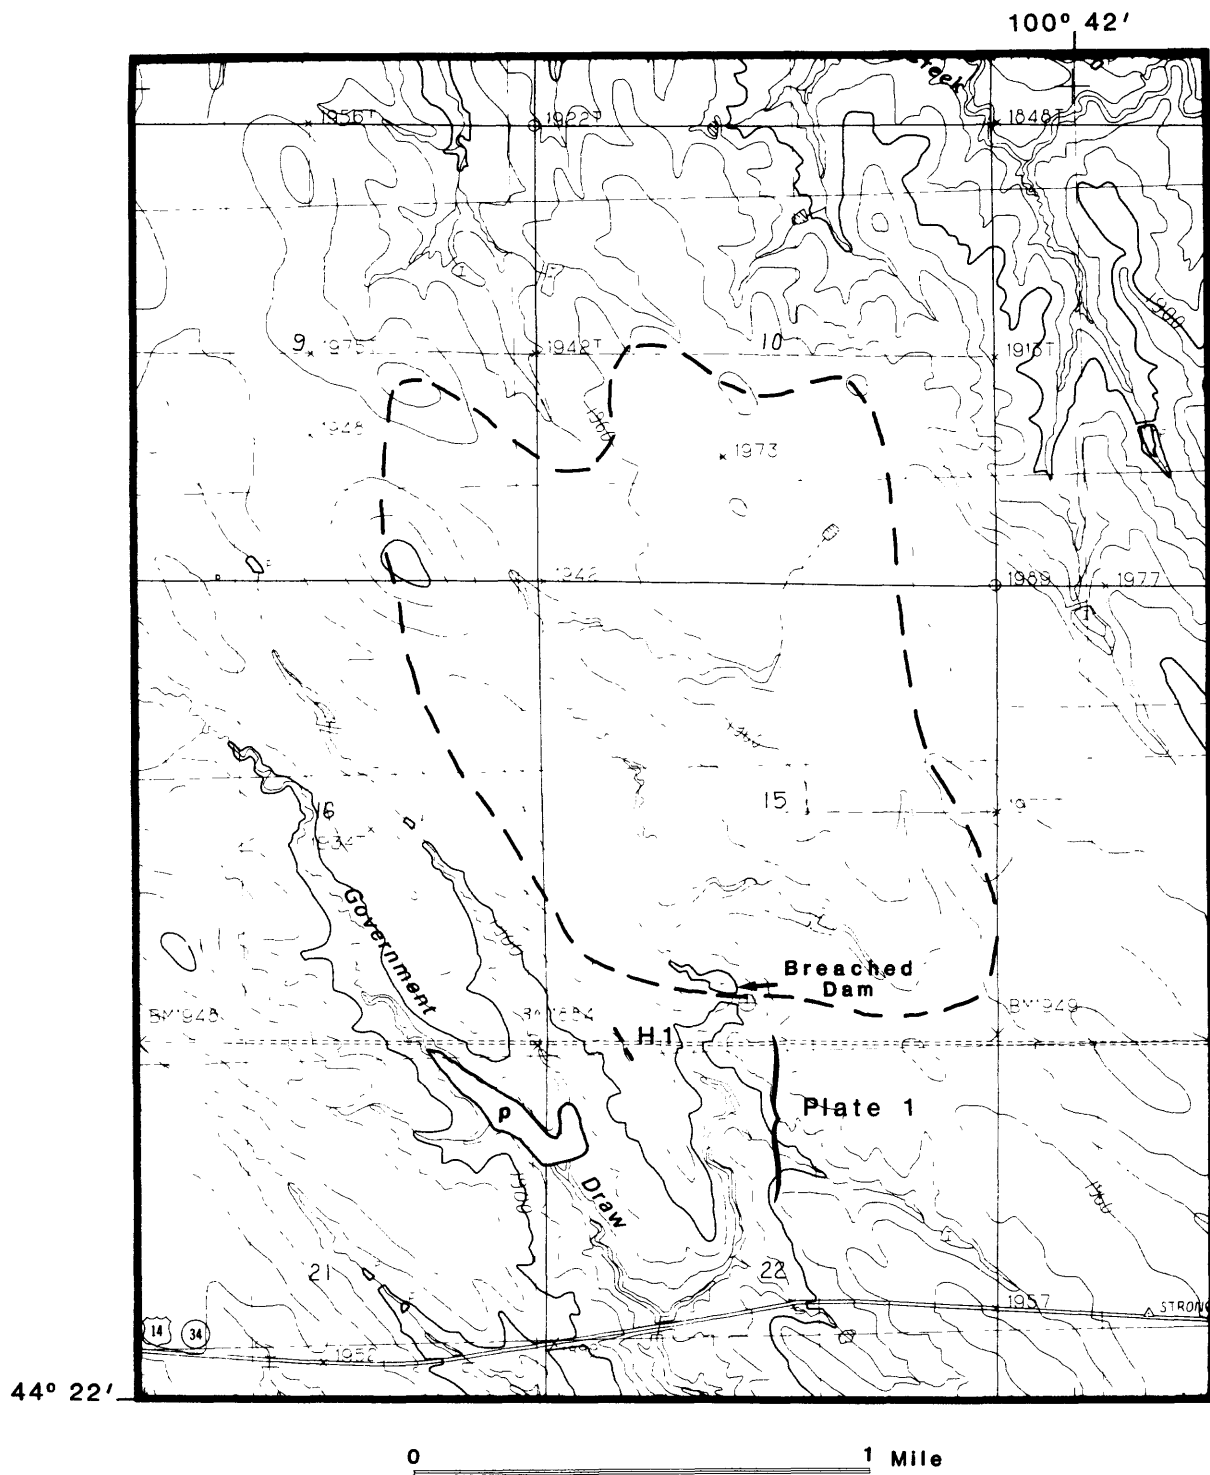
FIGURE 14. Index map showing fault at site H1 on new U.S. Highway 14 (double dashed line) with respect to new (since 1982) stock dam (P), enlarged drainage area (single dashed line) developed above breached dam (arrow), and location (brace) plate 1.

To determine if the highway fault at site H1 (fig. 14) could be an extension of any nearby faults, we examined nearby Government Draw and its tributaries for faults of similar strike. Resulting field data showed that faults found in a tributary east of site H1 (pl. 1) did not align with the highway fault. Investigation of Government Draw and its tributary immediately west of highway fault H1 was hampered by the lack of outcrop and the presence of a filled stock pond.

The knickpoint migration toward U.S. Highway-14 culvert is not related to uplift or faulting, but is believed to be a direct result of an increased drainage area above a breached dam that provides more runoff. If this problem is not addressed within the next few years, then both the culvert structure and the overlying road will be damaged.

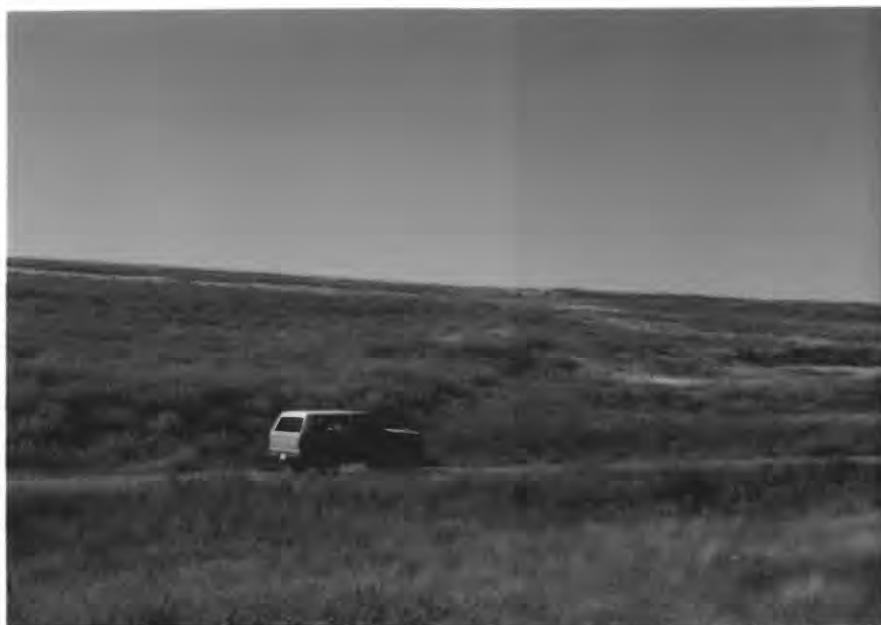
The last site of investigation is located on the eastern approach to the overflow spillway of the Oahe Dam on State Highway 1806 (H2, fig. 1). Here, movement along a fault has been causing pavement damage for several years. This fault is part of a complexly faulted area as mapped by the U.S. Army Corps of Engineers (1981). Since the spillway excavation and partial bridge construction in 1962, movement along a fault has occurred, creating a scarp 5 ft in height (fig. 15) on the west side of the spillway (Eric Stoss, U.S. Army Corps of Engineers, oral commun., 1988). This scarp is an extension of the fault that has also caused highway damage on the east side of the spillway. Along the scarp on the west side of the spillway, at least 80-85 ft of stratigraphic section is faulted out northwest of our trench site, leaving the upper lower Virgin Creek Member in contact with the Verendrye Member. The U.S. Army Corps of Engineers (1981) has determined 97 ft of displacement along a portion of this same fault in the overflow basin to the spillway southeast of our trench site.

FIGURE 15. Photograph showing closeup view of fault scarp on west side of the Oahe Dam spillway (fig. 17) at site H2 (fig. 1). Photograph taken in summer of 1986.

Since our field investigation began in 1983, State Highway 1806 at the Oahe spillway (site H2, fig. 1) has been repaired twice within the past 4 years as a result of underlying fault movement. However, field measurement of the fault scarp adjacent to the road on the west side of the spillway (site H2, figs. 1 and 15) indicates that the scarps have remained at 5 ft in height for the past 2 years. On the basis of aerial photographs provided by the U.S. Army Corps of Engineers, the scarp first appeared on the west side of the spillway sometime before August 1962 and by November 1962 was a prominent feature (fig. 17).

Site H2 may respond to the same recommendation as for site H1; that is, placing a drain near the fault and road junction, and a gypsum layer to slow or prevent swelling of clay and to fill in the downside of a fault scarp rather than relevel the road grade by excavation to slow or prevent further road damage.

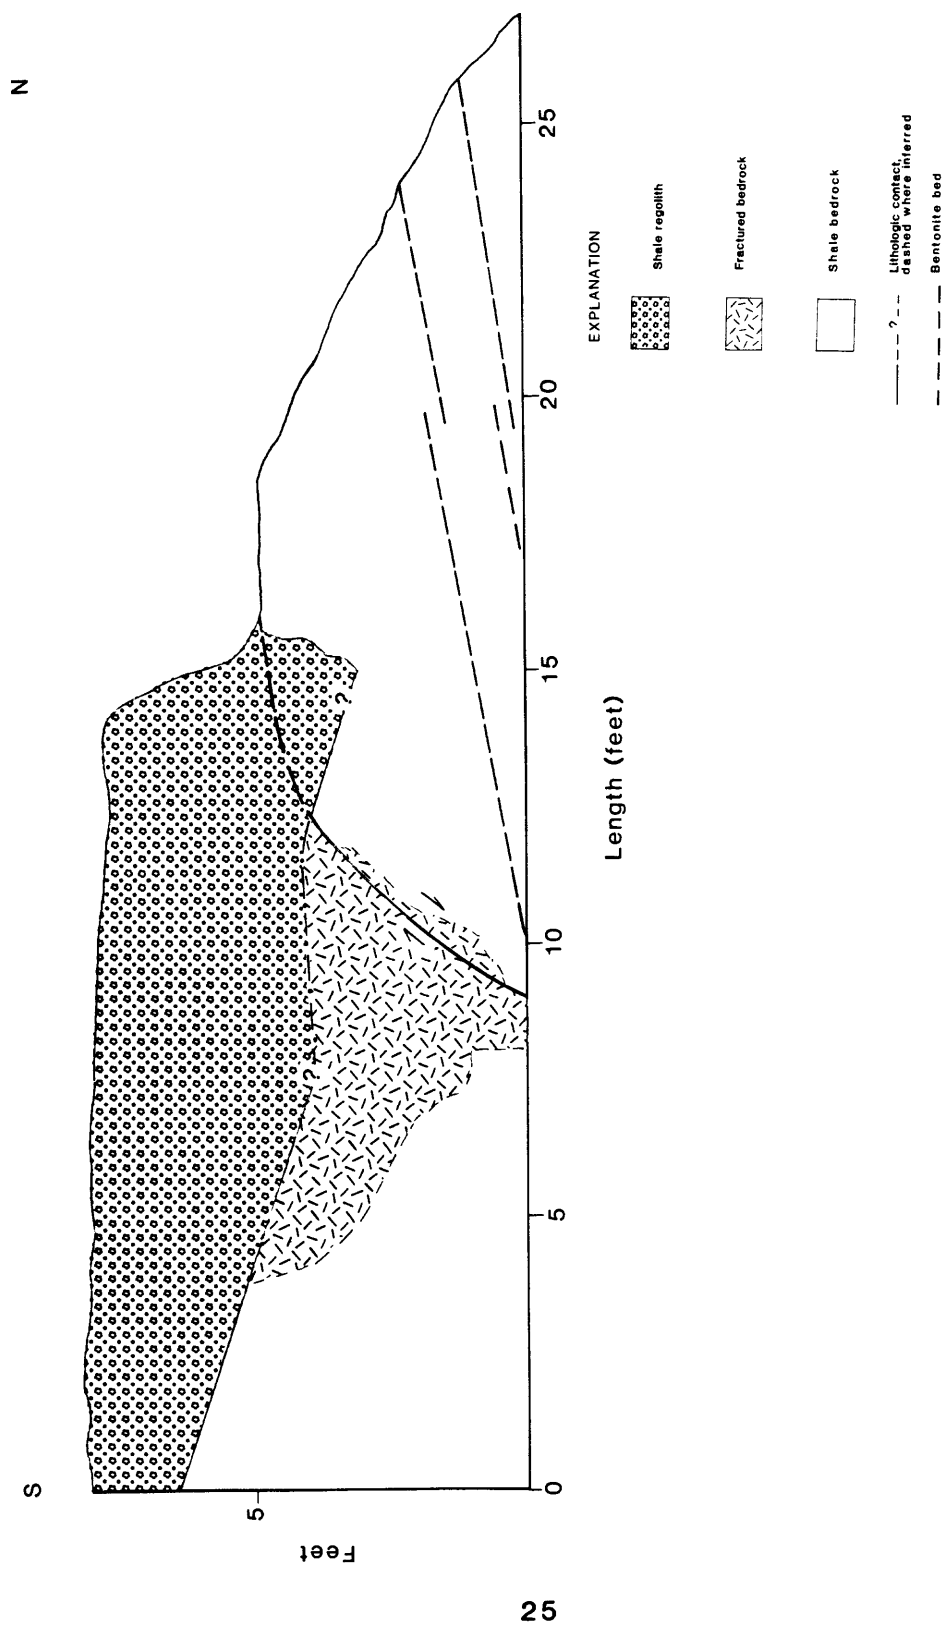
A trench emplaced across this fault (fig. 16) revealed damp bedrock walls with relatively more moisture present on fresh fracture surfaces than on surfaces exposed longer to the air. During the time the trench was open (less than 4 hrs), water did not accumulate on the trench floor. The trench walls, upon drying, flaked and spalled. Displacement along the fault, having a gouge less than 2 in. thick, was confined to only the Verendrye Member of the Pierre Shale. The shale-fracture surfaces were coated with both magnesium and iron oxide, suggesting water migration along the fracture planes. The gouge near the upthrown side of the fault was mixed with 1-1.5-in. shale-breccia fragments that were all slickensided.

FIGURE 16. Schematic profile of trench at site H2 (figs. 1 and 15) located on the west side of Oahe Dam spillway near State Highway 1806.

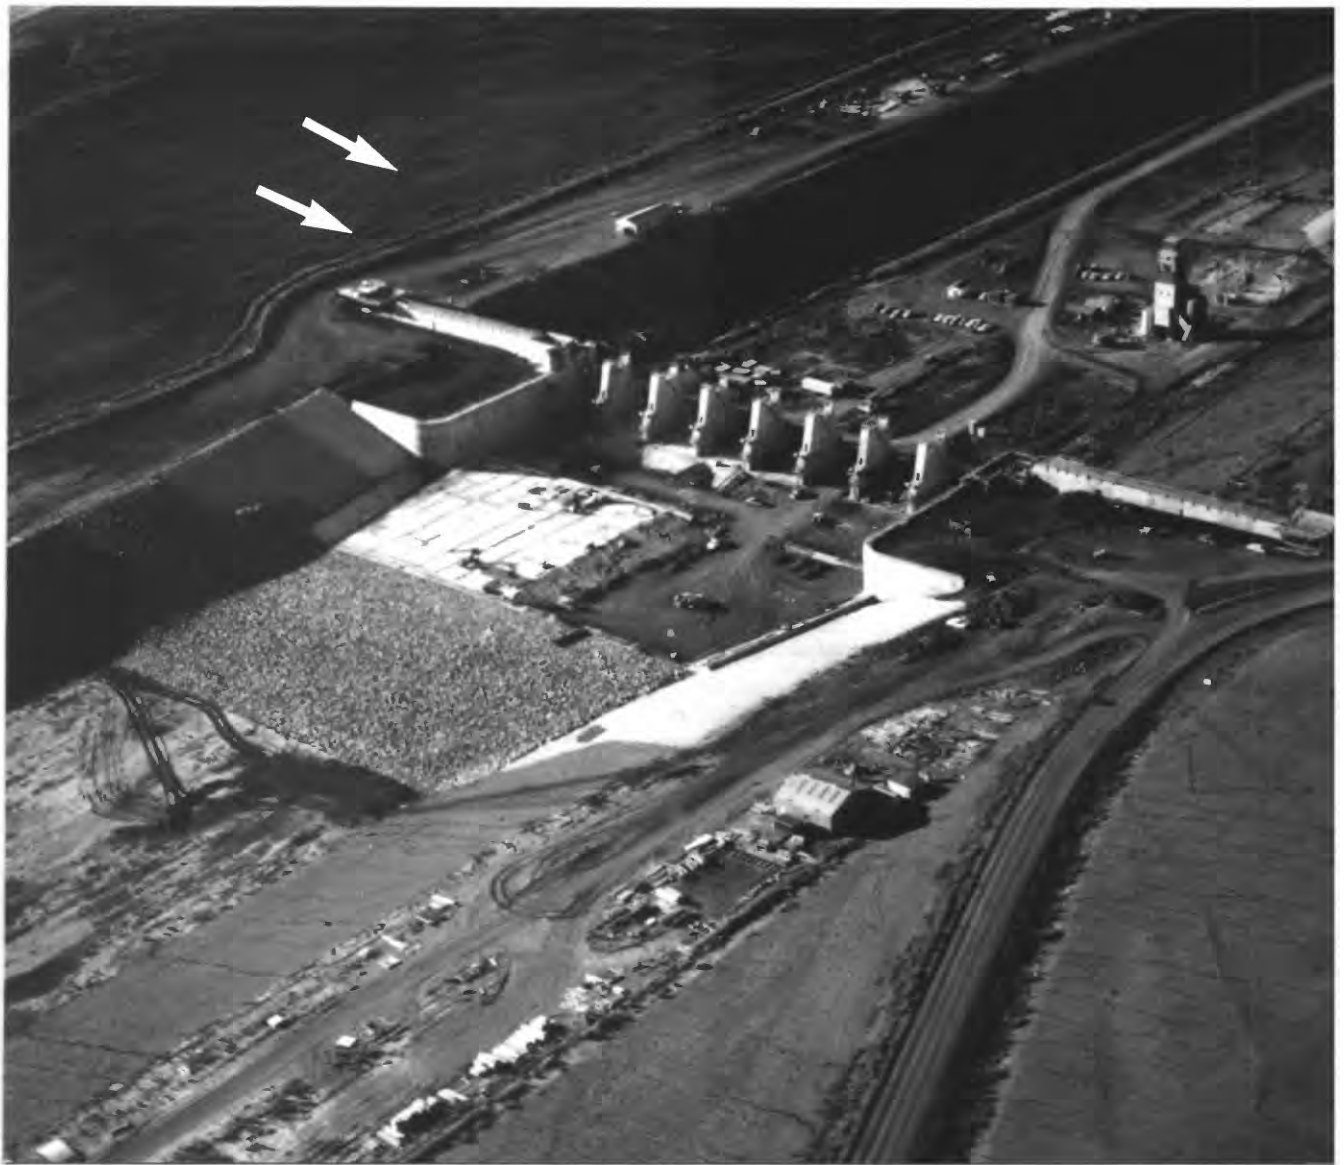
FIGURE 17. Aerial photo showing view toward the northwest of the Oahe Dam spillway during construction. Arrows mark fault trace. Photograph taken in November 1962; courtesy of the U.S. Army Corps of Engineers.

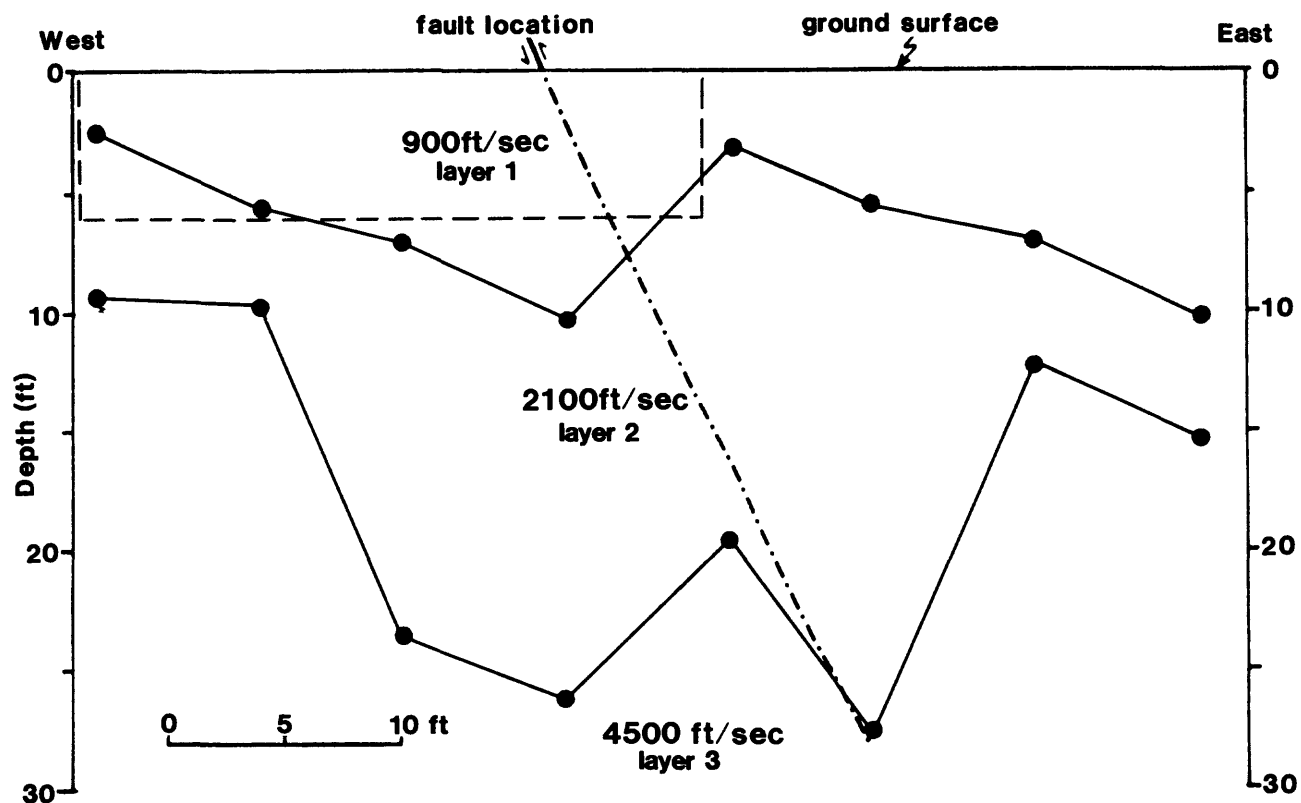
Highway 14 South Dakota
Refraction Data Interpretation
August 1988

The accompanying figure (A2) shows the seismic-velocity model developed from the interpreted seismic data. The calculated depths are dots in figure A1 below the surface shotpoint to layers 2 and 3. Lines were drawn connecting these control points to indicate the possible shape of the layer boundaries. The average seismic velocity is indicated within each layer: for layer 1, 900 ft/sec, for layer 2, 2100 ft/sec, and for layer 3, 4,500 ft/sec. These three velocities are typical of a dry topsoil (layer 1), a semi-consolidated moist clay (layer 2), and a dense, wet clay (layer 3). The position of the fault at the surface (upthrown block on the east) and its possible location in the subsurface are also indicated (fig. A2).

Figure A2. Seismic-velocity model for site H1 (fig. 1). Dots are calculated depths below surface shotpoint to layers 2 and 3. Lines connecting dots indicate probable shape of layer boundaries. Dashed line outlines position of trench T1 at site H1 (fig. 4). Dashed line and dots represent inferred fault-plane projection.

The subsurface location of the fault is estimated by the thickening of layer 2 in the middle of the profile, a 7-ft-high bump in the boundary between layers 2 and 3 (near the middle of the profile), and a fault trace observed in a 6-ft-deep trench at this site. The actual fault trace was not observed on the seismic records. The broader zone of layer 2, shown in the middle of the figure, may include parts of layer 3 that have been modified by movement on the fault or chemical changes associated with water circulation in the fault zone. These processes may have altered layer 3 sufficiently enough to slow the seismic signal and make layer 3 seismically indistinguishable from layer 2.
