ASSESSMENT OF HYDRAULIC CHANGES ASSOCIATED WITH REMOVAL OF
CASCADE DAM, MERCED RIVER, YOSEMITE VALLEY, CALIFORNIA

Open-File Report 88-733

Prepared in cooperation with the
NATIONAL PARK SERVICE

Sacramento, California
1989

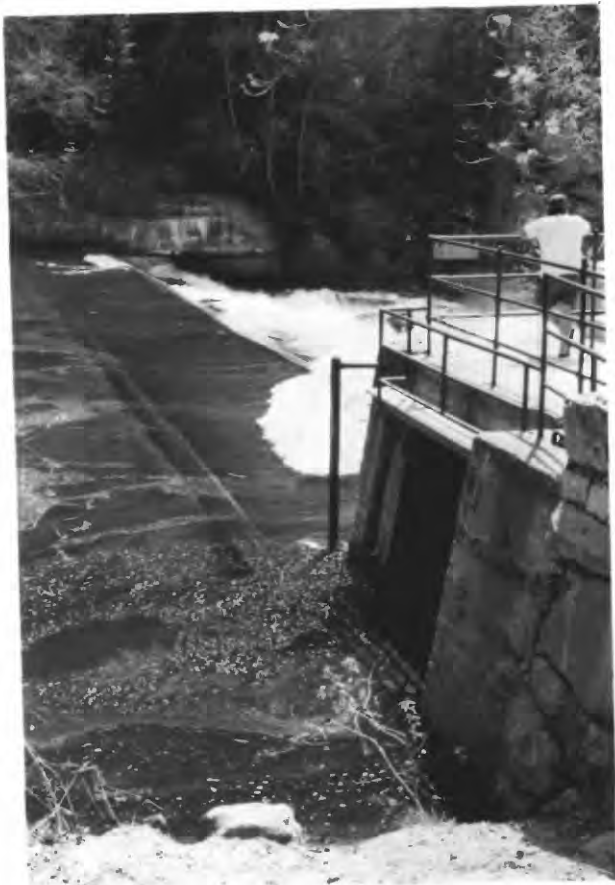
Cascade Diversion Dam structure, looking from right (north) bank.
Intake structure in foreground.

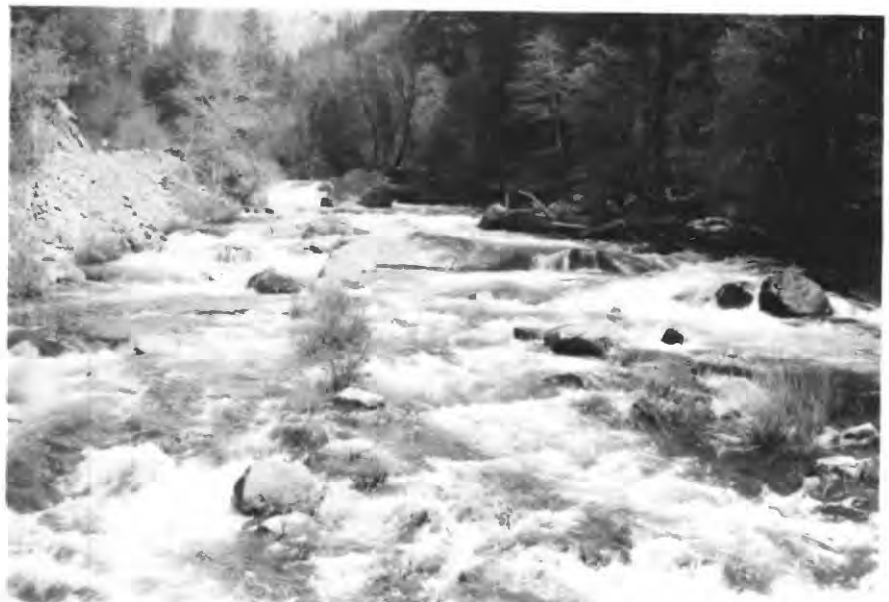
FIGURE 2. Merced River downstream from Cascade Diversion Dam. Photographed April 12, 1988.

View upstream of large boulders in
channel downstream from dam. Note
dam crest in center of photograph.

A large (old) rockfall from the left bank cliff located downstream from the dam has deposited large boulders in the channel (fig. 2). This deposit is about 200 ft downstream from the dam (fig. 4) and likely acts as a channel control and probably limits scour or channel degradation downstream from the dam.

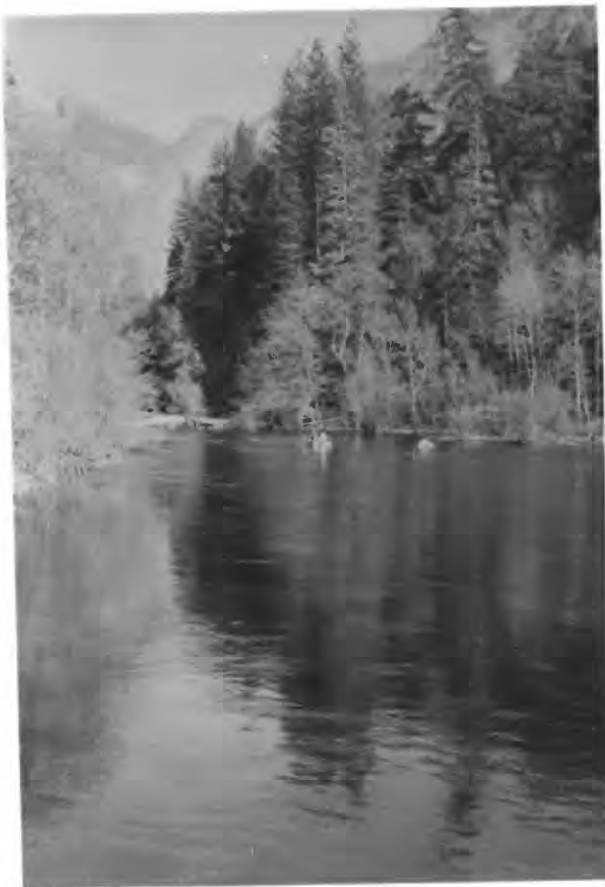
FIGURE 3. Merced River upstream from Cascade Diversion Dam. Photographed April 12, 1988.

View of diversion dam pool. Pool extends 550 feet upstream from dam.

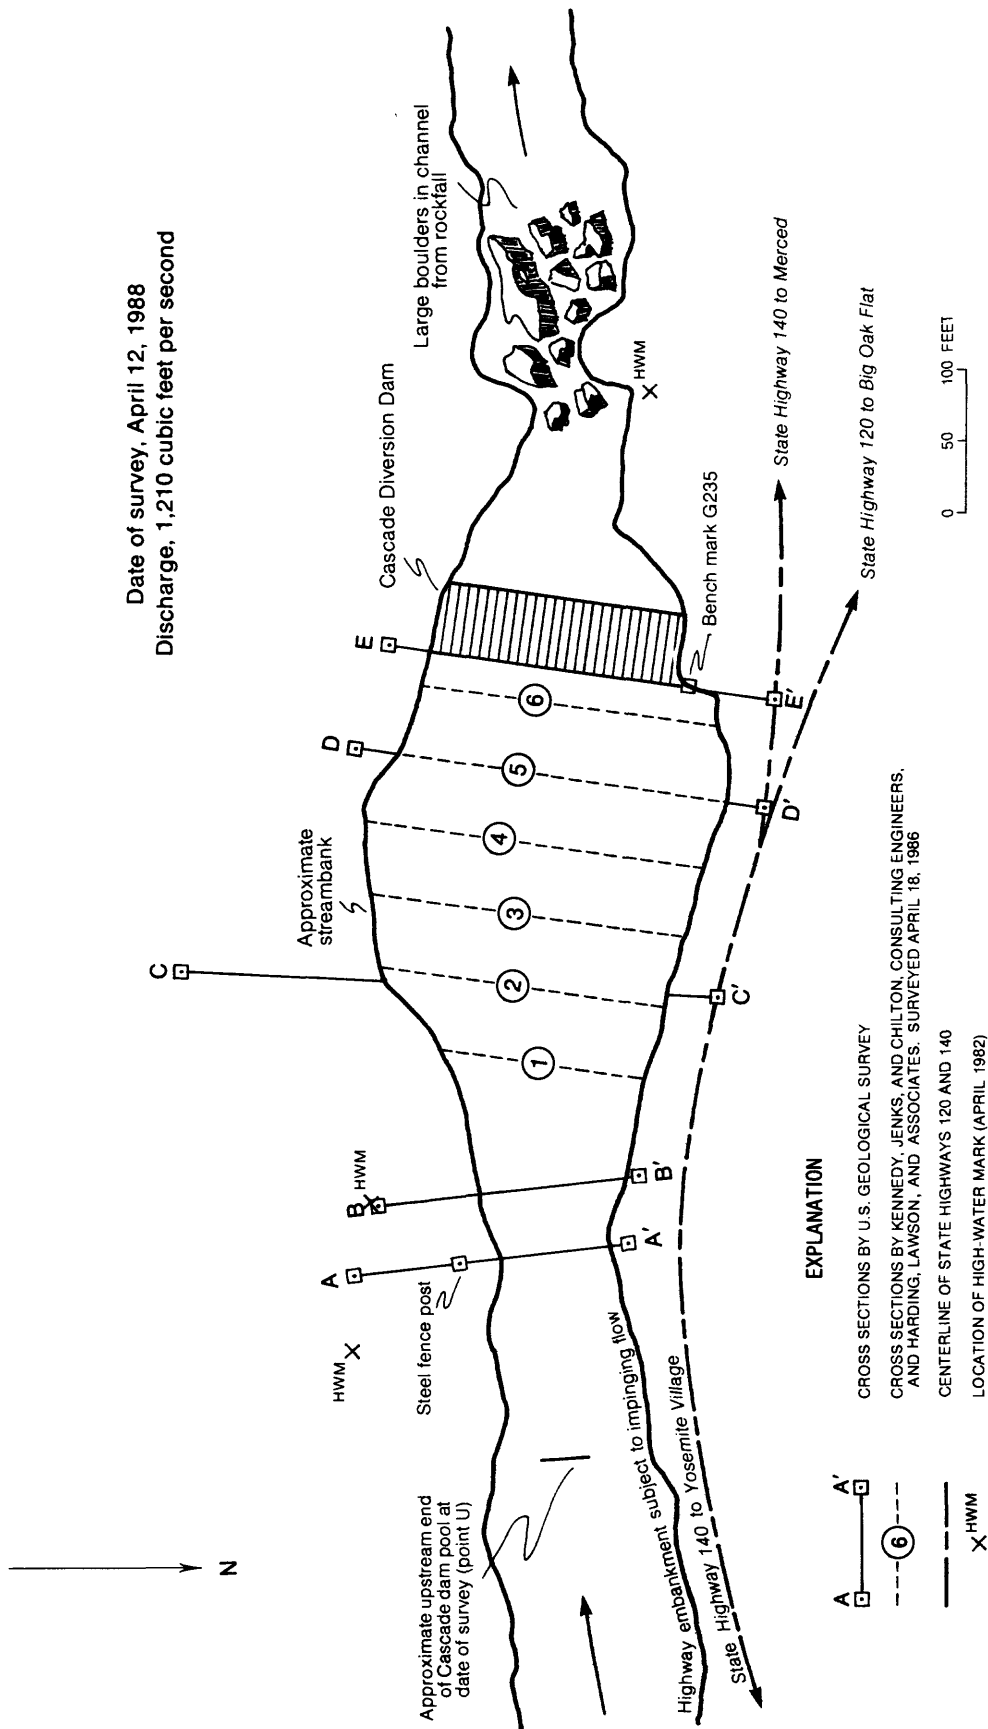
FIGURE 4. Diagram of Cascade Diversion Dam and study reach.

During large floods, as in December 1937, erosion of the State Highway 140 embankment upstream from the diversion dam between point U and cross section C may occur (fig. 4). In addition, inundation of the junction of State Highways 140 and 120 at the right bank abutment of the diversion dam (fig. 4), as noted during the floods of December 1937 and November 1950, may reoccur. At cross section B (table 2), the elevation of the toe of the rock riprap is about 3,810 ft, with the thalweg at this cross section at an elevation of 3,800 ft. As such, there is about 10 ft of channel bank below the toe of the riprap that is unprotected. However, present channel and pool conditions provide some protection of the State Highway 140 embankment because the pool tends to dissipate the kinetic energy (shear stress) associated with inflow from the upstream reach. Removal of the diversion dam will eliminate the storage pool, and the resultant energy dissipation. In addition, the channel alignment then may tend to migrate towards the right bank because of curvature of the channel, thereby increasing the possibility of erosion of the highway embankment.

If the dam is removed, the combination of inflow associated with high shear stress plus possible channel migration toward the State Highway 140 embankment suggests that bank protection will be needed at the site. Bank protection such as riprap would need to be installed at the toe of the embankment and to a point that is as high as the toe of the present riprap protection. The toe of the new bank protection should extend down to the elevation of 3,787 ft, which is the estimated thalweg profile (fig. 9), and extend upstream and downstream between point U and cross section C (fig. 4).

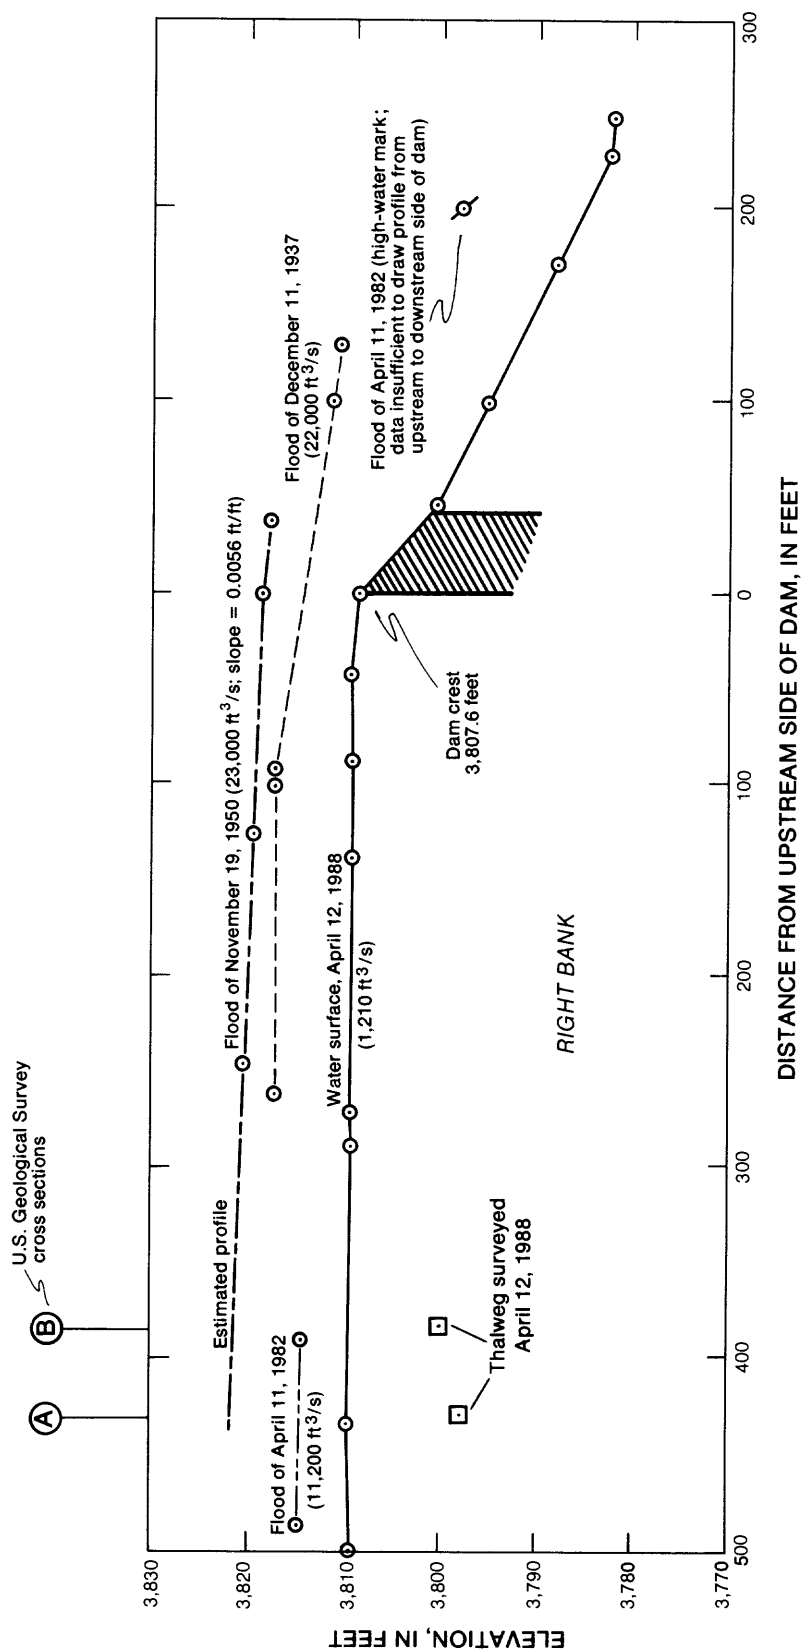
FIGURE 5. Profiles of selected historic floods at Cascade Diversion Dam.

in 1937, 1950, and 1982 are shown in figure 5. The high-water marks for the 1982 flood were found during site surveys in April 1988; the floods of December 1937 and December 1950 were documented by the Geological Survey in order to calculate flows over the dam. The location and elevation of high-water marks for the floods of December 1937 and November 1950 (fig. 5) indicate that State Highway 140 was inundated at least 2 ft deep north of the right bank abutment of the dam (fig. 4).

For the November 1950 flood, the water-surface slope in the vicinity of the dam was 0.0056 ft/ft (fig. 5), and the corresponding bed-shear stress was calculated to be 8.4 lb/ft². If the dam is removed, a maximum depth of flow of 24 ft at cross section A for flooding similar to that of November 1950 is expected to remain about the same (fig. 5). The channel-bed slope would increase to 0.0316 ft/ft (fig. 9), a value between the gradients of 0.06 and 0.01 ft/ft derived from the Geological Survey topographic map dated 1958. The corresponding bed-shear stress would be 47.3 lb/ft², nearly six times greater than the shear stress with the diversion dam in place.

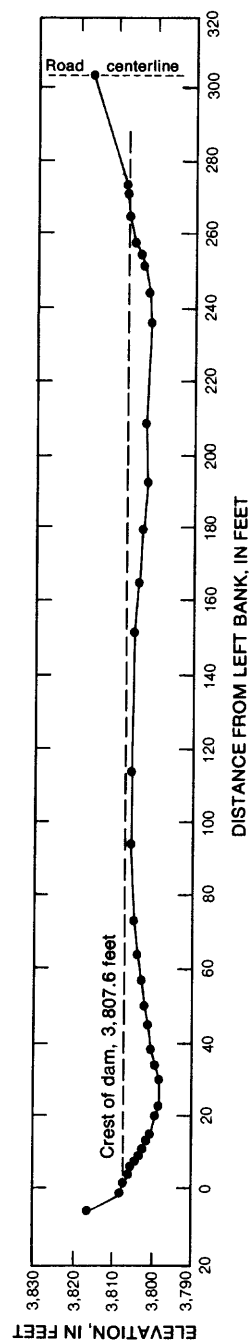
FIGURE 6. Cross section of streambed 25 feet upstream from Cascade Diversion Dam in 1931. (From topographic map by U.S. Bureau of Public Roads, dated July 1931).

The first report of sediment deposition in the pool upstream from the diversion dam was described in drawings by the U.S. Bureau of Public Roads dated July 1931. A cross section plot of the deposited material as surveyed in 1931 (fig. 6) was determined from a detailed topographic survey of the sediment deposits by the Bureau of Public Roads. Field notes by the Geological Survey after the 1937 flood report indicate that an island upstream from the dam, composed of sediment deposits in the pool, was removed prior to the 1938-39 flood season by the Bureau of Public Roads. According to reports by the resident engineer, the deposits were excavated to about 2.5 ft below the dam crest.

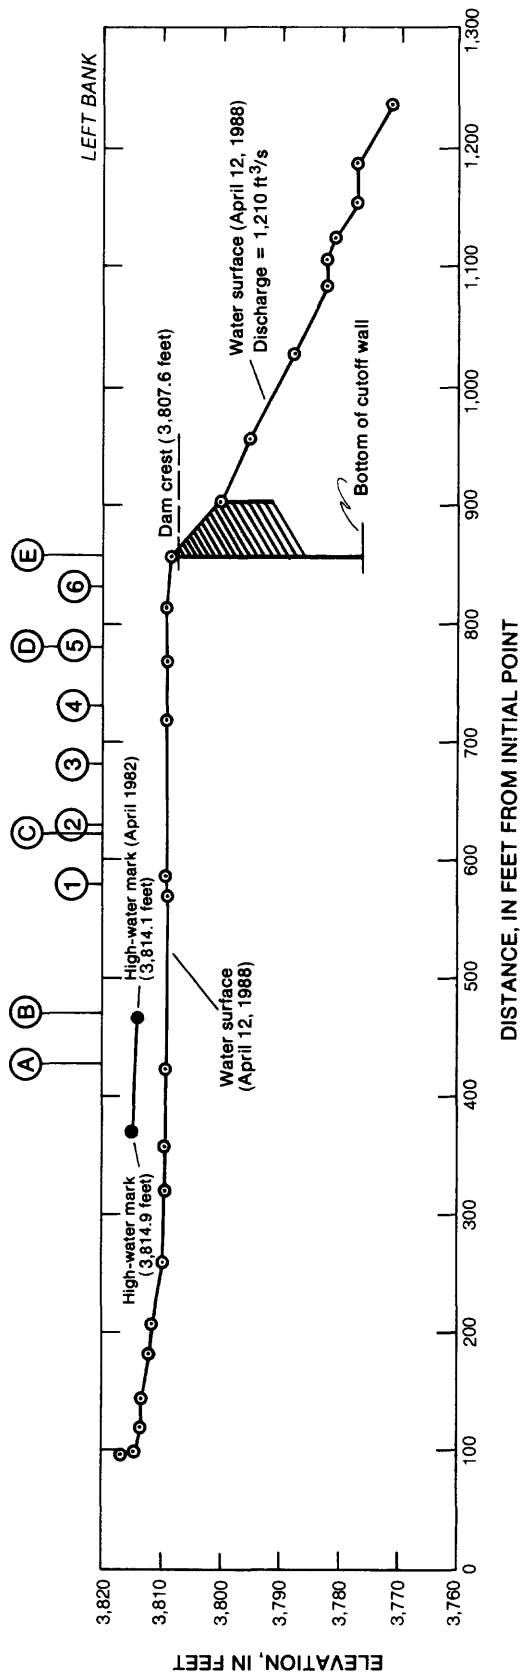
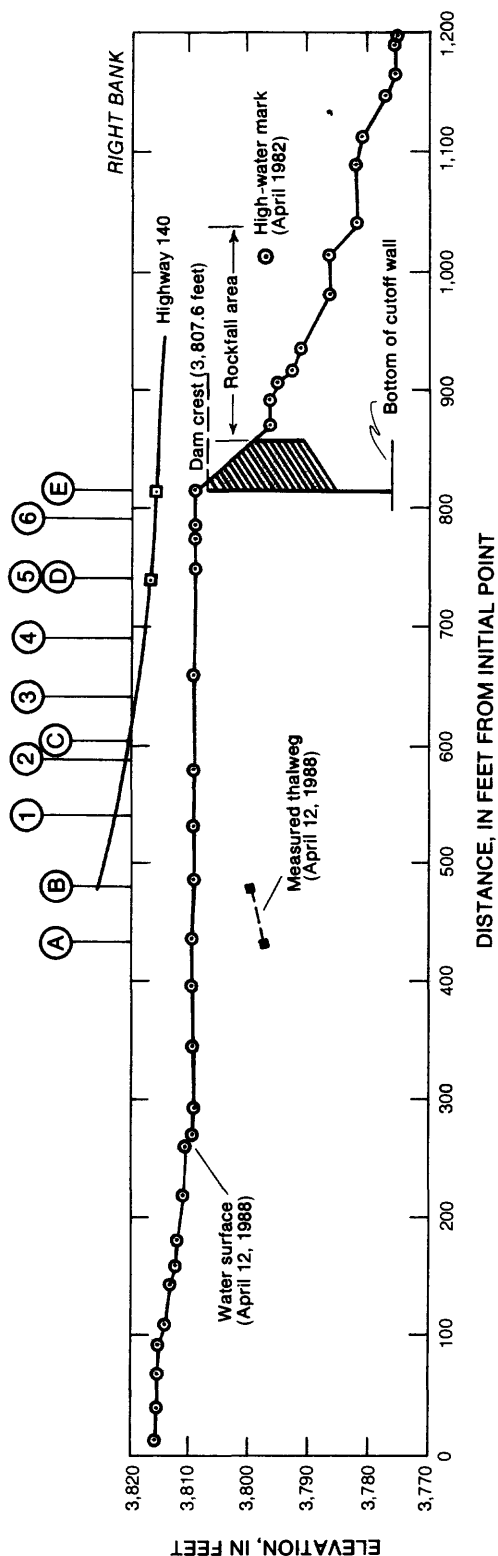
FIGURE 7. Water-surface profile of study reach on April 12, 1988.

The water-surface profile on April 12, 1988, is shown in figure 7. Backwater at this discharge extends about 550 ft upstream from the dam.

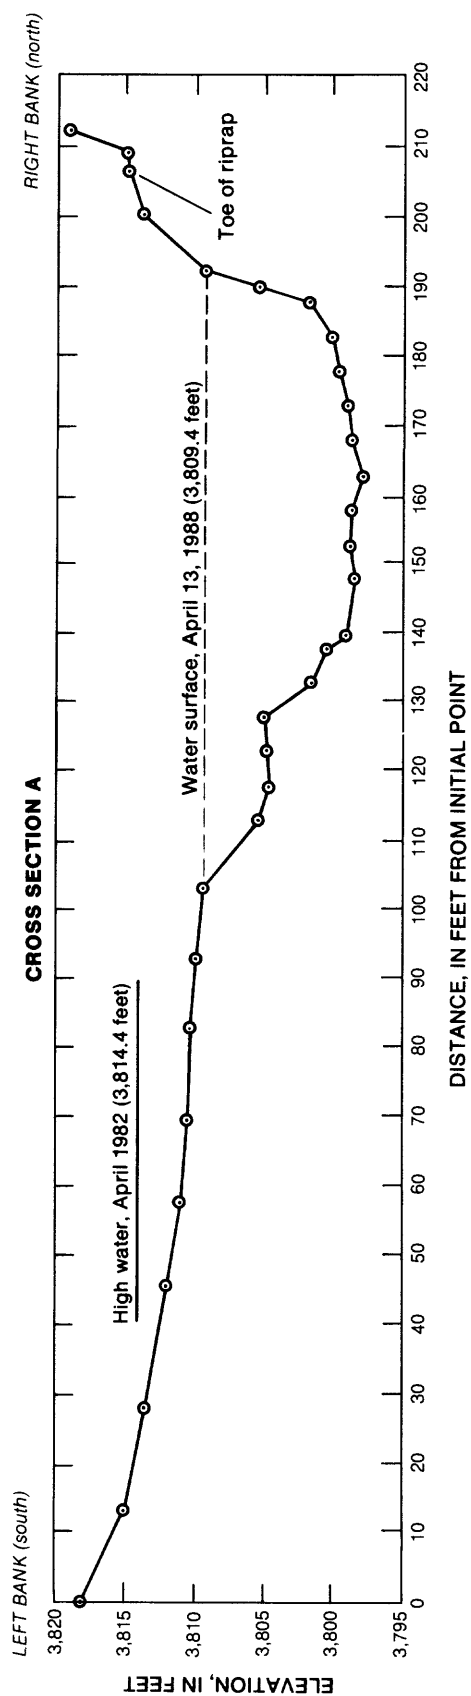
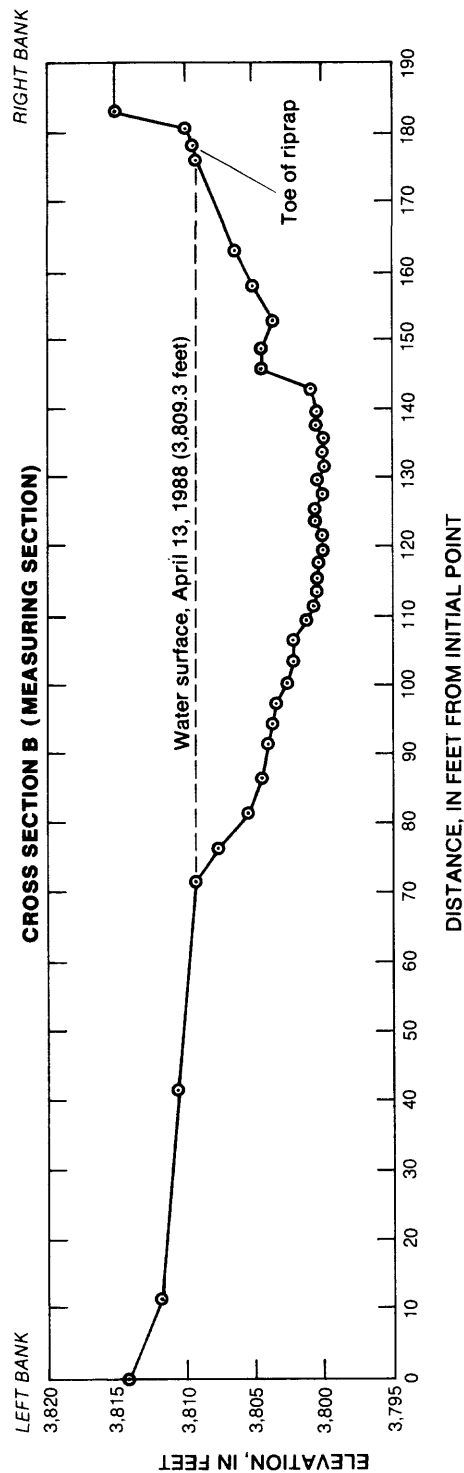
FIGURE 8. Cross sections A and B for April 1988 surveys.

Cross sections at A and B were surveyed (fig. 8). Parts of cross sections C, D, and E (figs. 4 and 7) were surveyed on the land only. A steel fence post on the left bank (south side) of the river at cross section A and several high-water marks, believed to be from the April 1982 flood (table 1), were found. A discharge measurement of 1,210 ft³/s was made April 13, 1988, at cross section B. At this location, all flow was in a downstream direction and no flow eddy or turbulence was evident at cross section A.

A tabulation of elevation data for the toe of the bank (base of State Highway 140 rock riprap and embankment), State Highway 140 pavement centerline, and channel thalweg at selected cross sections is given in table 2. The elevation data indicate the toe of the bank or that part of the highway embankment protected with rock riprap is about 10 ft higher than the channel thalweg at cross section B and about the level of the water surface when surveyed in April 1988.

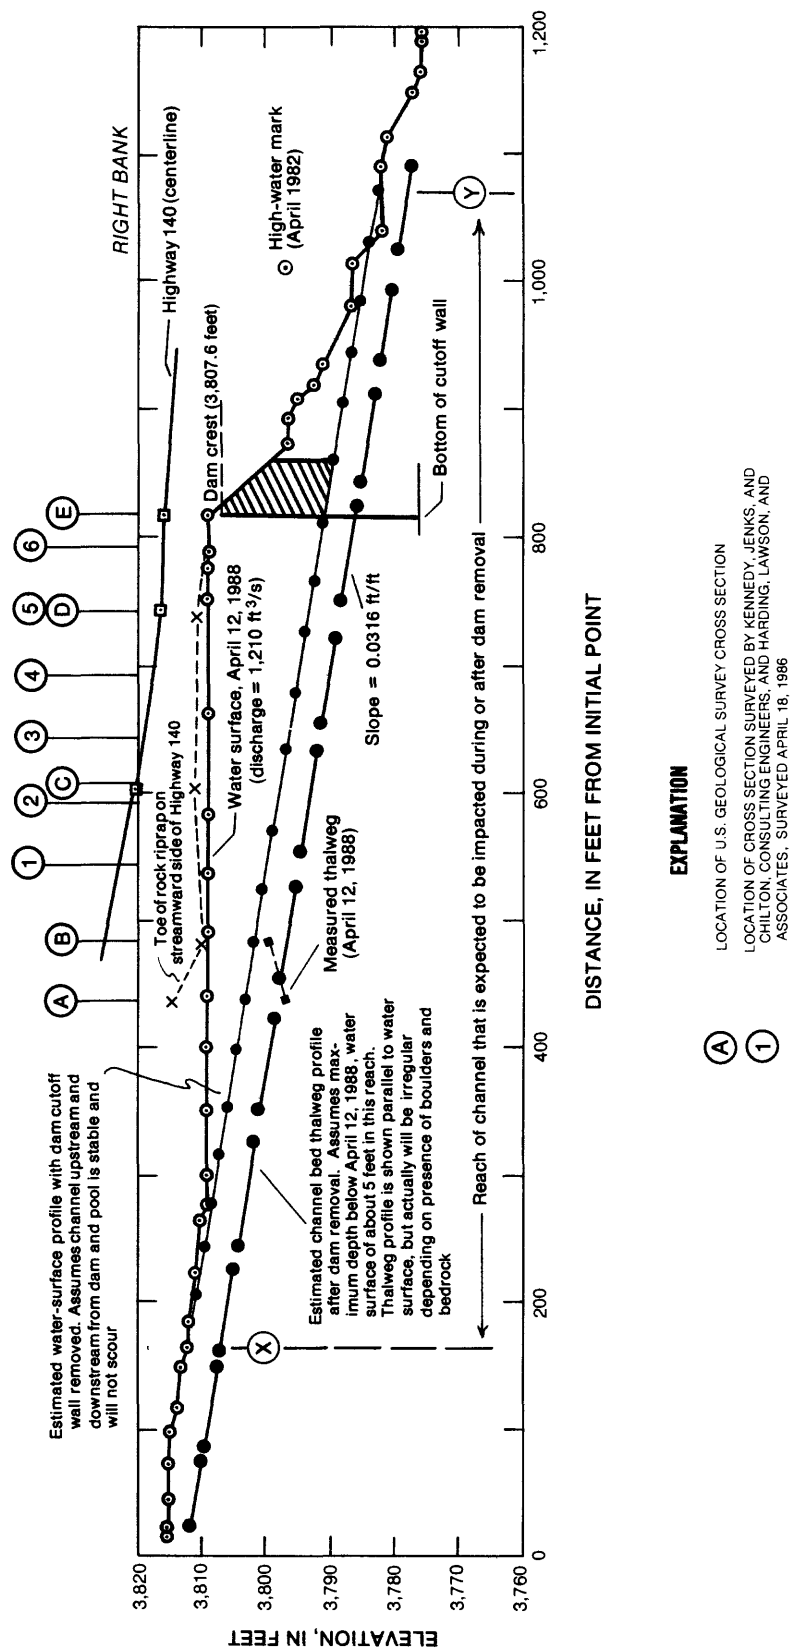
FIGURE 9. Profiles of water surface and thalweg for pre- and post-Cascade Dam conditions.

The proposed removal of Cascade Diversion Dam will affect the Merced River channel for a distance both upstream and downstream from the dam. As shown in figure 9, the water-surface profile for flow conditions such as on April 12, 1988, will probably change for a reach length greater than 600 ft upstream and 300 ft downstream from the dam. In addition, the water-surface profile at the site of the dam would be about 18 ft lower than the April 12, 1988, elevation. These estimates are based on the points of tangency with the existing water-surface profile (fig. 9), as determined during the April 1988 surveys. The upstream point of tangency is the farthest upstream location in the reach at which changes in the existing channel may occur, regardless of future modifications to the diversion dam. The point of tangency at the downstream end of the reach is considered to be a stable location because of the large boulders in the channel that were deposited from a rock-fall on the left bank (fig. 4). Even though erosive forces downstream from the dam are high because of the steep channel gradient in this reach (fig. 9), the channel has reached a state of equilibrium for present flow conditions. It is probable that these large boulders (fig. 2) will continue to stabilize the channel geometry in this part of the reach even if the dam is removed.

Associated with the lowering of the water surface will be a tendency for the active stream channel to incise within the former pool area and establish a new alignment. The thalweg elevation of the newly incised channel cannot be estimated with accuracy, but likely will approximate the existing thalweg elevation at points A and B (fig. 9), which are near the upstream end of the reach affected by the diversion dam. At the diversion dam, the future thalweg elevation could be as much as 21 ft lower than the present dam crest. With the dam removed, the future

thalweg profile (fig. 9) would be about 5 ft lower than the estimated water-surface profile, based on flows surveyed on April 12, 1988.
