DEPARTMENT OF THE INTERIOR
U.S. GEOLOGICAL SURVEY

The Intensity of the July 21, 1986, Chalfant Valley,
California, Earthquake

Open-File Report 89-135

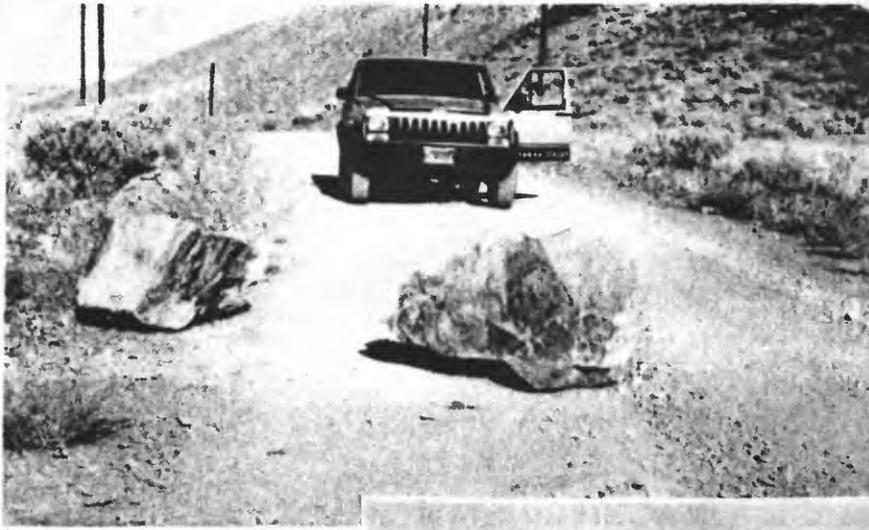
Numerous rockfalls were reported in Chidago Canyon and the canyons of the White Mountains; spectacular dust clouds were associated with these rockfalls. Rockfalls were also observed, during our NEIC survey, all along Fishslough Road (see fig. 3) Some roads were temporarily blocked by boulders; however, no thoroughfares were blocked.

Figure 4. A road blocked by a boulder in the Chalfant Valley after the Chalfant event (photo from Kahle and others, 1986).

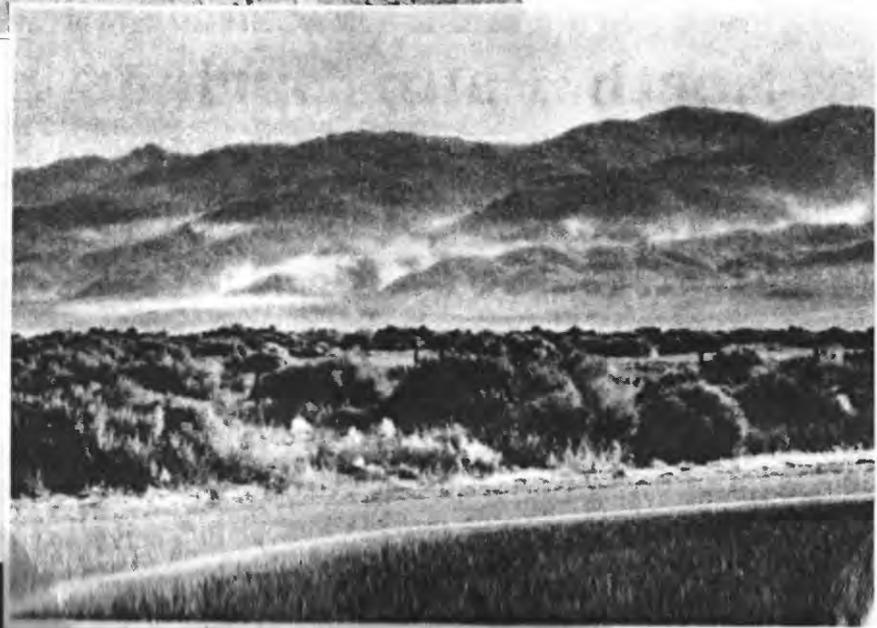
Figure 5. Dust rising out of canyons, in the White Mountains caused by rockslides and rockfalls during the Chalfant event (photo from Kahle and others, 1986).

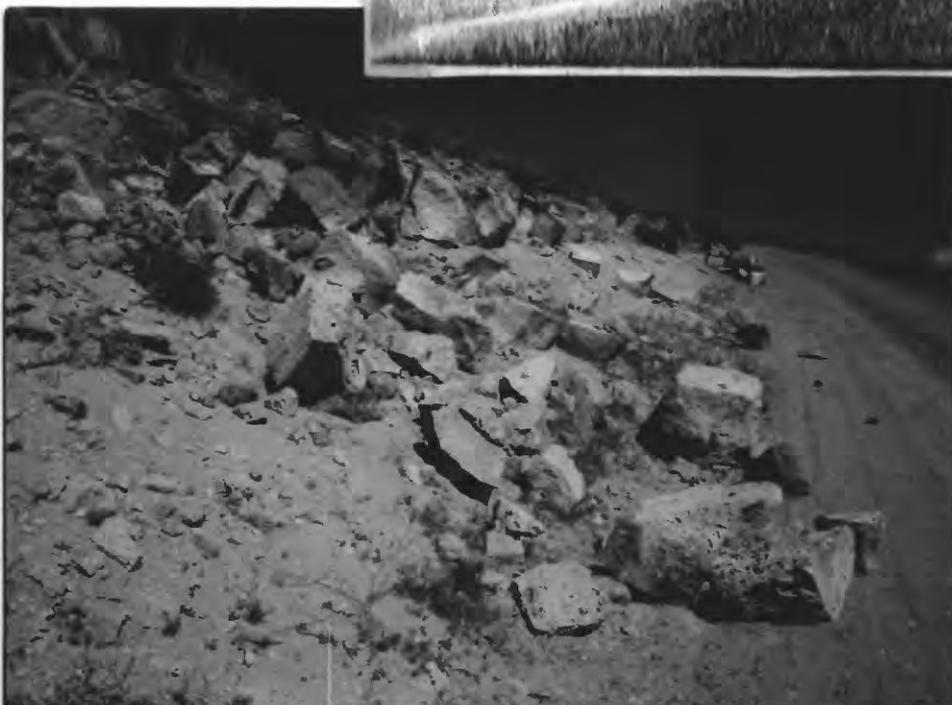
Figure 6. Rockfall along Fish Slough Road.

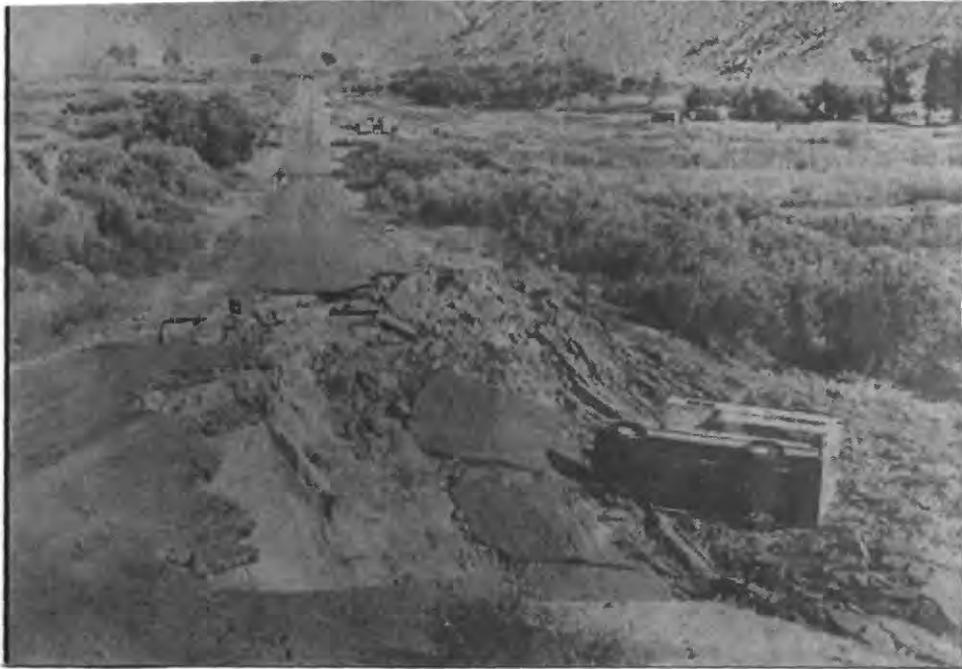
A landslide occurred in 25 m of roadfill, on the Pleasant Valley Dam Road, over a marshy area in the Owens River Valley southeast of Lake Crowley (Bryant and others, 1986) (see figs. 3 and 7). The slide occurred about 16 km south of the epicenter and about 10.5 km northeast of Bishop. It temporarily stranded campers and overturned a camper trailer located at the head of the slide--no injuries were reported. Inspection by one geologist indicates that the landslide was caused by liquefaction of saturated alluvial soils at the base of the roadfill (Kahle and others, 1986). Another observer noted that the soil failure involved both fill and underlying saturated soft clayey sediment. Mud was extruded and flowed along the toe of the slide (Bryant and others, 1986). During the NEIC survey, we noted that a portion of the slide was at the intersection of the road and a presently unused irrigation ditch which possibly could have been a catchment for runoff, aiding in the saturation of soils (see fig. 8).

Figure 7. Landslide which occurred in 25 m of roadfill on the Pleasant Valley Dam Road (photo from press report).

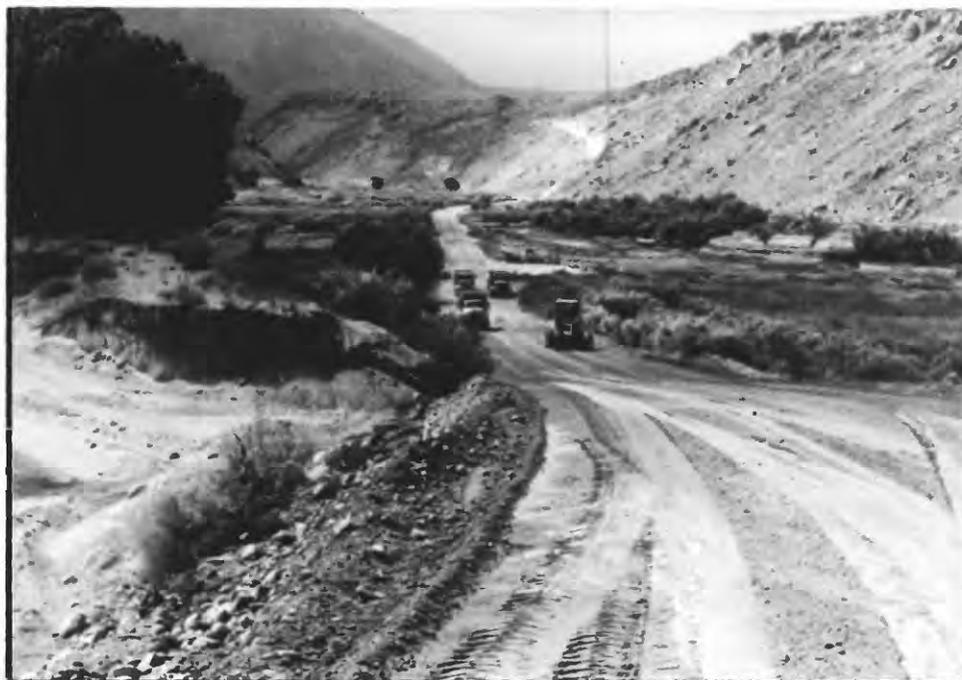
Figure 8. After picture of the Pleasant Valley Dam Road; shows intersection of road with an old irrigation ditch.

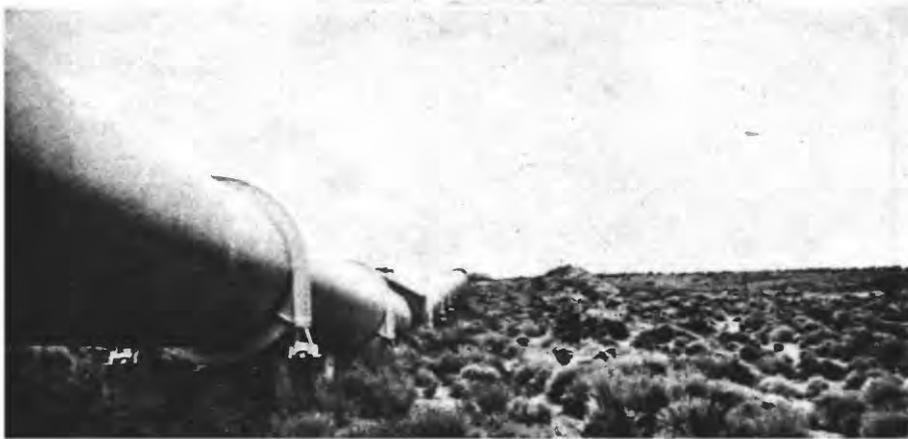
An intensity MM VI was assigned to damage of pipe supports. During the earthquake, part of a 19.2-km-long, 2.4-m-diameter pipe sustained support damage. The pipe is the portion of the Los Angeles aqueduct that connects the Gorge plants (see fig. 3). This pipe has pin supports that allow longitudinal movement from thermal expansion. The earthquake caused the pins to slide laterally as much as 51 mm. In some locations, it caused set bolts to shear. The reinforced concrete footings for these pin supports cracked and spalled, and anchor bolts pulled (Bryant and others, 1986). Five or six of these concrete footings along the pipe were damaged in this way (see figs. 9 and 10). This damage is attributed to lateral movement (Duane Buckholtz, personal communication).

Figure 9. The 19.2-km-long pipe connecting the Owens Gorge power plant system (photo from Bryant and others, 1986).

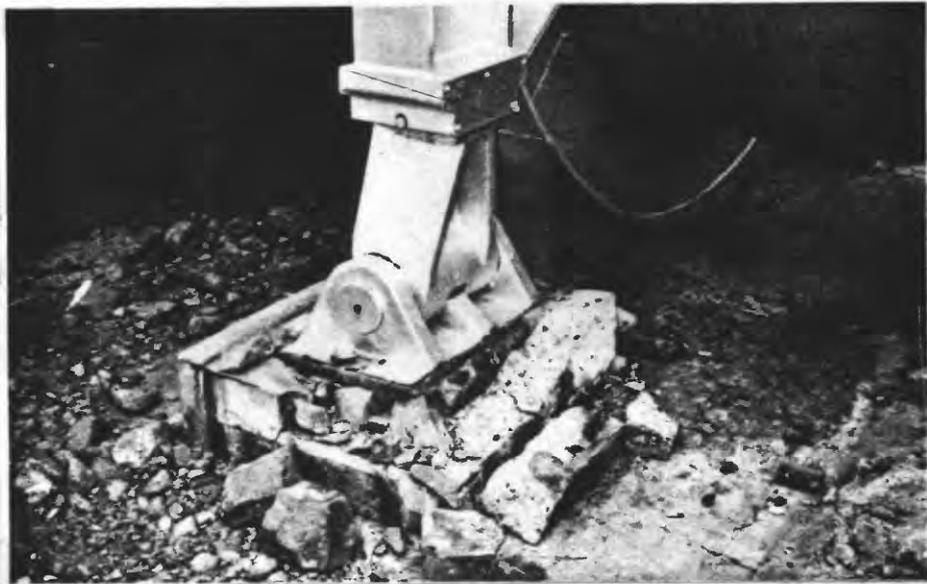
Figure 10. Concrete supports for the pipe (photo from Bryant and others, 1986).

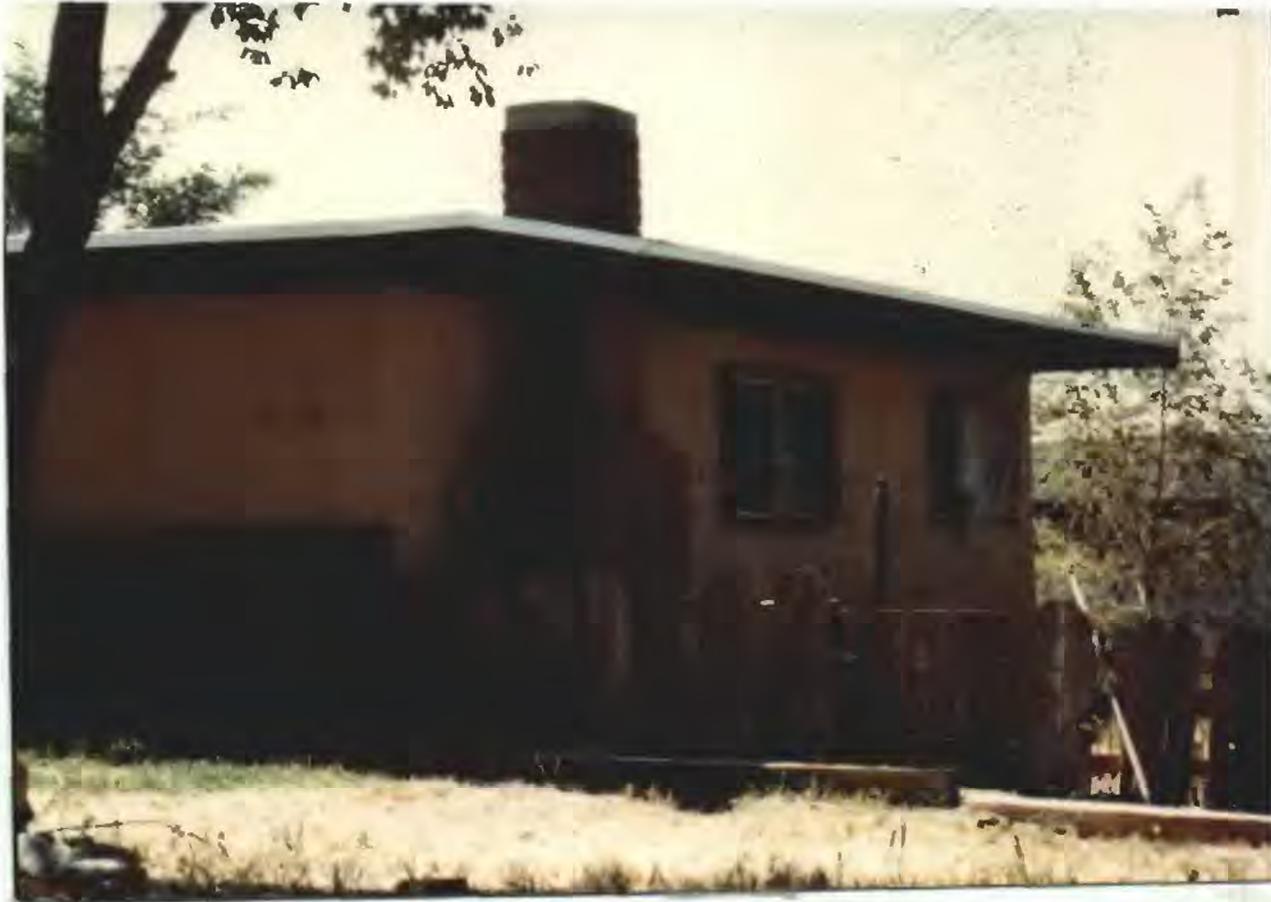
Figure 11. Permanent dwelling, in Chalfant, on Mountain View Drive. A few bricks have been loosened from the chimney.

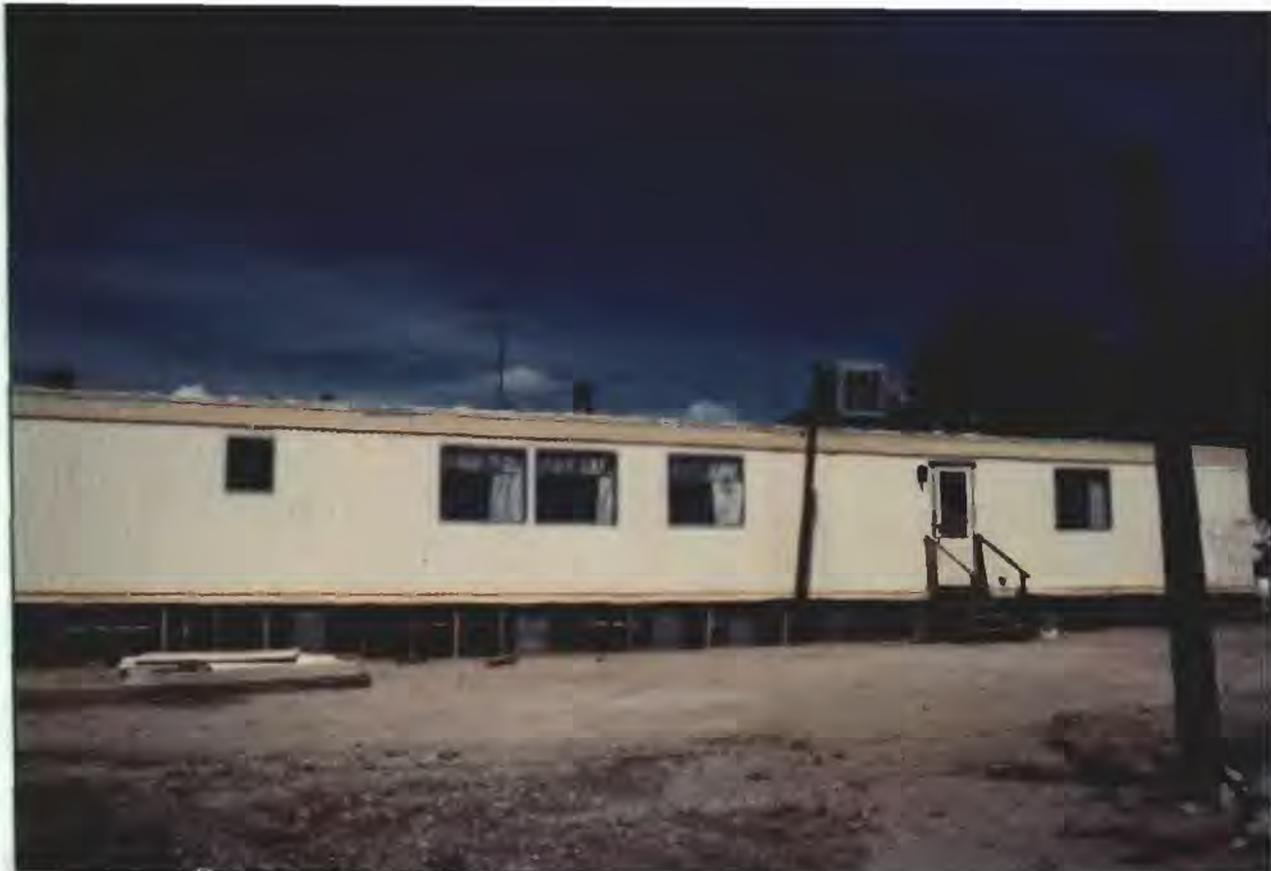
Figure 12. Mobile home, in Chalfant, on Mountain View Drive and Chase Avenue. It has been releveled back on its supports.

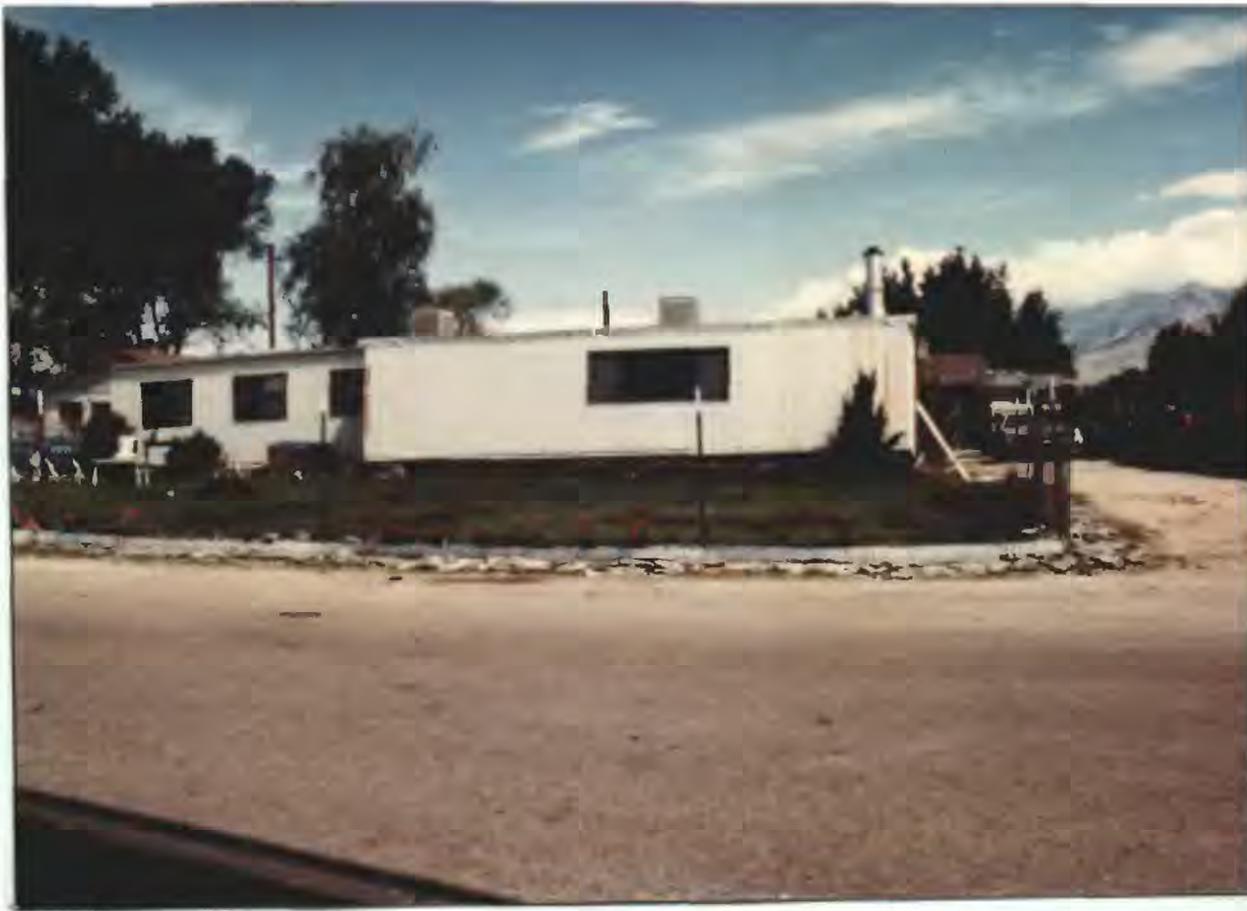
All of Chalfant's 145 structures (mainly one-family residence mobile homes) sustained damage to their contents (many items were thrown off shelves and glass items broken). Of these structures, 53 mobile homes (single and double width) were shaken off their foundations. Most of these mobile home foundations were hollow, concrete block masonry; some were tripods. Only one home in Chalfant was damaged irreparably; the double width mobile home, on Mountain View Avenue, that was thrown off its supports (press report) (see figs. 13 and 14).

Figure 13. Mobile home, in Chalfant, off its supports (irreparably damaged) on Mountain View Avenue.

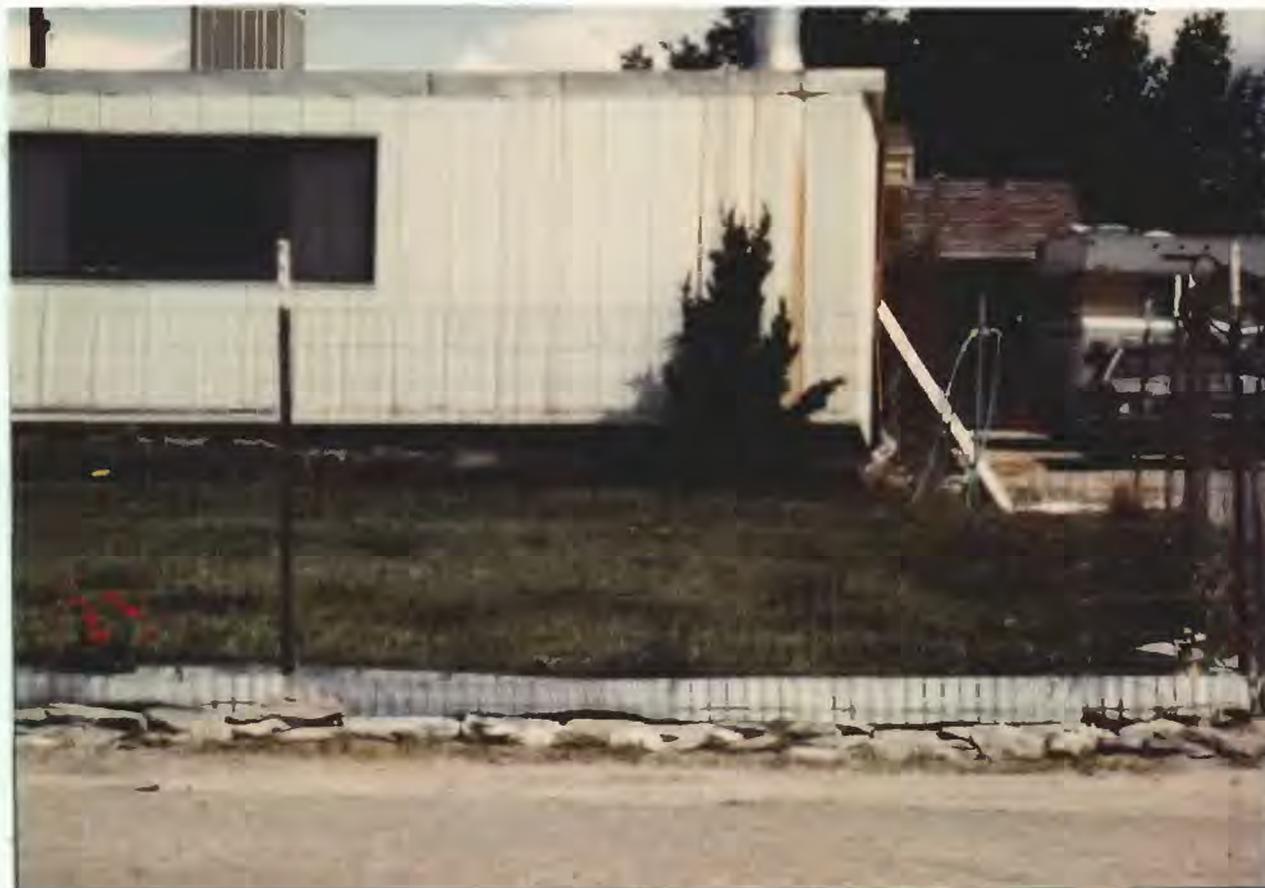
Figure 14. Close up of above photo.

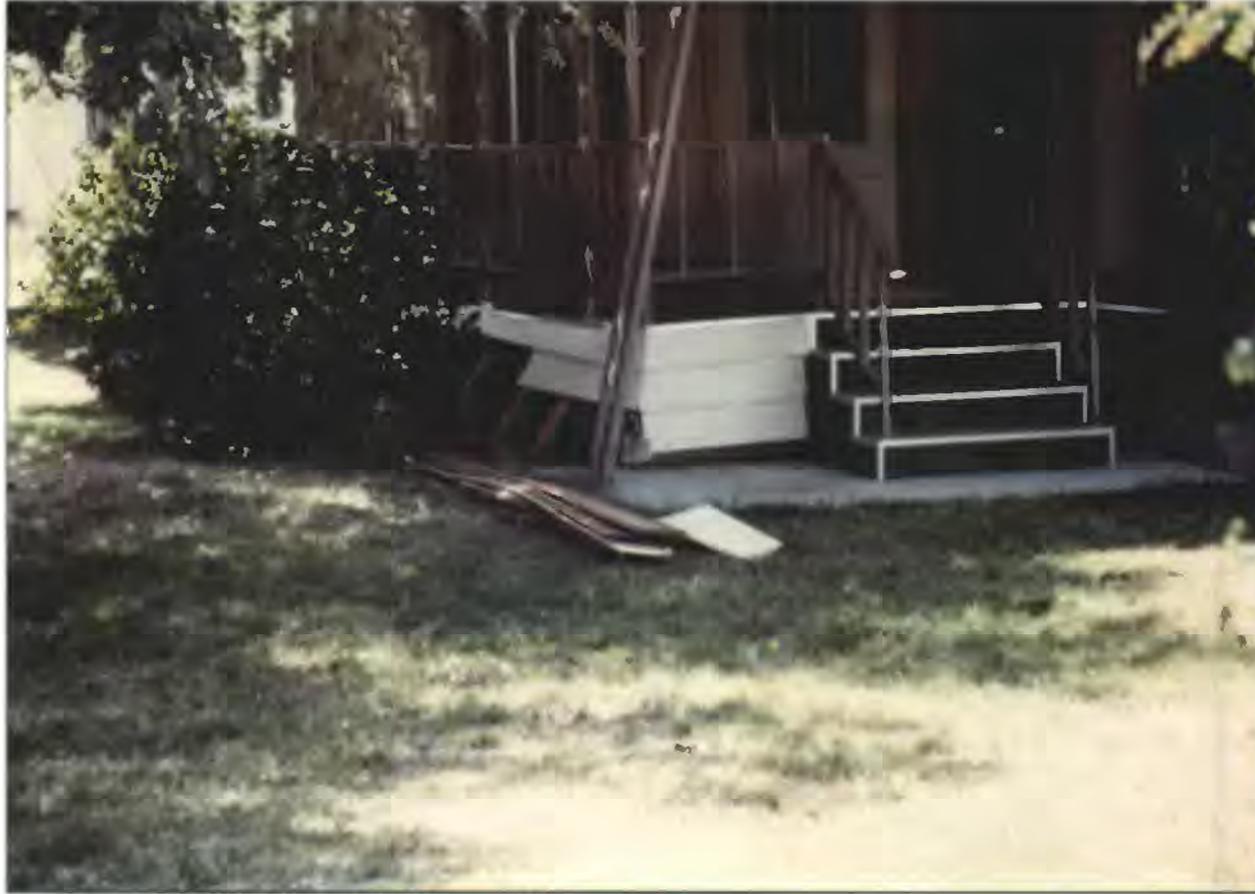
Figure 15. Mobile home, in Chalfant, across from the town park. The supports are leaning.

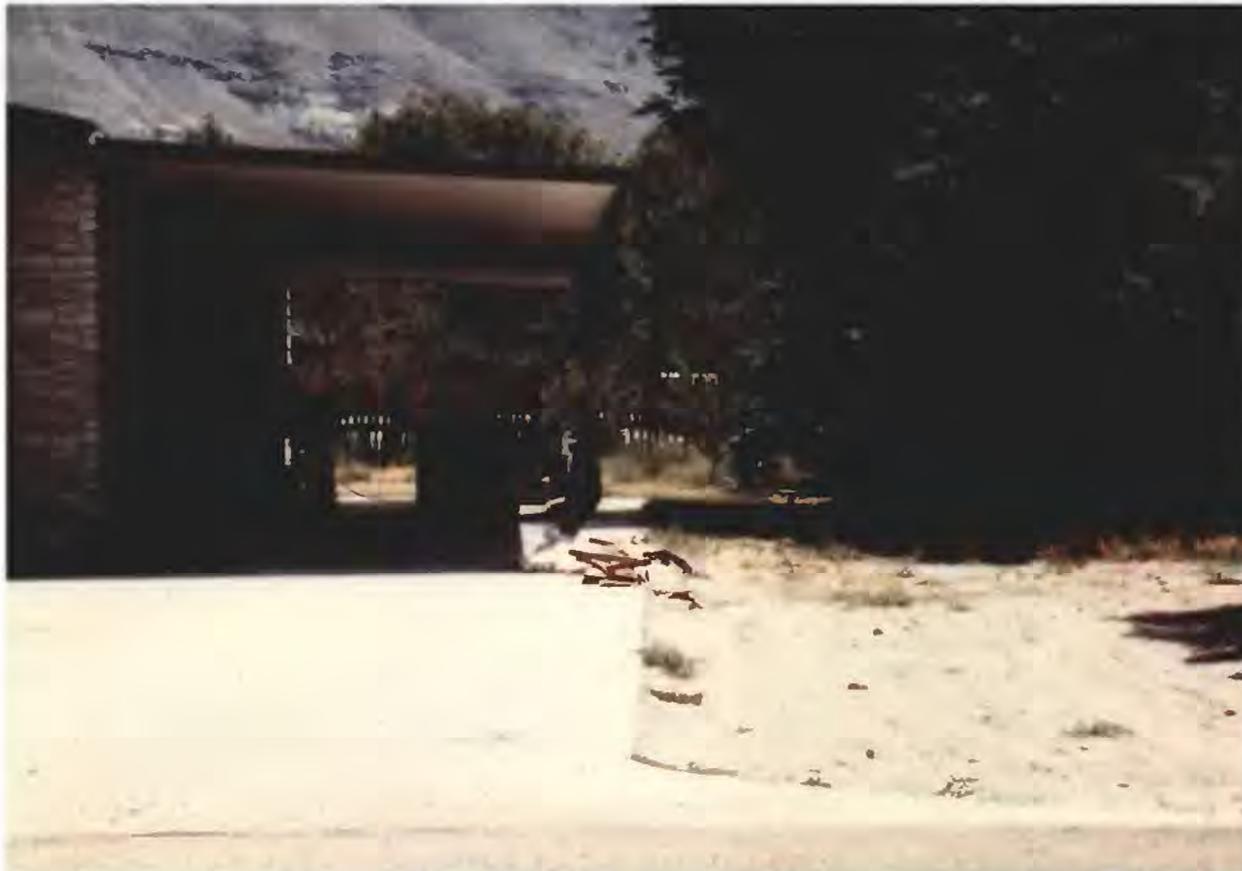
Figure 16. The other side of the above mobile home. Porch supports are torqued.

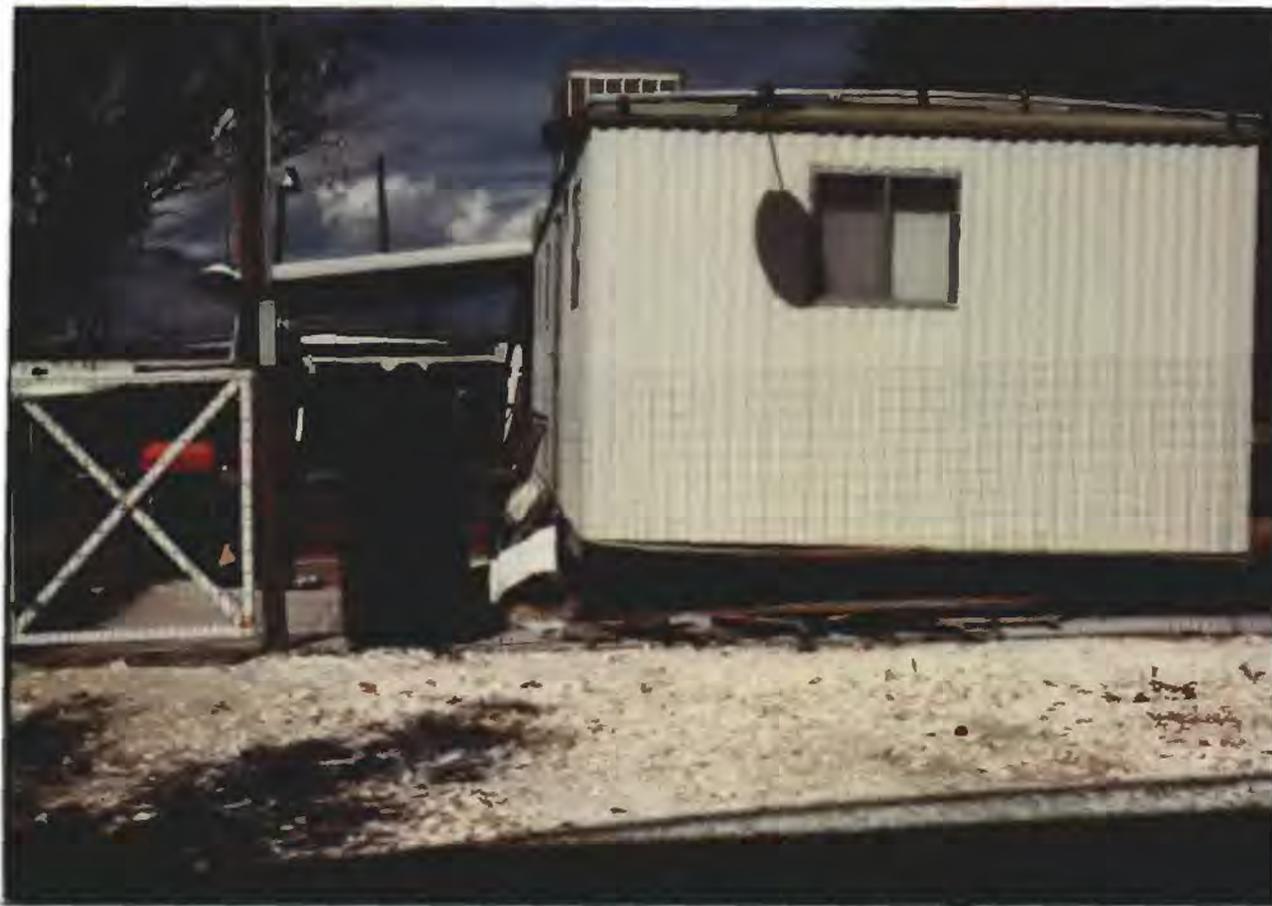
Figure 17. Mobile home, in Chalfant, on Chase Avenue off of its supports.

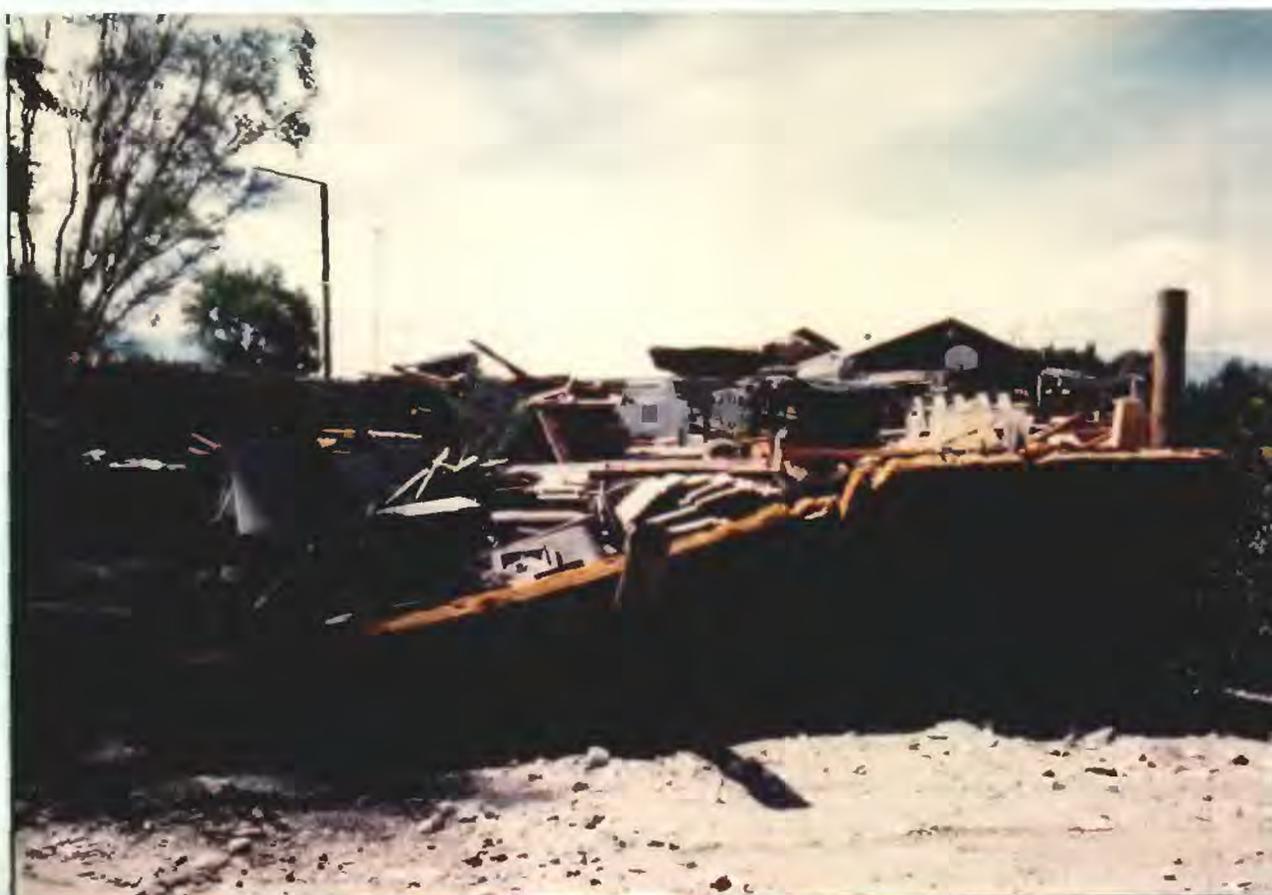
Figure 18. Virginia Avenue in Chalfant. The fence is bent by cement slabs which have slid.

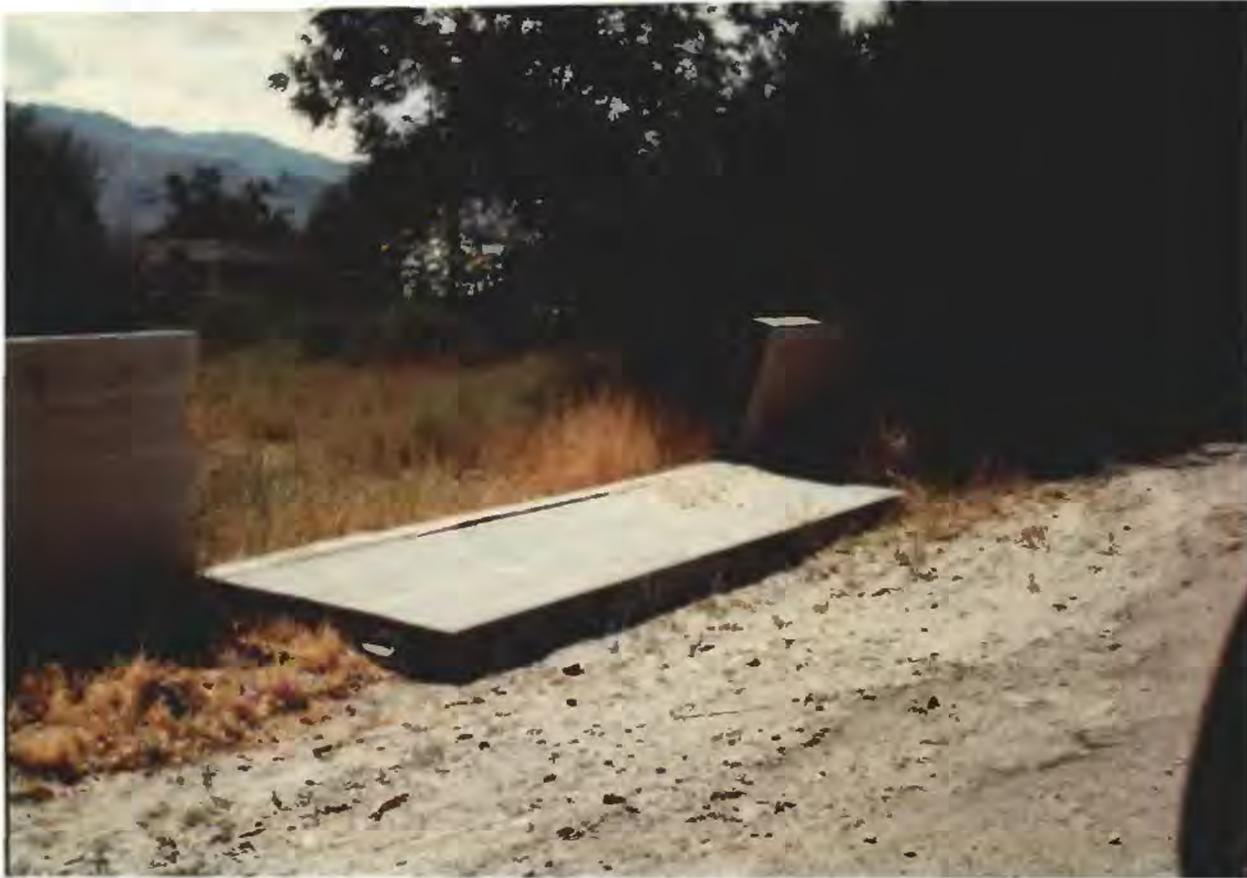
Figure 19. Fallen cinderblock fence, in Chalfant, on Chase Avenue.

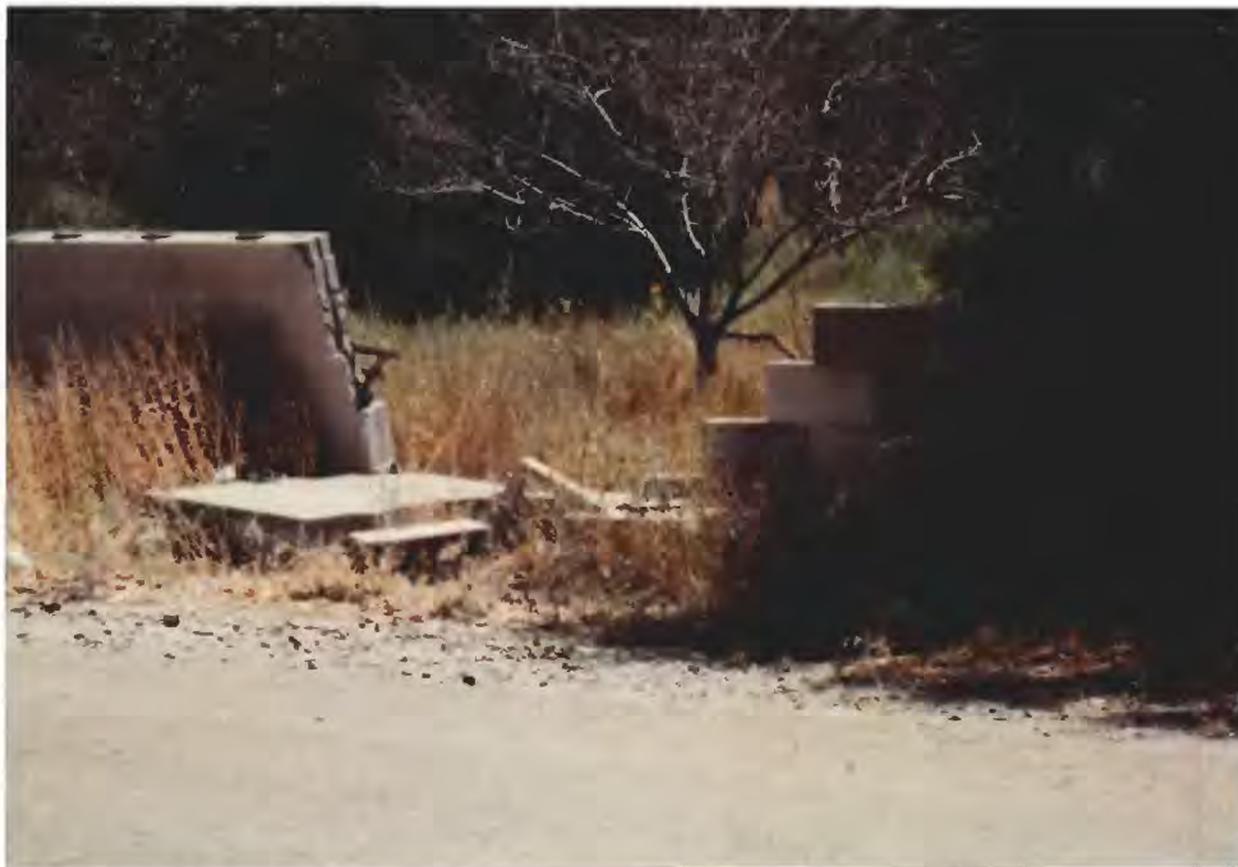
Figure 20. Fallen cinderblock fence, in Chalfant, on Chase Avenue.

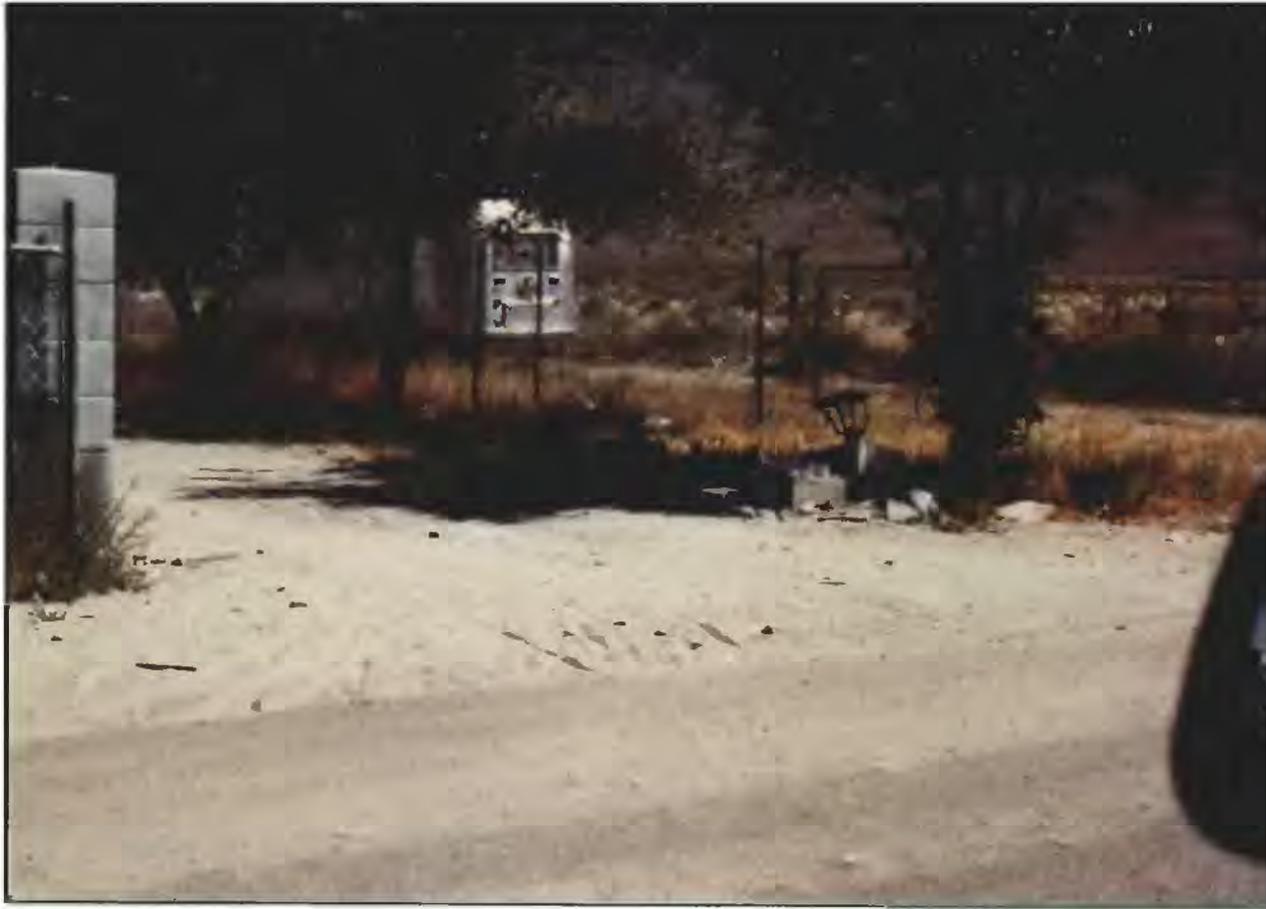
Figure 21. Two gate posts in Chalfant. The one on the right fell; the one on the left, supported by the fence, did not.

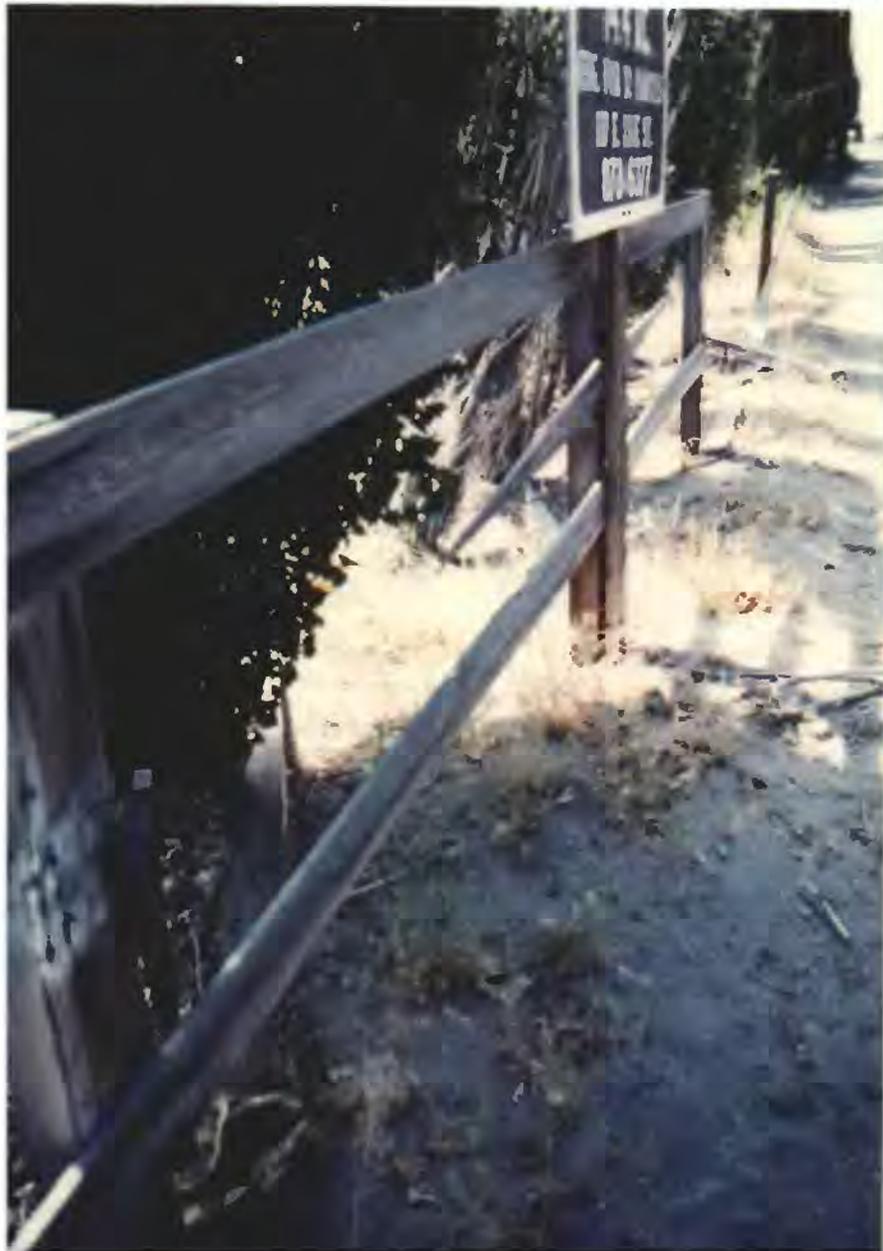
Figure 22. Wooden fence broken, in Chalfant, on Chase Avenue.

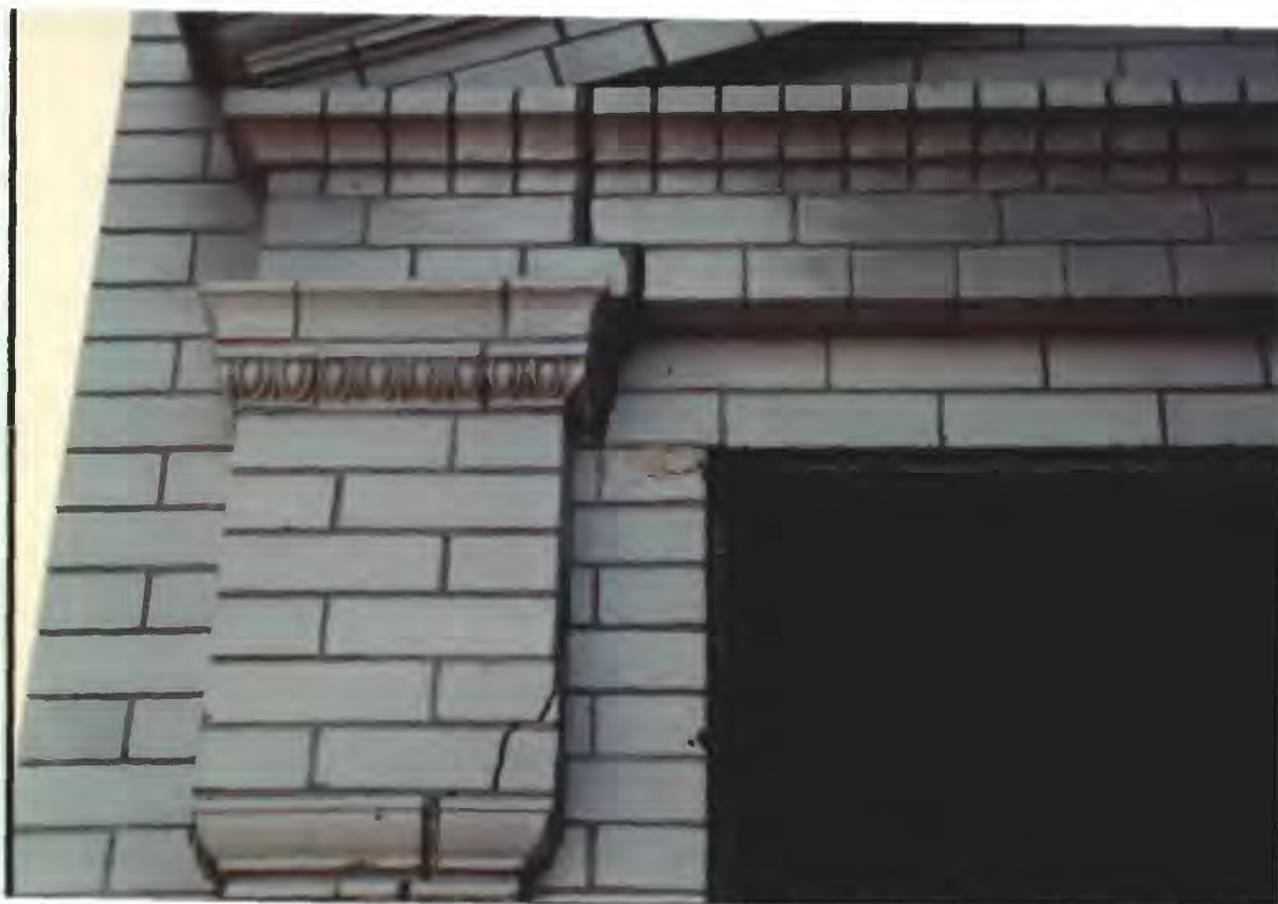
Figure 23. First Sierra Bank in Bishop (Main Street and Line Street). There was cracking and separating of brick facade.

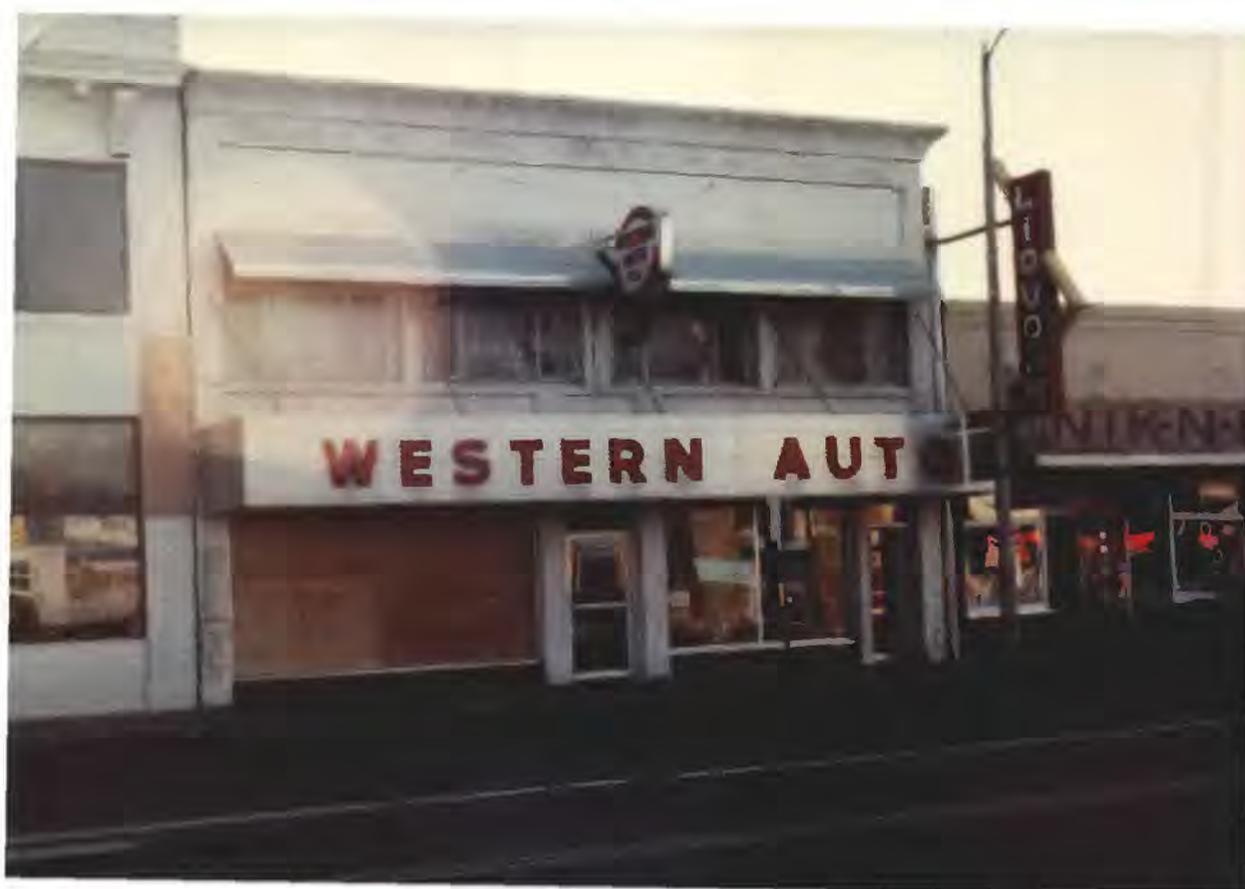
Figure 24. Western Auto (Main Street) in Bishop; the window was broken and subsequently reboarded.

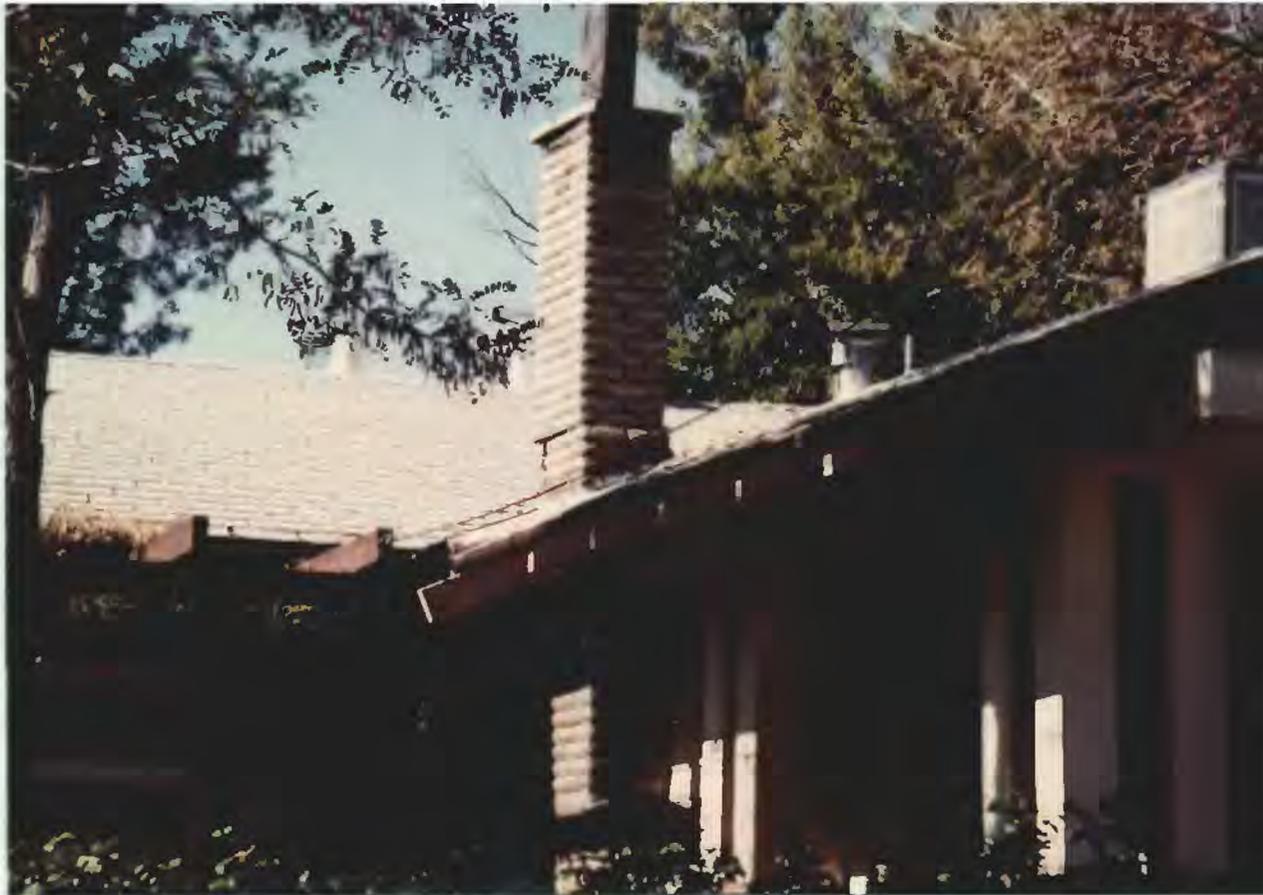
Figure 25. Realty World (178 E. Line Street). A chimney was broken just above the roofline.

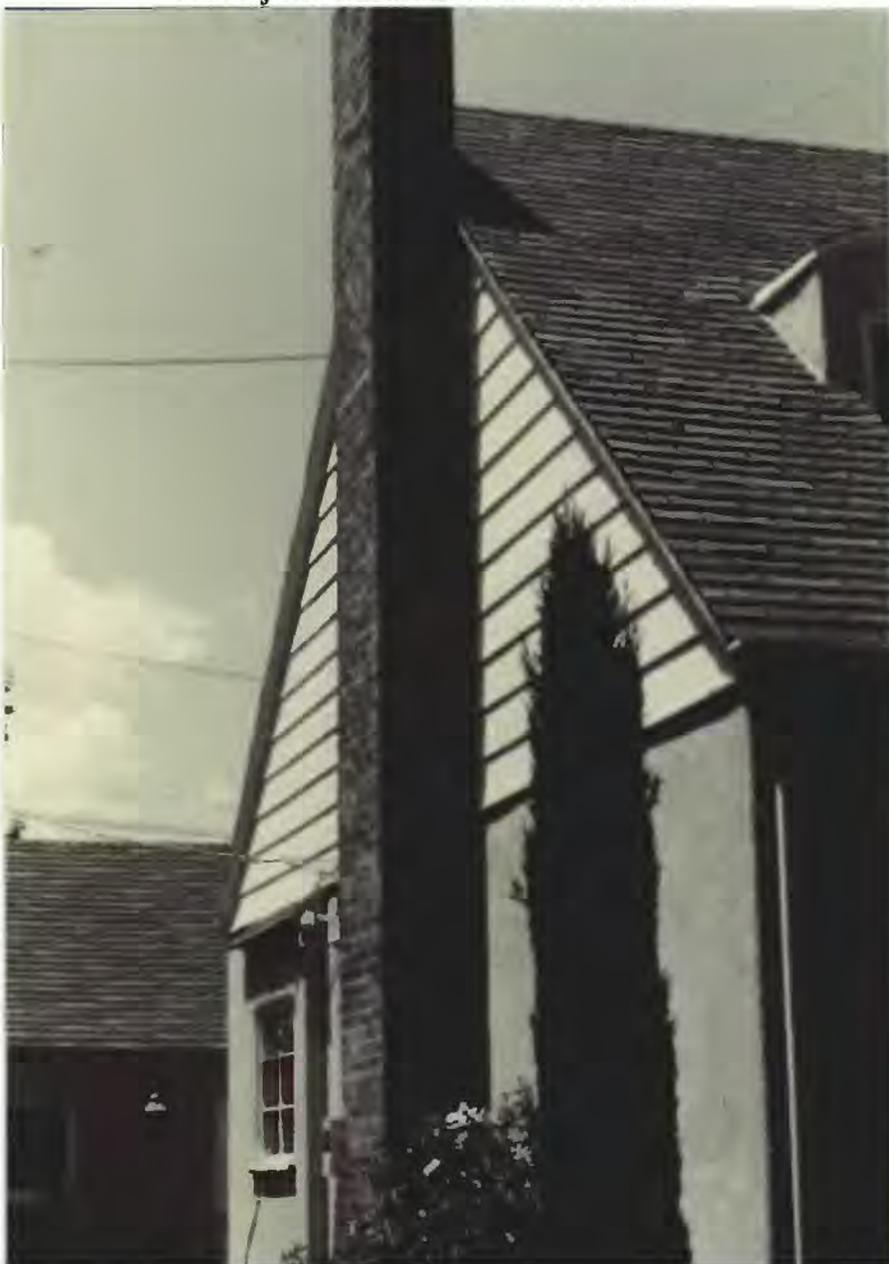
Figure 26. A residence in Bishop (Home Street and Pine Street). The chimney separated about 35 mm from the house.
