DEPARTMENT OF THE INTERIOR
U.S. GEOLOGICAL SURVEY

The Intensity of the July 21, 1986, Chalfant Valley,
California, Earthquake

Open-File Report 89-135

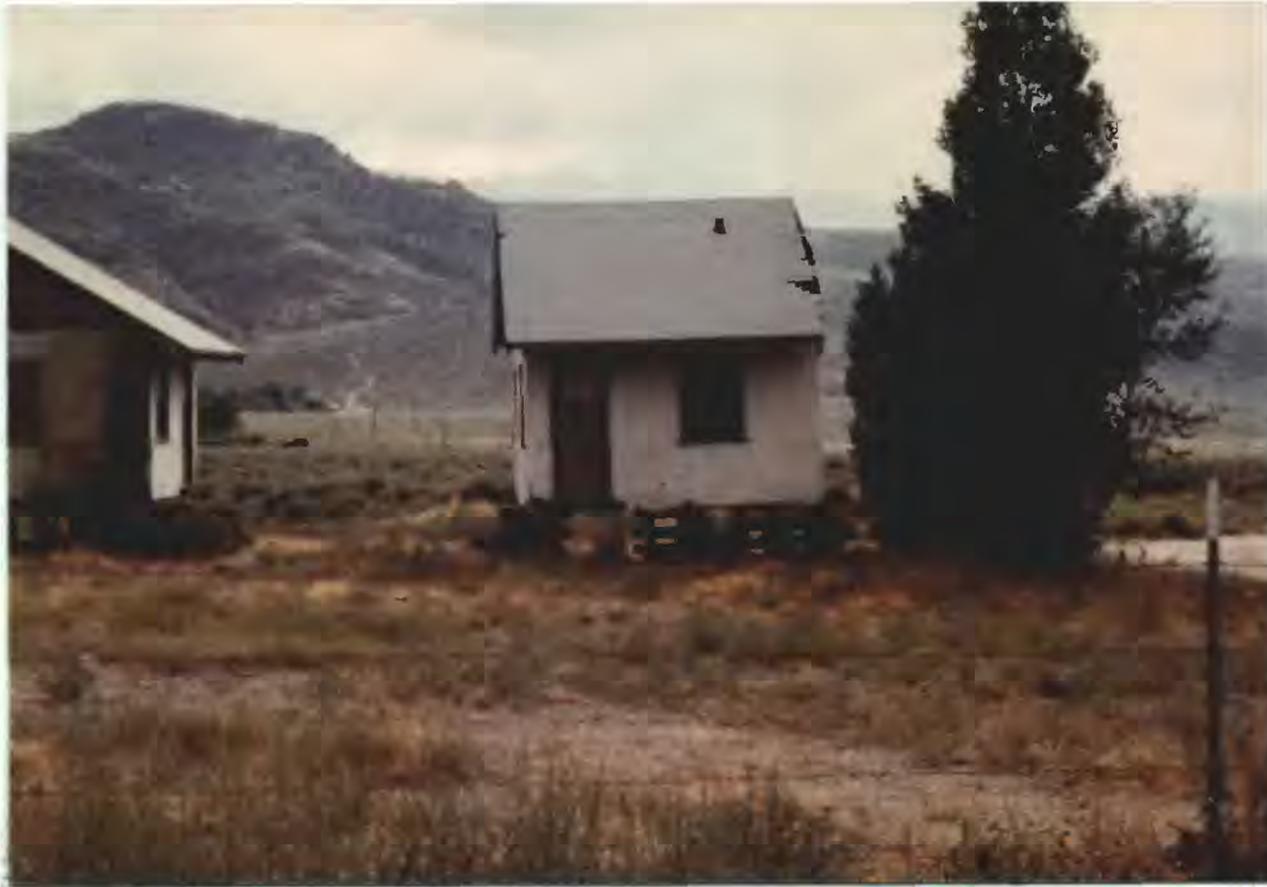
Figure 27. These houses on supports, just south of Benton, apparently didn't fall during the earthquake.

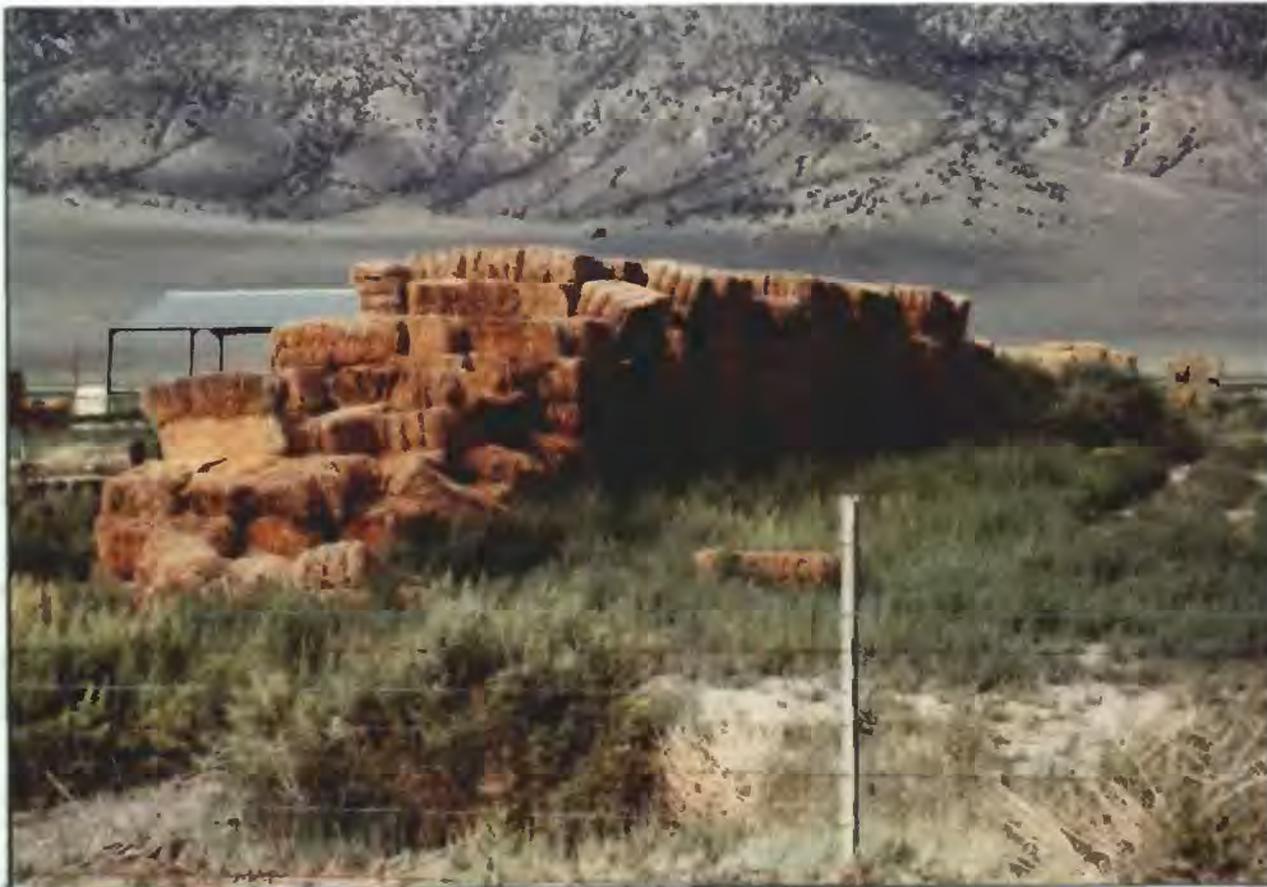
Figure 28. A haystack, just south of Benton, with a few stacks out of kilter.
