DEPARTMENT OF THE INTERIOR

U.S. GEOLOGICAL SURVEY

Maps showing landslide features and related ground deformation  
in the Woodlawn area of the Manoa Valley,  
City and County of Honolulu, Hawaii

Open-File Report 89-290

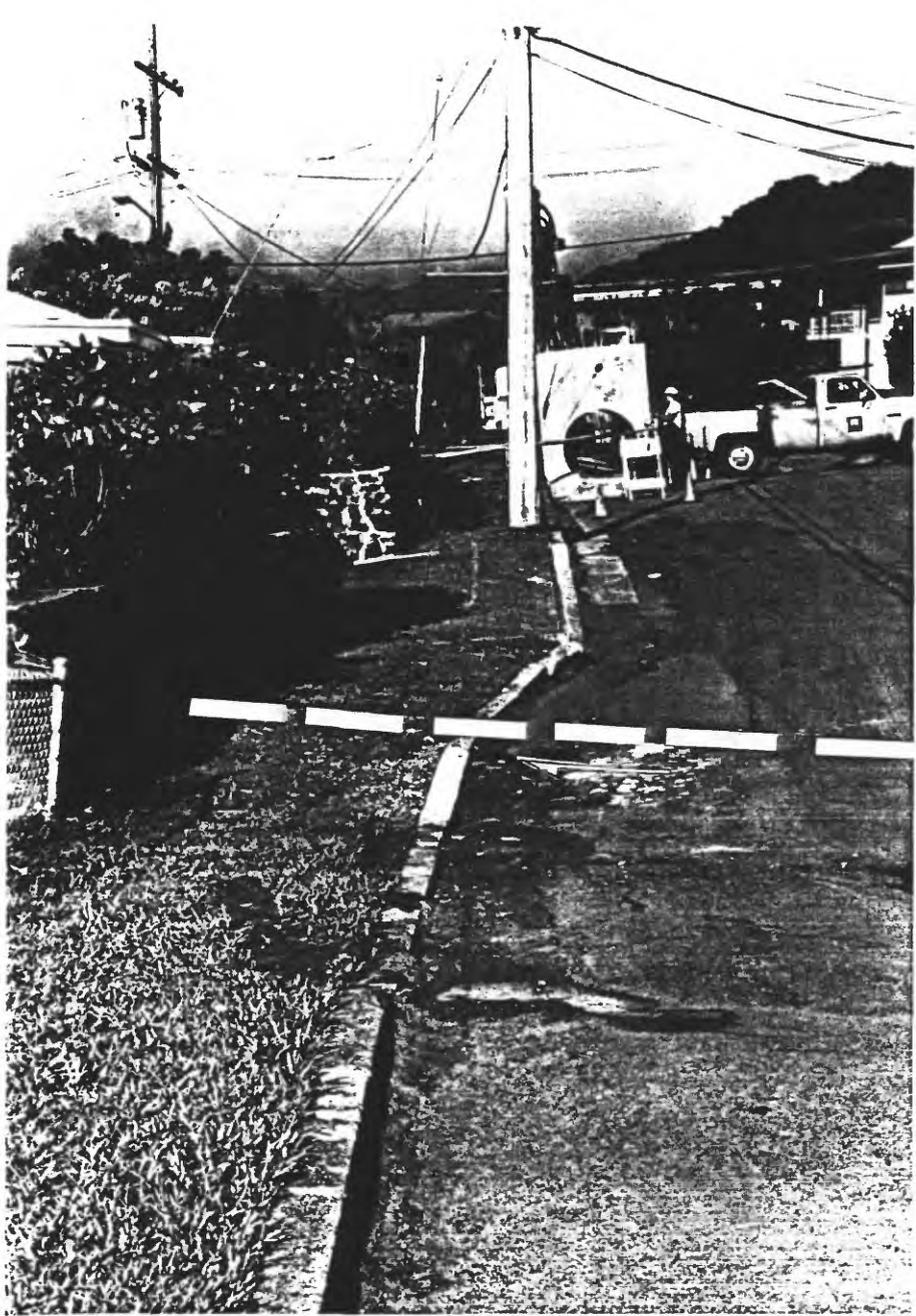
A

Figure 2. Photographs showing examples of damage on the Alani-Paty landslide. A. Offset caused by shearing is evident in the curb at 3069 Lanikaula Street. The curb line in the foreground has been displaced to the left about 3 feet relative to the curb line in the background. Note the absence of evidence for deformation in the lawn to the left. The dashed line shows the approximate location of the shear fracture that bounds the north flank of the landslide, and the arrow indicates the direction of movement.

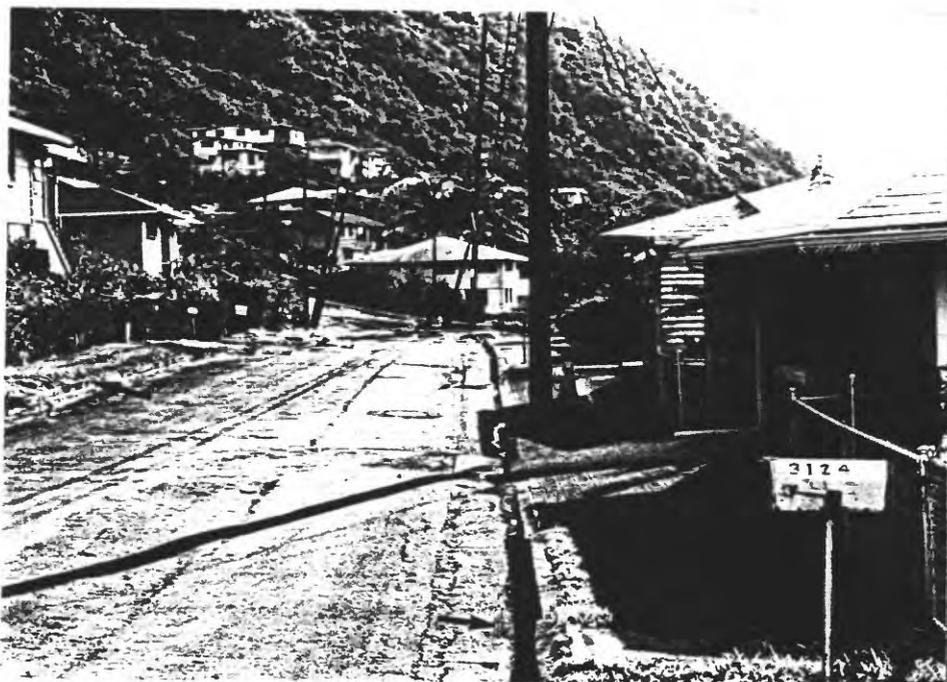
*B*

Figure 2. (continued) B. View toward the southwest along Lanikaula Street toward the intersection with Woolsey Place. Tilted curbstones (arrow at bottom center), bulging of lawns downslope from walls on the left (arrow at left center), and formation of bumps in the street (center) are evidence for shortening. Much damage has been repaired including replacement of some utility poles (background).

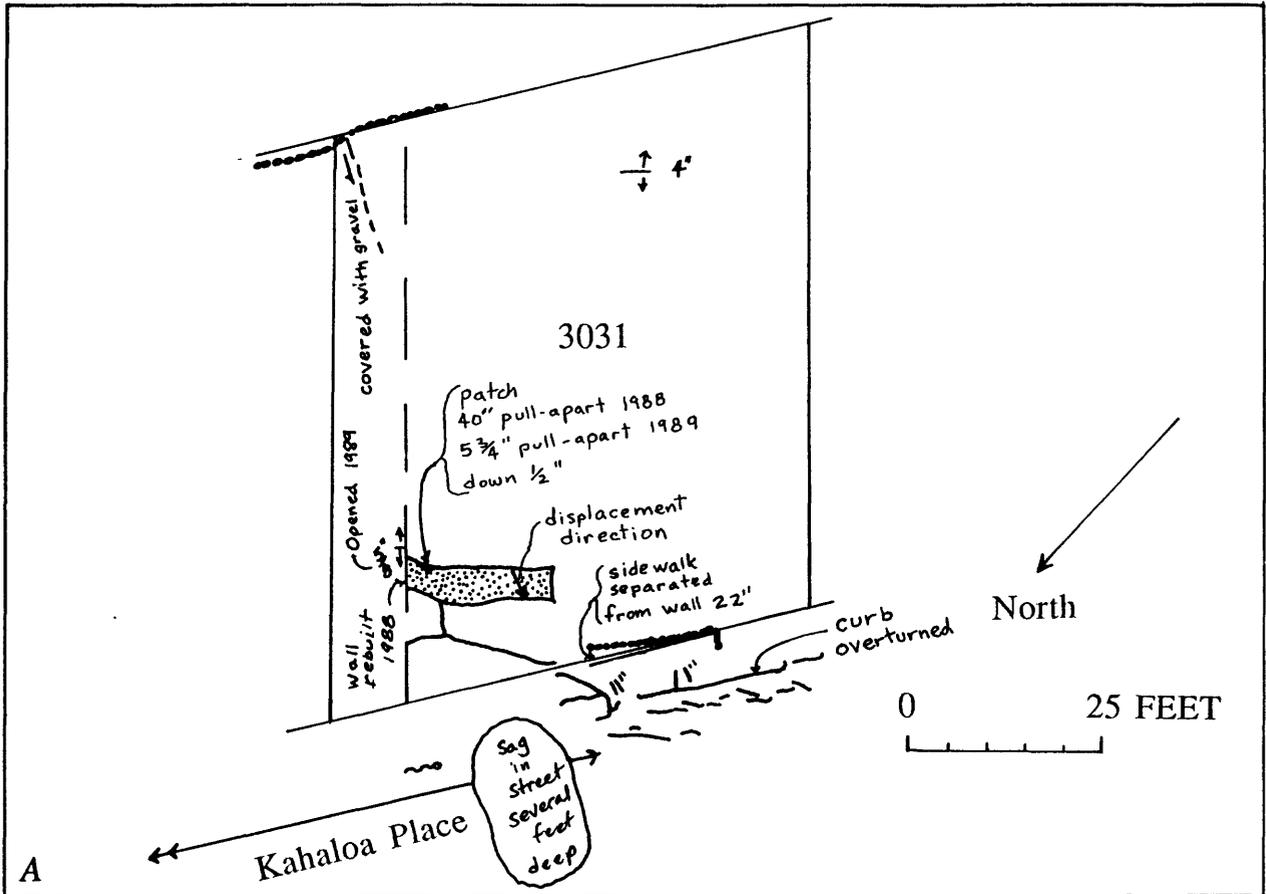
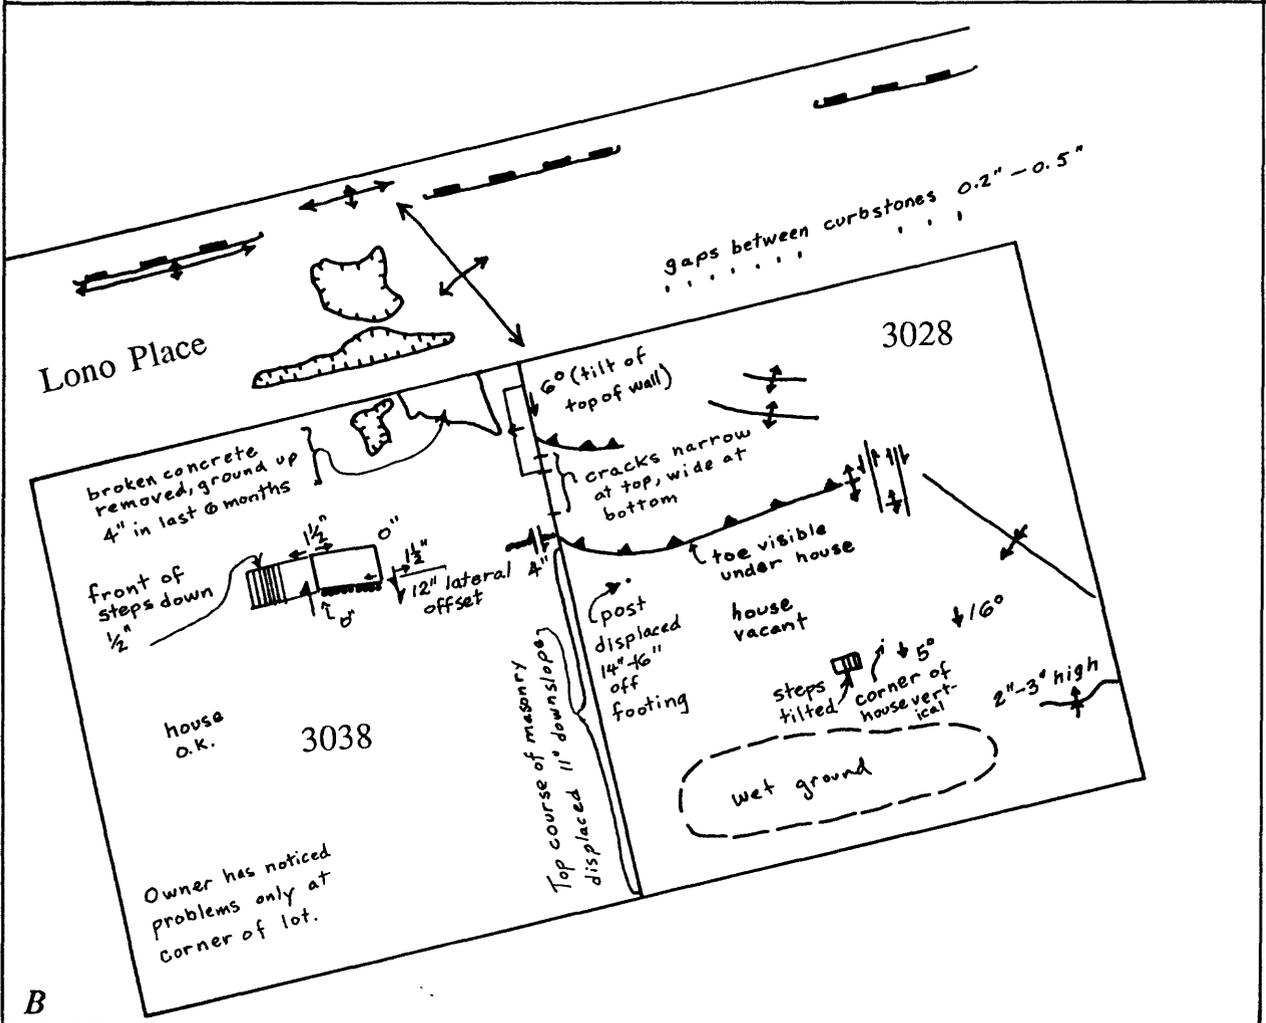
Figure 3. Examples of field maps. A. Part of a field map showing cracks and lateral offsets at 3031 Kahaloa Place. B. Part of field map showing evidence of shortening in Lono Place and shortening across toe at 3028 Lono Place.

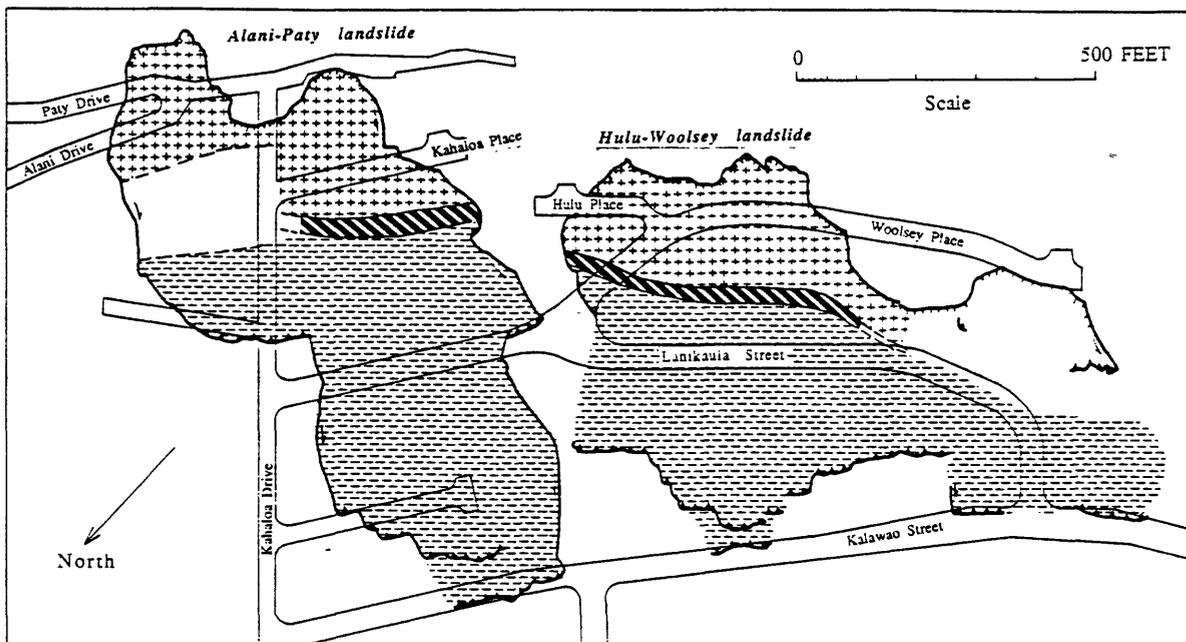
Plate 2 contains a summary of the data we collected on ground deformation in and around the landslides. There is a symbol on the map at each location where we were able to unequivocally determine that the landslide had stretched, shortened, or sheared. The data from plate 2 have been summarized in figure 5 to show the general parts of the Alani-Paty and Hulu-Woolsey landslides that are stretching, shortening, or being displaced without significant deformation.

Figure 5. Map showing pattern of deformation of parts of the Alani-Paty and Hulu-Woolsey landslides. The areas of dark, diagonal stripes represent ground that is being neither stretched nor shortened. Deformation in the Alani-Paty landslide north of Kahaloa Drive is complex due to the development of several internal left-lateral shear fractures there. The existence of two failure surfaces, one 10 ft deep and the other about 25 ft deep, near the intersection of Kahaloa Drive and Kahaloa Place indicates that the pattern of deformation in this part of the Alani-Paty landslide might be even more complex than indicated by the shear fractures. Data on deformation in the southern part of the Hulu-Woolsey landslide are insufficient to completely characterize the pattern of deformation there.
