**GEOLOGIC EVIDENCE FOR TRIGGERED SLIP ON THE
CALAVERAS FAULT DURING THE MAGNITUDE 7.1 LOMA PRIETA
EARTHQUAKE OF OCTOBER 17, 1989**

P.H. McClellan¹ and E.A. Hay²

OPEN-FILE REPORT
89-641

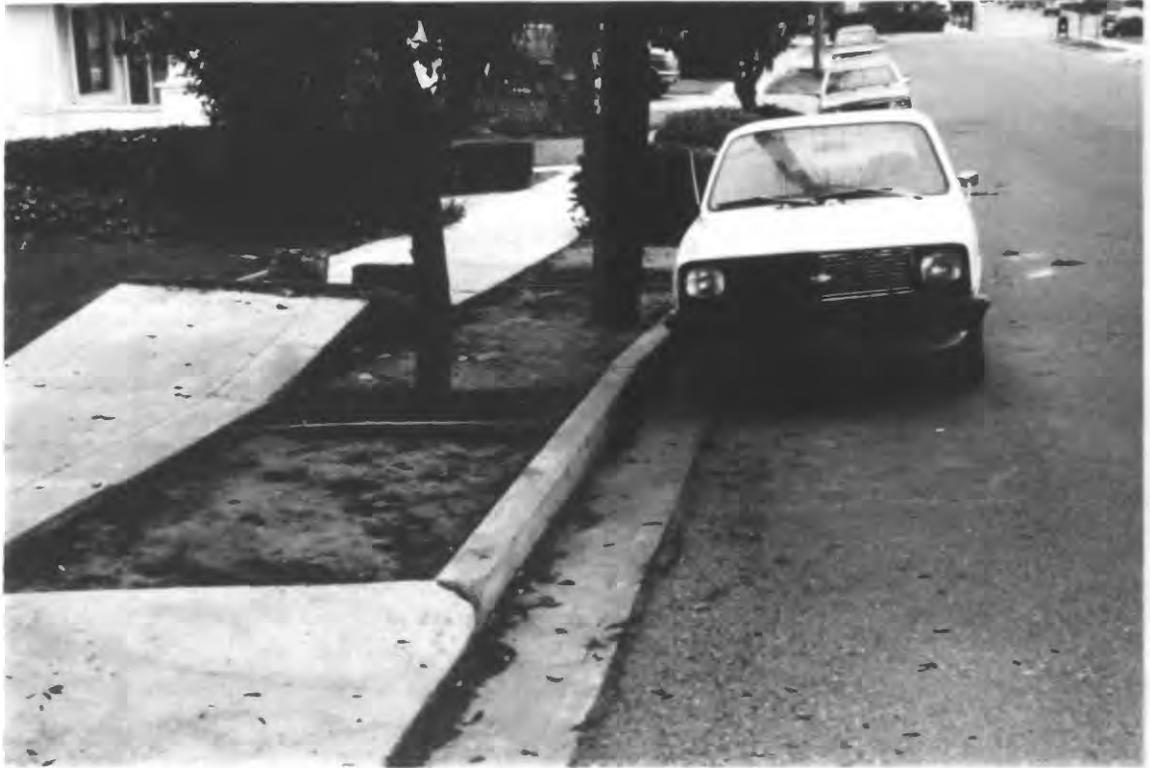
At B Street, between Powell and West Streets, well-developed old shear cracks step across the asphalt roadway along the fault. After the recent earthquake, damage was clearly evident at the south end of the asphalt shear zone where, along the sidewalk, two concrete slabs were compressed in an east-west direction into a upward tent-like buckle (Fig. 3). Across the street at the north end of the shear zone the asphalt surface was broken, possibly from a utility repair, and the hole recently in-filled with fresh sand and gravel. In the adjacent driveway and sidewalk recent cracks were apparent among the older ones, some lined with fragments of freshly broken concrete, and a concrete water-meter box centered in the sidewalk was bisected by a fracture and right-laterally offset (Fig. 4). Most, if not all, of this offset was probably the result of slow fault creep during the years preceding the October earthquake; however, the broken meter box and exposed meter within it, like many other earthquake damage sites in town, was blocked by a barricade.

FIGURE 3. View toward west of buckled concrete pavement at south side of B Street, between Powell and West Streets, where Calaveras fault intersects sidewalk in Hollister.

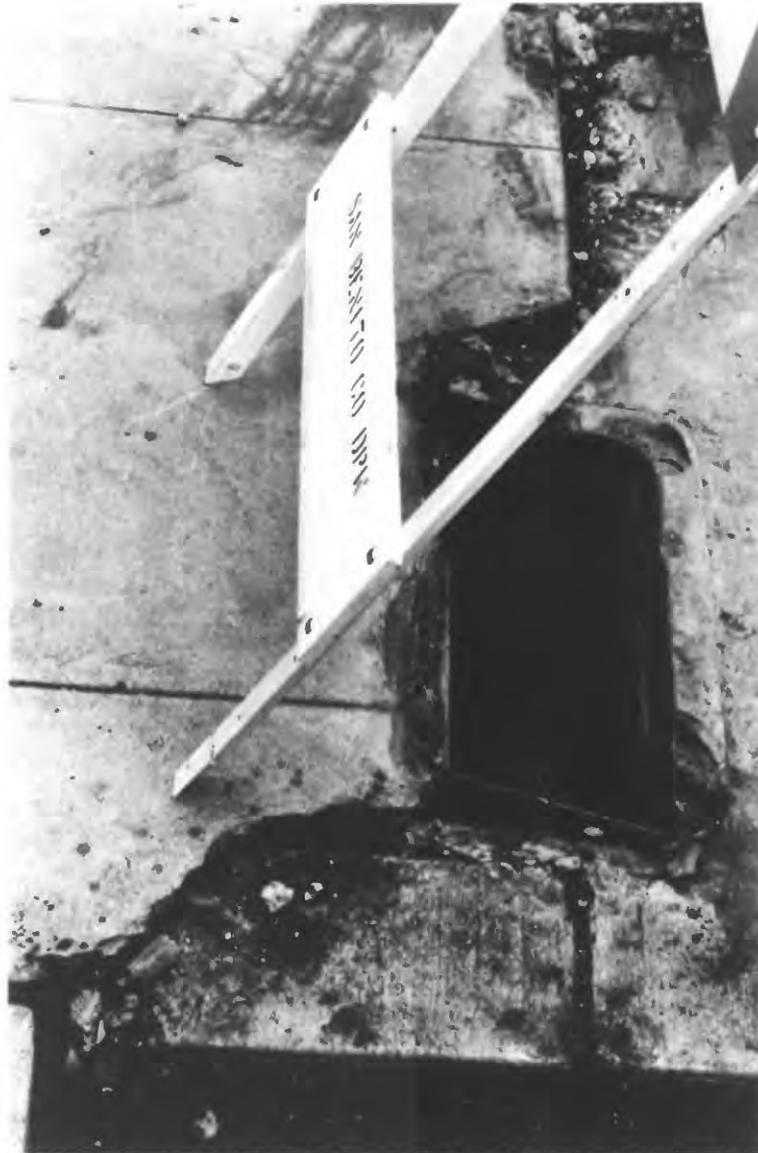
FIGURE 4. Right-laterally faulted concrete water-meter box and surrounding sidewalk at north side of B Street in Hollister (north is toward bottom of picture) where sidewalk intersects Calaveras fault.

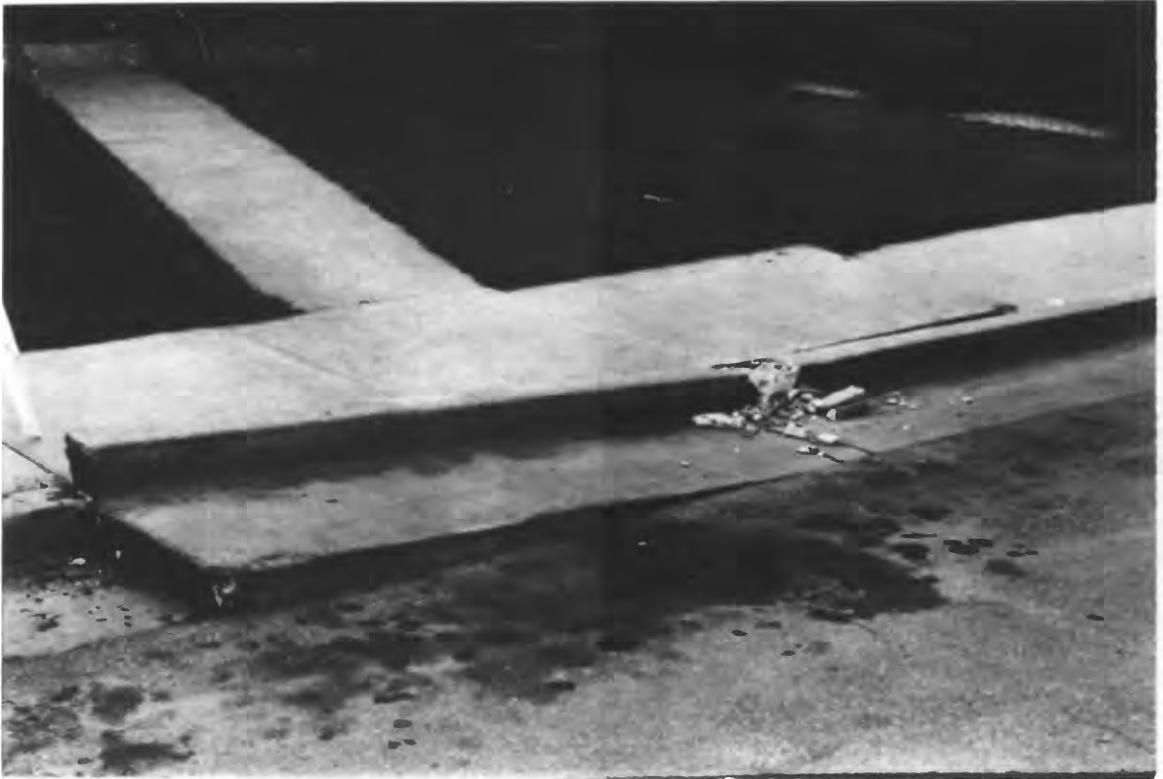
Along the west side of Suiter Street (a north-south street) approximately one block north of A Street (Fig. 5A), the concrete curb and slabs in a 3-meter-long section of sidewalk were compressed in a north-south direction and underthrust a distance of at least one centimeter by an adjacent slab from the north (Fig. 5B). Suiter Street parallels the fault and lies within the creeping zone or along the western edge of it; although much of the observed deformation we describe may have developed within this zone during the years prior to the earthquake, how much is unknown to us. Nevertheless, pebble-sized concrete fragments in the gutter where the curb had freshly

FIGURE 5A. North-south concrete sidewalk in Hollister along west side of Suiter Street, longitudinally shortened apparently by movement along the Calaveras fault zone.

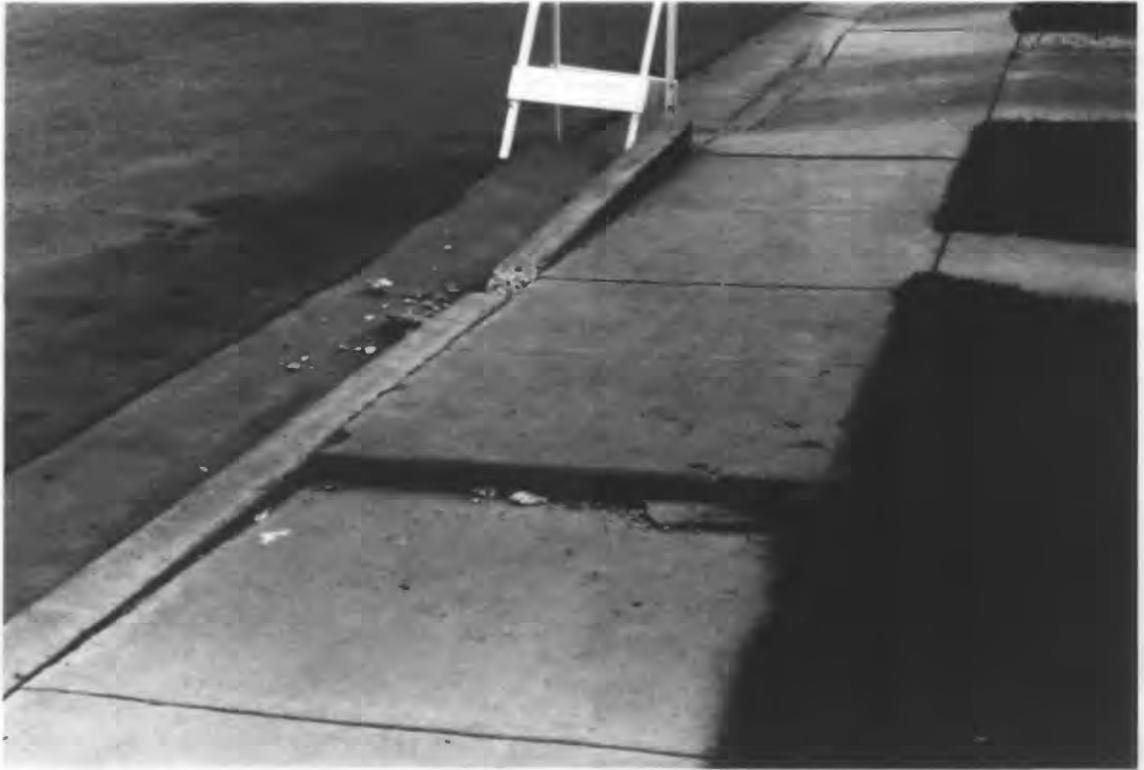
FIGURE 5B. View toward south of sidewalk in Fig. 5A. Note shortening of sidewalk indicated by overthrusting of far concrete slab toward viewer.

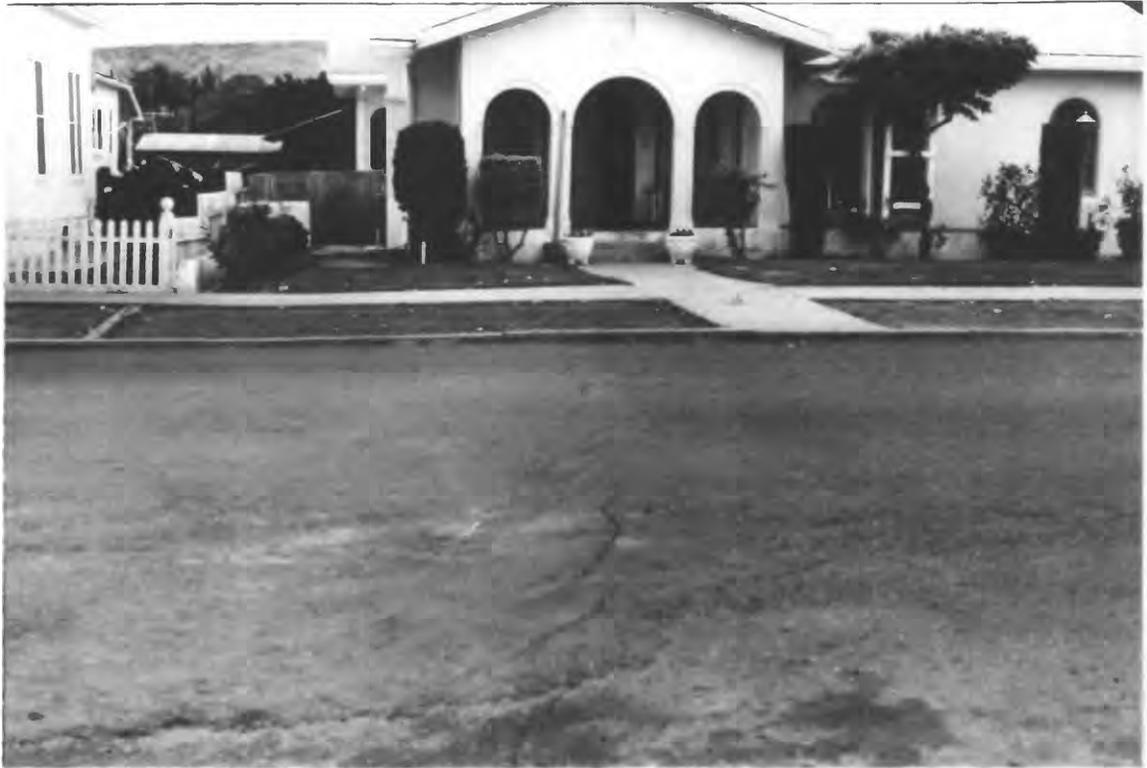
Where the fault crosses 5th Street, between Powell and West Streets, pavement damage from decades of cumulative fault creep also is clearly evident in the well-developed, left-stepping shear cracks crossing the old roadway and the right-laterally offset sidewalk slabs (Fig. 6). During our visits barricades lined much of this block to the west of the fault where the north edge of the roadway had been excavated and back-filled during emergency water-line repairs following the earthquake. The clearest evidence of recent surface movement along the fault in Hollister was seen here where the north end of the zone of en echelon shears crossing the roadway meets a free-standing (not sidewalk-bordered) concrete curb. The 3- to 4-meter-long section of curb crossing the fault here appears relatively new (or recently resurfaced) compared to the adjacent curb sections to the east or west. At the time of our visit, this curb section was broken at two places which were approximately 1.5 m apart (Fig. 7). The western break was a single transverse fracture (strike north-south, dip vertical) offset right-laterally by approximately 2.5 cm (much of this displacement is probably due to prior aseismic creep). The eastern break was a more complex diagonal rupture (strike approximately N45E, dip SE) showing approximately 5 mm of right-lateral offset.

FIGURE 6. View northward along active western trace of Calaveras fault zone at 5th Street, between Powell and West Streets in Hollister. Note en echelon shear cracks in asphalt pavement, and breaks in the free-standing concrete curb at far edge of street (close-up views in Figs. 7 and 8).

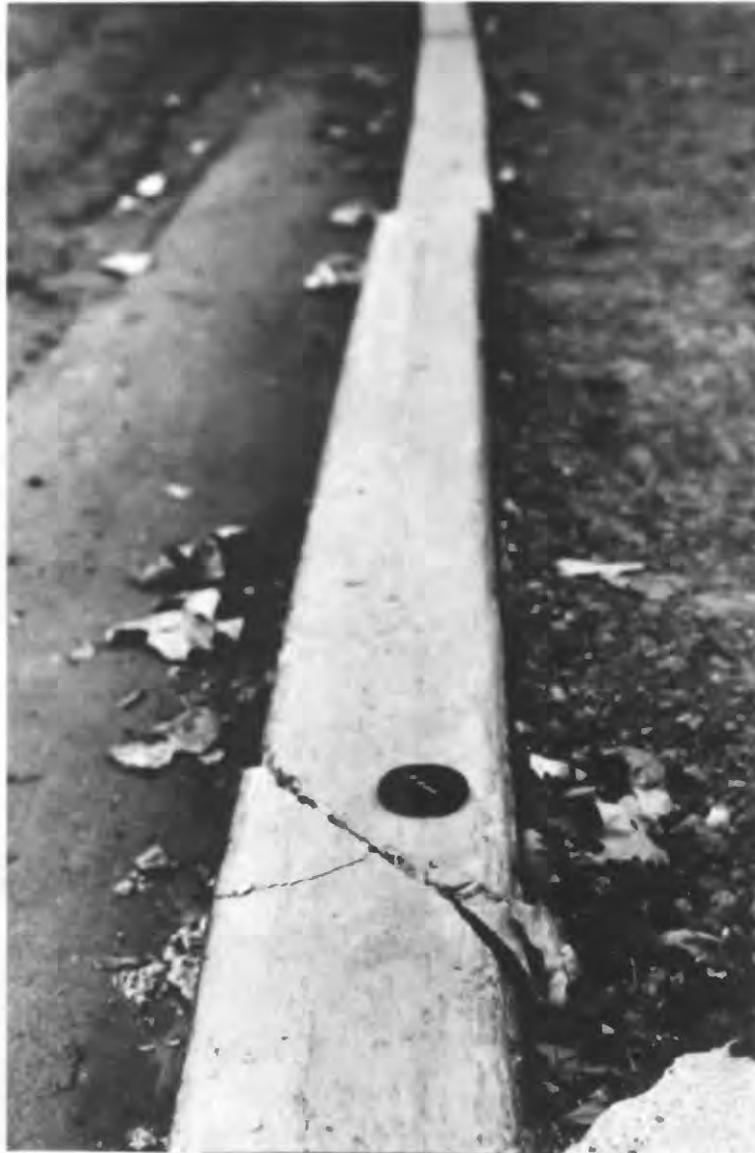
As explained below, the displacement evident in the fractured curb along 5th Street, at least in part, is associated closely in time with the October 17, 1989 Loma Prieta earthquake.

- (2) Freshly broken fragments of concrete up to 10 cm long had fallen or were in the process of spalling into the gutter from the diagonal break in this curb. According to the Hollister Department of Streets, Trees and Maintenance, this gutter is swept weekly on a Tuesday route (oral commun., representative of the City of Hollister, October 31, 1989). Thus, the curb was shattered after being last swept on Tuesday October 17 (at some

FIGURE 7. Free-standing concrete curb at north edge of 5th Street, between Powell and West Streets in Hollister, crossing creeping zone of Calaveras fault (view toward west). Diagonal break (foreground) is very recent as indicated by concrete rubble in gutter, and shows about 5 mm of right-lateral displacement. Transverse break (background) is older and shows 25-30 mm of displacement, but recent movement here also is indicated by cracks in soil to right (close-up views in Figs. 8A and 8B).

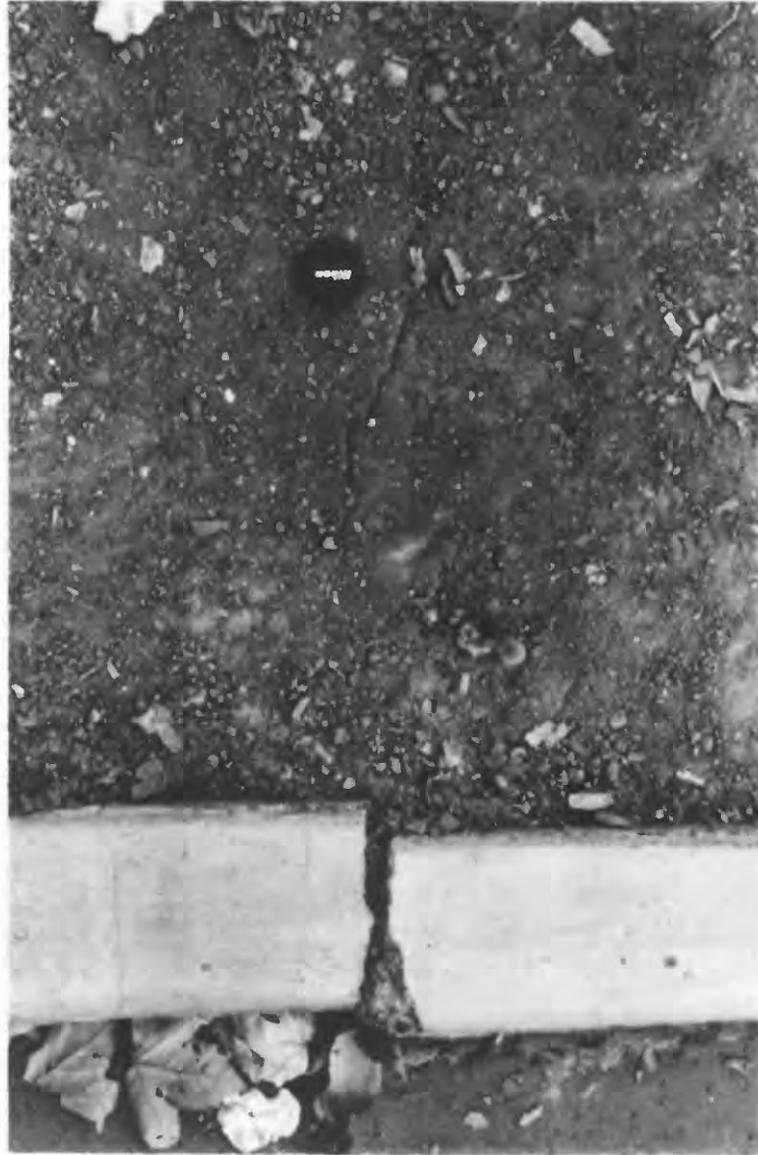
- (1) At the time of our visit on October 20, 1989 an open crack (strike generally north-south) parted by 2 to 3 mm was visible in a plot of soil between the transverse fracture in the curb and the adjacent sidewalk (Fig. 8A). The ephemeral nature of this soil fracture is illustrated by the photograph in Figure 8B (in which fracture is now erased) taken 24 hours after that in Figure 8A and following a "trace" (less than 0.01 inches) of rainfall (oral commun., representative of US National Weather Service, October 31, 1989). The last measurable rainfall in Hollister prior to October 20 was 0.34 inches on September 29, 1989, 18 days before the Loma Prieta earthquake. Thus, this soil crack was formed during the 21 days between September 29 and October 20.

FIGURE 8A. Close-up view (from Fig. 7, background) of transverse break in concrete curb where active zone of the Calaveras fault crosses north edge of 5th Street, between Powell and West Streets in Hollister. Photograph taken at 13:00 on October 20, 1989. In the loose dry soil near lens cover note fresh crack parted by several mm possibly due to very recent fault slip (last significant rainfall was 21 days before photograph).

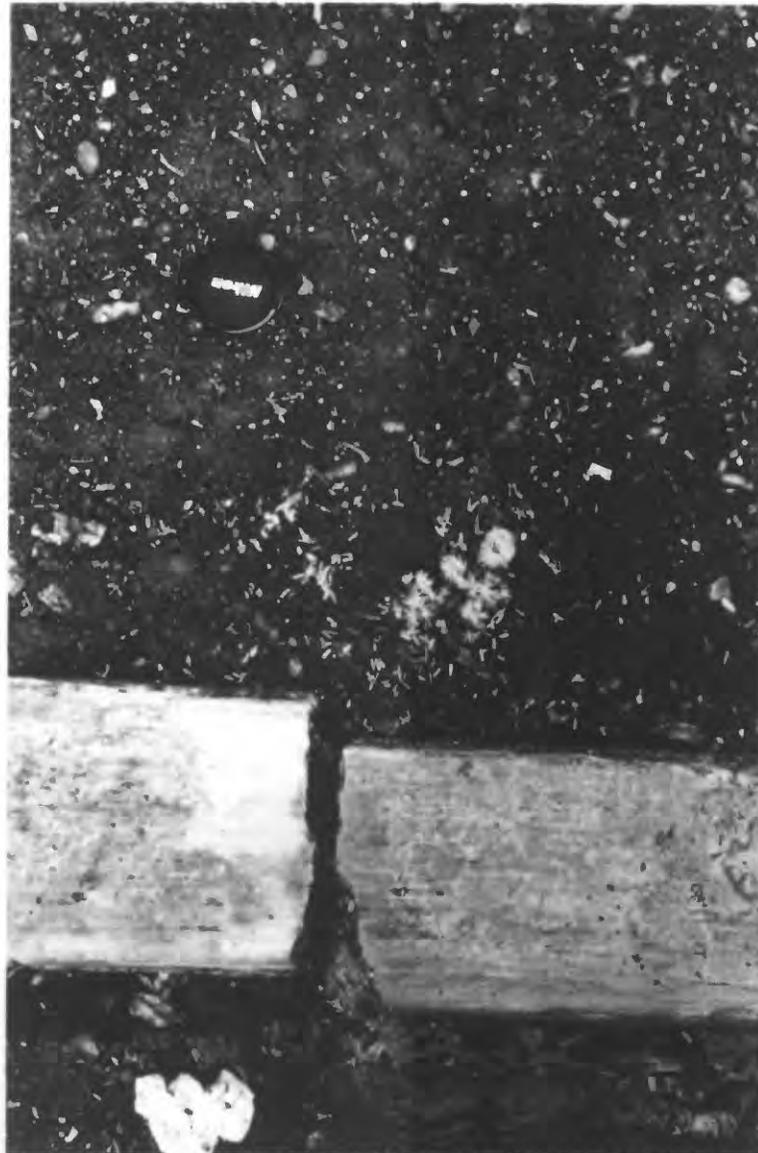
FIGURE 8B. Same curb and soil area as in Fig. 8A, at 13:00 on October 21, 1989, following a "trace" of rainfall (recorded at US National Weather Service Hollister station) within preceding 24 hours. The absence here of the soil crack photo-documented 24 hours earlier (in Fig. 8A) indicates ephemeral nature of these soil features.

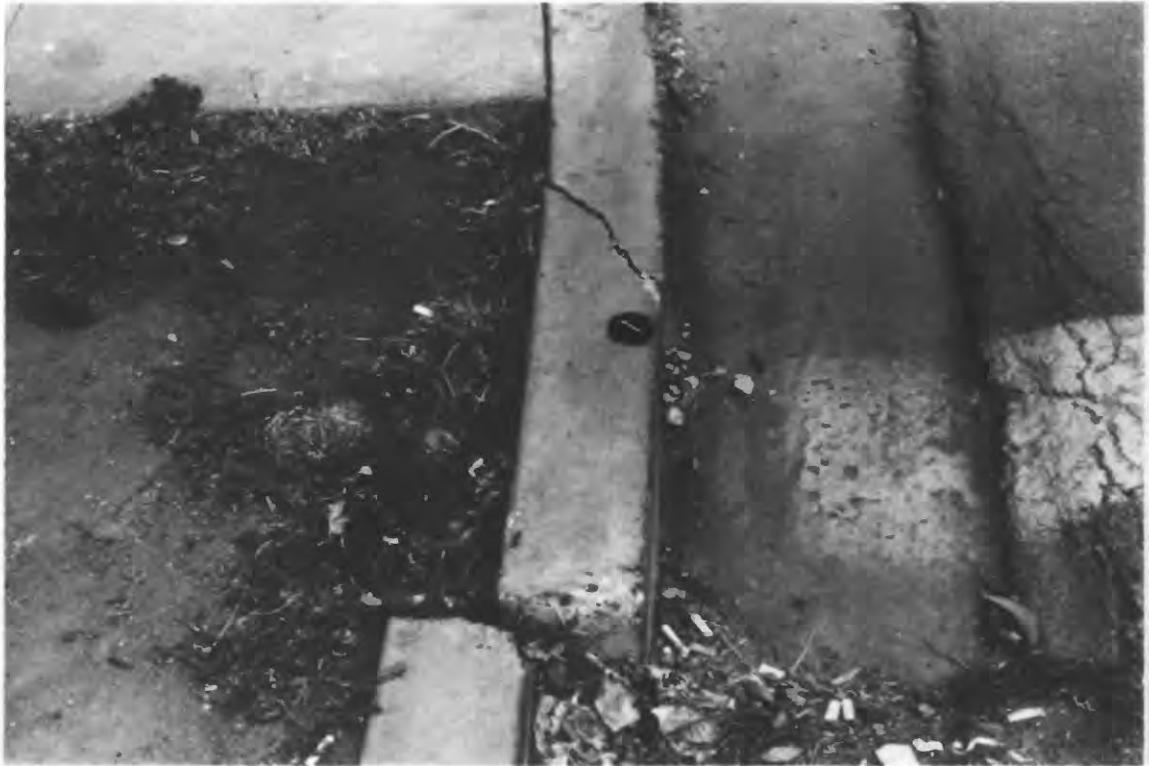
Along South Street, between Powell and West Streets, approximately 10 cm of accumulated right-lateral shear is concentrated between two old sections of the south curb (also free-standing). Within one-half meter to the west of this old break, however, the curb is also broken by a fresh diagonal break (strike approximately N45E) very similar to that observed along 5th Street (noted above) and showing a right-lateral offset of approximately one cm (Fig. 9).

FIGURE 9. View toward west of south curb along South Street at Calaveras fault, between Powell and West Streets in Hollister. Note many years of accrued fault displacement between offset curb sections. Diagonal fracture, displaced right-laterally by about 5 mm, is very recent (note rubble remaining in gutter) and probably related to Loma Prieta earthquake of October 17, 1989.

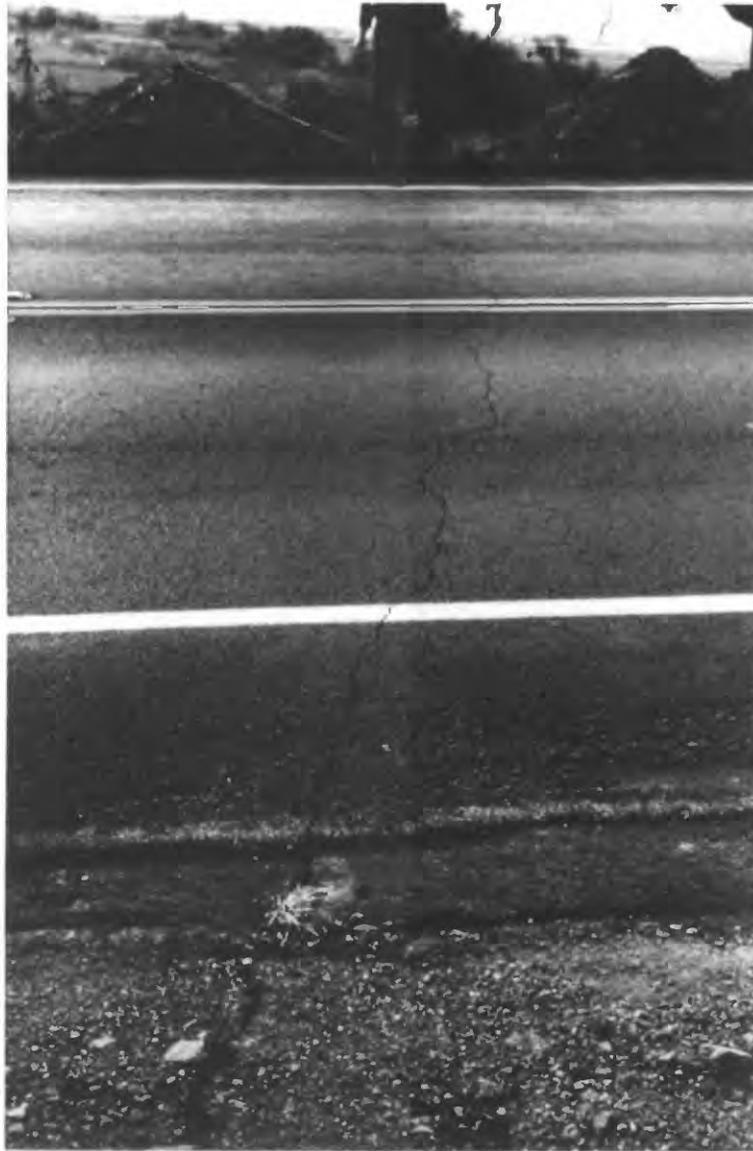
After the Loma Prieta earthquake we observed a single continuous crack extending entirely across the asphalt of Highway 152 and into the gravel fill of the roadbed on the north and south sides of the highway (Fig. 11). The pavement rupture was located about 65 meters east of BM 160. In the fill at the north edge of the highway at least three left-stepping en echelon cracks were visible that were parted by up to 5 mm (Fig. 12); additional soil cracks were visible 10 meters north of the highway in a pasture where the strike of the highway shear zone projected across the compacted tire tracks of a dirt road (Fig. 13). The fracture in the asphalt and those in the adjacent fill formed a zone trending approximately N17W. However, where this fracture crossed painted highway stripes right-lateral offset was clearly evident (Fig. 14) and extension across the fracture indicated shear in a direction of approximately N61W (Fig. 15). These crack and displacement orientations are not unlike those observed here after the moderate earthquakes in 1979 and 1984. At the time of our visit at 11:00 on October 21, 1989 (90 hours after the Loma Prieta earthquake) 5 mm of right-lateral highway offset was measured parallel to this shear direction.

FIGURE 11. Single continuous crack through asphalt pavement of Highway 152 north of San Felipe Lake where recent slip occurred on an active trace of the Calaveras fault zone (view toward south).

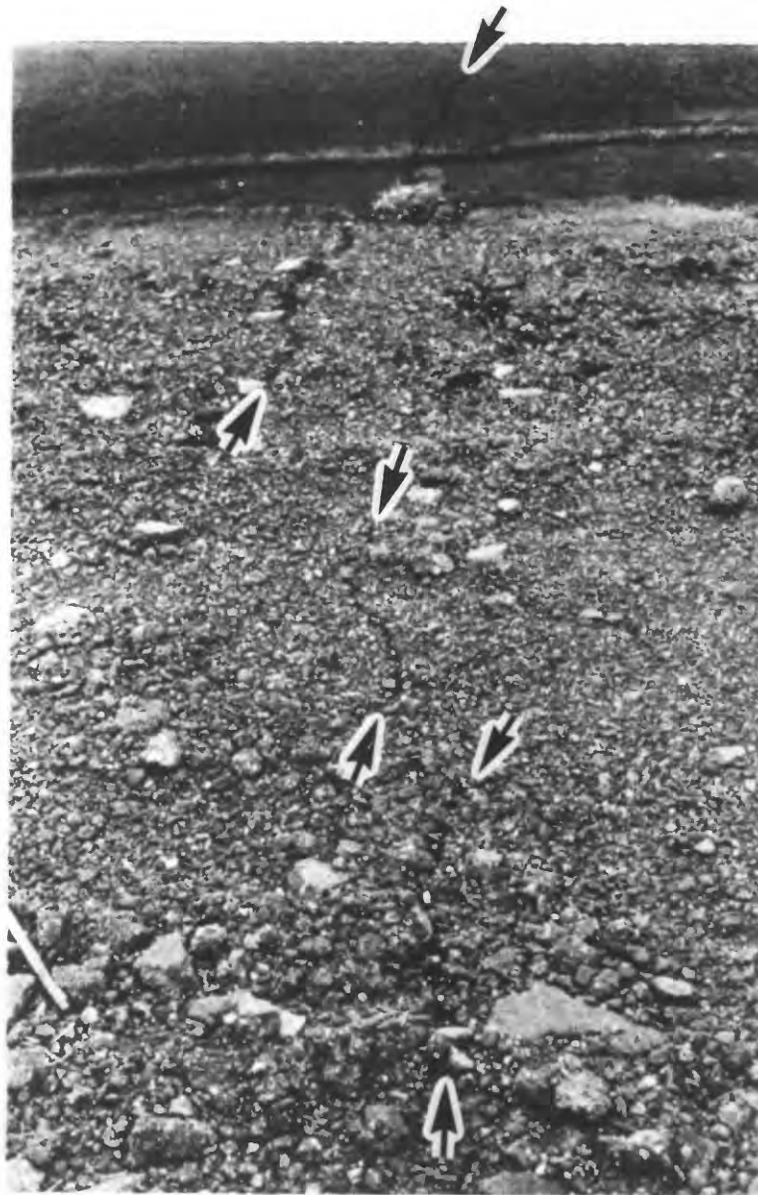
FIGURE 12. Recent en echelon cracks in gravel fill of roadbed at north side of Highway 152 north of San Felipe Lake (view toward south). Each crack is delimited by a pair of opposing arrows; en echelon zone is contiguous with asphalt crack across highway (Fig. 11). Photograph taken on October 21, 1989.

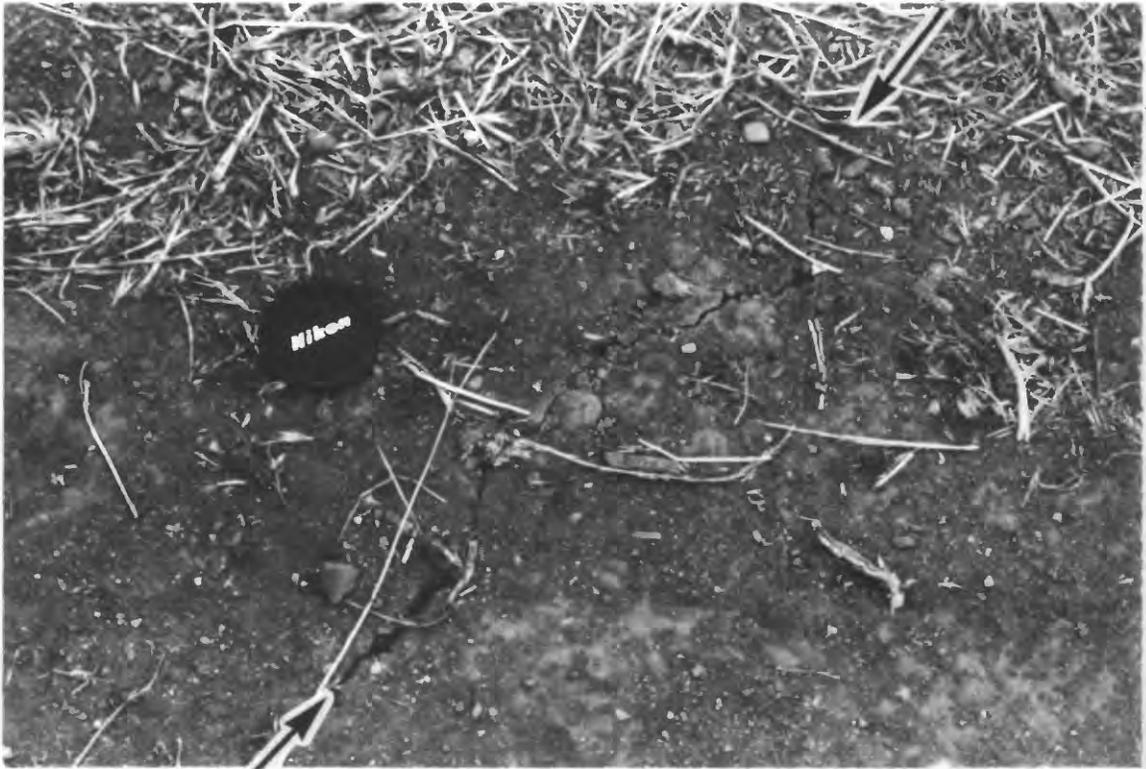
FIGURE 13. Fresh soil crack (between arrows) across tire track in dirt road 10 meters north of asphalt fracture in Highway 152 (Fig. 11) north of San Felipe Lake (north is toward lower left corner). Photograph taken on October 21, 1989. Note that crack is still evident in spite of a light rainfall within preceding 24 hours; this is probably attributed to the somewhat compacted condition of the soil beneath tire track and the insignificant rainfall amount (0.01 inch recorded at the US National Weather Service Gilroy station).

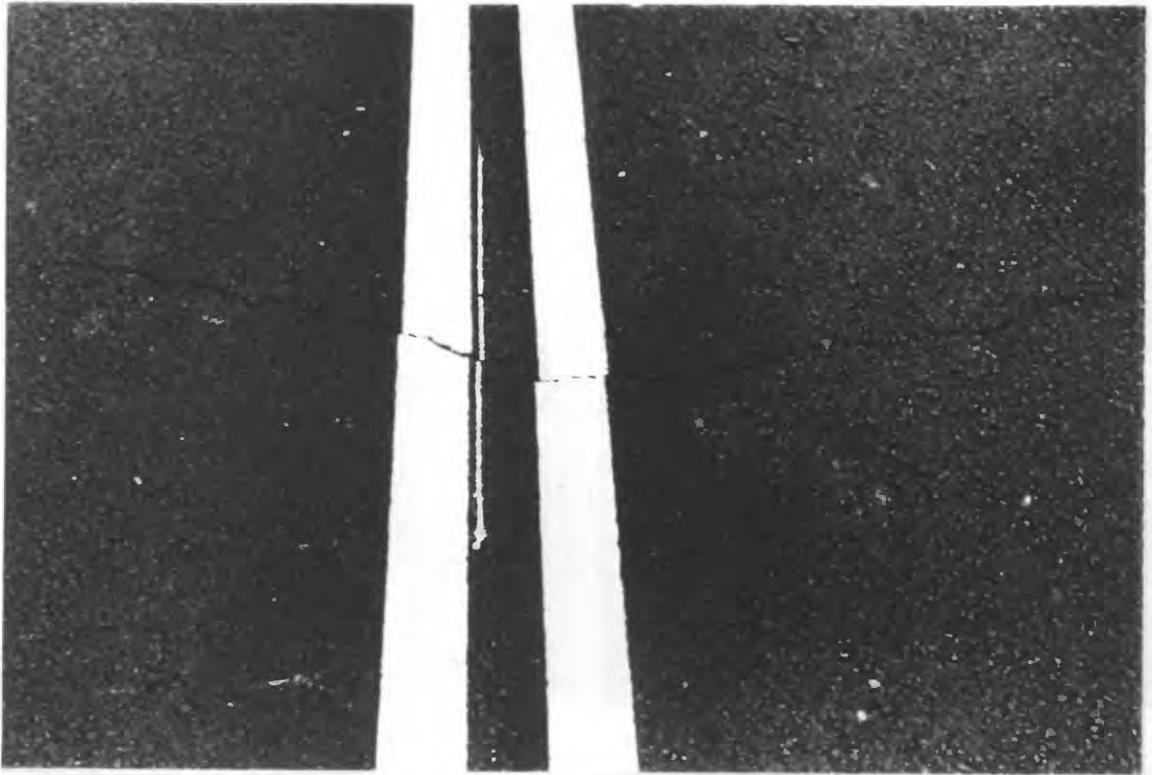
FIGURE 14. View toward east of median stripes of Highway 152 north of San Felipe Lake, clearly showing right-lateral displacement along a trace of Calaveras fault zone. Photograph was taken on October 21, 1989.

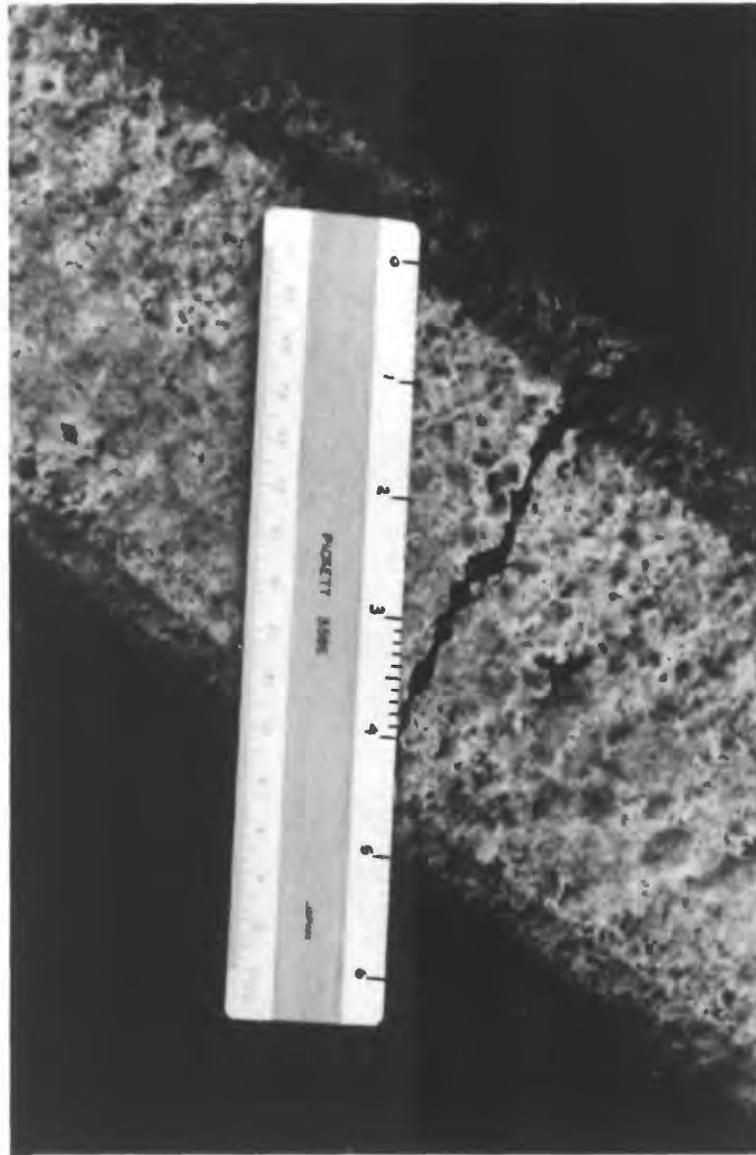
FIGURE 15. South border line of Highway 152 north of San Felipe Lake (north is toward upper right corner of photograph). Note tension cracks which show 0.2 inches (5 mm) of right-lateral displacement and a shear direction of N61W. Photograph was taken on October 21, 1989. Scale (retouched for clarity) is in inches.

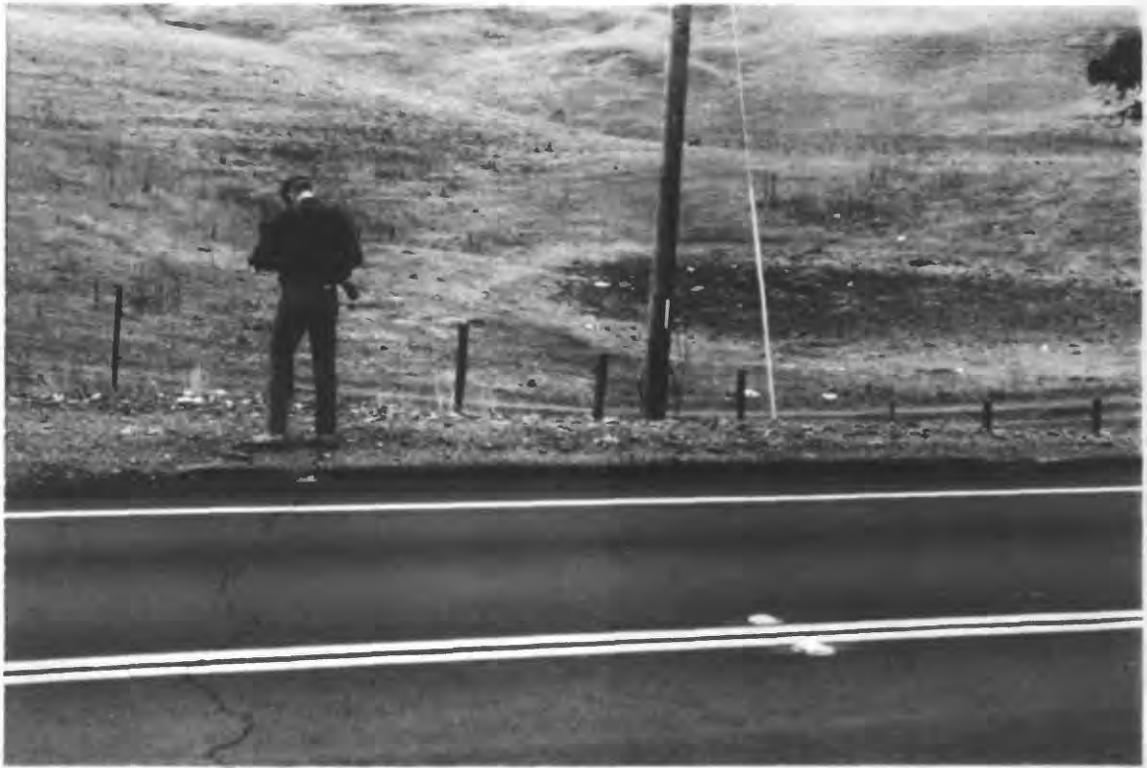
Along the north edge of the highway approximately 100 meters to the east of the throughgoing fracture noted above are two smaller arcuate cracks that extend 1 to 2 meters across the pavement of the westbound lane. This pair of small cracks and the principal throughgoing fracture to the west coincide approximately with the east and west boundaries, respectively, of a closed depression (sag pond) north of and crossed by the highway (Fig. 16).

FIGURE 16. Sag pond (in right-center of view) within Calaveras fault zone on north side of Highway 152 north of San Felipe Lake. This closed depression is bounded on west by shear zone (expressed as the asphalt fracture between arrow and observer's right foot), documented in Figs. 11 through 15, and on east by another zone of shears that cut into north lane of highway.

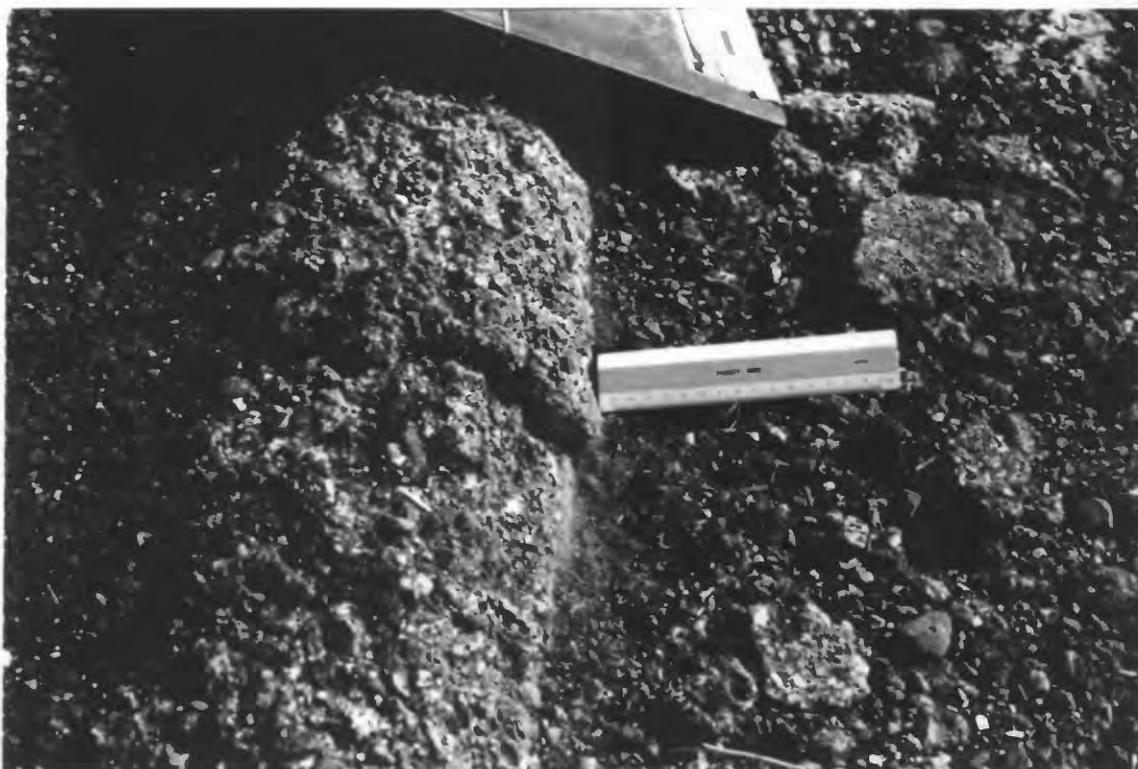
at these locations, probably from aseismic creep and possibly in association with previous earthquakes. At the location of the principal fracture noted above, at least 15 mm of total slip is recorded in the older road surface (Fig. 17).

FIGURE 17. View toward east of recent asphalt pavement of road surface (far left) against older asphalt berm (center) along south side of Highway 152 north of San Felipe Lake, at south end of highway rupture in Fig. 11. Note that older berm is displaced right-laterally approximately 0.6 inches (15 mm) compared to 5 mm offset of recent asphalt pavement.
