**DEPARTMENT OF THE INTERIOR
U.S. GEOLOGICAL SURVEY**

**Preliminary isoseismal map for the Santa Cruz (Loma Prieta), California, earthquake of
October 18, 1989 UTC**

Open-File Report 90-18

**National Earthquake Information Center
U.S. Geological Survey
Denver, Colorado**

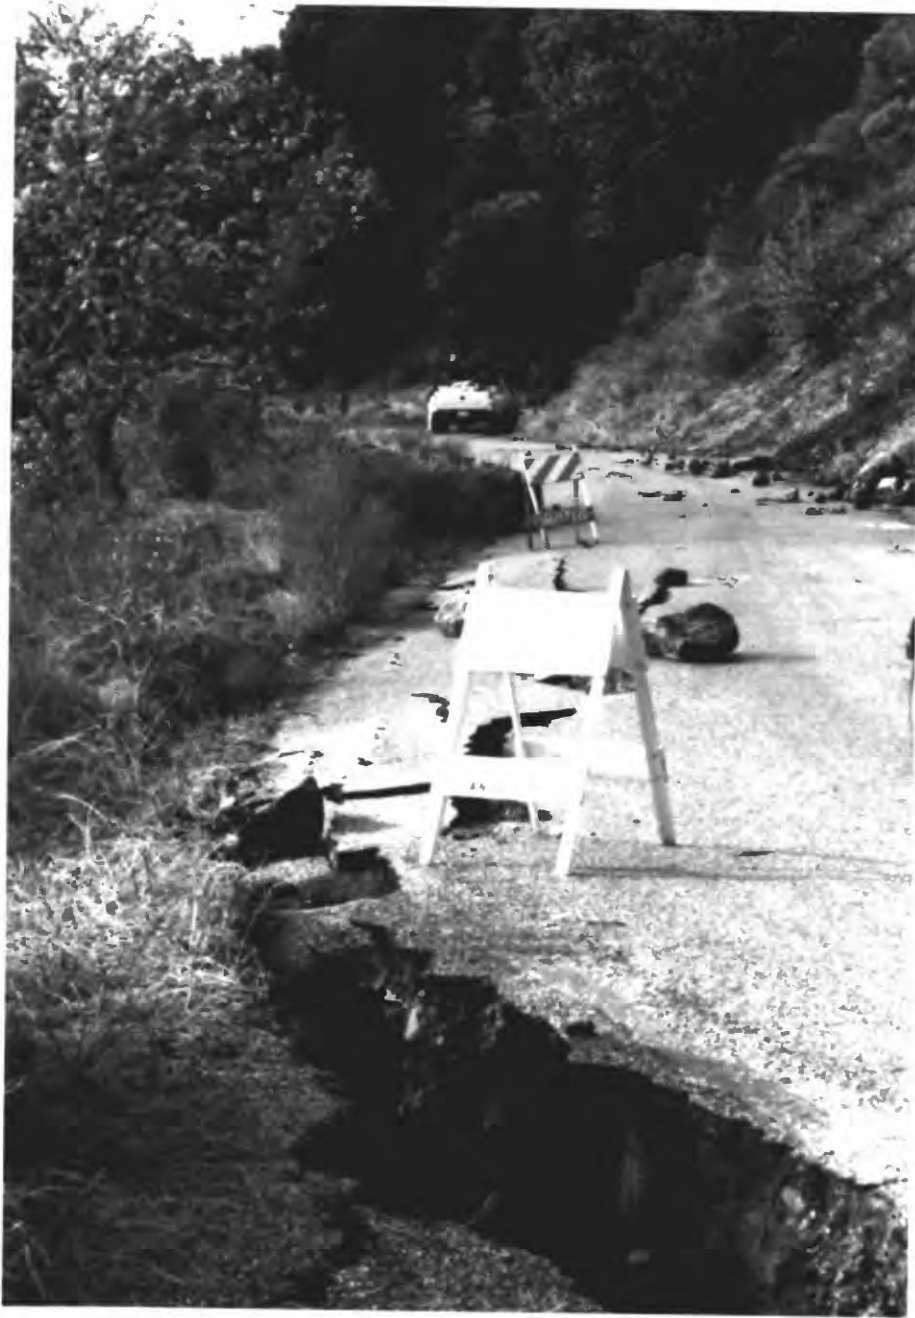
According to Townley and Allen, other locations that were affected by the 1865 earthquake were Santa Clara, San Jose, and in the Santa Cruz Mountains (Santa Cruz Gap Road). The region near Santa Cruz Gap Road sustained effects similar to those caused by the 1989 earthquake (fig. 3): downed chimneys, many landslides, and large fissures. While no damage data are listed for Los Gatos in 1865, artesian wells were reported disturbed causing water flow to increase in area streams.

Figure 3. Fissures along Highland Way (south extension of Summit Road) about 5 miles southeast of highway 17.

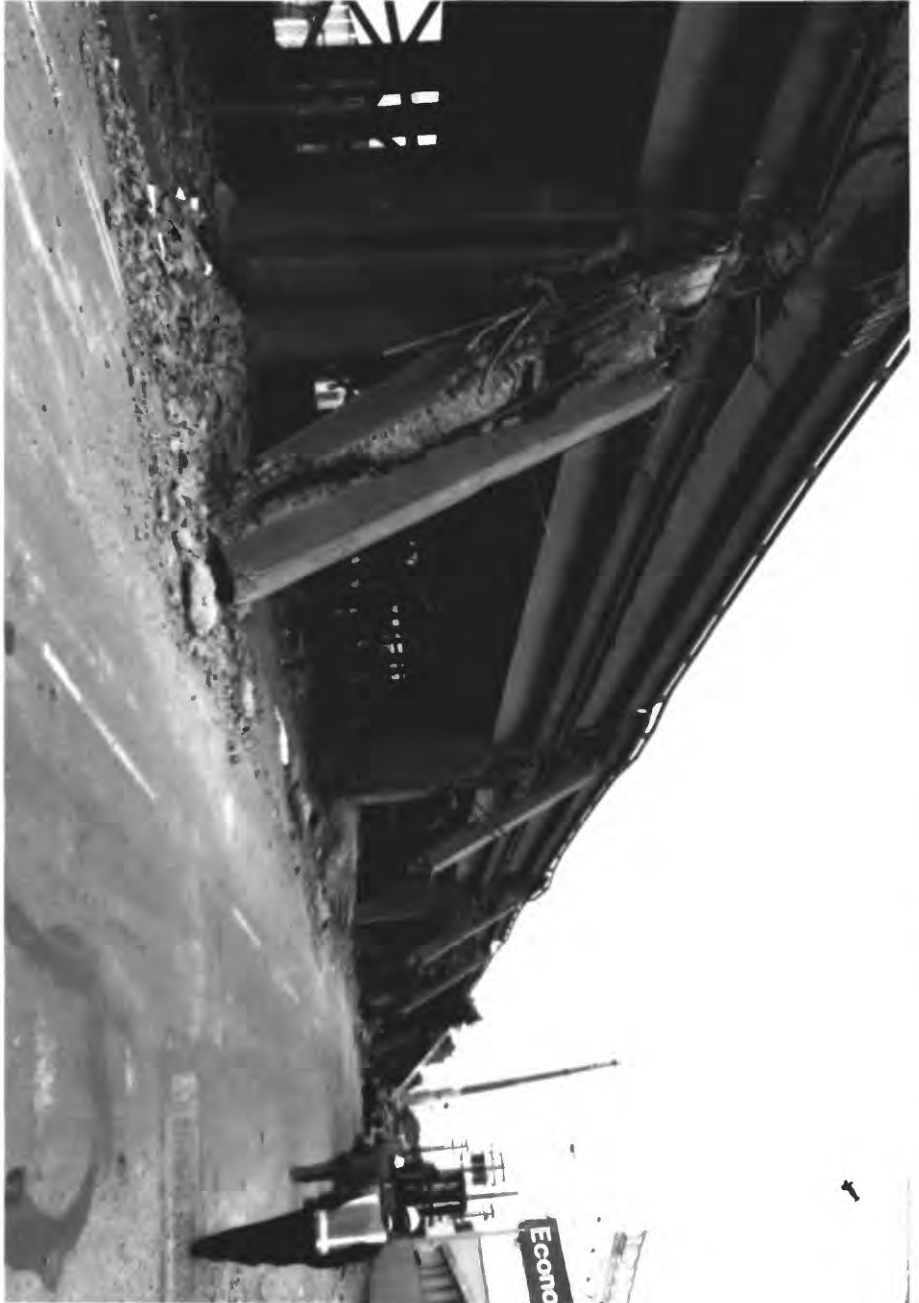
The Nimitz Freeway in Oakland (Interstate 880) along Cypress Street— Approximately 1.25 miles of the double-decked, five-lane, freeway of reinforced concrete collapsed. This collapse killed 41 people and injured many others (Plafker and Galloway, 1989). The upper deck collapsed onto the lower deck when the reinforced-concrete columns failed (fig. 4).

Figure 4. Collapsed Nimitz Freeway along Cypress Street (Interstate 880) in Oakland (photo by E. V. Leyendecker).

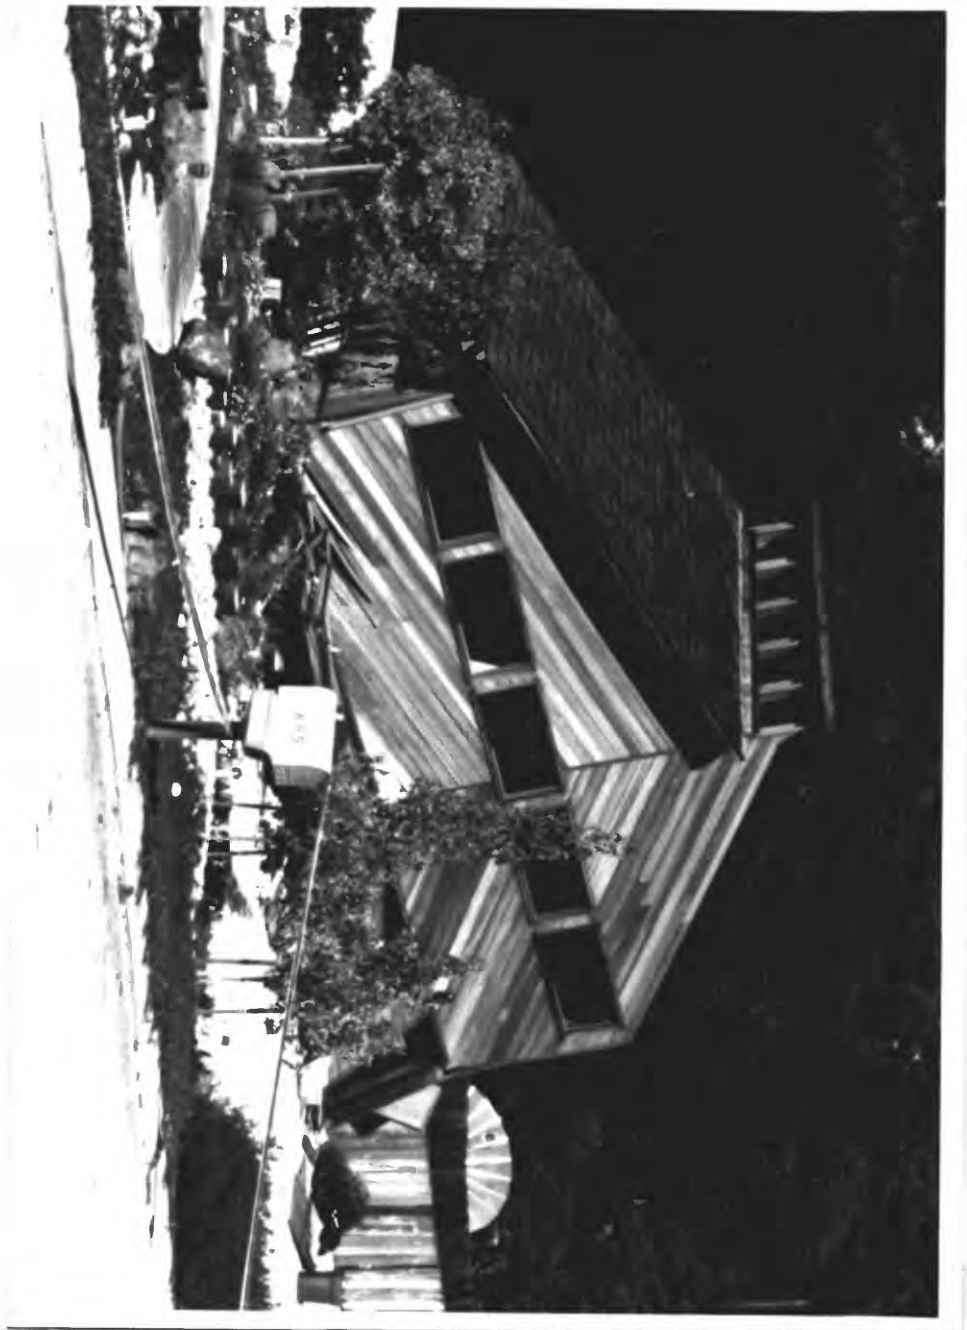
Boulder Creek— Eighty-two houses were destroyed or severely damaged (fig. 5), and an estimated 300 houses sustained major damage. Three houses burned from earthquake-related fires. The most severe damage occurred at the following locations: Rebecca Drive in Boulder Creek where 9 houses were destroyed, 5 slid downhill when the ground failed; Madrone Drive in Forest Park where 8 houses were shaken down; and Blue Ridge Drive and Wildwood Road where 12 and 16 houses respectively, were reported destroyed. Along Highway 9 ground failures and landslides were common. Following the earthquake, waterflow was reported to increase in Foreman Creek. Throughout the Boulder Creek area windows, chimneys, and items in homes and businesses were broken.

Figure 5. Collapsed home on Rebecca Drive in Boulder Creek.

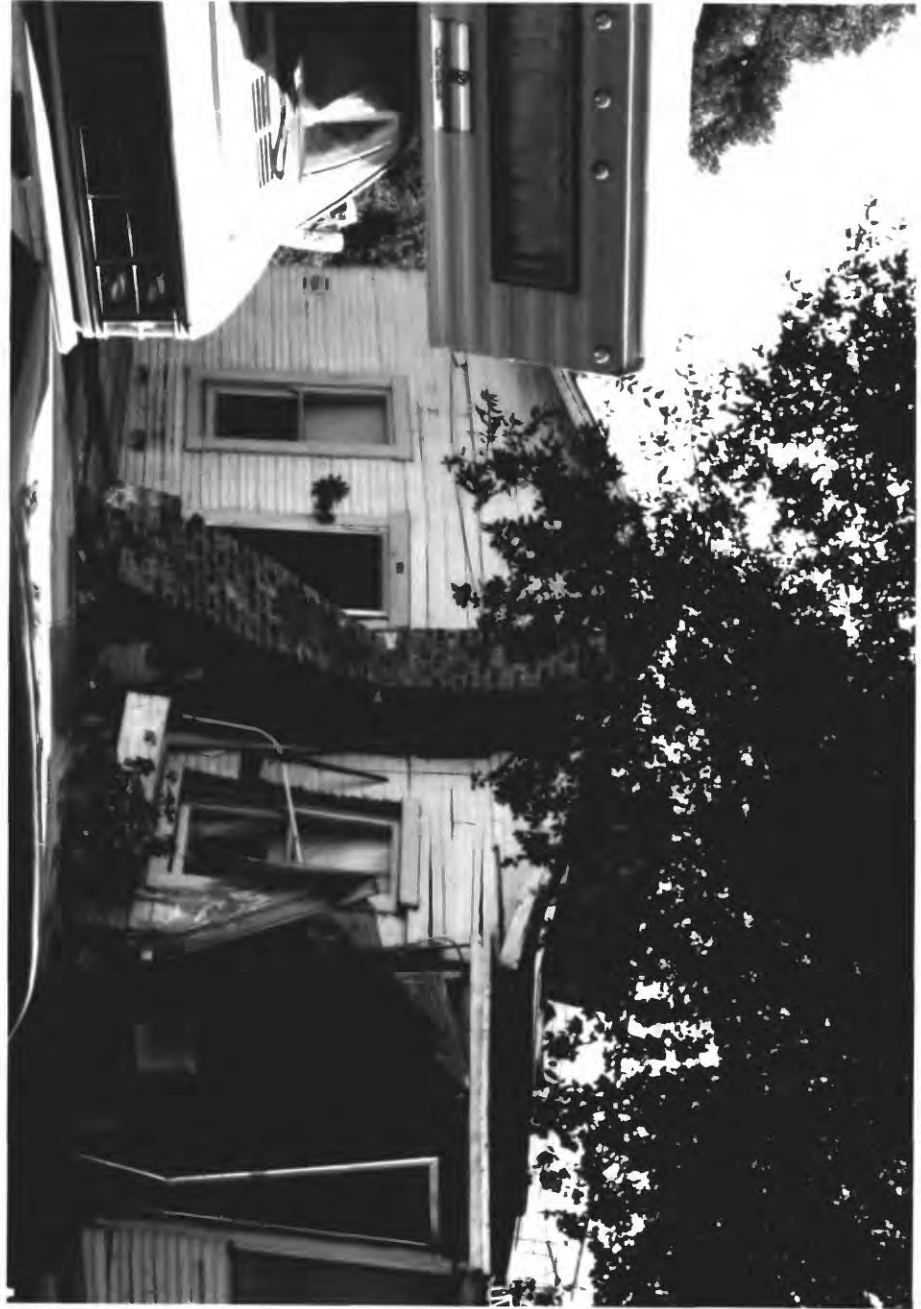
Corralitos— Houses were shaken off their foundations; most were older houses (fig.6). One home had part of a gable thrown down. The Holy Eucharist Church rectory collapsed, and the ceiling in the church fell. The asphalt approaches to the closed Corralitos Creek bridge, on Browns Valley Road, were down in relation to the concrete bridge. The greatest downward offset at the bridge was a few inches on the west side and about a foot on the east side. A block west of Corralitos Creek bridge (Browns Valley Road) one of the oldest homes in Corralitos was condemned—it had survived the 1906 earthquake. It was a wood-frame house that shifted on its wood foundation. Water flow increased in the area artesian springs and in Corralitos Creek (California Division of Forestry's Corralitos Fire Station personnel, personal communication). A Corralitos fireman, who was outside at the time of the earthquake onset, described the sound as being similar to a distant shotgun blast; it was followed by a noise like that of an approaching freight train. He also stated that it was difficult to stand. No foreshocks were reported felt in Corralitos.

Figure 6. House in Corralitos thrown off its foundation breaking the chimney.

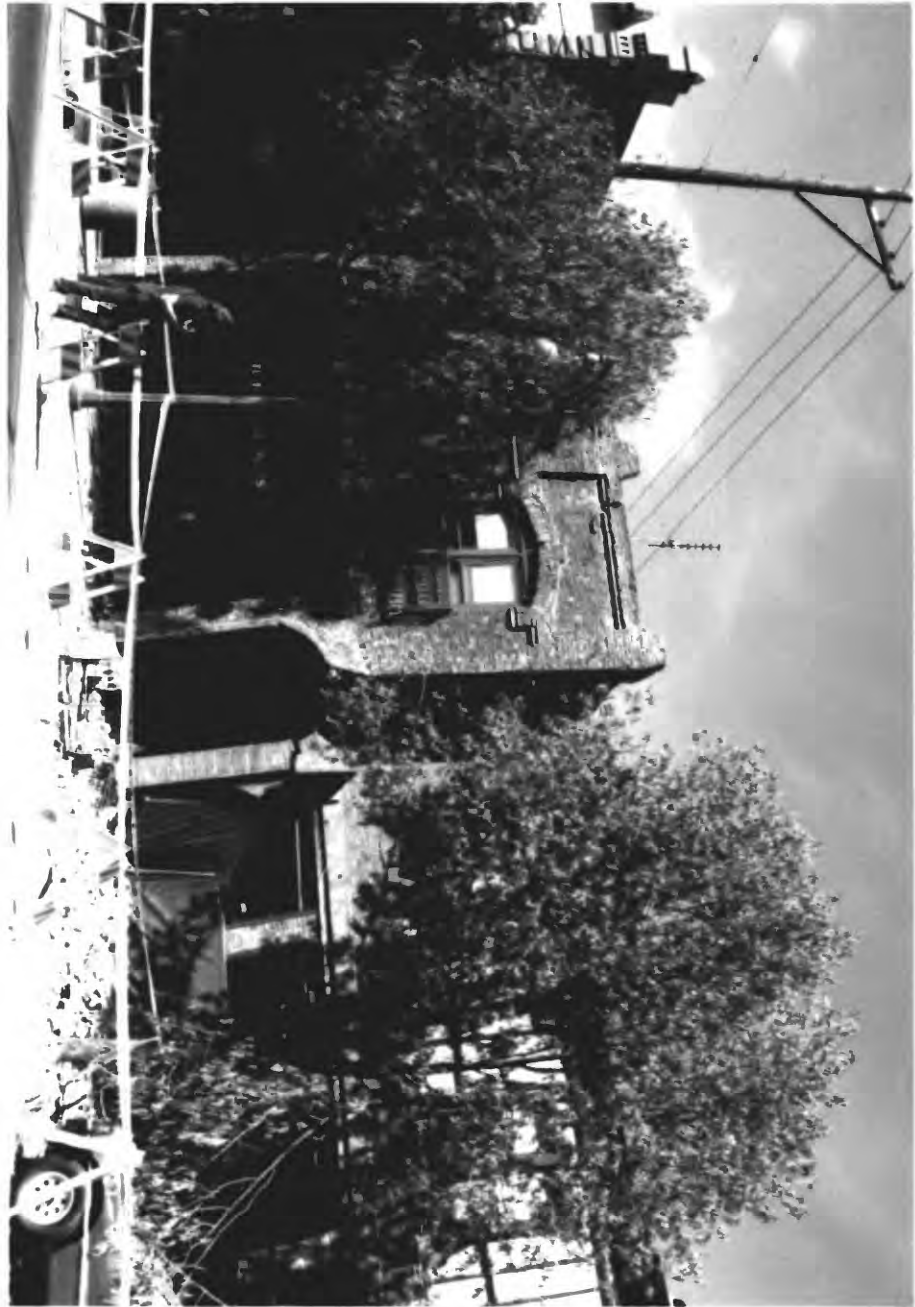
Los Gatos— Brick buildings in the business area (East Main Street) were cracked; walls bulged, and a few walls partially collapsed (fig. 7). Many houses were thrown off their foundations along Tait, Wilder, and Massol Avenues. Chimneys throughout this area were shaken down or broken at roof lines. In other areas of Los Gatos, less severe damage to buildings occurred west of Highway 17. Gas and water lines were broken throughout the town; sidewalks were buckled, and many of the contents of houses and businesses were broken or damaged.

Figure 7. Wracked, twisted, and broken brick building on East Main Street in Los Gatos.

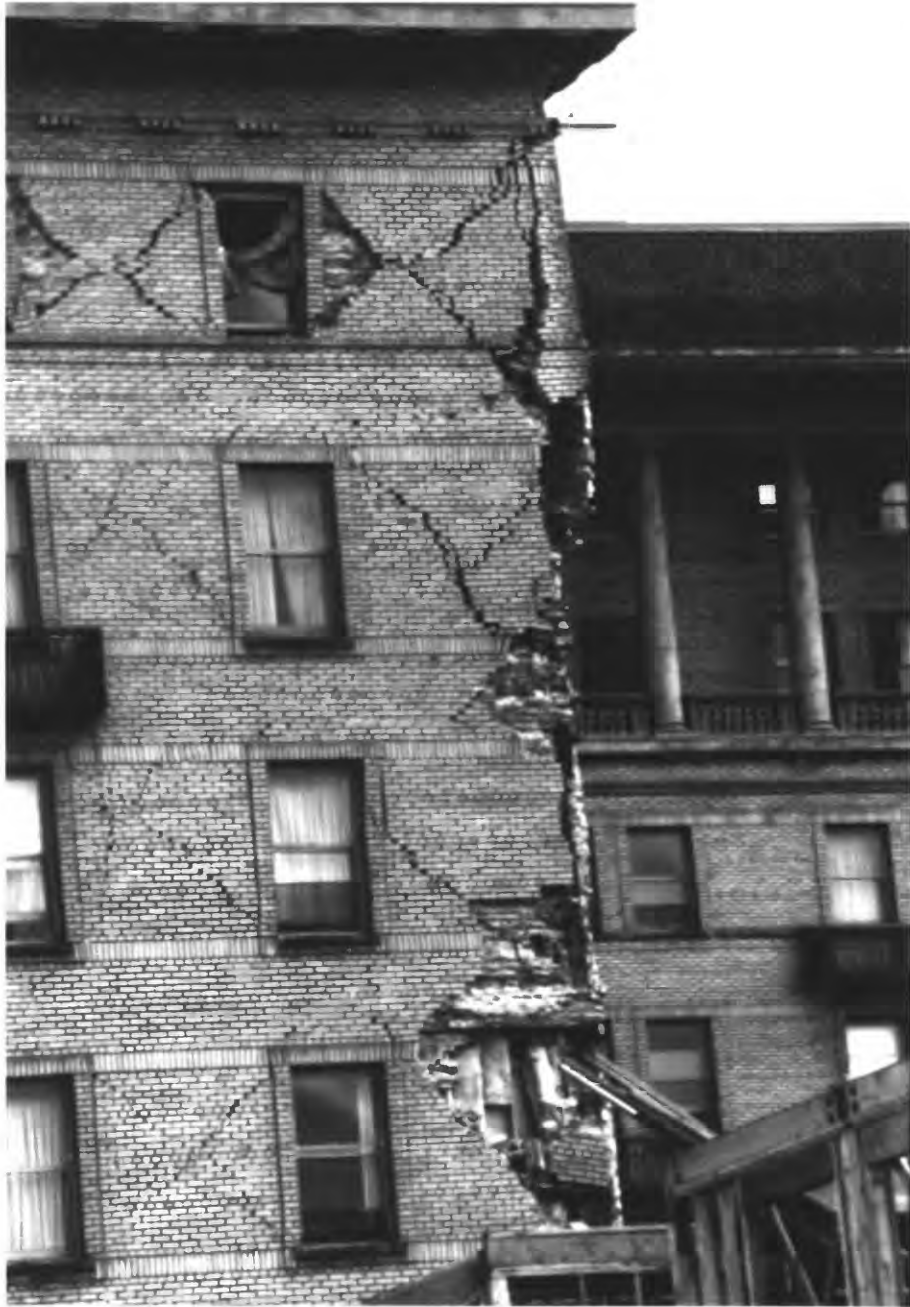
Oakland (Hotel Oakland at 13th and Harrison Streets)— The west wing of the seven-story brick structure was severely cracked and some of the exterior brick wall had fallen into the street (fig. 8). Much of the west wall exhibited X-fractures between windows. The west wing was closed. Other parts of the hotel walls were cracked, but less severely than the west wing. Plaster fell into the courtyard from the east wing. Many windows were broken.

Figure 8. Damage to Hotel Oakland at the corner of 13th and Harrison Streets in Oakland.

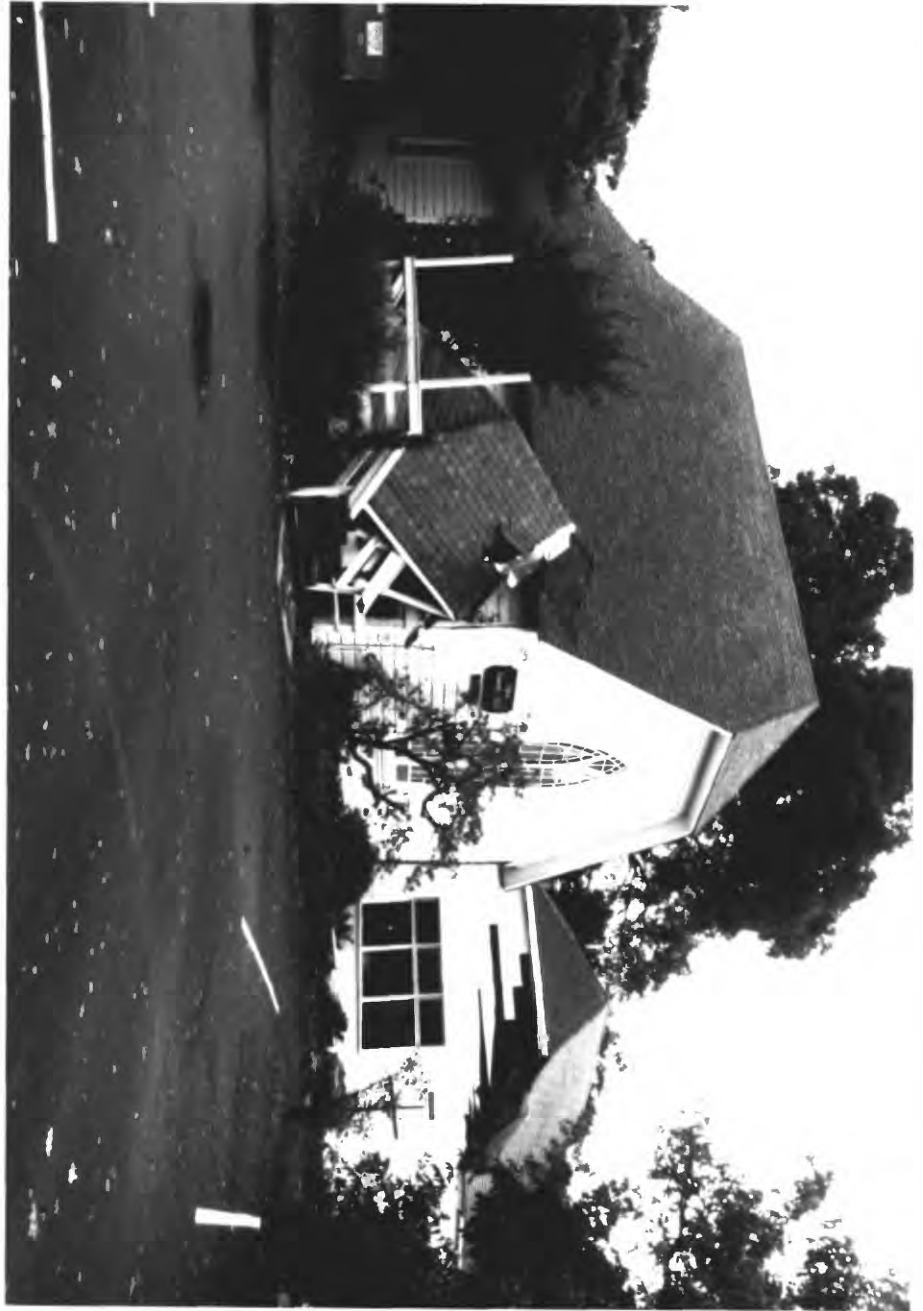
Santa Cruz Mountains (Skyland Community Church located about 0.7 miles east of Redwood Lodge)— A two-building, wood church connected by a wood passageway. The main church building was shaken off its foundation toward the smaller building. The porch of the church collapsed, and a chimney on the smaller building broke at the roof line and tore away part of the wood siding (fig. 9).

Figure 9. Damage to Skyland Community Church at the intersection of Skyland and Miller Roads in the Santa Cruz Mountains.

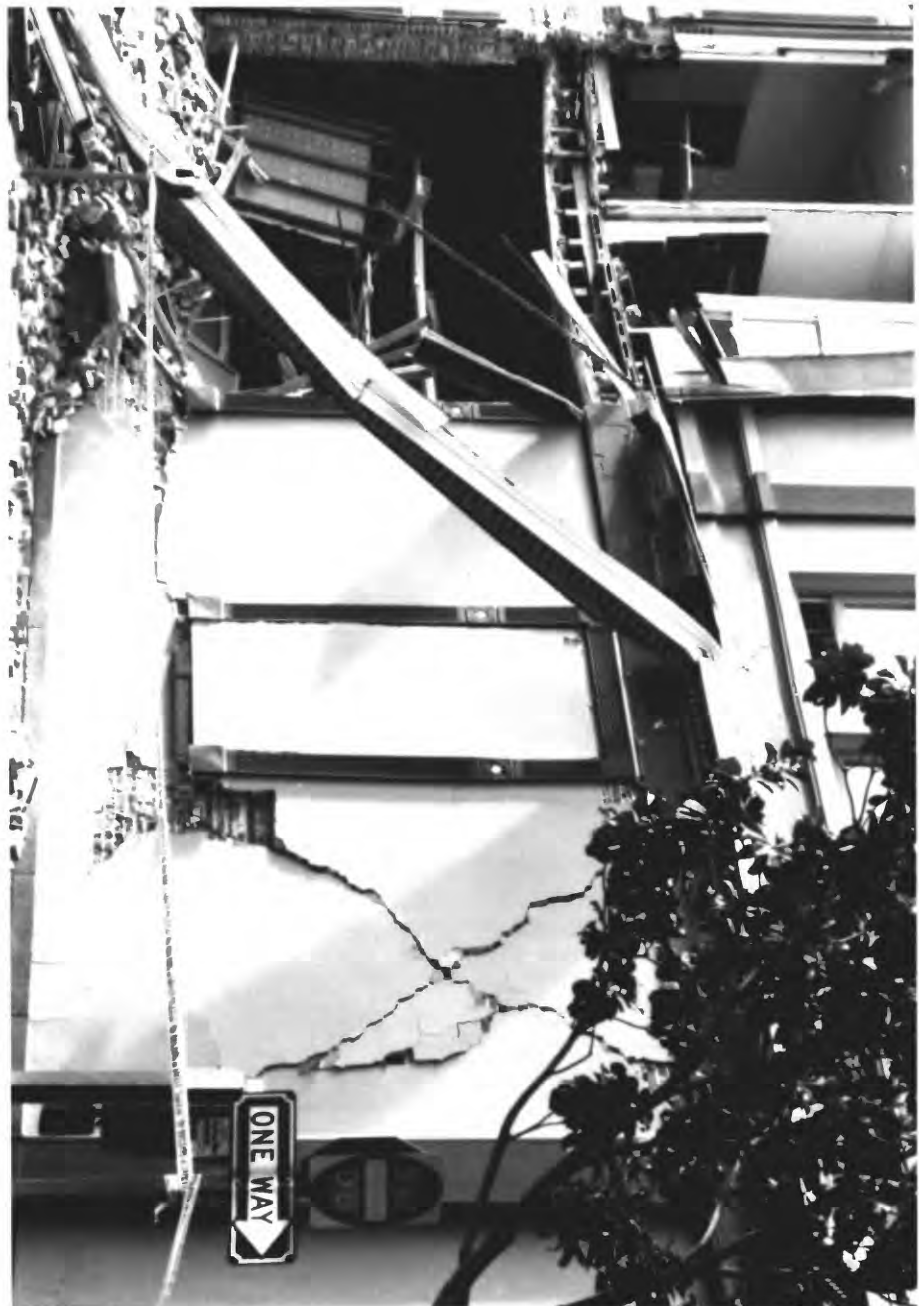
Santa Cruz— The most severe damage occurred along the Pacific Garden Mall (a six-block shopping mall on Pacific Street) in the older downtown area, where three people were killed. Many businesses on the mall were old, refurbished-brick structures. The worst damage was to the unreinforced brick and masonry buildings, where walls or parts of walls had collapsed (fig. 10); in other buildings roofs had fallen, destroying the interiors. Many plate glass windows shattered and building walls were severely cracked. Masonry buildings in other areas of the city sustained structural damage; some buildings were condemned. Many of the houses on Myrtle Street were shaken off their foundations; had chimneys collapse; had walls severely cracked, and had furniture overturned. Water and gas mains and sewer lines were broken in the city.

Figure 10. Damage to a business on the Pacific Garden Mall, Santa Cruz, at Pacific Avenue and Lincoln Street.

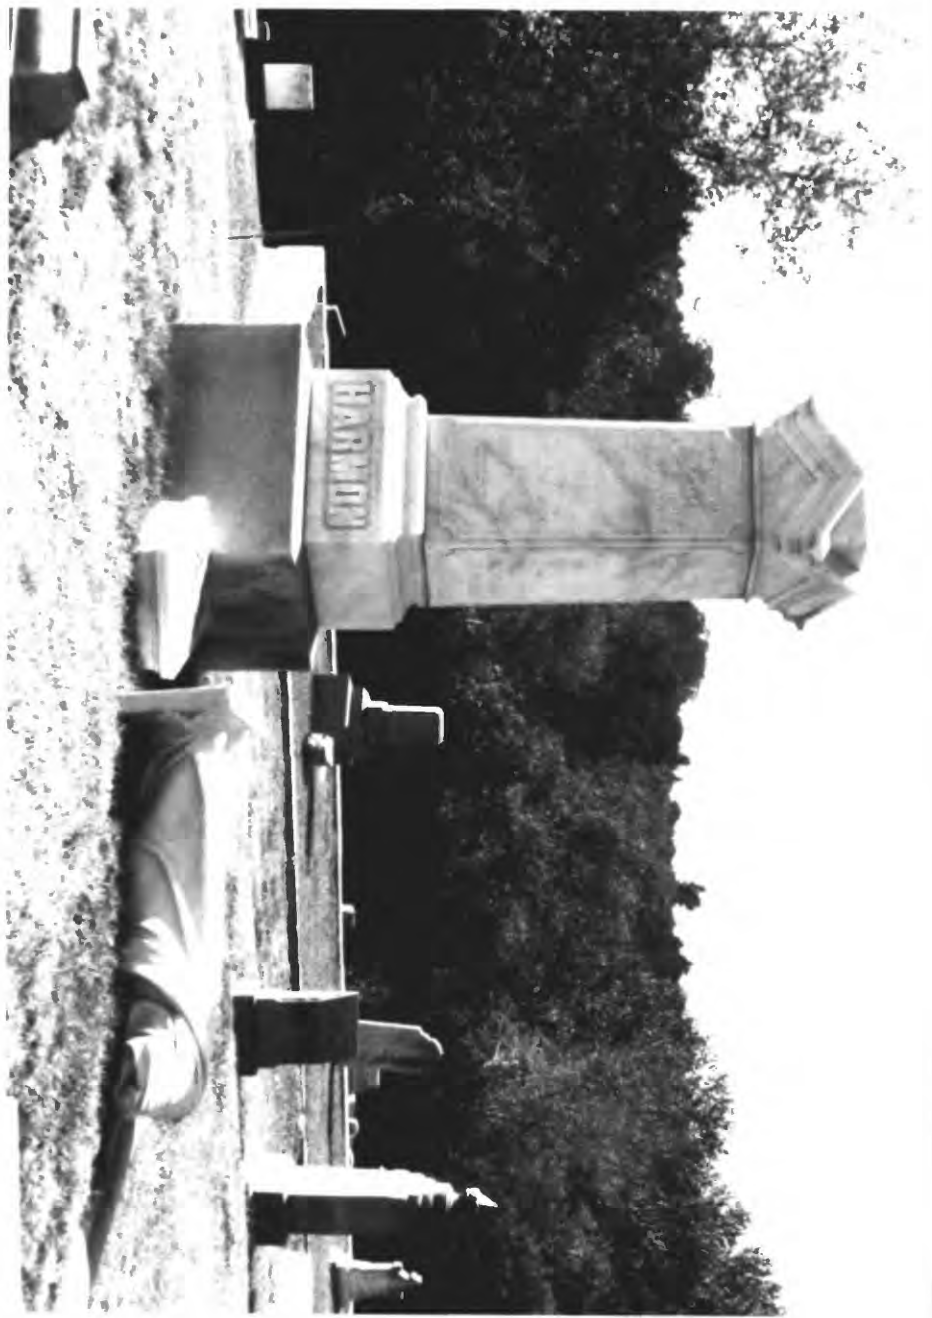
Santa Cruz (I.O.O.F. Cemetery on Graham Hill Road)— Many monuments were toppled or rotated. Some of the larger, multiple-segment monuments had only the top segment (urns, statues, etc.) shaken off. Some monuments had both fallen and rotated segments (fig. 11).

Figure 11. Fallen monument at the I.O.O.F. Cemetery in Santa Cruz.

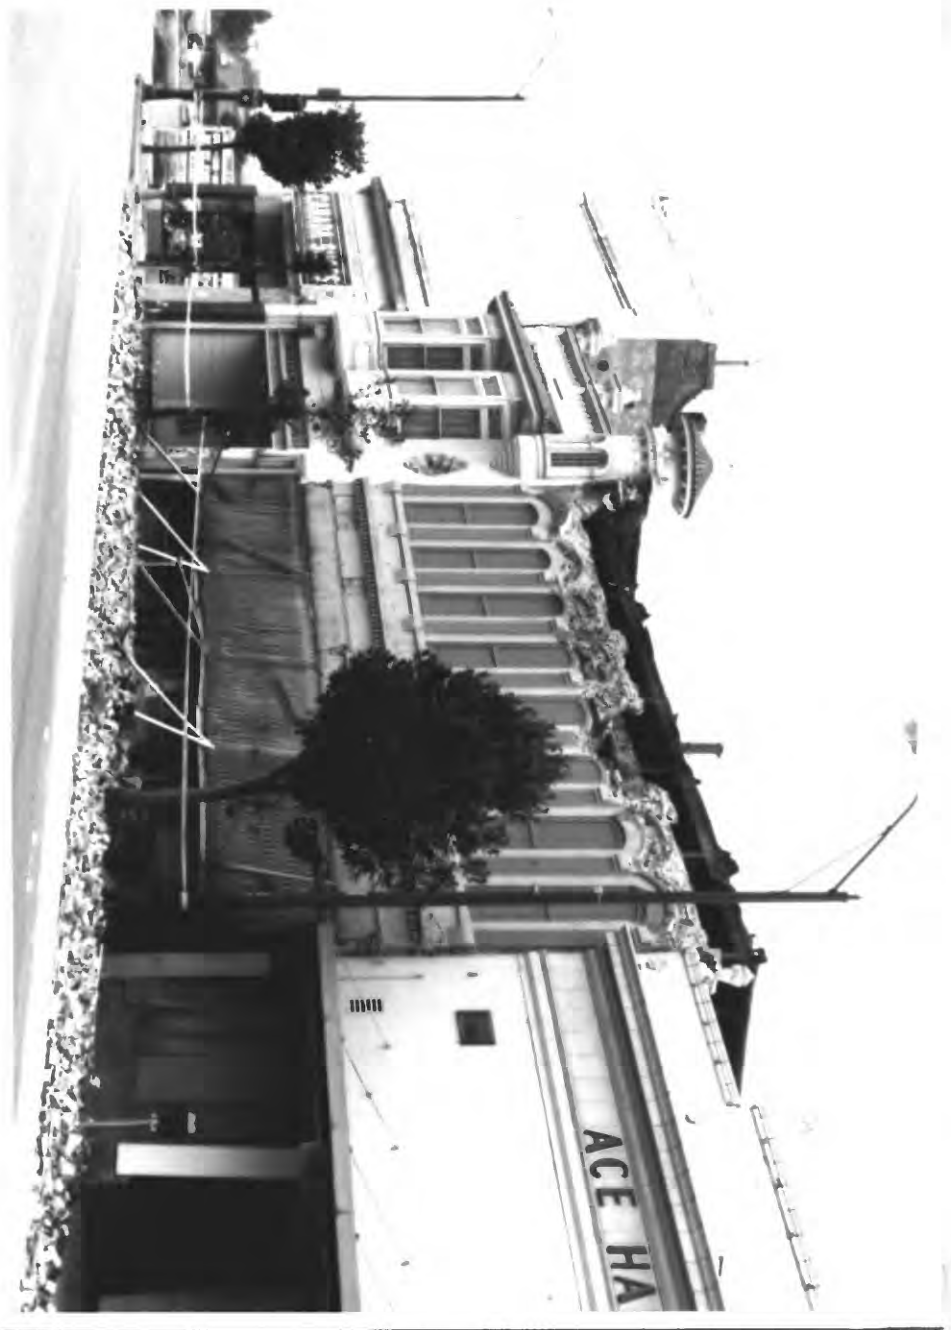
Watsonville— Many of the unreinforced-masonry buildings on Main Street were severely damaged; either from severely cracked exterior walls, partially collapsed exterior walls (fig. 12), or other major structural damage. The I.O.O.F. Building on Beech Street had the upper portion of the front, brick wall collapse killing one person (fig. 13). Saint Patricks Catholic Church was severely damaged by fallen sections of the exterior brick walls. Over 50 homes were knocked off their foundations; most of these were located on Brennen, Lincoln, and Jefferson Streets, and Stanford Avenue (fig. 14 and 15).

Figure 12. Damage to a commercial building on Main Street in the downtown area of Watsonville.

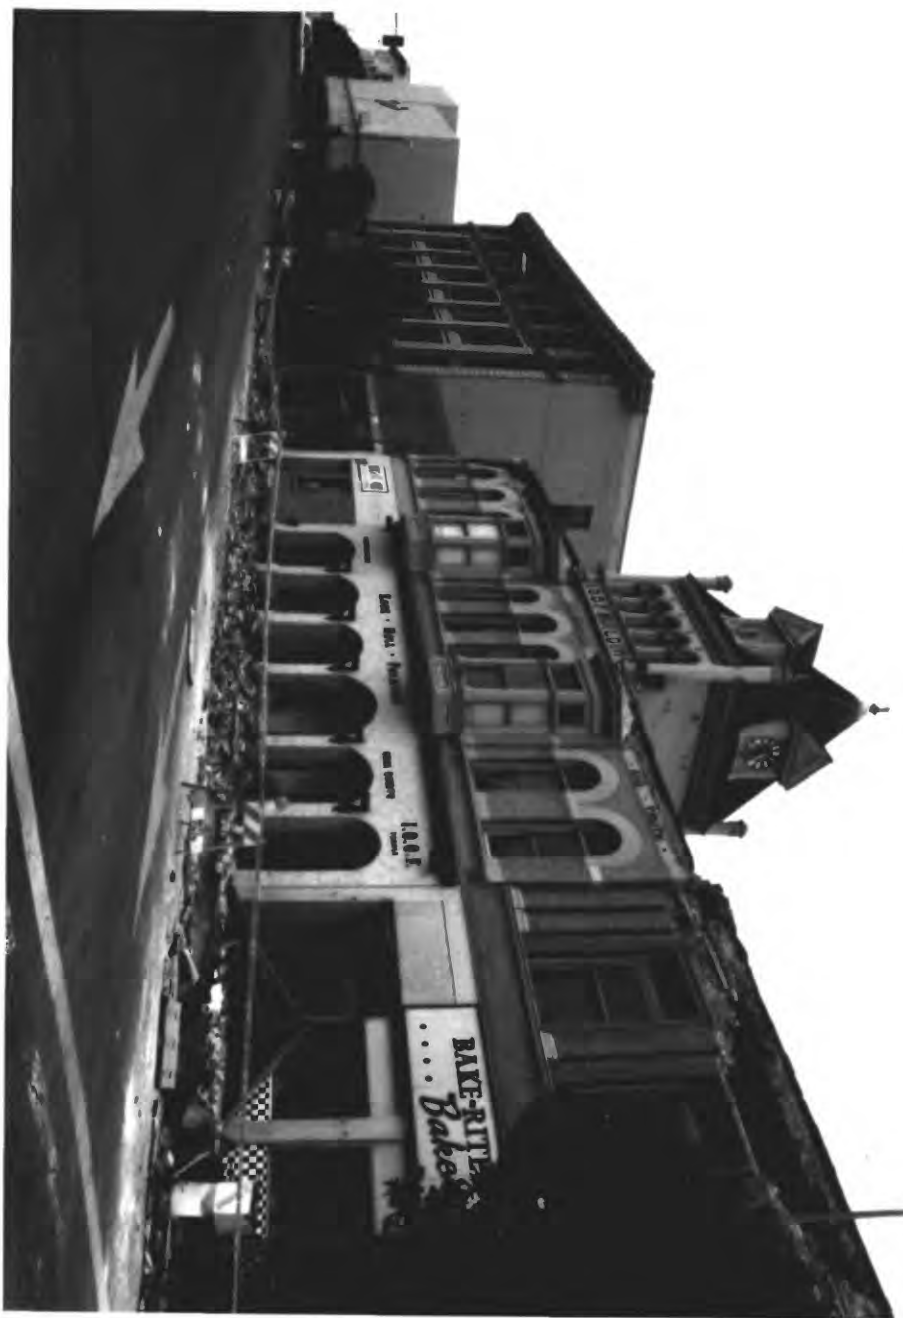
Figure 13. Damage to the I.O.O.F. Building on East Beach Street in Watsonville.

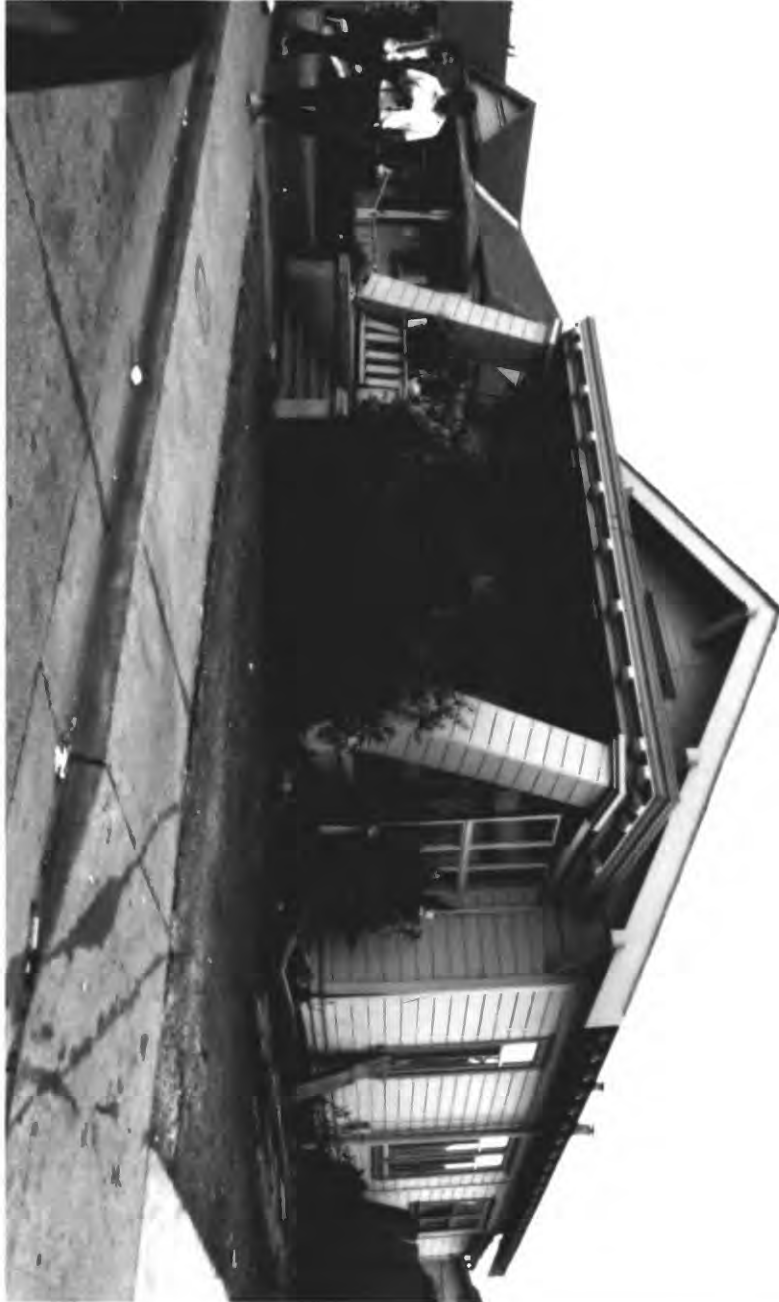
Figure 14. A house shaken off its foundation on Jefferson Street in Watsonville.

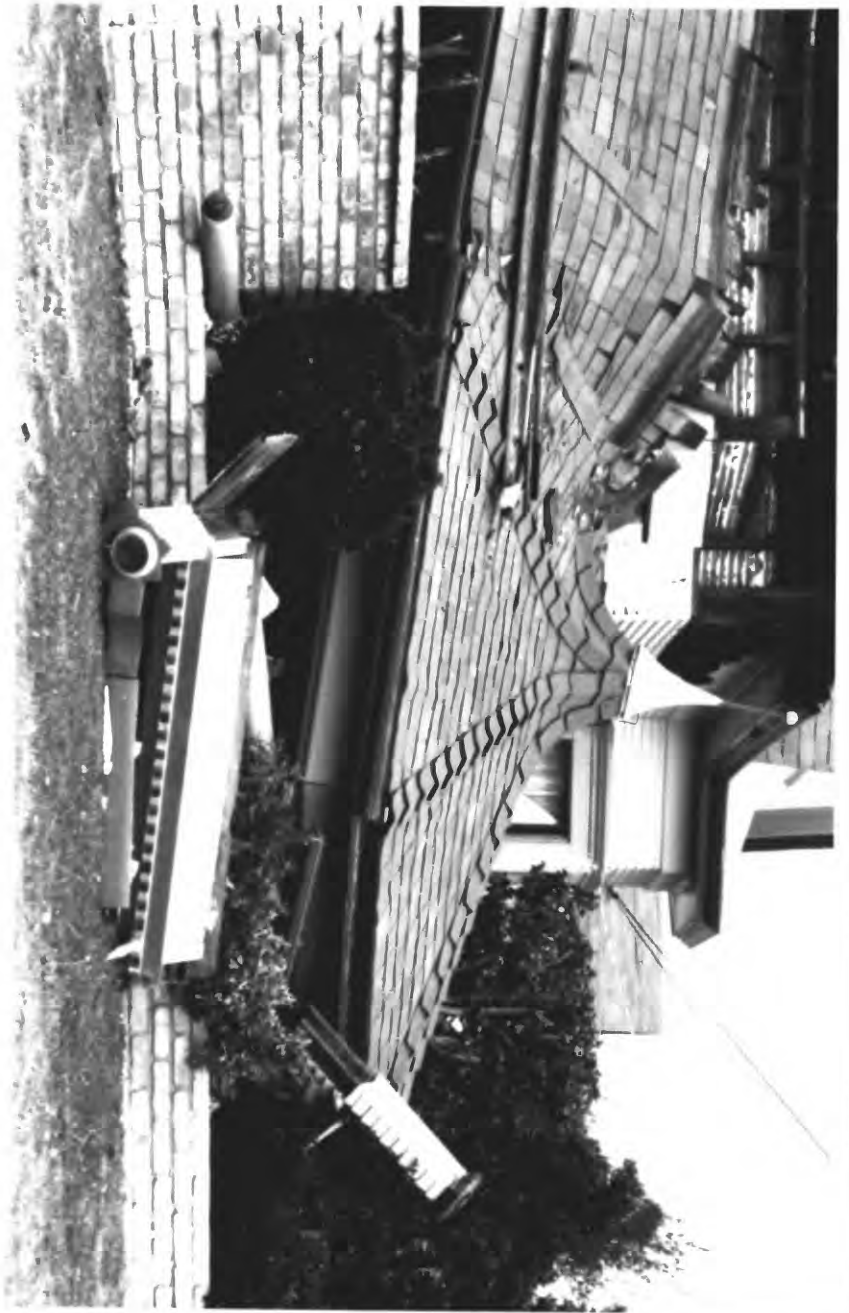
Figure 15. Collapsed porch on a house on Fifth and Jefferson Streets in Watsonville.
