Department of the Interior  
U.S. Geological Survey

EFFECTS OF THE LOMA PRIETA EARTHQUAKE  
ON THE MARINA DISTRICT  
SAN FRANCISCO, CALIFORNIA

OPEN-FILE REPORT 90-253

April 20, 1990

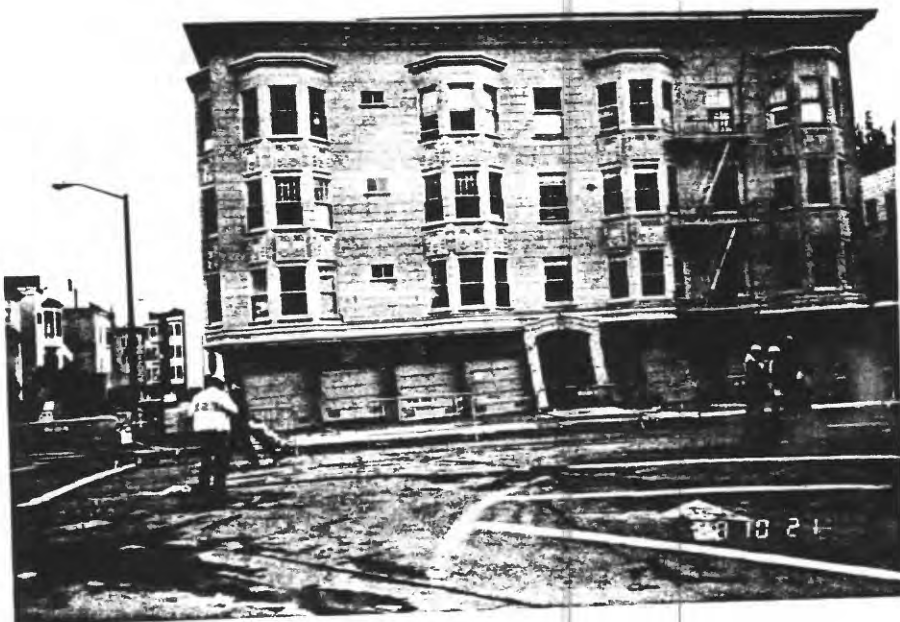
Figure 1

- Figure 1. This building, like many others in the Marina District, was at the corner of the block and had a soft first story. The upper floors are stiffer than the first floor.
- Figure 2. (a) The building was built on land where an 8' sewer pipe crossed. During the earthquake, differential settlement in the vicinity of the pipe adversely affected the building. (b) the differential settlement of the pipe caused a 1"/foot slope on the sidewalk and consequently considerable damage to the building.
- Figure 3. The timber in many buildings was deteriorated as in this one.
- Figure 4. (a) Some buildings were not at all or insufficiently bolted to the foundation. This building on Jefferson Street of the Marina District suffered from both the pounding effect from the adjacent buildings; and (b) the lack of sufficient anchorage of the building to the foundation.

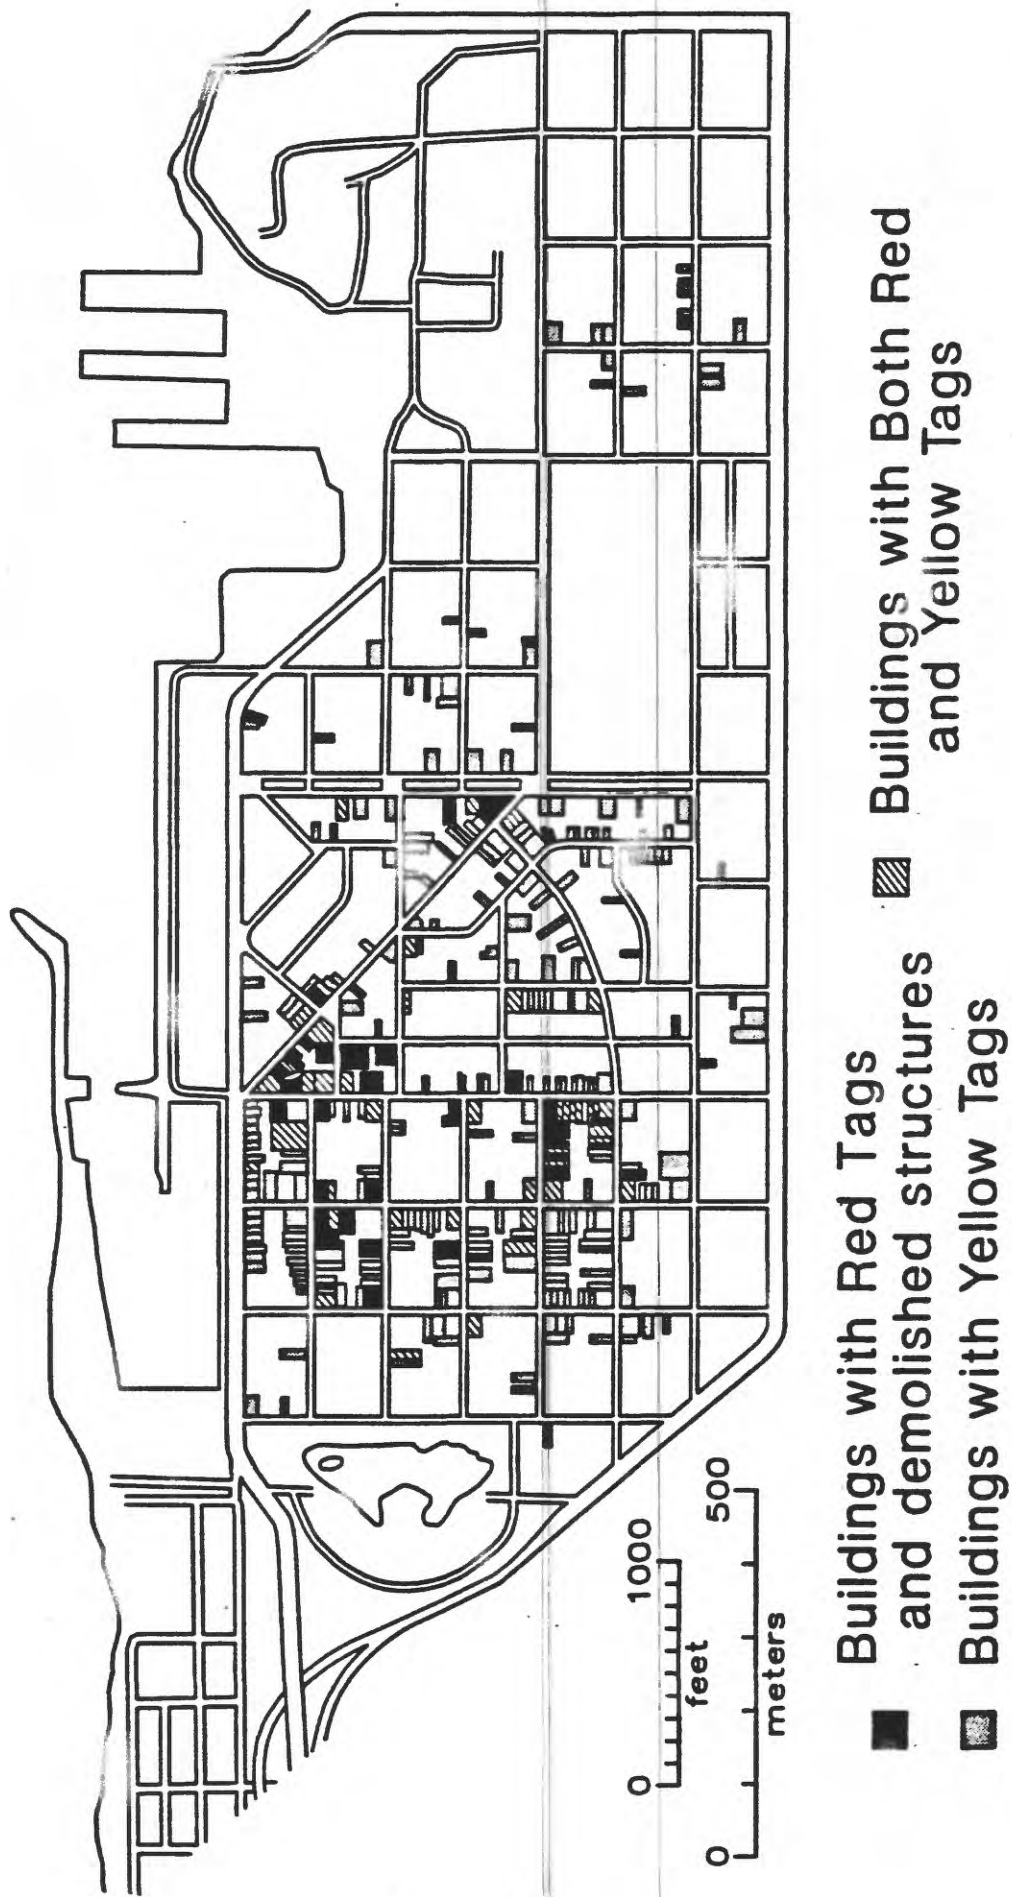
Figure 1. Buildings in the Marina District with red or yellow tags from the City of San Francisco Building Department following the October 17, 1989 Loma Prieta earthquake.

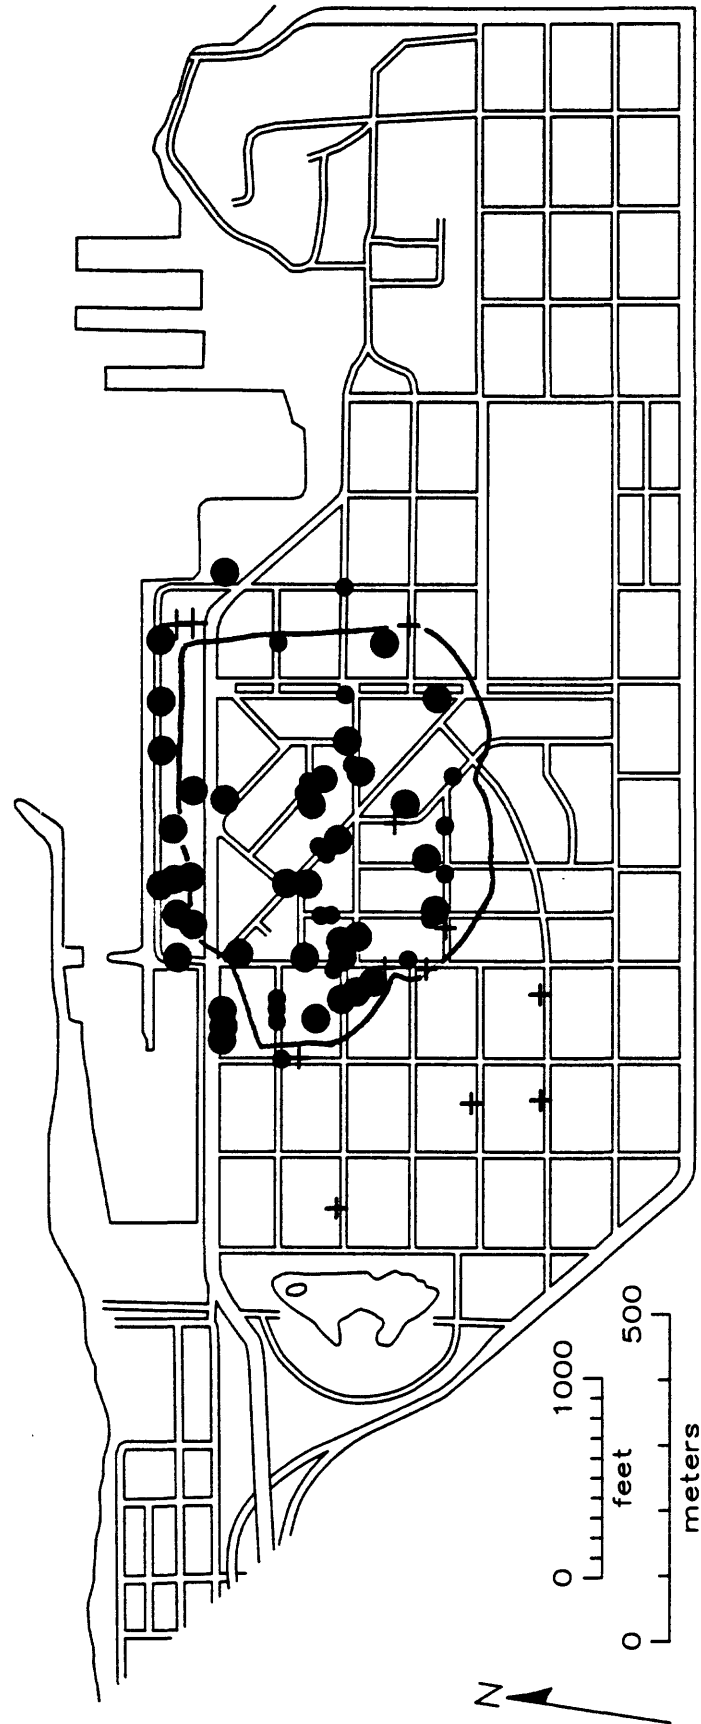
Figure 6. Location of sand boils. Sand boils are found primarily in the area

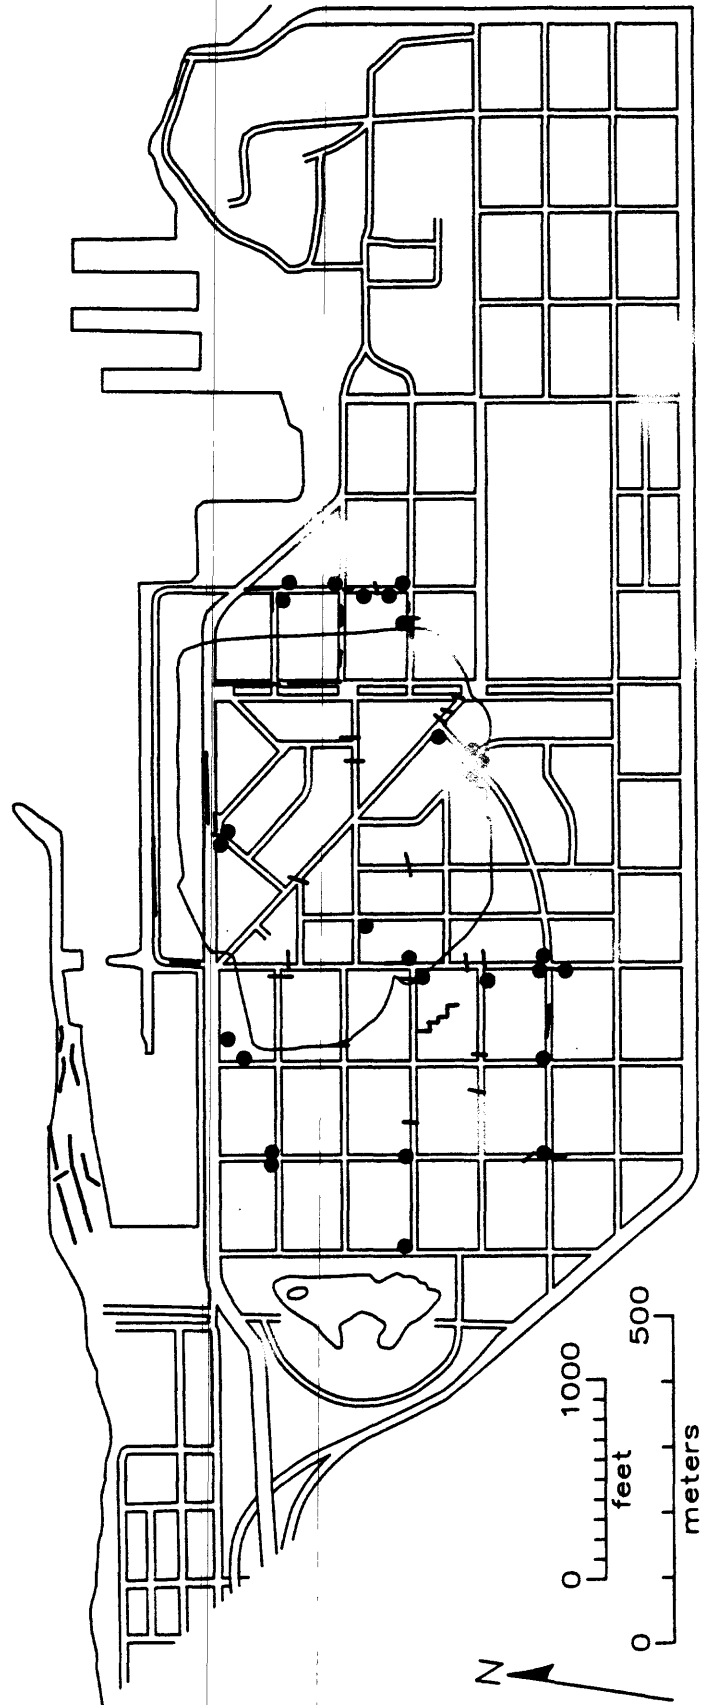
Figure 7. Distribution of cracks and curb damage.

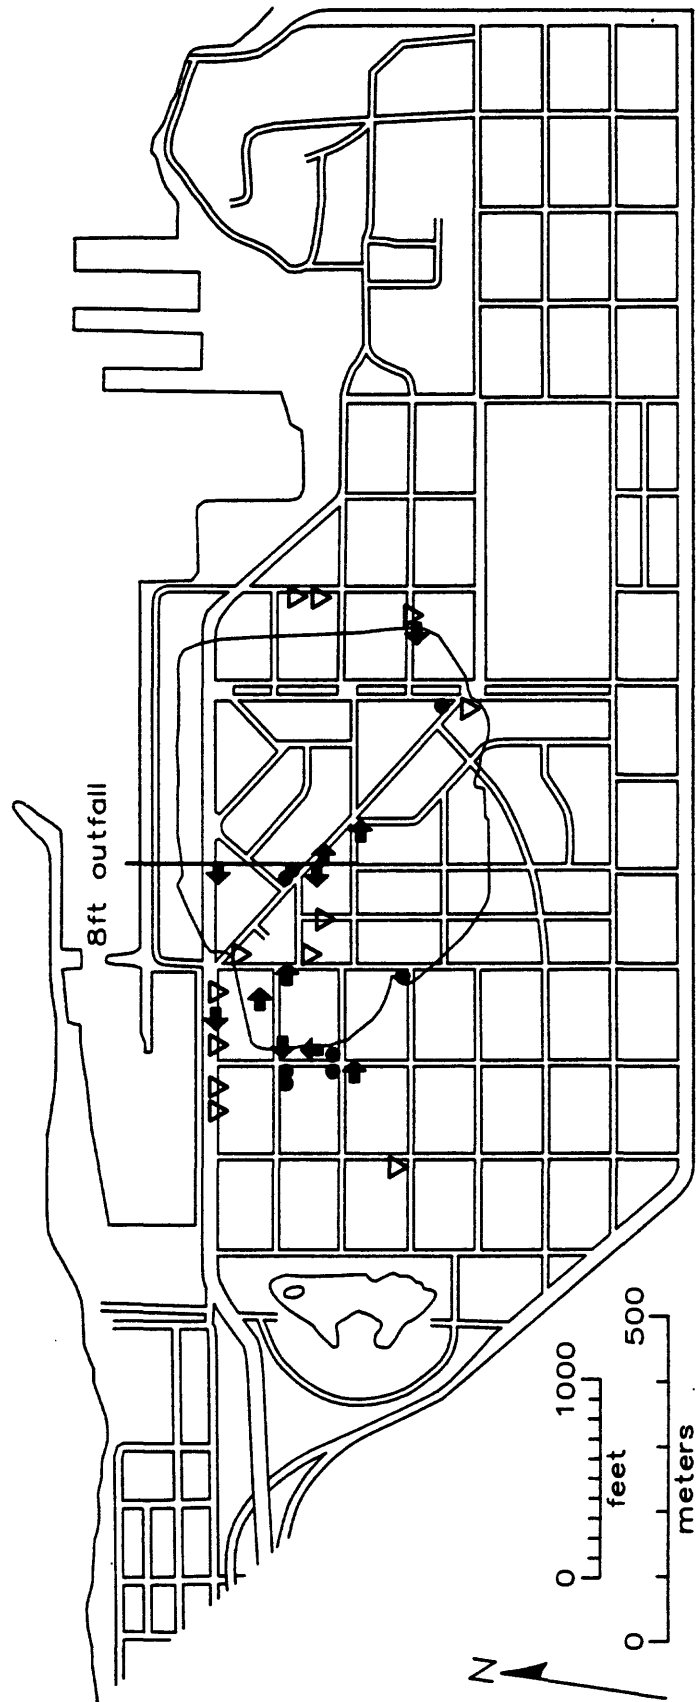
- Demolished      ◆ Tilted      ▼ Settled
- Figure 8. Buildings that were demolished, badly tilted, or displaying large settlements are generally confined to the areas that were filled.

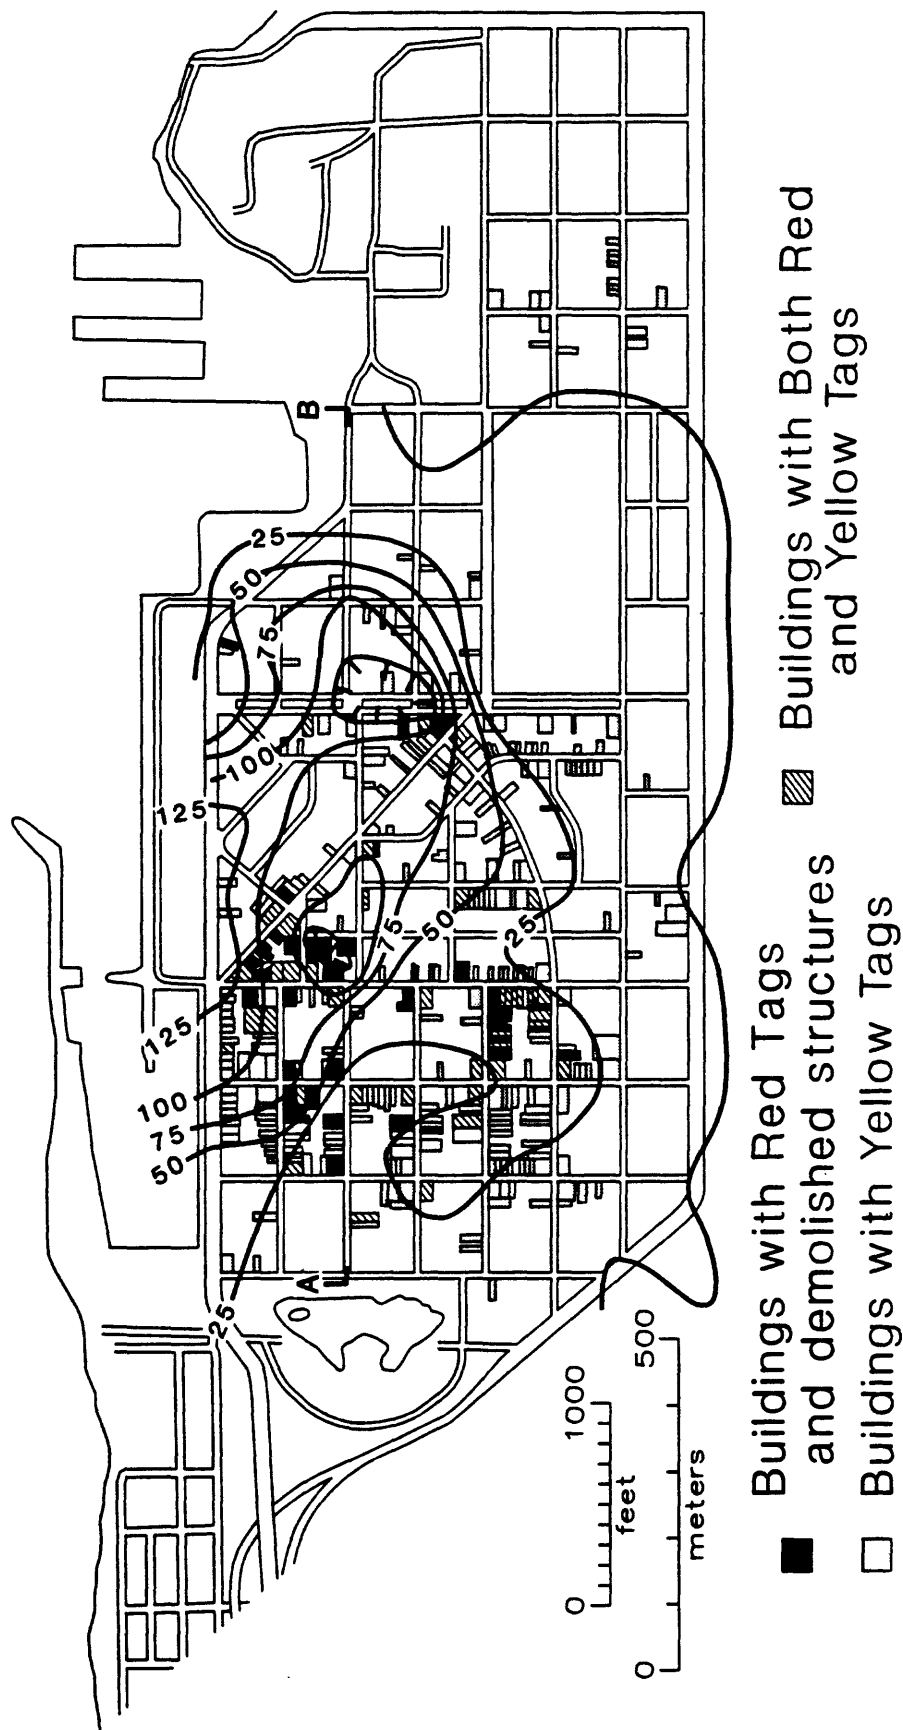
Figure 16. Red and yellow tag damage map (Seekins, this volume) is superimposed with 1974-1989 settlement contours. No points were surveyed east of Laguna or west of Baker.

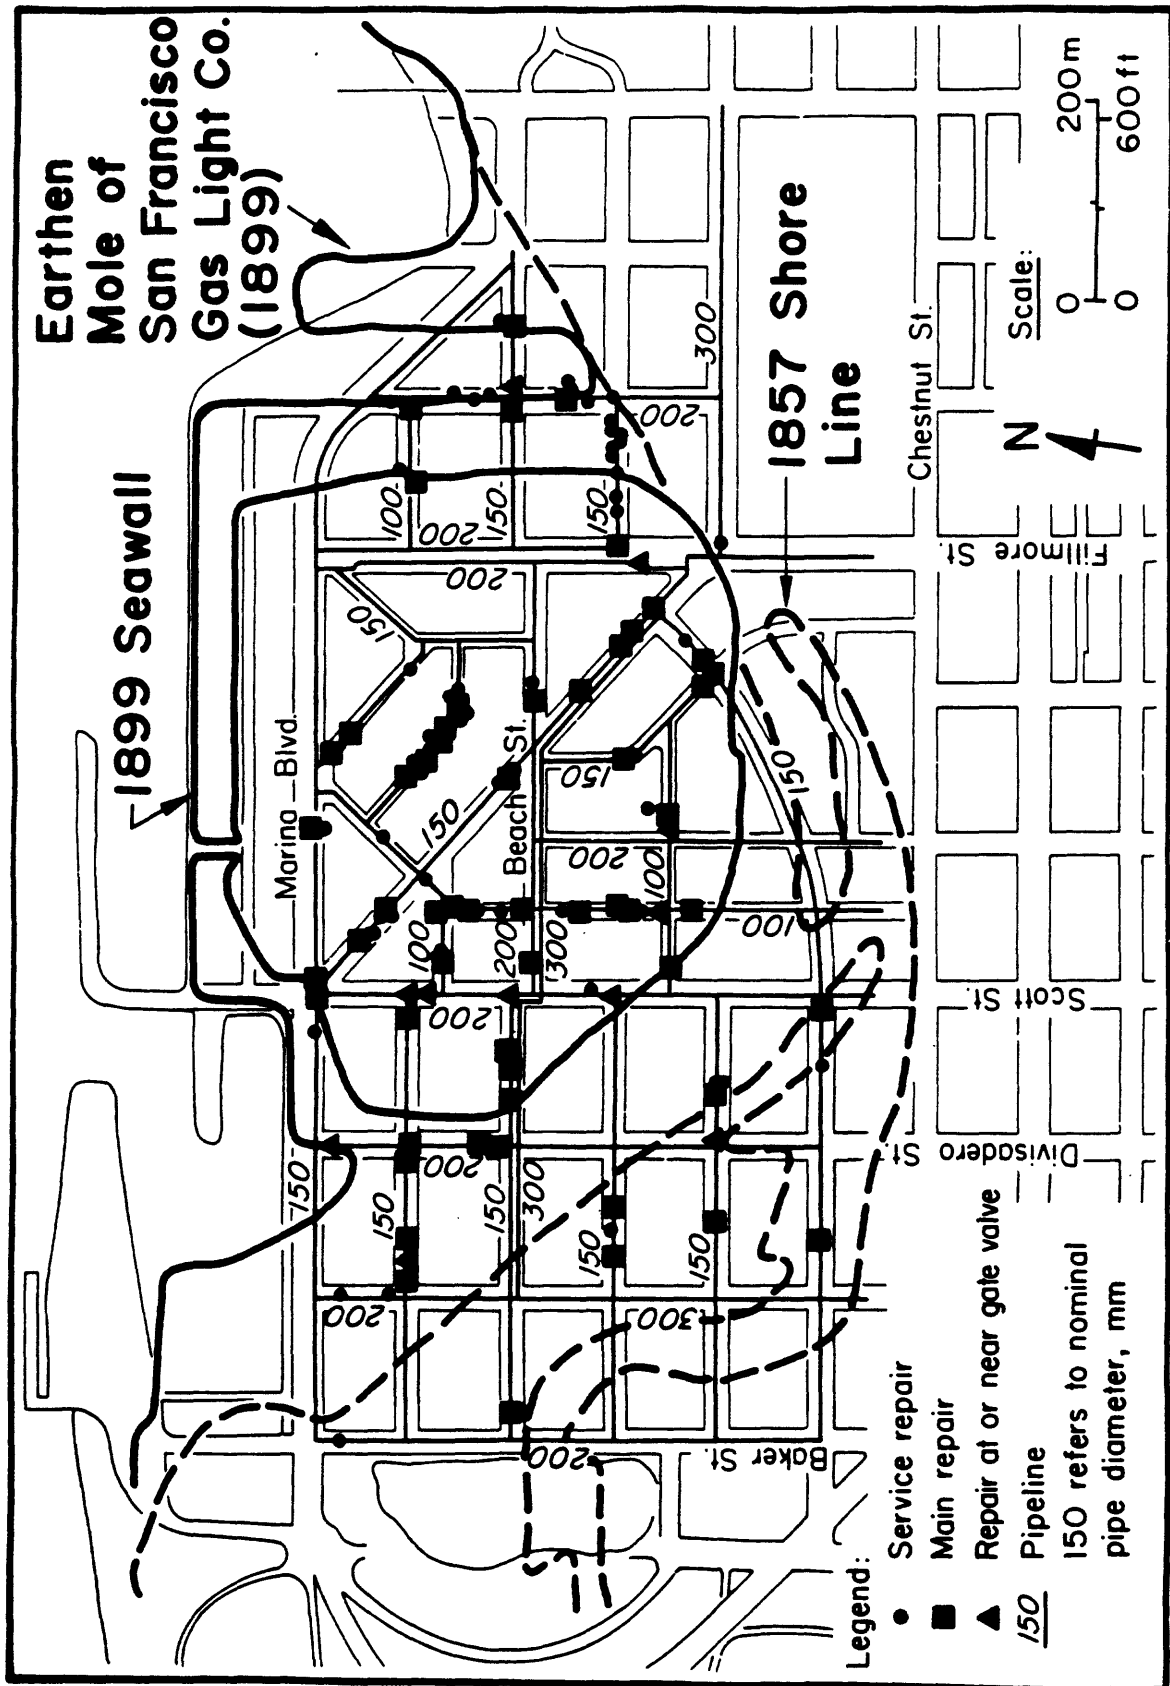
Figure 1. Map view of repairs to Municipal Water Supply System in the Marina District.

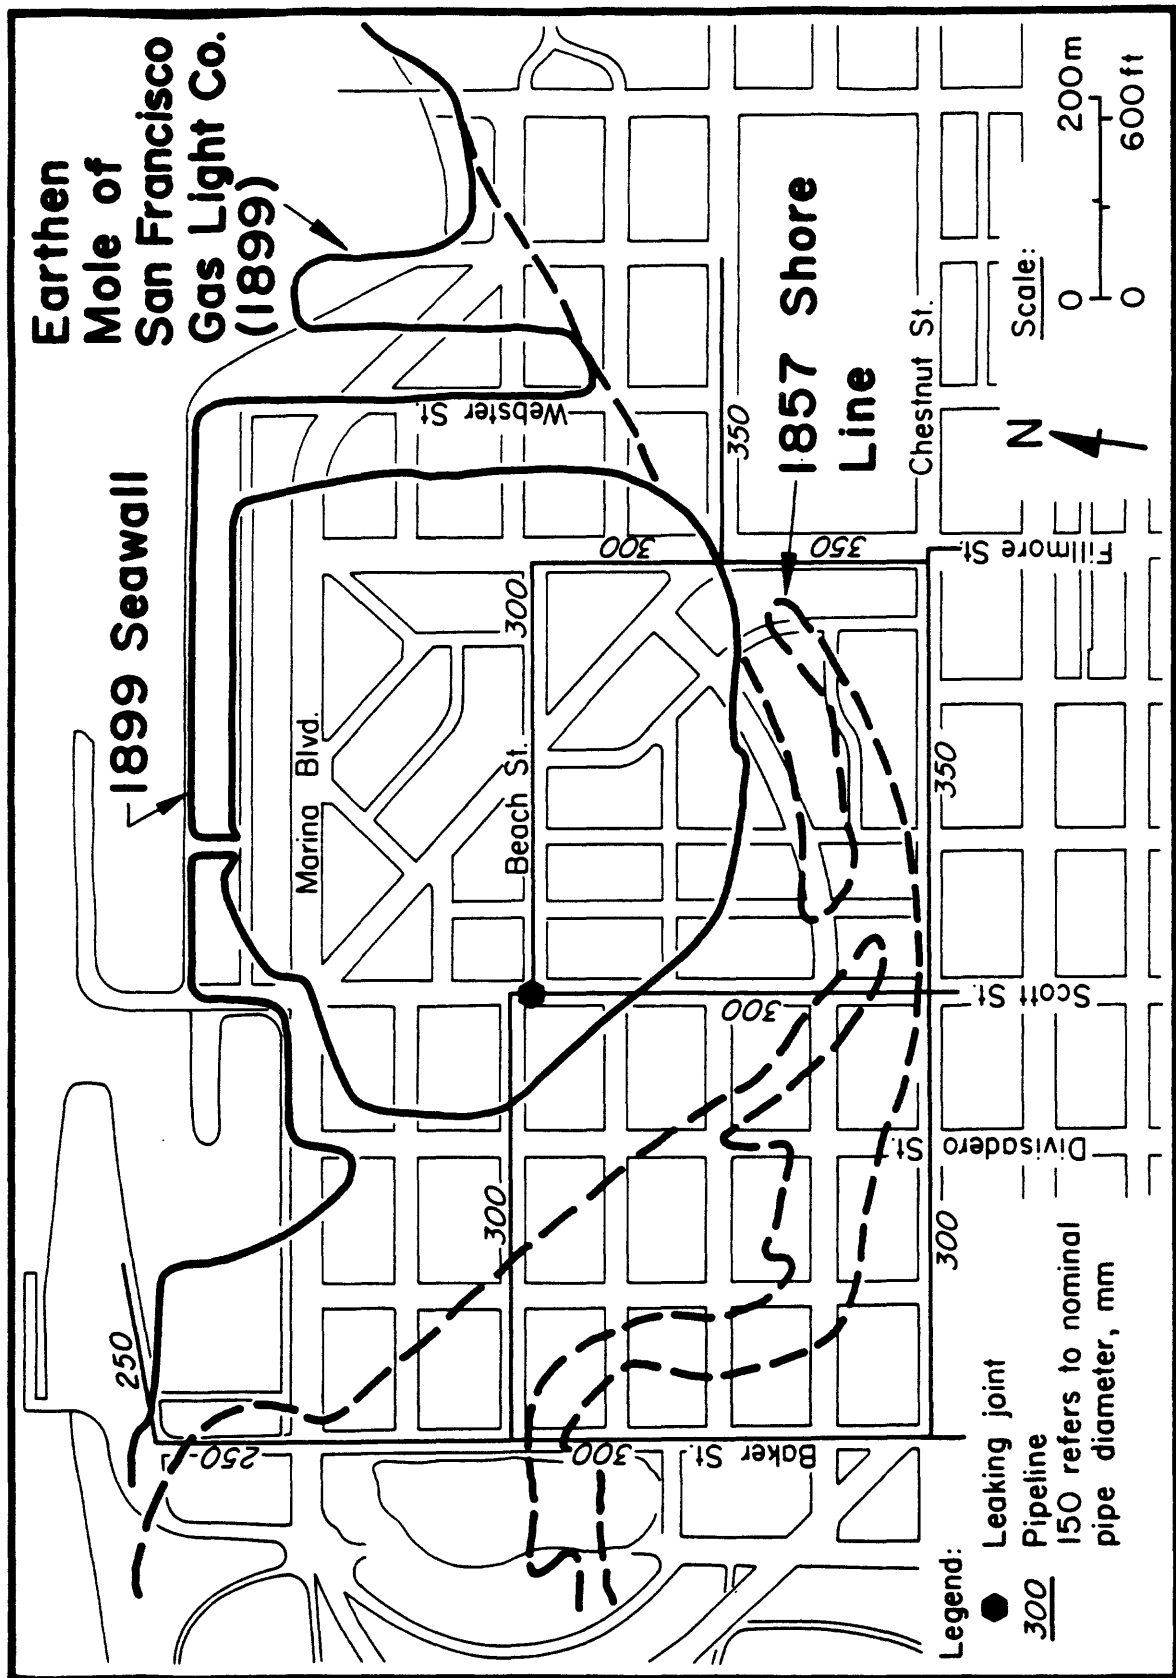
Figure 3. Map view of repairs to Auxiliary Water Supply System in the Marina District.
