U.S. Geological Survey

Summary of Geotechnical and Hydrologic Data
Collected Through April 30, 1990,
for the Alani-Paty Landslide,
Manoa Valley, Honolulu, Hawaii

Open-File Report 90-531

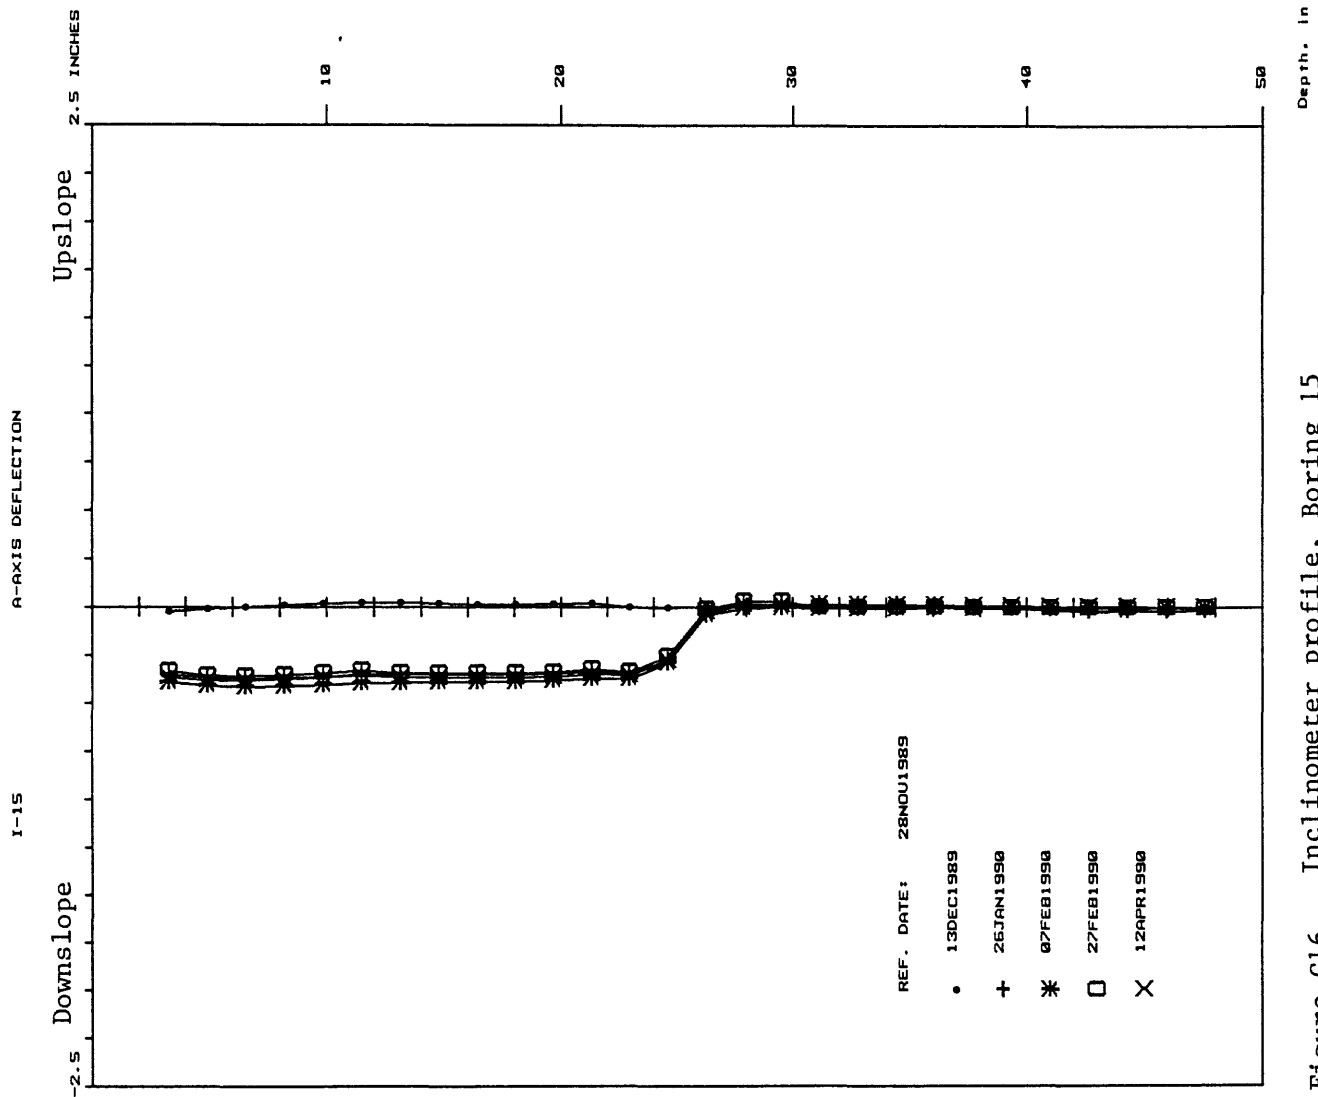
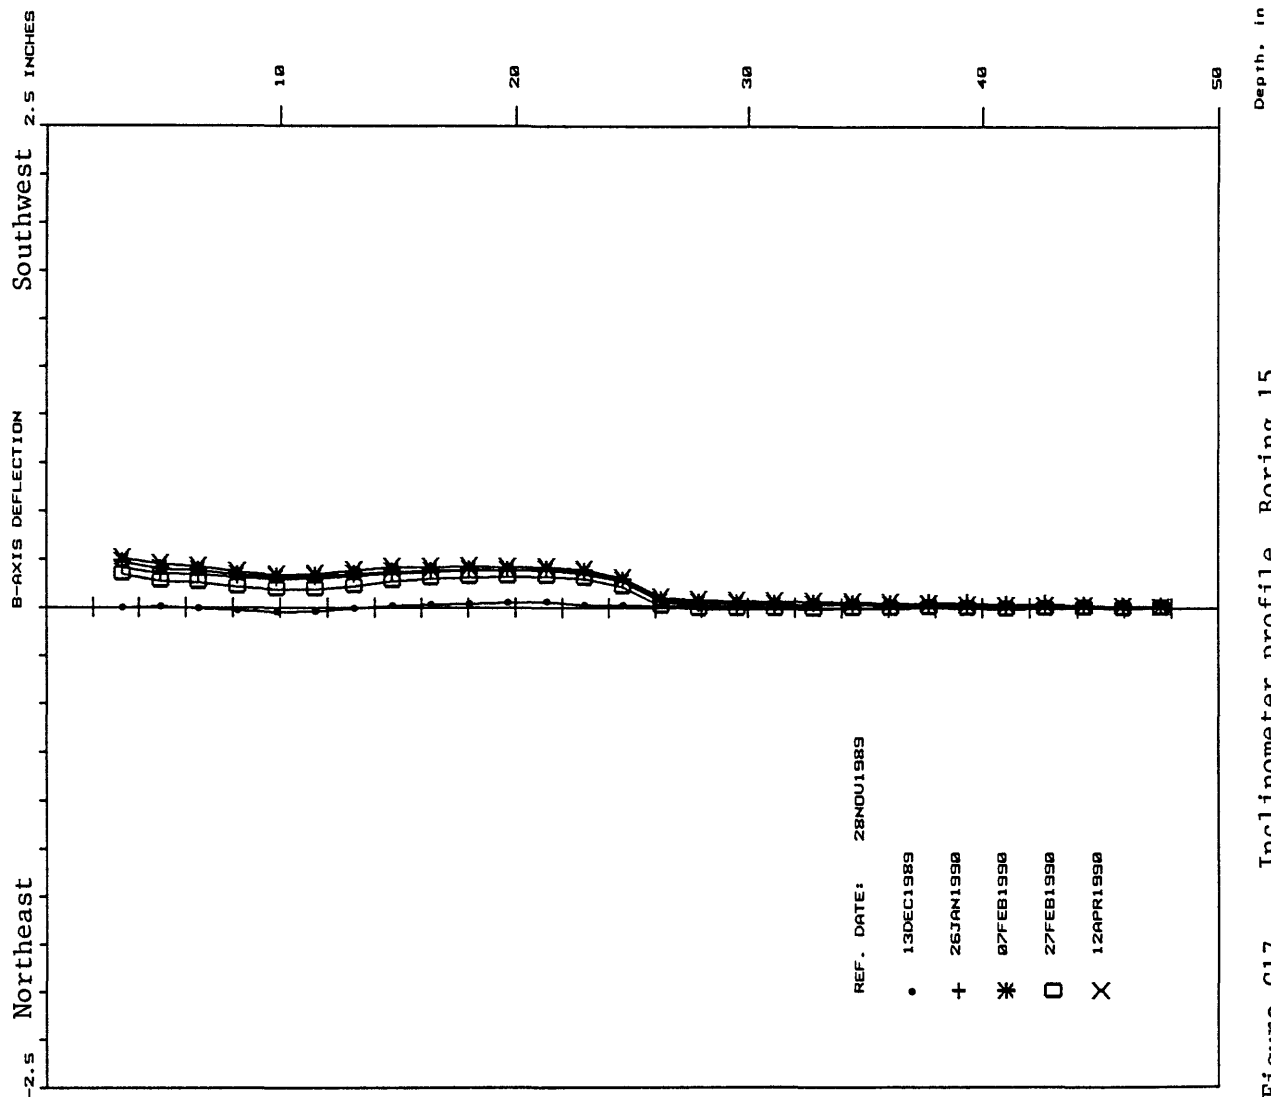
Inclinometer measurements were made in two locations (borings 10 and 15, see fig. 2 and Appendix C) where incipient movement was suspected (Baum and others, 1989) and in one place (boring 6) that appears to be stable ground between the Hulu-Woolsey and Alani-Paty landslides. The inclinometer in Boring 15 indicates sliding occurred at a depth of 26 ft during January 1990. Thus far, borings 6 and 10 have shown only small random deflections but no unequivocal evidence of sliding.

Figure C16. Inclinometer profile, Boring 15

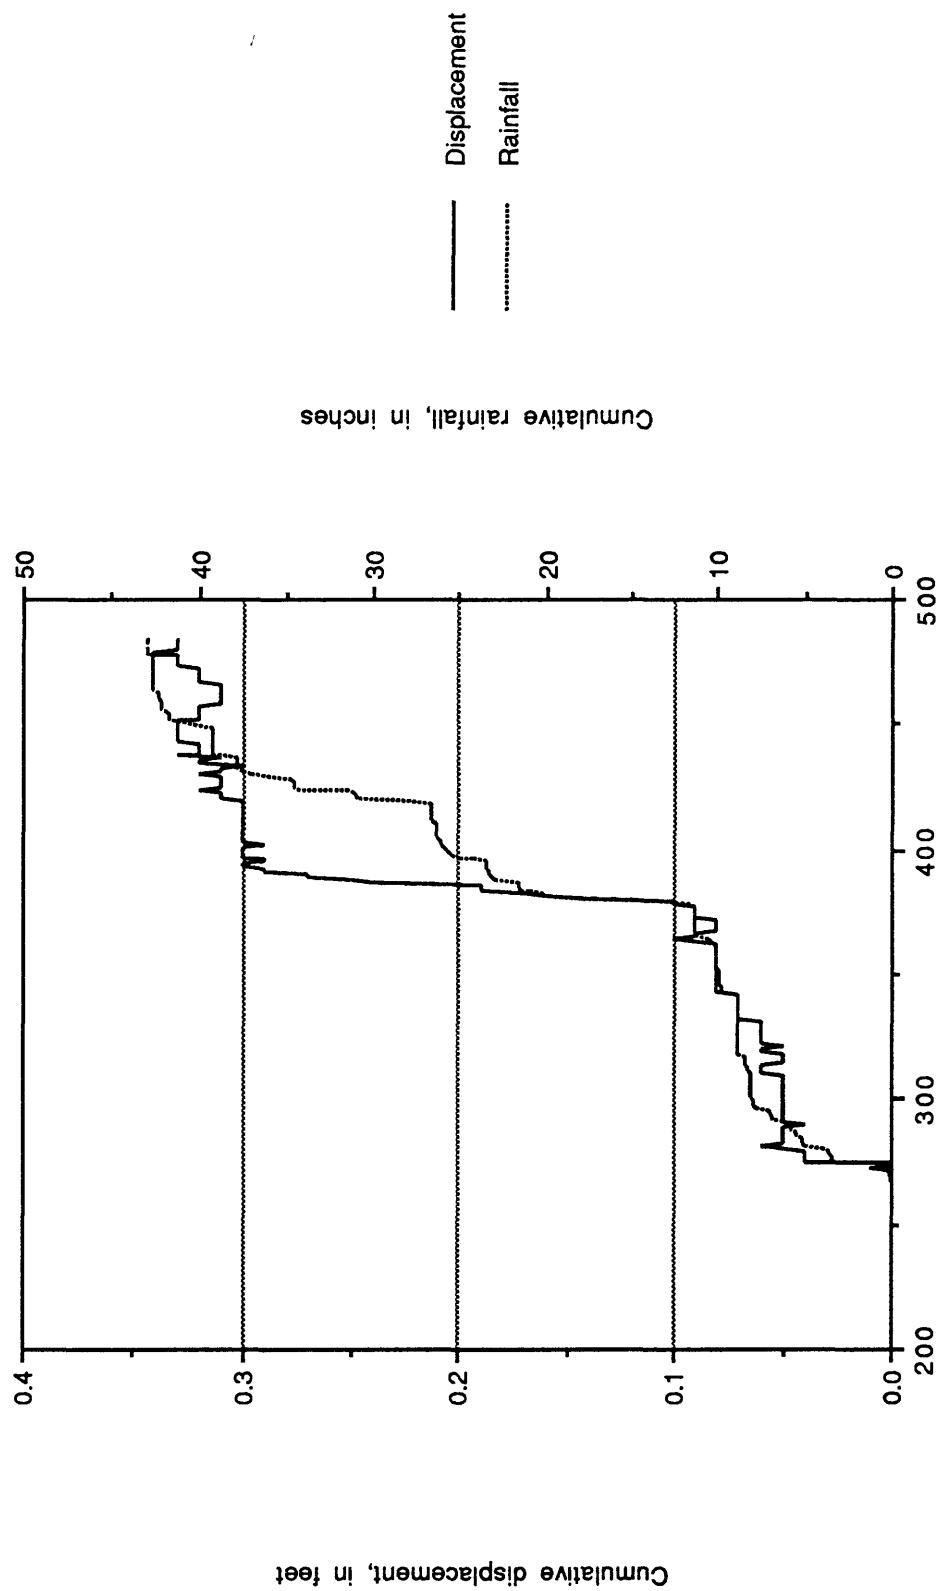
Figure E1. Rainfall and displacement at the head of the Alani-Paty landslide

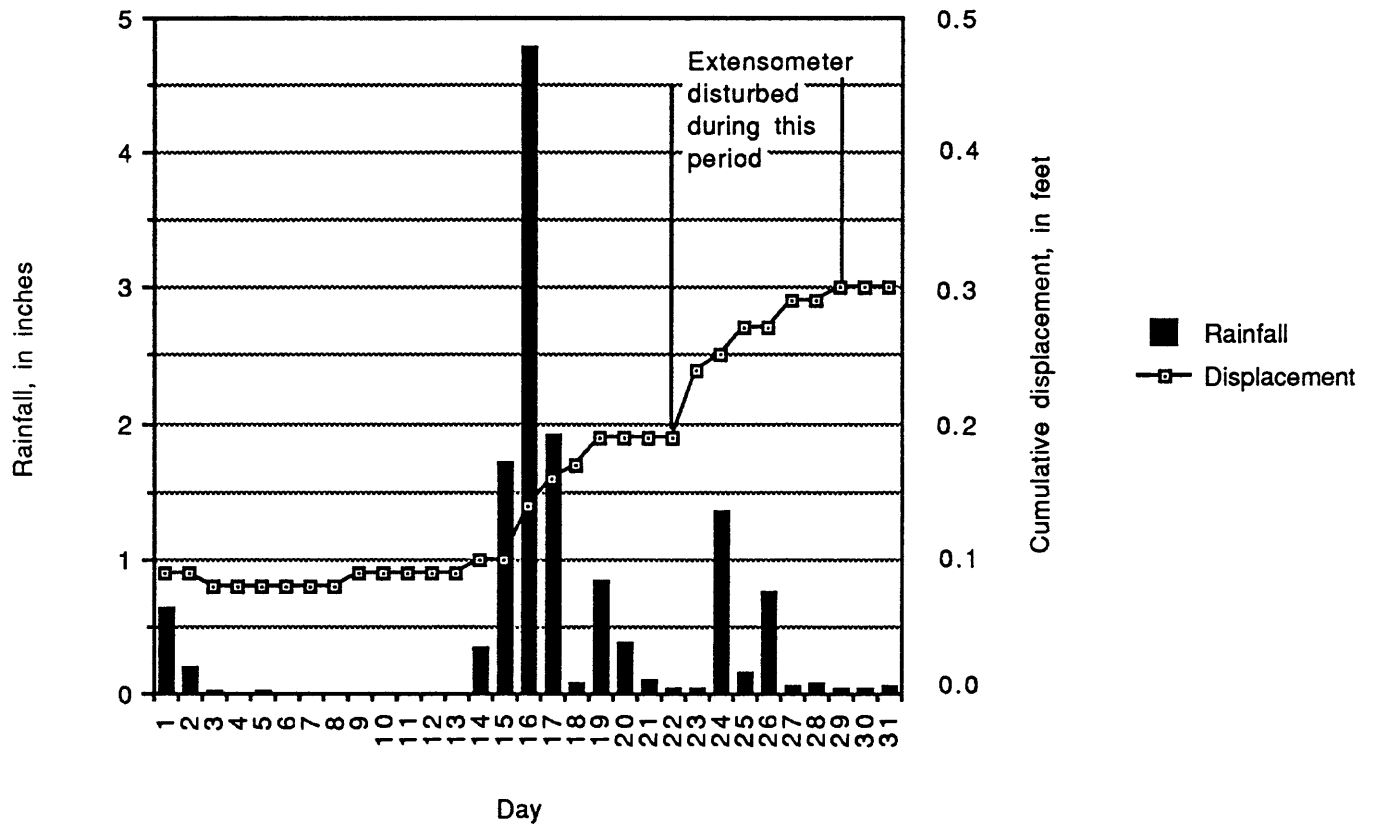
Rainfall and movement of the landslide -- Rainfall for the period from September 26, 1989, to April 24, 1990, totaled 44 in. at the head of the landslide. Most of this fell during October 1989 and January, February, and March 1990. Surface displacement (at the headscarp, fig. 2) from September through April totaled approximately 0.3 ft, and much of the displacement occurred during and after storms (Appendix E). Approximately 0.05 ft of movement occurred during and after a storm on October 3, 1989. Also, 0.1 ft of movement occurred from January 15 to 19, during and after a storm that lasted from January 14 to 18, 1990. An additional 0.1 ft of movement was recorded a few days later, from January 23 to 29, 1990. The nature of this additional movement is uncertain; our recorder appeared to have been disturbed during this time but tape and level surveys indicate that cumulative displacement at the extensometer site from September 13 to April 27 was slightly greater than that recorded by the extensometer (Appendix E). Creeping movements between storms account for the remaining displacement.

We used monthly surveys to check the displacement recorded by the extensometer. Using tape and level, we measured the distance from a point on the wall where the recorder was anchored to two points on the tree where the cable was attached. Our surveys indicate that cumulative displacement from September 13, 1989, to April 27, 1990, ranges from 0.35 to 0.41 ft. Displacement determined by the surveys is slightly greater than the displacement of 0.33 ft recorded by the extensometer for the period from September 25, 1989 to April 30, 1990. The surveys indicate displacement ranging from 0.12 to 0.22 ft between December 13, 1989, and February 7, 1990. The extensometer recorded 0.22 ft of displacement during the same period, which includes the questionable movement recorded from January 23 to January 29, 1990.

Figure E2. Daily increments rainfall and cumulative displacement at the head of the Alani-Paty landslide during January 1990

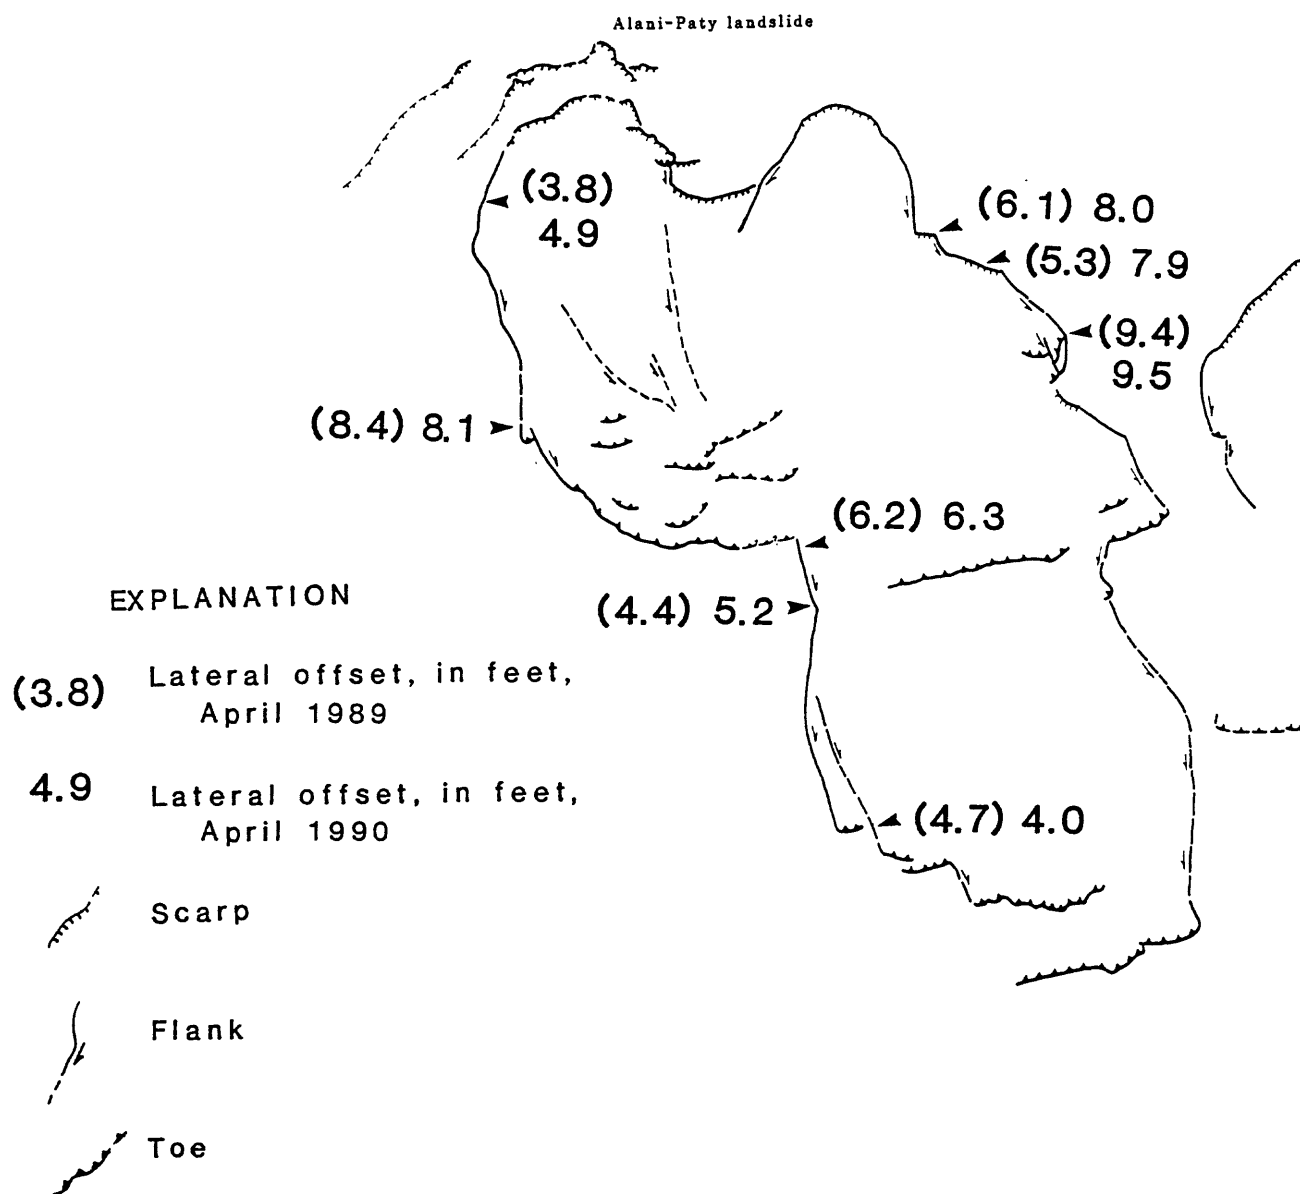
Crude measurements indicate that the head of the landslide moved approximately 1 ft between April 1989 and April 1990. Most of this movement must have occurred before our extensometer was put into operation.

We made crude estimates of total displacement by measuring offsets of curbs and walls where they cross the lateral boundaries of the landslide. We measured the offsets by standing on one side of the boundary and sighting along a curb or wall on the opposite side. We then measured the perpendicular distance from the wall or curb on our side of the boundary to the projection of the wall or curb on the opposite side. Precision of the measurements varies from site to site, but averages about ± 0.5 ft.

Figure E3. Map showing lateral offsets of curbs and stone walls at boundaries of the Alani-Paty landslide. Base (map of landslide boundaries) from Baum and others (1989).
