**CHANNEL AND BANK STABILITY OF STANDING PINE CREEK  
AT STATE HIGHWAY 488 NEAR FREENY, LEAKE COUNTY,  
MISSISSIPPI**

By D. Phil Turnipseed and K. Van Wilson, Jr.

U.S. GEOLOGICAL SURVEY  
Open-File Report 92-112

Prepared in cooperation with the  
MISSISSIPPI STATE HIGHWAY DEPARTMENT

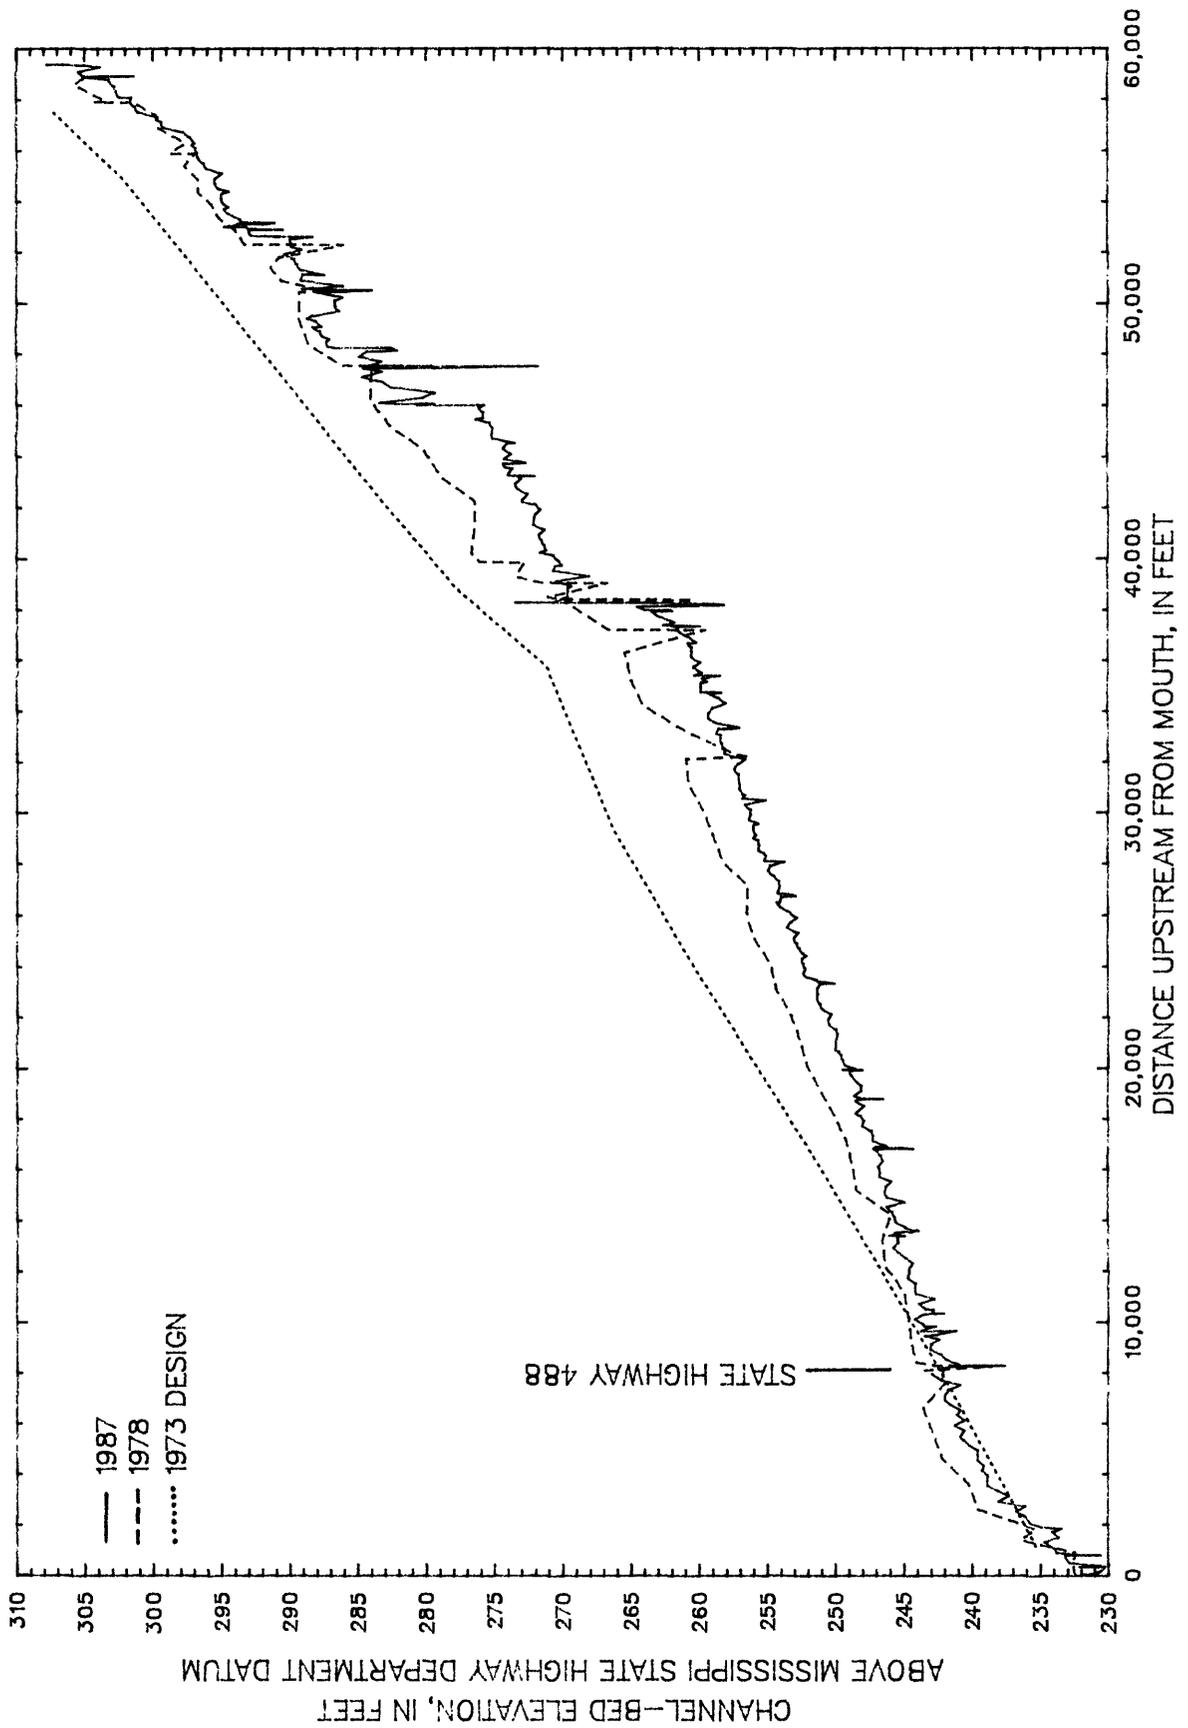
Three channel-bed profiles (1973, 1978, and 1987) for Standing Pine Creek (fig. 2) were obtained from the SCS for use in this study. Standing Pine Creek aggraded from 1973 to 1987 from the mouth to about 8,000 ft upstream and degraded farther upstream; however, the channel reach from the mouth to about 11,000 to 13,000 ft upstream filled between 1973 and 1978 and was dredged twice (U.S. Soil Conservation Service, 1987). Therefore, the profiles in figure 2 do not actually show the full magnitude of aggradation that occurred between 1973 and 1987 in the lower channel reaches. The headward progressing channel-bed degradation has decreased the channel gradient with time in the lower 7 or 8 miles of the stream (fig. 2), thus, decreasing the stream power. This reduction in stream power, in turn, reduces the amount of bed material that the stream is capable of transporting. The average channel bed slope in the vicinity of State Highway 488 decreased from about 5.6 ft/mi in 1973 to about 2.8 ft/mi in 1987. The channel bed slope in 1987 also seems to be representative of the 1991 slope.

Figure 2.--Channel-bed profiles in 1973, 1978, and 1987 for Standing Pine Creek.

The channel bed at State Highway 488 seems to have aggraded more than 2 ft from 1973 (when channelized) to 1978 (fig. 2), but the crossing is located in a channel reach that was dredged twice between 1973 and 1978 (U.S. Soil Conservation Service, 1987). The channel bed in the vicinity of State Highway 488 aggraded from 1973 to 1978, but to a much greater extent than the available elevations indicate. The elevations for 1978, 1985-88, and 1991 indicate only about 1.5 ft of degradation from 1978 to 1991 (fig. 4). A flood with about a 25-year recurrence interval occurred in April 1979 on Standing Pine Creek and probably scoured the channel bed, but the extent of the scour is unknown. Channel-bed shifts are likely even during moderate flows because the channel bed consists mostly of fine-grained sand. Due to these factors, channel-bed gradation

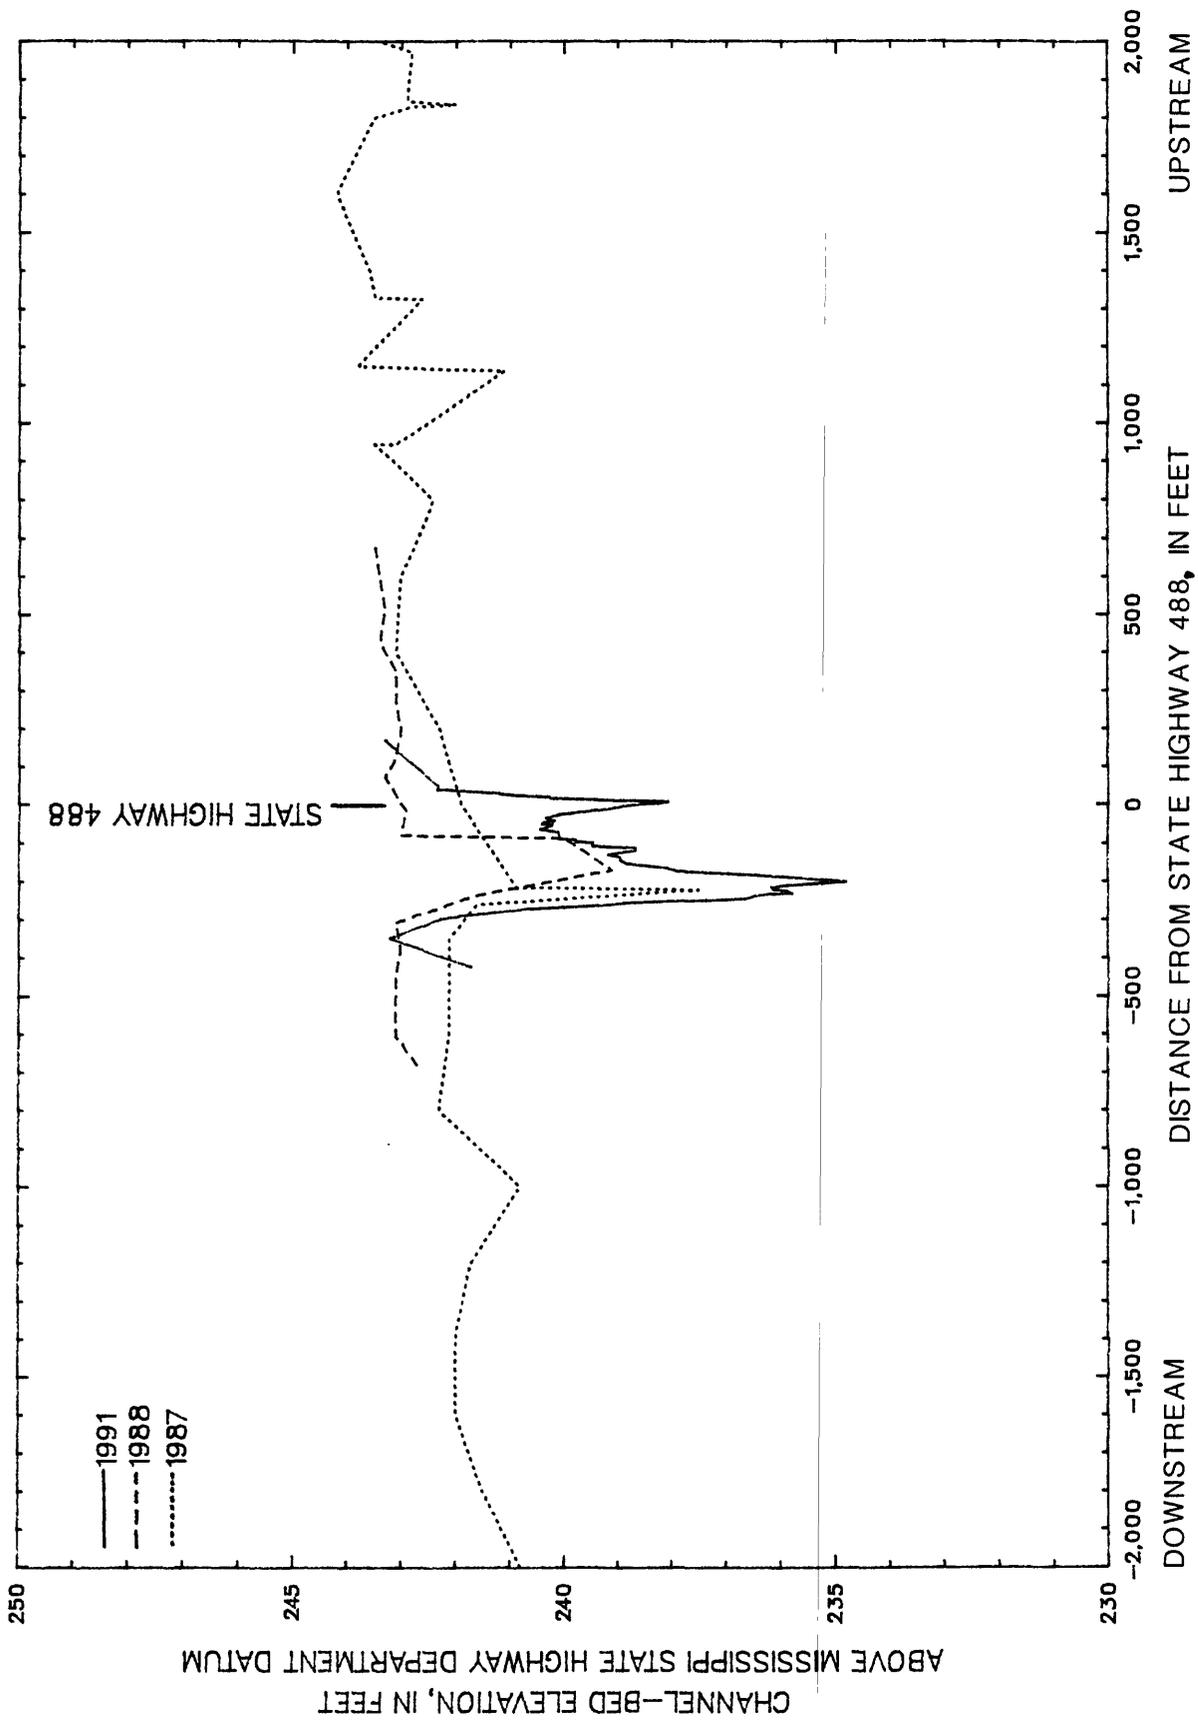
Channel-bed profiles obtained in 1987, 1988, and 1991 indicate a scour hole in the vicinity of State Highway 488 (fig. 3). The minimum bed elevations obtained in the scour hole were 237.5, 239.1, and 234.8 ft for the 1987, 1988, and 1991 surveys, respectively. The most accurate measurement of minimum bed elevation in the scour hole was obtained in 1991 by personnel of the USGS using a fathometer attached to a boat. The 1987 and 1988 profiles were limited to wadable depths, and therefore, the minimum bed elevations obtained are probably somewhat higher than the actual minimum bed elevation at the time of the surveys. From the 1991 profile, the scour hole is a maximum of 8.4 ft deep (about 200 ft downstream from

Figure 3.--Channel-bed profiles in 1987, 1988, and 1991 for Standing Pine Creek in the vicinity of State Highway 488 near Freeny.

State Highway 488) and about 520 ft in length. It appears that between 1987 and 1988, the hole scoured longitudinally. Between 1988 and 1991, the hole also appears to have scoured longitudinally, probably due to flooding in 1991.

shown in figure 3. As determined from field observations, channel profiles, and cross sections, the scour hole in the vicinity of State Highway 488 has a significant effect on the channel-bed elevation at the State Highway 488 bridge but not on elevations representative of the channel-bed slope for the channel reach upstream and downstream.

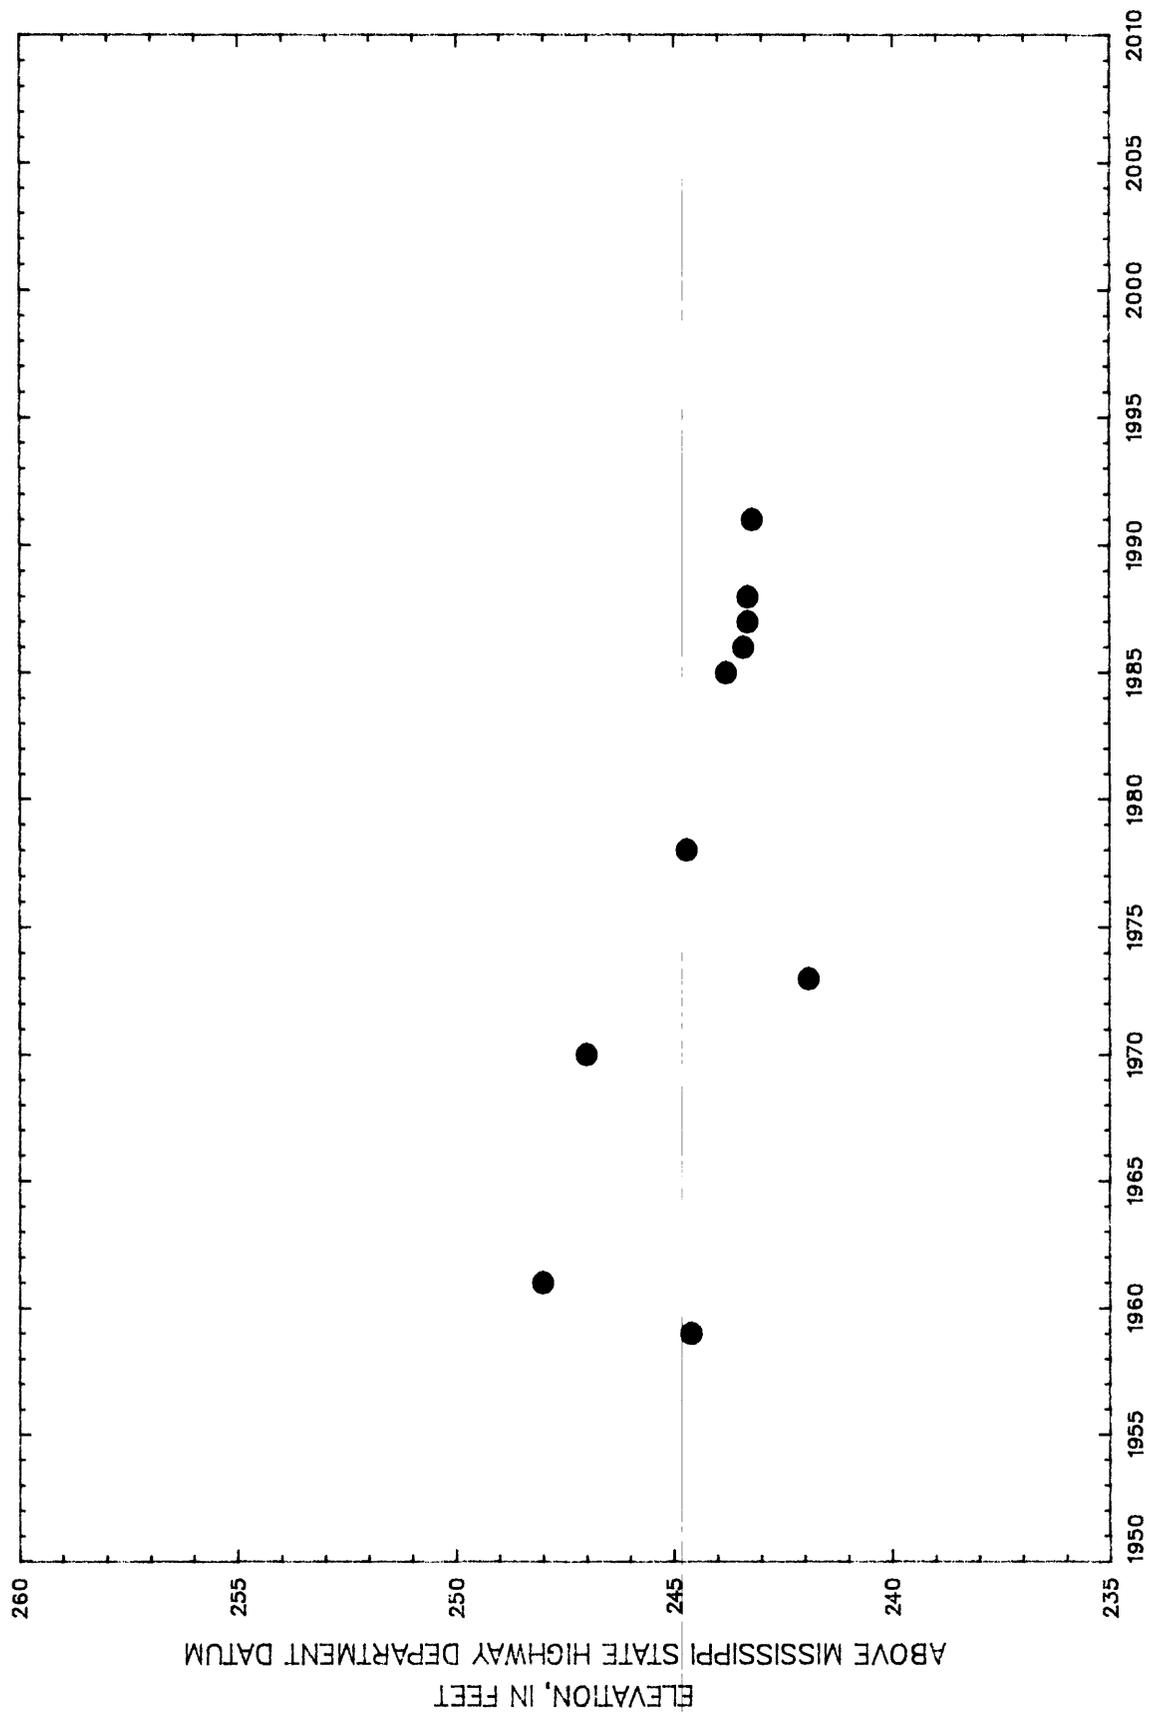
Figure 4.--Average channel-bed elevation for Standing Pine Creek at State Highway 488 near Freeny, 1958-91.

processes were not expressed as a power function with time. Based on the available bed elevations, the channel bed seems to be near equilibrium in the vicinity of State Highway 488; this conclusion is supported by field observations in 1988 and 1991. The 1991 elevation is only 1.3 ft higher than the 1973 elevation and, therefore, aggradation is not expected to pose a severe problem at this site in the near future. These assumptions could be negated by additional channel modifications or the occurrence of unusually large destructive flooding, which could alter ongoing gradation processes.

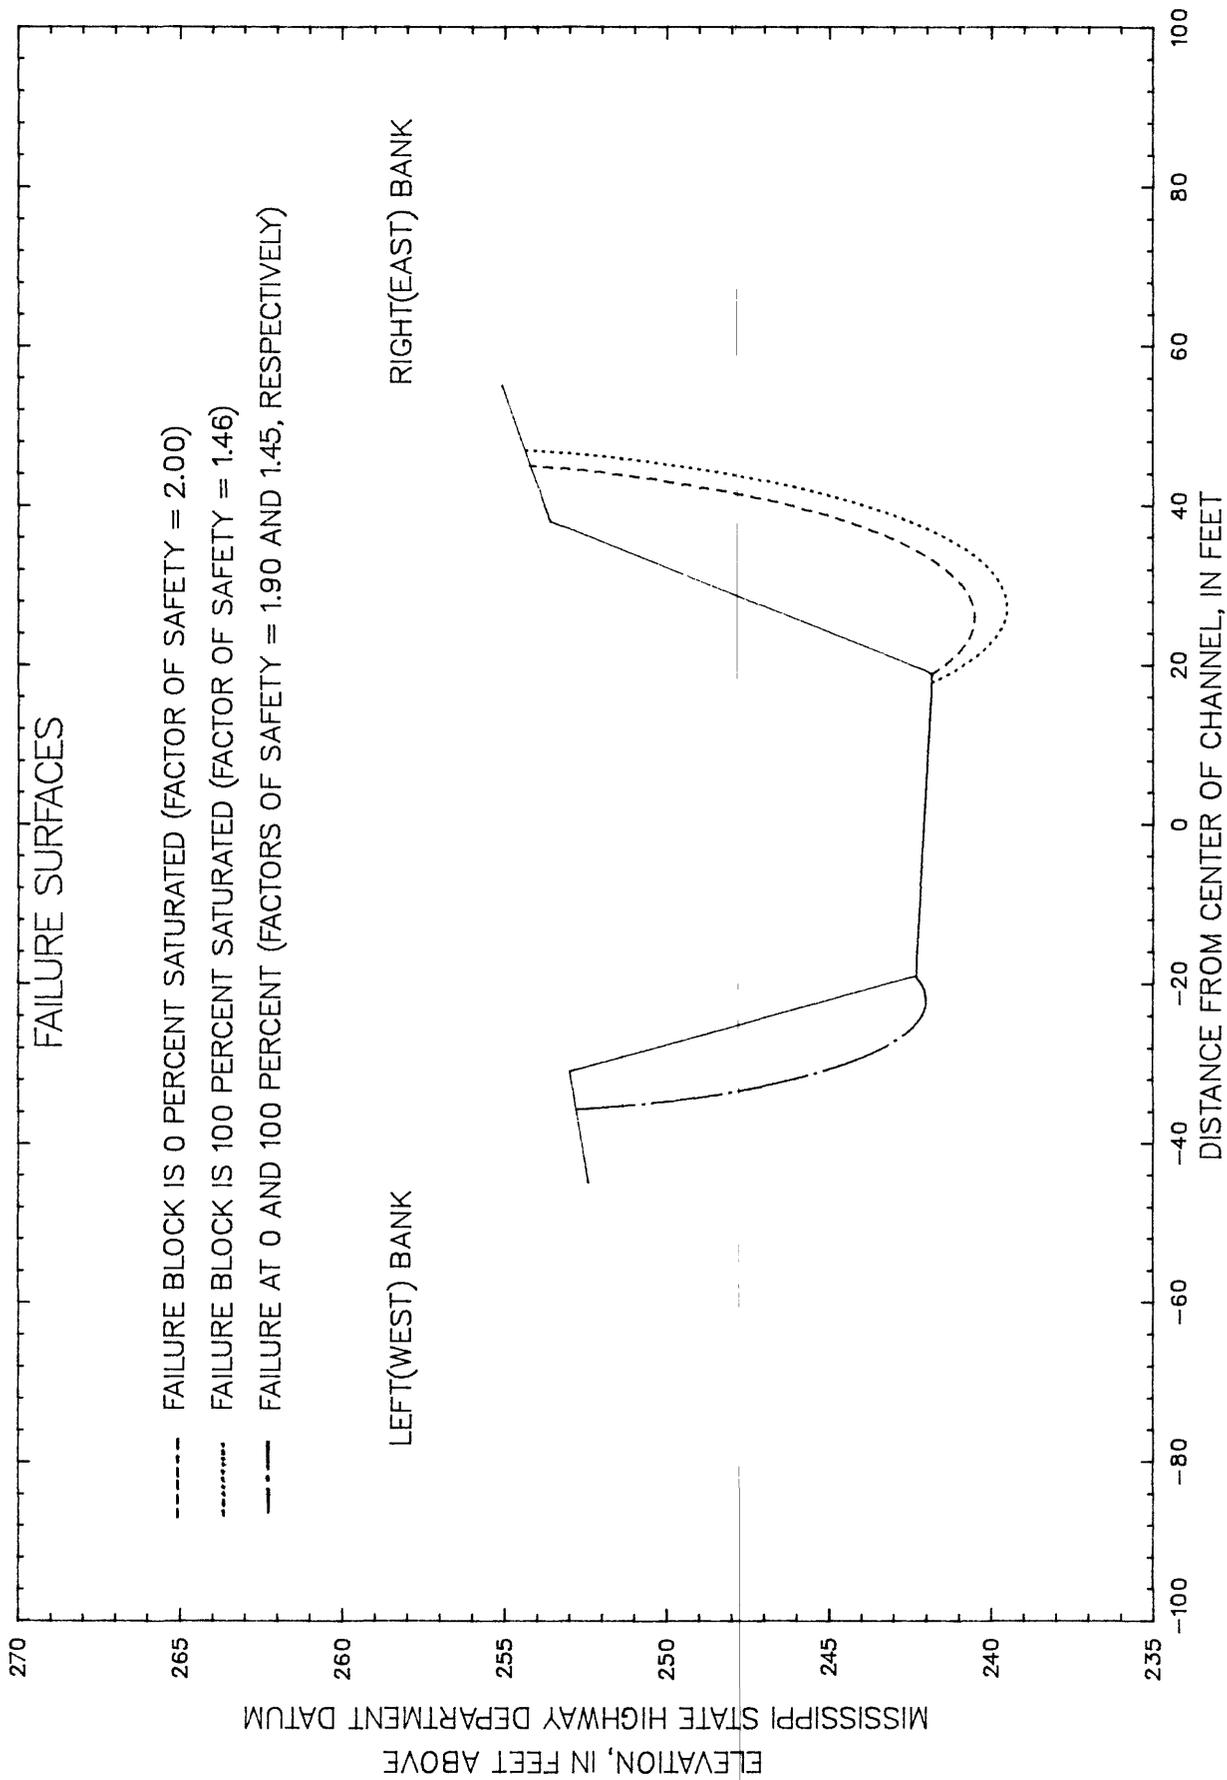
The critical rotational-failure surfaces for 0- and 100-percent bank saturation for the channel cross sections surveyed in 1988 are shown in figures 5, 6, and 7. Failure-block widths on the right and left banks at the upstream cross section are about 4 and 7 ft, respectively (fig. 5); widths on the right and left banks downstream are about 9 and 5 ft, respectively (fig. 7). The average failure-block width of about 6 ft agreed reasonably well with the average width of about 7 ft observed in the field. For the cross section located at the bridge (fig. 6), the critical failure surface intersects the ground at and below top of bank. This is probably because of the added weight of the riprap reinforcement in the upper part of the bank.

Figure 7.--Cross section showing critical failure surfaces for channel banks on Standing Pine Creek 100 feet downstream from State Highway 488 near Freeny, 1988.

In 1991, field observations of the channel reach between 100 ft downstream and 100 ft upstream from the bridge indicated some minor failures of riprap in the lower part of the banks at the bridge where the underlying geotextile lining is exposed. In 1991, the scour hole extended through the bridge. Average bed elevation was about 2, 3, and 1 ft lower than the 1988 bed elevation at the cross section located 100 ft downstream, at the bridge, and 100 ft upstream, respectively. Factors of safety were recomputed by lowering the bed at each cross section. Minimum factors of safety for 100-percent bank saturation were computed to be 1.18 at 100 ft downstream, 1.18 at the bridge, and 1.48 at 100 ft upstream from the bridge. The factors of safety were lowered by using lower channel-bed elevations, but there were no significant differences in failure surfaces shown in figures 5, 6, and 7.

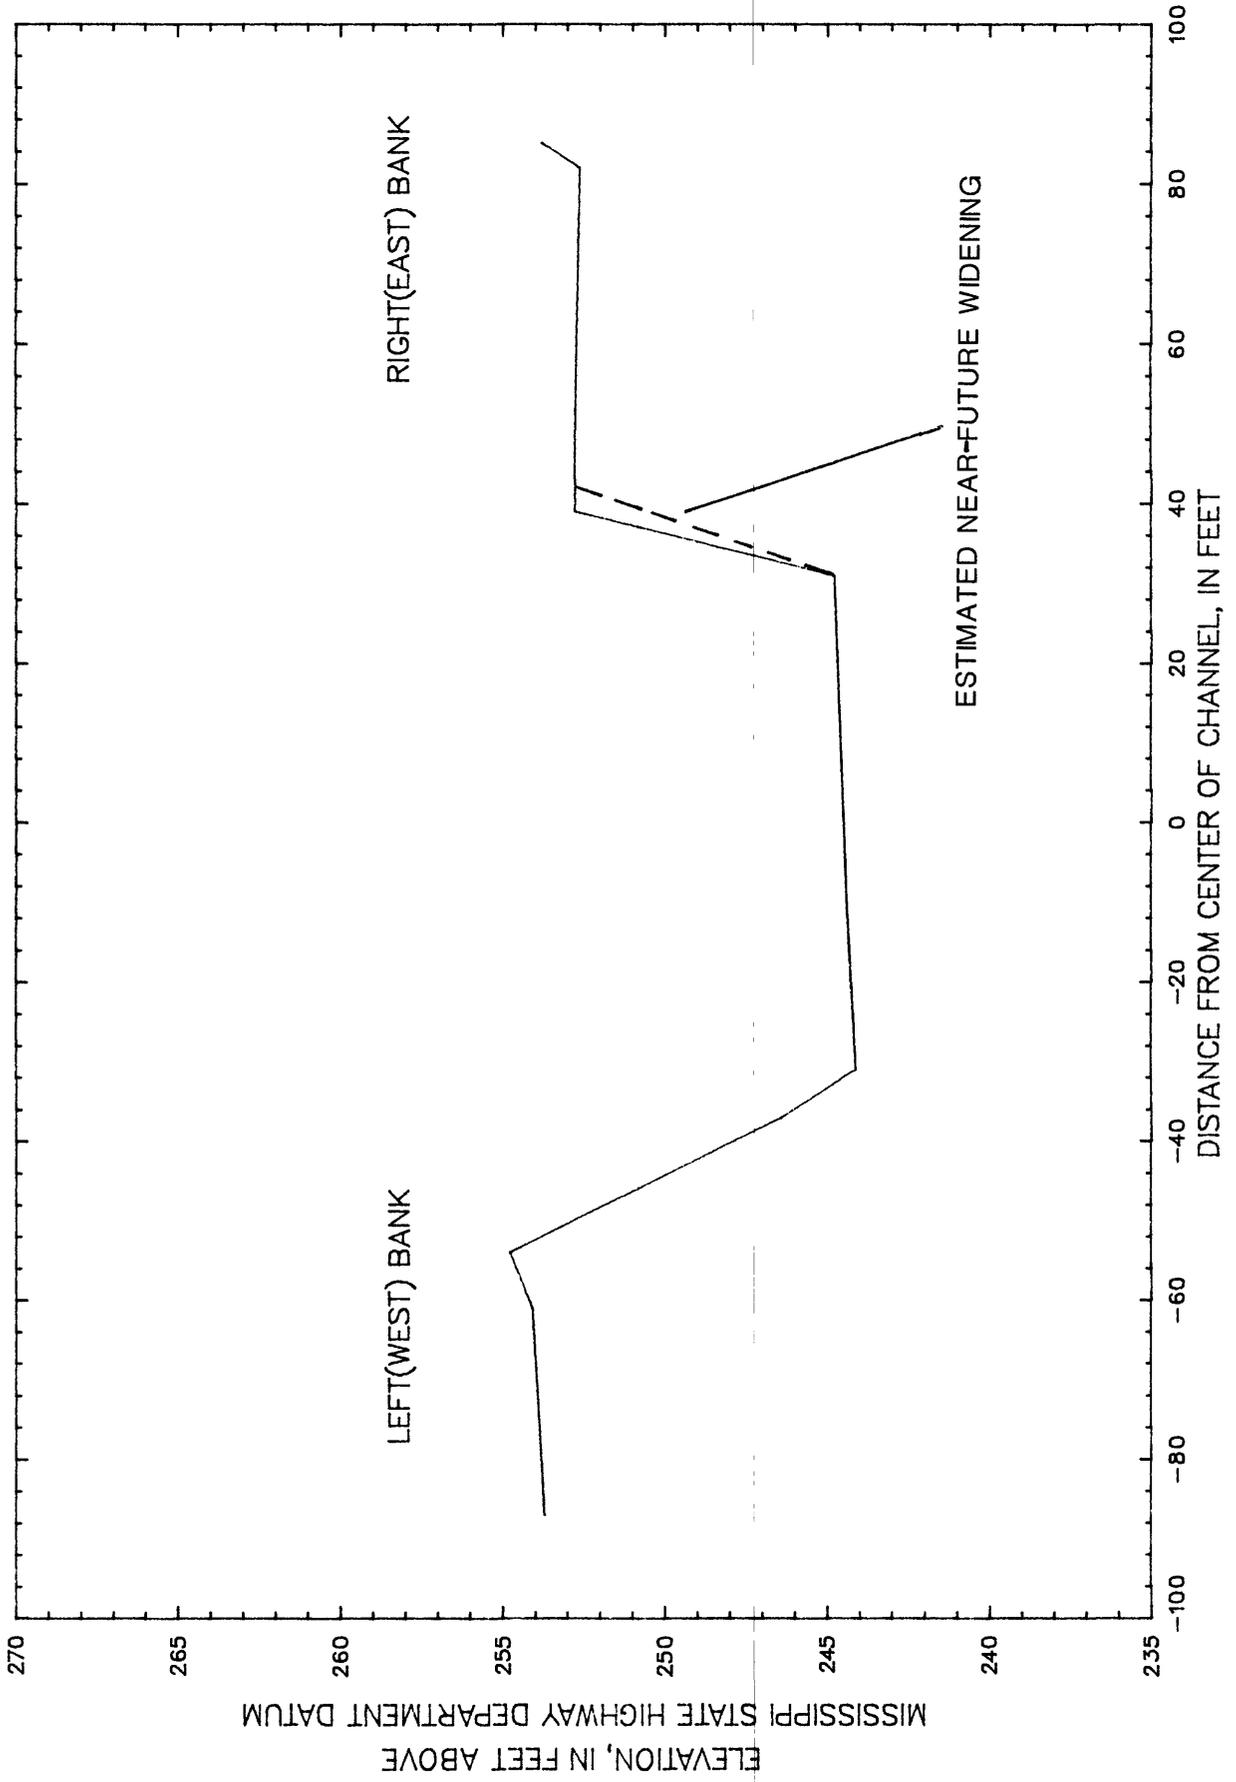
Estimates of near-future (10 to 20 years) channel widening can be obtained at many sites by projecting the streambank slough-line angle on a plotted cross section (Simon and Hupp, 1986b). Extension of the slough line was not used for the State Highway 488 crossing, however, because slough lines at the site are not well established. A temporary angle of stability was estimated for each bank in each available cross section by averaging the existing bank angle and the angle of internal friction of the bank material, a technique developed by Spangler and Handy (1973). Estimates of near-future channel widening were made by extending the temporary angle of stability (figs. 8, 9). This indicates that the bankfull channel width could increase about 3 ft at the cross section located about 100 ft upstream of the crossing and about 5 to 10 ft at the cross section located 100 ft downstream of the crossing. Widening analysis at the bridge was omitted because of the riprap reinforcement of the banks. Channel-widening processes in the past are assumed to be representative of those in the near future. This assumption could be negated by additional channel modifications or the

Figure 8.--Cross section showing estimates of near-future channel widening for Standing Pine Creek 100 feet upstream from State Highway 488 near Freeny, 1988.

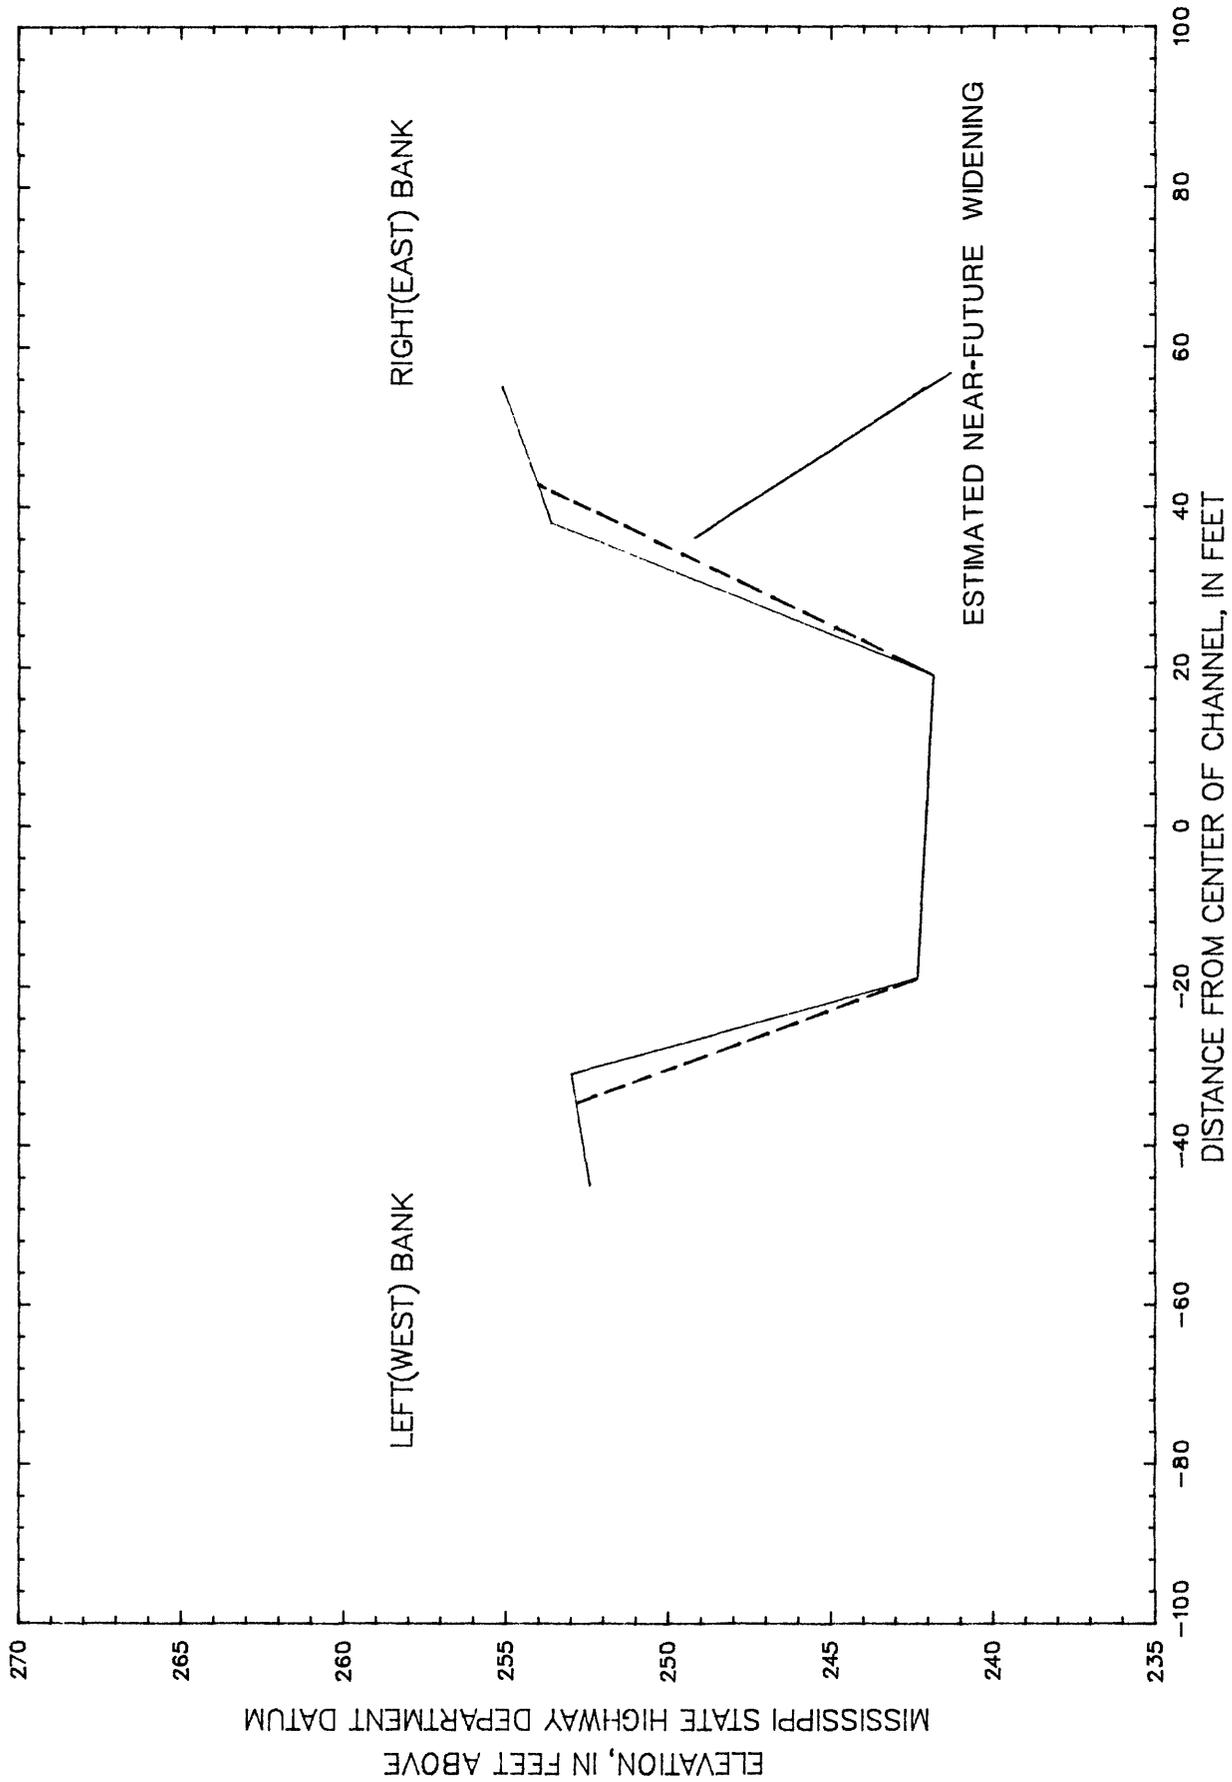
Figure 9.--Cross section showing estimates of near-future channel widening for Standing Pine Creek 100 feet downstream from State Highway 488 near Freeny, 1988.
