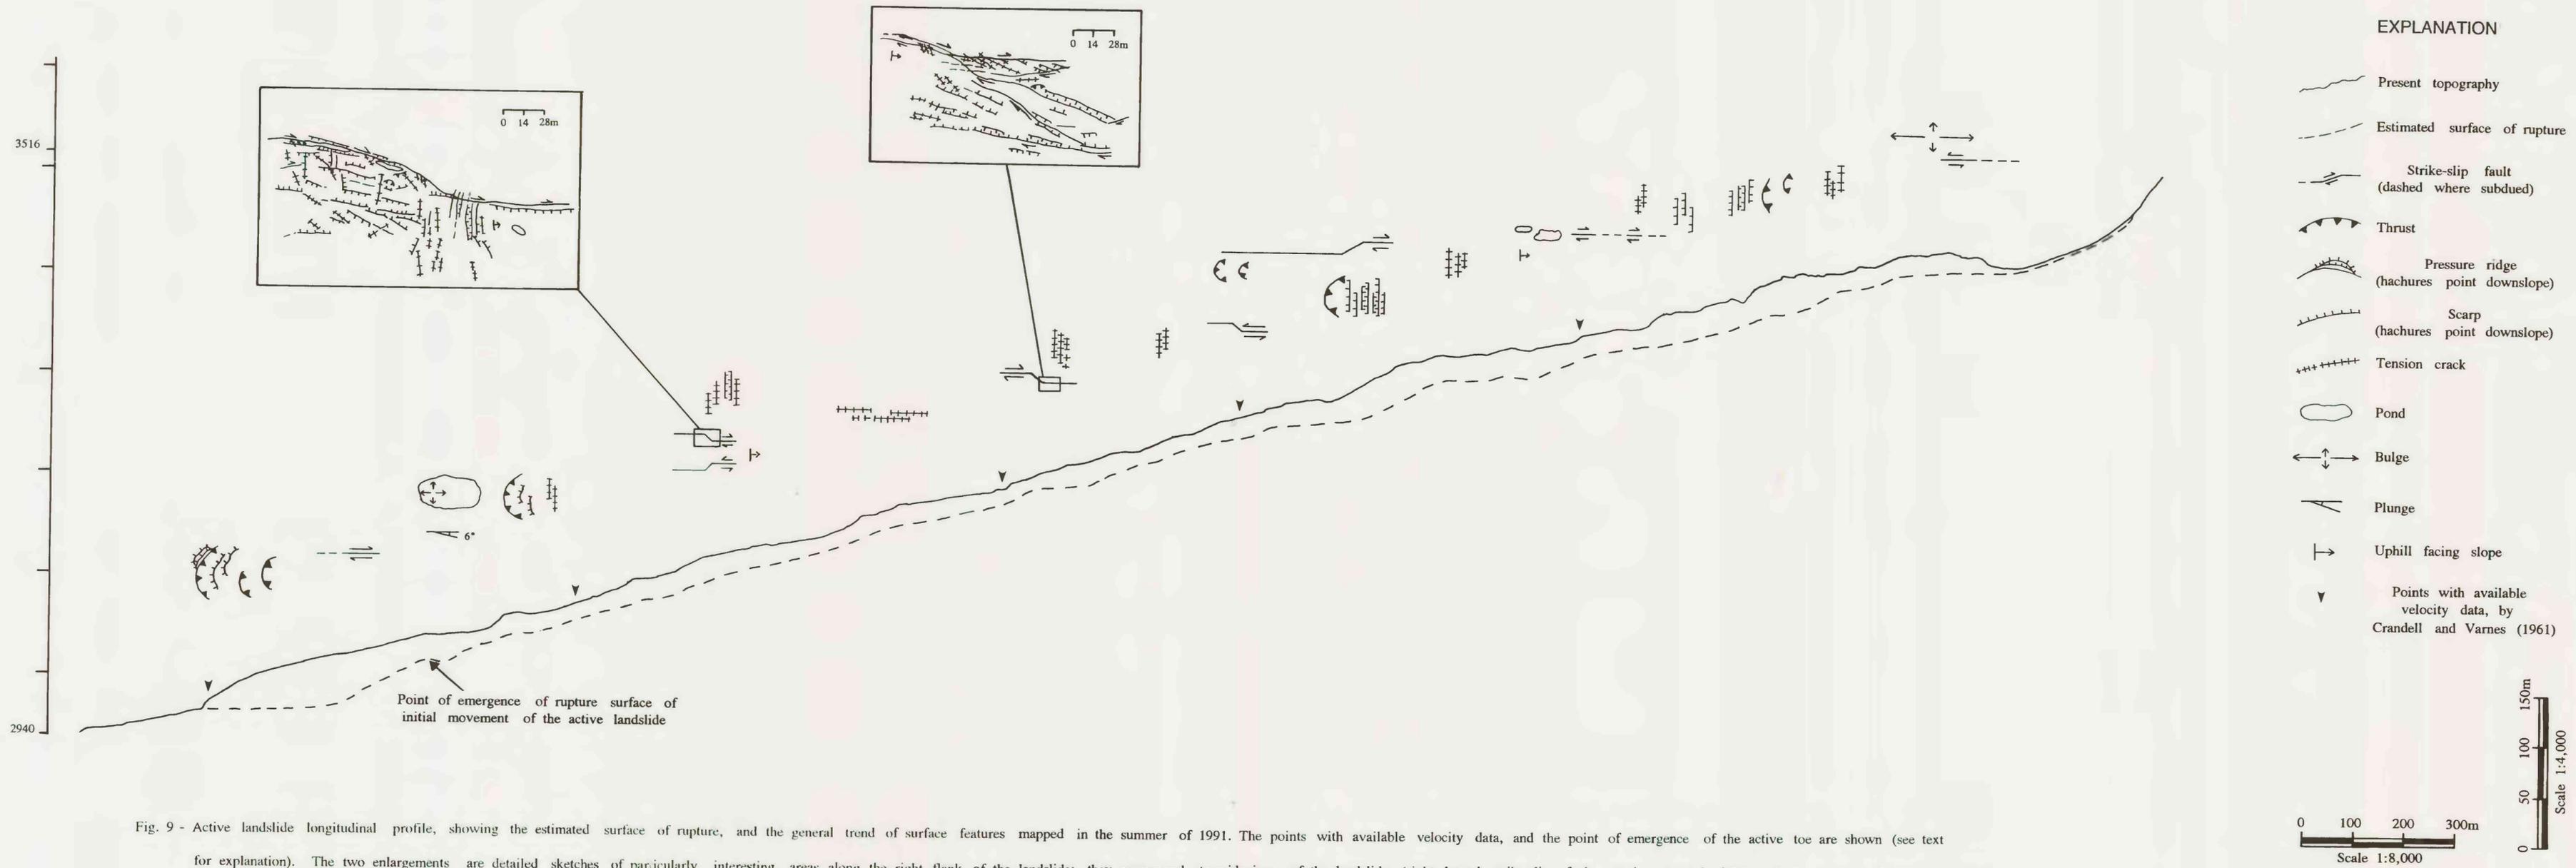
Fig. 9 - Active landslide longitudinal profile, showing the estimated surface of rupture, and the general trend of surface features mapped in the summer of 1991. The points with available velocity data, and the point of emergence of the active toe are shown (see text for explanation). The two enlargements are detailed sketches of particularly interesting areas along the right flank of the landslide; they correspond to widenings of the landslide (right lateral strike-slip fault stepping toward right) and show mostly features usually associated to areas of dilation (Guzzi and Parise, 1991).
