U.S. DEPARTMENT OF THE INTERIOR

U.S. GEOLOGICAL SURVEY

Surface features and kinematics of the
Slumgullion landslide, near Lake City, Colorado

Open-File Report 92-252

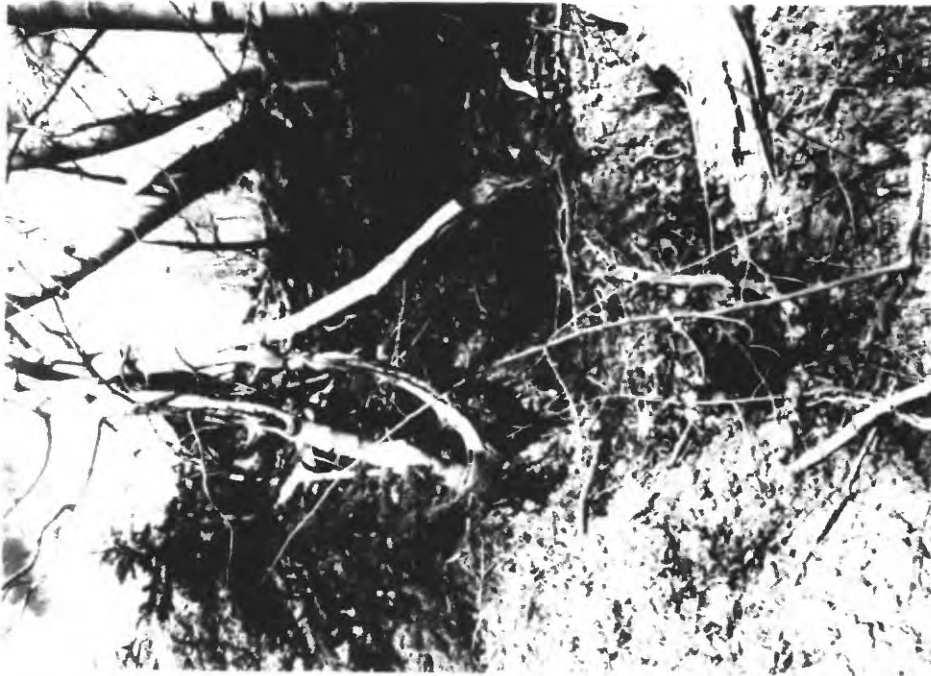
Figure 4 - Examples of split trees on the north side of the toe area of the active landslide: a) tree split into four parts, along a complex fault having opening and right-lateral strike-slip motion. Overall opening is 1.8 m, right-lateral displacement is 0.5 m. b) aspen tree split along a tension crack; opening is 0.7 m. For photo location, see fig. 3.

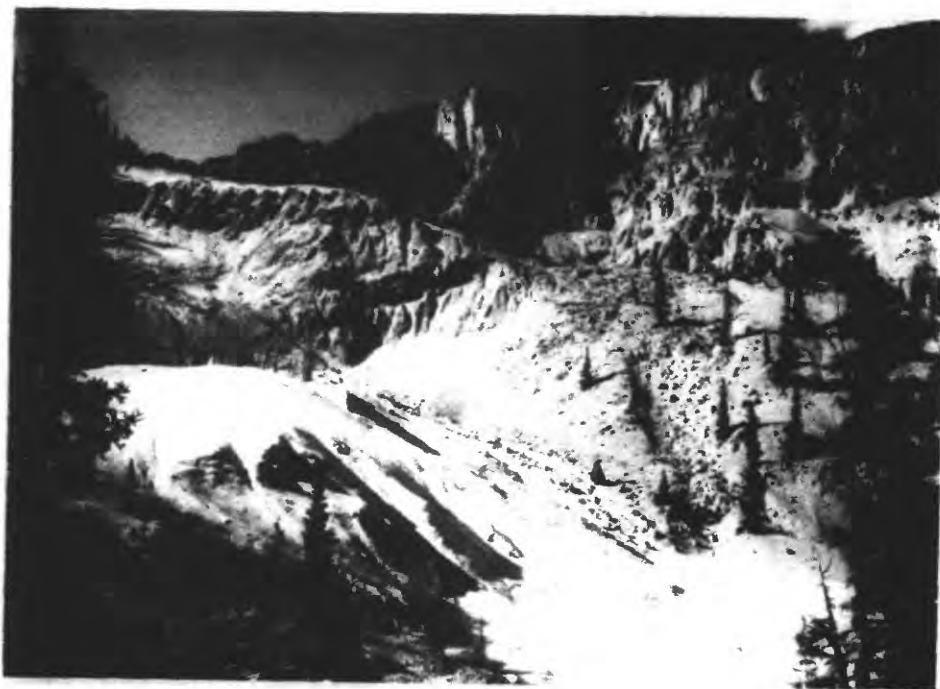
Figure 5 - View of the west part of the headscarp area. Note the abundance of yellow (light-colored) clay-rich material in the lower part of the scarp and the well developed badlands formed in landslide deposit in the foreground. For photo location, see fig. 3.

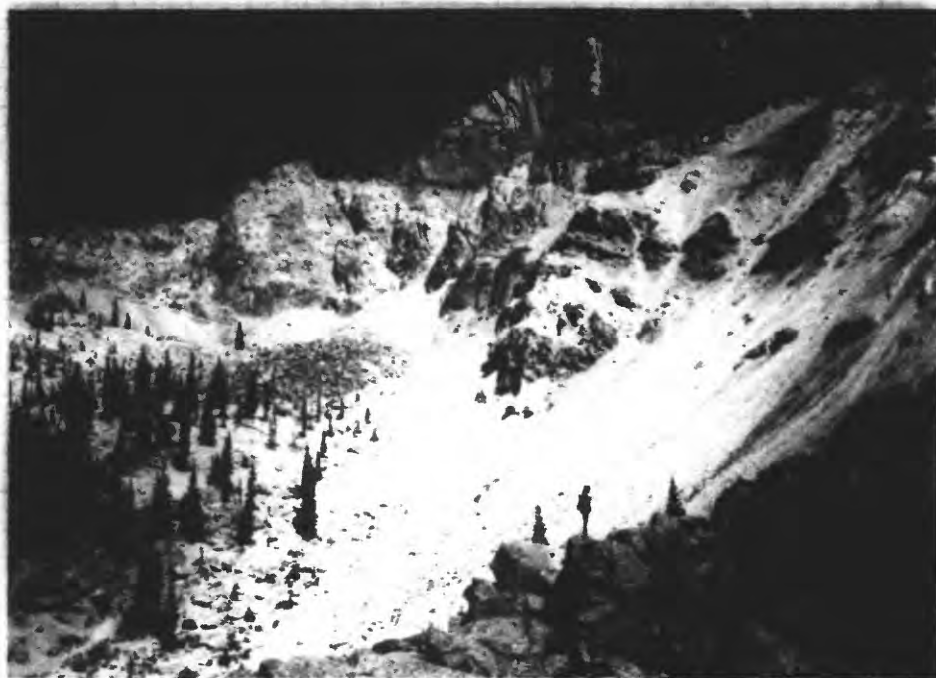
Figure 8 - View of the western part of the source area, showing some of the talus accumulations at the base of the scarp. Coarser materials are concentrated in the lower part forming a bulge. The person on the boulder in the foreground gives the scale. For photo location, see fig. 3.

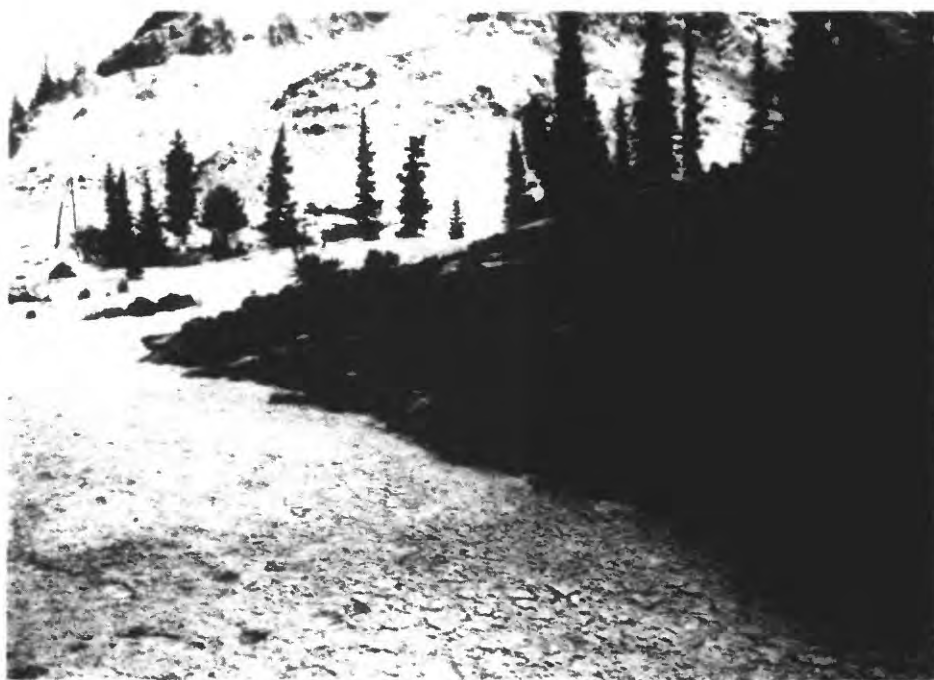
Figure 9 - Partially buried tongue of rock debris adjacent to a lacustrine deposit of clayey material in the head regions of the inactive landslide. For photo location, see fig. 3.

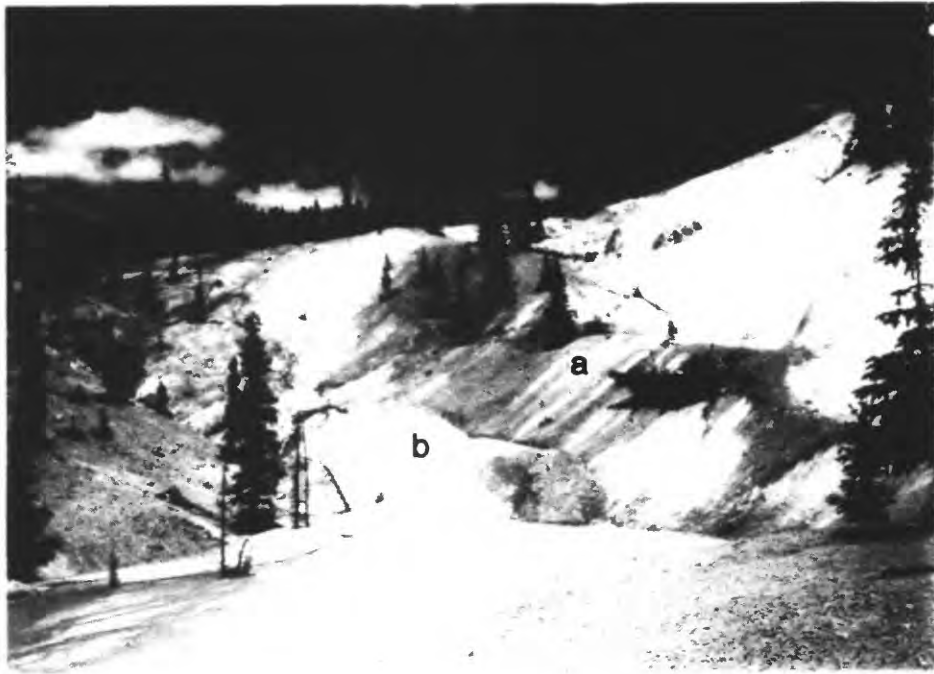
Figure 10 - Flank ridges on older, inactive landslide formed in the yellow clay-rich landslide deposit. The boundary of the inactive landslide is out of view about 50 m to the right side of the photograph. The boundary of the active landslide is a few meters out of view to the left of the photograph. Note the difference in the height of the two flank ridges visible in this view. The larger ridge (a), on the right side may correlate with the initial failure 700 years ago, and the younger ridge (b) may record a separate episode of movement between initial failure and the currently active part of the Slumgullion landslide. For photo location, see fig. 3.

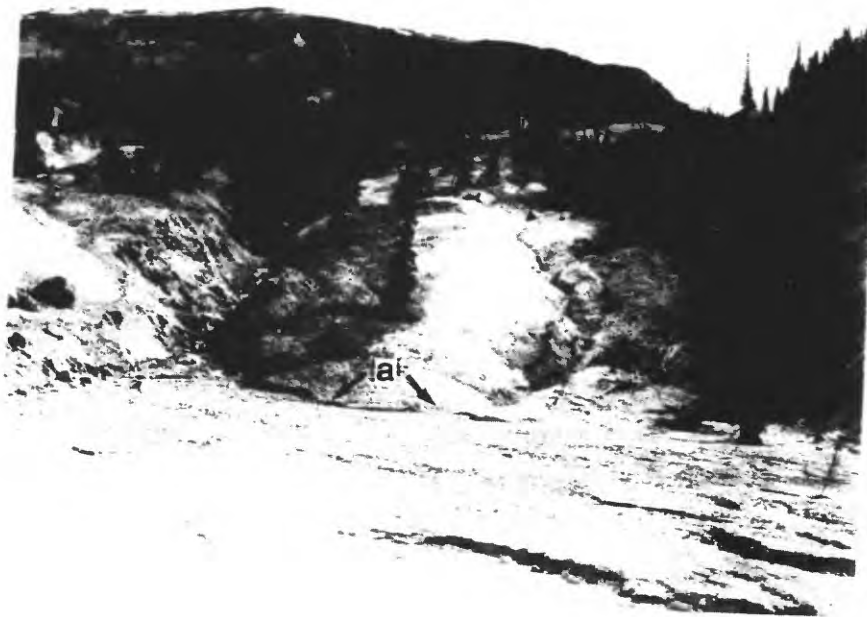
Figure 12 - View of small thrust fault (a) at edge on a dry pond, looking upstream along the left flank. The thrust fault is about 15 m wide and does not present a steep scarp in its frontal part. For photo location, see fig. 3.

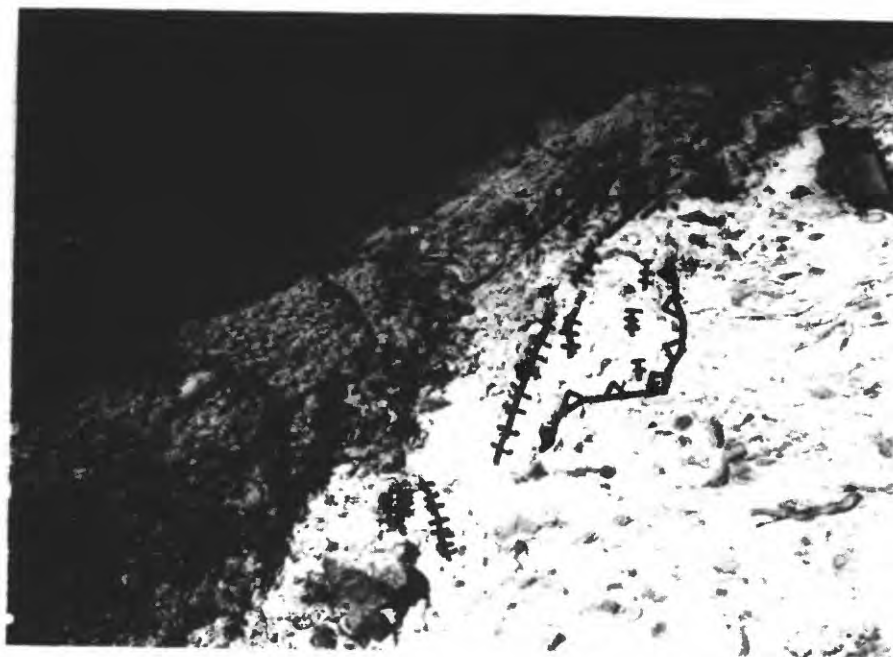
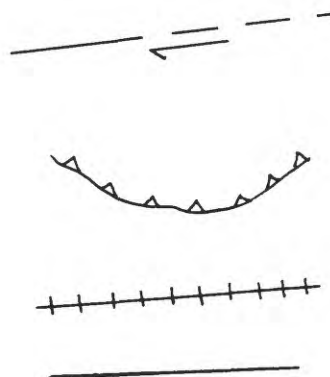
At Slumgullion, the strike-slip faults form cracks from 0.05 to 0.3 m wide and few tens of centimeters deep. The faults are typically bounded by a zone of disturbed material with average width of 0.5 m (fig. 13). The strike-slip faults may be accompanied along their length by scarps ranging in height from a few centimeters to meters. Features characteristic of strike-slip faults elsewhere, including fault segments (Segall and Pollard, 1980; Deng and others, 1986; Sylvester, 1988), steps with associated compressional or extensional structures (Freund, 1974; Aydin and Nur, 1982; Mann and others, 1983), en echelon tension cracks (Freund, 1974; Segall and Pollard, 1980; Pollard and others, 1982; Deng and others, 1986; Sylvester, 1988), and en echelon folds (Fleming and Johnson, 1989) are also present at the Slumgullion landslide.

Figure 13 - Detail of the fault zone on the left flank of the landslide. The trace of the left-lateral strike-slip fault and the associated set of en echelon cracks are highlighted. In the middle of the photograph, the ground is broken by en echelon tension cracks, and the course of the strike-slip fault is not clearly defined. The field board, on the upper right corner of the photograph, is about 1 meter in height. For photo location, see fig. 3.

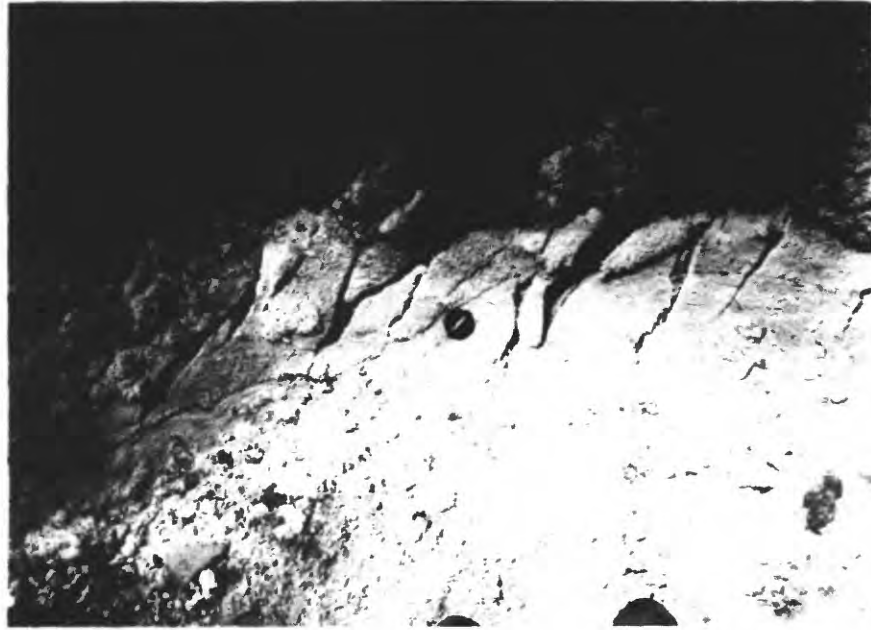
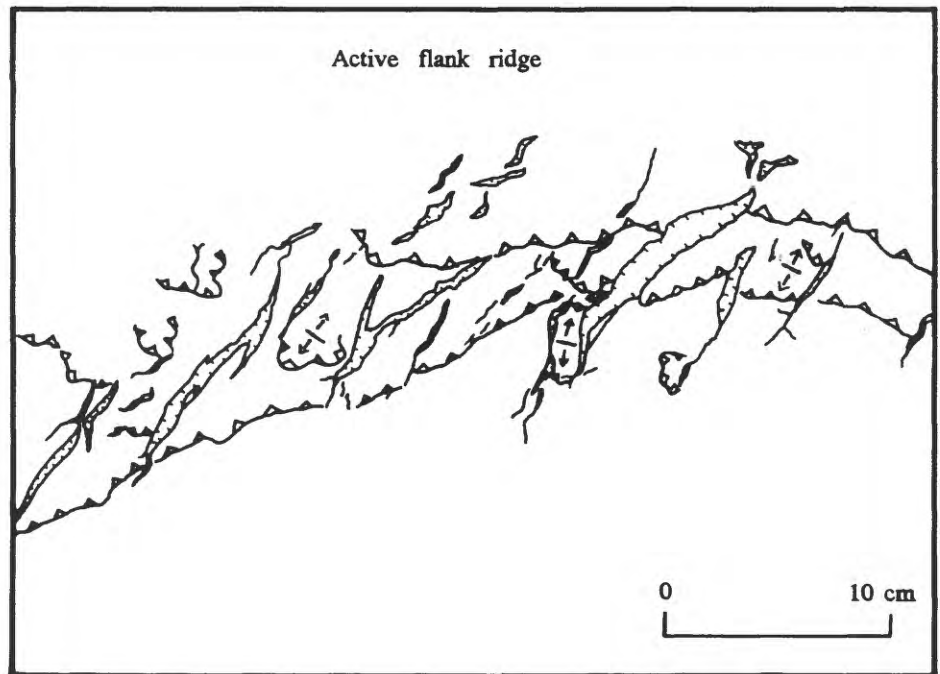
Figure 14 shows an example of the association of tension cracks, thrust faults and folds within the left-lateral strike-slip fault zone that bounds the left flank, at station 2,800 m. En echelon tension cracks are oriented with angles from 35° to 55° counterclockwise from the main shear surface (parallel to the long side of the photograph). The cracks are as much as 6 cm wide near midlength; maximum length is about 40 cm. Some of the cracks bifurcate at their terminations. Folds and thrust faults show two different trends. Folds are at right angles to tension cracks, while thrust faults make an angle of about 50° with the en echelon cracks, i.e. about 25° counterclockwise from the strike-slip fault.

Figure 14 - Association of en echelon tension cracks, folds and thrust faults in the vicinity of the left-lateral strike-slip fault bounding the left flank of the active landslide. Fig. 14b is a sketch made from the photograph. The course of the strike-slip fault is parallel to the long side of the photograph; the dark material at the top of the photograph is part of the active flank ridge being formed. Lens cap is 5.2 cm in diameter. For photo location, see fig. 3.

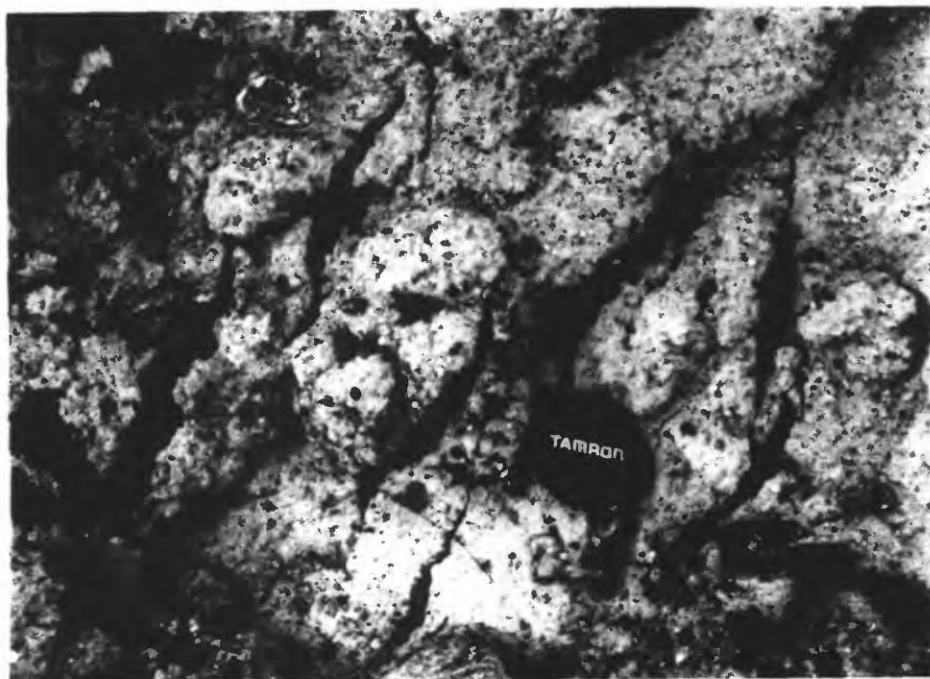
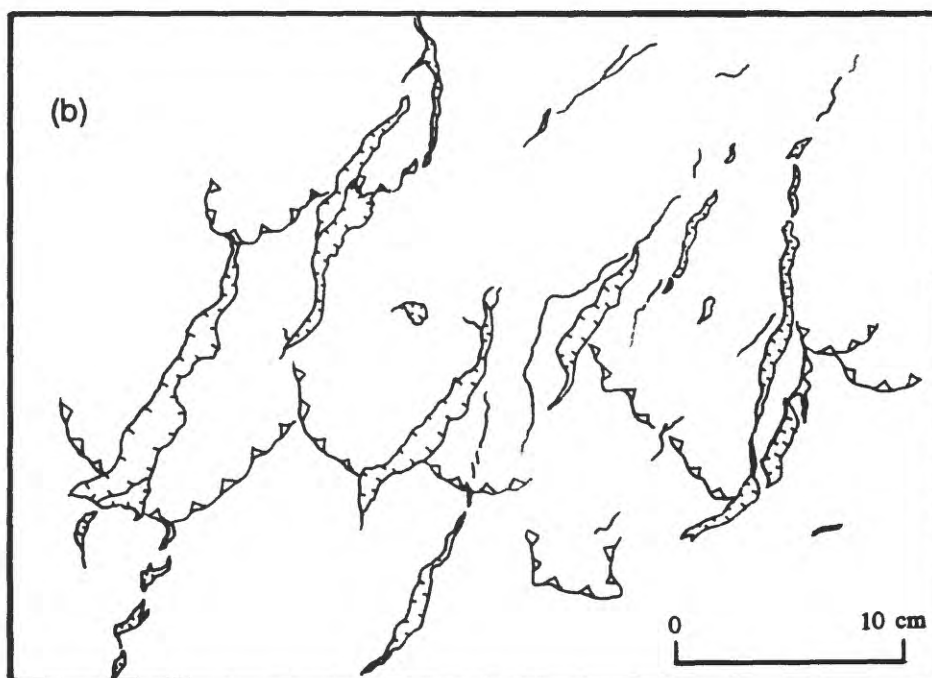
Another example of the association between en echelon cracks and thrust faults in the vicinity of a left-lateral strike-slip fault within the landslide, at station 2,000 m, is shown in figure 15.

Figure 15 - En echelon tension cracks and thrust faults associated with a left-lateral strike-slip fault on the left flank of the active landslide. The course of the strike-slip fault is parallel to the long side of the photograph. Fig. 15b is a sketch made from the photograph. The cracks present both simple and sigmoidal shapes, with maximum width occurring at their midlength, and with length several times greater than the width. Lens cap is 5.2 cm in diameter. Thrust faults are generally at right angles to the cracks. For photo location, see fig. 3.

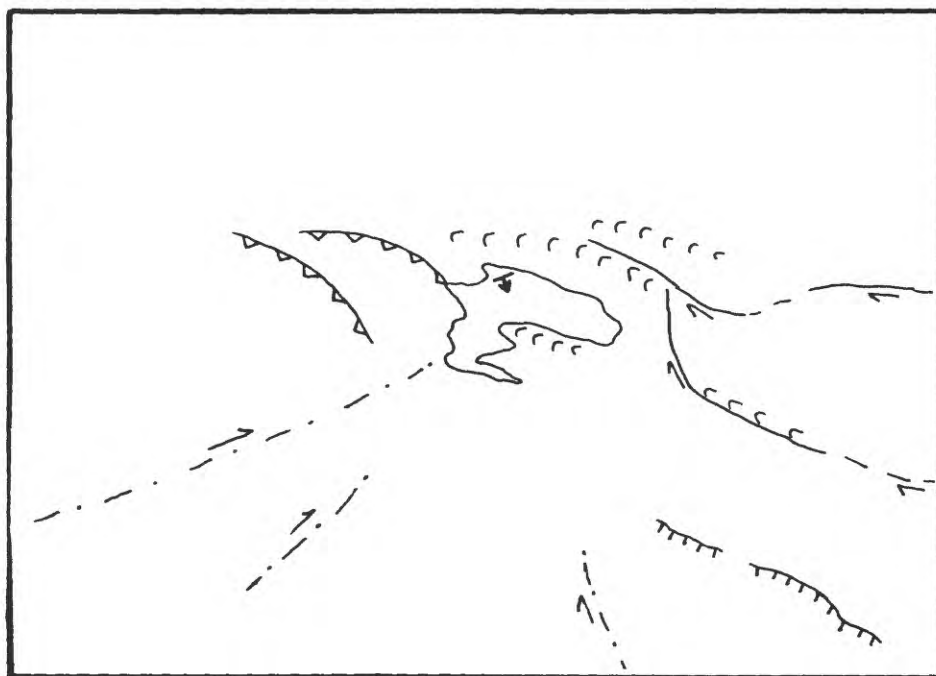
Figure 16 - a) Downhill view of basin on the right flank caused by right bend in strike-slip fault. b) Sketch of features visible on the photograph. The basin is being filled by material entering the basin through a complex system of right-lateral strike-slip faults and thrust faults. For photo location, see fig. 3.

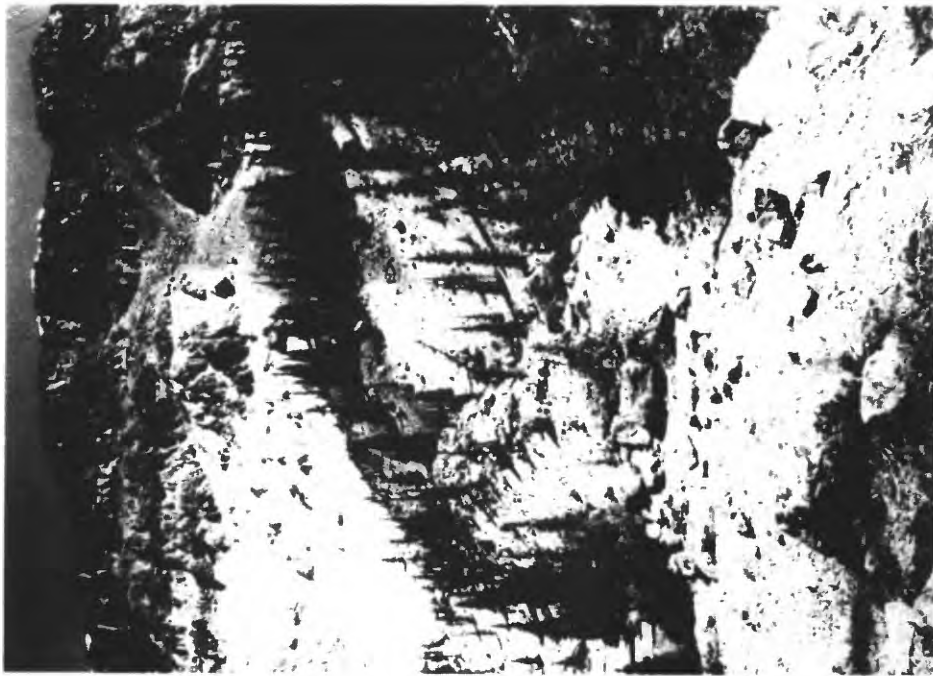
Fig. 18 - Upper part of the left flank of the active landslide: a) looking uphill; b) looking downhill. The prominent flank ridge extends from the distal part of the largest rock-debris apron present in the source area. A pond has formed outside the flank ridge where it curves to the right. Note the concentration of coarser material and boulders at the top of the ridge. Farther downslope, such coarse material is much less common. For photo location, see fig. 3.

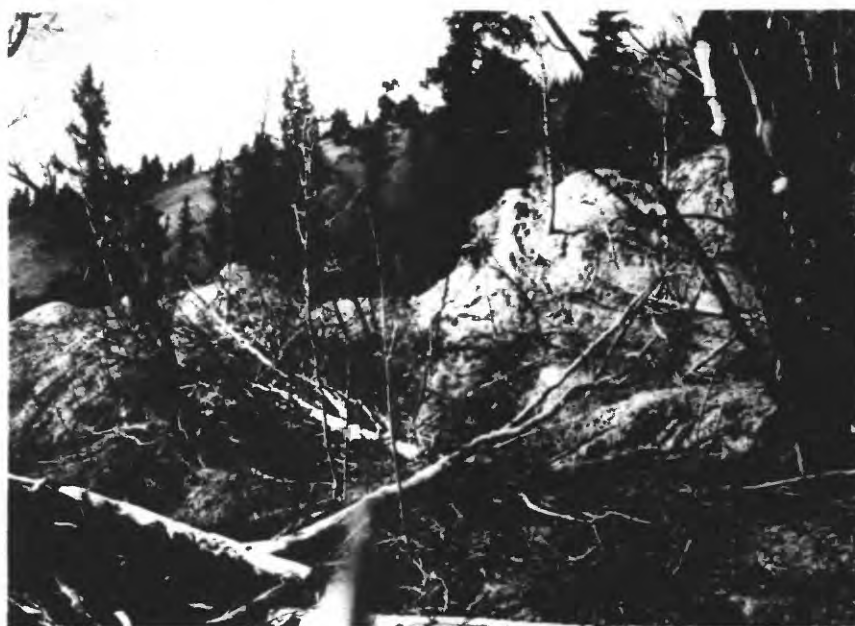
Fig. 20 - View of flank ridge on the right side of the active landslide that is broken by normal faults and tension cracks, which trend about normal to the trend of the ridge. Person on the left side of the photograph gives scale. For photo location, see fig. 3.

normal faults and tension cracks, oriented at right angles with it (fig. 20). The normal faults form a series of small grabens, as much as 7 m wide and 3 m deep. These normal faults and tension cracks accomodate stretching of the flank ridge and indicate an increase in displacement rate here.

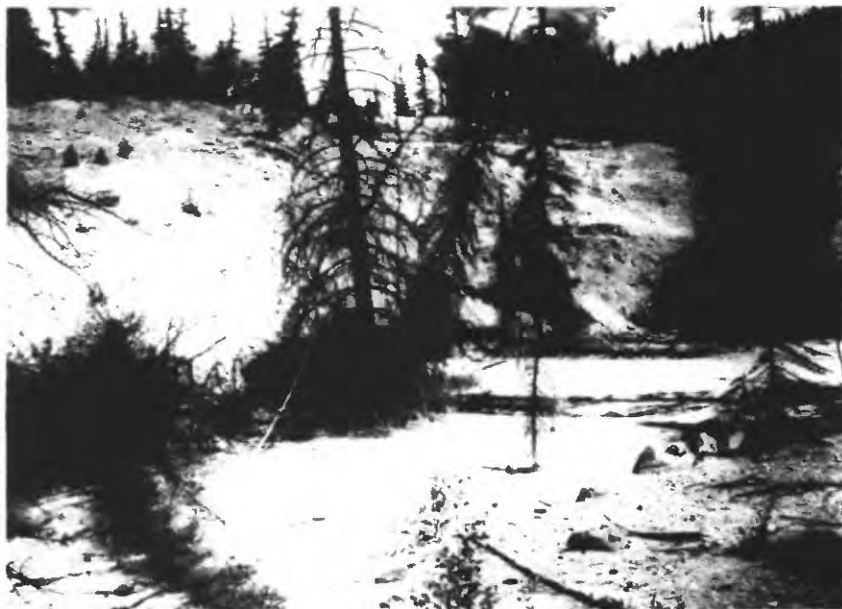
Figure 23 - View of the active toe, which here is about 7 m high. The non-moving ground is in the foreground. Trees at left have been overrun by the toe. The trees in the middle of the view have been killed by partial burial by sediment washed from the actively moving part. For photo location, see fig. 3.

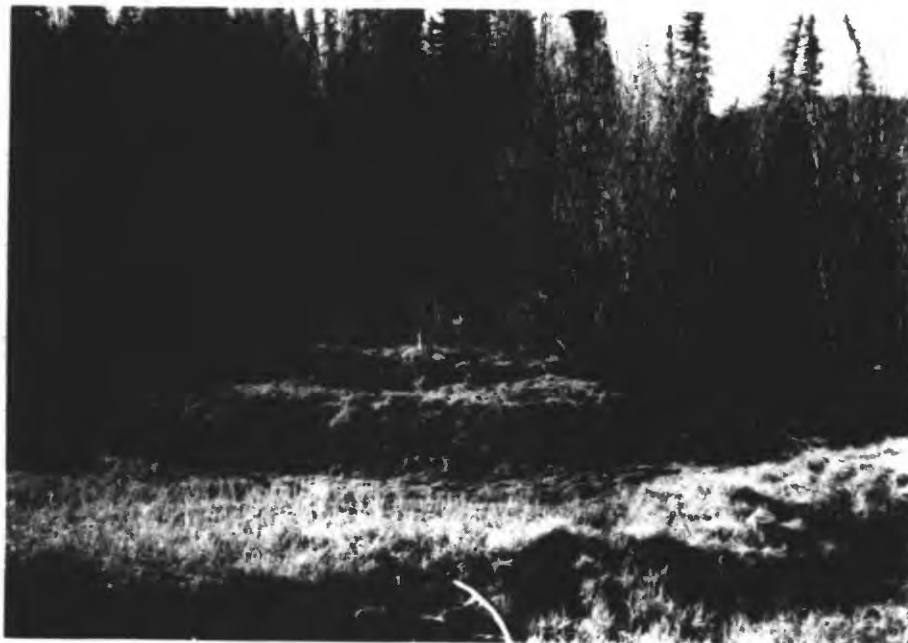
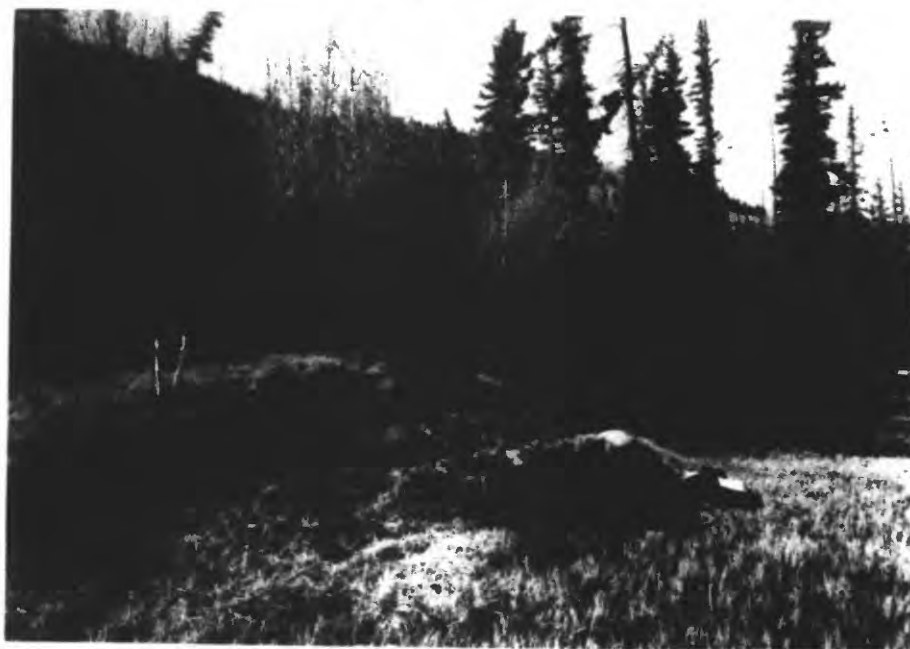
Fig. 24 - Pressure ridges in marshy areas adjacent to the northwestern edge of the active toe: a) frontal view; b) lateral view. The steps are up to 1.2 m high, and broken by transverse cracks up to 0.8 m wide. For photo location, see fig. 3.

0.3 m to 1.2 m. The material is very soft and soaked with water; also ponds have formed in the area in front of the pressure ridges. Each step seems to push the one in front of it and in such a way to overthrust it. There are several tension cracks transverse to the steps, with width from 0 to 0.8 m, and variable orientation.
