**CHANNEL AND BANK STABILITY OF BAKERS CREEK
AT STATE HIGHWAY 547 NEAR PORT GIBSON,
CLAIBORNE COUNTY, MISSISSIPPI**

**U.S. GEOLOGICAL SURVEY
Open-File Report 92-636**

By D. Phil Turnipseed and W. Trent Baldwin

Jackson, Mississippi
1992

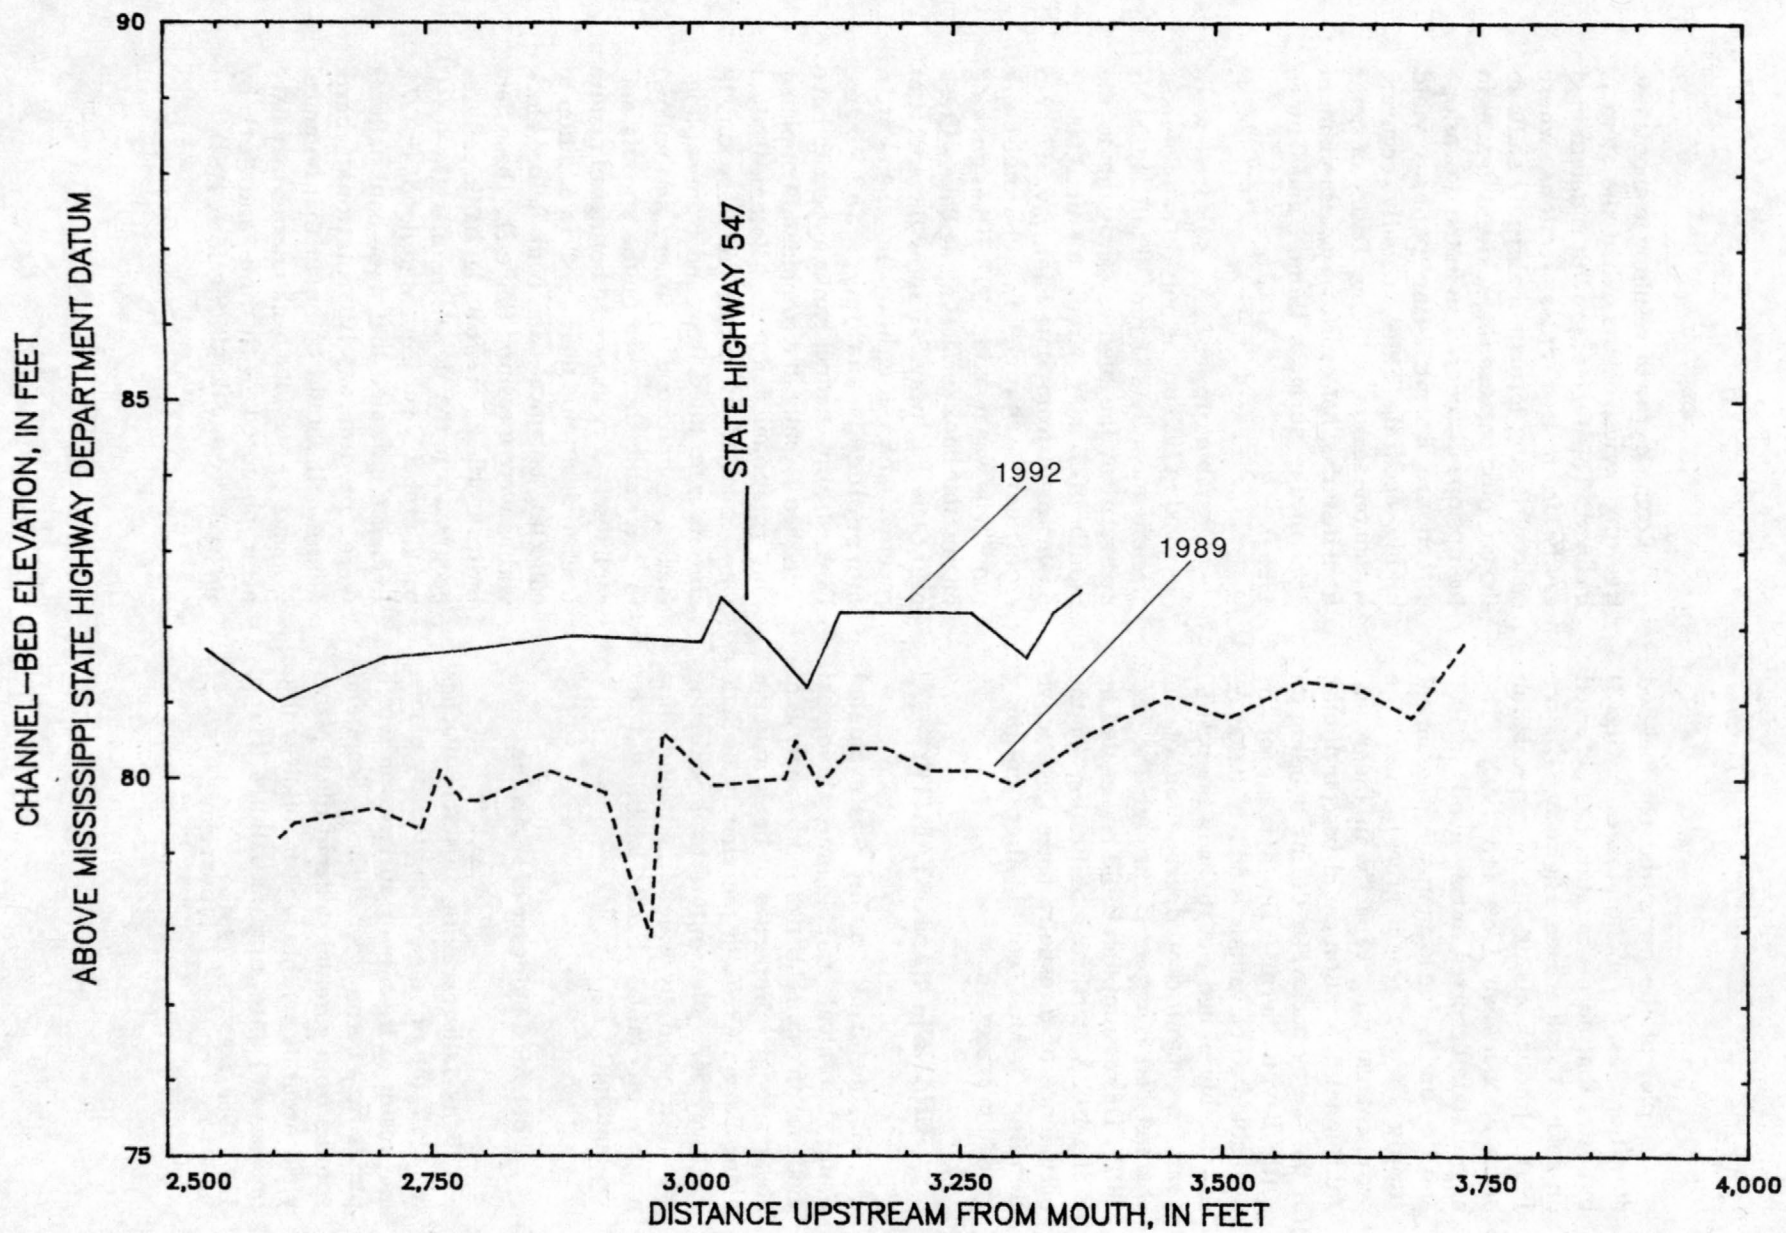
Figure 2.—Channel-bed profiles in 1989 and 1992 for Bakers Creek in the vicinity of State Highway 547 near Port Gibson.

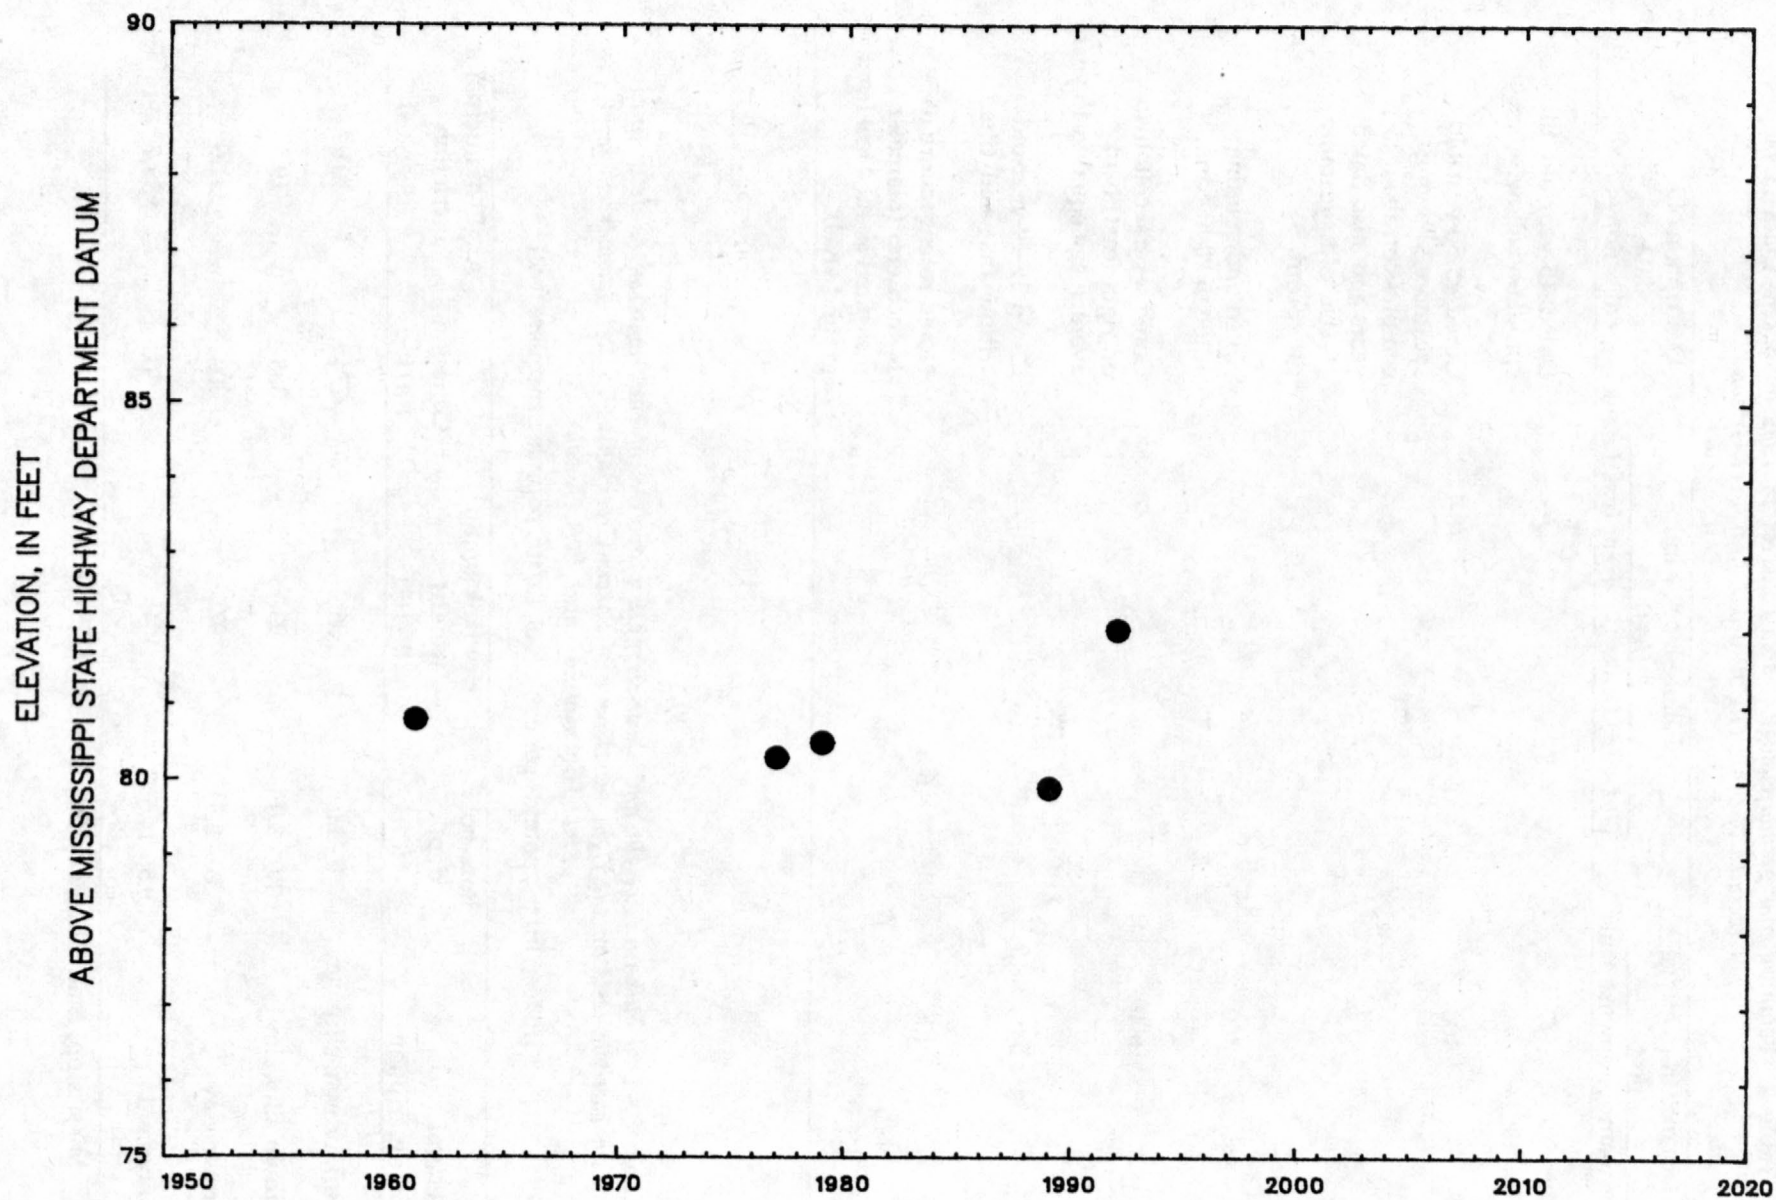
A plot of the measured channel-bed elevations as a function of time (fig. 3) indicates that no degradation has occurred on Bakers Creek at State Highway 547 since 1961, although about 2 ft of aggradation occurred between 1989 and 1992. The aggradation occurred during floods in 1990 and 1991 and is due to an upstream sediment supply to the reach greater than the sediment carrying capacity in the reach. Additional deposition could be contributed at the site by backwater during flooding on Little Bayou Pierre. The average of the available bed elevations is 80.7 ft. Based on the stability of bed elevations in the past 30 years, no significant degradation of the channel bed is expected through the year 2010. This assumption could be negated by channel or watershed modifications or the occurrence of unusually large destructive flooding, which could alter on-going gradation processes.

Figure 3.—Measured channel-bed elevations for Bakers Creek at State Highway 547 near Port Gibson, 1961-92.

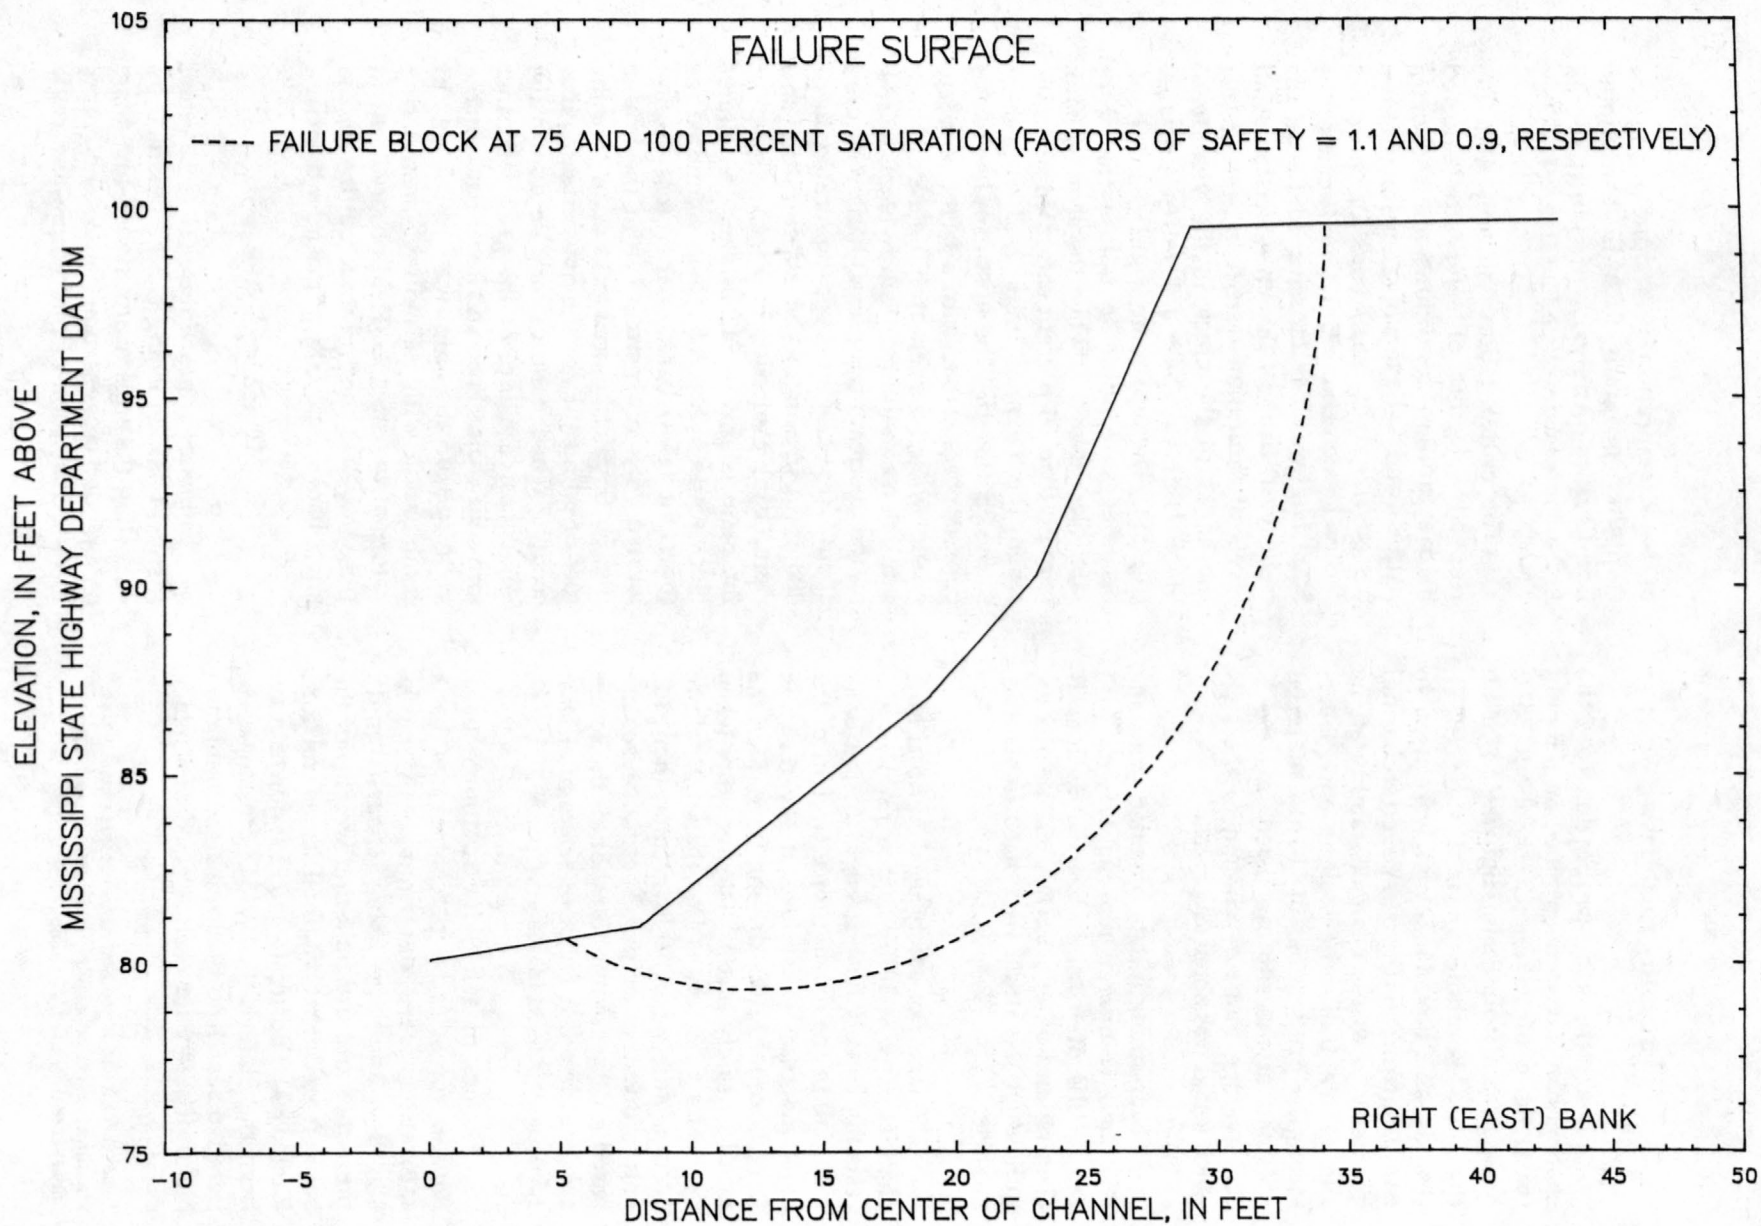
The critical-failure surfaces with the respective factors of safety for selected bank-saturation conditions are shown in figures 4 and 5. Factors of safety ranged from 0.6 on the right (east) bank of the cross section located about 75 ft downstream of the State Highway 547 crossing to 1.8 on the right (east) bank of this cross section at all levels of saturation tested, indicating that the banks of the creek in the vicinity of State Highway 547 are fairly unstable (fig. 5). The upstream right (east) bank becomes susceptible to failure (factor of safety less than 1.5) when the channel bank is more than 50 percent saturated and fails when the channel bank is 100 percent saturated (fig. 4). The upstream left (west) bank appears stable, with a factor of safety greater than 1.5 even at 100-percent bank-saturation conditions. Failure-block widths on the upstream right (east) bank measured about 7 ft near a cross section located about 200 ft upstream of the sheet piling and riprap bank protection in place upstream of the State Highway 547 bridge. A failure-block width of about 5 ft was computed for the right (east) bank of the cross section located 75 ft downstream from the bridge (fig. 5). Smaller failure blocks occur near the toes of both banks of the downstream cross section. These failures may be due to the non-cohesive nature of the gray sand that forms the channel bed and lower banks in the vicinity of the highway crossing in combination with the natural meandering nature of the stream. Field observations in 1989 and 1992 confirm undercutting on the lower banks, especially at meander bends.

Figure 4.—Bank profile showing critical failure surfaces for the right (east) bank of Bakers Creek, 300 feet upstream from State Highway 547 near Port Gibson, 1989.

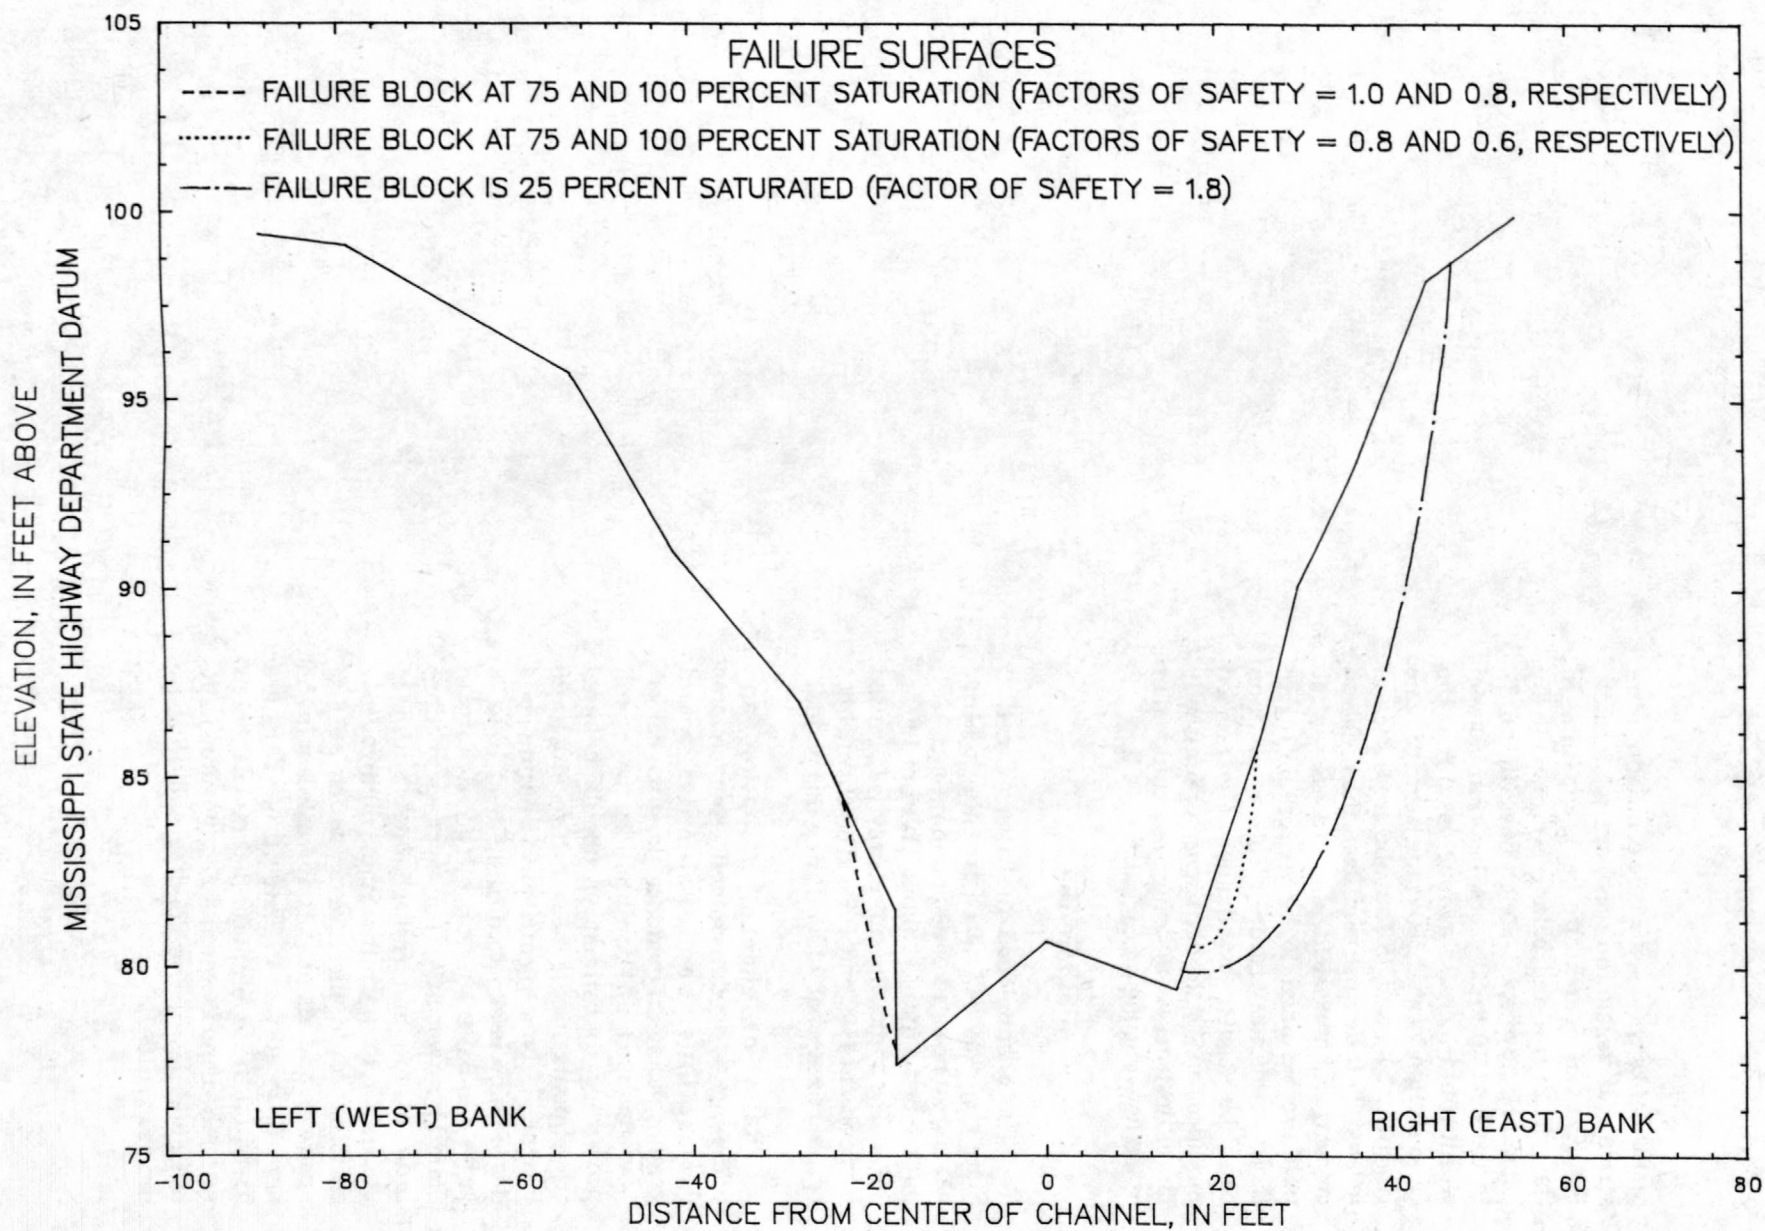
Figure 5.—Cross section showing critical failure surfaces for channel banks on Bakers Creek, 75 feet downstream from State Highway 547 near Port Gibson, 1989.

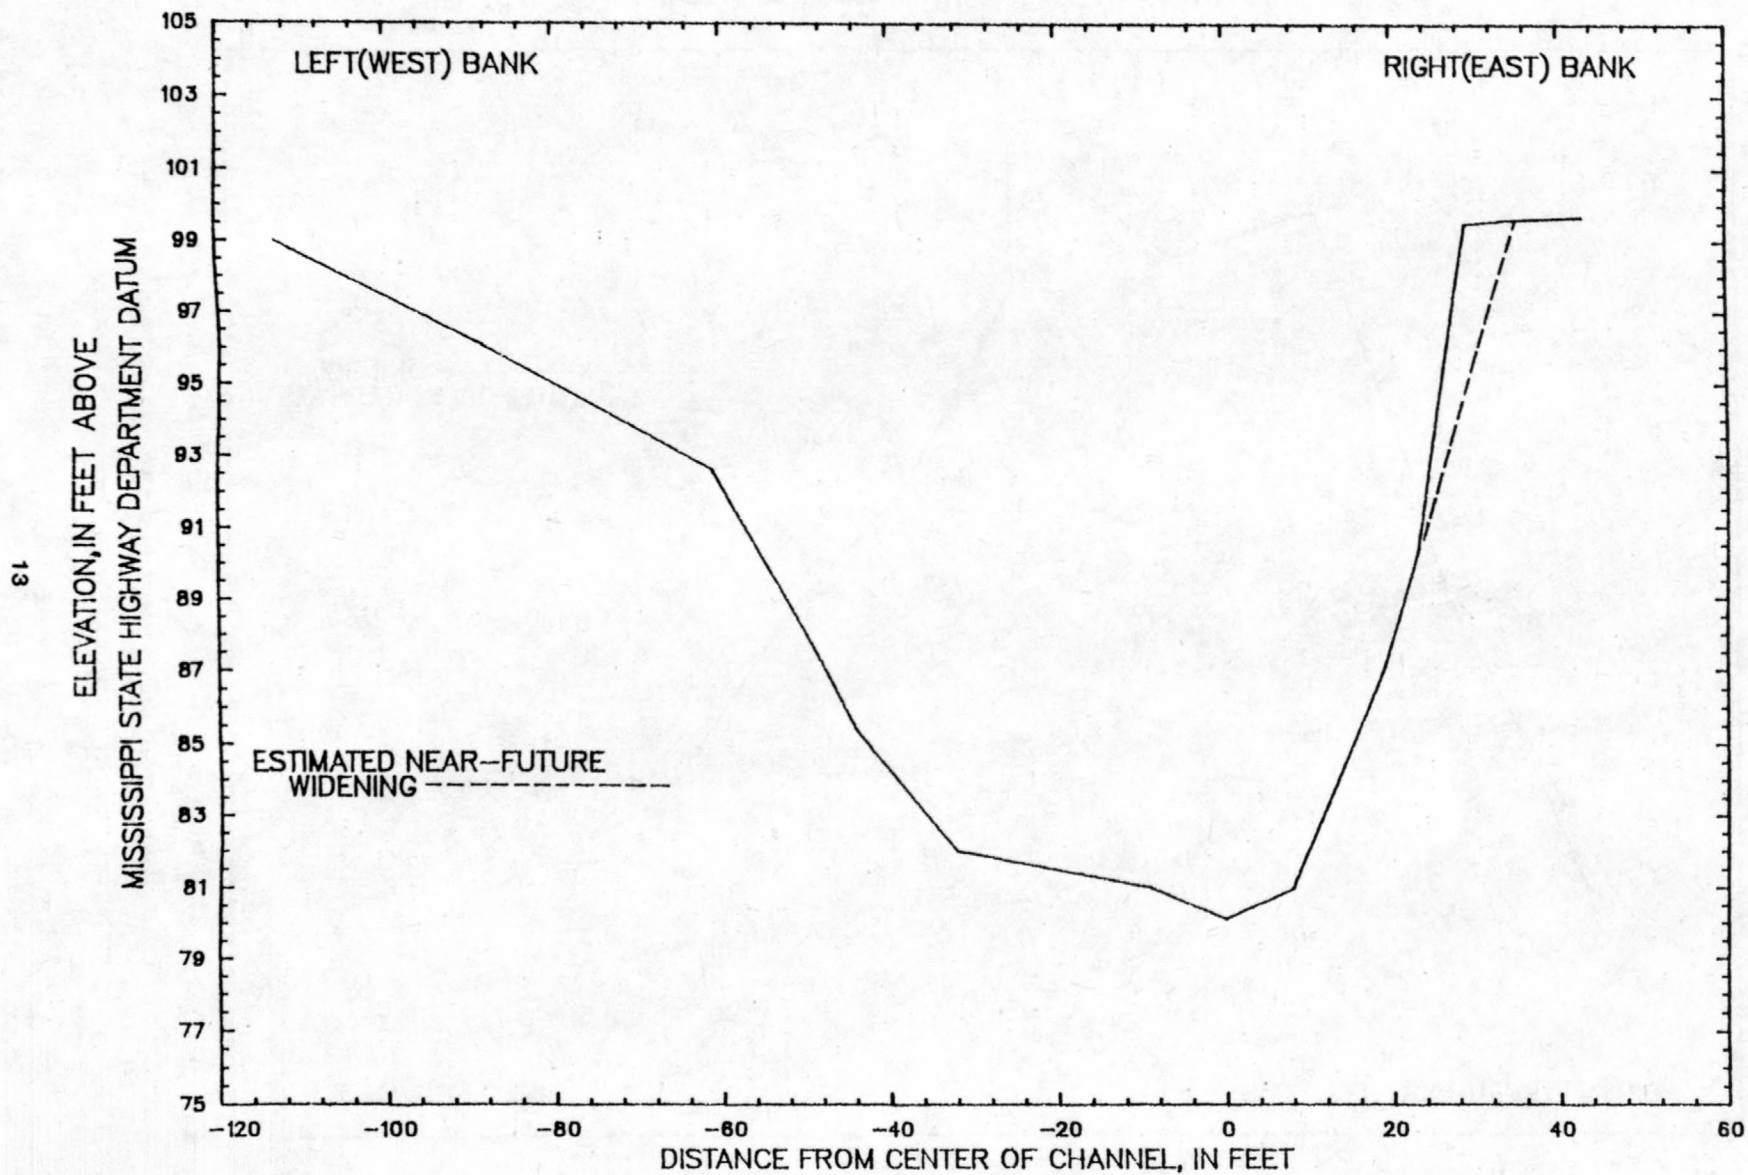
on the banks was used where conditions were stable and vegetation was well established. Estimates of near-future bank widening in the vicinity of the bridge were made by extending developed slough lines (figs. 6, 7). In the next 10 to 20 years, bankfull channel width could increase as much as 8 ft at the cross section located 300 ft upstream of State Highway 547, and 15 ft at the cross section located 75 ft downstream from the highway crossing. Channel-widening processes in the past are assumed to be representative of those in the near future. This assumption could be negated by channel or watershed modifications or the occurrence of unusually large, destructive flooding that could alter on-going widening processes.

Figure 6.--Channel cross section showing estimate of near-future widening for Bakers Creek, 300 feet upstream from State Highway 547 near Port Gibson, 1989.

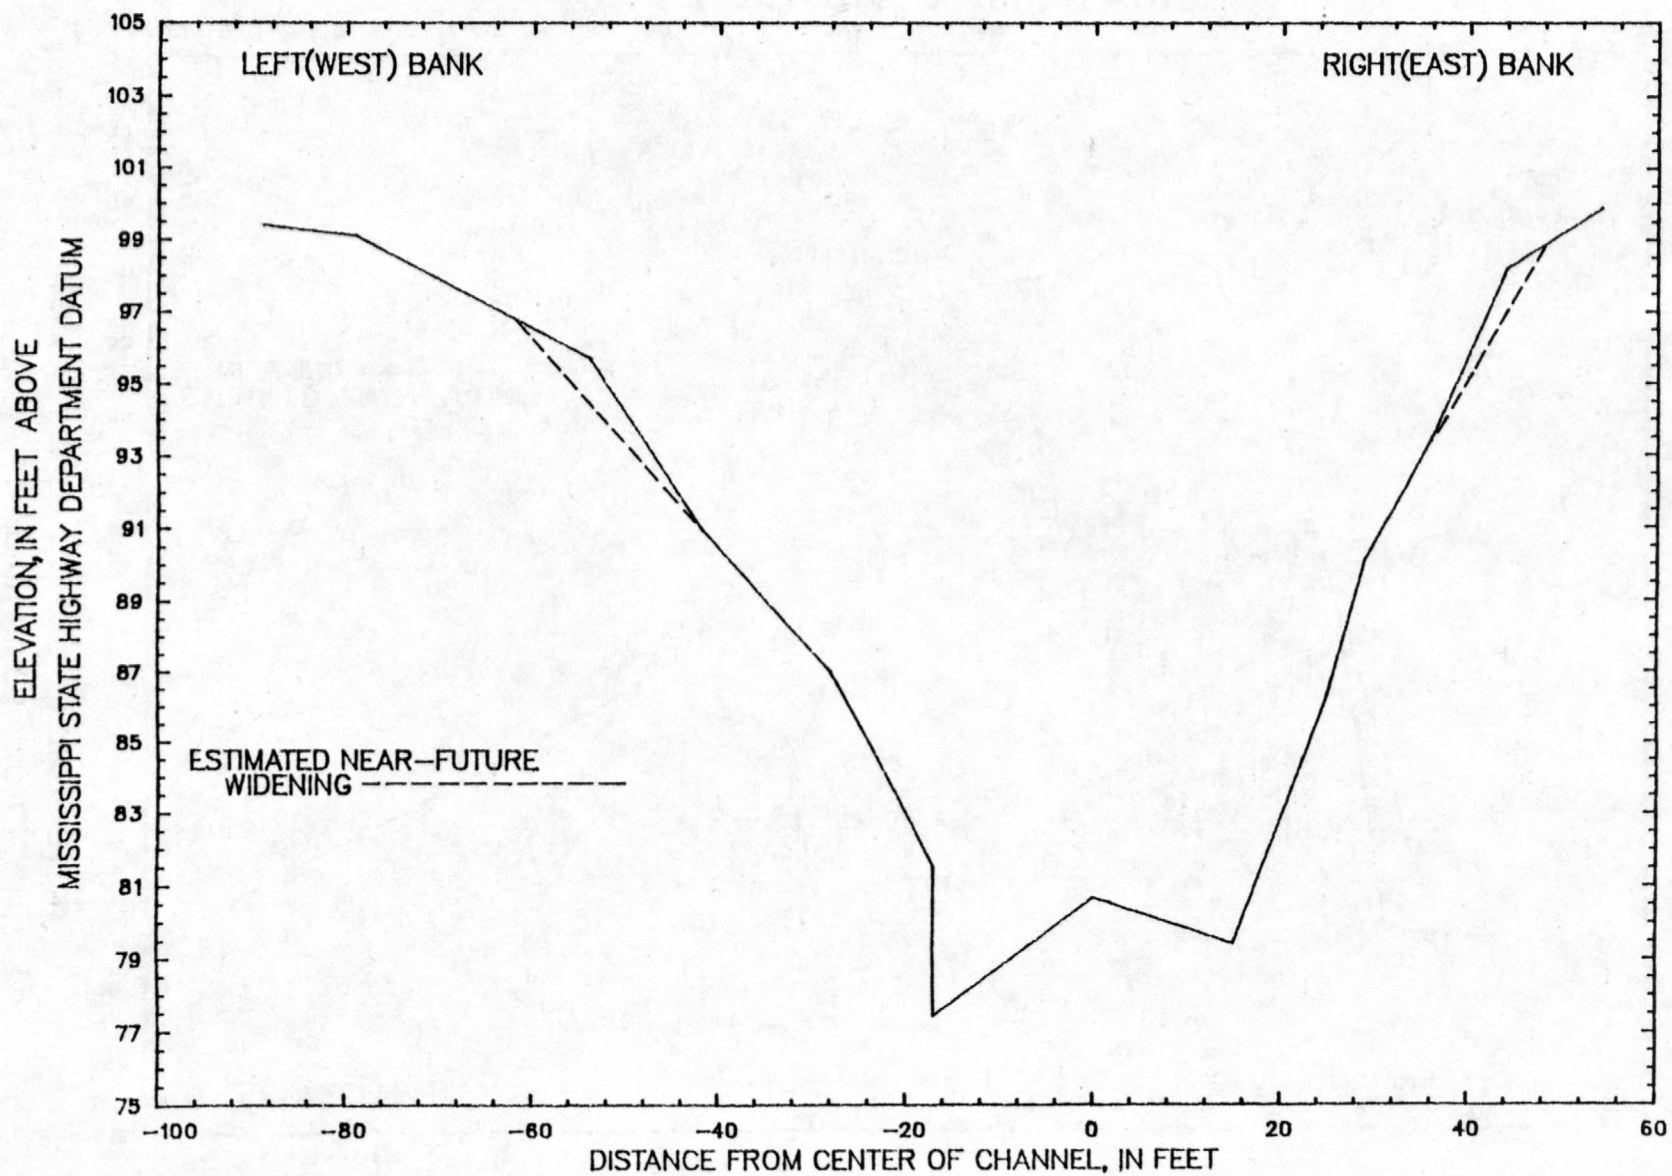
Figure 7.--Channel cross section showing estimates of near-future widening for Bakers Creek, 75 feet downstream from State Highway 547 near Port Gibson, 1989.
