**U.S. DEPARTMENT OF THE INTERIOR  
U.S. GEOLOGICAL SURVEY**

**RECONNAISSANCE REPORT ON THE 12 OCTOBER 1992  
DAHSHUR, EGYPT, EARTHQUAKE**

Open-File Report 93-181

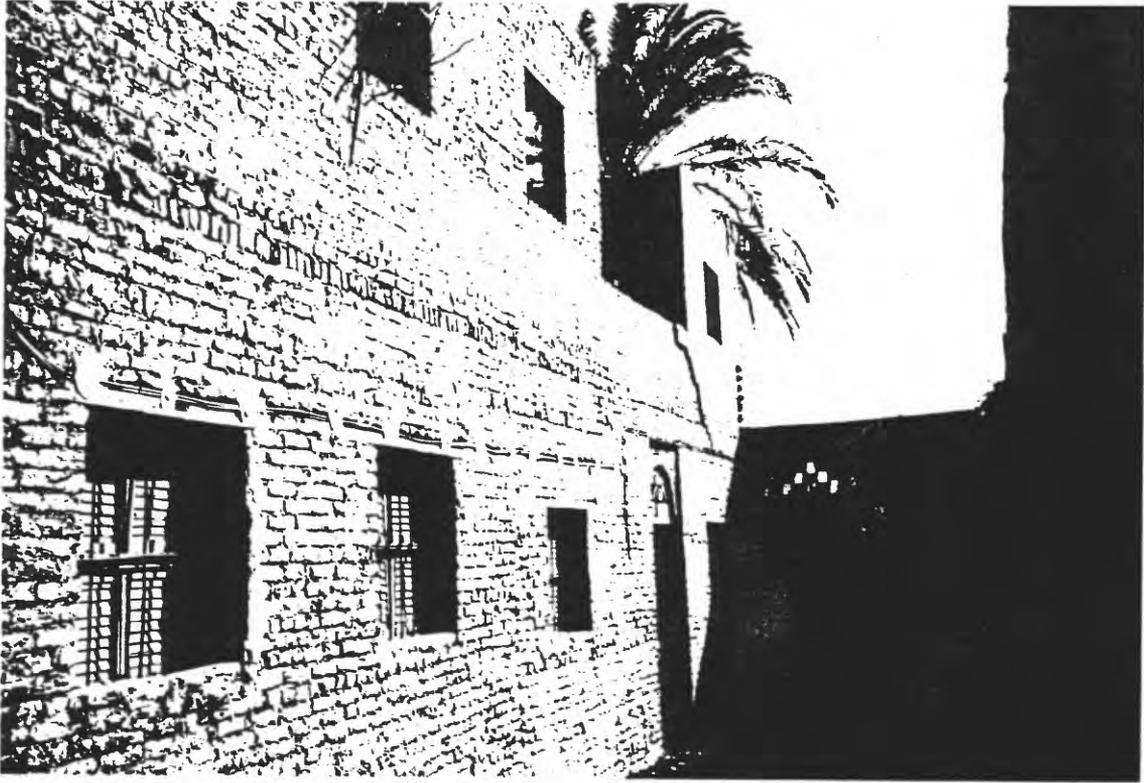
Figure 1. A brick masonry building without timber reinforcement or tie-beams.

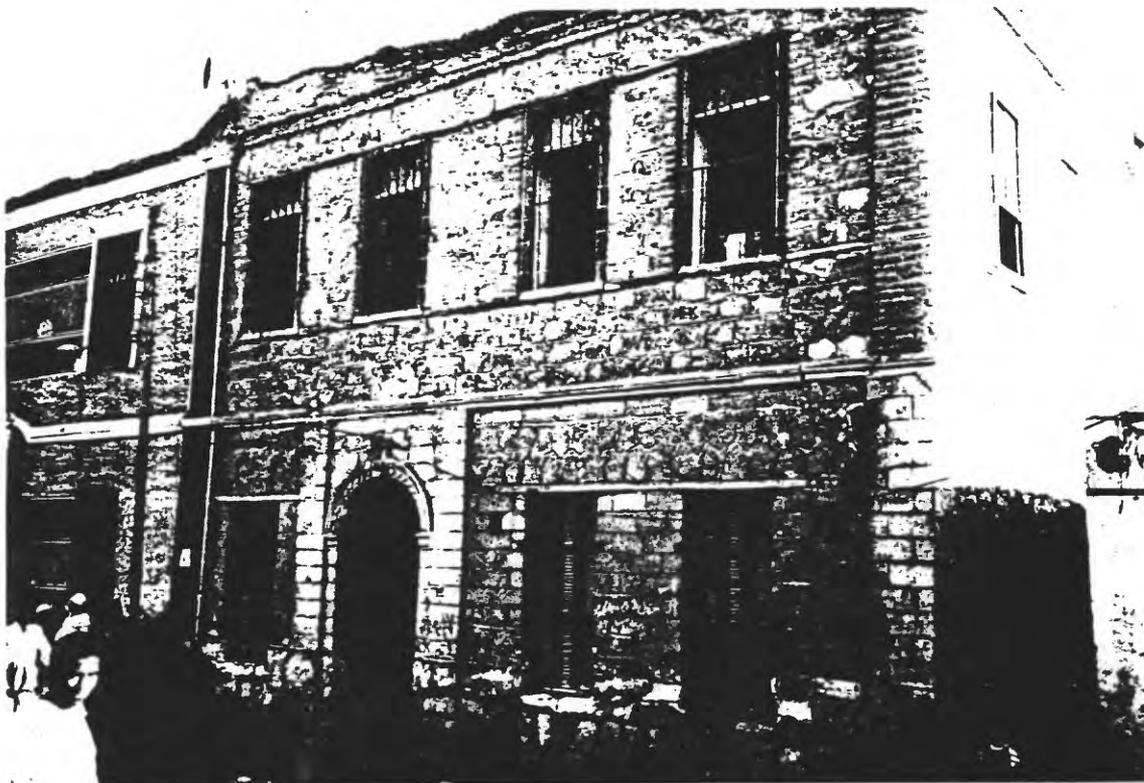
Figure 2. Separation at the corner of stone masonry building.

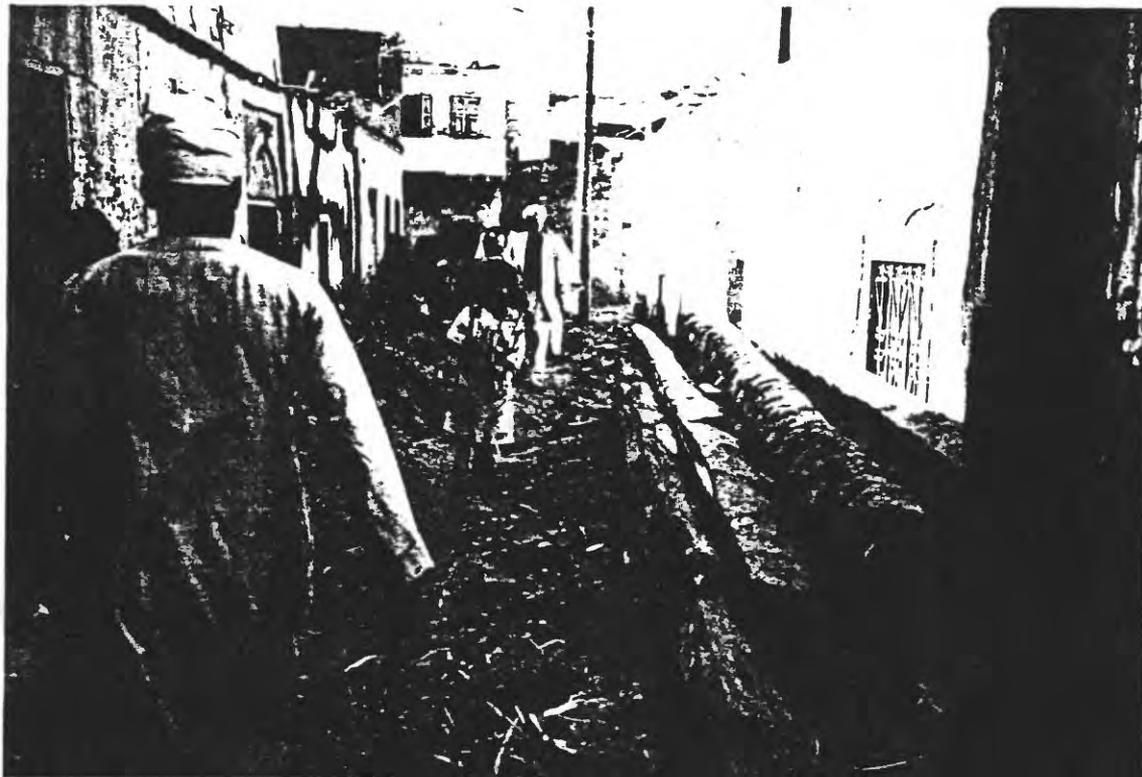
Figure 3. Rubble of collapsed adobe buildings and unprocessed palm tree trunks.

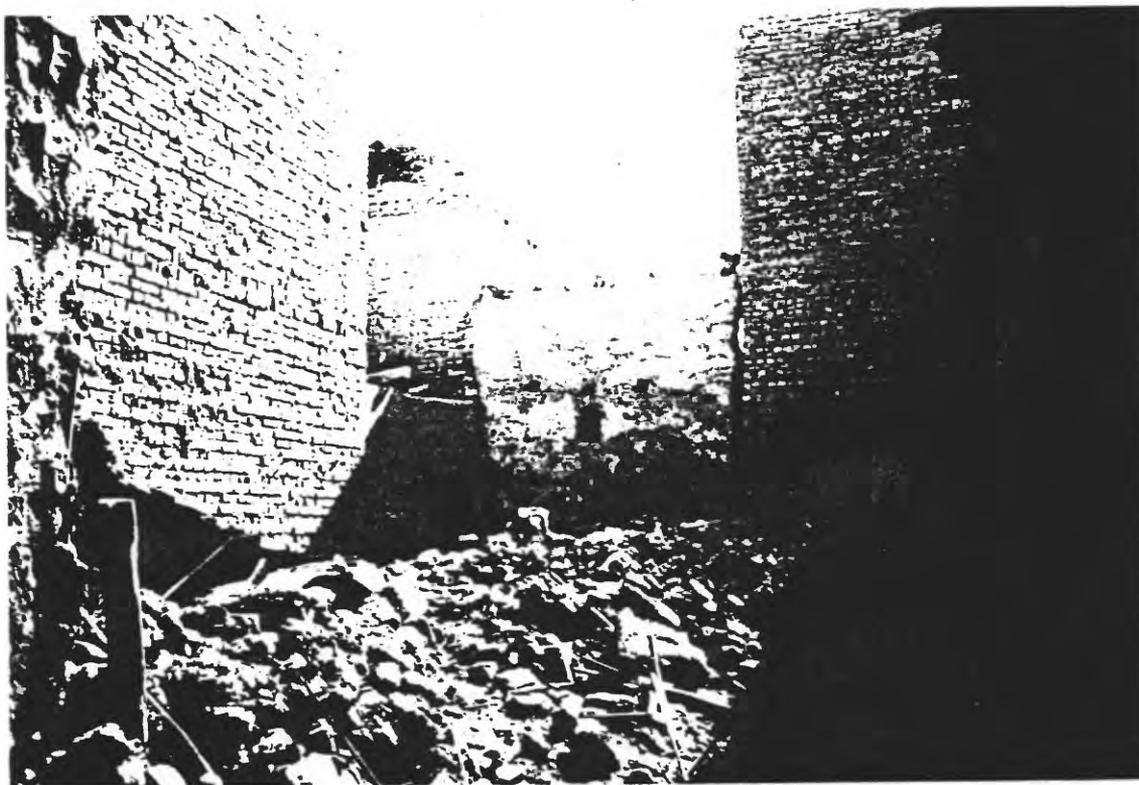
Figure 4. Collapsed adobe building surrounded by those standing up.

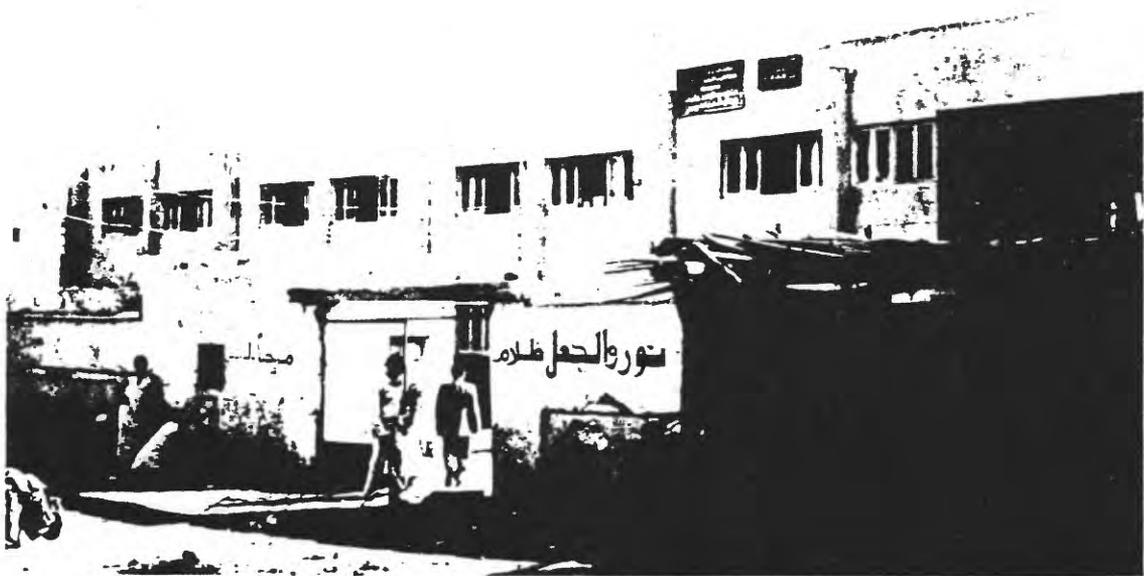
4. Identify beforehand local buildings to be used as emergency shelters. In Girza, the reconnaissance team observed that the most substantial building in the village, a reinforced concrete-framed school, was closed because it was deemed unsafe when only a parapet fell and the walls had minor cracks. No structural damage was apparent. Many people in the village were without shelter because of damage to, or destruction of, their homes and a good many

Figure 6. School Building (Girza).

others were still living in seriously damaged adobe dwellings. The suggestion was made that the remaining parapet be removed or braced so it would not fall in aftershocks, and that the school be used for shelter of the homeless and those still living in seriously damaged dwellings.

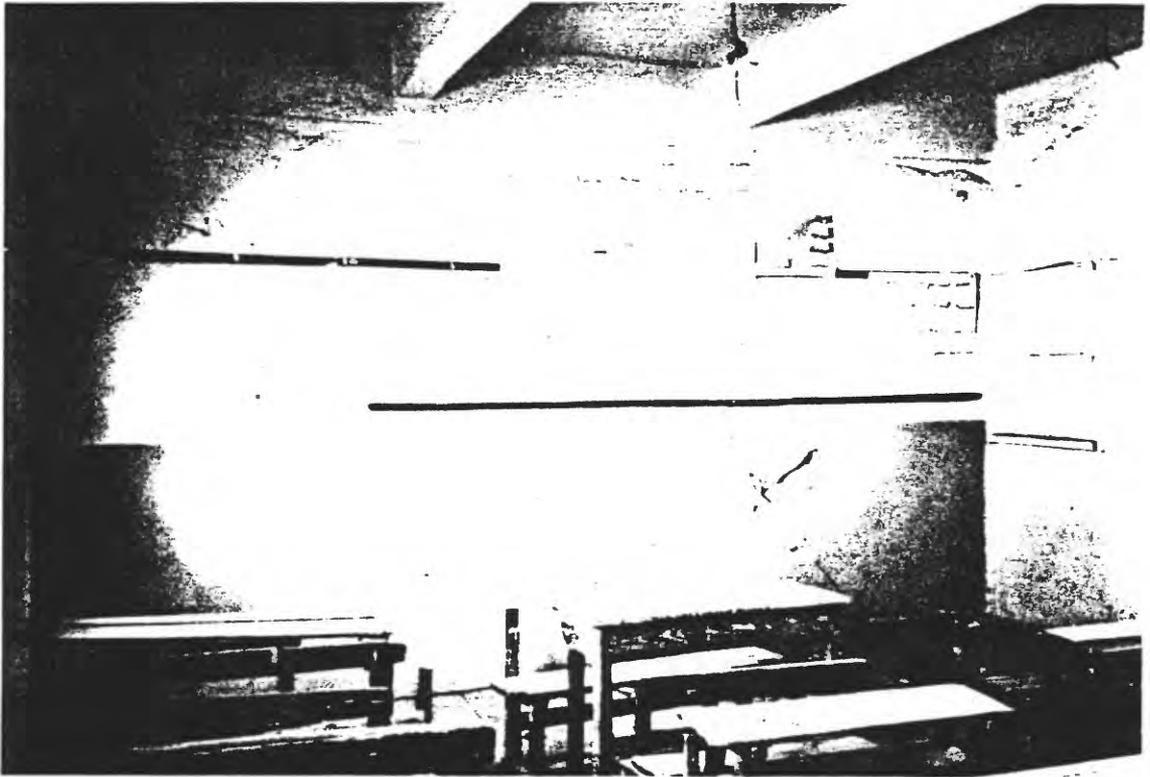
Figure 7. Diagonal cracks and separation of infill walls.

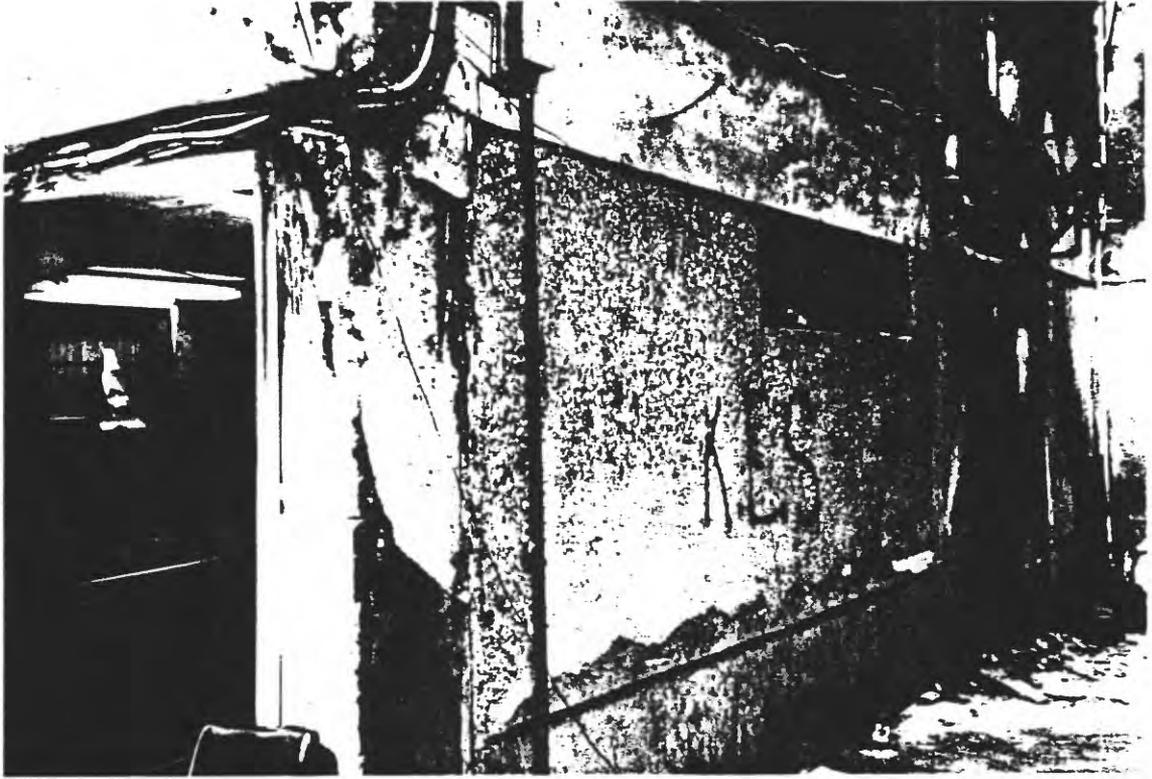
Figure 13. Damaged corner column of soft-story entrance level of the six-story building.

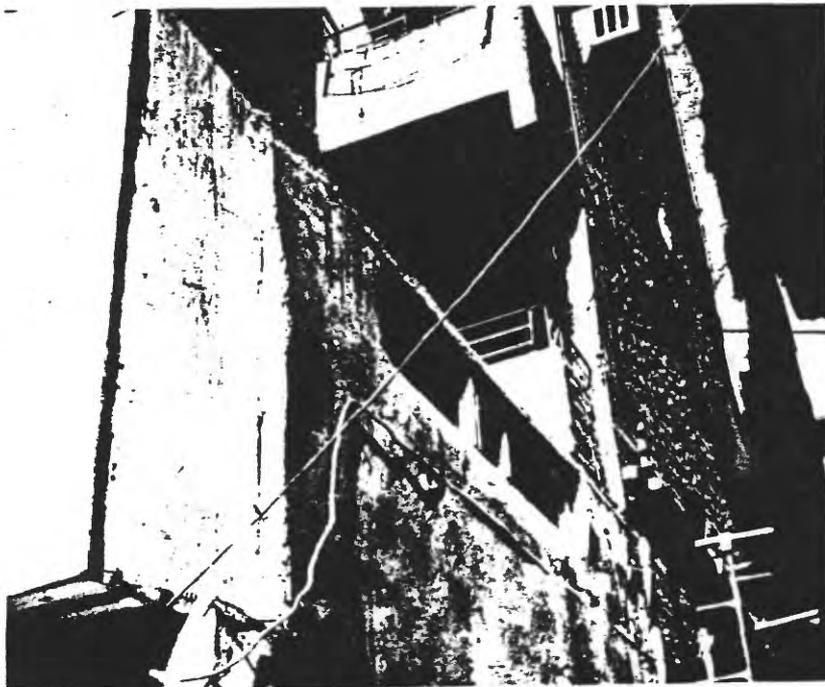
Figure 15. Damaged column (already cosmetically repaired).

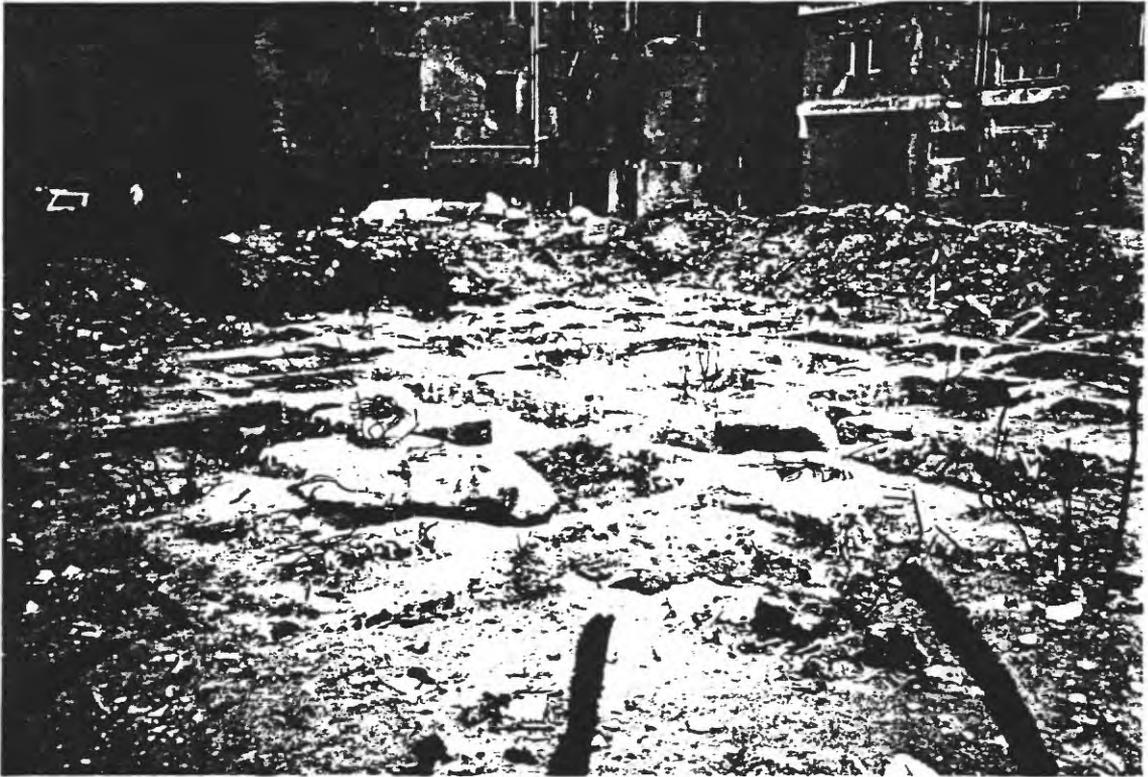
Figure 16. Foundation of the eight (later modified to fourteen) story building that collapsed.
