U.S. DEPARTMENT OF THE INTERIOR
U.S. GEOLOGICAL SURVEY

**BROAD BELTS OF SHEAR ZONES AS THE COMMON FORM OF SURFACE
RUPTURE PRODUCED BY THE 28 JUNE 1992
LANDERS, CALIFORNIA, EARTHQUAKE**

Open-File Report 93-348

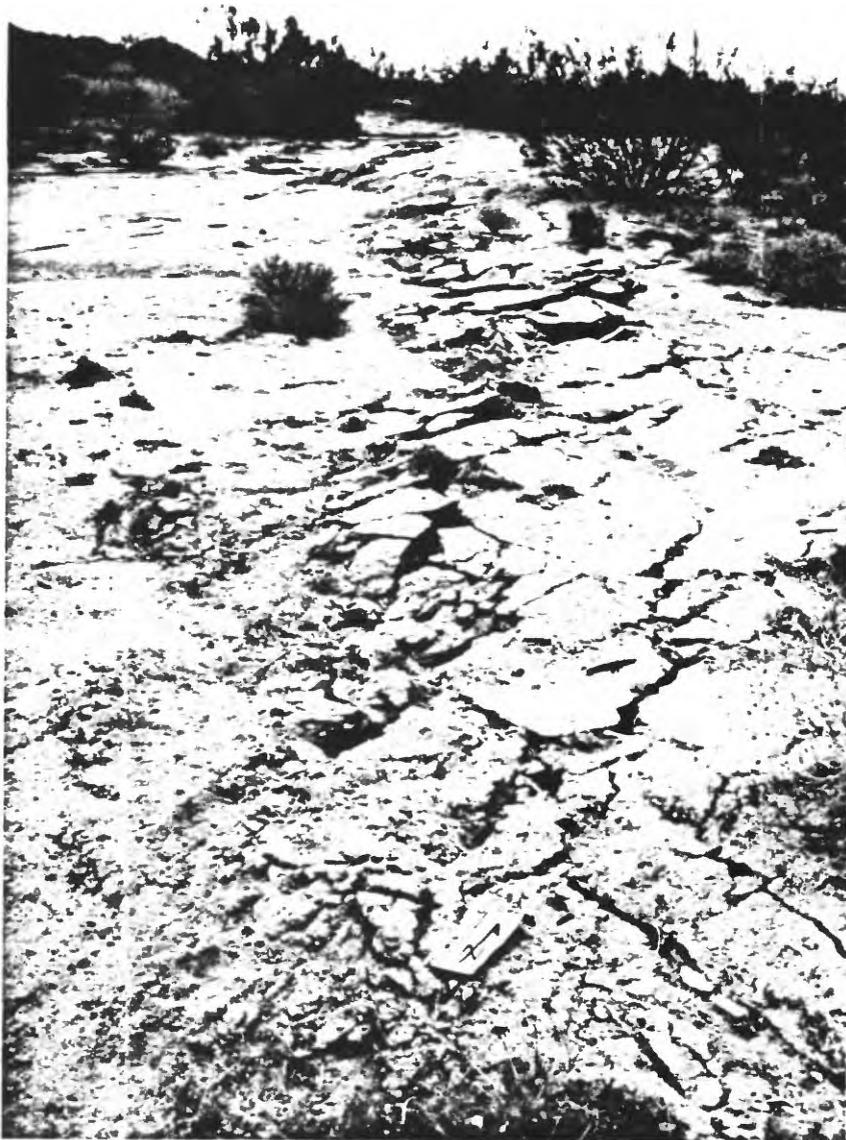
A.

The details of the Happy Trail shear zone are illustrated in a series of photographs in figure 4. Figure 4A is a view NW, along 30 or 40 m of the SW flank of the Happy Trail shear zone, where the shear zone passes from a parking area (in the foreground), through the dirt road (in the distance), and in front of the large bush visible on the horizon to the left. The width of the shear zone, about 4 m, is marked by the width of en echelon fracturing; the right-lateral shift accommodated across the shear zone is a few decimeters. The ground within the shear zone has been thrust upward about 1 dm with respect to ground to the SW (left). The soil in the foreground is sandy and soft, so the fracturing is relatively poorly developed and preserved. Even here, though, we can recognize many of the elements. We see en echelon fractures, with highly irregular traces, oriented roughly N-S. We see thrust or buckled ground along the left side, where the blocks of ground bounded by the en echelon fractures have been pushed toward the south.

Figure 4. A narrow shear zone, the Happy Trail shear zone, within the Johnson Valley belt of shear zones. A, View N.30°W. along SW wall of narrow shear zone. Shear zone about 4 m wide accommodated a few decimeters of right-lateral shift. In foreground, soil is soft and sandy and fractures are poorly developed. In background, shear zone crosses firmly compacted dirt road where fractures are well developed, as shown in following photos.

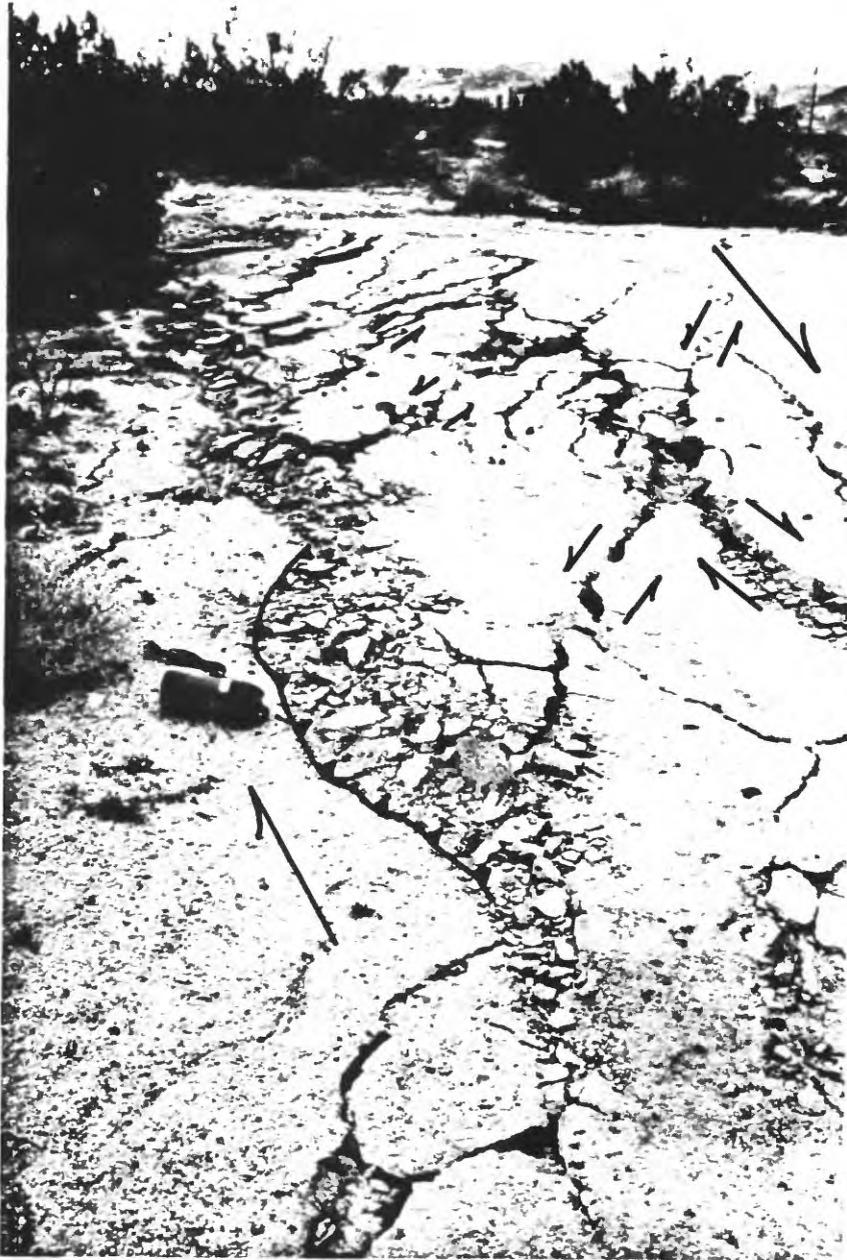
B.

The rest of the photos show the compact soil in the roadway, in the background in figure 4A. Figure 4B is a view about N.15°W., along the SW wall of the shear zone. The walls of the shear zone (marked roughly by arrows) are oriented about N.30°W. One flank of the shear zone, in the foreground, is well defined by thrusting and buckling, which has broken the surficial materials into piles of soil chips. The thrust blocks are bounded by long, N-S-oriented en echelon fractures. These extend for several meters and their far ends define the ragged, opposite (NE) flank of the shear zone. Although the traces of these fractures vary considerably, and many are highly

Figure 4. *B*, View N.15°W. diagonally from SW side to NE side of shear zone, at dirt road, in upper part of *A*. Width of shear zone indicated by right-lateral arrows on far left and far right of photo. SW wall of shear zone in foreground. En echelon cracks oriented N-S about 20° clockwise from view. Most cracks have been transformed into left-lateral fractures, as indicated by arrows. Thrusts (one shown) all along SW wall mark where blocks of ground, bounded by N-S en echelon fractures, have been pushed laterally during rotation of blocks. The ground in the toes of the thrusts is highly broken and seen as piles of soil chips.

Finally, there is a very narrow, 0.1 to 0.5 m wide, right-lateral shear zone that represents more intense shearing locally within the Happy Trail shear zone (upper right quadrants of figs. 4B and 4C). The narrower shear zone itself is composed, in part, of short en echelon tension cracks, stepping left and defining a zone perhaps 0.5 m wide (as shown to the left of the right-lateral arrows in fig. 4C) and in part by a much narrower rupture zone, perhaps 1 dm wide (as shown in the right-hand side of fig. 4C). The tension cracks within this narrower shear zone are oriented N-S, just as they are in the broader Happy Trail shear zone, but are much shorter and more closely spaced. This *narrower shear zone offsets* the long N-S tension cracks/left-lateral fractures of the Happy Trail shear zone by perhaps 1 dm, indicating that it formed later in the development of the Happy Trail shear zone. It may be a guide to a fault within the shear zone below. It is clear, in this case, that the narrower shear zone, or fault, appeared after the shear zone appeared.

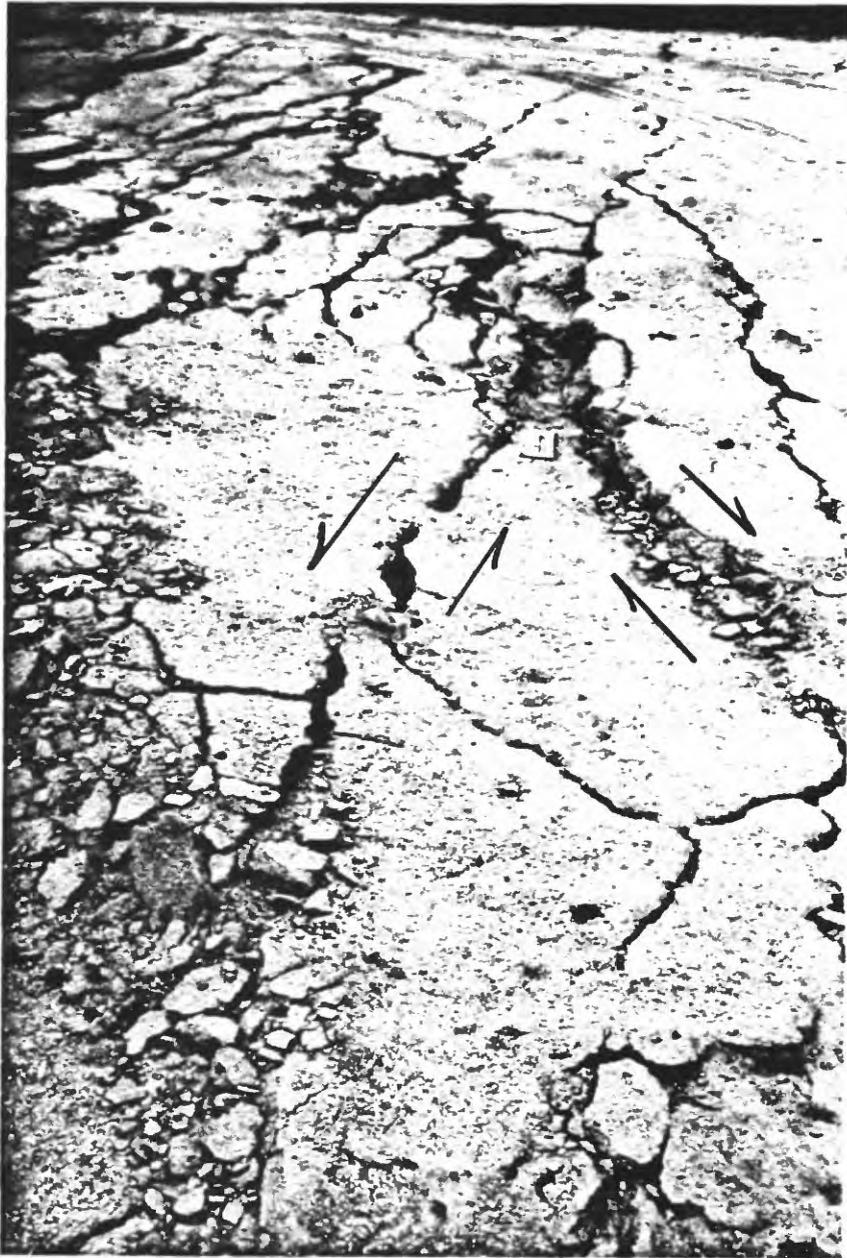
C.

Figure 4. C, View north along one of an echelon fractures shown in B. Note pull-apart near left-lateral arrows. Offset of irregularities, pull-aparts, and thrusts indicates that fractures have accommodated left-lateral shift. Right-lateral arrows near midwidth of shear zone depict a narrow right-lateral shear zone of more intense shearing within the broader zone.

irregular, the average trace is remarkably straight. Figure 4C, a closer view of one trace, shows offset of the irregularities along the walls of the fractures, indicating that the fractures accommodated left-lateral shearing, as well as opening.

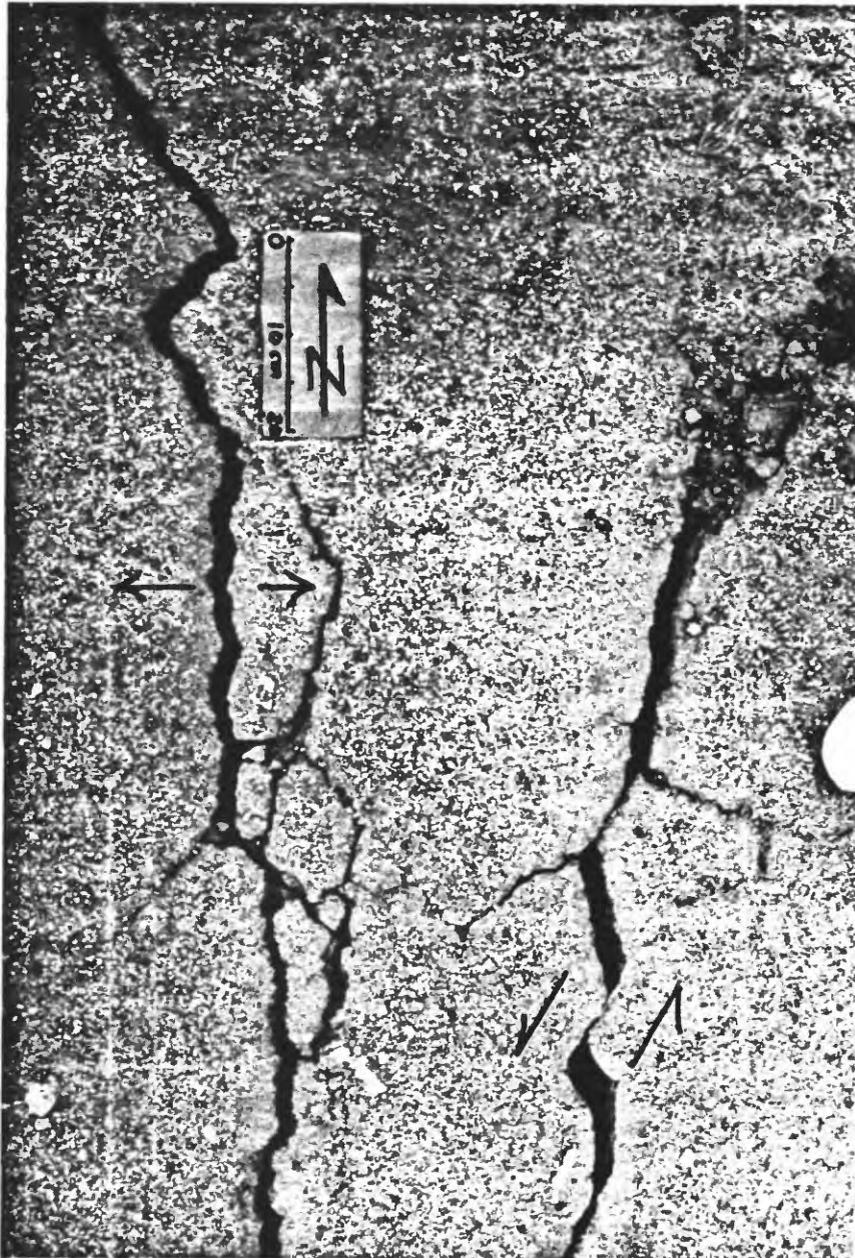
D.

Figure 4. *D*, Plan view of a left-lateral fracture and a tension crack at locations of double vertical arrows shown in the upper left part of *C*. Traces of both fractures are highly irregular and interlocking, indicating that fractures started as tension cracks. Fracture on west (left) side is a tension crack. The tension crack probably is younger than the tension crack/left-lateral fracture.

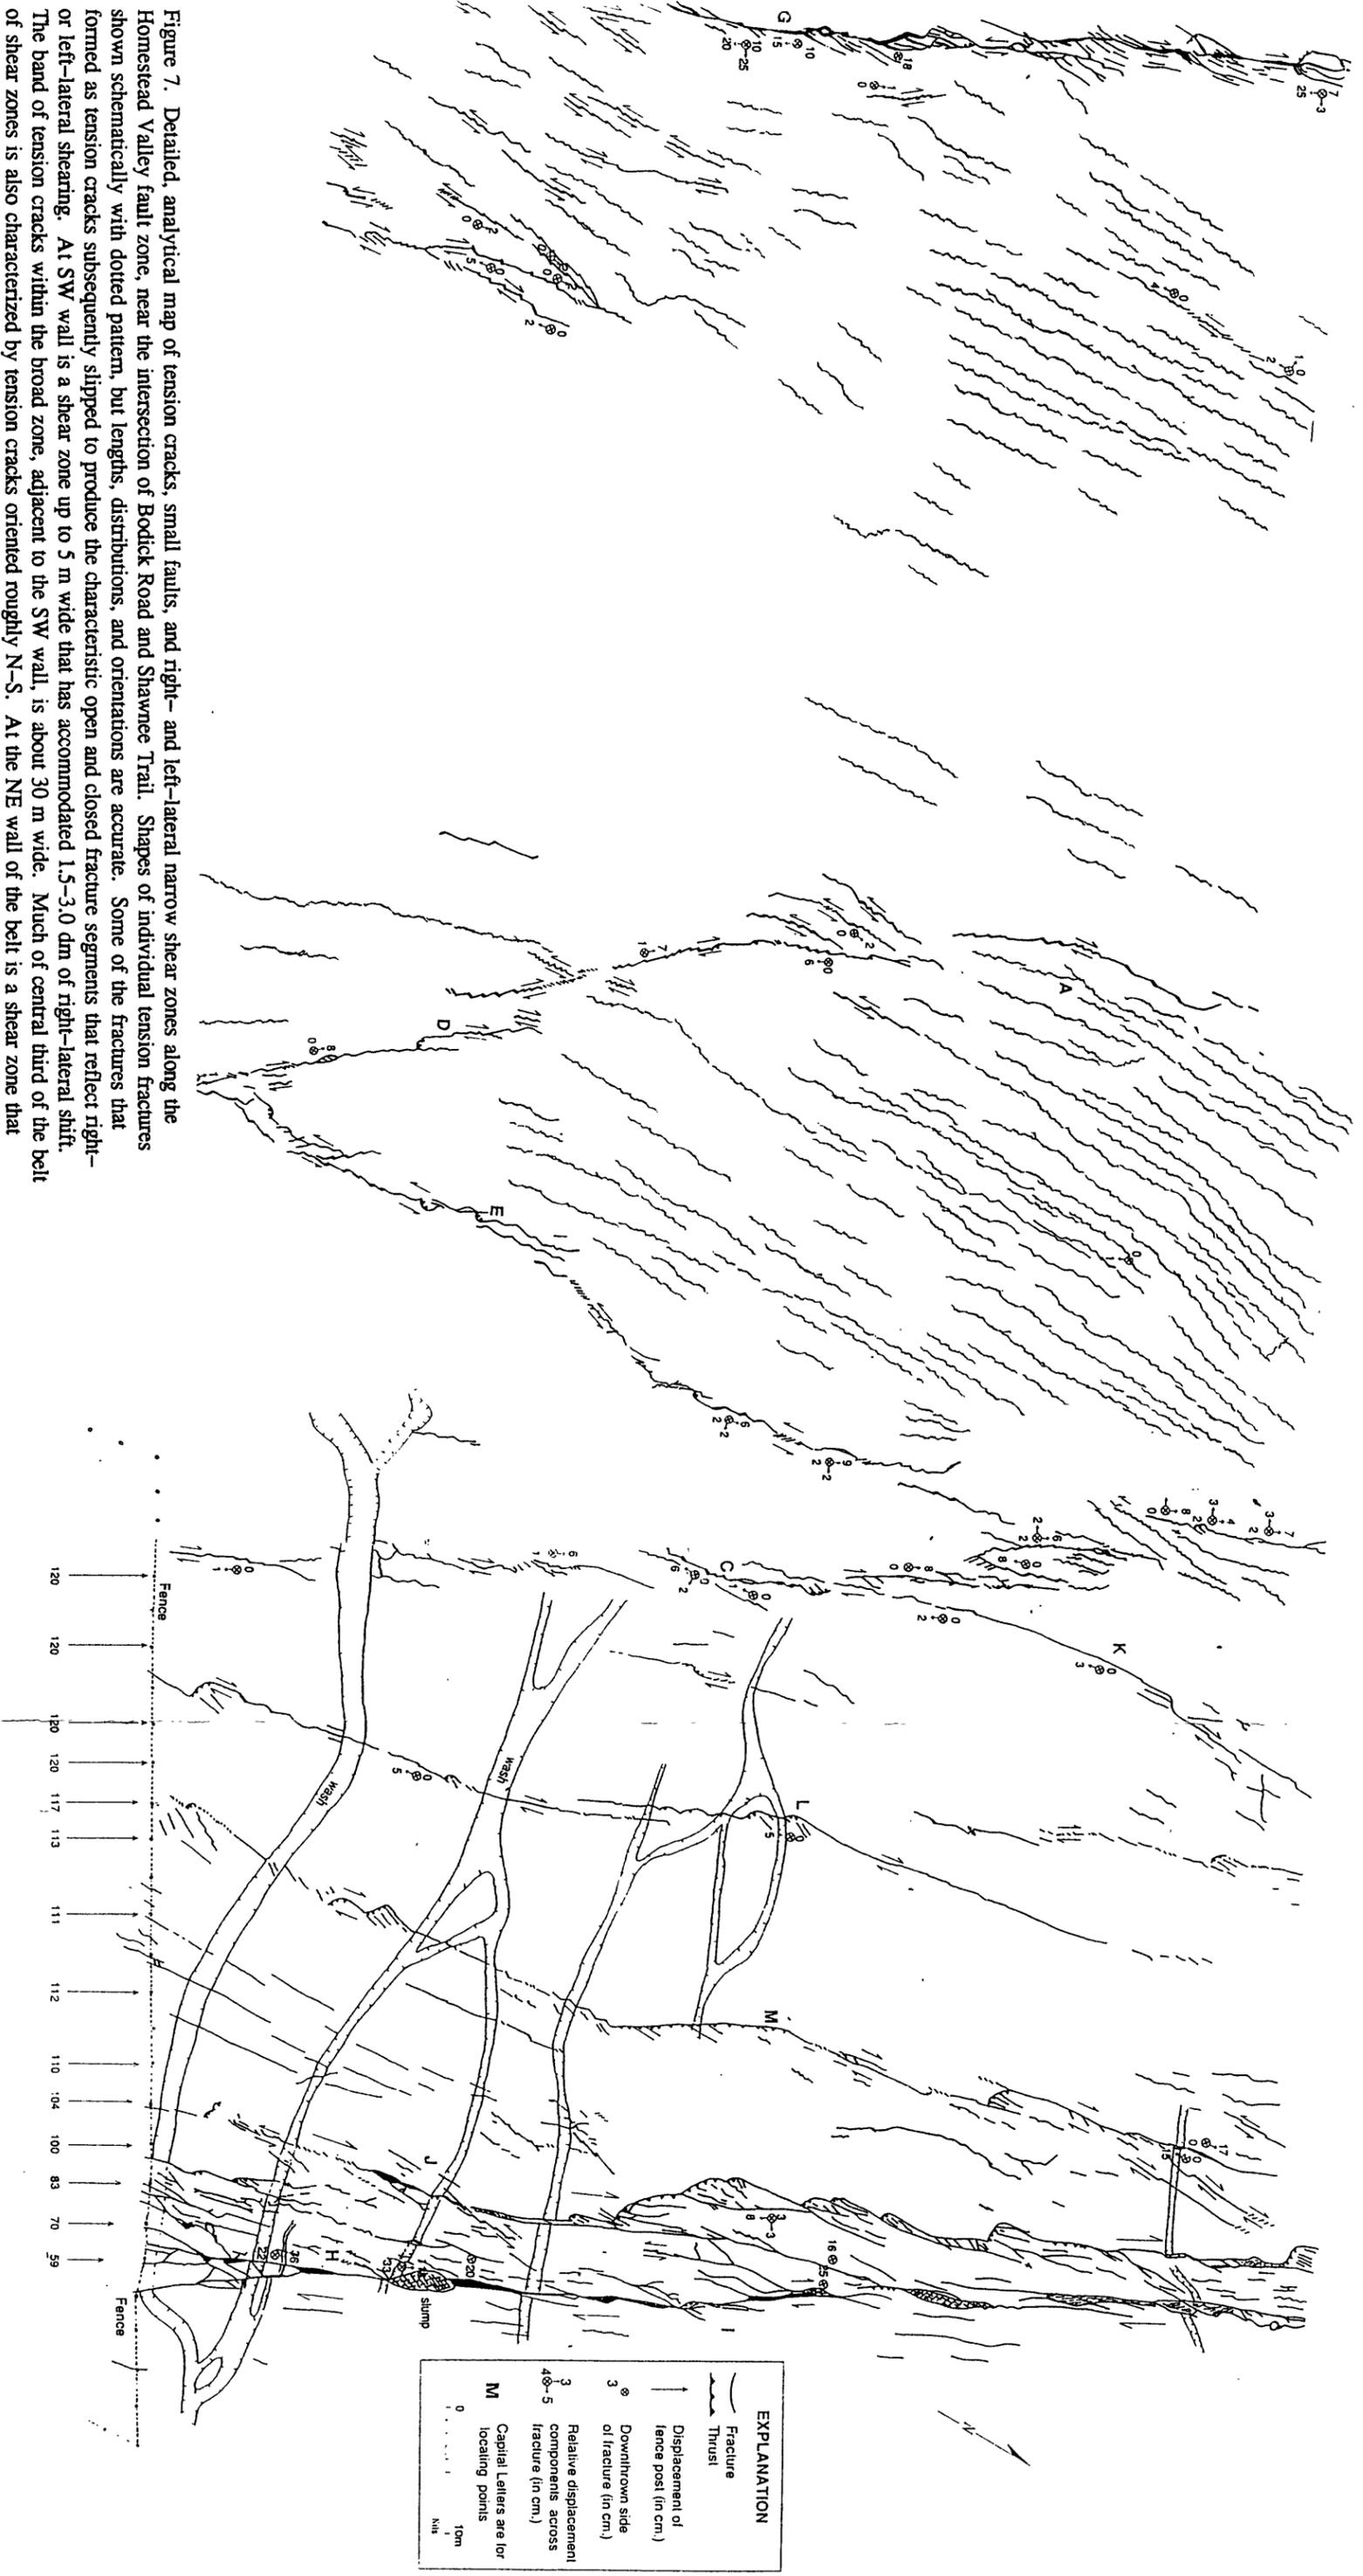
Characteristically, the orientation of tension cracks throughout the area is N-S (see, for example, fig. 7). The tension cracks are scattered throughout the width of the shear zone, but are most common in two areas. One area is a belt parallel to the SW edge of the broad shear zone (fig. 7). The other is a wedge shape near midwidth in the shear zone (fig. 7). Traces of individual tension cracks extend irregularly for 1 m to perhaps 10 m (fig. 8A). Although variable, their apertures are generally a few millimeters to perhaps a centimeter. They have rough walls--characteristic of tensile failure--and their traces are extremely irregular (fig. 8B). In many ways the tension cracks resemble cracks in a tile floor, where the crack works its way across the floor, turning left or right through large angles, and generally following the mortar between tiles. In this case, the tension cracks follow soil peds, older shrinkage cracks or other vertical, prismatic structures in the dense sedimentary deposits and create characteristic zig-zag paths. We infer that the highly irregular fracturing we see at the ground surface is merely *guide fracturing* related to straighter tension cracks below the ground surface. The overall trend of the traces of the irregular cracks are remarkably consistent throughout the shear zone, and individual fractures can be traced for many meters. There are very few examples of tension cracks whose average trace wanders significantly.

Figure 7. Detailed, analytical map of tension cracks, small faults, and right- and left-lateral narrow shear zones along the Homesstead Valley fault zone, near the intersection of Bodick Road and Shawnee Trail. Shapes of individual tension fractures shown schematically with dotted pattern, but lengths, distributions, and orientations are accurate. Some of the fractures that formed as tension cracks subsequently slipped to produce the characteristic open and closed fracture segments that reflect right- or left-lateral shearing. At SW wall is a shear zone up to 5 m wide that has accommodated 1.5-3.0 dm of right-lateral shift. The band of tension cracks within the broad zone, adjacent to the SW wall, is about 30 m wide. Much of central third of the belt of shear zones is also characterized by tension cracks oriented roughly N-S. At the NE wall of the belt is a shear zone that accommodated more than half of the right-lateral shearing of the entire belt. This shear zone is complex and is up to 12 m wide, generally widening from NW to SE. Its east side is marked by a scarp, up to 3 dm high, and its west side is marked by thrusts. Within the zone are tension cracks and left-lateral fractures oriented N-S, and right-lateral fractures generally oriented about N.30°W. Components of differential displacement normal to fence line indicated along base of diagram.

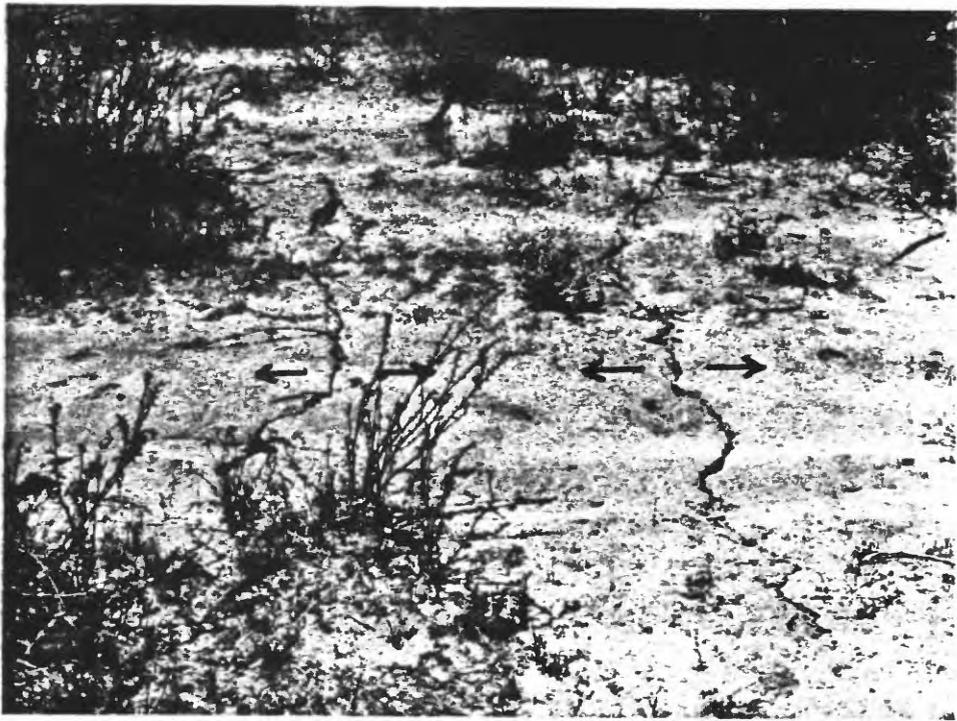
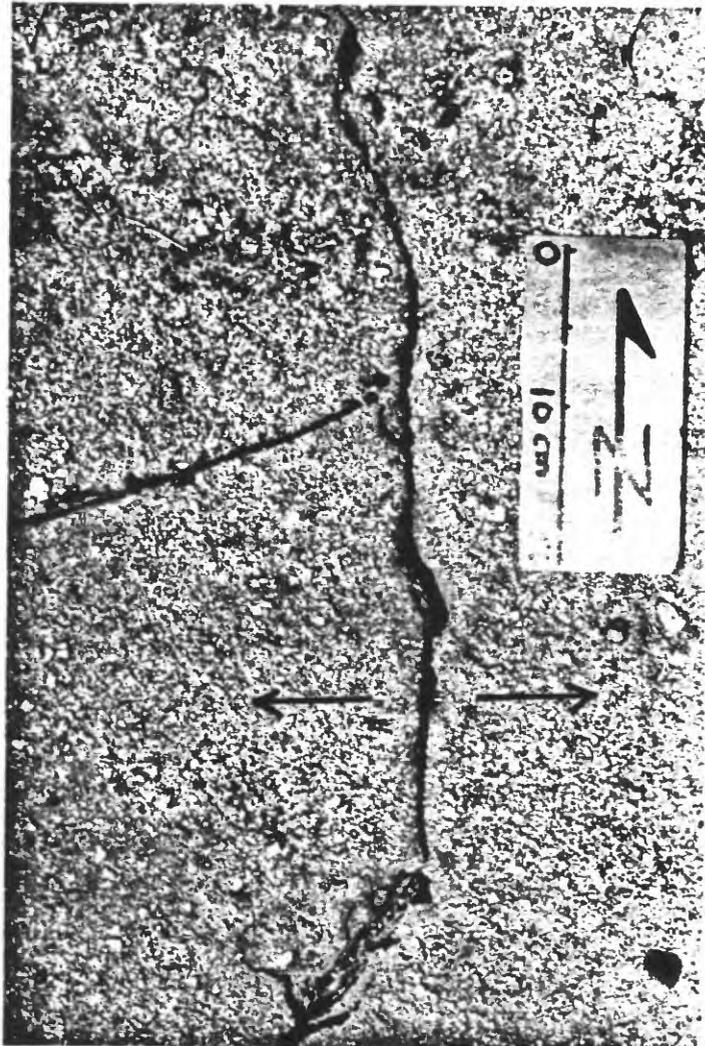
Figure 8. Detailed views of tension cracks shown schematically in figure 7. A, View north along traces of several tension cracks at locality A (figs. 6 and 7), near midwidth of the broad shear zone at Bodick Road. Zig-zag, roughly sawtooth pattern of interlocking elements in walls of tension cracks is characteristic. Strong overall trend suggests a straighter crack beneath ground surface; B, Closer plan view showing irregularities in trace. Dark line on left is a twig, not a crack.

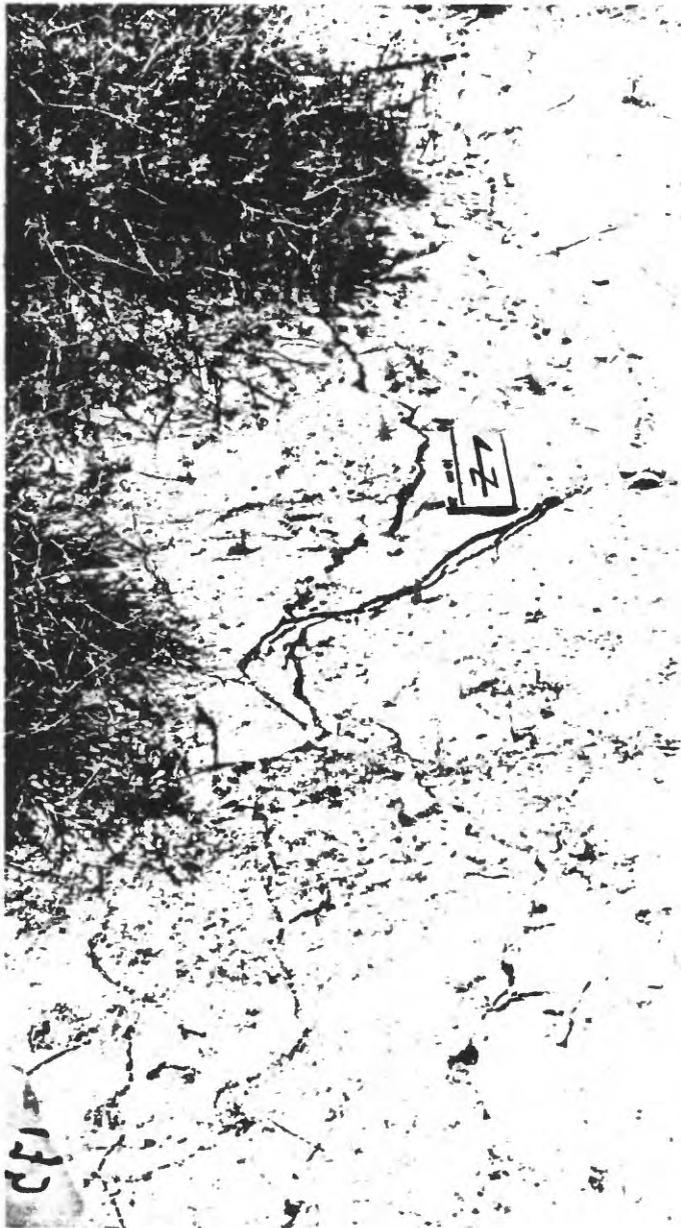
A.

Figure 9. Fracture that started as tension crack and then slipped in left-lateral sense near bounding, right-lateral shear zone at SW wall of belt of shear zones (locality B, figs. 6 and 7). A, View north along trace. Trace highly irregular, just like tension cracks, but fracture here slipped in left-lateral sense.

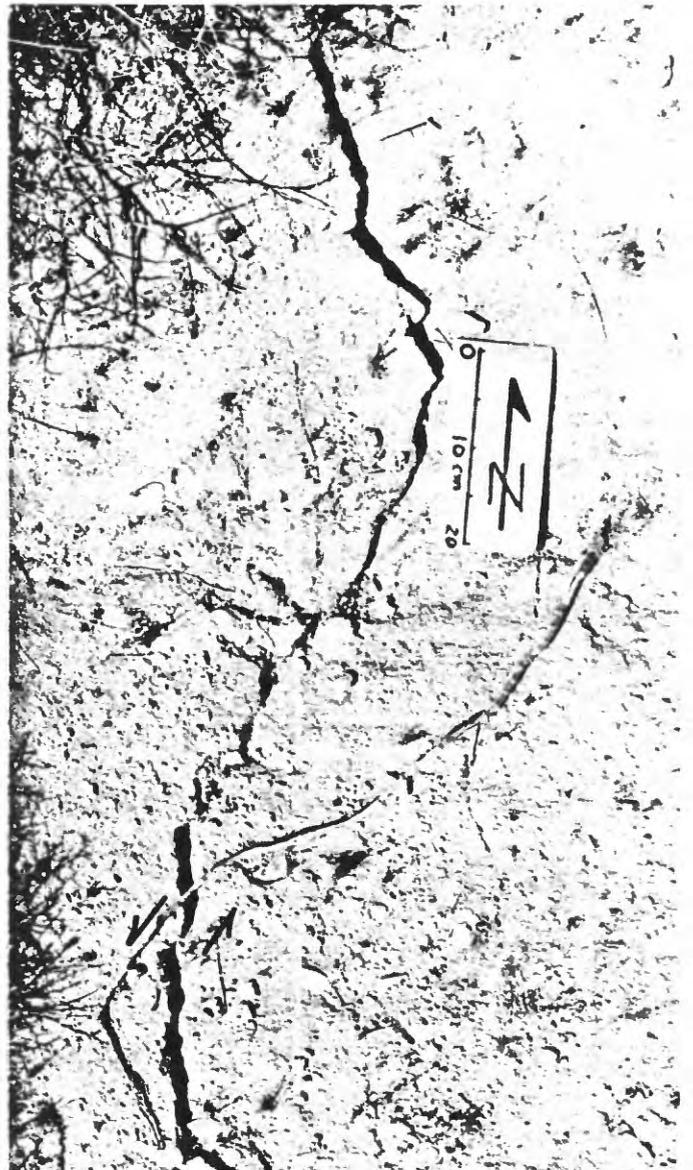
B.

B, Plan view of same fracture, showing left-lateral and dilational movement. Segments trending about N.30°E. are closed, whereas segments trending N-S to N.30°W. are open, reflecting net left-lateral, differential displacement toward NE.

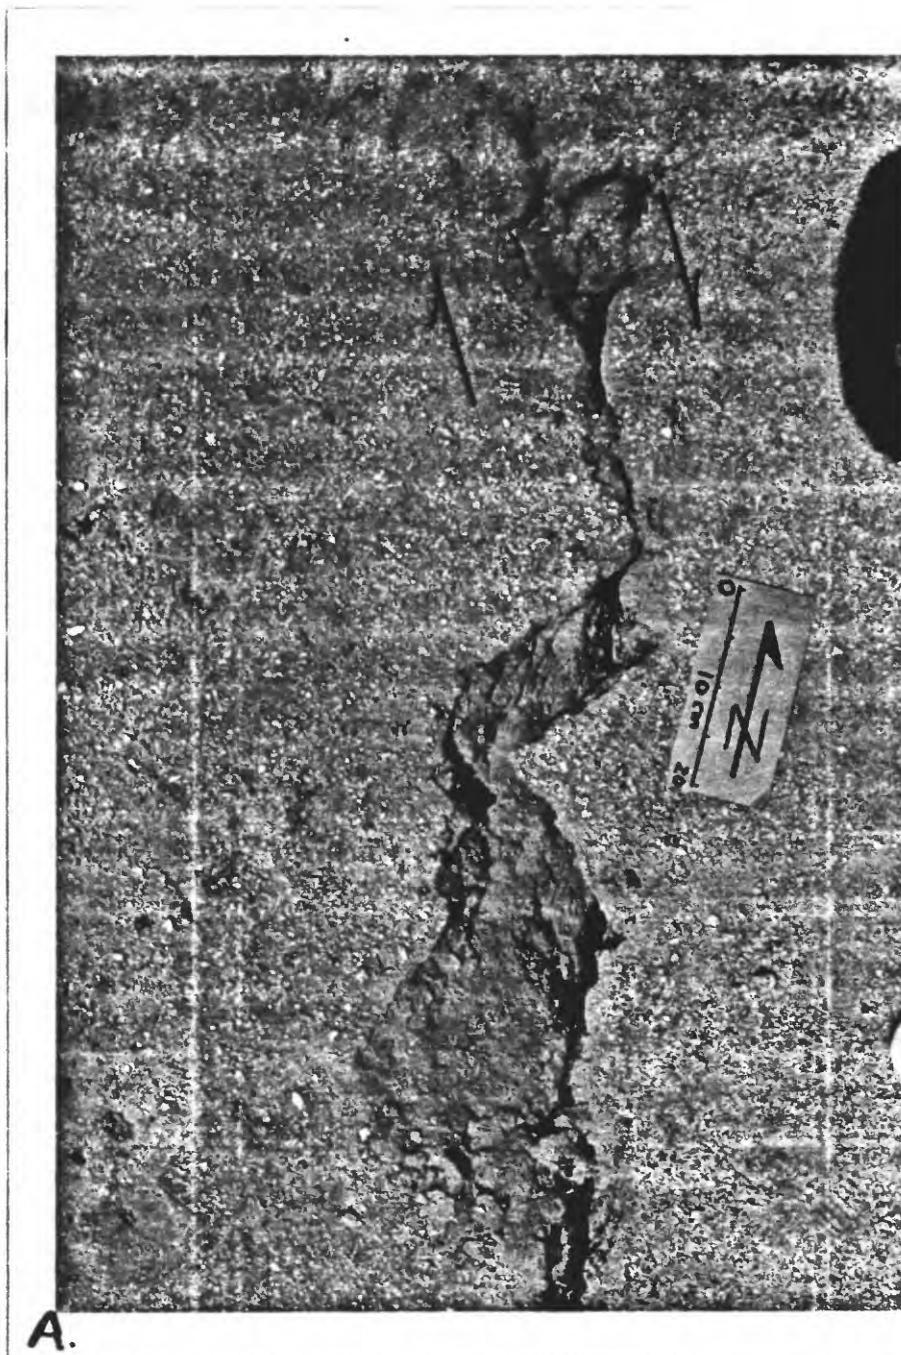
Figure 11. Right-lateral fractures. A, Fracture with right-lateral shift within right-lateral shear zone near midwidth of belt of shear zones at Bodick Road (locality C, figs. 6 and 7). Average trend about N.20°W. Components of differential displacement are 6 cm right lateral, 2 cm dilational, and 0 cm vertical. Rough break at surface suggests failure in tension. However, a few centimeters below surface, fracture is straight rather than zig-zag, as appears to characterize tension cracks (figs. 8 and 9).

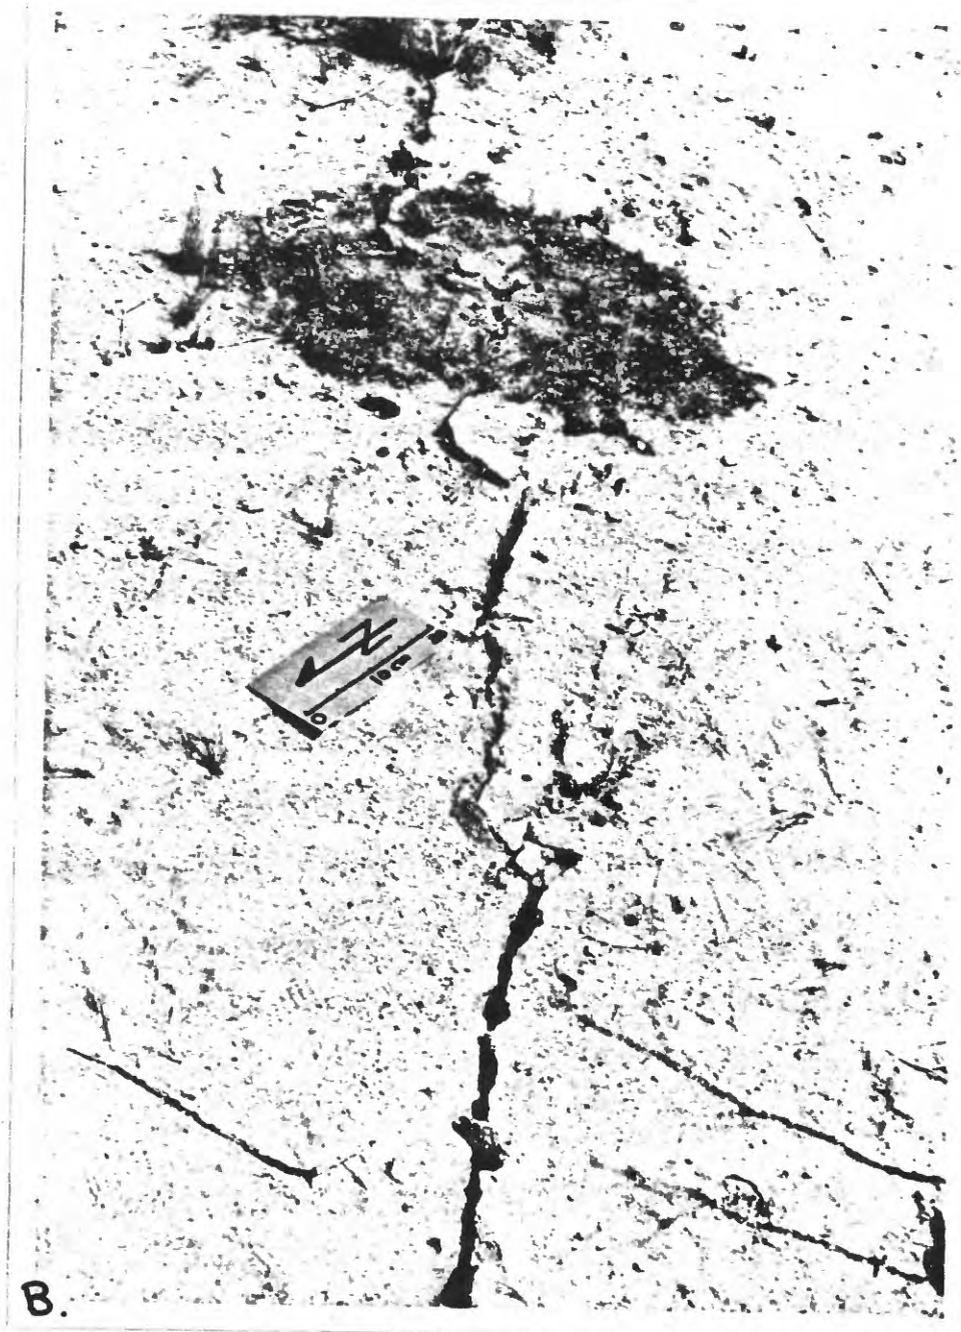
Figure 11. *B*, Fracture in right-lateral shear zone trending N.45°W. near midwidth of belt of shear zones at Bodick Road (locality D, figs. 6 and 7). View S.30°E. of compound fracture consisting of shorter elements, 1-3 m long and stepping left.

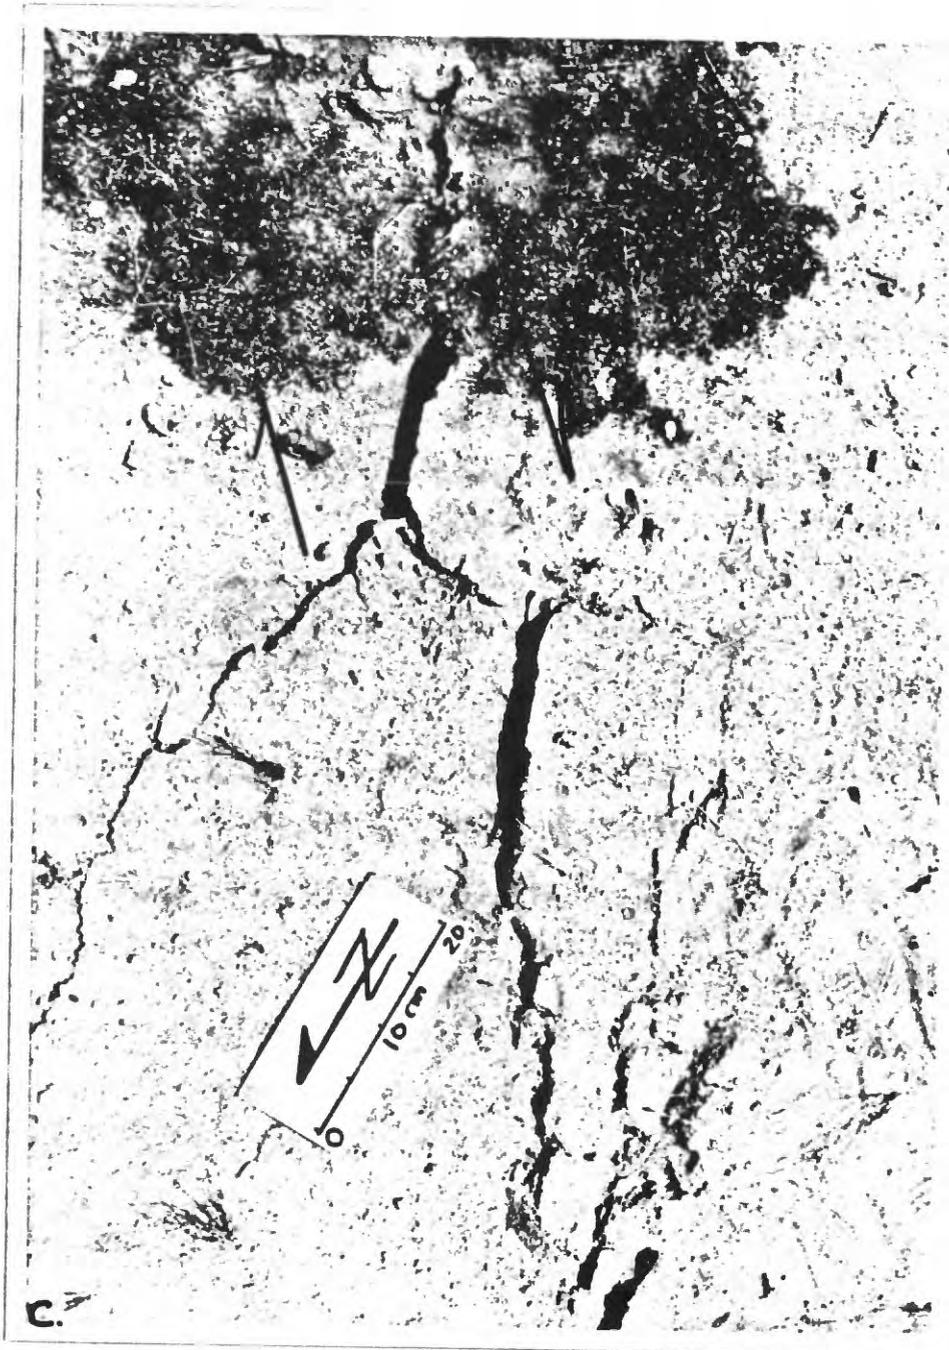
Figure 11. *C*, Plan view of the fracture in *B*. The shorter elements are open where the right-lateral shift steps right. The steps are compressed and, in places, folded or thrust.

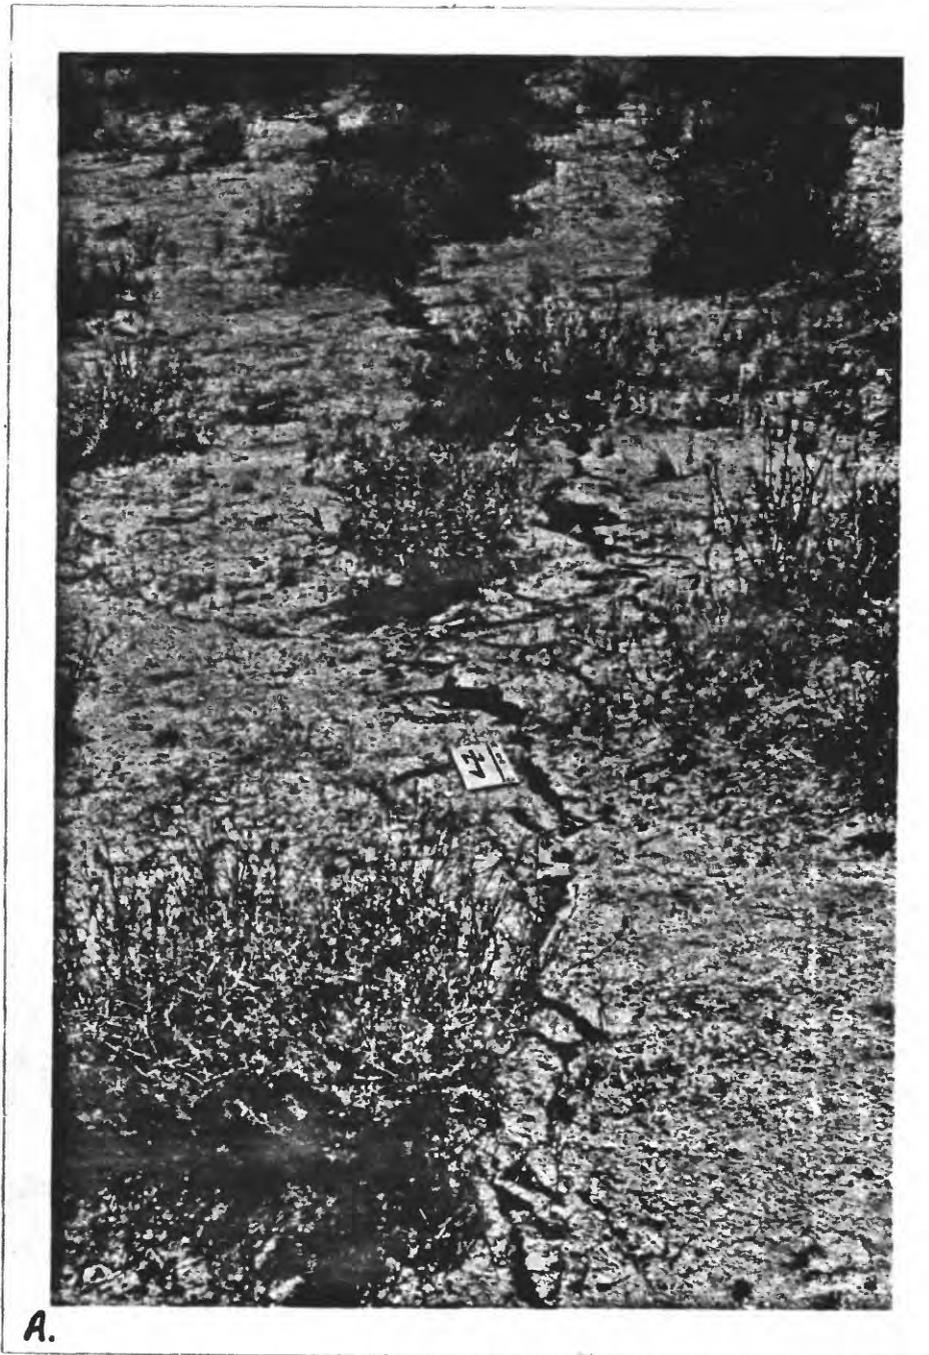
A left-lateral shear zone (locality E, figs. 6 and 7) connects the two right-lateral shear zones at C and D. The fractures trending along the axis of the shear zone have accommodated about 6–9 cm of left-lateral, 2 cm of dilation, and 2 cm of vertical (downthrown on E) movement. Much of the length of the shear zone appears to be coalesced tension cracks, oriented about N–S. The fracture elements over part of the length of the shear zone are en echelon tension cracks (with individual cracks oriented N.30° to 40°W), suggesting a left-lateral shear zone or fault at depth. Figure 13A (locality E) shows two long elements of the left-lateral shear zone viewed toward the south. The element in the foreground is about 3 m long, and that in the background is about 7 m long. The elements step right, and between them is a thrust,

Figure 13. Fractures in N-S-trending left-lateral shear zone that connects right-lateral shear zones near midwidth of belt of shear zones at Bodick Road (locality E, figs. 6 and 7). A, View south along fracture, showing fracture segments that step right. Vegetation obscures a thrust connecting the two fractures.

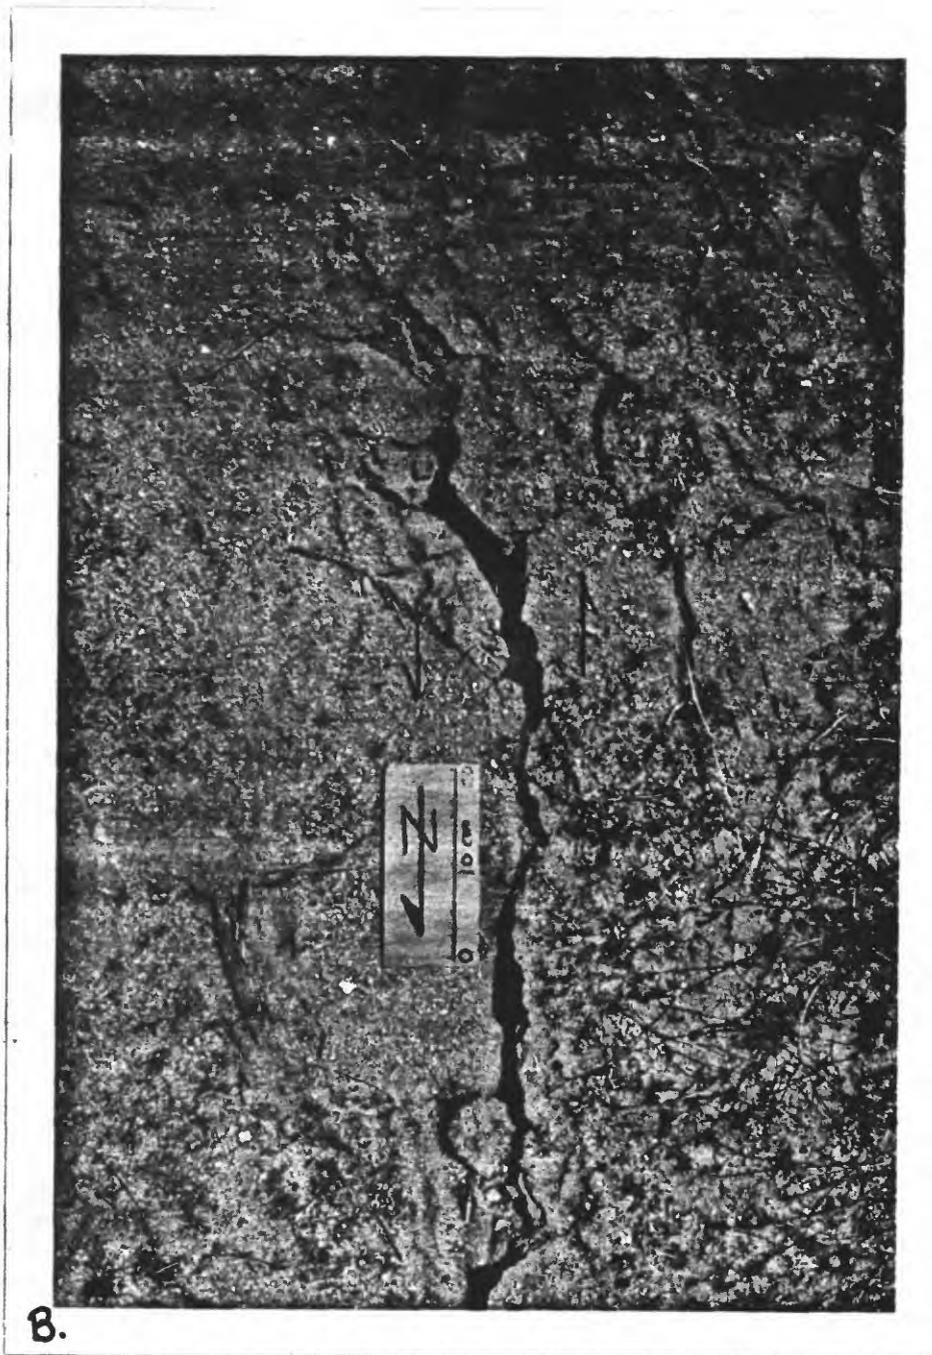
Figure 13. *B*, Plan view of one of the fractures, showing closed segments trending $N.15^{\circ}E.$ and open segments trending up to $N.30^{\circ}W.$

partially obscured by vegetation in the photograph, but shown on the map at locality E (fig. 6). Figure 13B shows the northern element near the thrust. It consists of closed segments, trending N-S, and open segments trending more westerly, reflecting the left-lateral slip. The overall pattern of this left-lateral shear zone suggests coalesced fractures with orientations ranging from N.20°E. to N.20°W.

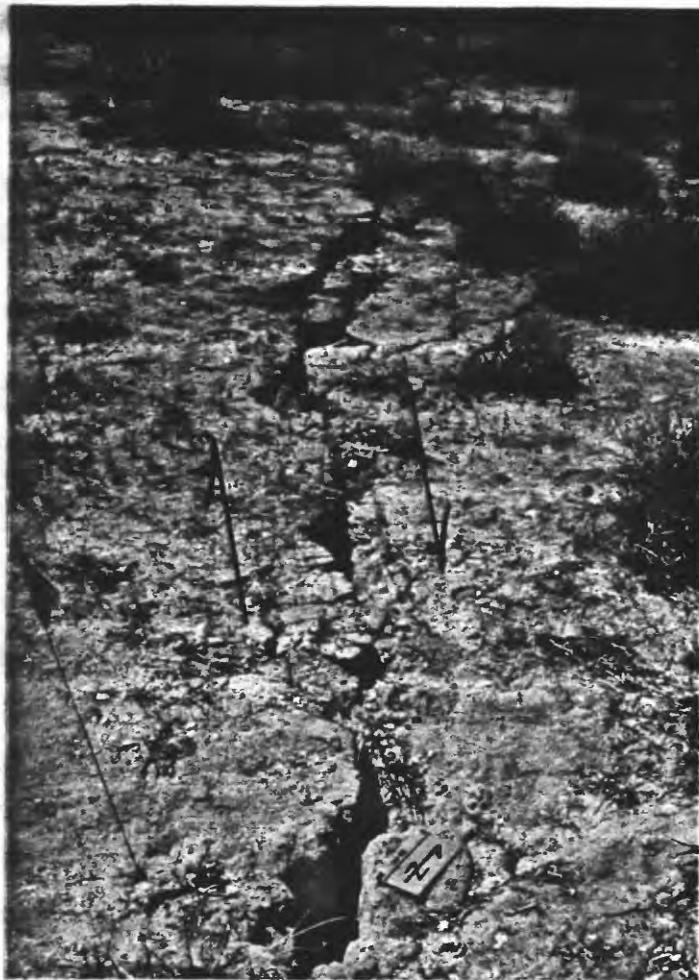
Figure 14. Narrow bounding shear zone along SW side of broad belt of shear zones. *A*, View about N.30°W. (locality G, figs. 6 and 7). The belt of shear zones is on the right in the view. Narrow shear zone accommodates 1.5 dm right-lateral and 1 dm vertical components of differential displacement. *B*, Oblique view N.40°W. along bounding, narrow shear zone along SW wall of belt of shear zones (locality F, figs. 6 and 7). In the middle distance is a set of en echelon, or overlapping fractures trending N-S. Right-lateral shift 13 cm, opening 3 cm, and downthrown on NE side about 5 cm.

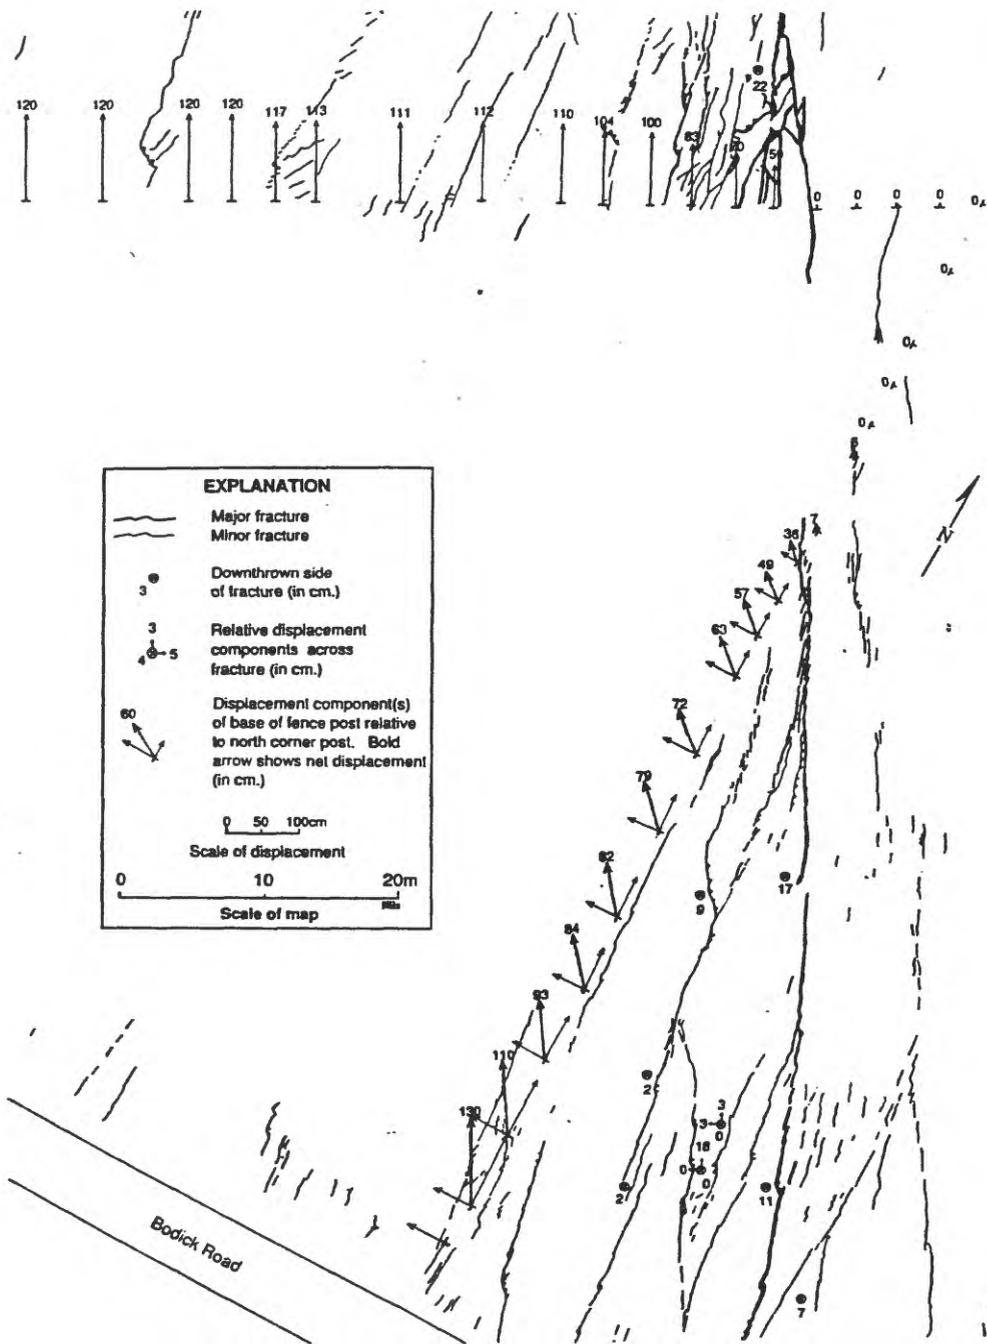
Figure 15. Distribution of differential displacements across NE half of belt of shear zones in Bodick Road area, as indicated by offset of fence lines. Total displacements shown in N-S fence, NW components shown in SW-NE fence. Most of differential displacement was accommodated by shear zones within a few meters of the NE wall of the belt of shear zones.

As indicated in figure 15, between the fifth fence post (about 0.5 m NE of the flank) and the sixth fence post (3 m to the NW, within the shear zone), the right-lateral component of the differential displacement is 0.59 m. Of the two fractures we mapped in this ground (fig. 17), the one bounding the shear zone apparently accommodated most of the offset. In one length of about 6 m, between the sixth and seventh posts, we found three fractures that accommodated an additional 0.11 m of offset, so the net is 0.7 m. The seventh and eighth posts are in ground crossed by three fractures, and the offset increases a further 0.13 m (fig. 15), so the total is 0.83 m. Between the eighth and ninth posts, over a total width of about 12 m, there is only one large fracture and the additional offset is about 0.7 m. The 10th fence post is at the inner boundary of the bounding shear zone, and it is offset about 1.04 m.
