U.S. DEPARTMENT OF THE INTERIOR
U.S. GEOLOGICAL SURVEY

**BROAD BELTS OF SHEAR ZONES AS THE COMMON FORM OF SURFACE
RUPTURE PRODUCED BY THE 28 JUNE 1992
LANDERS, CALIFORNIA, EARTHQUAKE**

Open-File Report 93-348

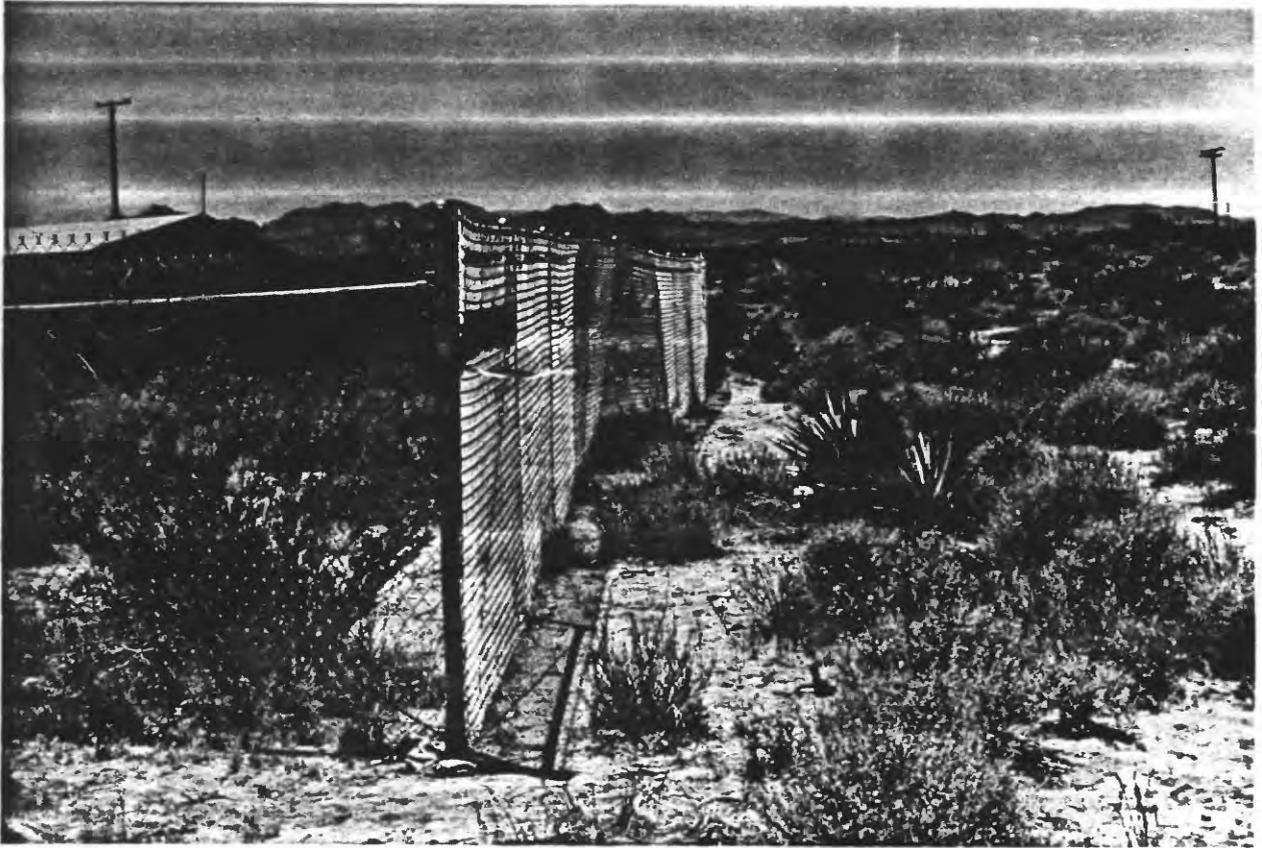
Figure 16. View SW along fence line from north corner, as shown in figure 15. Large offset (0.6 m) between fifth and sixth fence posts and total offset of 1.2 m across broader zone.

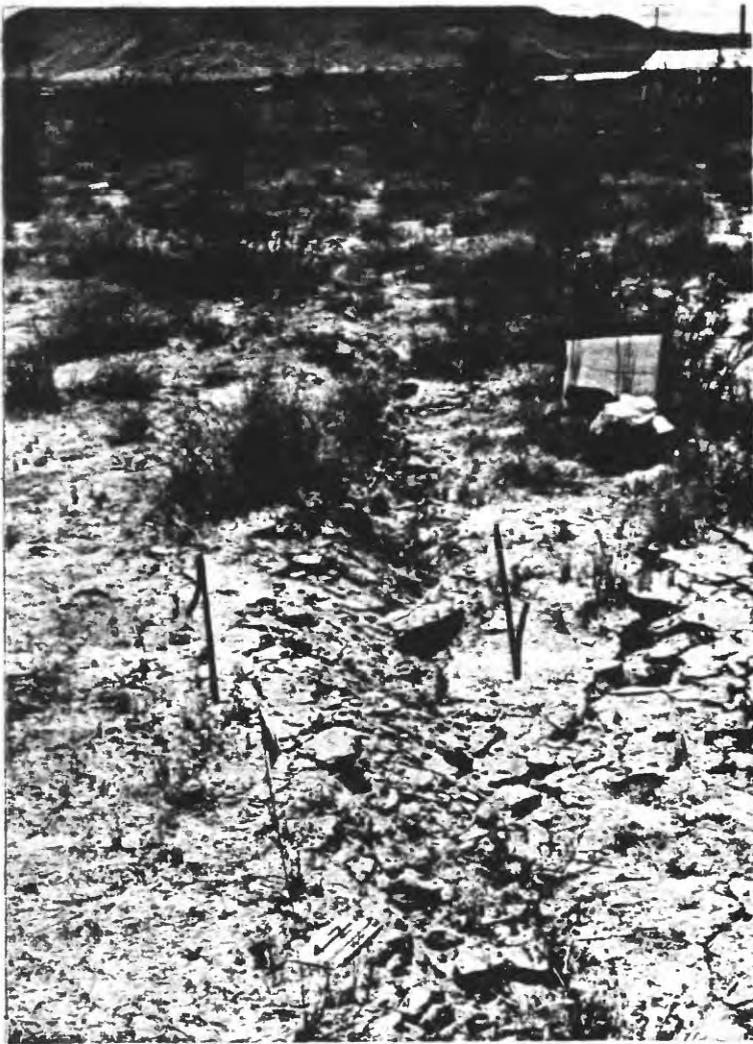
A.

Figure 17. NE wall of bounding narrow shear zone. Fractures here accommodated about 6 dm of right-lateral offset. A, View SE along scarp on NE side of bounding shear zone. Belt of shear zones to right, unfractured ground to left. N-S tension crack/left-lateral fracture identified with arrows. The scarp here is marked by wedge-shaped mass of loose soil chips (locality I, figs. 6 and 7). In background is ranch and fence shown in figures 15 and 16. B, View NE of vertical scarp about 4 dm high facing SW (locality H, figs. 6 and 7) at the NE wall of the belt of shear zones at Bodick Road. Scarp defined by zone of subparallel fractures. Note rough, irregular surface of bounding fracture indicating formation in tension. Small crack, marked c, visible several meters NE of belt of shear zones. Small crack shown on map (locality H, fig. 7).

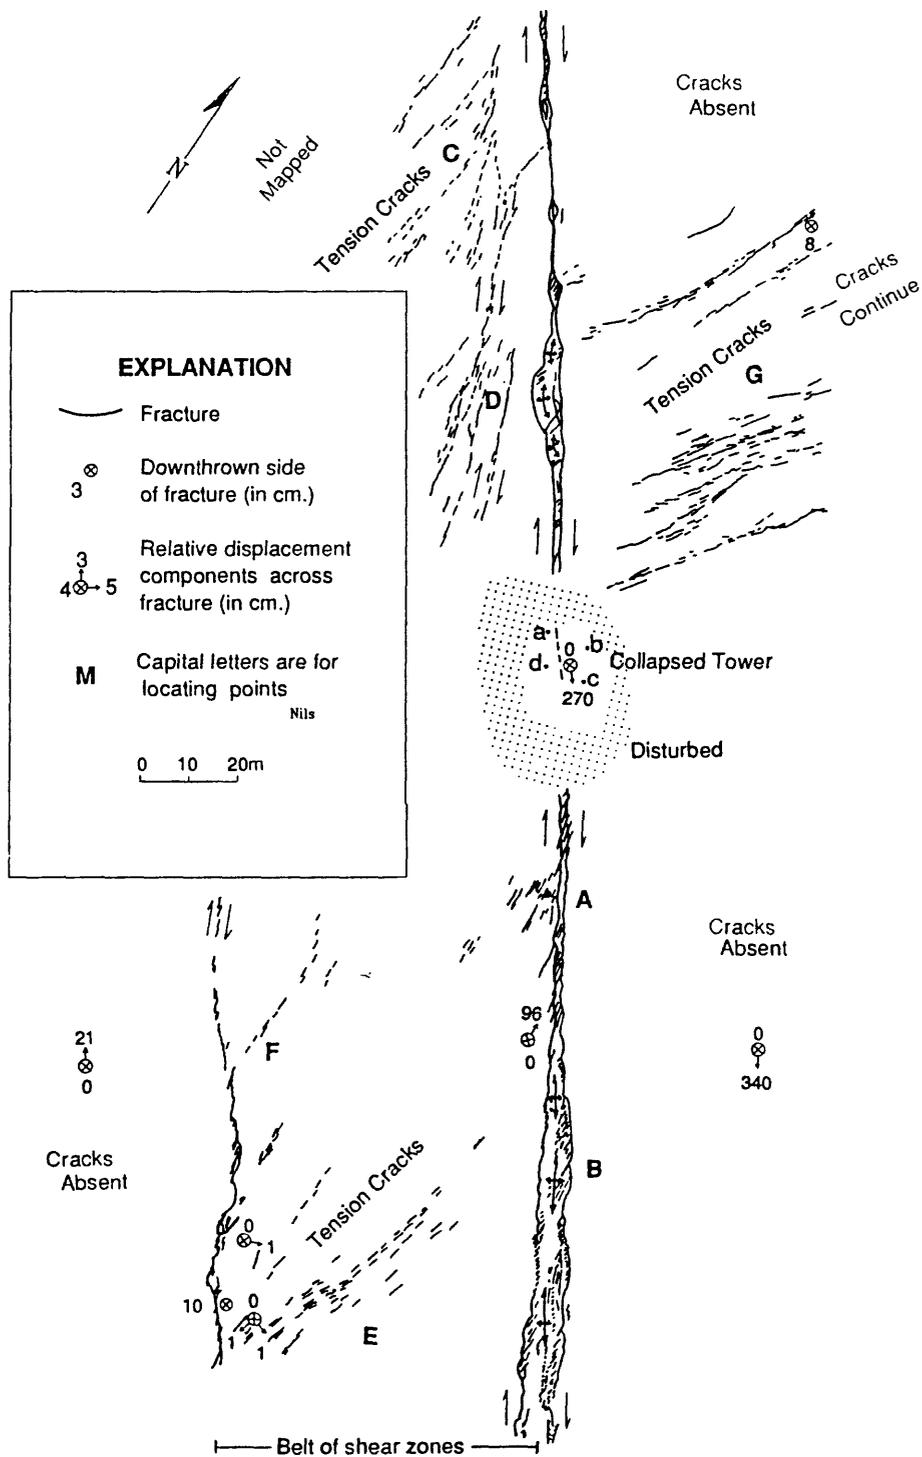
Figure 19. Synoptic map of fractures that define the rupture zone along the Emerson fault where the single-tower powerline crosses the fault (fig. 17). Overall shift across belt about 3.6 m. Belt of shear zones about 60 m wide here (compared to 160 m at Bodick Road). Each side of belt defined by relatively straight, narrow shear zones. Narrow shear zone on right (NE) side accommodated about 2.7 m of right-lateral shifting, according to analysis of deformed legs of tower that straddled this shear zone, shown at midlength of map. Tension cracks within belt of shear zones generally oriented about N-S to N.10°E., whereas tension cracks outside NE side of belt, which apparently are part of a stepover structure with the Camp Rock fault zone, are oriented about N.30°E. to N.40°E.

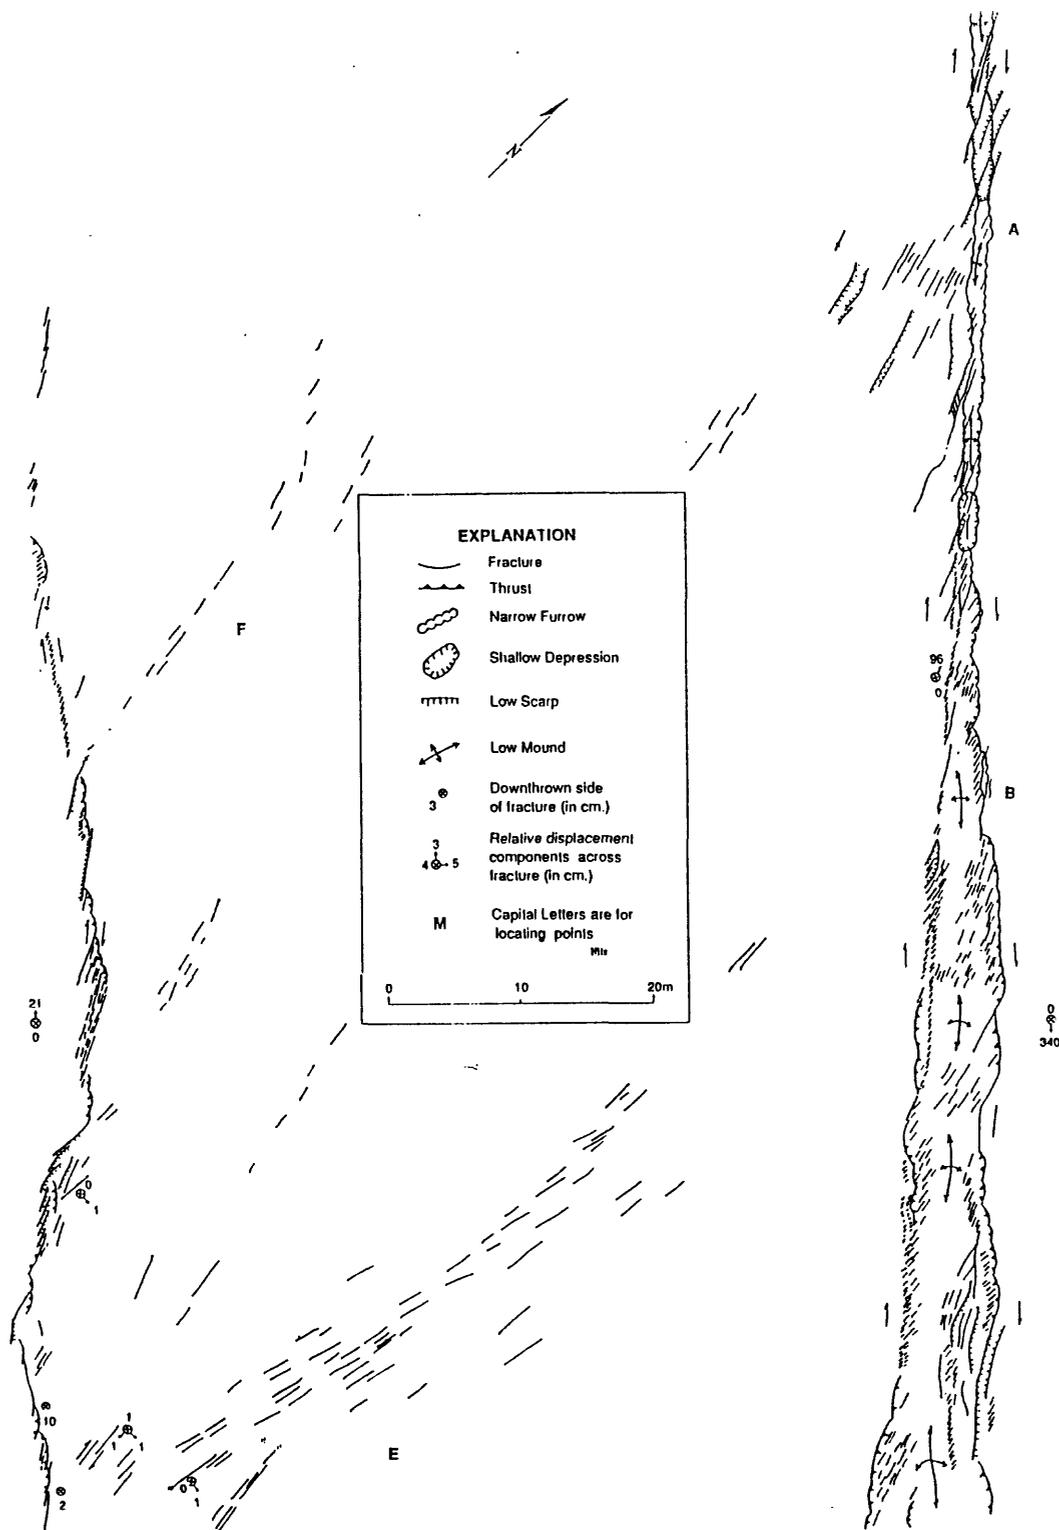
Figure 20. Analytical map of fractures in SE part of powerline area. NE wall of belt marked by narrow shear zone or "mole track" that broadens from a few decimeters to 2 m in NW to about 8 m in SE. This narrow shear zone offset the ground about 2.5 m. It is marked by an echelon fractures, thrusting on one or both sides, and series of low domes and shallow basins along its trace. Only south end of SW wall of belt of shear zones was mapped, although it was traced to NW and SE of area mapped, as shown by double lines in Figure 18. The SW wall is also marked by a narrow shear zone, but the shear zone accommodated only about 2 dm of offset, it is irregular, and appears to be composed of an echelon shear zone segments. Shear zone about 0.5–3 m wide and dominated by long en echelon fractures, thrusts and occasional right-lateral fractures, and narrow bands of en echelon cracks. A few zones of tension cracks, oriented roughly N–S (N.15°W. to N.15°E.), are scattered across the belt of shear zones.

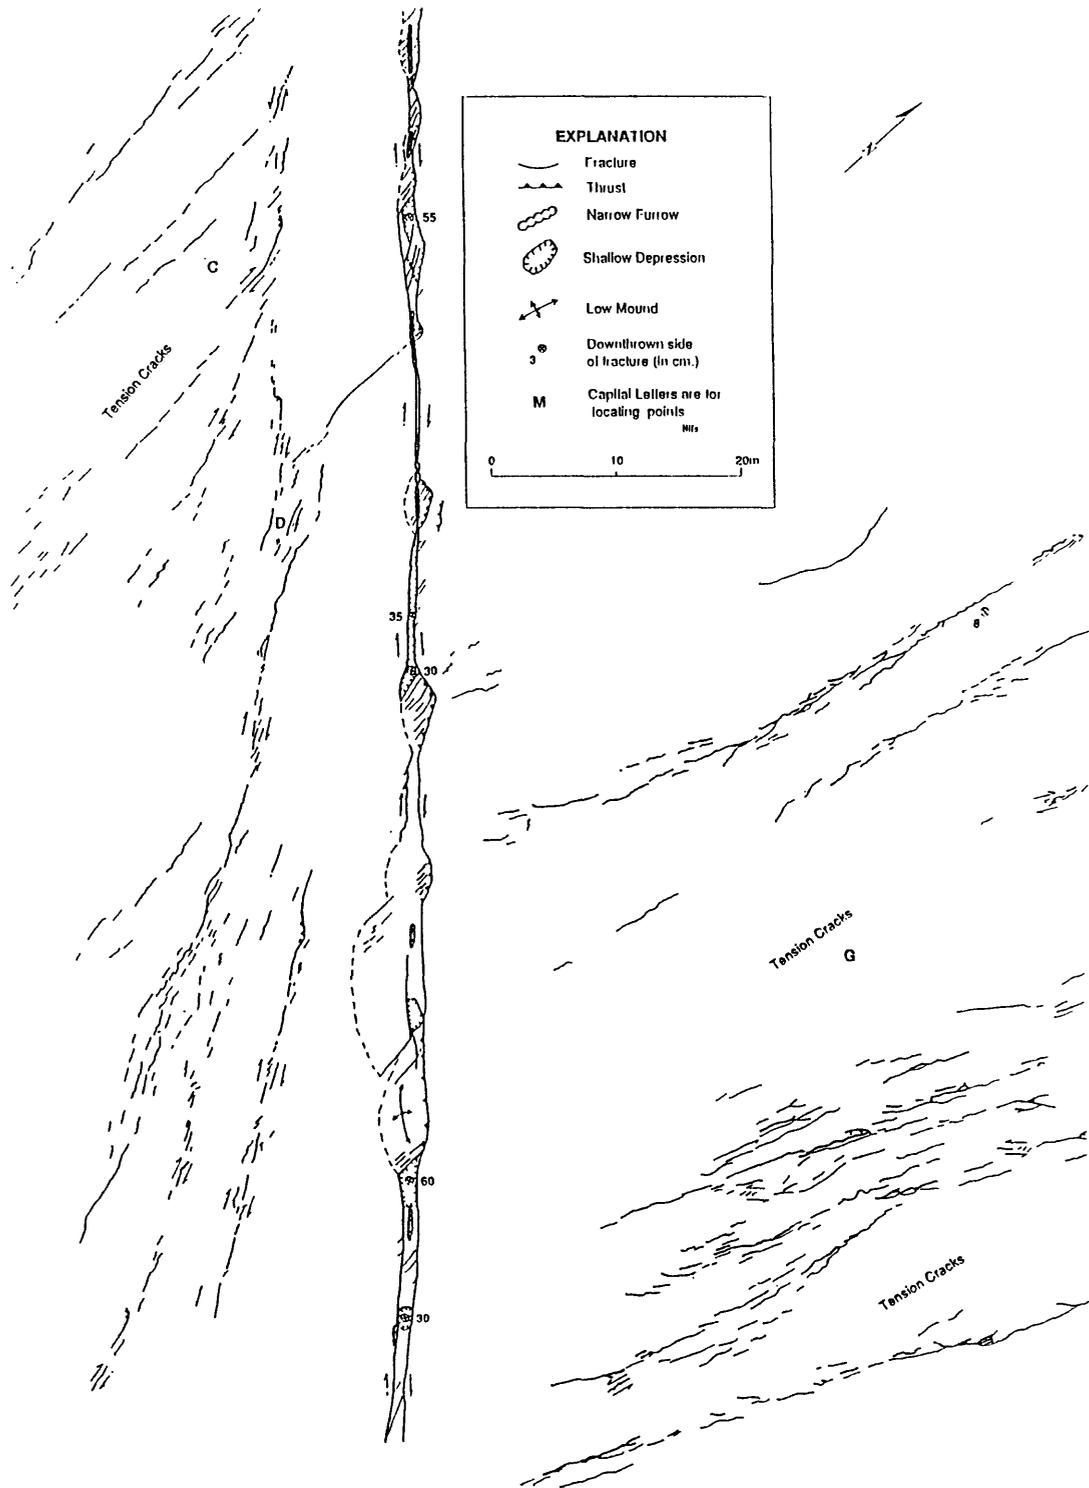
Figure 21. Analytical map of fractures in NW part of single-tower powerline area. Only the ground near the NE wall of the belt was mapped there (fig. 18). Near the NE wall, there are a few narrow zones of right-lateral shearing (C and D) subparallel (inclined at a small clockwise angle) to the walls of the shear zone. The narrow shear zone along the NE wall of belt is a "mole track" that pinches to a width of perhaps 3 dm and swells to a width of 6 m along its length. This is the shear zone that offset the ground about 2.5 m. It contains many en echelon fractures and there are thrusts on one or both sides of the zone; the axis of the shear zone consists of a series of low domes and shallow basins. In a few places, there is a very narrow furrow, perhaps marking the trace of a fault below. To the NE of the NE wall of the belt (at locality G) is a swarm of tension cracks oriented 60° to 70° clockwise from wall of belt. The tension cracks have been traced about 0.5 km to the NE, across the valley. They presumably connect with the Camp Rock fault zone on the NE side of the valley (fig. 18).
