Preliminary Report on Examination of Column Capitals
at the Jefferson Memorial, Washington, D.C.

Elaine S. McGee and Mary E. Woodruff

Open-File Report 93-350

1993

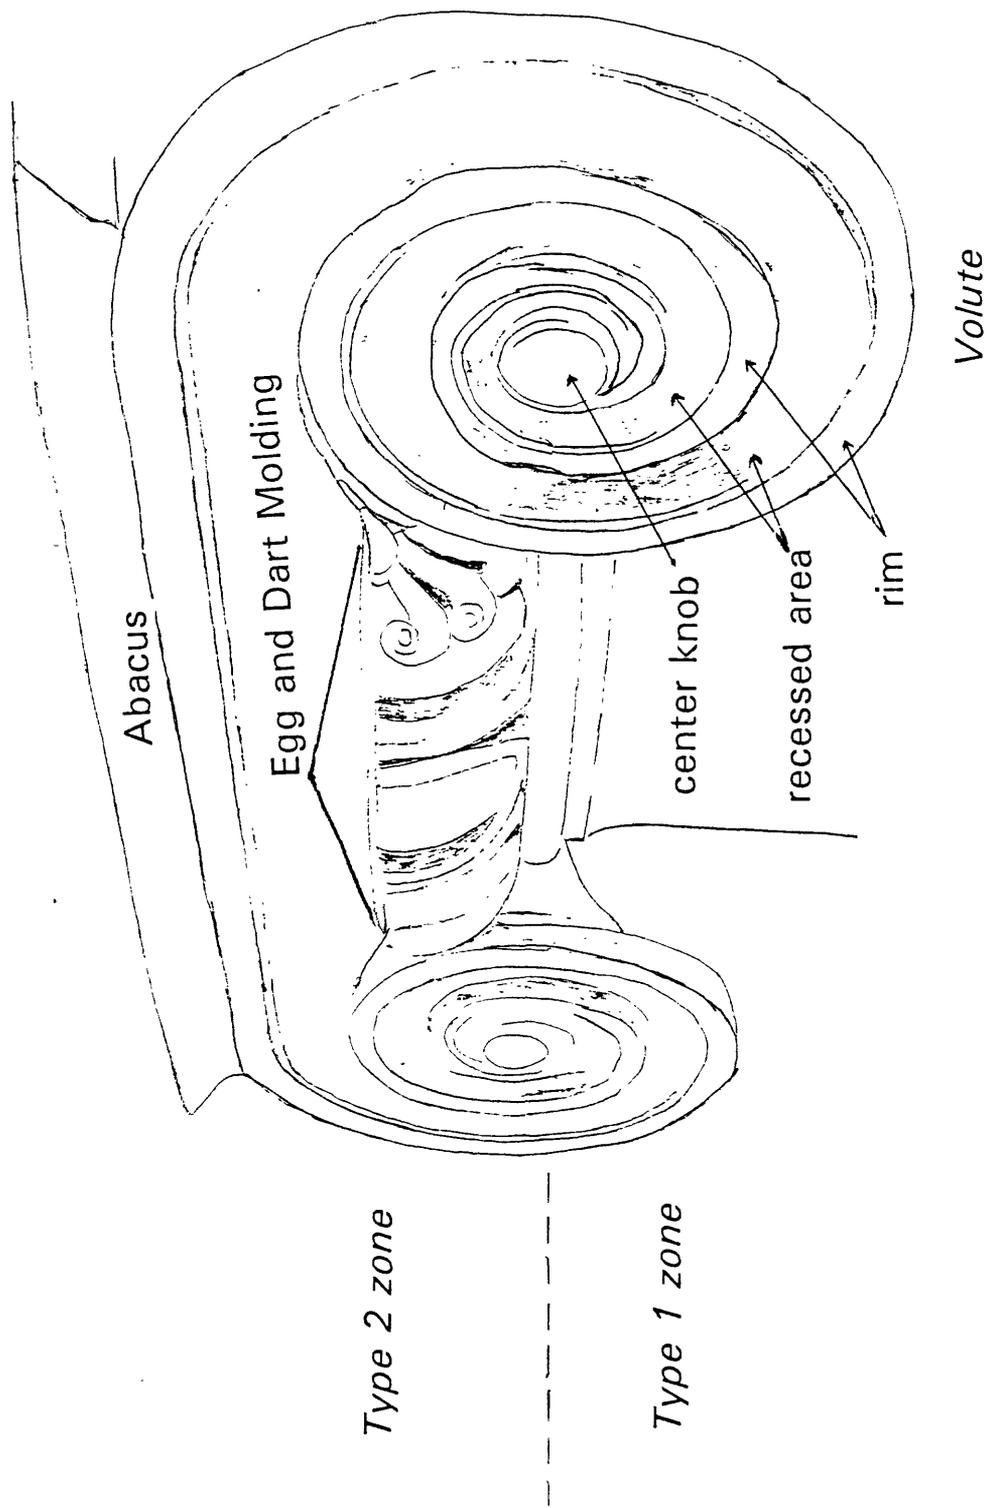
We use three categories for cracks on the capitals, to indicate the general location of the crack and to aid comparisons with the broken volutes. **Type 1** cracks are linear openings in the lower half of the volute; they are found on the volutes in the same general area as the fracture planes where some pieces were removed earlier (Fig. 2 A,B) (McGee, 1991). **Type 2** cracks are also fine lines or openings, but are

located at the center knob or above, where the stone is more massive (Fig. 2 A,C). We suspect that these cracks are less likely to lead to failure of the volute than type 1 cracks, because of the geometry and the mass of stone that would be involved. **Type 3** indicates the loss of small pieces of stone anywhere on the capital, and may also reflect poor local integrity of the stone; this type does not appear to indicate future loss of larger pieces (Fig. 2 A,D). Typically type 3 flaws are located near the designated volute, usually on the abacus corner or on the egg and dart trim. We have found a few horizontal cracks on the backs of some volutes (on the flared part); these are identified as type 1 or type 2, based on which region they would fall into if a plane were extended from the crack to the face of the volute.

Figure 2A. Parts of a column capital and area of Type 1 and Type 2 cracks.

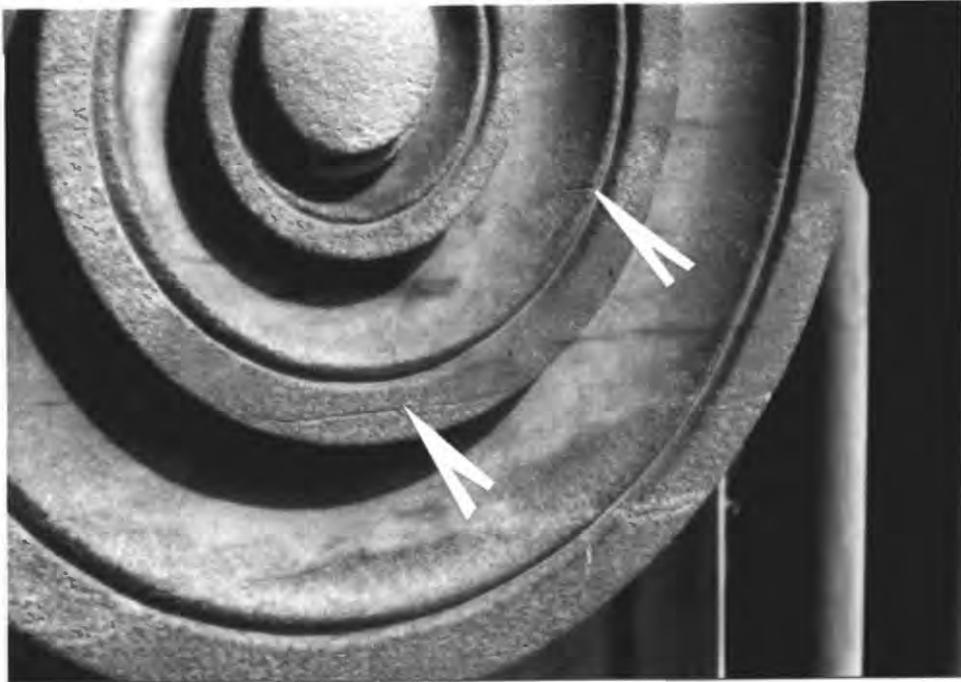
Figure 2B. Example of Type 1 cracks, volute # 33B.

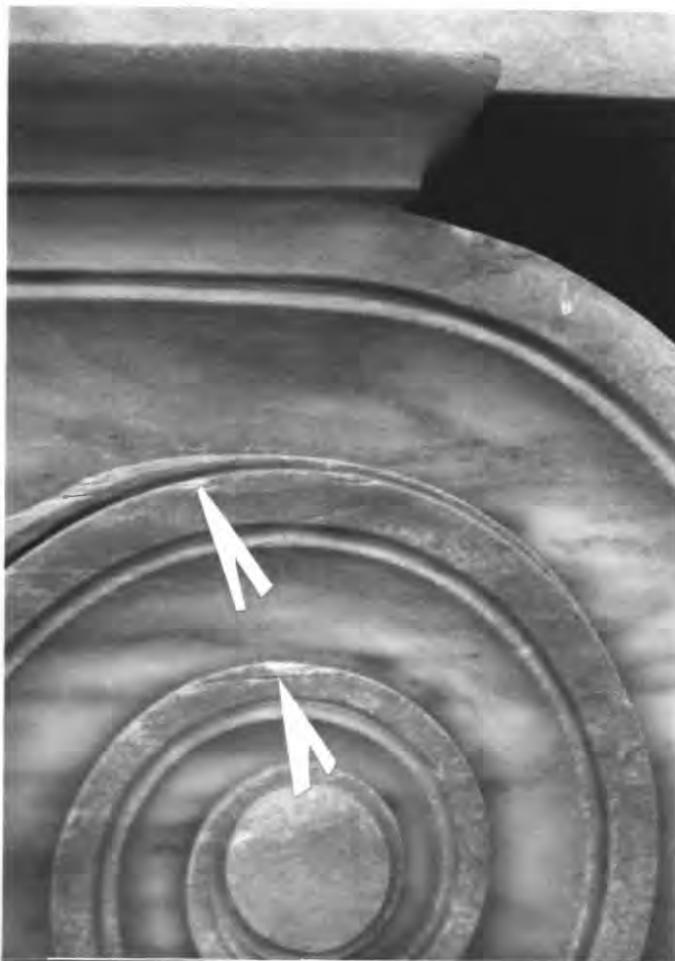
Figure 2C. Example of Type 2 cracks, volute # 26B.

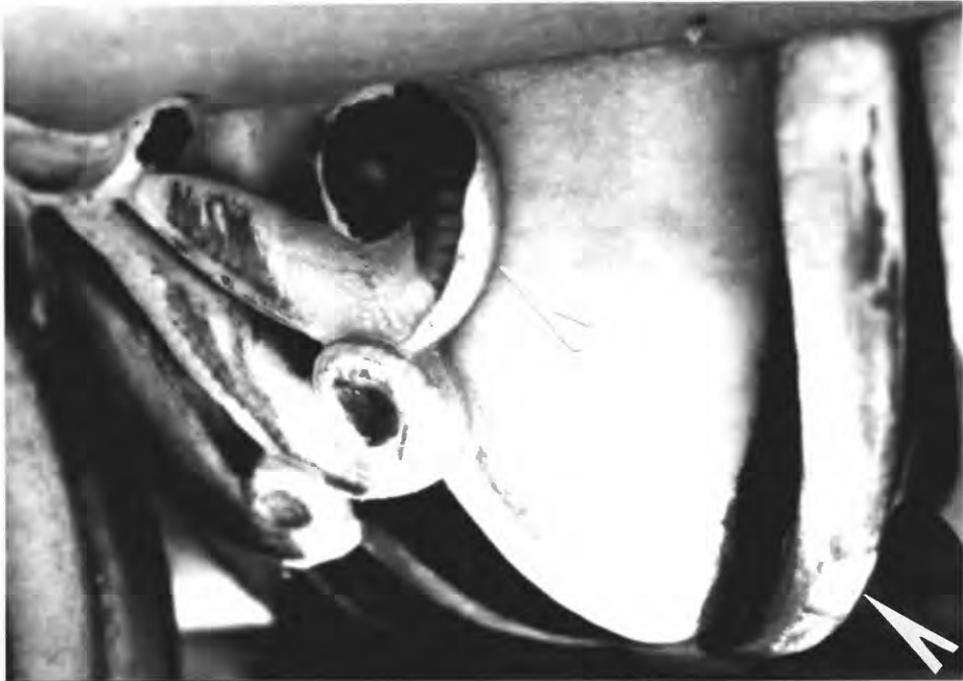
Figure 2D. Example of Type 3 flaw, egg and dart near volute # 19A.

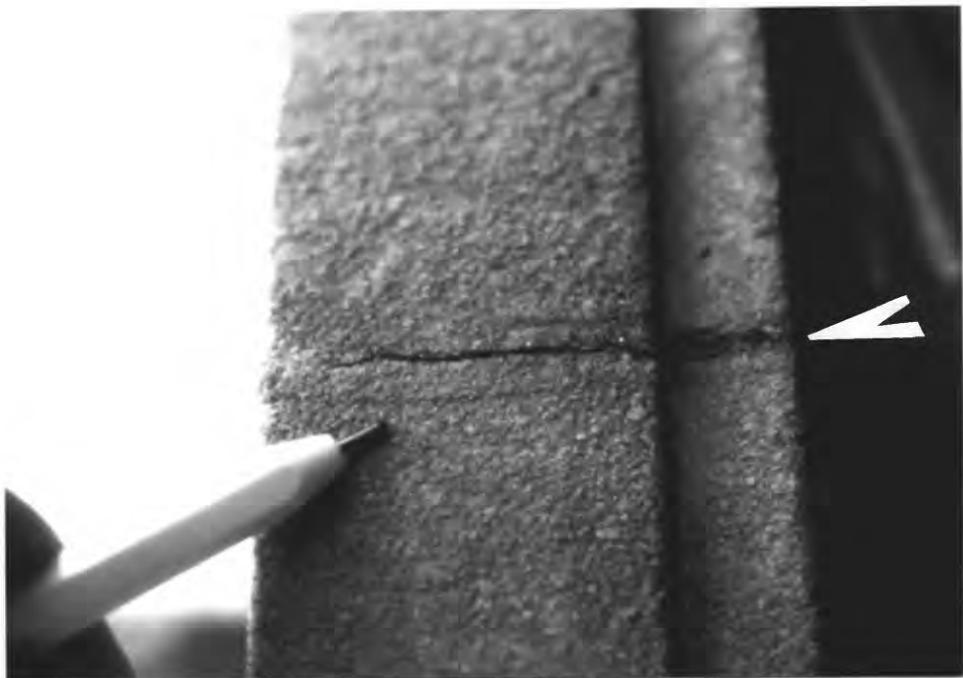
Some of the cracks we have identified are clearly related to inclusion traces in the marble (Fig. 3). The crack occurs among inclusion traces, and sometimes small pieces of mica (the typical inclusion phase) can be seen in the bottom of the crack. Other cracks occur where there is no evidence of any inclusions, but there appears to be a slight change in the coloration or texture of the calcite grains in the area of the crack (Fig. 4). We identify these features as "grain changes" and we believe they indicate a textural change in the marble that may reflect a zone of weakness from former shear planes that were present when the marble formed. On some volutes it is impossible to tell whether inclusion planes or textural changes exist where there is a crack (Fig. 5). These features were most difficult to identify on sheltered volutes that retain some of the stone surface finish, or on volutes that have accumulated surficial alteration crusts. We tried to document correlations between cracks and inclusion traces or grain changes, whenever it was possible to identify them, because these features may give clues to why the cracks occur where they do.

Figure 3. Crack along a mica inclusion, volute # 36B.

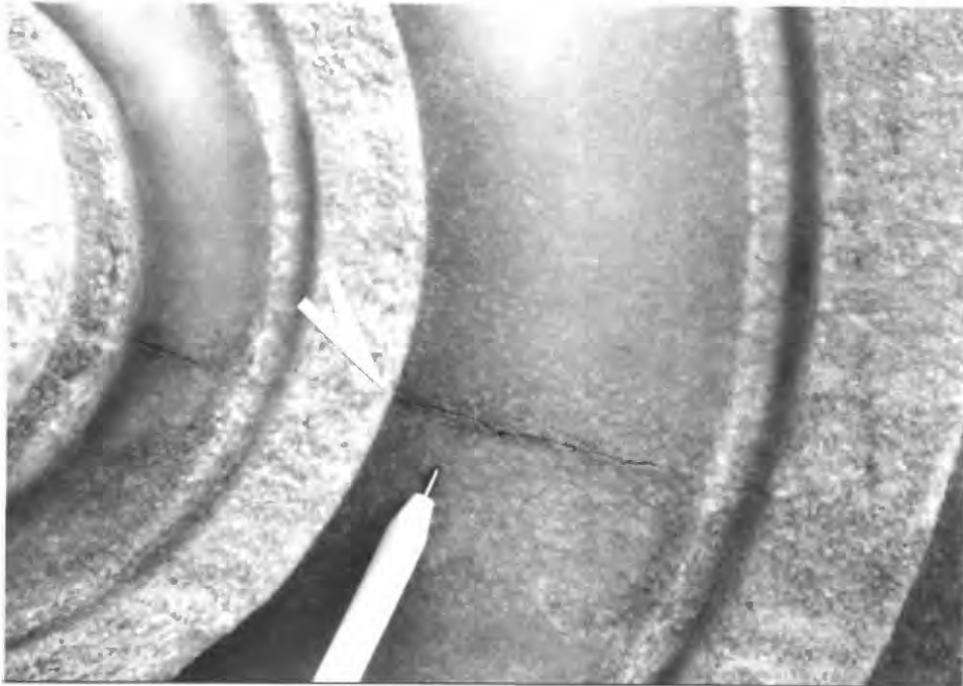
Figure 4. Crack associated with a texture or grain change, volute # 27B.

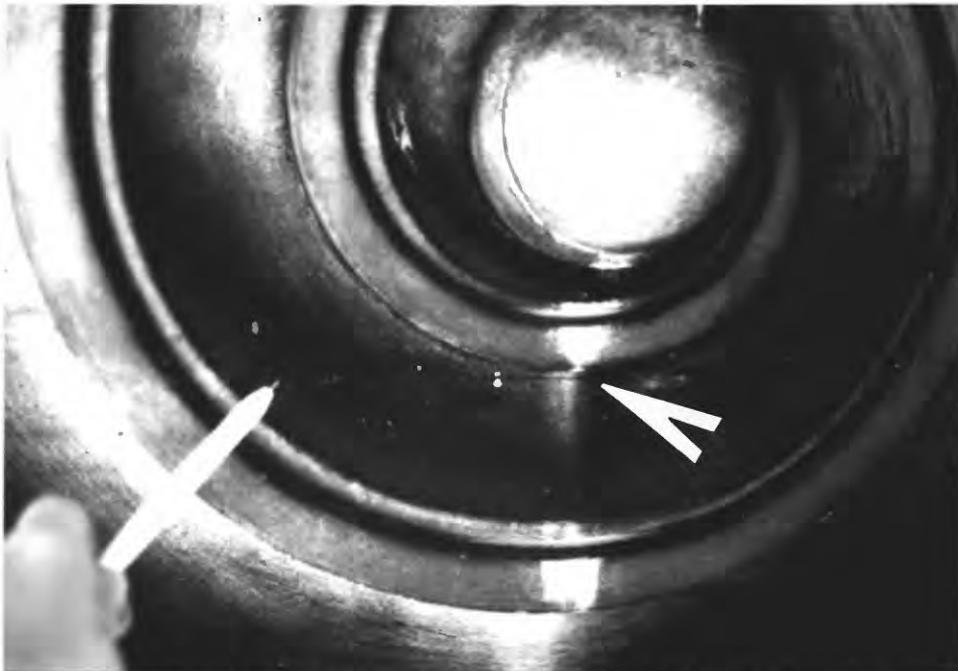
Figure 5. The blackened alteration crust on volute # 10C obscures grain and inclusion features that might be associated with the crack.

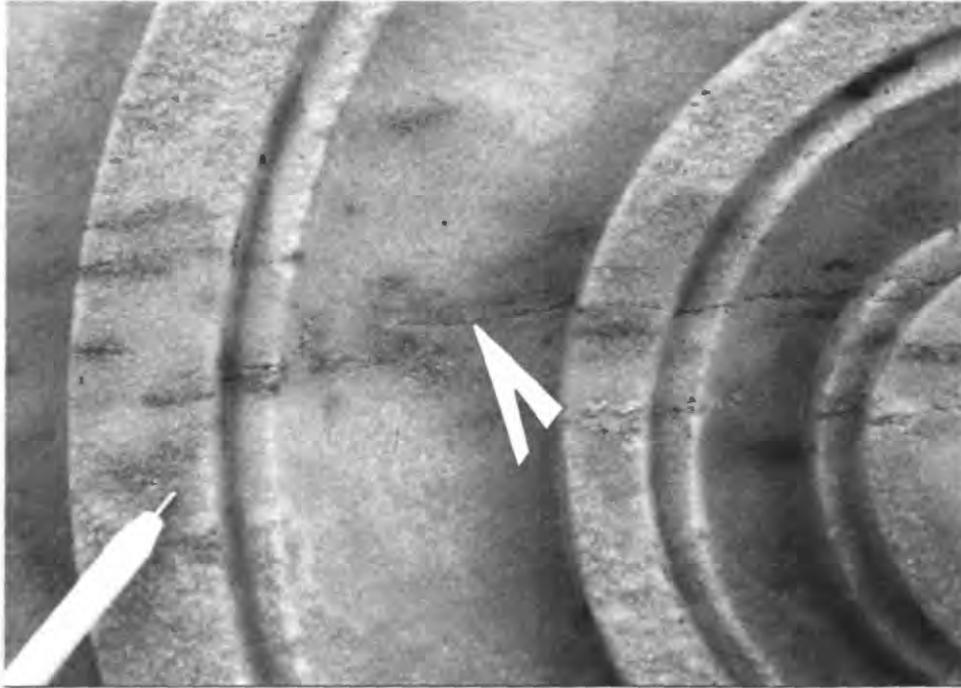
Cracks in the volutes occur singly and in clusters. Some exposed volutes have inclusion rich areas that have developed clusters of cracks (Fig. 6). Of greatest concern are volutes where several cracks appear to be collinear, and appear at several points on the volute face, at approximately the same distance from the bottom of the volute (Fig. 7). In some cases, traces of cracks (often associated with inclusions) can be followed around the edge of the volute rim, or a slightly open inclusion trace on the back of a volute appears to be at approximately the same level as a small crack on the face of the volute. Any feature, or combination of features, that indicates the existence of a plane of weakness in the stone is likely to be significant because the volute may fail along such a plane.

Figure 6. Some cracks are clearly associated with inclusion rich areas; volute # 18C.

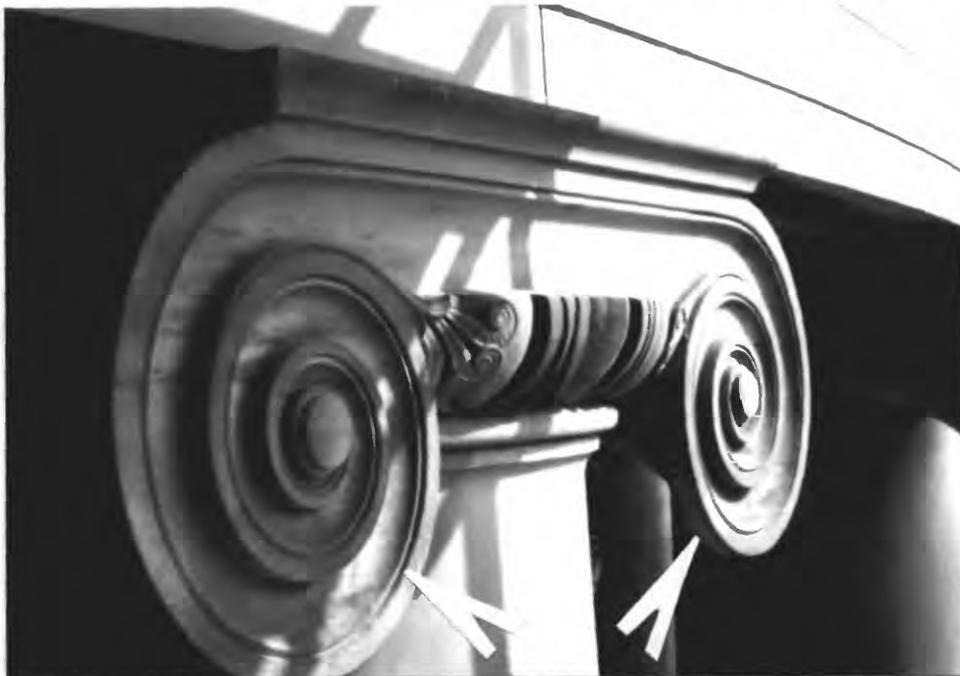
Figure 7. Collinear cracks cross both the B and C volutes on column # 33. Note that the cracks are difficult to see even from a small distance (compare with Figure 2B).

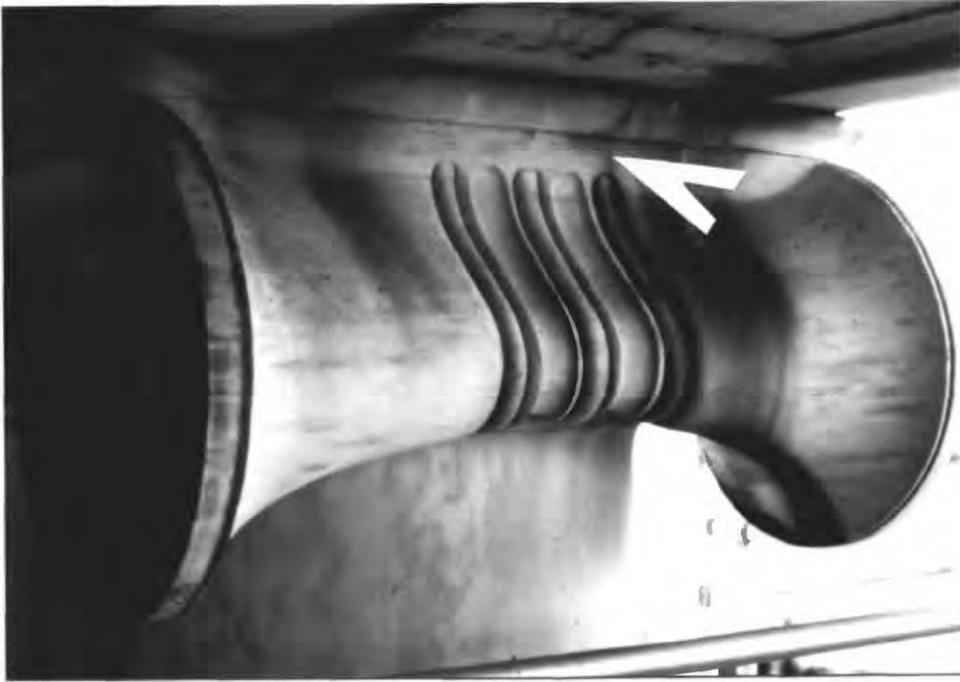
We found unusual cracks on two column capitals, but we have not included them in the tabulations or our discussions because they appear to be unrelated to the problem of the broken volutes. Columns 19 C-D & 18 C-D both have a vertical crack that extends from the abacus into the scroll between the C and D volutes (Fig. 8). There is no inclusion trace or evidence of grain change at either place.² These cracks are unusual because of their vertical orientation; we have not seen cracks that trend in such a manner on any other capitals examined to date. It is possible that these cracks may be caused by structural problems (e.g., building settling). These columns are in the vicinity of column 54 which has a similar vertical crack in the top drum of the column shaft, and was monitored in a study by Hartman-Cox Architects (1991). The columns are also in an area of the Memorial that shows signs of settling.

Figure 8A. Vertical crack on column 19, between C and D volutes.

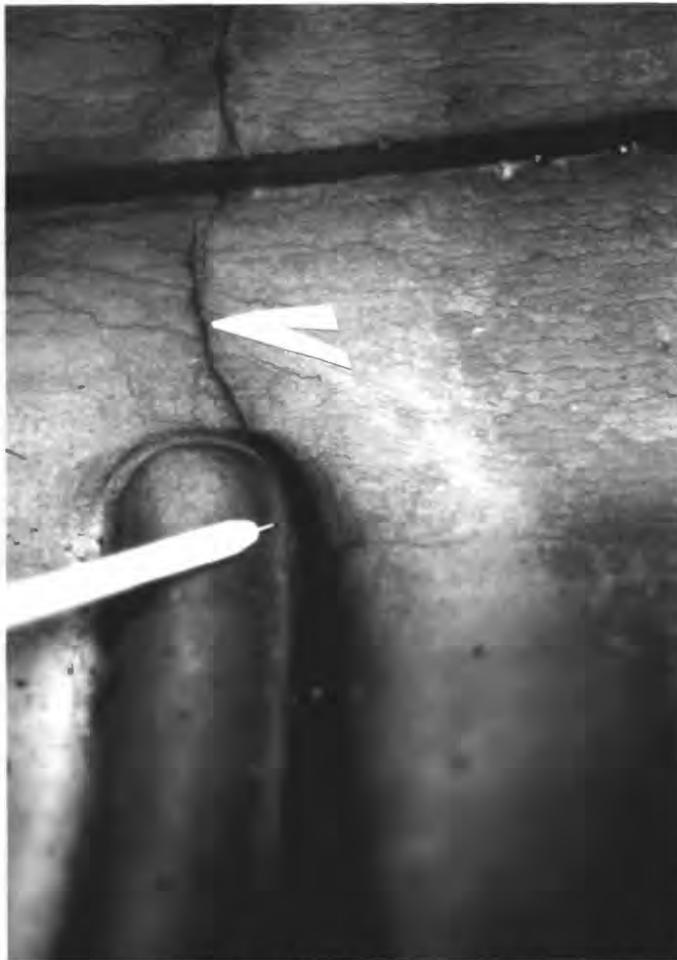
Figure 8B. Detail of the crack on 19 C-D; the crack continues along the bottom of the groove to the right of the pen tip.

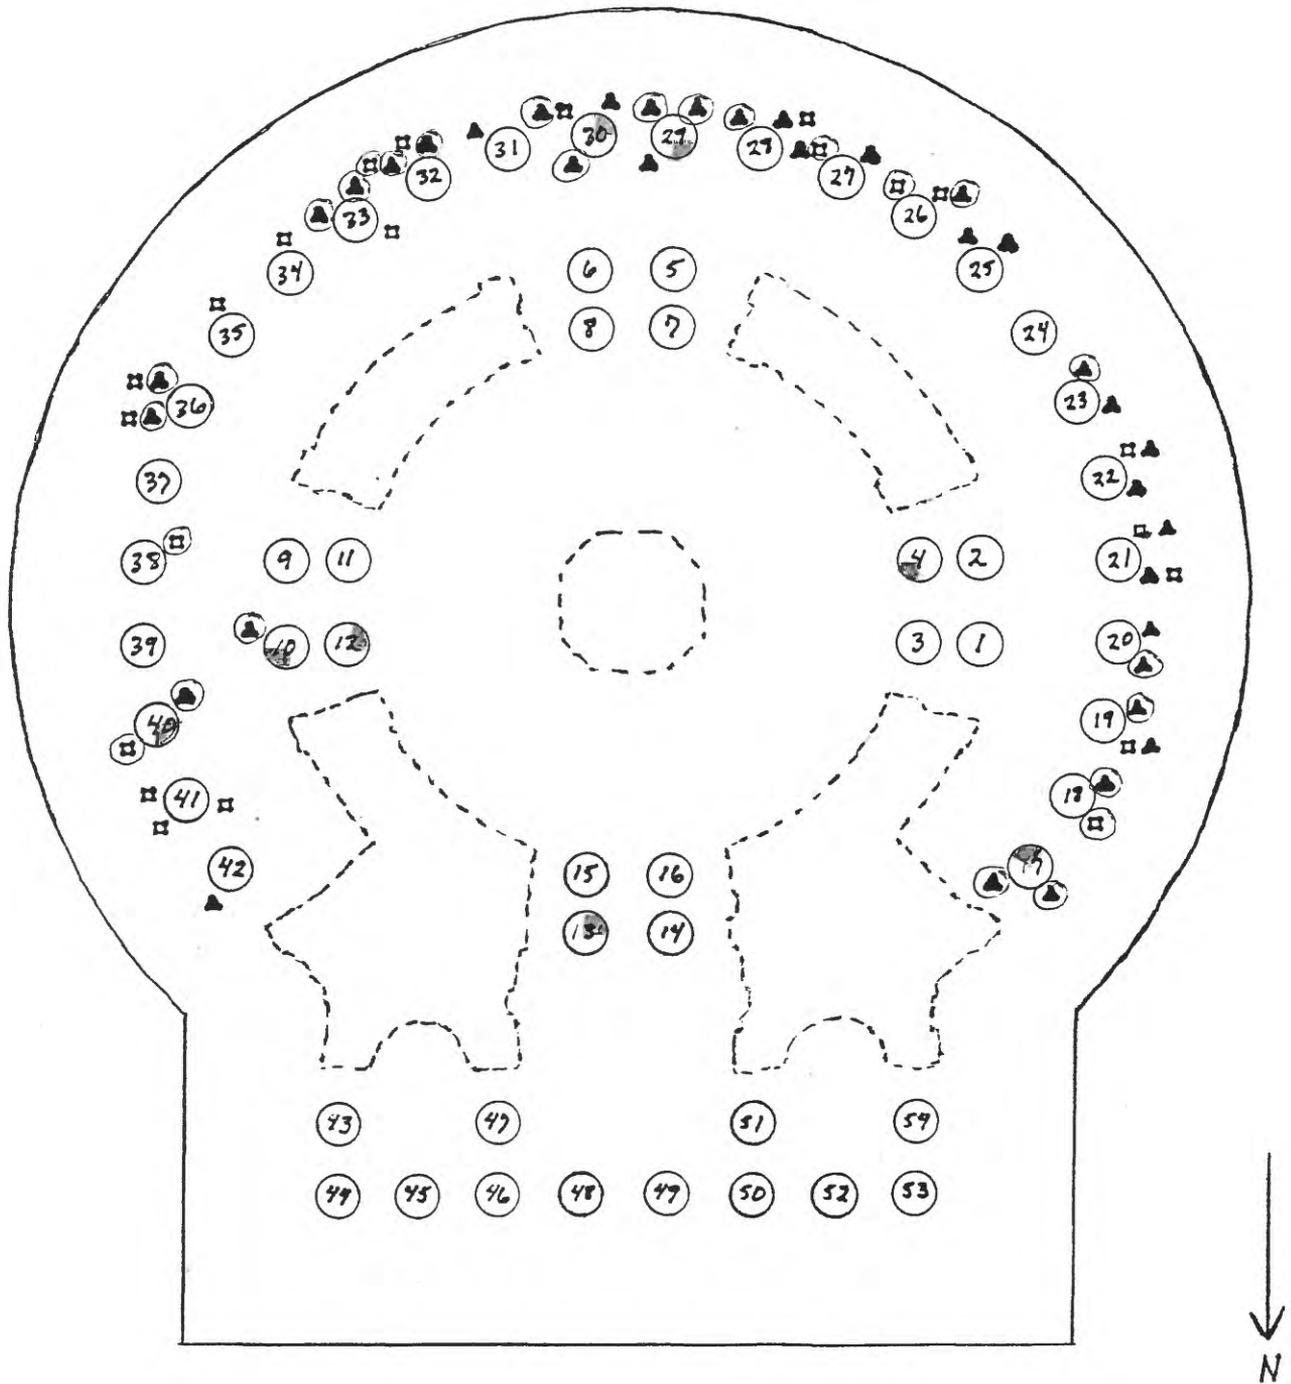
The cracked volutes are evenly distributed around the Memorial, as are the column capitals from which pieces fell or were removed (Fig. 9). It appears that open cracks are slightly more prevalent on the south side of the Memorial (columns 34 - 25), however the number of open cracks may just reflect a stronger contribution from weathering agents in this area. General observation suggests that outward facing volutes have rougher surfaces in this area of the Memorial compared to volutes on the east and west sides. In addition, the predominant local wind direction is from the south (oral communication, inquiry of National Oceanic and Atmospheric Administration (NOAA)), so the wind may have accentuated small surficial cracks or indentations resulting in more open cracks in this area.

Figure 9. Map of the type 1 and type 2 cracks identified to date.

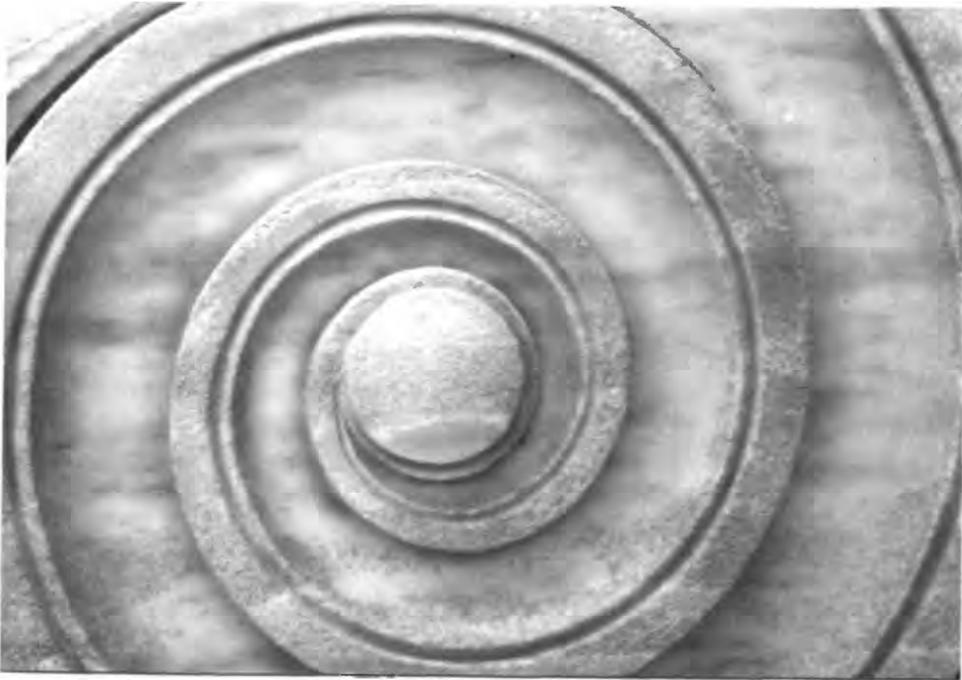
Access to the exterior (B and C) column capitals, that became available in the present study, showed that cracks or possible weaknesses in the marble may be related to textural features of the marble as well as to areas of silicate inclusions. It is much easier to identify features associated with cracks on the volutes that have been exposed to weathering agents. On sheltered volutes, surface polish and accumulated surficial alteration crusts obscure grain texture features, and may even make recognition of inclusion traces difficult. During our examination of the volutes, we have assessed features such as inclusions or changes in the grain size or texture that occur in the vicinity of cracks and indentations. Such features in the marble might reveal why a crack appears at that particular location. Among the main cracks identified in table 2, changes in grain texture around cracks are more common than the presence of inclusions; 22 cracks are associated with grain changes, 11 are associated with inclusions, and in four cases no feature associated with the crack can be identified. While inclusion traces generally occur in clusters or cross several similar parts of a column capital, textural changes are subtle and thus harder to discern. Weathering of the exposed volutes shows textural differences in the marble as bands of coarse, slightly gray grains adjacent to less coarse, tan grains (Fig. 10). X-ray diffraction analysis of samples taken from these adjacent zones showed only calcite,

Figure 10. Textural changes on an exposed volute (# 24B) without any cracks.
