**U.S. DEPARTMENT OF THE INTERIOR
U. S. GEOLOGICAL SURVEY**

**THE SCOTTS MILLS, OREGON, EARTHQUAKE OF
MARCH 25, 1993: INTENSITIES, STRONG-MOTION
DATA, AND TELESEISMIC DATA**

Open-File Report 94-163

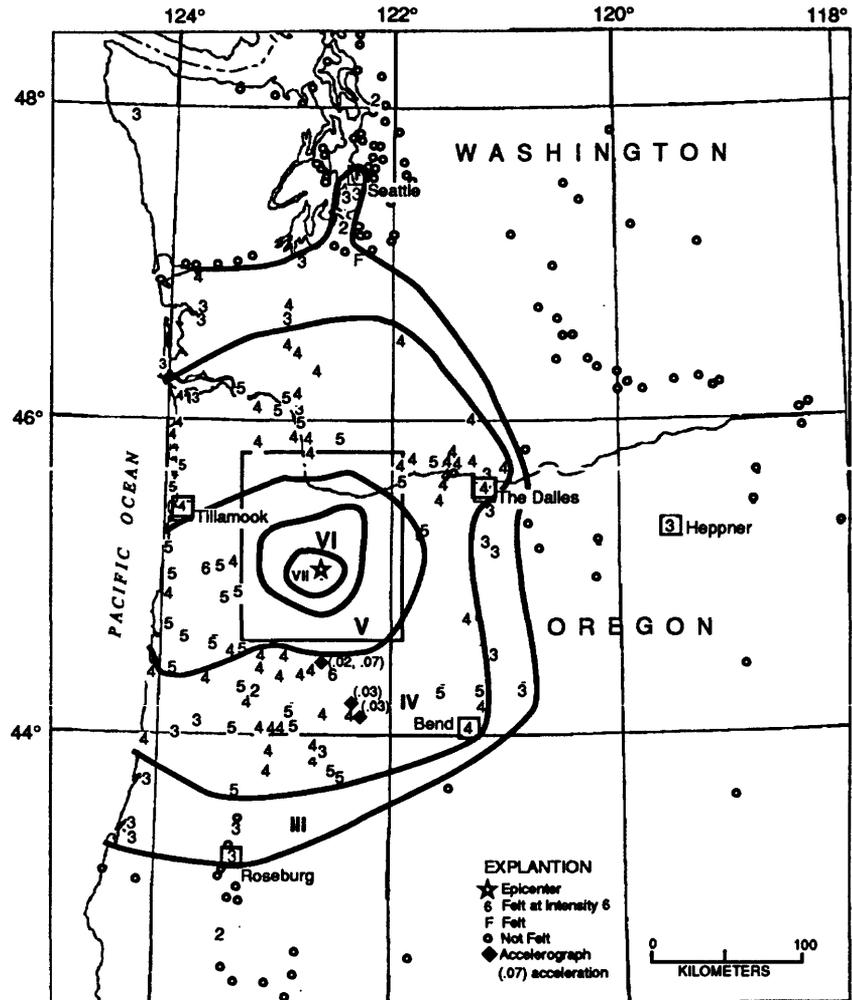
Figure 2. Isoseismal map for the Scotts Mills, Oregon, earthquake of March 25, 1993. Roman numerals represent average Modified Mercalli intensities for the regions between isoseismals; Arabic numerals represent intensities in individual towns or zip-code regions. Squares represent towns identified on the figure. Shown also are three sites at which the U.S. Geological Survey Cooperative Strong-Motion Network accelerographs were triggered in the Scotts Mills earthquake. Peak accelerations in units of g ($1g = \text{local acceleration of gravity, } \sim 980 \text{ cm/sec}^2$) are shown in parentheses next to the accelerograph sites. Multiple values are those recorded by different accelerographs triggered at that site (table 2). Near-source intensities and accelerograph sites are plotted in figure 3, which is an enlarged view of the area within the box.

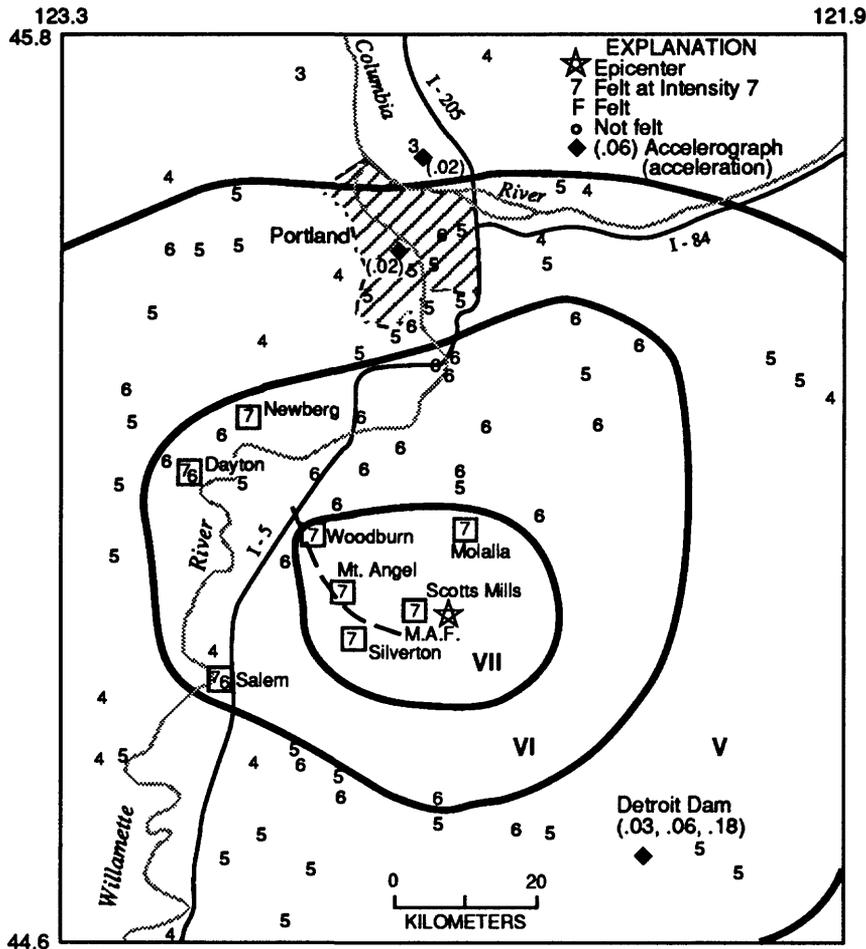
Figure 3. Near-source intensities and sites at which U.S. Geological Survey Cooperative Strong-Motion Network accelerographs were triggered in the Scotts Mills earthquake. Roman numerals represent average Modified Mercalli intensities for the regions between isoseismals; Arabic numerals represent intensities in individual towns or zip-code regions. Squares represent towns identified on the figure. Peak accelerations in units of g ($1g = \text{local acceleration of gravity, } \sim 980 \text{ cm/sec}^2$) are shown in parentheses next to the accelerograph sites. Multiple values shown for Detroit Dam are those recorded by three different accelerographs triggered at that site (table 2). MAF = Mount Angel fault.
