U.S. DEPARTMENT OF THE INTERIOR  
U.S. GEOLOGICAL SURVEY

Preliminary Evaluation of the Fire-Related Debris Flows  
on Storm King Mountain,  
Glenwood Springs, Colorado

Open File Report 95-508

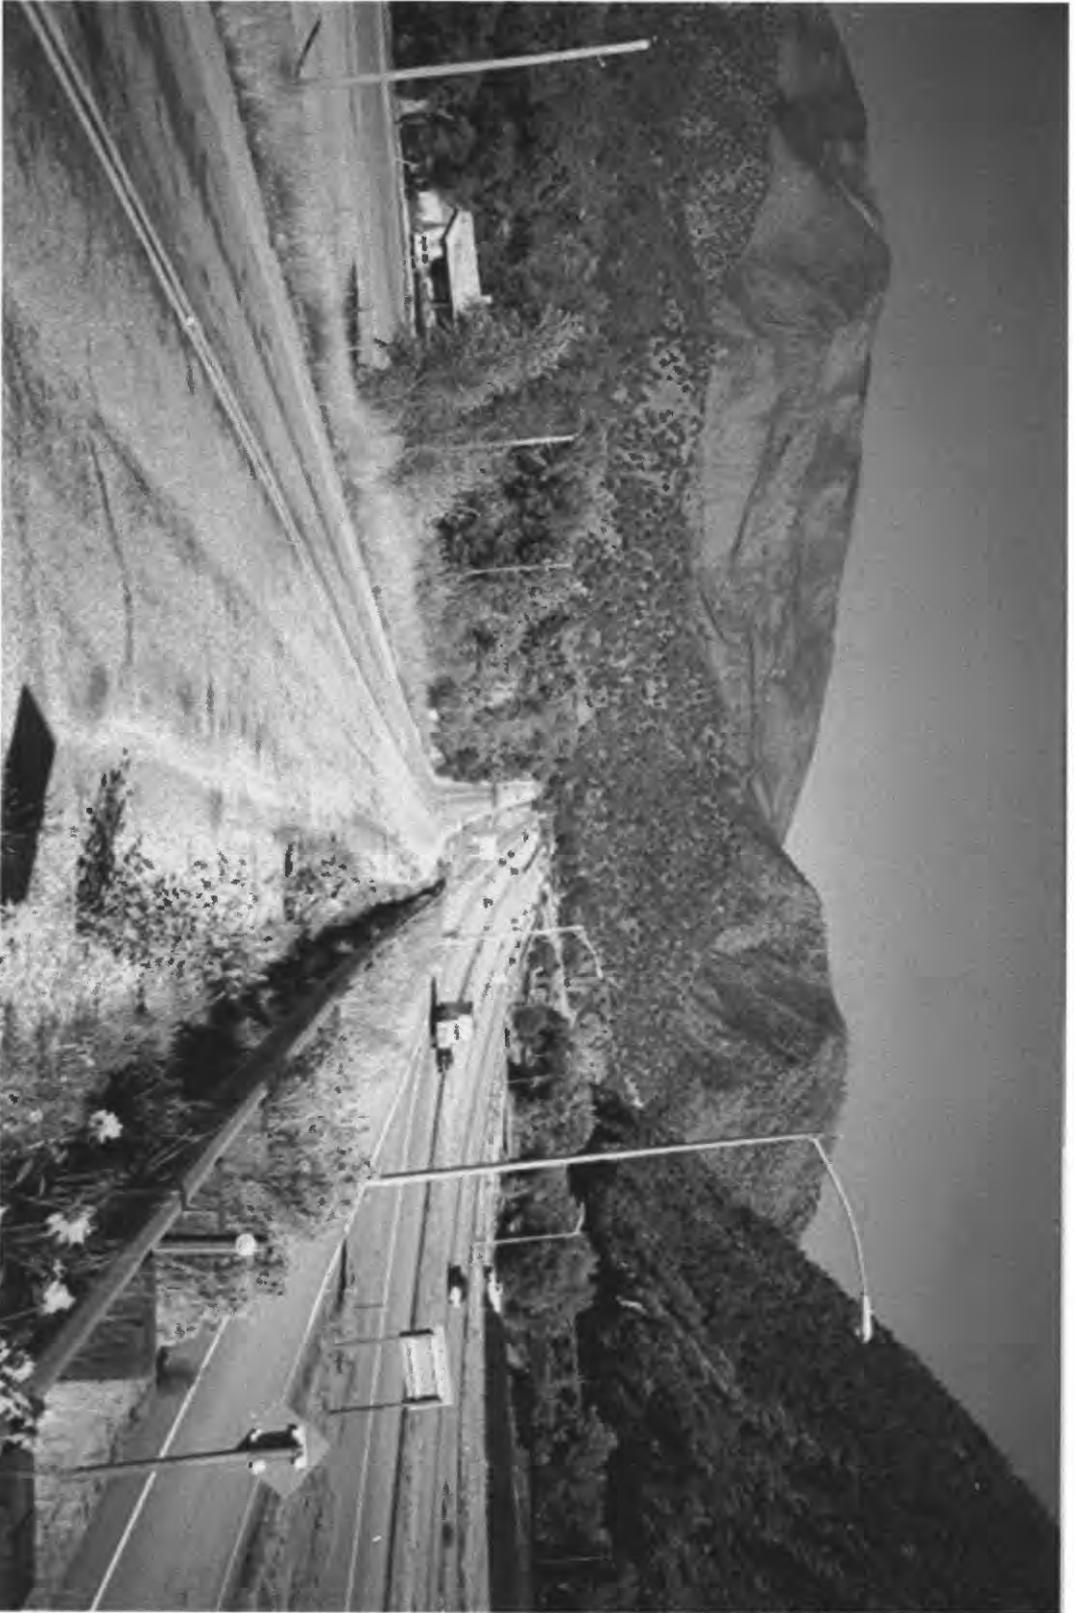
The South Canyon fire burned approximately 2000 acres of pinyon-juniper and mountain shrub vegetative communities (Plate 1 and Figure 2). The most intensely burned area extends from roughly 0.5 mile up the mountain side to near the summit of the mountain, and is characterized by the complete burning of large branches and many major tree trunks, completely burned brush and grass, and the presence of both dark and white ash (Figure 4). Some sandstone outcrops were fractured by the intense thermal stresses. The burnt soil is loose and friable, and approximately 2 to 4 inches in depth (Figure 5). Two samples of burnt soil (taken from the same location but at depths of 0-1 inch and 1-4 inches) were classified as silty sand (Table 1). The grain-size distribution of the burned soil is essentially the same as that for unburned soil (Figure 3A), indicating no discernable alteration in grain-size distribution occurs with burning. The average dry density of three samples of burned soil is 0.026 lb/in<sup>3</sup>.

**Figure 2.** Storm King Mountain after the burn. View is from west to east. Photograph by Pat Rogers, Colorado Geological Survey.

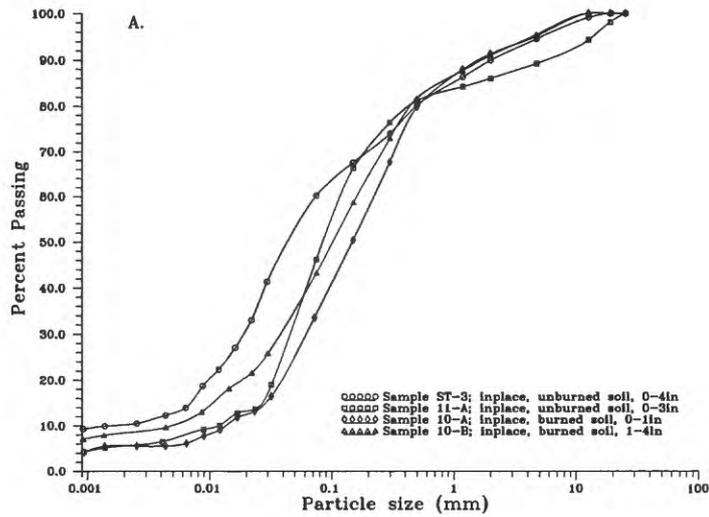
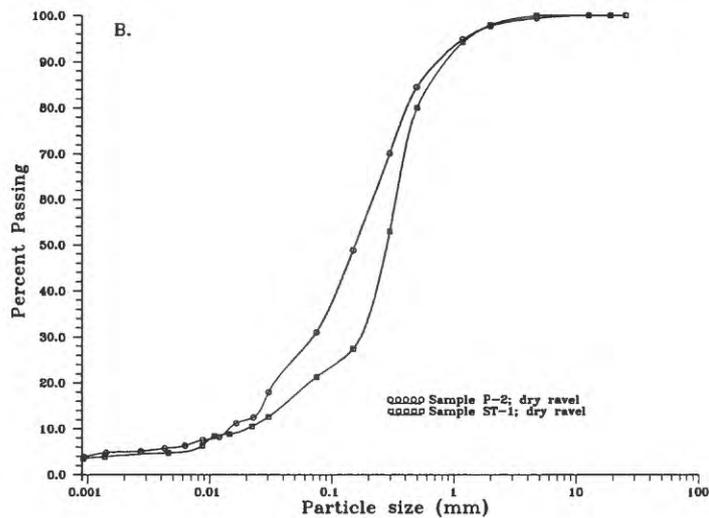
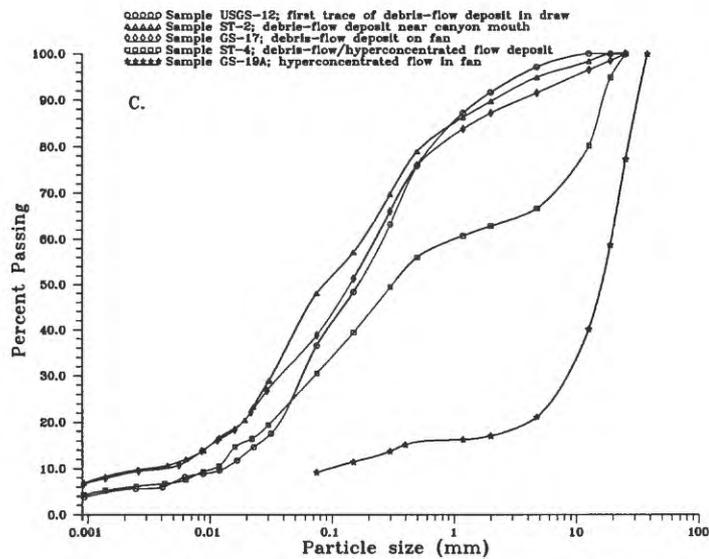
**Figure 3.** Grain-size distribution curves for: A. in-place burned and unburned soils, B. dry ravel material, and C. slurry.

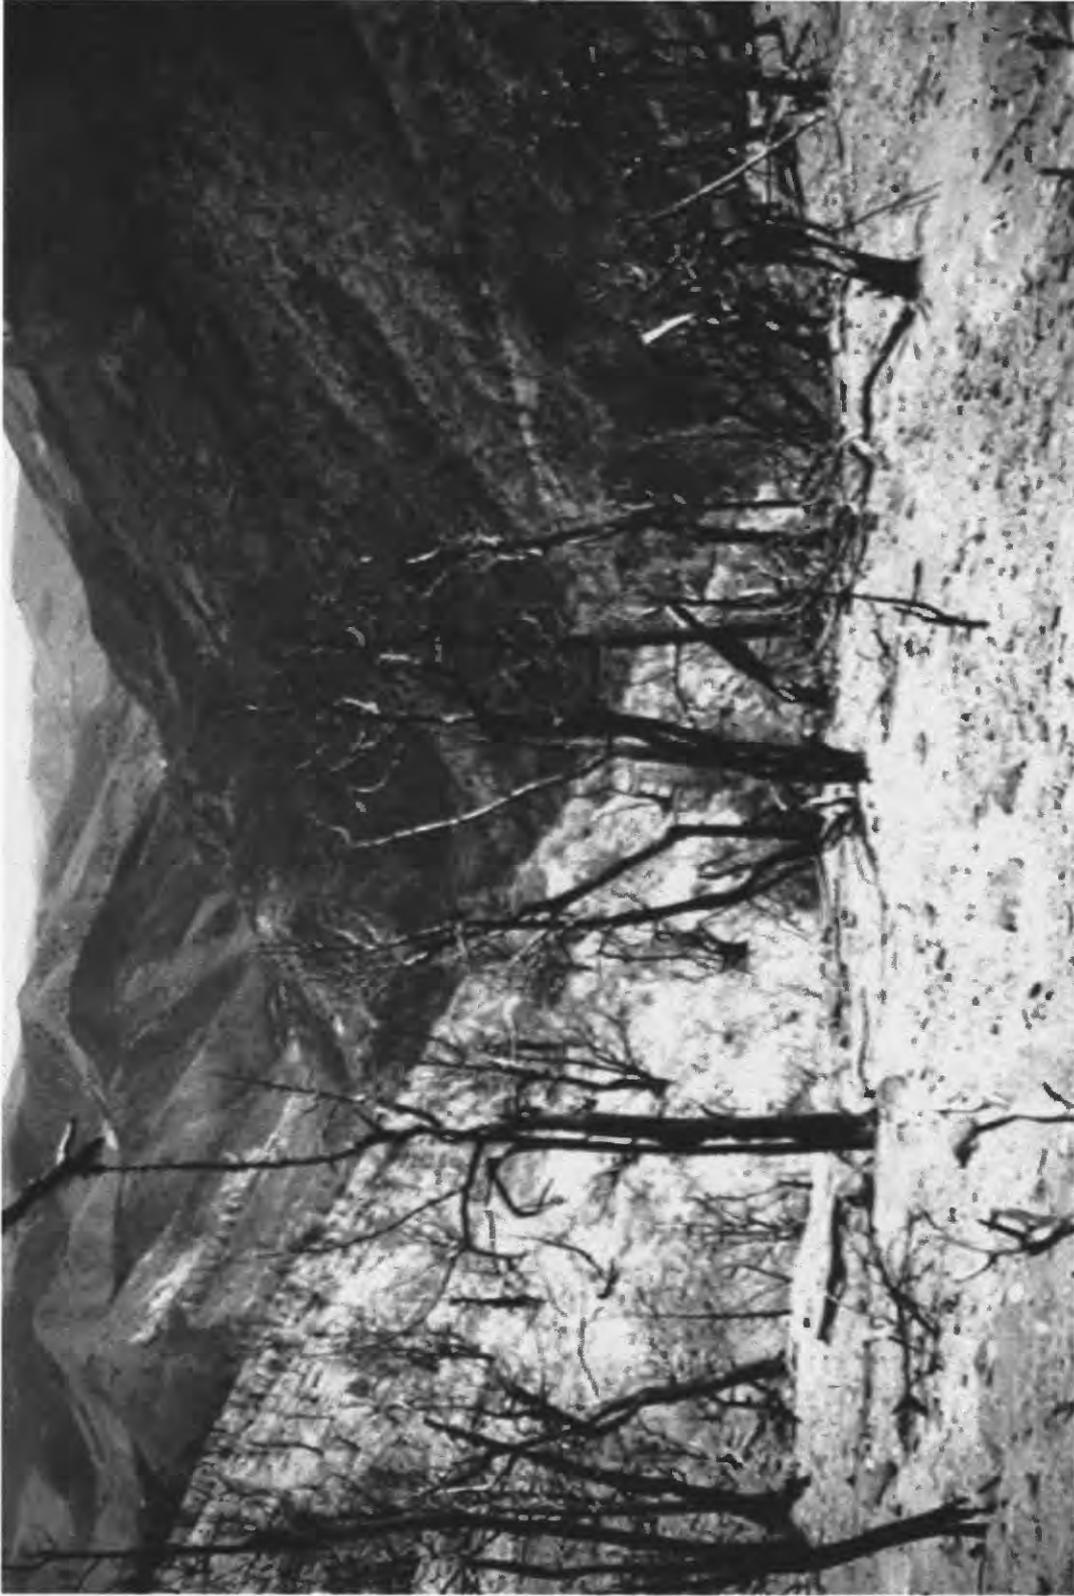
**Figure 4.** Area of intense burn showing degree of destruction of vegetation, and loose surficial soil and white ash in foreground. Photograph by Roger Pihl, Colorado Geological Survey.

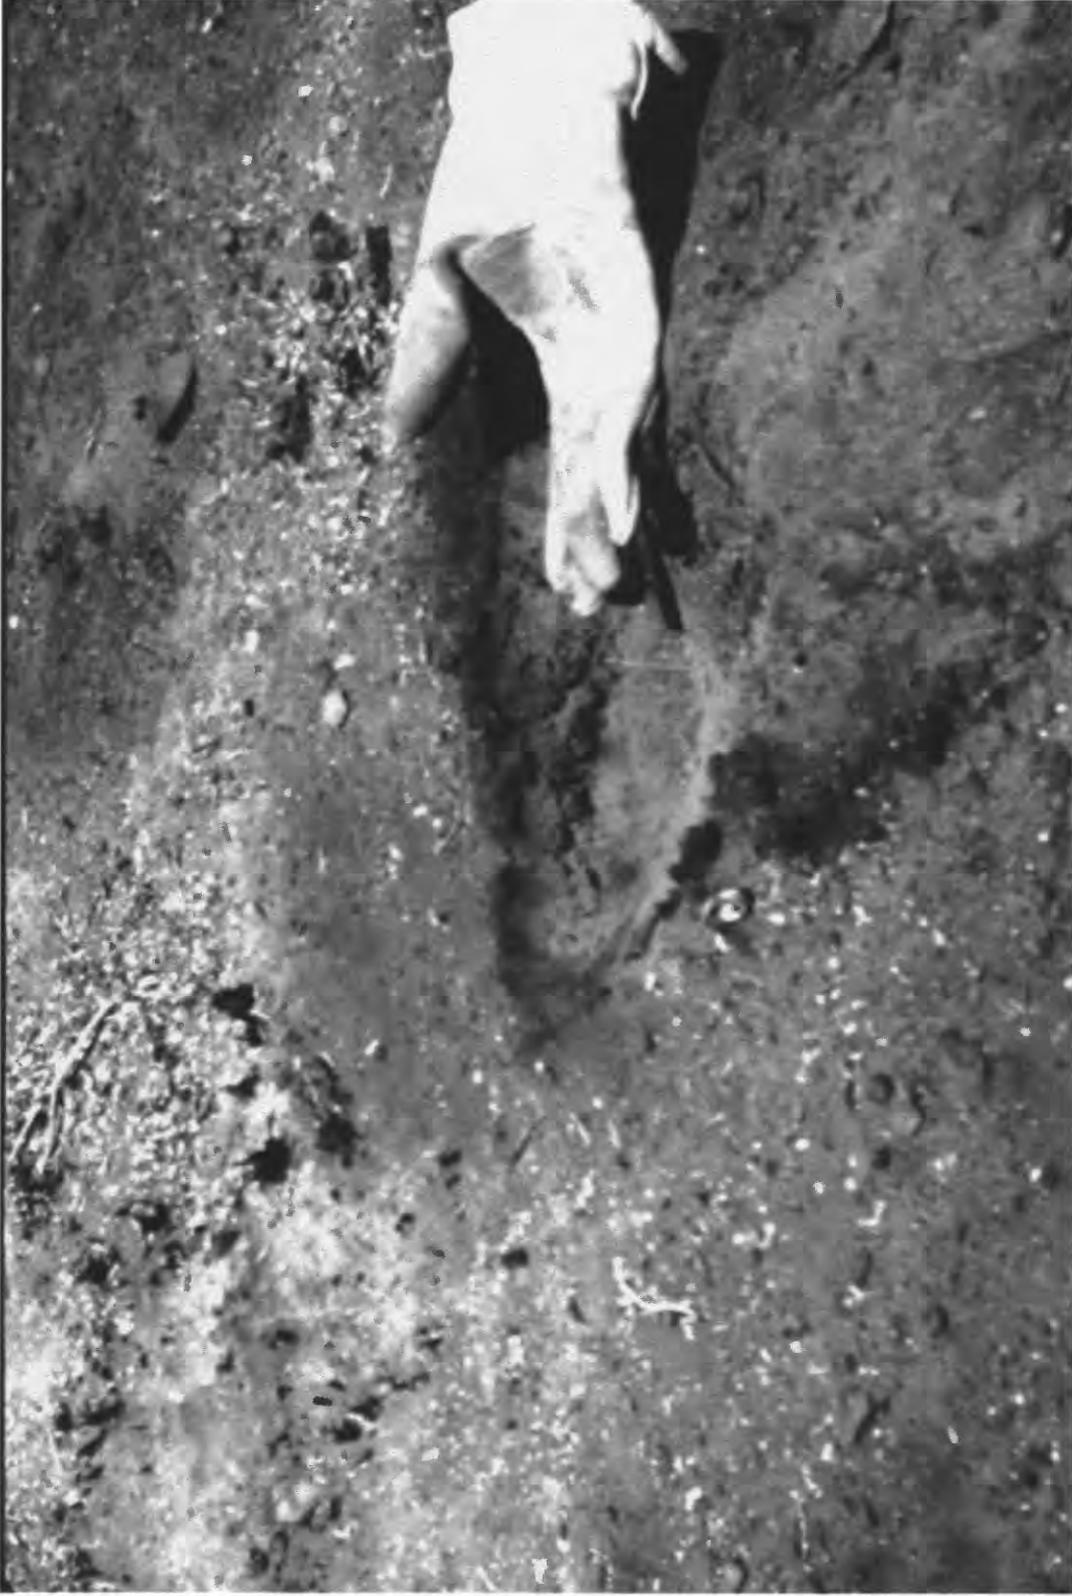
**Figure 5.** Close up view of loose surficial soil and ash. Loose material is approximately 2 inches thick. Photograph by Roger Pihl, Colorado Geological Survey.

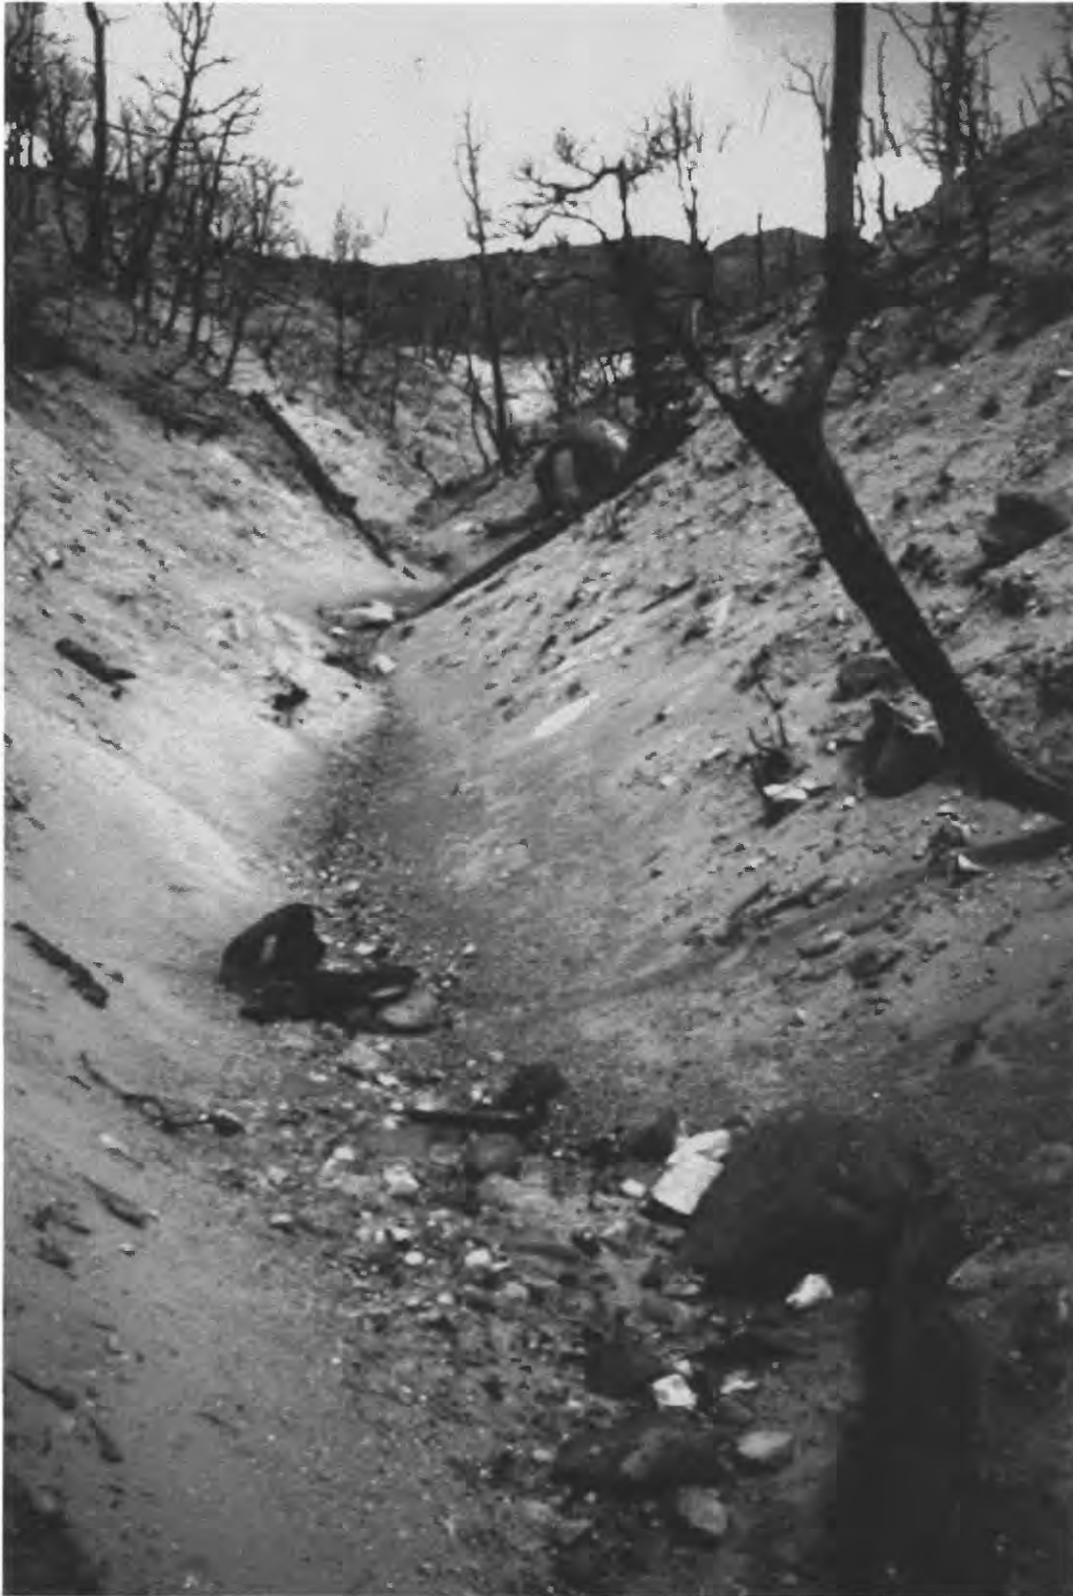
**Figure 6.** Photograph of loose, fine-grained material transported by dry ravel and wind and deposited in side channels. Deposits, which may be up to 3 feet thick, supplied material for debris flow events in September. Photograph by Roger Pihl, Colorado Geological Survey.

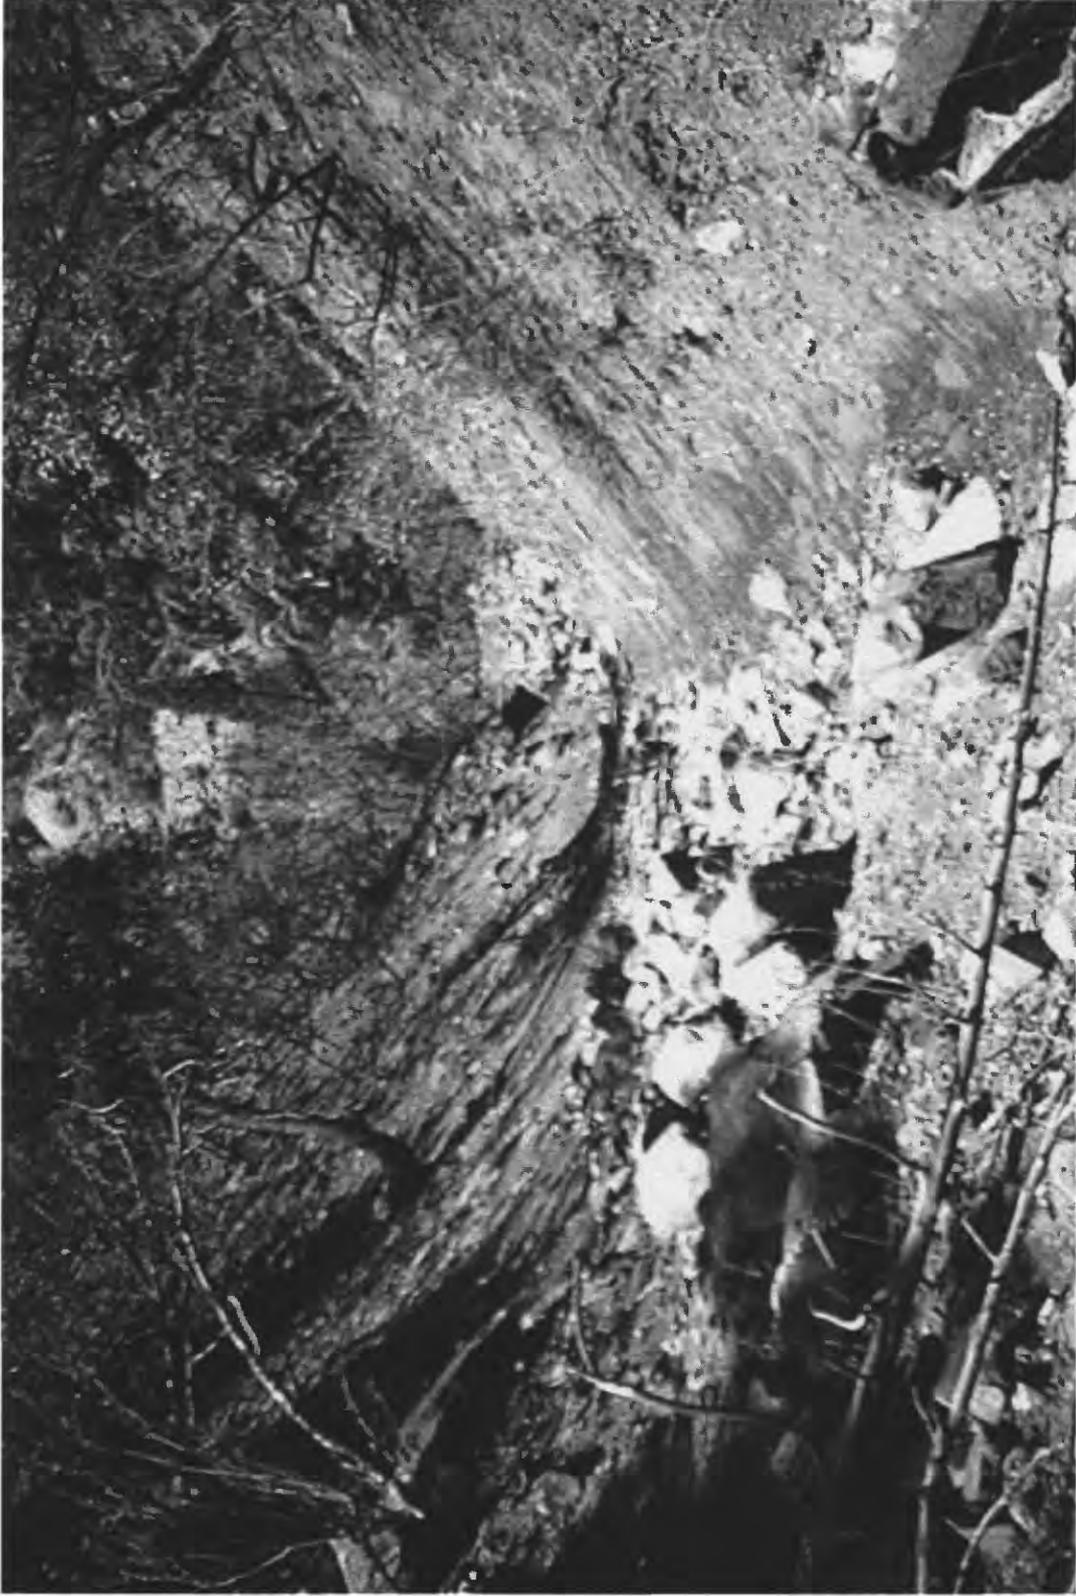
**Figure 7.** View down channel C before flows. Note small apron of loose dry ravel material deposited along margins of channel and the larger loose boulders; both materials were available for entrainment by the September flow events. Photograph by Roger Pihl, Colorado Geological Survey.

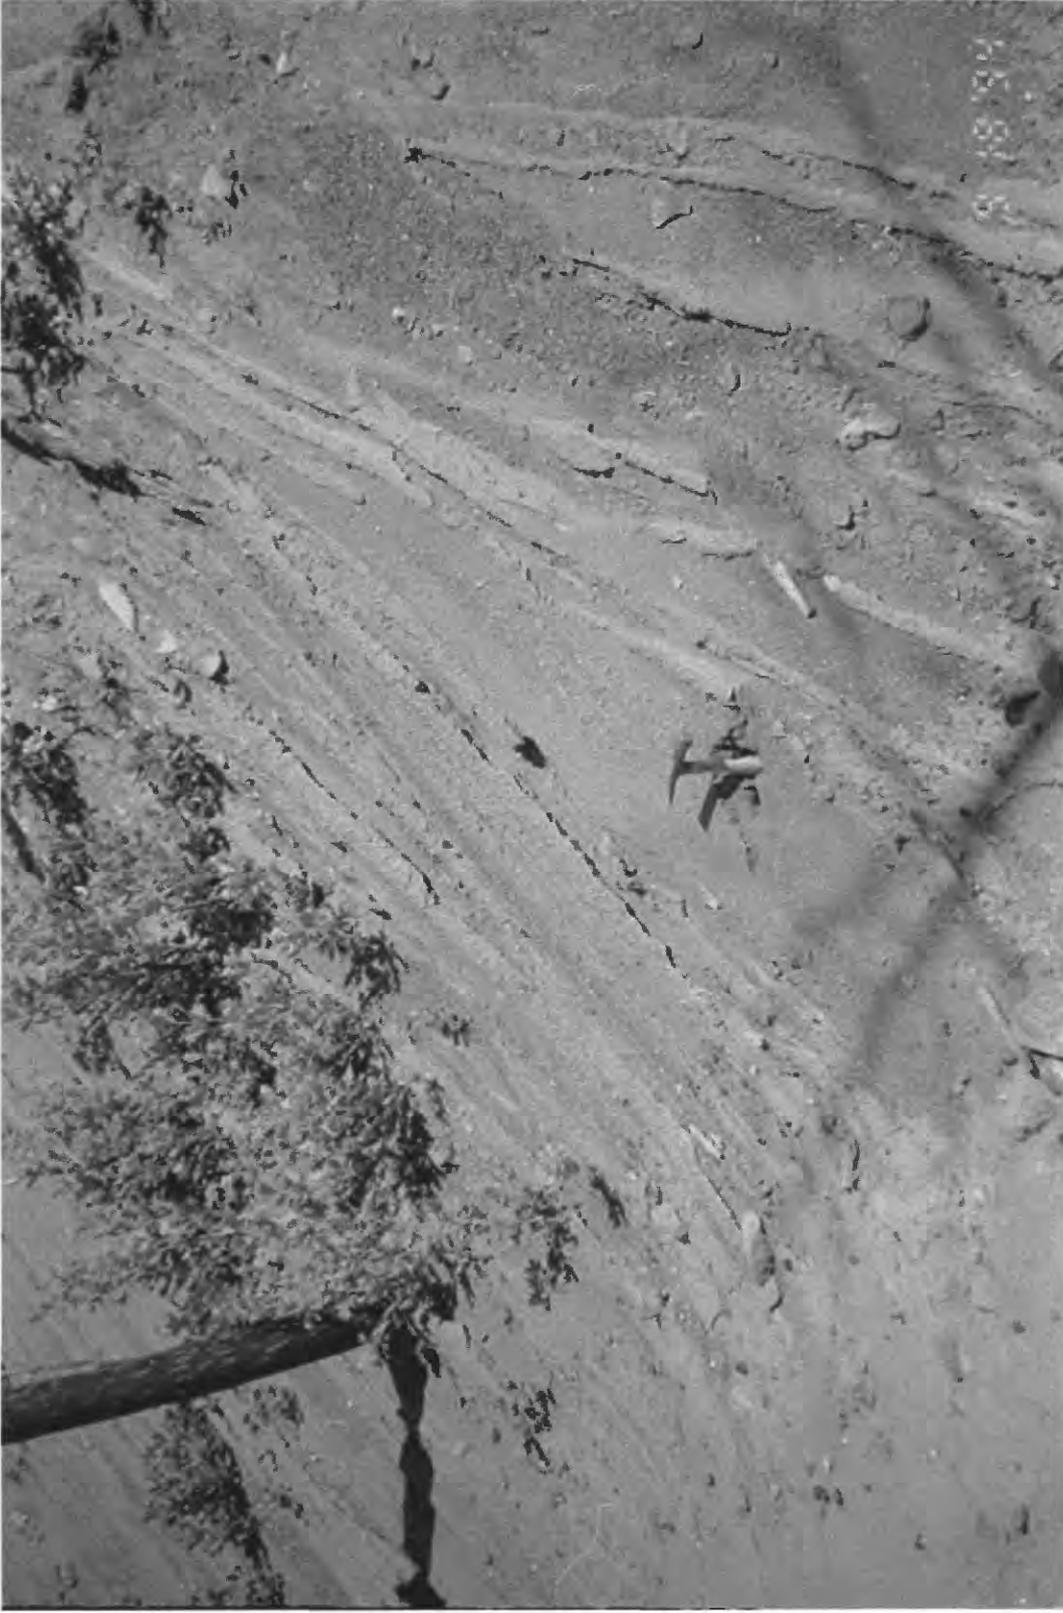
**Figure 8.** Photograph of dry ravel material deposited as apron on hillside. Photograph by Susan Cannon, U.S. Geological Survey.

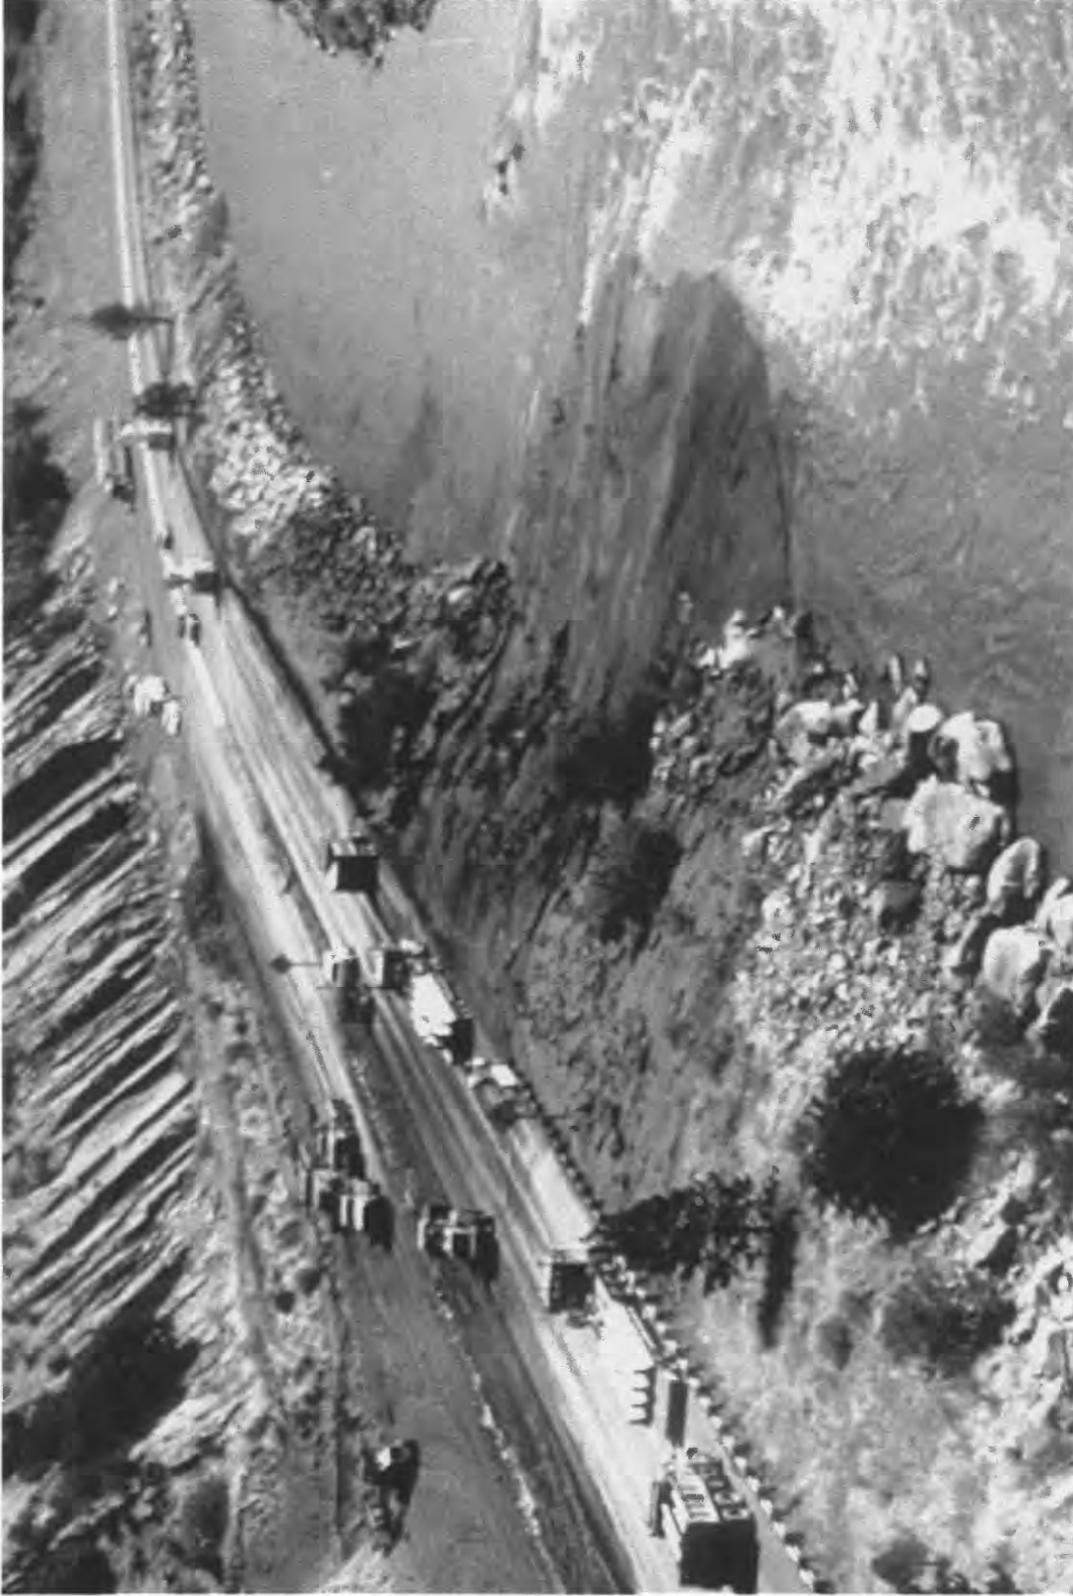
**Figure 9.** Photograph of deposits at drainage B showing fan of material deposited in the Colorado River. Photograph taken on September 2, 1994 by Bob Elderkin, Bureau of Land Management.

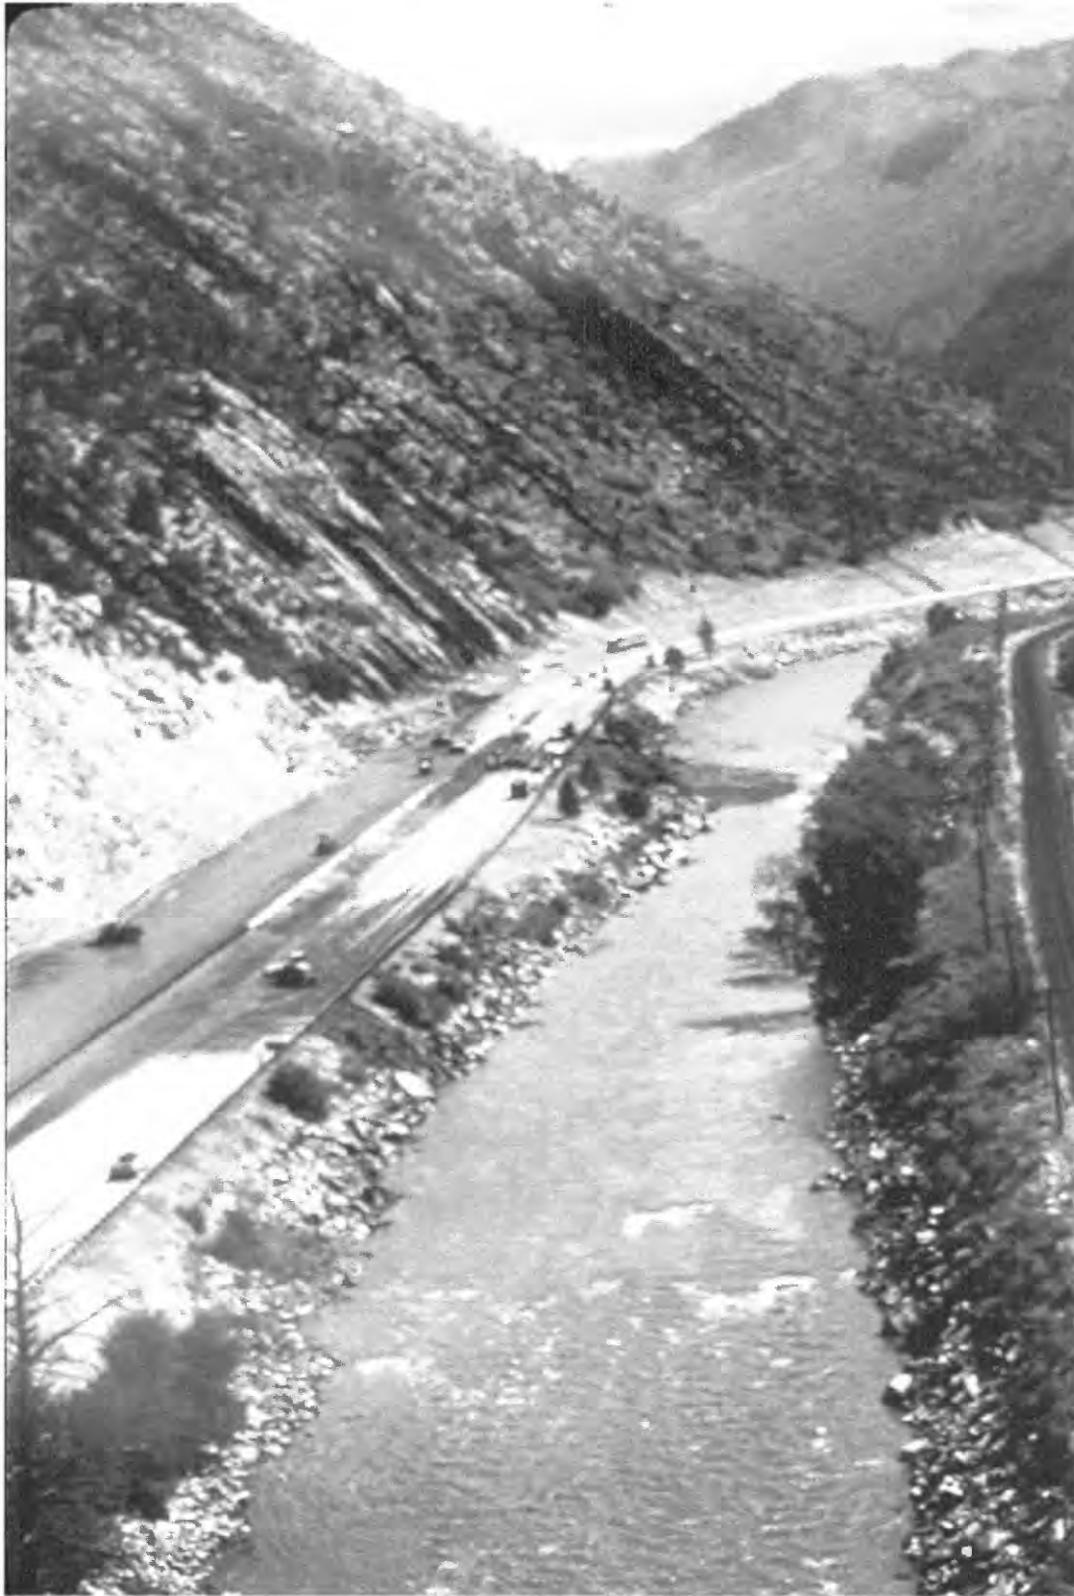
**Figure 10.** Photograph of material from drainage B showing extent of deposits westward along I-70. Photograph taken on September 2, 1994 by Bob Elderkin, Bureau of Land Management.

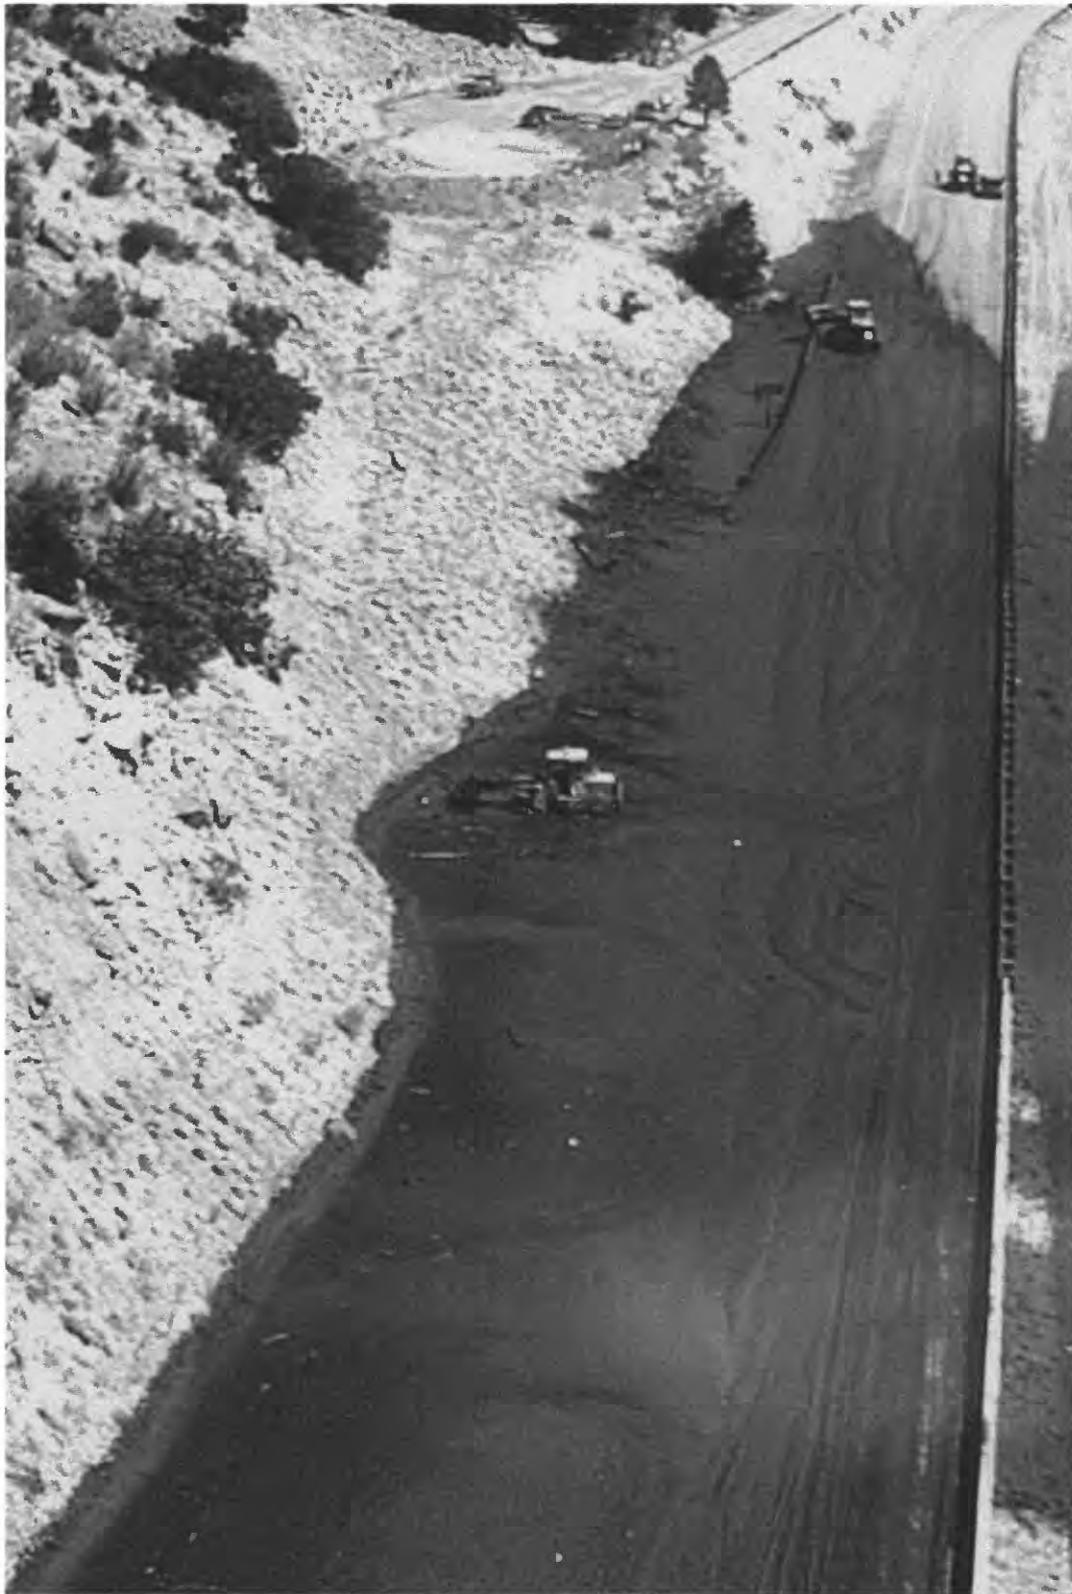
**Figure 11.** Photograph showing extent and character of material from drainage B deposited along I-70. Material traveled westward from drainage B to the mouth of drainage B. Note the fluid character of the deposits as they engulf the wheels of the front-end loader. Photograph taken on September 2, 1994 by Bob Elderkin, Bureau of Land Management.

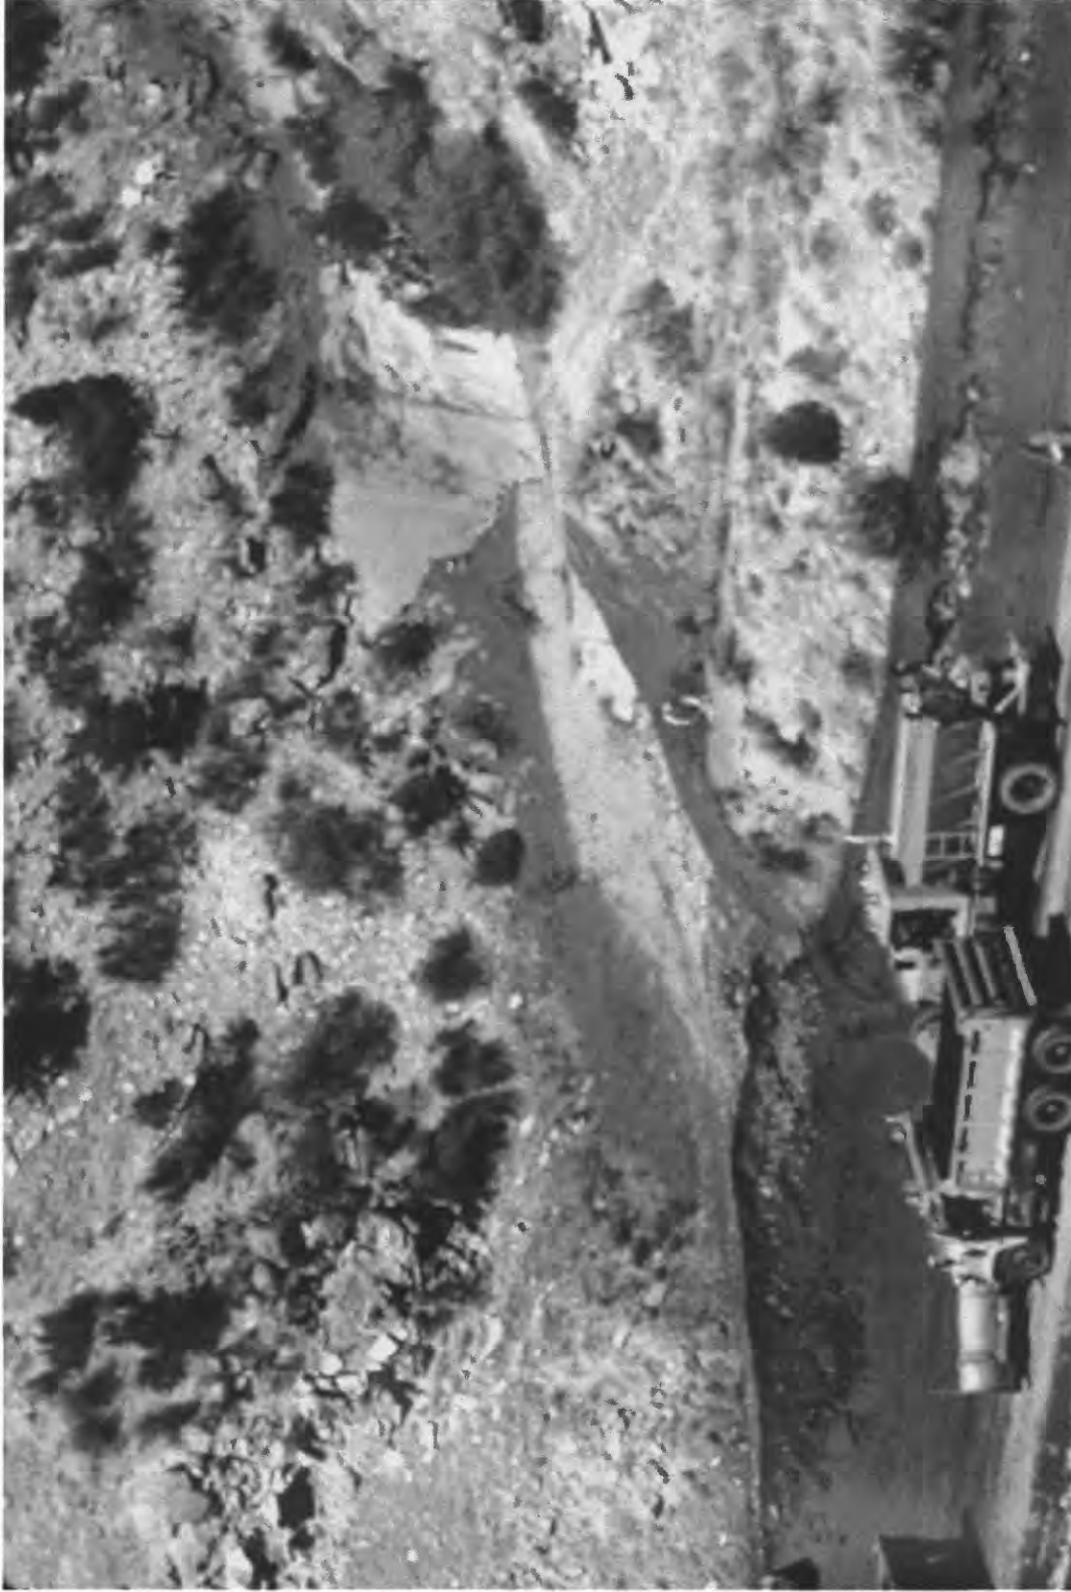
**Figure 12.** Photograph of path and deposits from flow down drainage B. Note deposit of larger-sized material right at mouth of the canyon and the more fluid character of the material that traveled down I-70. Photograph taken on September 2, 1994 by Bob Elderkin, Bureau of Land Management.

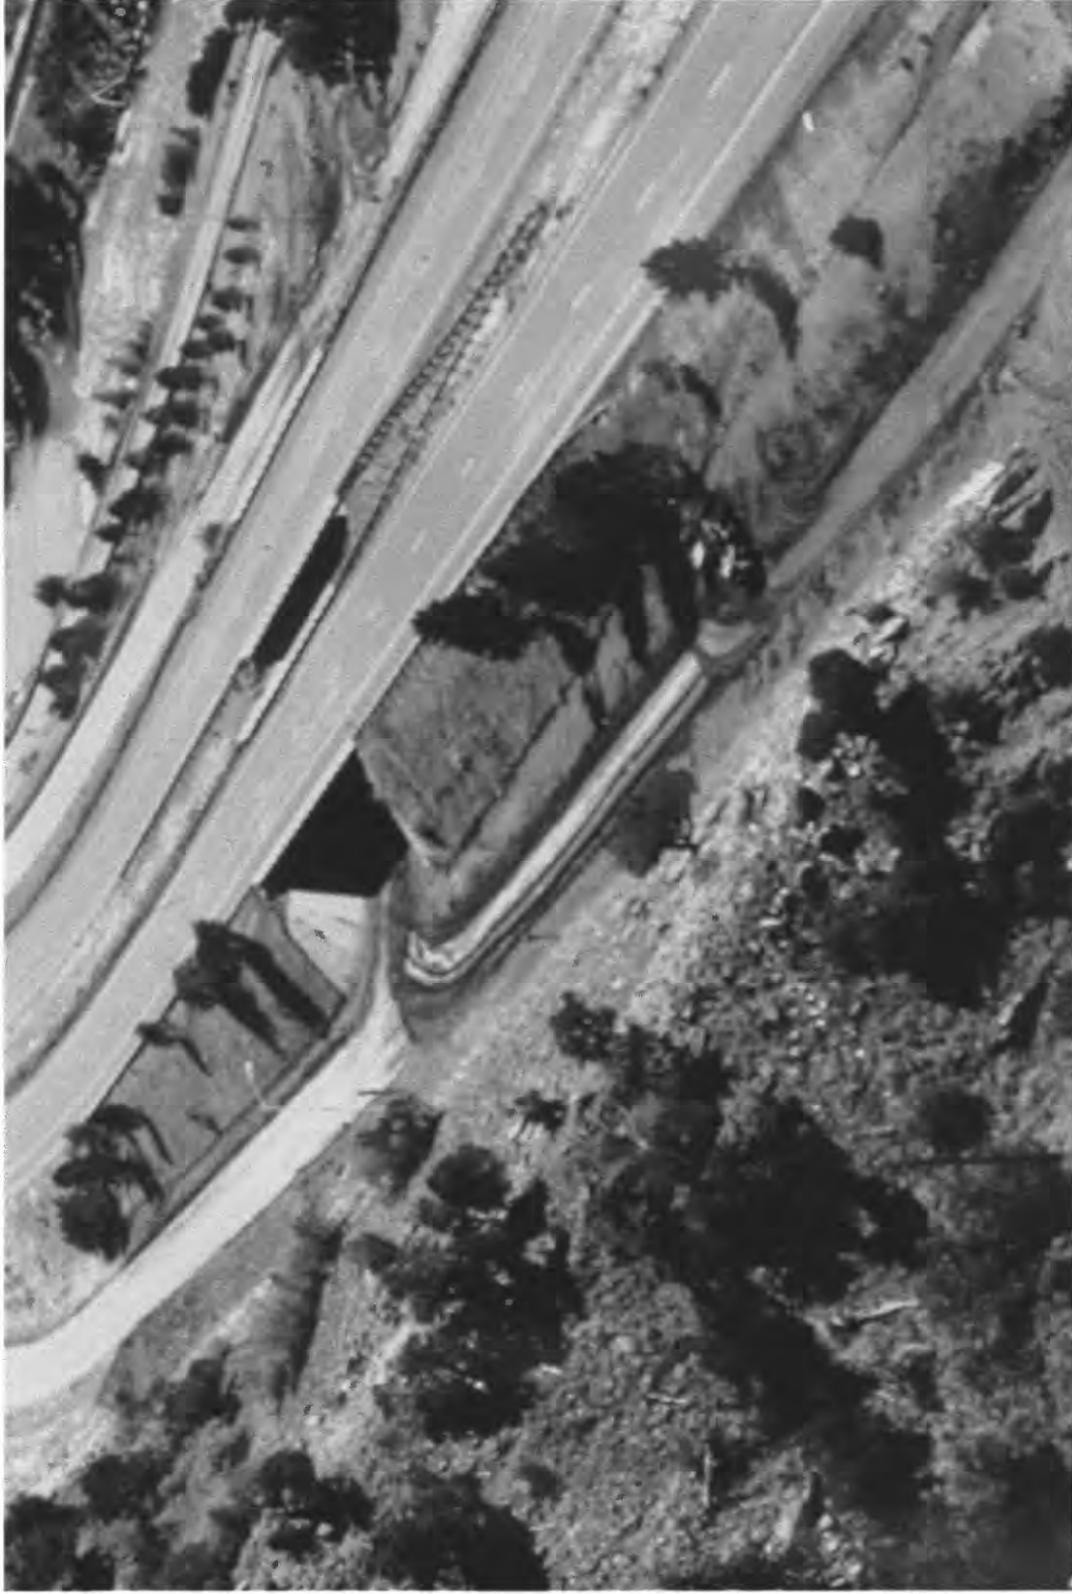
**Figure 13.** Photograph of deposits from drainage C. Material exited the canyon, traveled down the access road, under the I-70 overpass, and downslope to the Colorado River. Photograph taken on September 2, 1994 by Bob Elderkin, Bureau of Land Management.

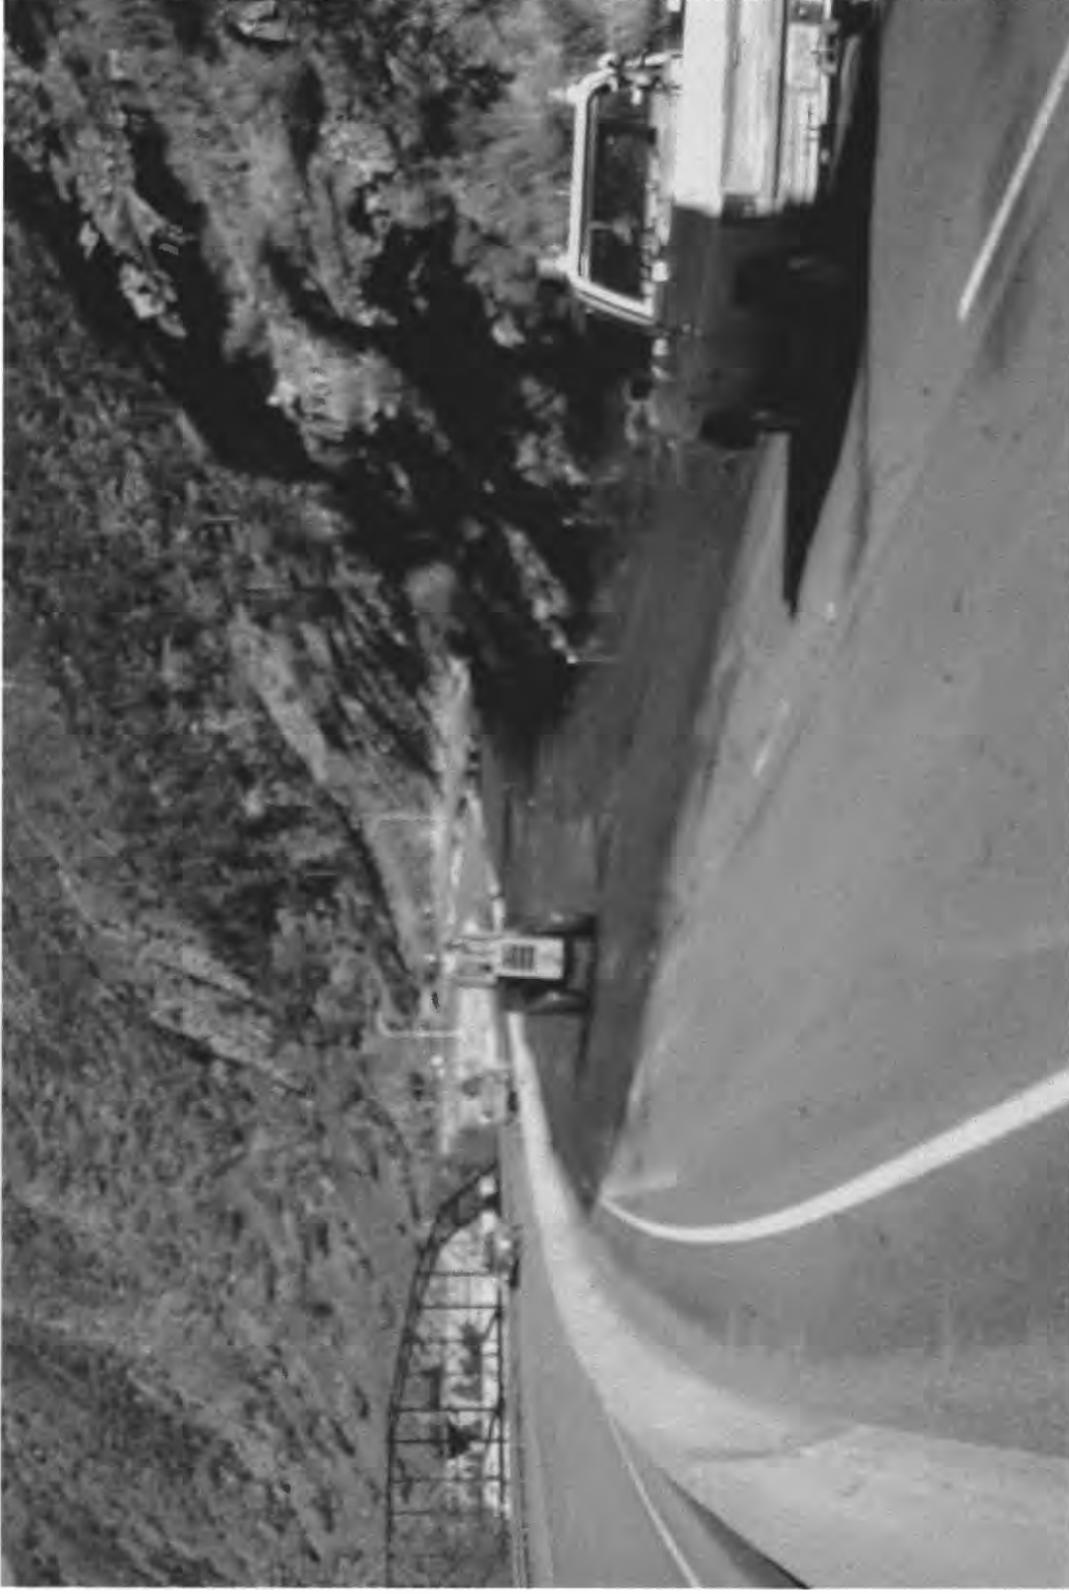
**Figure 14.** Material deposited at base of drainage I. Bridge over Colorado River at South Canyon Creek is visible in distance. Photograph by Roger Pihl, Colorado Geological Survey.
