U.S. DEPARTMENT OF THE INTERIOR  
U.S. GEOLOGICAL SURVEY

Preliminary Evaluation of the Fire-Related Debris Flows  
on Storm King Mountain,  
Glenwood Springs, Colorado

Open File Report 95-508

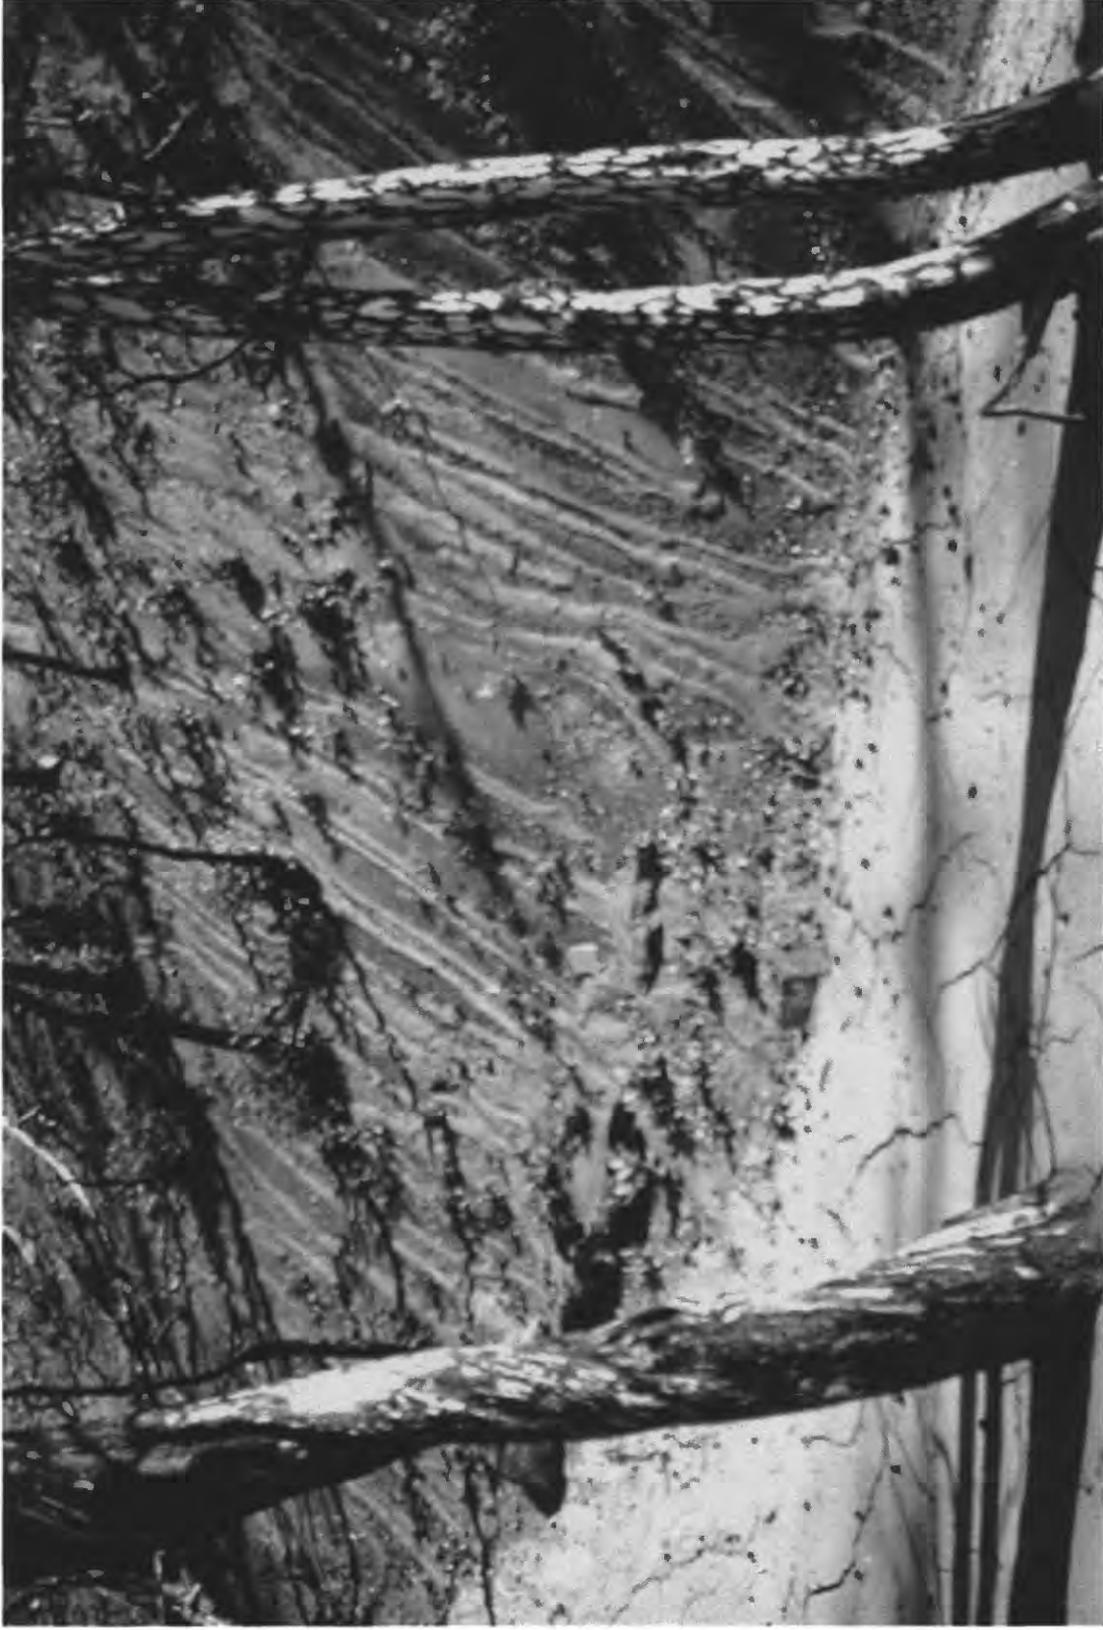
On Storm King Mountain, the formation of rills and gullies was observed in both the in-place, burned mineral soil and in the aprons of dry ravel material on the side slopes leading to drainages (Figure 15). Rills started up high on the slopes and their relative density, depth, and width increased with distance down slope. Formation of rills and gullies served to contribute loose mineral soil from the hillsides into the channels, as well as to provide efficient transportation routes for surface runoff. This is a self-perpetuating process; as the flow volume increases, more material is entrained, and the rills and gullies deepen and widen.

**Figure 15.** Photograph of rills and gullies on a blanket of loose, dry ravel material deposited on hillside. Rills and gullies also formed in burned surficial soil on hillsides. The average depth of rills on hillsides is estimated to be 1.5 inches, and the process removed approximately 15% of loose surficial material. Photograph by Roger Pihl, Colorado Geological Survey.

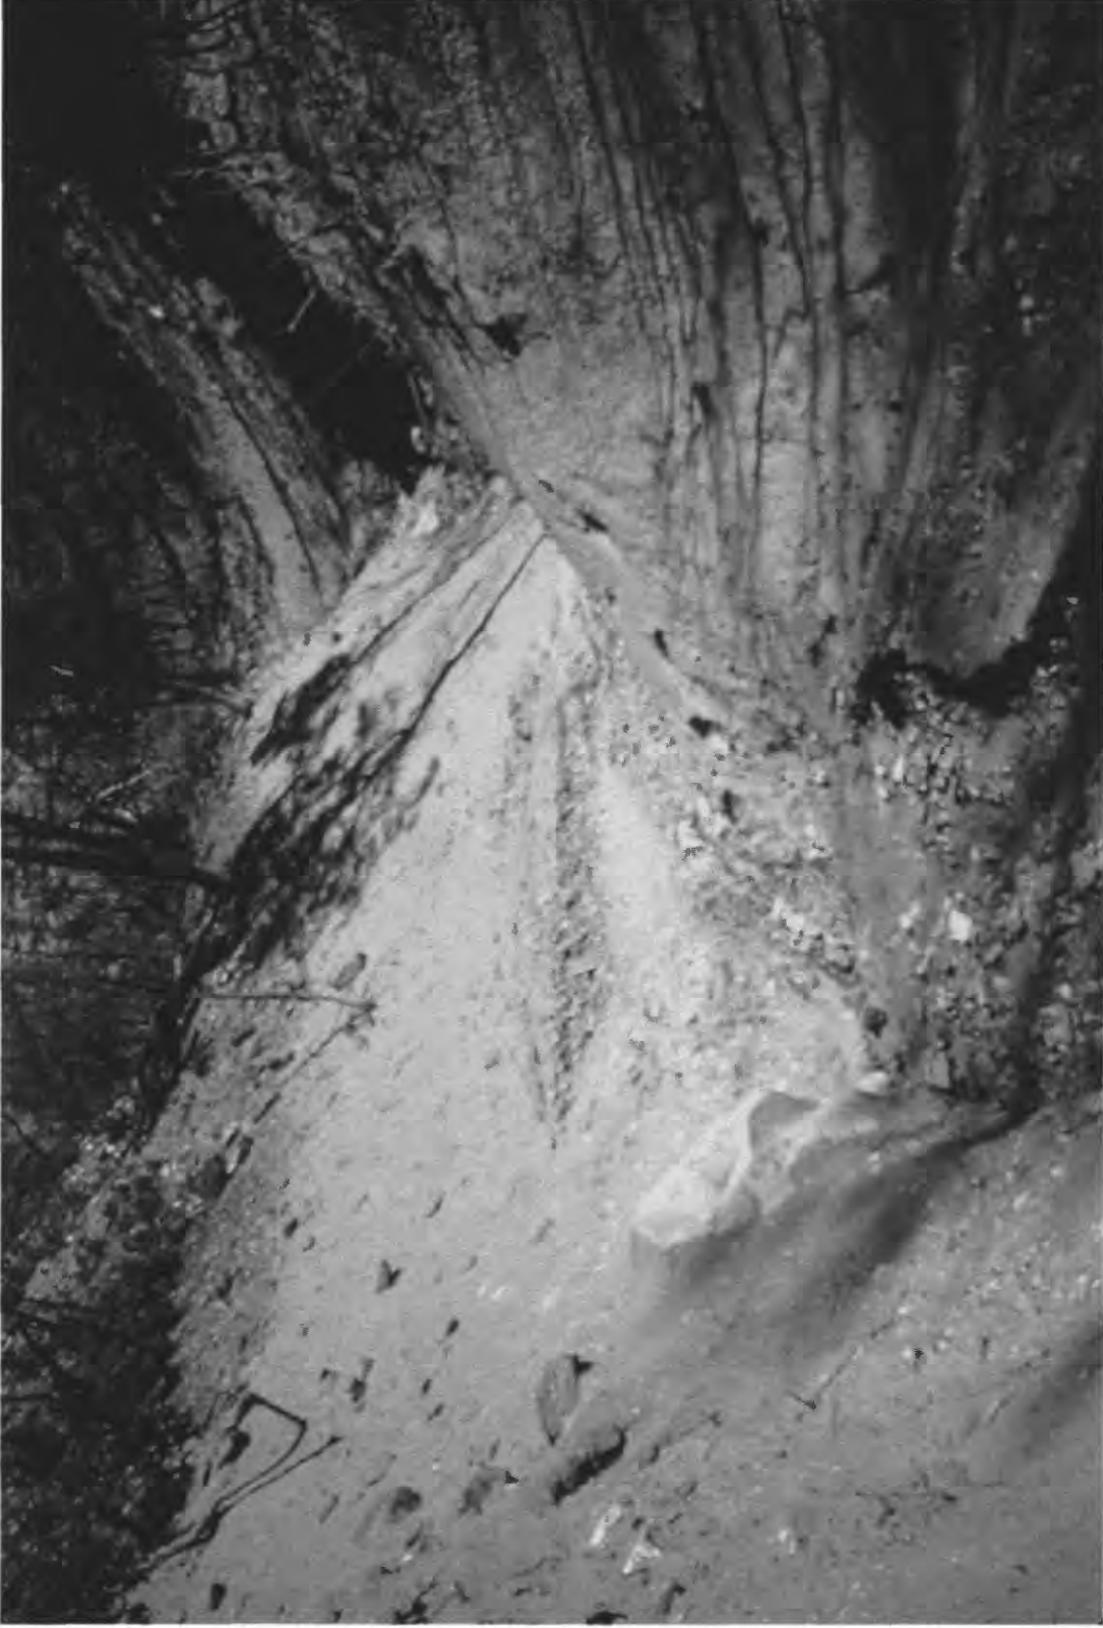
**Figure 16.** Deposits left in path of debris flow in drainage C. Material was deposited as a thin veneer of mud, and was particularly thin at margins of deposit. Photograph by Roger Pihl, Colorado Geological Survey.

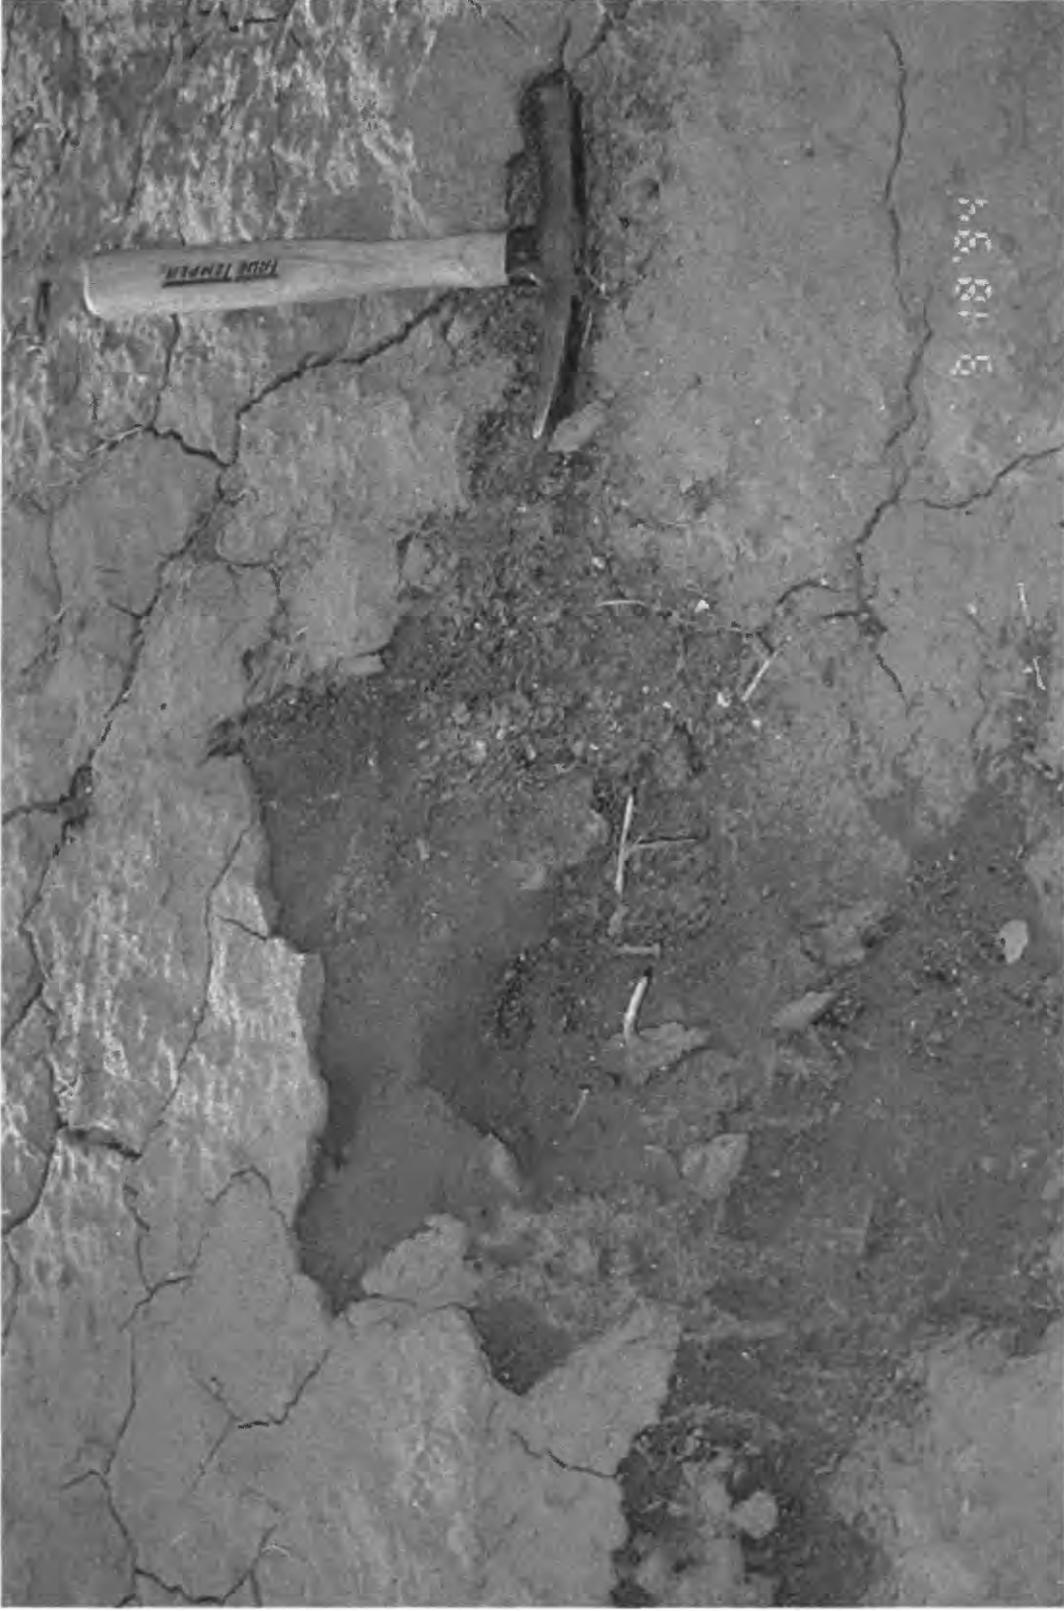
In general, the flows show an interesting combination of both debris- and hyperconcentrated-flow processes. As the flows traveled down the canyons, and particularly at the mouths of the canyons where material cascaded over high sandstone cliffs, they can be considered as hyperconcentrated. Figure 16 shows the deposits left by the passage of a flow through drainage C. At the margins of the flow path, the material deposited was very thin, indicating a high water content. In addition, as shown in Figure 17, the loose, friable mineral

**Figure 17.** Thin deposit of debris flow overlying very loose, friable ash and burned mineral soil. Undisturbed character of underlying material illustrates the low strength of the material deposited on top. Photograph by Susan Cannon, U.S. Geological Survey.

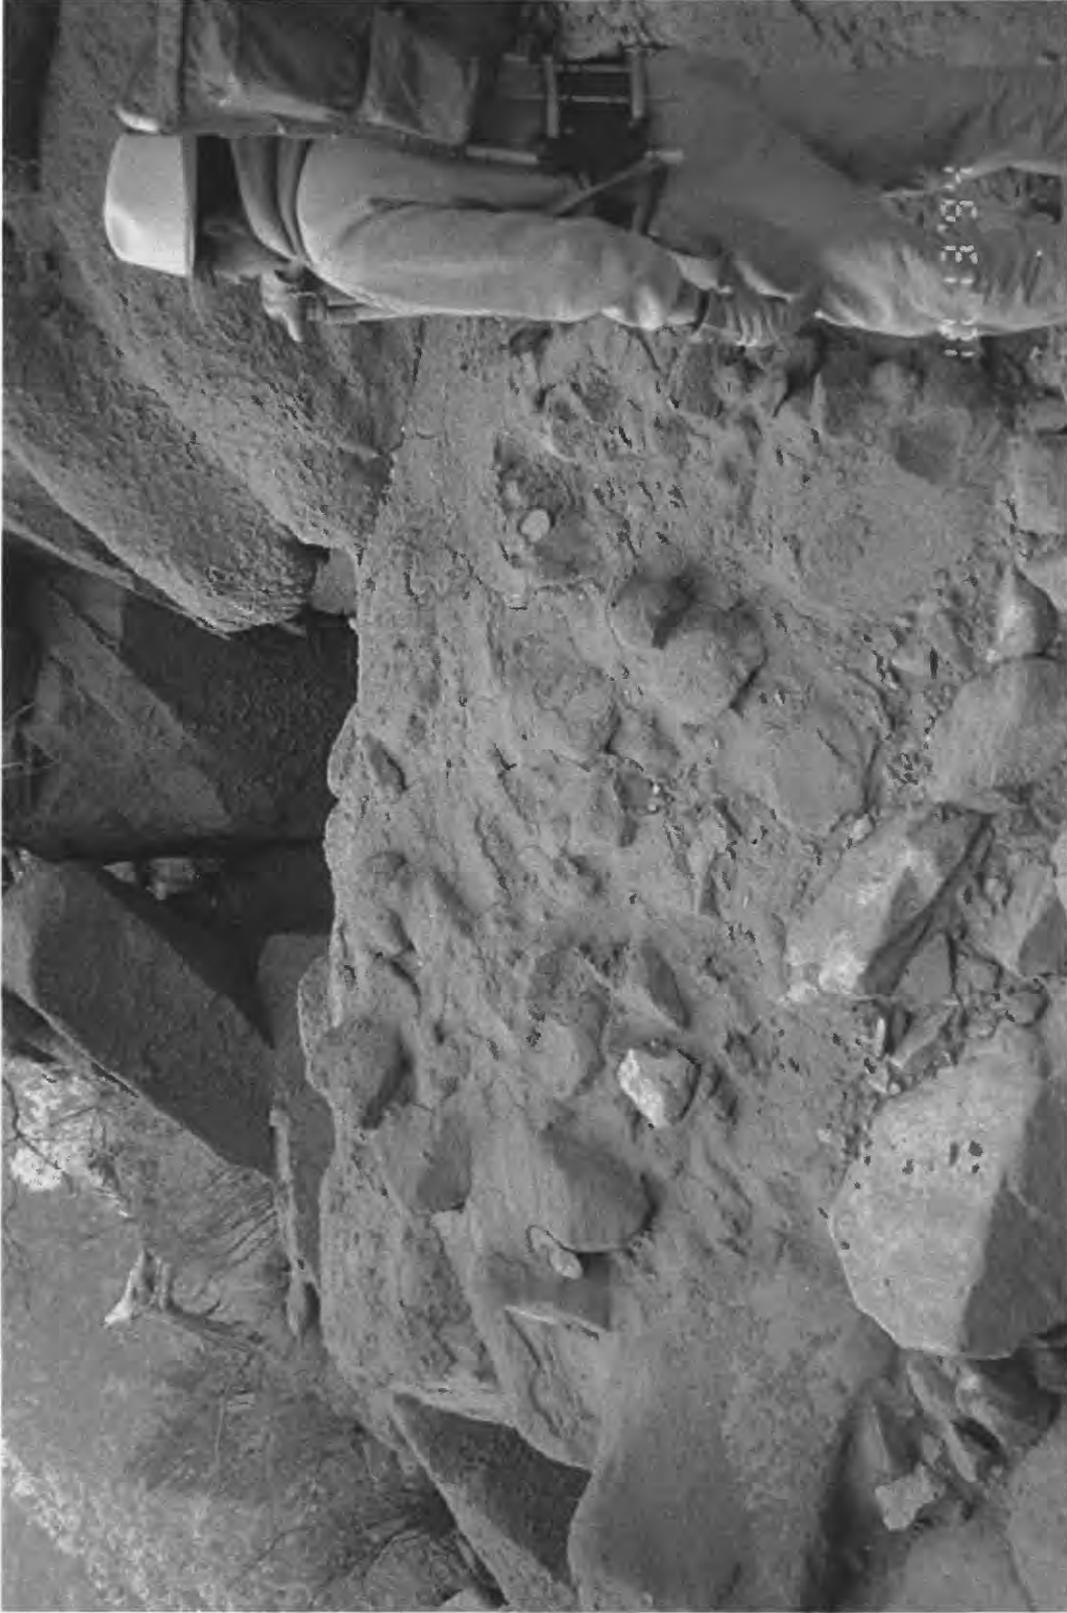
**Figure 18.** Material deposited near axis of flow in drainage C. This material was more viscous, indicating a higher strength than the material deposited at the margins of the flow. Photograph by Susan Cannon, U.S. Geological Survey.

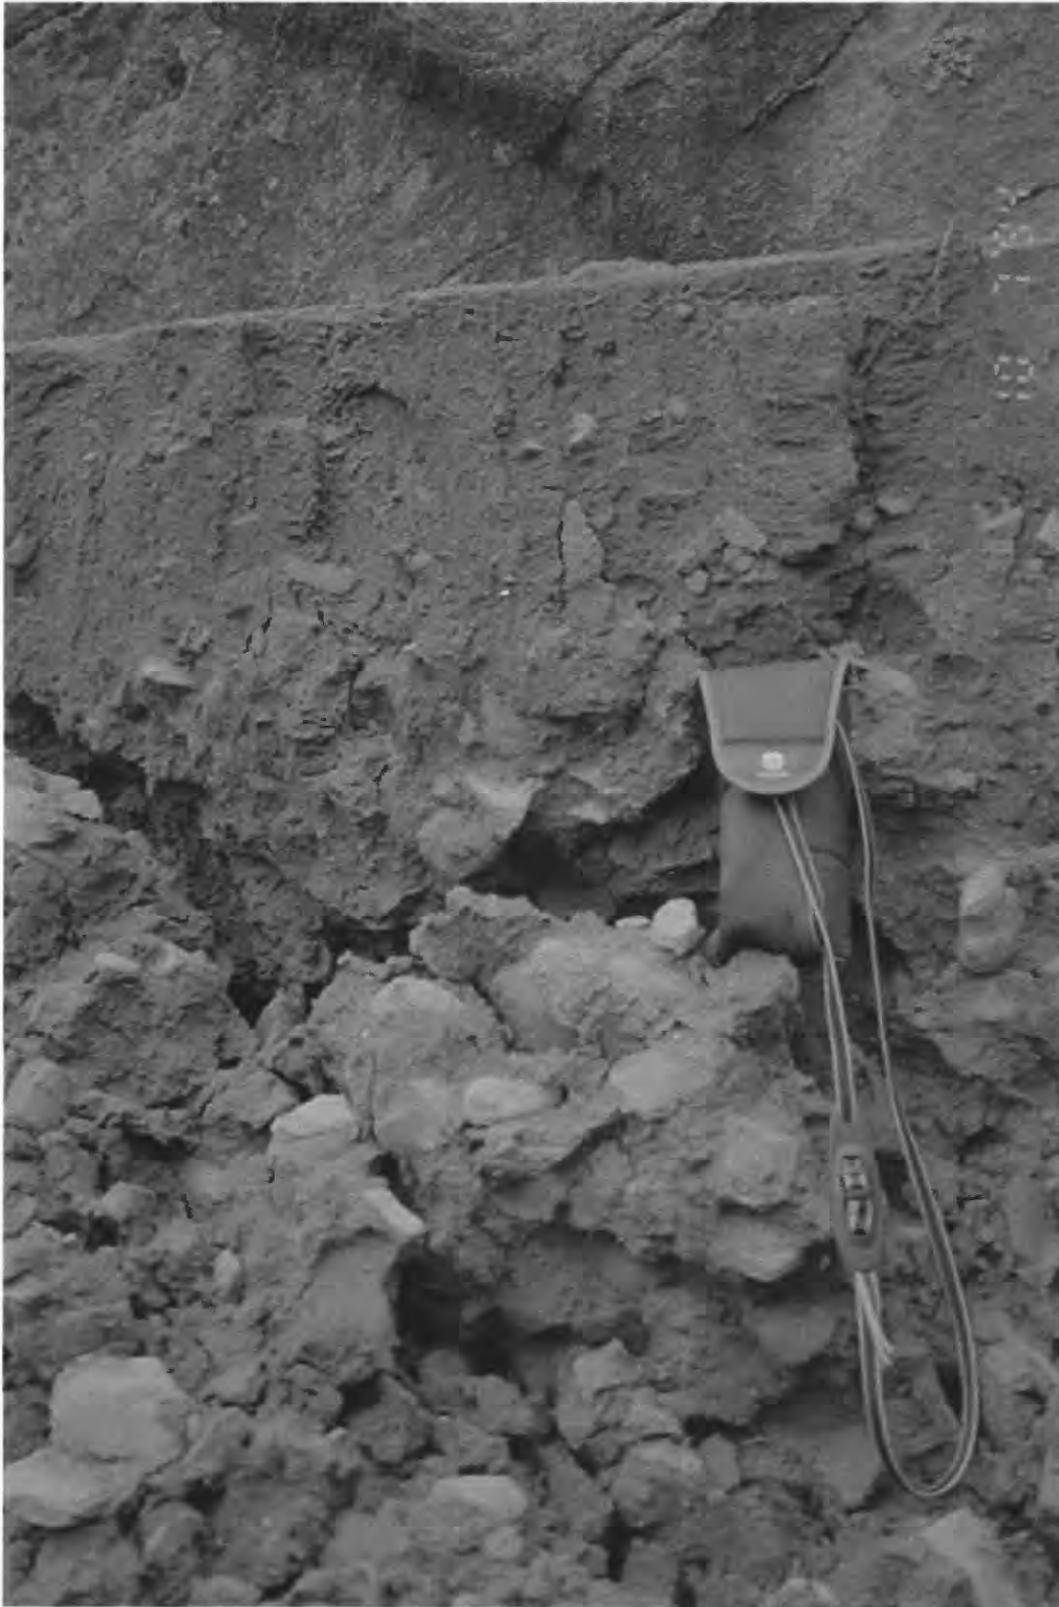
**Figure 19.** Cut in hyperconcentrated flow deposits at mouth of drainage C showing fine-grained, well-sorted material on top grading into gravel-sized, clast-supported material at a depth of approximately one foot. Photograph by Susan Cannon, U.S. Geological Survey.
