LEVEL II SCOUR ANALYSIS FOR
BRIDGE 42 (HARDELMSTR0042) on
ELM STREET, crossing
COOPER BROOK,
HARDWICK, VERMONT

U.S. Geological Survey
Open-File Report 96-565

Prepared in cooperation with
VERMONT AGENCY OF TRANSPORTATION
and
FEDERAL HIGHWAY ADMINISTRATION

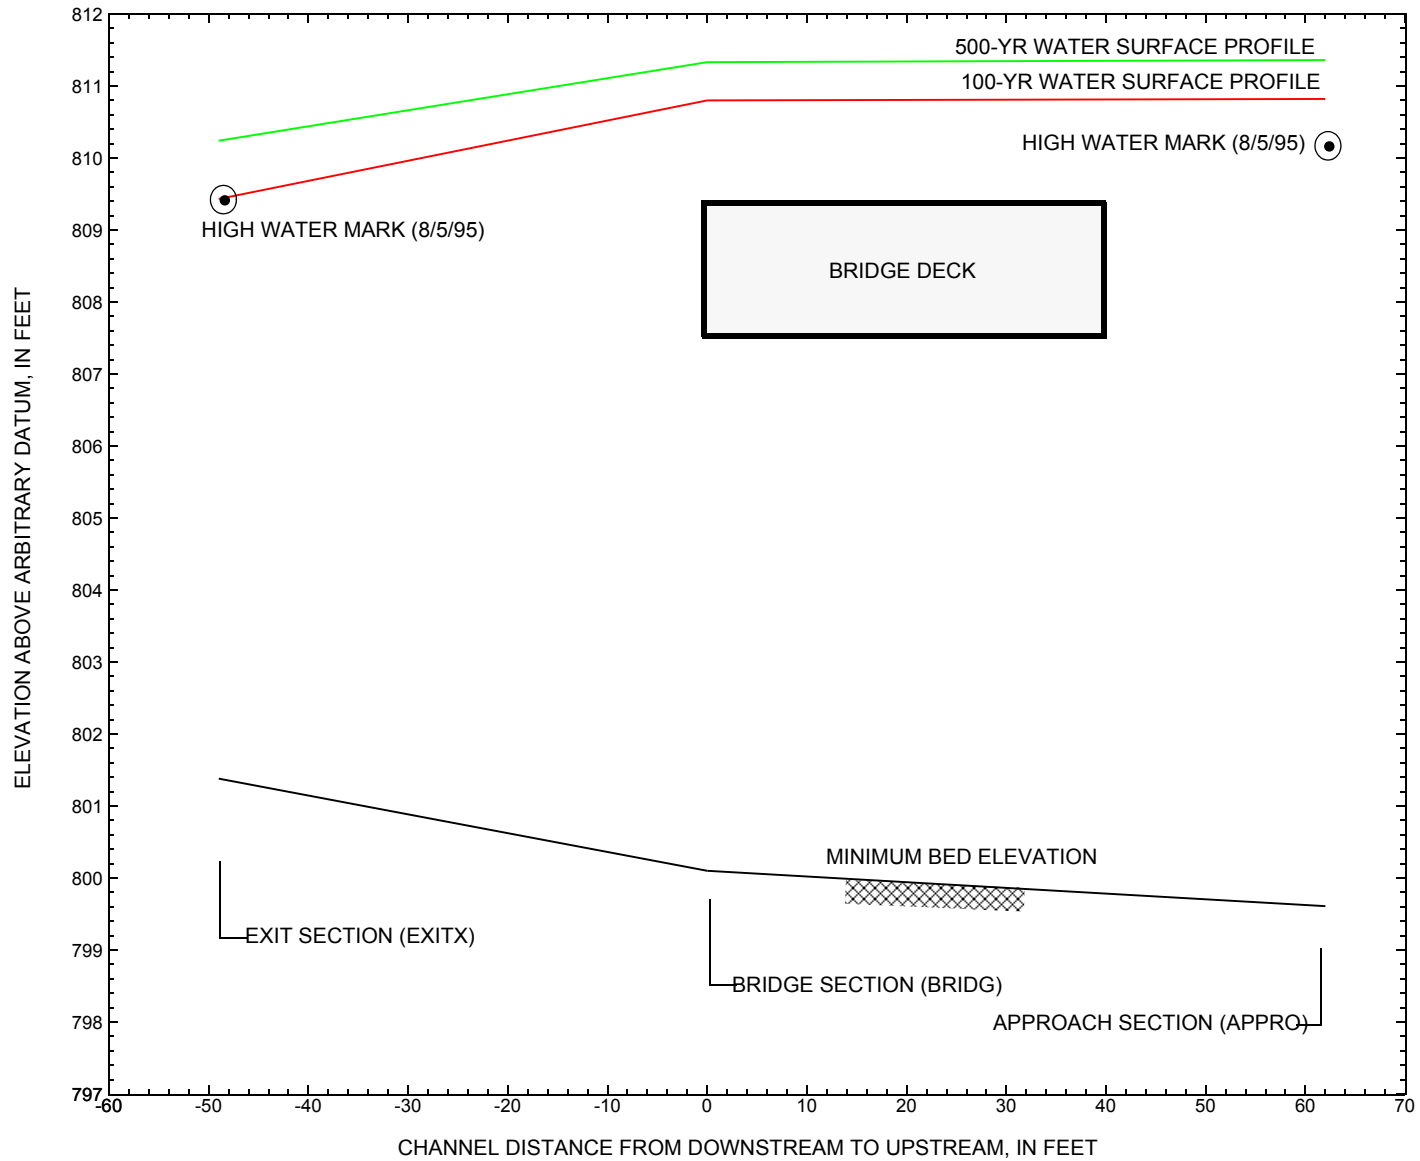
Figure 7. Water-surface profiles for the 100- and 500-yr discharges at structure [HARDELMSTR0042](#) on Elm Street, crossing [Cooper Brook, Hardwick, Vermont](#).

Hydraulic analyses of the reach were done by use of the Federal Highway Administration's WSPRO step-backwater computer program (Shearman and others, 1986, and Shearman, 1990). The analyses reported herein reflect conditions existing at the site at the time of the study. Furthermore, in the development of the model it was necessary to assume no accumulation of debris or ice at the site. Results of the hydraulic model are presented in the Bridge Hydraulic Summary, Appendix B, and figure 7.

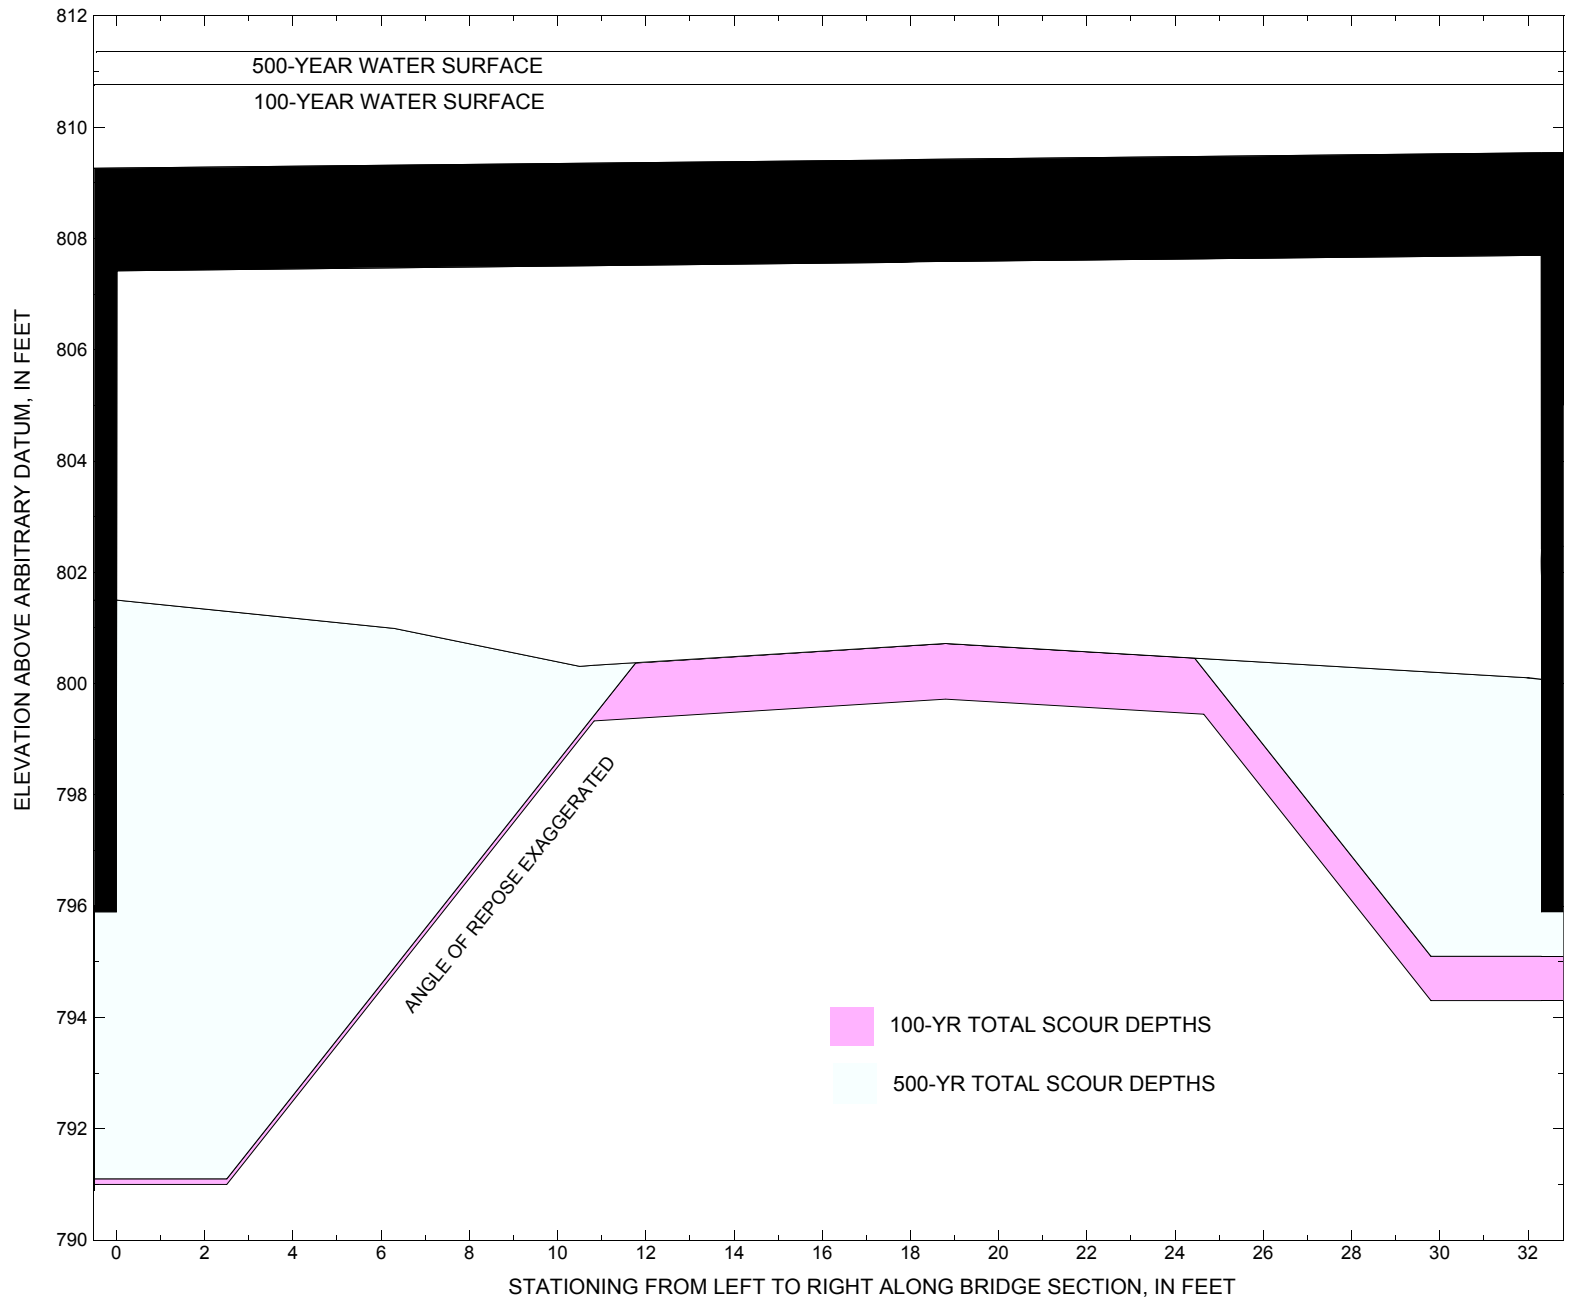
Figure 8. Scour elevations for the 100-yr and 500-yr discharges at structure [HARDELMSTR0042](#) on Elm Street, crossing [Cooper Brook](#), [Hardwick](#), Vermont.

Scour depths were computed using the general guidelines described in Hydraulic Engineering Circular 18 (Richardson and others, 1993). Scour depths were calculated assuming an infinite depth of erosive material and a homogeneous particle-size distribution. The results of the scour analysis are presented in tables 1 and 2 and a graph of the scour depths is presented in figure 8.

Contraction scour was computed by use of the [live-bed contraction scour equation \(Richardson and others, 1993, p. 33, equation 16\)](#). For contraction scour computations, the average depth in the contracted section (AREA/TOPWIDTH) is subtracted from the depth of flow computed by the scour equation (Y2) to determine the actual amount of scour. All three discharges resulted in submerged orifice flow. The results of Chang's contraction scour (Richardson and others, 1995, p. 145-146) for these events were also computed and can be found in appendix F. Because the Chang equation for pressure flow scour was derived solely with data for clear-water scour, it is not currently understood how well it would predict in live-bed conditions. Therefore, although pressure flow conditions exist for all three of the modelled flows, the reported scour depths were computed using Laursen's live-bed contraction scour equation. In this case, the incipient road-overflow model resulted in the worst-case contraction scour with a scour depth of 3.4 ft. The incipient road-overflow also resulted in the worst-case total scour.

Abutment scour was computed by use of the [Froehlich equation \(Richardson and others, 1993, p. 49, equation 24\)](#). Variables for the Froehlich equation include the Froude number of the flow approaching the embankments, the length of the embankment blocking flow, and the depth of flow approaching the embankment less any roadway overtopping.

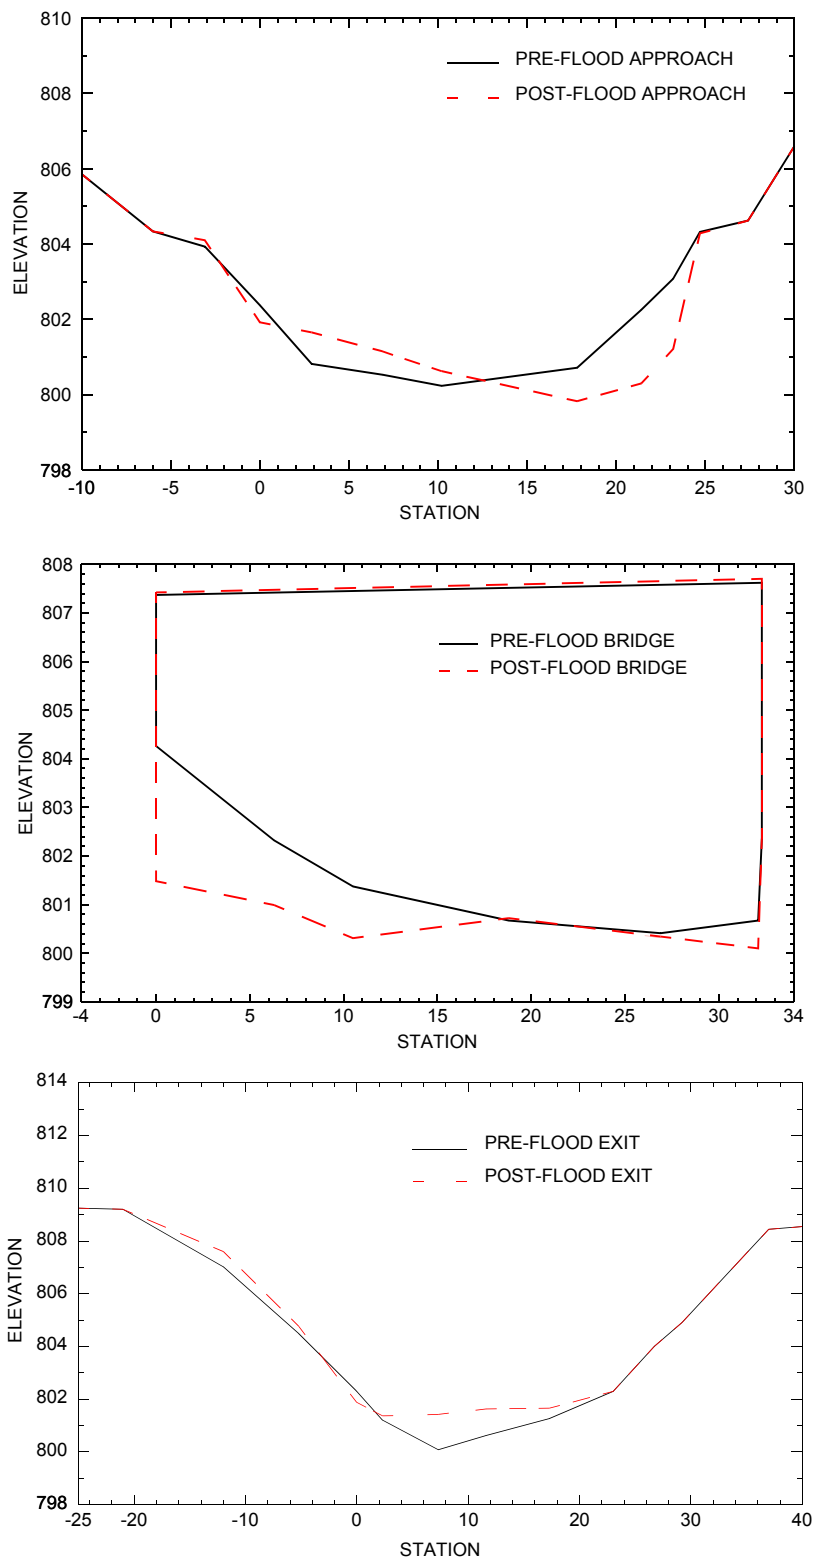
Figure G-1. Pre- (July 24, 1995) and post-flood (August 8, 1995) surveys of three cross sections in the vicinity of Hardwick bridge 42 on Elm Street, Hardwick, Vermont.

On August 17, 1995 the site was revisited to investigate the effect of the August 4-5, 1995 flood on the structure. Channel features such as scour holes and point bars were shifted by the high flow event. Details of these changes can be found in the Level I data form in Appendix E. Additional details describing conditions at the site are included in the Level II Summary and Appendices D and G.
