LEVEL II SCOUR ANALYSIS FOR BRIDGE 41 (WODSTH00750041) on TOWN HIGHWAY 75, crossing HAPPY VALLEY BROOK, WOODSTOCK, VERMONT

U.S. Geological Survey
Open-File Report 96-567

Prepared in cooperation with
VERMONT AGENCY OF TRANSPORTATION
and
FEDERAL HIGHWAY ADMINISTRATION

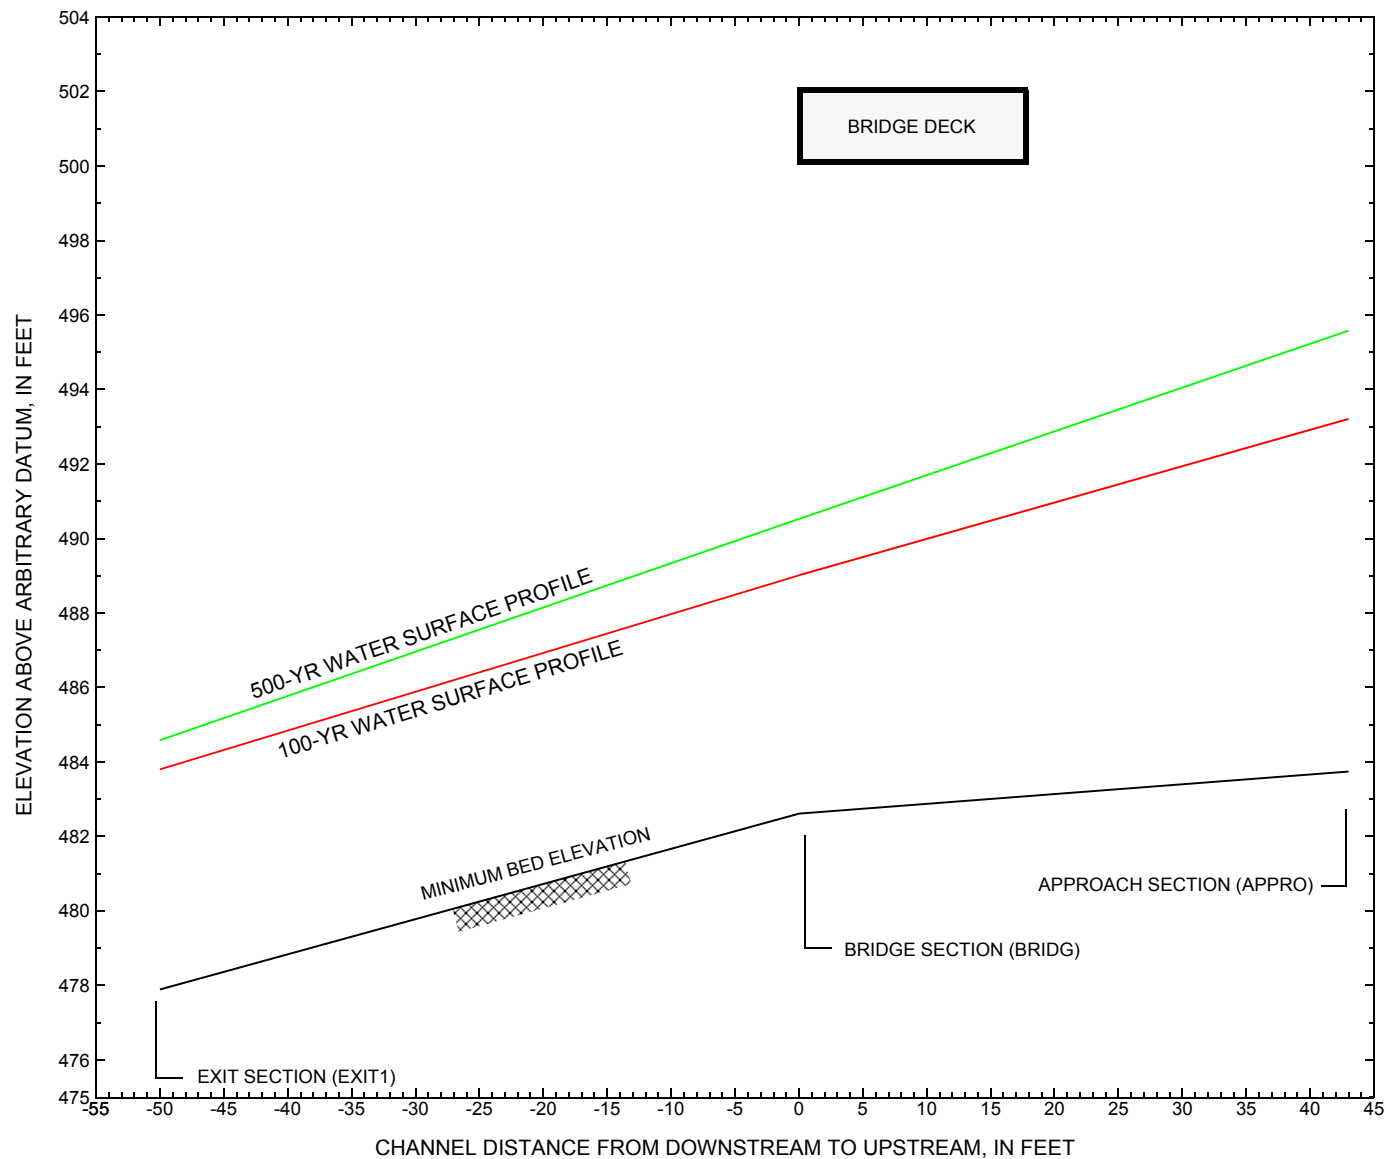
Figure 7. Water-surface profiles for the 100- and 500-yr discharges at structure [WODSTH00750041](#) on town highway 75, crossing [Happy Valley Brook, Woodstock, Vermont](#).

Hydraulic analyses of the reach were done by use of the Federal Highway Administration's WSPRO step-backwater computer program (Shearman and others, 1986, and Shearman, 1990). The analyses reported herein reflect conditions existing at the site at the time of the study. Furthermore, in the development of the model it was necessary to assume no accumulation of debris or ice at the site. Results of the hydraulic model are presented in the Bridge Hydraulic Summary, Appendix B, and figure 7.

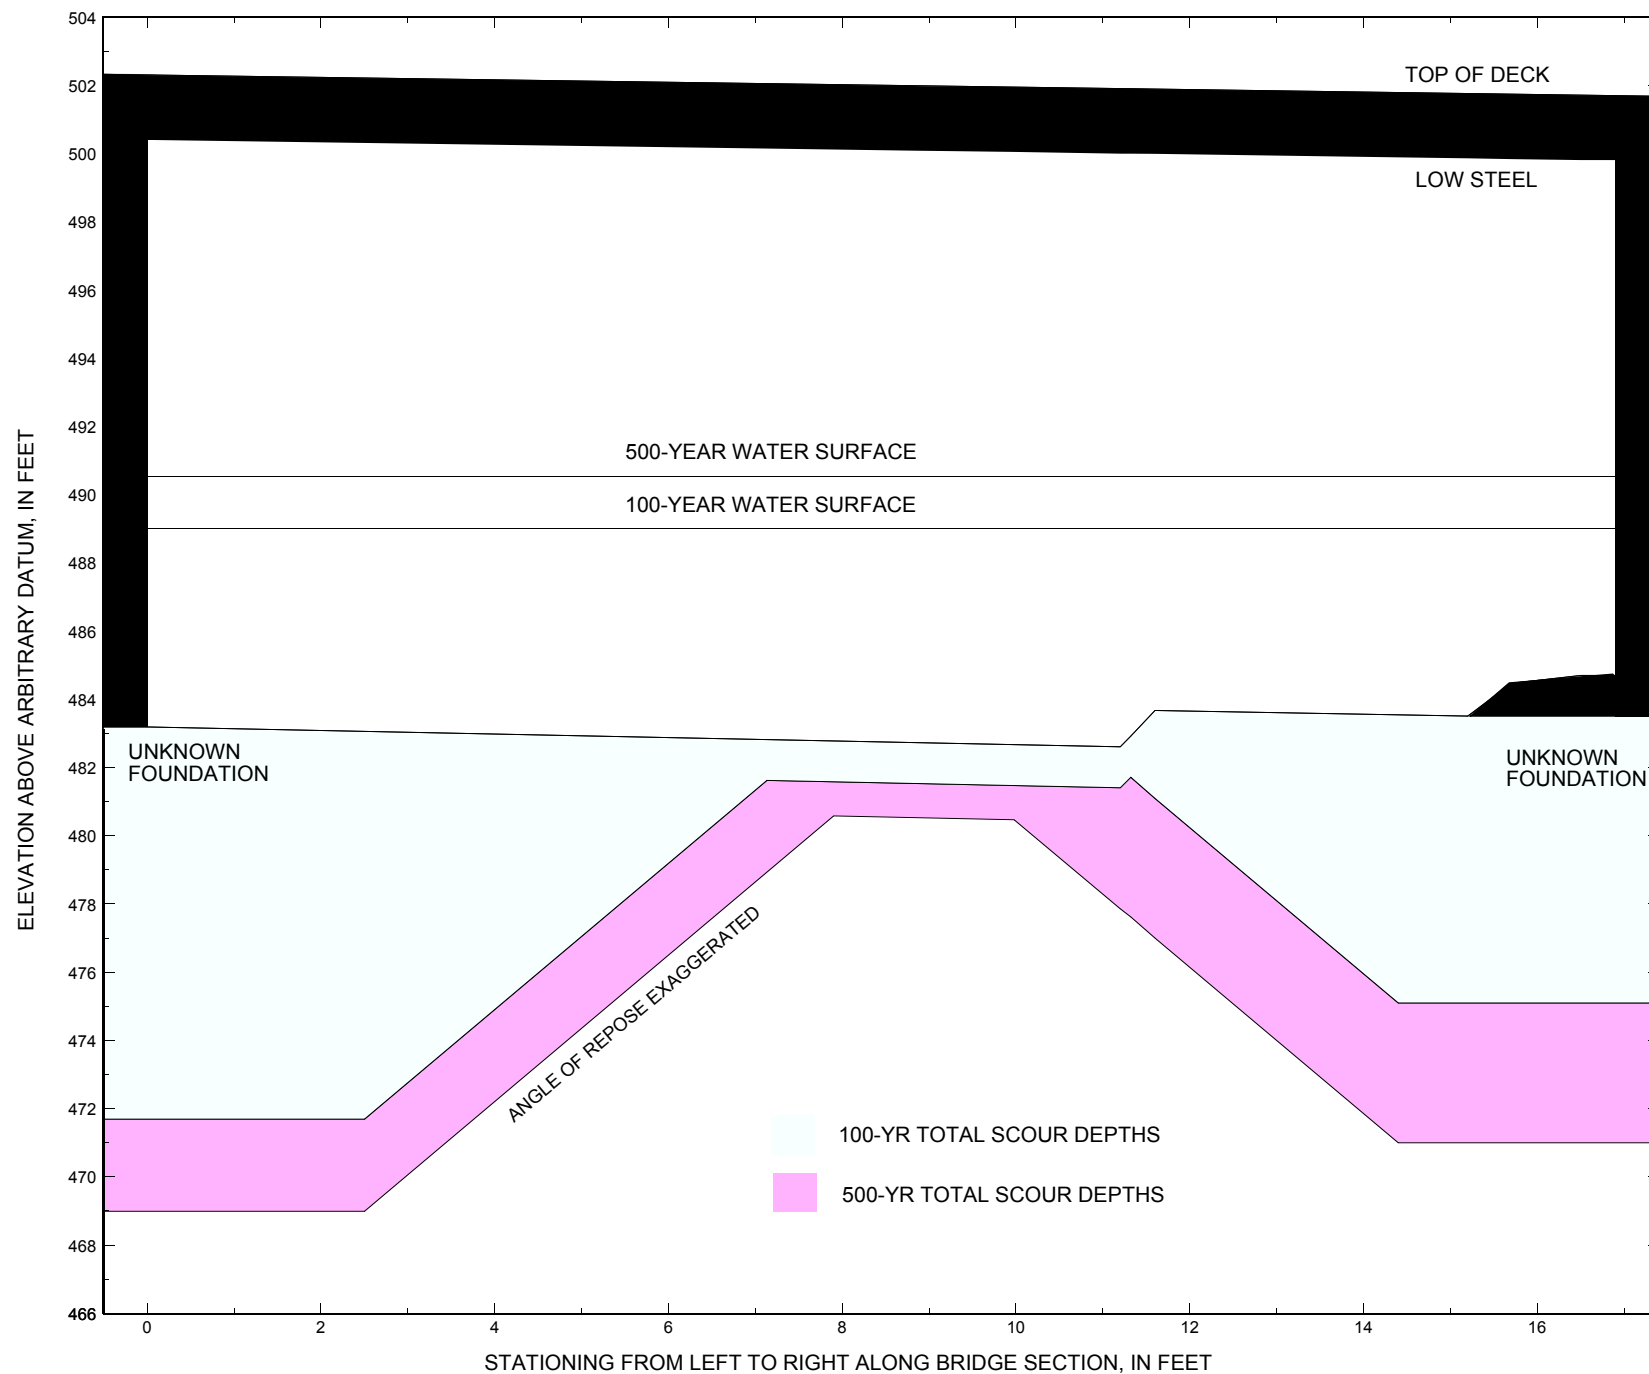
Figure 8. Scour elevations for the 100-yr and 500-yr discharges at structure [WODSTH00750041](#) on town highway 75, crossing [Happy Valley Brook, Woodstock, Vermont](#).

Contraction scour for all modelled flows ranged from 1.3 to 2.2 ft. The worst-case contraction scour occurred at the 500-year discharge. Abutment scour ranged from 7.2 to 12.0 ft. The worst-case abutment scour occurred at the 500-year discharge. Additional information on scour depths and depths to armoring are included in the section titled “Scour Results”. Scoured-streambed elevations, based on the calculated scour depths, are presented in tables 1 and 2. A cross-section of the scour computed at the bridge is presented in figure 8. Scour depths were calculated assuming an infinite depth of erosive material and a homogeneous particle-size distribution.

Scour depths were computed using the general guidelines described in Hydraulic Engineering Circular 18 (Richardson and others, 1995). Scour depths were calculated assuming an infinite depth of erosive material and a homogeneous particle-size distribution. The results of the scour analysis are presented in tables 1 and 2 and a graph of the scour depths is presented in figure 8.
