LEVEL II SCOUR ANALYSIS FOR BRIDGE 45B (BRIDTH0004045B) on TOWN HIGHWAY 4, crossing an unnamed DAILEY HOLLOW BRANCH TRIBUTARY, BRIDGEWATER, VERMONT

U.S. Geological Survey
Open-File Report 96-568

By ERICK M. BOEHMLER

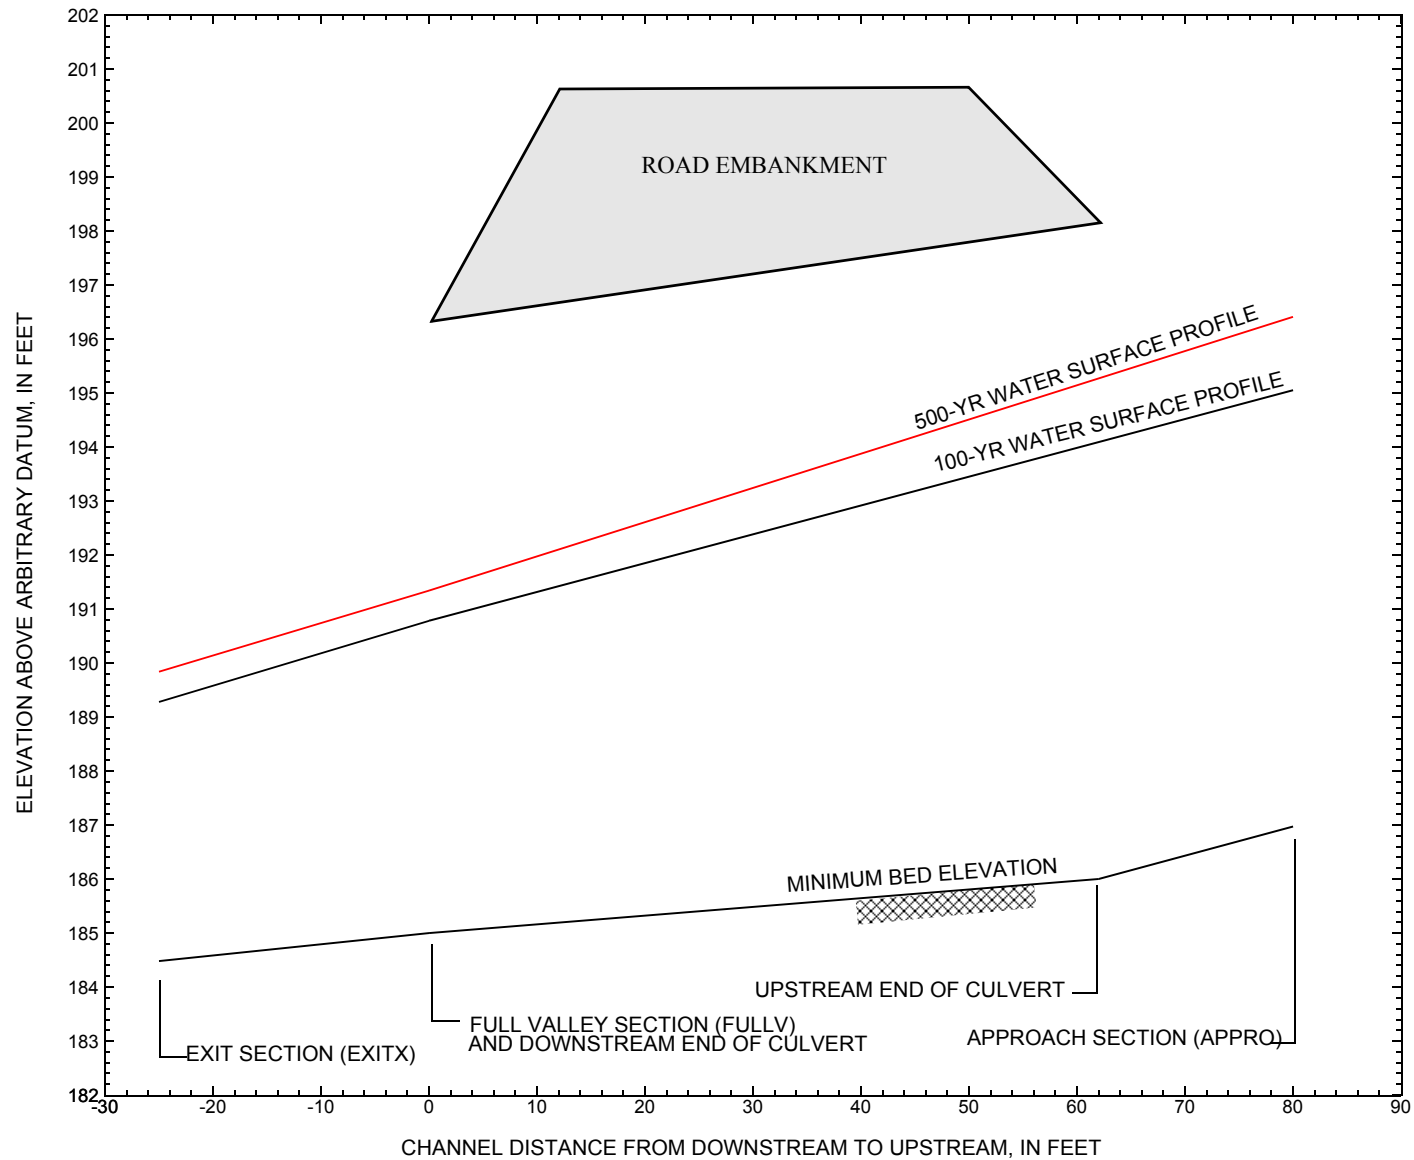
Figure 7. Water-surface profiles for the 100- and 500-yr discharges at structure [BRIDTH0004045B](#) on town highway 4, crossing an unnamed Dailey [Hollow Branch Tributary, Bridgewater, Vermont](#).

100-year discharge 975 ft³/s
 Water-surface elevation in bridge opening 190.8 ft
 Road overtopping? N Discharge over road -- ft/s
 Area of flow in bridge opening 93.0 ft²
 Average velocity in bridge opening 10.5 ft/s
 Maximum WSPRO tube velocity at bridge -- ft/s

500-year discharge 1200 ft³/s
 Water-surface elevation in bridge opening 191.3 ft
 Road overtopping? N Discharge over road -- ft/s
 Area of flow in bridge opening 102.4 ft²
 Average velocity in bridge opening 11.7 ft/s
 Maximum WSPRO tube velocity at bridge -- ft/s

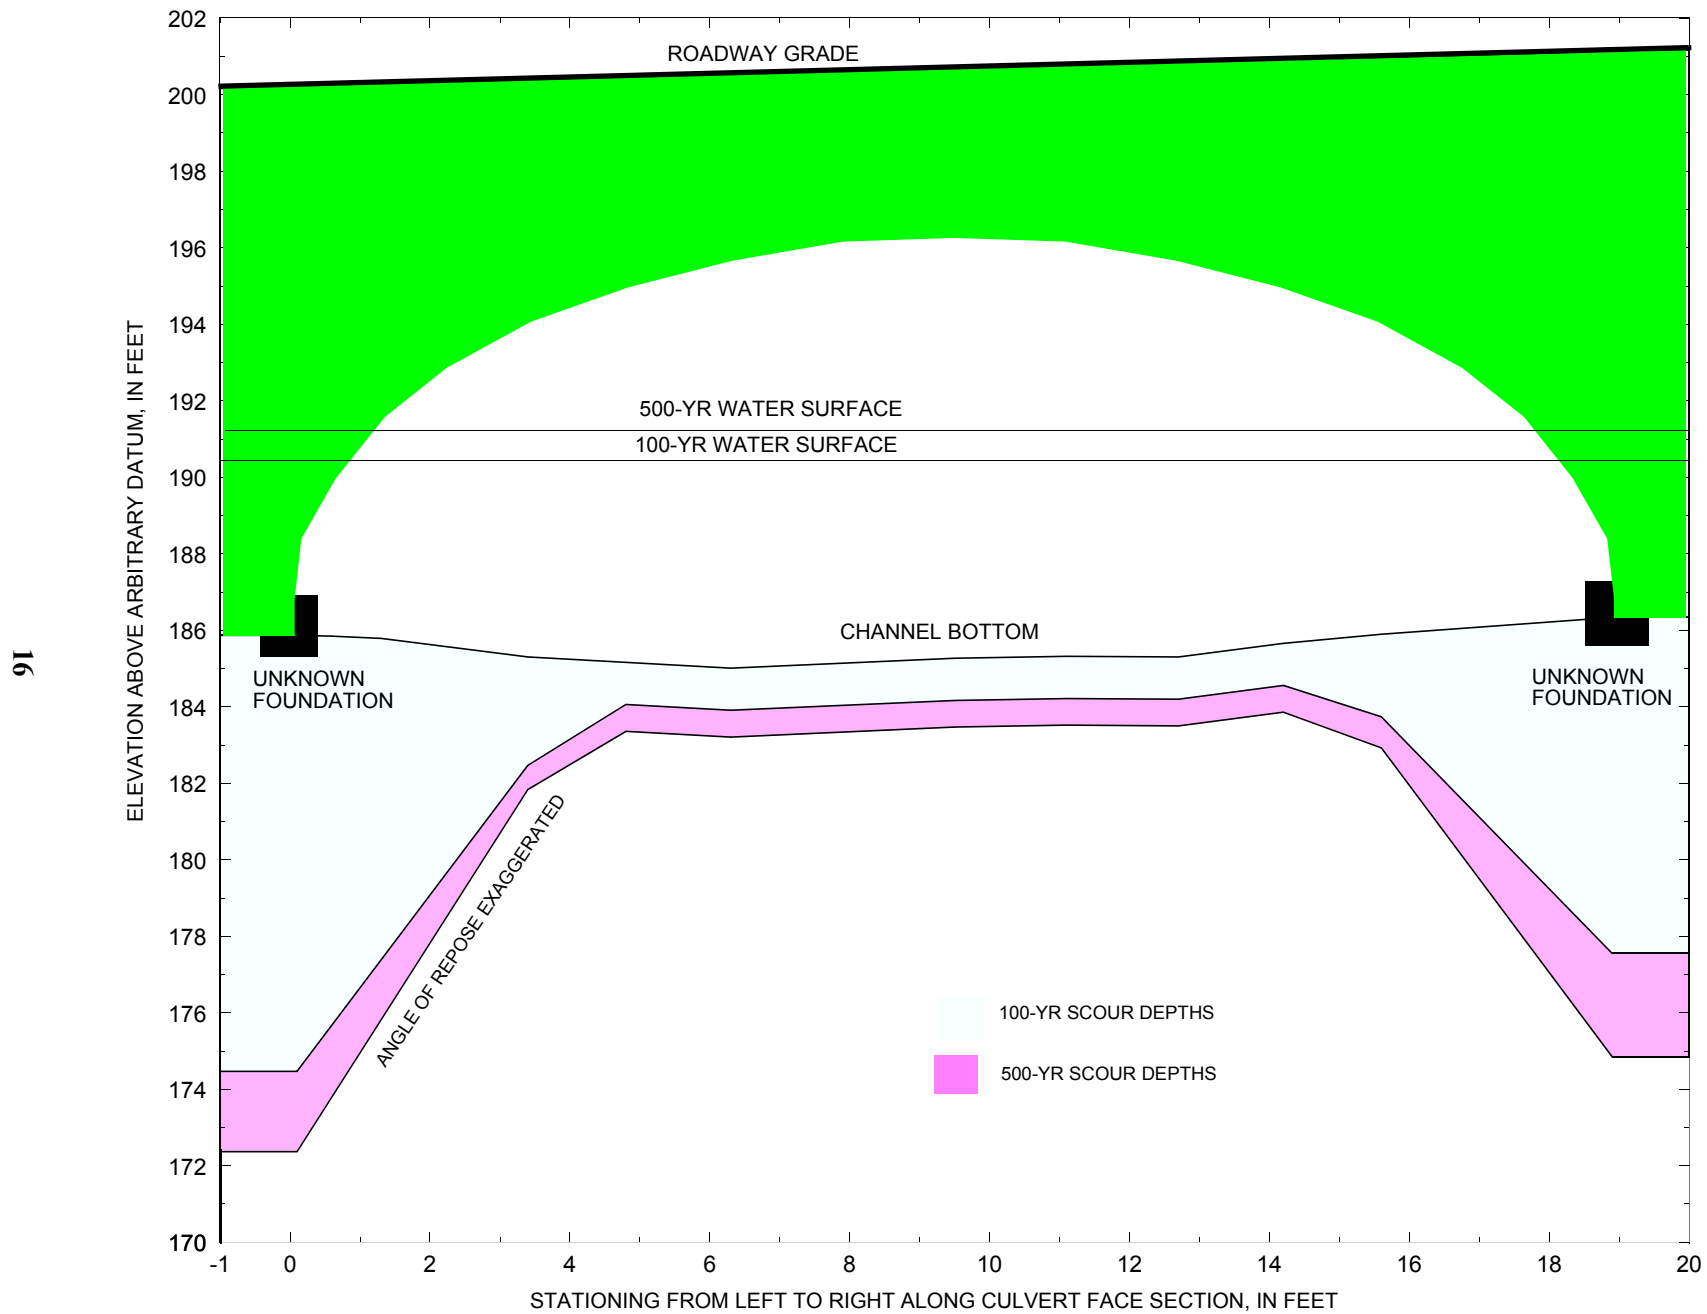
Figure 8. Scour elevations for the 100-yr and 500-yr discharges at structure [BRIDTH0004045B](#) on town highway 4, crossing an unnamed Dailey [Hollow Branch Tributary, Bridgewater, Vermont](#).

Contraction scour for all modelled flows ranged from 1.1 to 1.8 ft. The worst-case contraction scour occurred at the 500-year discharge. Abutment scour ranged from 7.7 to 11.7 ft. The worst-case abutment scour occurred at the 500-year discharge. Additional information on scour depths and depths to armoring are included in the section titled “Scour Results”. Scoured-streambed elevations, based on the calculated scour depths, are presented in tables 1 and 2. A cross-section of the scour computed at the bridge is presented in figure 8. Scour depths were calculated assuming an infinite depth of erosive material and a homogeneous particle-size distribution.

<i>Abutment scour</i>	10.3	11.7	--
<i>Left abutment</i>	7.7 ⁻	9.7 ⁻	-- ⁻
<i>Right abutment</i>	-- ⁻	-- ⁻	-- ⁻
<i>Pier scour</i>	--	--	--
<i>Pier 1</i>	--	--	--
<i>Pier 2</i>	--	--	--
<i>Pier 3</i>	--	--	--

<i>100-yr discharge</i>	<i>500-yr discharge</i>	<i>Incipient overtopping discharge</i>
	<i>(D₅₀ in feet)</i>		
<i>Abutments:</i>	1.9	2.2	--
<i>Left abutment</i>	1.9	2.2	--
<i>Right abutment</i>	-- ⁻	-- ⁻	-- ⁻
<i>Piers:</i>	--	--	--
<i>Pier 1</i>	-- ⁻	-- ⁻	-- ⁻
<i>Pier 2</i>	-- ⁻	-- ⁻	-- ⁻
