# LEVEL II SCOUR ANALYSIS FOR BRIDGE 28 (HARDTH00300028) on TOWN HIGHWAY 30, crossing the LAMOILLE RIVER, HARDWICK, VERMONT

U.S. Geological Survey  
Open-File Report 96-569

Prepared in cooperation with  
VERMONT AGENCY OF TRANSPORTATION  
and  
FEDERAL HIGHWAY ADMINISTRATION

By SCOTT A. OLSON and JAMES R. DEGNAN

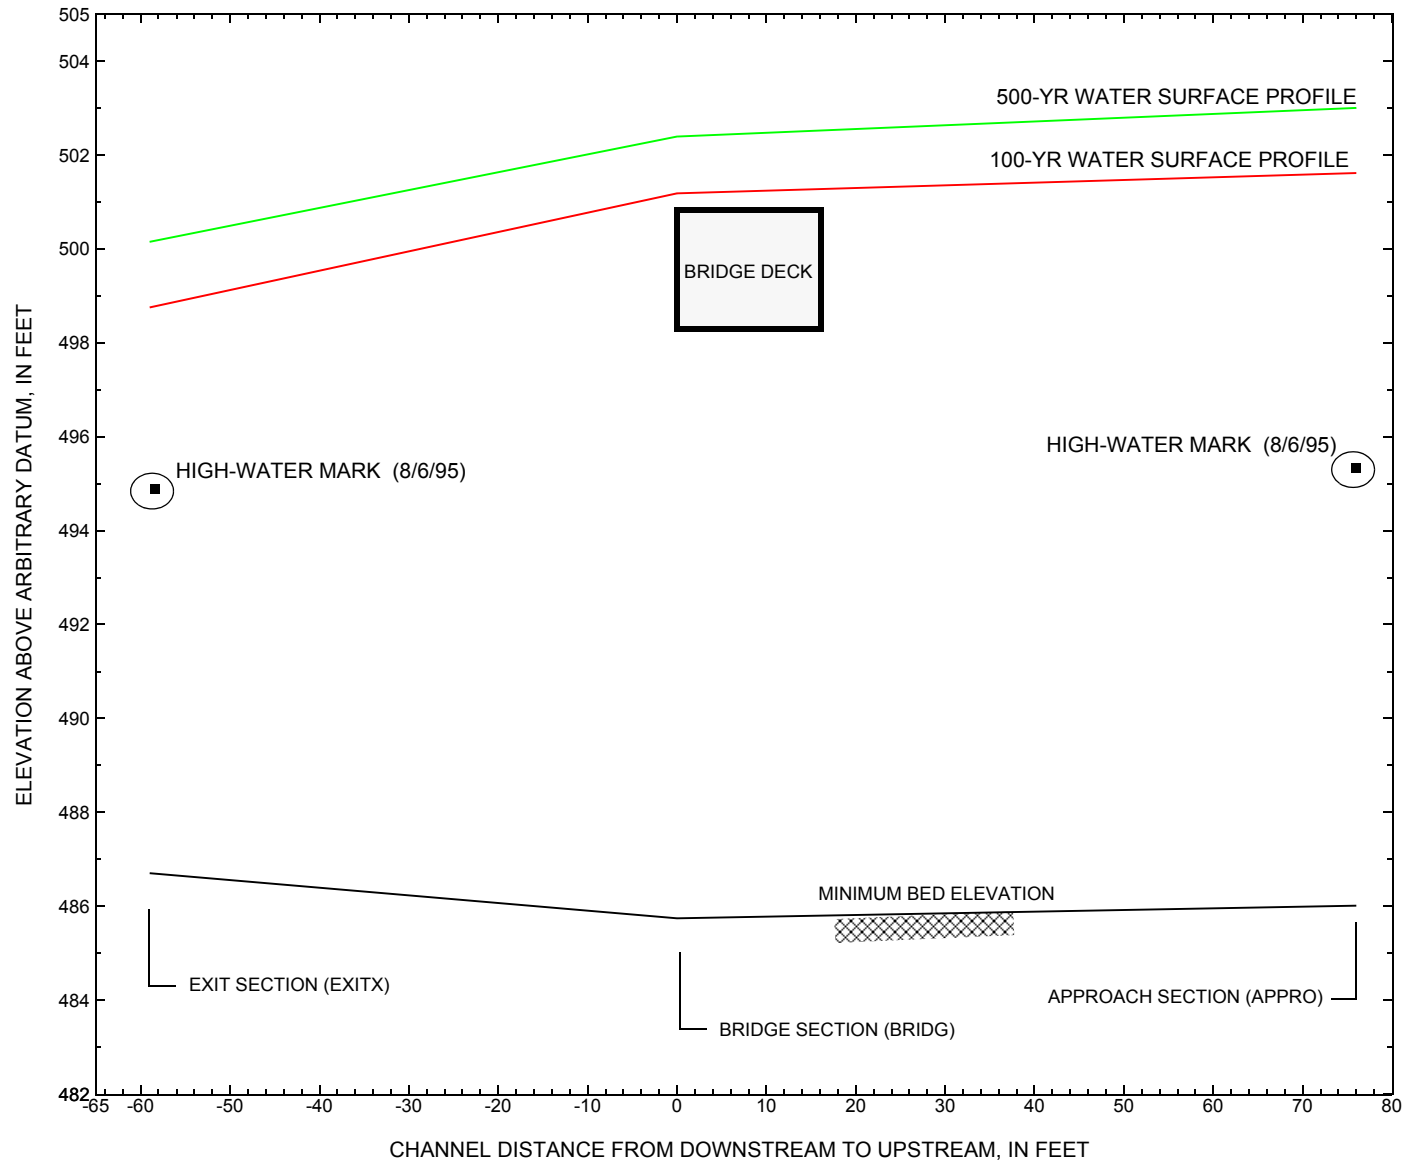
Figure 7. Water-surface profiles for the 100- and 500-yr discharges at structure [HARDTH00300028](#) on town highway 30, crossing the Lamoille River, Hardwick, Vermont.

Water-surface elevation at Approach section with bridge 501.6  
 Water-surface elevation at Approach section without bridge 499.1  
 Amount of backwater caused by bridge 2.5 ft

Water-surface elevation at Approach section with bridge 503.0  
 Water-surface elevation at Approach section without bridge 500.5  
 Amount of backwater caused by bridge 2.5 ft

Water-surface elevation at Approach section with bridge 498.3  
 Water-surface elevation at Approach section without bridge 496.8  
 Amount of backwater caused by bridge 1.5 ft

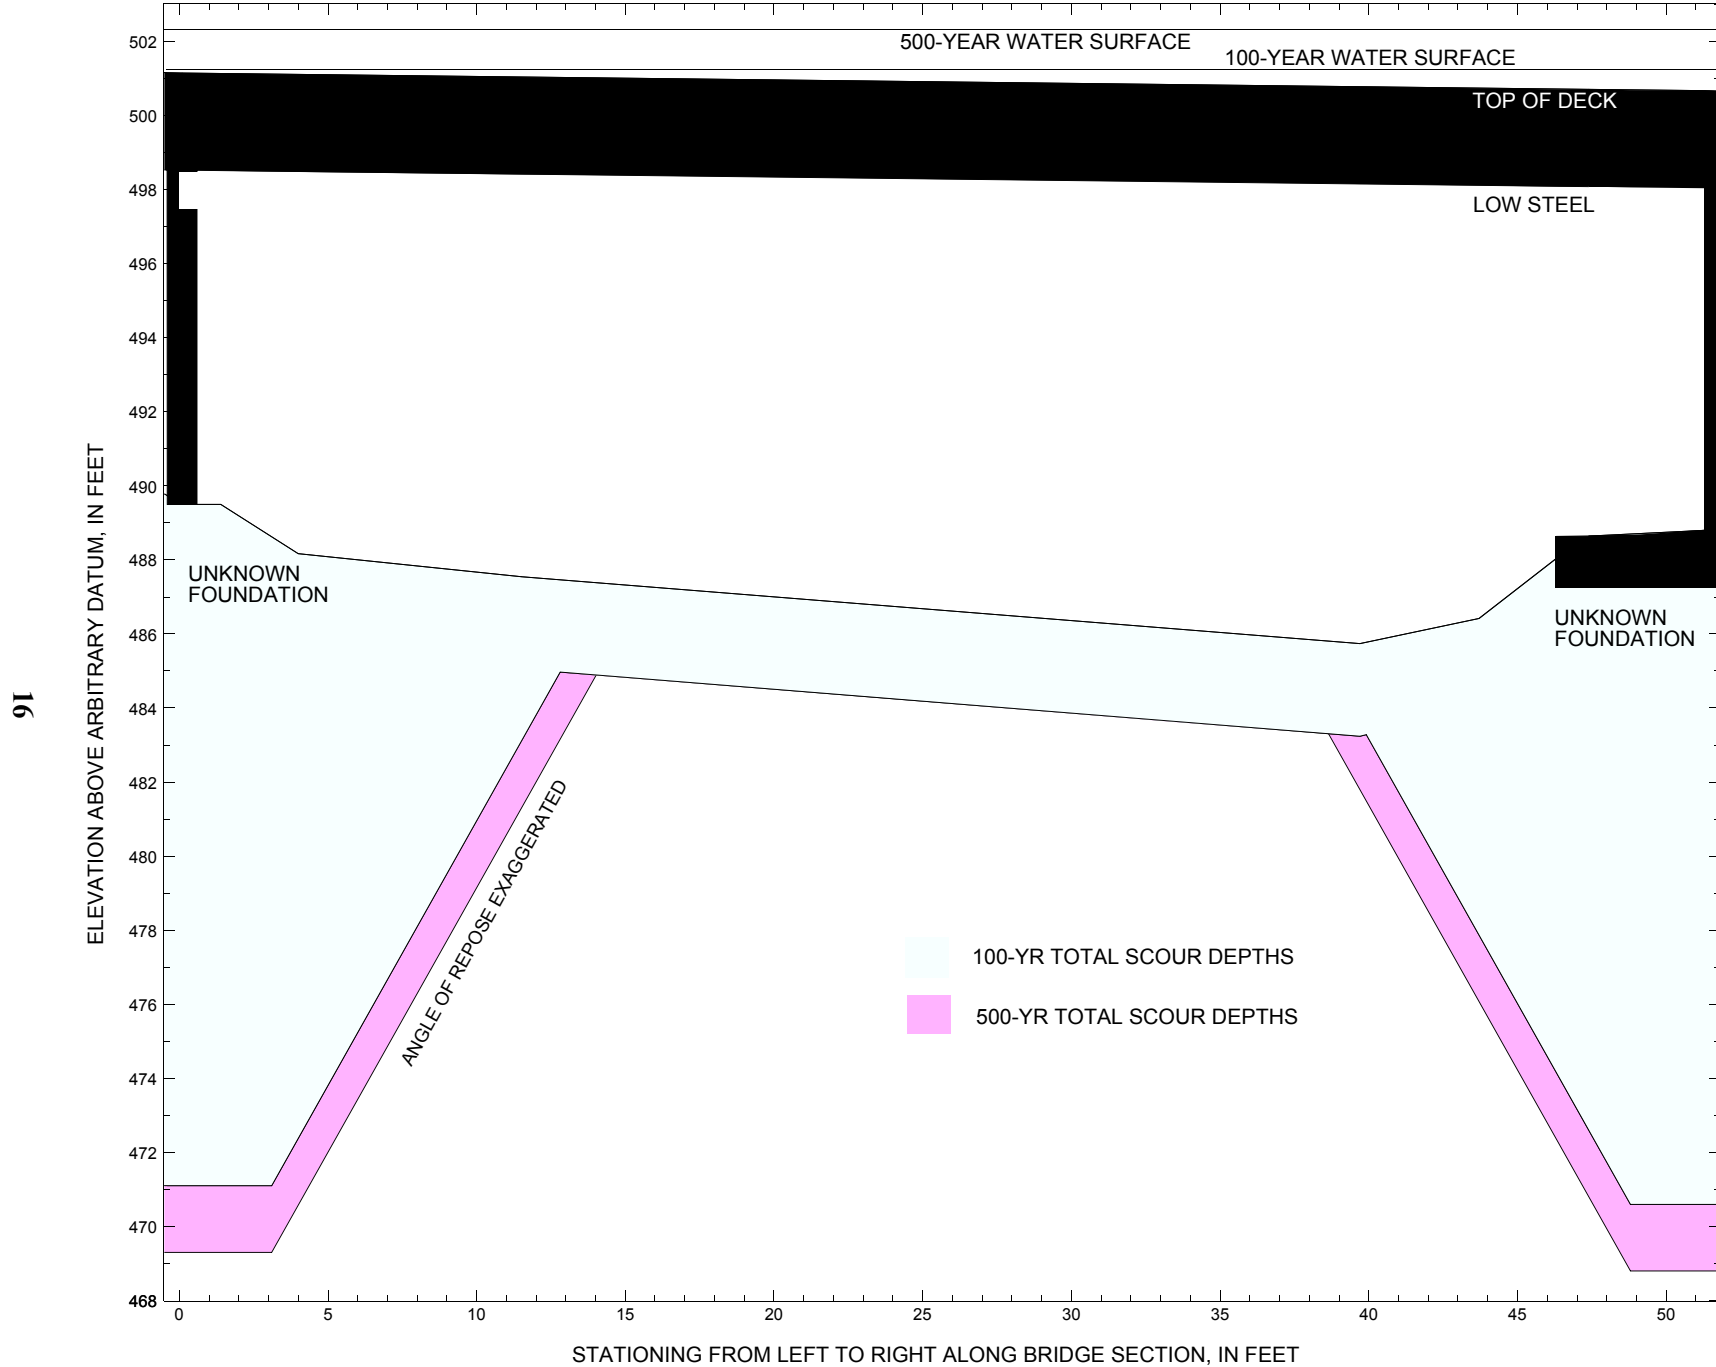
Figure 8. Scour elevations for the 100-yr and 500-yr discharges at structure [HARDTH00300028](#) on town highway 30, crossing the [Lamoille River, Hardwick, Vermont](#).

Contraction scour for all modelled flows ranged from 1.9 to 2.5 ft. The worst-case contraction scour occurred at the 100-year discharge. Abutment scour ranged from 11.2 to 17.8 ft. The worst-case abutment scour occurred at the 500-year discharge. Additional information on scour depths and depths to armoring are included in the section titled “Scour Results”. Scoured-streambed elevations, based on the calculated scour depths, are presented in tables 1 and 2. A cross-section of the scour computed at the bridge is presented in figure 8. Scour depths were calculated assuming an infinite depth of erosive material and a homogeneous particle-size distribution.

Abutment scour was computed by use of the [HIRE equation](#) (Richardson and others, 1995, p. 49, equation 29) [because the HIRE equation is recommended when the length to depth ratio of the embankment blocking flow exceeds 25.](#) Variables for the [HIRE equation](#) include the Froude number of the flow approaching the embankments, the length of the embankment blocking flow, and the depth of flow approaching the embankment less any roadway overtopping.

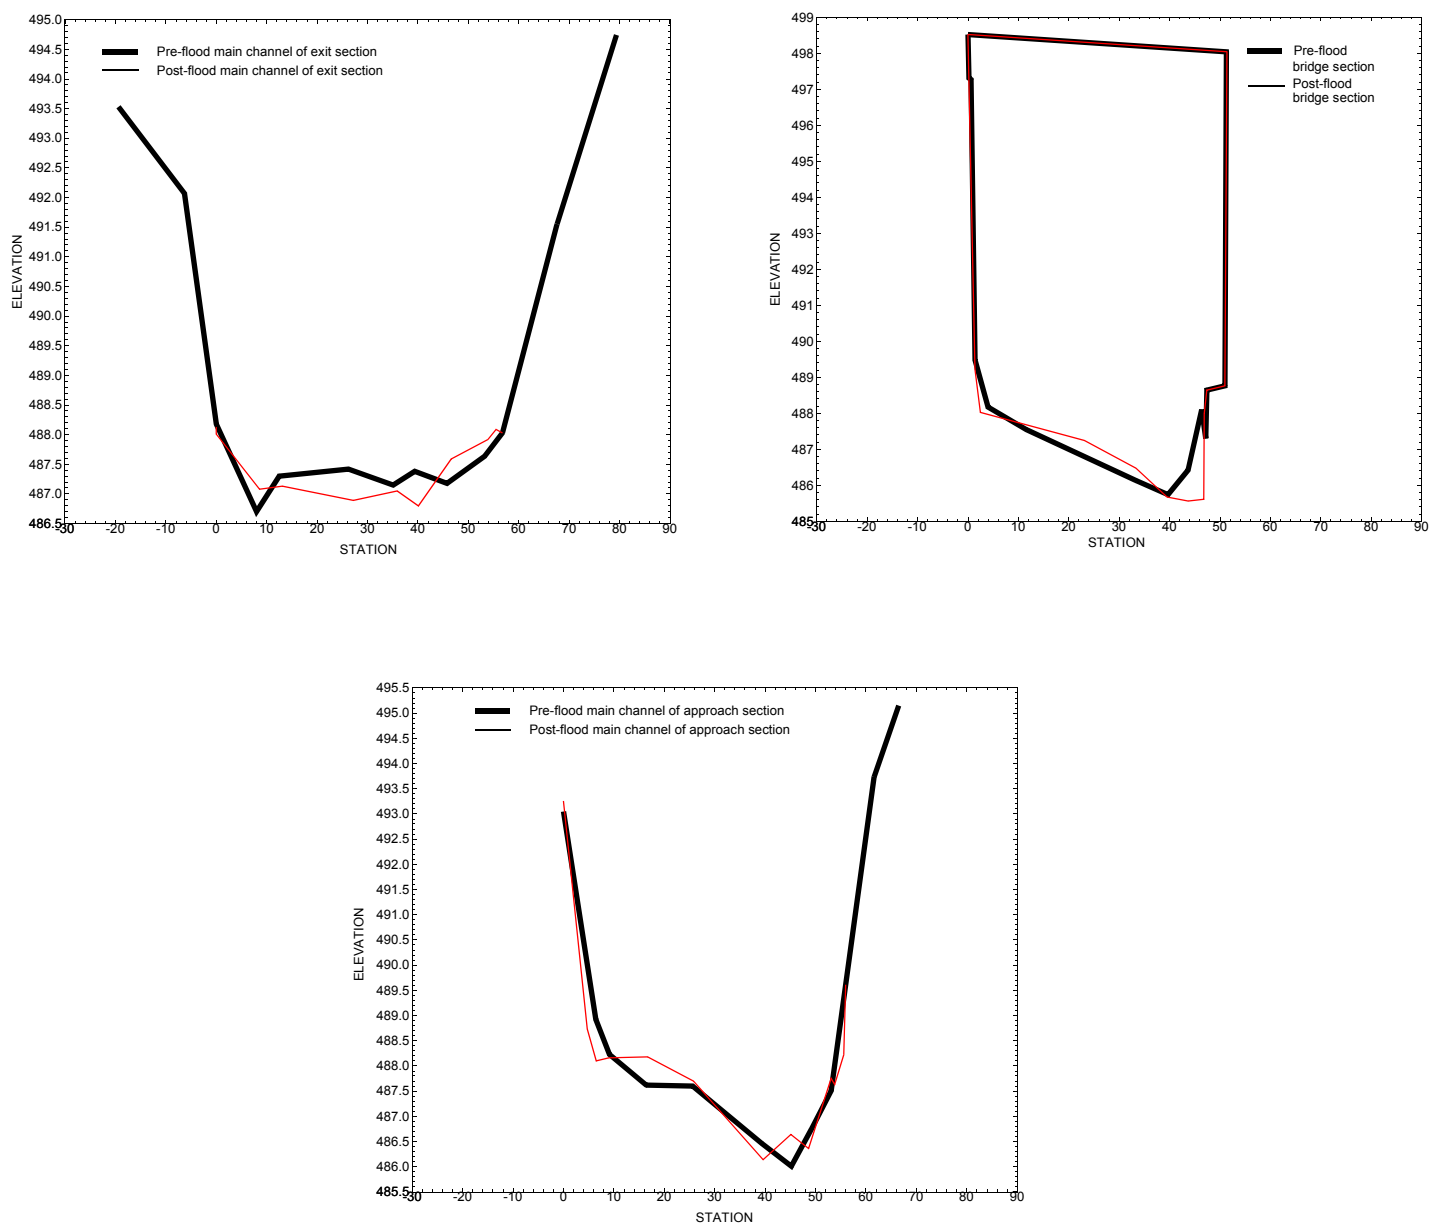
Figure G-1. Pre- and post-flood plots of channel bottom at the cross-sections identified on p. 10 of this report under the section 'Description of Water Surface Profile model (WSPRO) analysis, Cross-sections used in WSPRO analysis'.
