LEVEL II SCOUR ANALYSIS FOR BRIDGE 7 ([BERKTH00030007](#)) on [TOWN HIGHWAY 3](#), crossing the [PIKE RIVER](#), [BERKSHIRE](#), VERMONT

U.S. Geological Survey
Open-File Report [96-645](#)

By Erick M. Boehmler and Donald L. Song

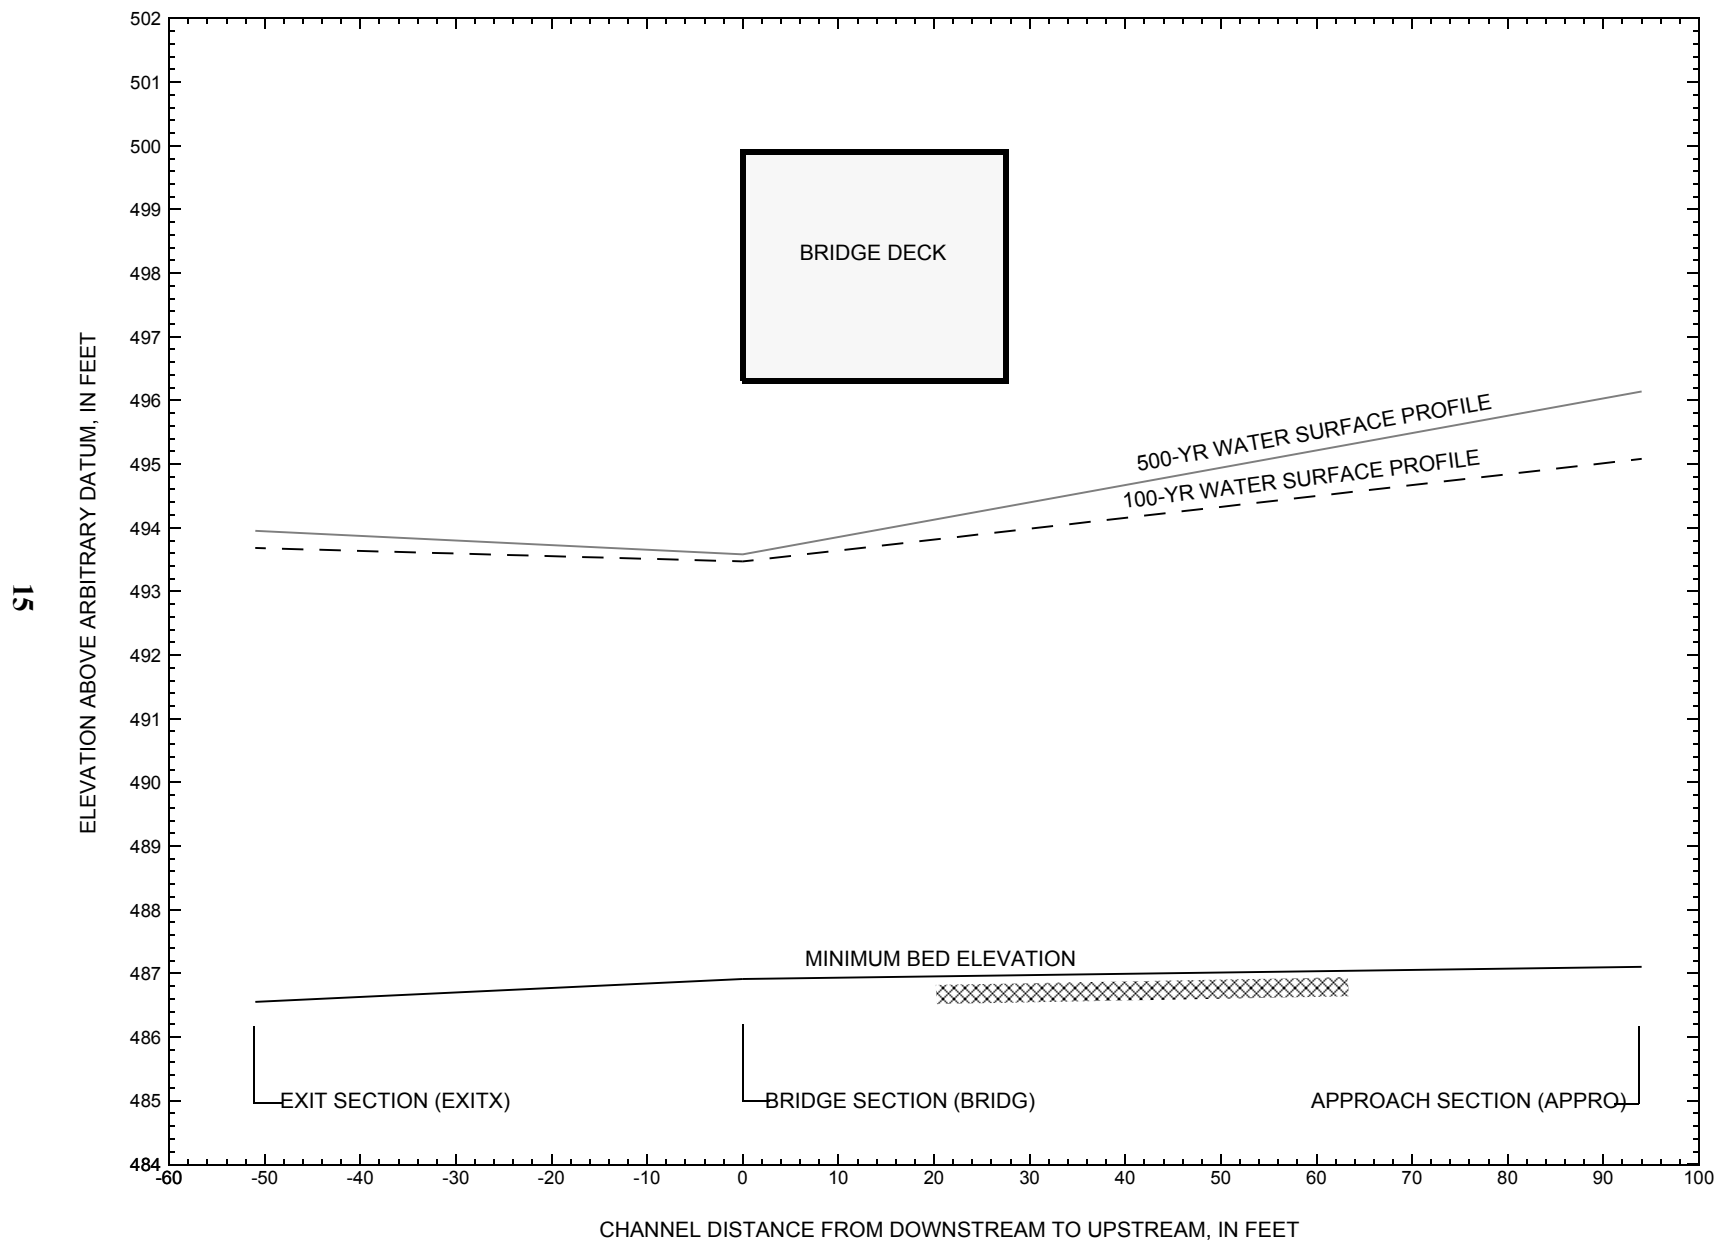
Water-surface elevation at Approach section with bridge 495.1
 Water-surface elevation at Approach section without bridge 493.9
 Amount of backwater caused by bridge 1.2 ft

Water-surface elevation at Approach section with bridge 496.1
 Water-surface elevation at Approach section without bridge 494.1
 Amount of backwater caused by bridge 2.0 ft

Figure 7. Water-surface profiles for the 100- and 500-yr discharges at structure [BERKTH00030007](#) on Town Highway 3, crossing [Pike River](#), [Berkshire](#), Vermont.

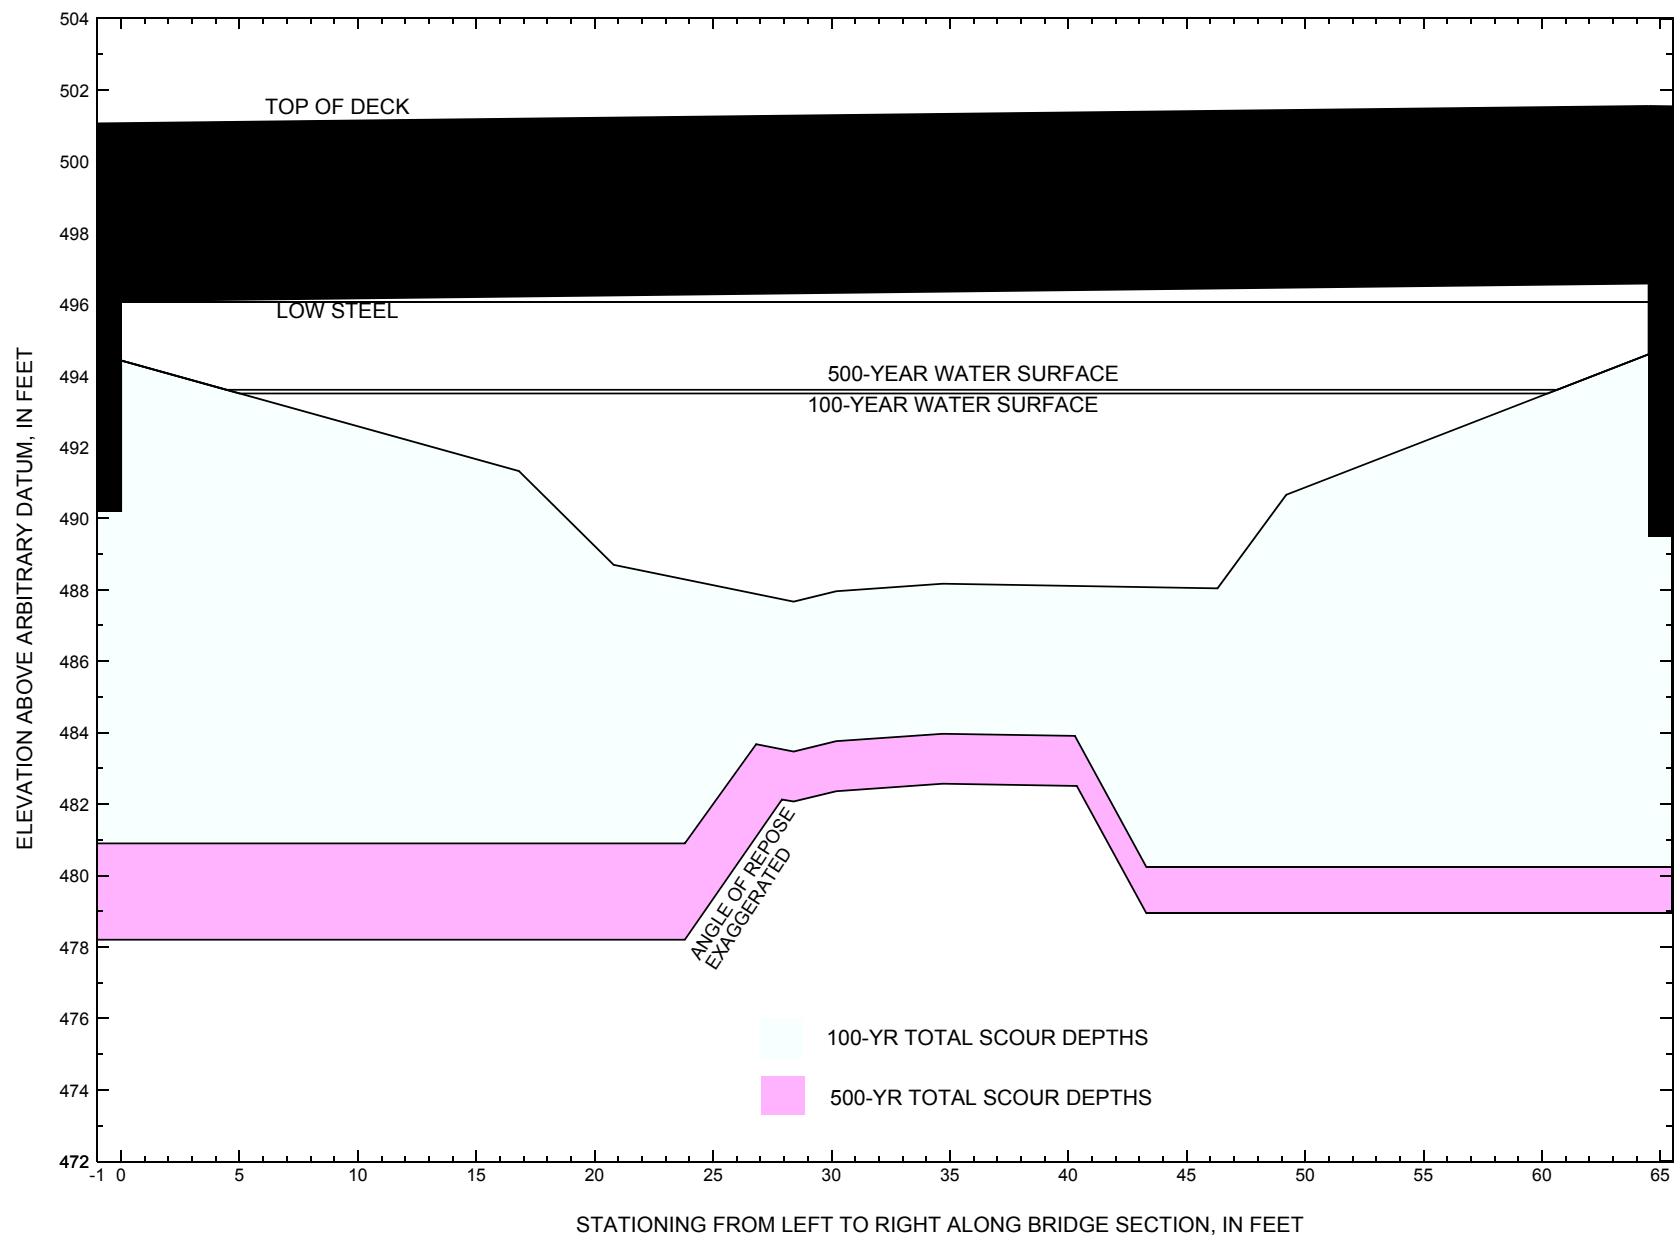
Contraction scour for all modelled flows ranged from 4.2 to 5.6 ft. The worst-case contraction scour occurred at the 500-year discharge. Abutment scour ranged from 3.5 to 4.9 ft. The worst-case abutment scour also occurred at the 500-year discharge. Additional information on scour depths and depths to armoring are included in the section titled “Scour Results”. Scoured-streambed elevations, based on the calculated scour depths, are presented in tables 1 and 2. A cross-section of the scour computed at the bridge is presented in figure 8. Scour depths were calculated assuming an infinite depth of erosive material and a homogeneous particle-size distribution.

Because the influence of scour processes on the spill-through embankment material is uncertain, the scour depth at the vertical concrete abutment walls is unknown. Therefore, the total scour depths were applied for the entire spill-through embankment below the elevation at the toe of each embankment, as shown in figure 8.

Figure 8. Scour elevations for the 100-yr and 500-yr discharges at structure [BERKTH00030007](#) on Town Highway 3, crossing [Pike River, Berkshire, Vermont](#).
