LEVEL II SCOUR ANALYSIS FOR BRIDGE 6 (VICTTH00010006) on TOWN HIGHWAY 1, crossing the MOOSE RIVER, VICTORY, VERMONT

U.S. Geological Survey
Open-File Report 97-6

Prepared in cooperation with
VERMONT AGENCY OF TRANSPORTATION
and
FEDERAL HIGHWAY ADMINISTRATION

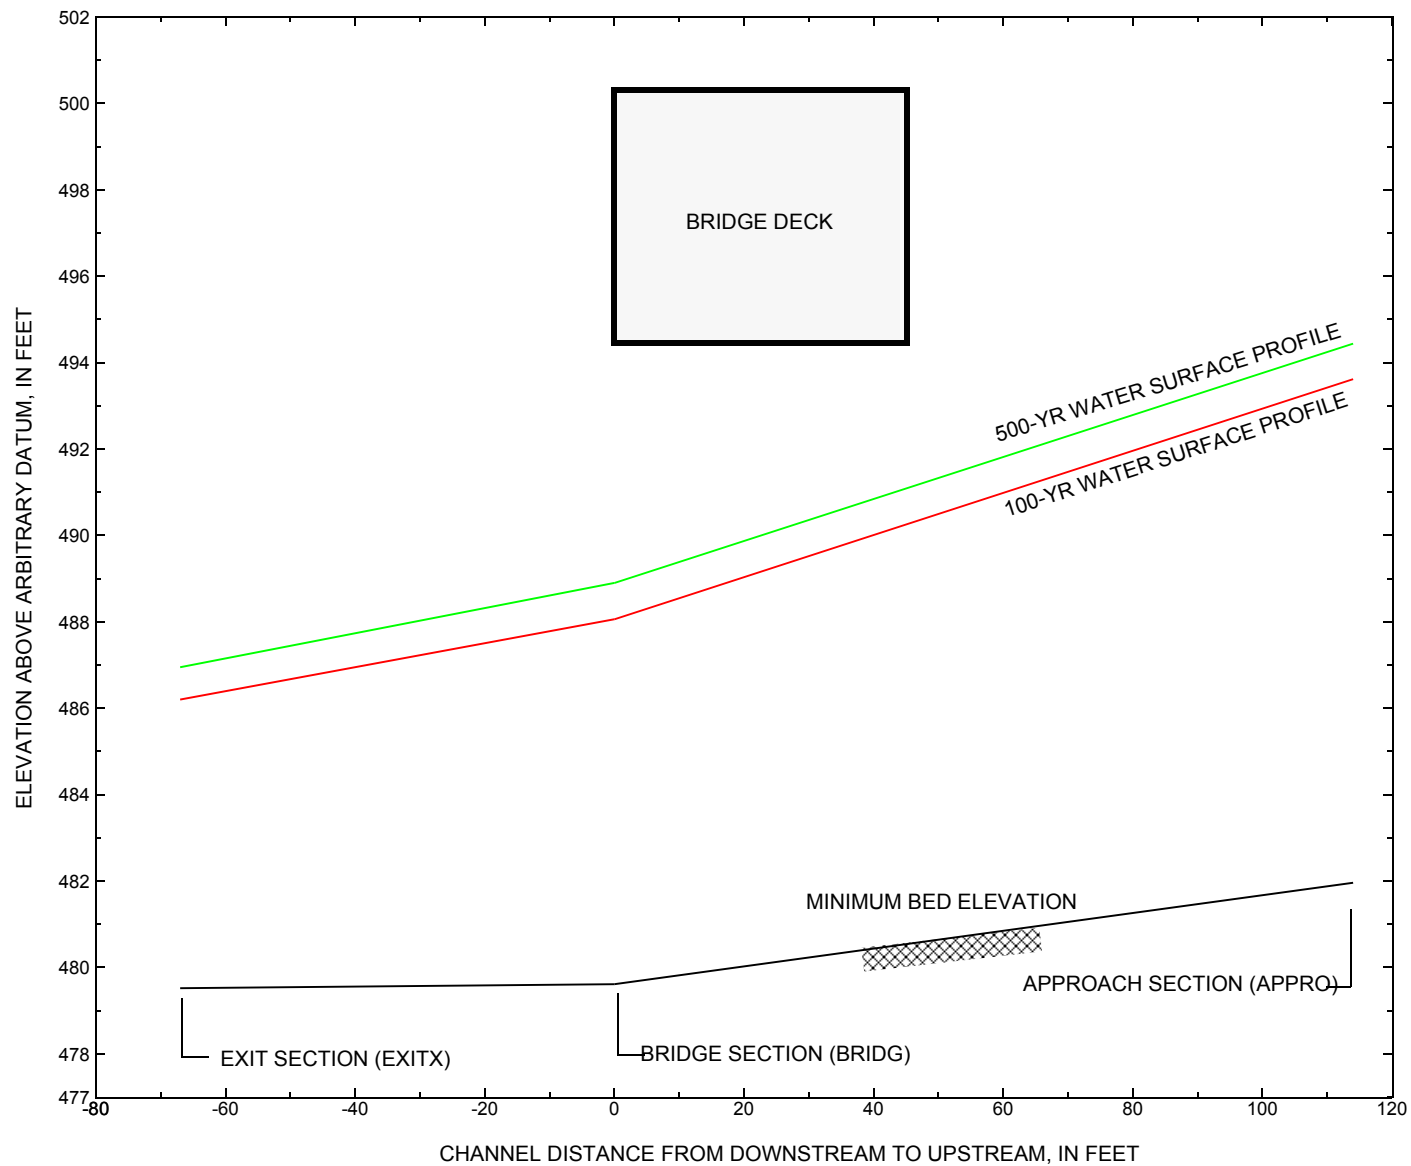
Figure 7. Water-surface profiles for the 100- and 500-yr discharges at structure VICTTH00010006 on Town Highway 1, crossing the Moose River, Victory, Vermont.

100-year discharge 3,120 *ft³/s*
Water-surface elevation in bridge opening 488.1 *ft*
Road overtopping? N *Discharge over road* -- *ft³/s*
Area of flow in bridge opening 250 *ft²*
Average velocity in bridge opening 12.5 *ft/s*
Maximum WSPRO tube velocity at bridge 15.8 *ft/s*

Water-surface elevation at Approach section with bridge 493.6
Water-surface elevation at Approach section without bridge 489.3
Amount of backwater caused by bridge 4.3 *ft*

500-year discharge 3,870 *ft³/s*
Water-surface elevation in bridge opening 488.9 *ft*
Road overtopping? No *Discharge over road* -- *ft³/s*
Area of flow in bridge opening 295 *ft²*
Average velocity in bridge opening 13.1 *ft/s*
Maximum WSPRO tube velocity at bridge 16.7 *ft/s*

Water-surface elevation at Approach section with bridge 494.4
Water-surface elevation at Approach section without bridge 490.0
Amount of backwater caused by bridge 4.4 *ft*

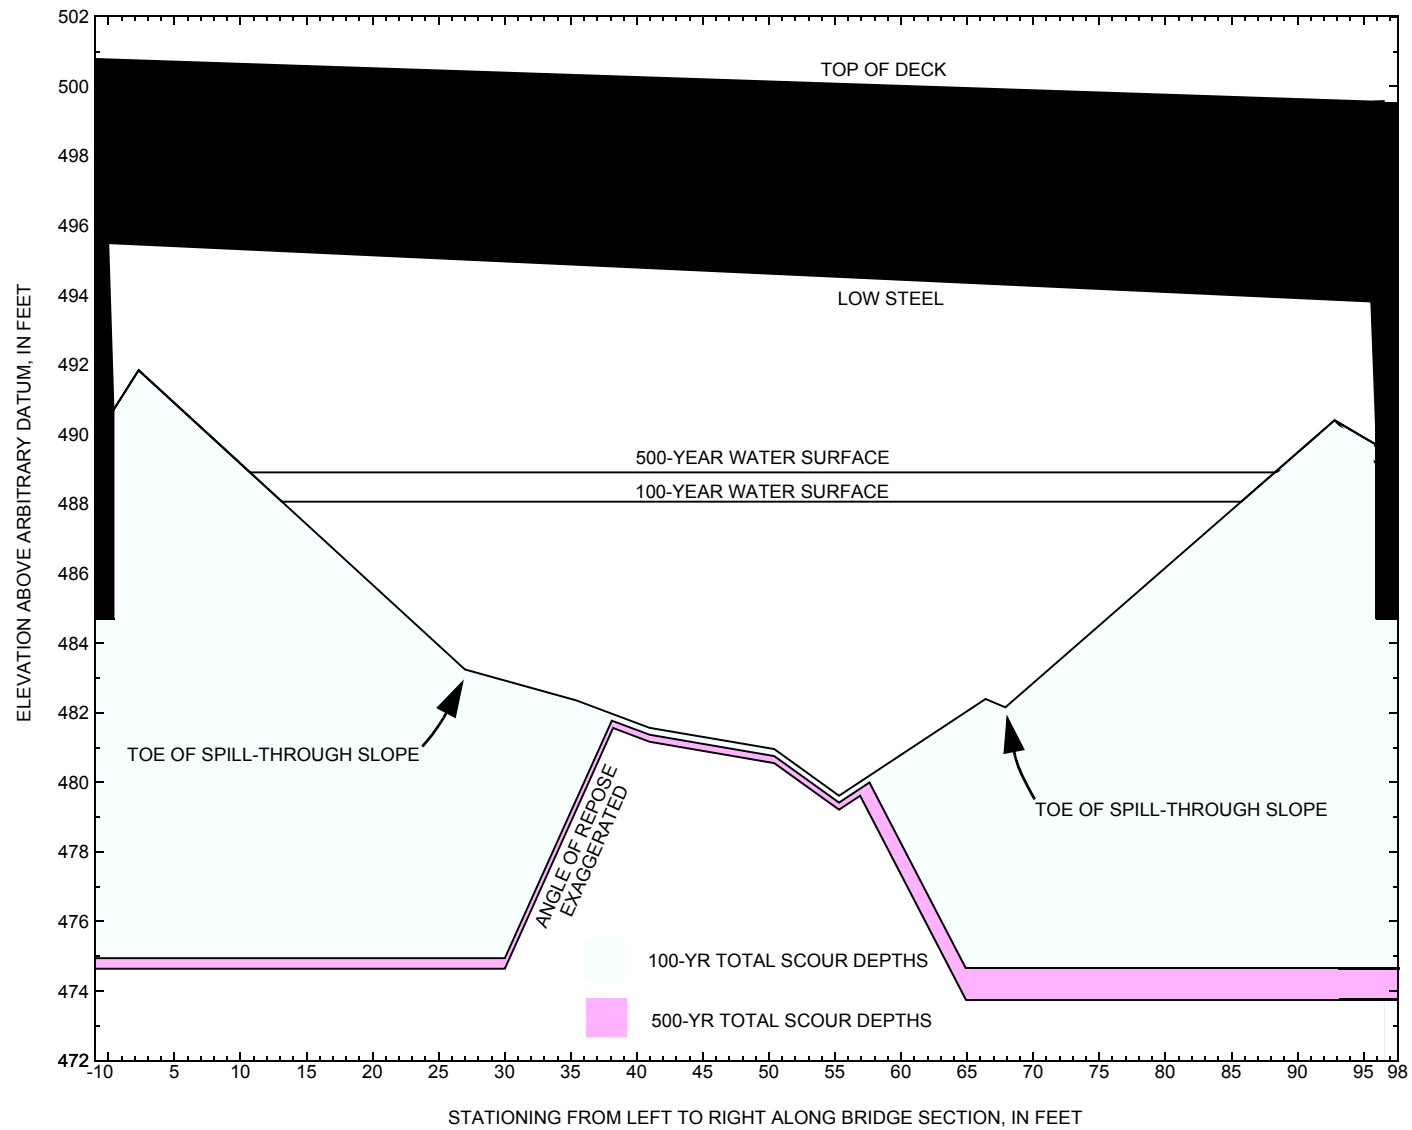
Figure 8. Scour elevations for the 100-yr and 500-yr discharges at structure VICTTH00010006 on Town Highway 1, crossing the Moose River, Victory, Vermont.

Scour depths were computed using the general guidelines described in Hydraulic Engineering Circular 18 (Richardson and others, 1995). Scour depths were calculated assuming an infinite depth of erosive material and a homogeneous particle-size distribution. The results of the scour analysis are presented in tables 1 and 2 and a graph of the scour depths is presented in figure 8.

Because the influence of scour processes on the spill-through embankment material is uncertain, the scour depth at the vertical concrete abutment walls is unknown. Therefore, the total scour depths were applied for the entire spill-through embankment below the elevation at the toe of each embankment, as shown in figure 8.

<i>Abutment scour</i>	8.1	8.2	--
<i>Left abutment</i>	7.3	8.0	--
<i>Right abutment</i>			
<i>Pier scour</i>	--	--	--
<i>Pier 1</i>	--	--	--
<i>Pier 2</i>	--	--	--
<i>Pier 3</i>

<i>100-yr discharge</i>	<i>500-yr discharge</i>	<i>Incipient overtopping discharge</i>
	<i>(D₅₀ in feet)</i>		
<i>Abutments:</i>	1.8	2.0	--
<i>Left abutment</i>	1.8	2.0	--
<i>Right abutment</i>	--	--	--
<i>Piers:</i>	--	--	--
<i>Pier 1</i>	--	--	--
<i>Pier 2</i>	--	--	--
