LEVEL II SCOUR ANALYSIS FOR BRIDGE 8 (DANVTH00020008) on TOWN HIGHWAY 2, crossing MORRILL BROOK, DANVILLE, VERMONT

U.S. Geological Survey
Open-File Report 97-104

By MICHAEL A. IVANOFF

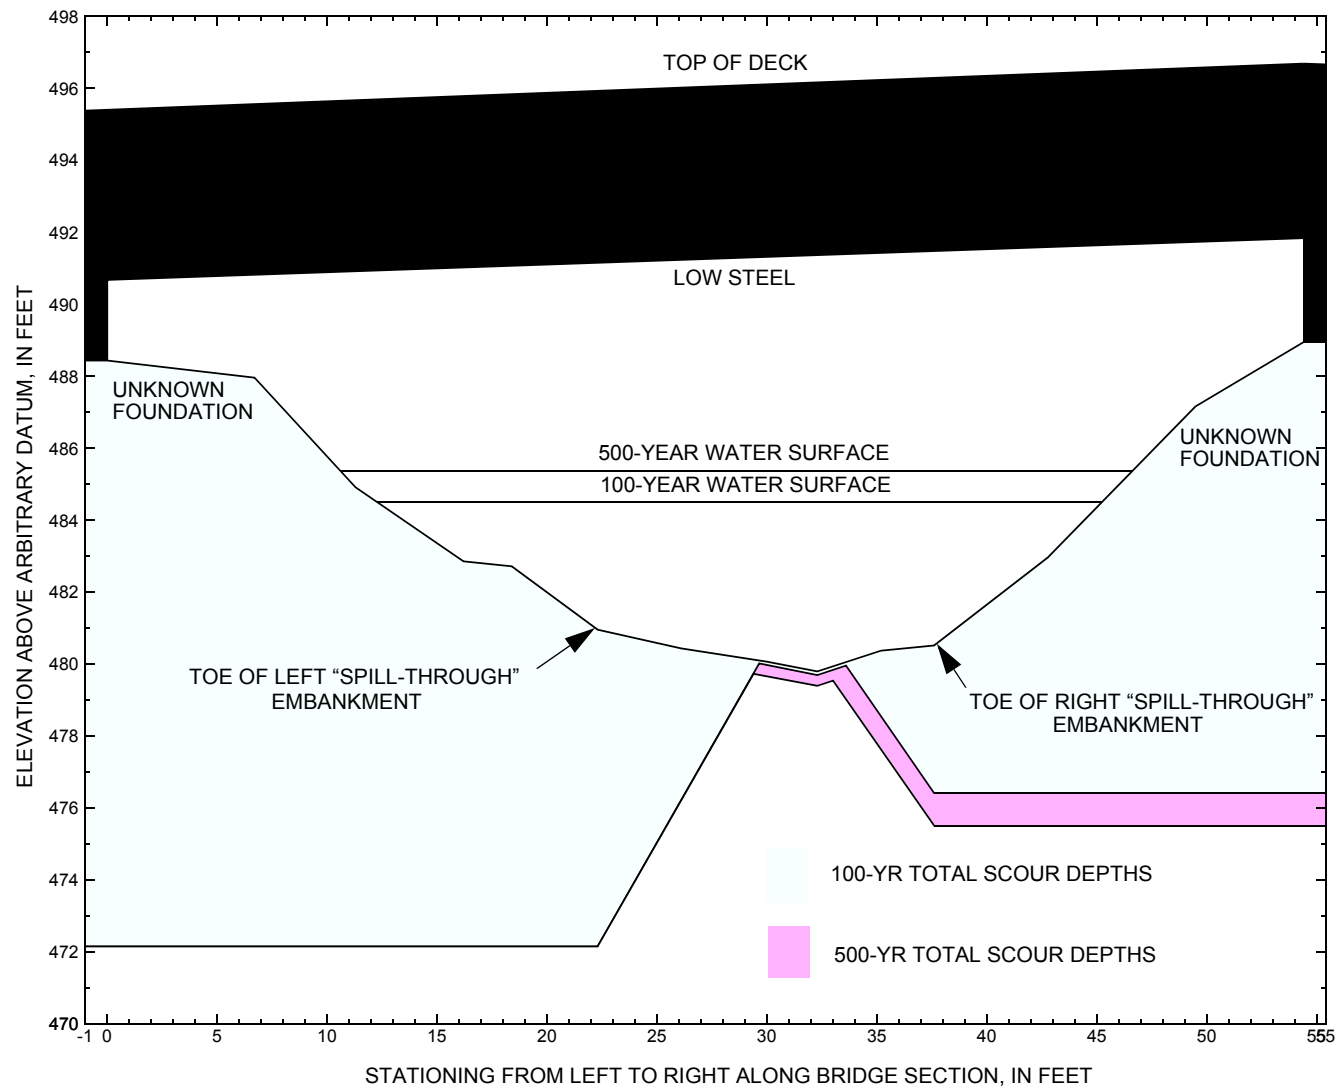
Figure 8. Scour elevations for the 100-yr and 500-yr discharges at structure DANVTH00020008 on Town Highway 2, crossing Morrill Brook, Danville, Vermont.

Contraction scour for modelled flows ranged from 0.1 to 0.4 ft. The worst-case contraction scour occurred at the 500-year discharge. Abutment scour ranged from 4.0 to 8.7 ft. The worst-case abutment scour occurred at the 100-year discharge. Additional information on scour depths and depths to armoring are included in the section titled “Scour Results”. Scoured-streambed elevations, based on the calculated scour depths, are presented in tables 1 and 2. A cross-section of the scour computed at the bridge is presented in figure 8. Scour depths were calculated assuming an infinite depth of erosive material and a homogeneous particle-size distribution.

Because the influence of scour processes on the spill-through embankment material is uncertain, the scour depth at the vertical concrete abutment walls is unknown. Therefore, the total scour depth computed at the toe of each abutment was applied to the entire area of the embankment, as shown in figure 8.
