LEVEL II SCOUR ANALYSIS FOR
BRIDGE 6 (MORRTH00030006) on
TOWN HIGHWAY 3 (FAS 238), crossing
RYDER BROOK,
MORRISTOWN, VERMONT

U.S. Geological Survey
Open-File Report 97-105

By Erick M. Boehmler and Robert E. Hammond

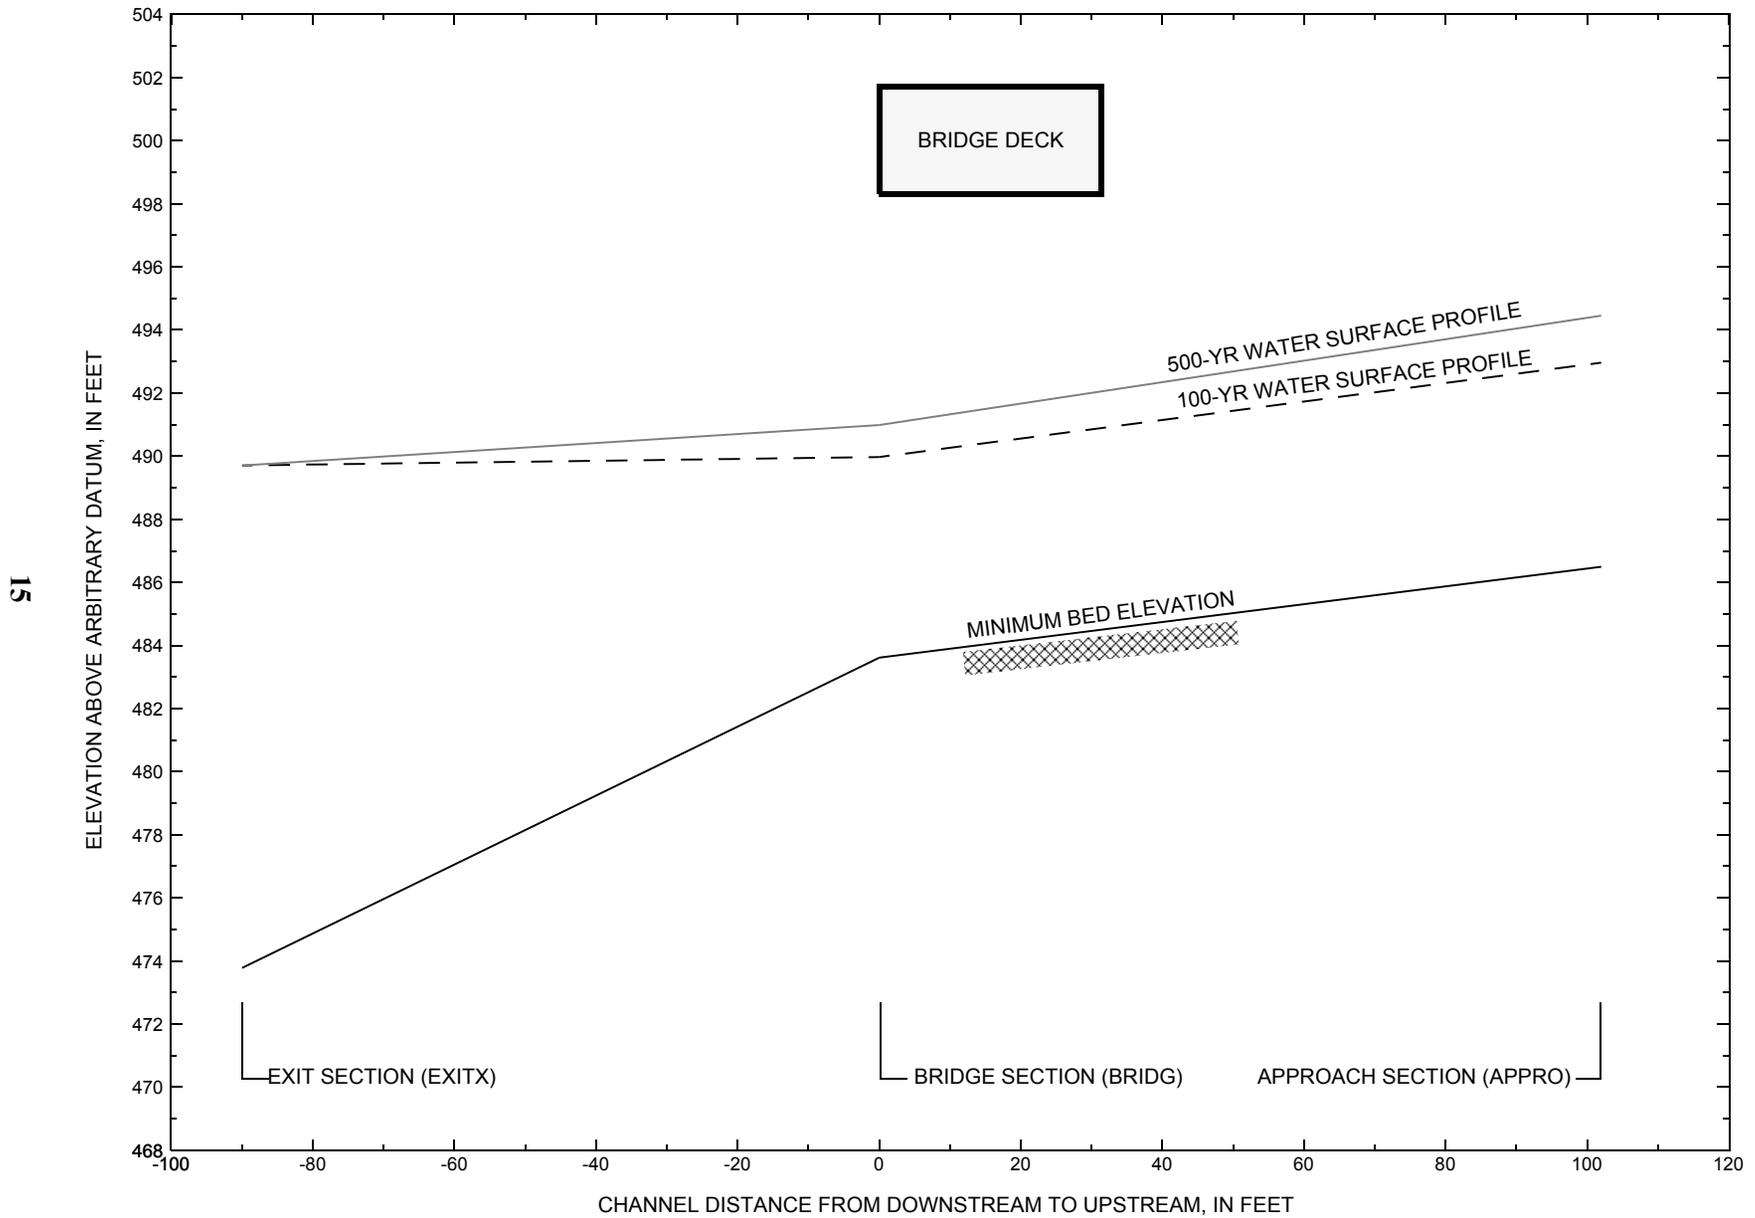
Figure 7. Water-surface profiles for the 100- and 500-yr discharges at structure MORRTH00030006 on Town Highway 3, crossing Ryder Brook, Morristown, Vermont.

Hydraulic analyses of the reach were done by use of the Federal Highway Administration's WSPRO step-backwater computer program (Shearman and others, 1986, and Shearman, 1990). The analyses reported herein reflect conditions existing at the site at the time of the study. Furthermore, in the development of the model it was necessary to assume no accumulation of debris or ice at the site. Results of the hydraulic model are presented in the Bridge Hydraulic Summary, Appendix B, and figure 7.

For the 100- and 500-year discharges, WSPRO assumes critical depth at the bridge section. Supercritical models were developed for these discharges. After analyzing both the supercritical and subcritical profiles for each discharge, it was determined that the water surface profile does pass through critical depth within the bridge opening. Thus, the assumptions of critical depth at the bridge are satisfactory solutions assuming the starting water surface is at or below the elevation applied in these hydraulic analyses.

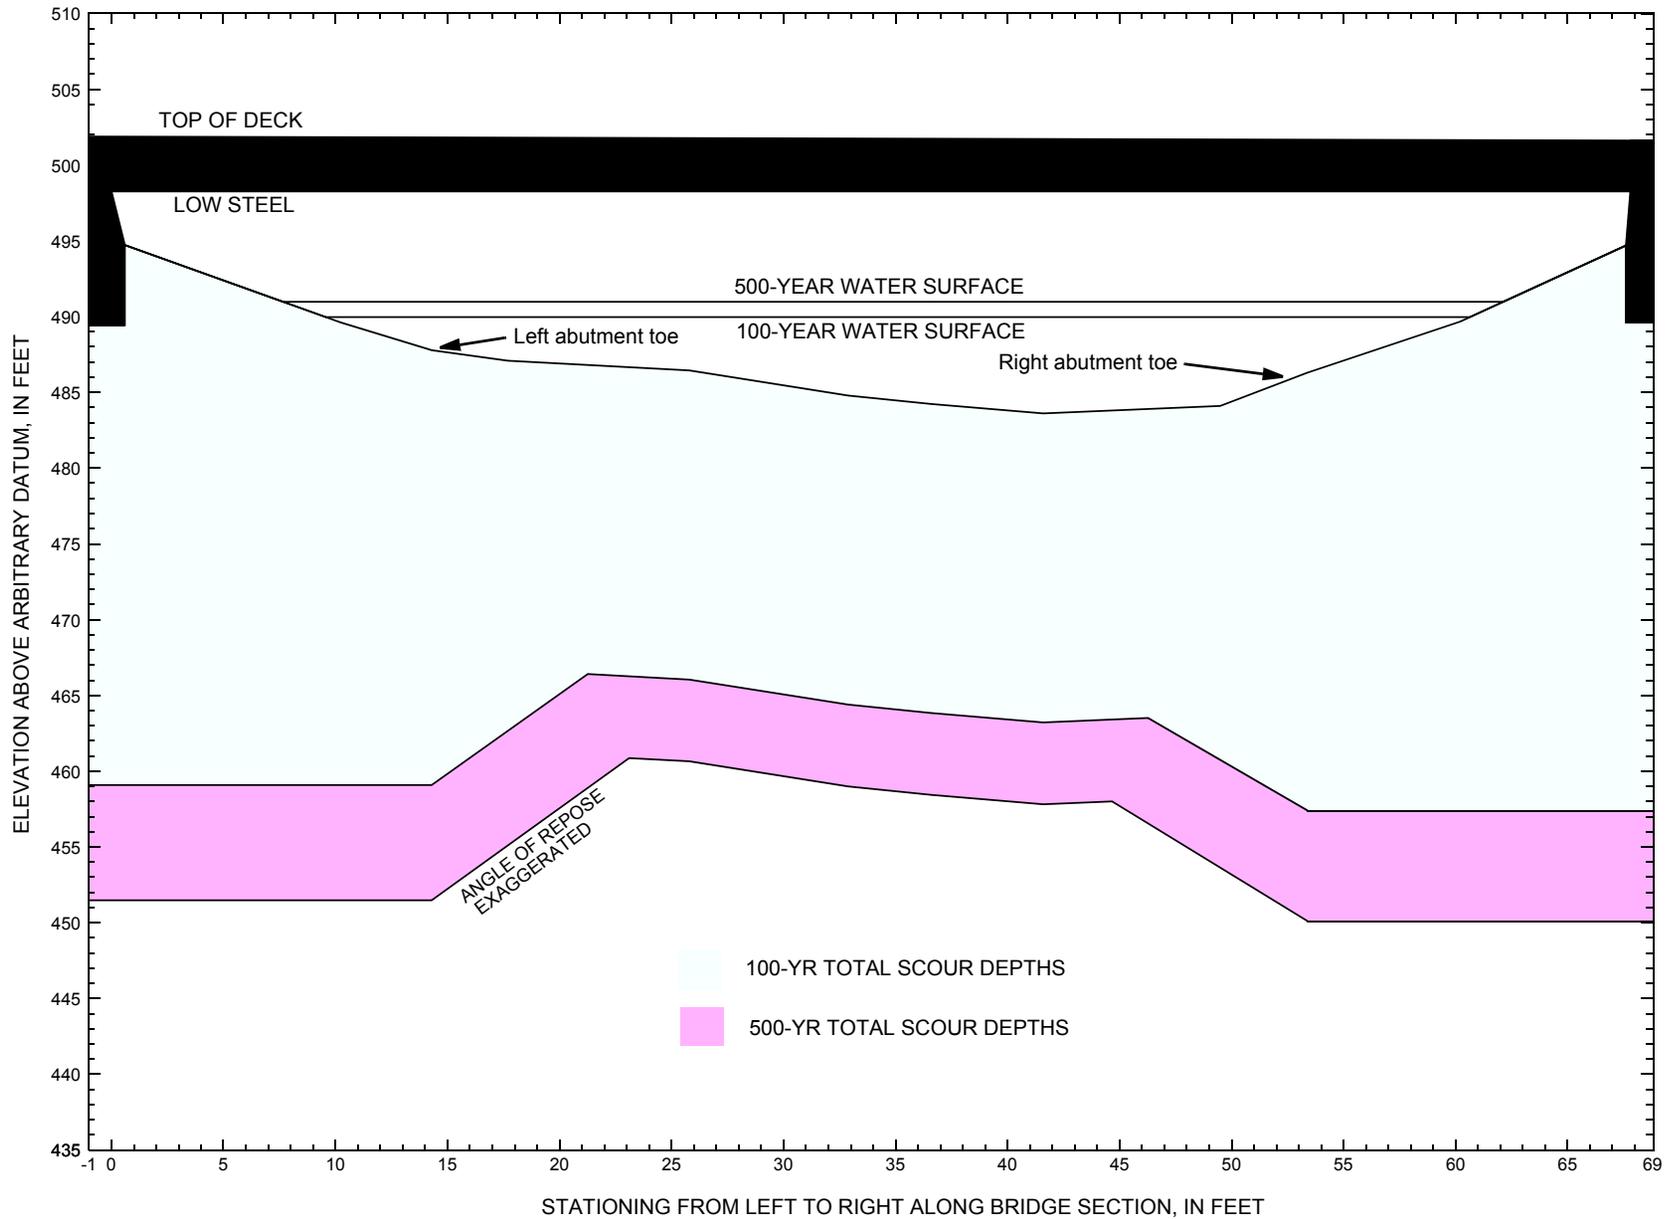
Figure 8. Scour elevations for the 100-yr and 500-yr discharges at structure MORRTH00030006 on Town Highway 3, crossing Ryder Brook, Morristown, Vermont.

Contraction scour for all modelled flows ranged from 20.4 to 25.8 ft. The worst-case contraction scour occurred at the 500-year discharge. Abutment scour ranged from 8.3 to 10.5 ft. The worst-case abutment scour also occurred at the 500-year discharge. Additional information on scour depths and depths to armoring are included in the section titled “Scour Results”. Scoured-streambed elevations, based on the calculated scour depths, are presented in tables 1 and 2. A cross-section of the scour computed at the bridge is presented in figure 8. Scour depths were calculated assuming an infinite depth of erosive material and a homogeneous particle-size distribution.

Scour depths were computed using the general guidelines described in Hydraulic Engineering Circular 18 (Richardson and others, 1995). Scour depths were calculated assuming an infinite depth of erosive material and a homogeneous particle-size distribution. The results of the scour analysis are presented in tables 1 and 2 and a graph of the scour depths is presented in figure 8.

Because the influence of scour processes on the spill-through embankment material is uncertain, the scour depth at the vertical concrete abutment walls is unknown. Therefore, the total scour depths computed at the toe of each spill-through embankment were applied for the entire area of each embankment as shown in figure 8.
