# LEVEL II SCOUR ANALYSIS FOR BRIDGE 7 (MORRTH00020007) on TOWN HIGHWAY 2 (FAS 239), crossing RYDER BROOK, MORRISTOWN, VERMONT

U.S. Geological Survey  
Open-File Report 97-190

Prepared in cooperation with  
VERMONT AGENCY OF TRANSPORTATION  
and  
FEDERAL HIGHWAY ADMINISTRATION

By Erick M. Boehmler and Robert E. Hammond

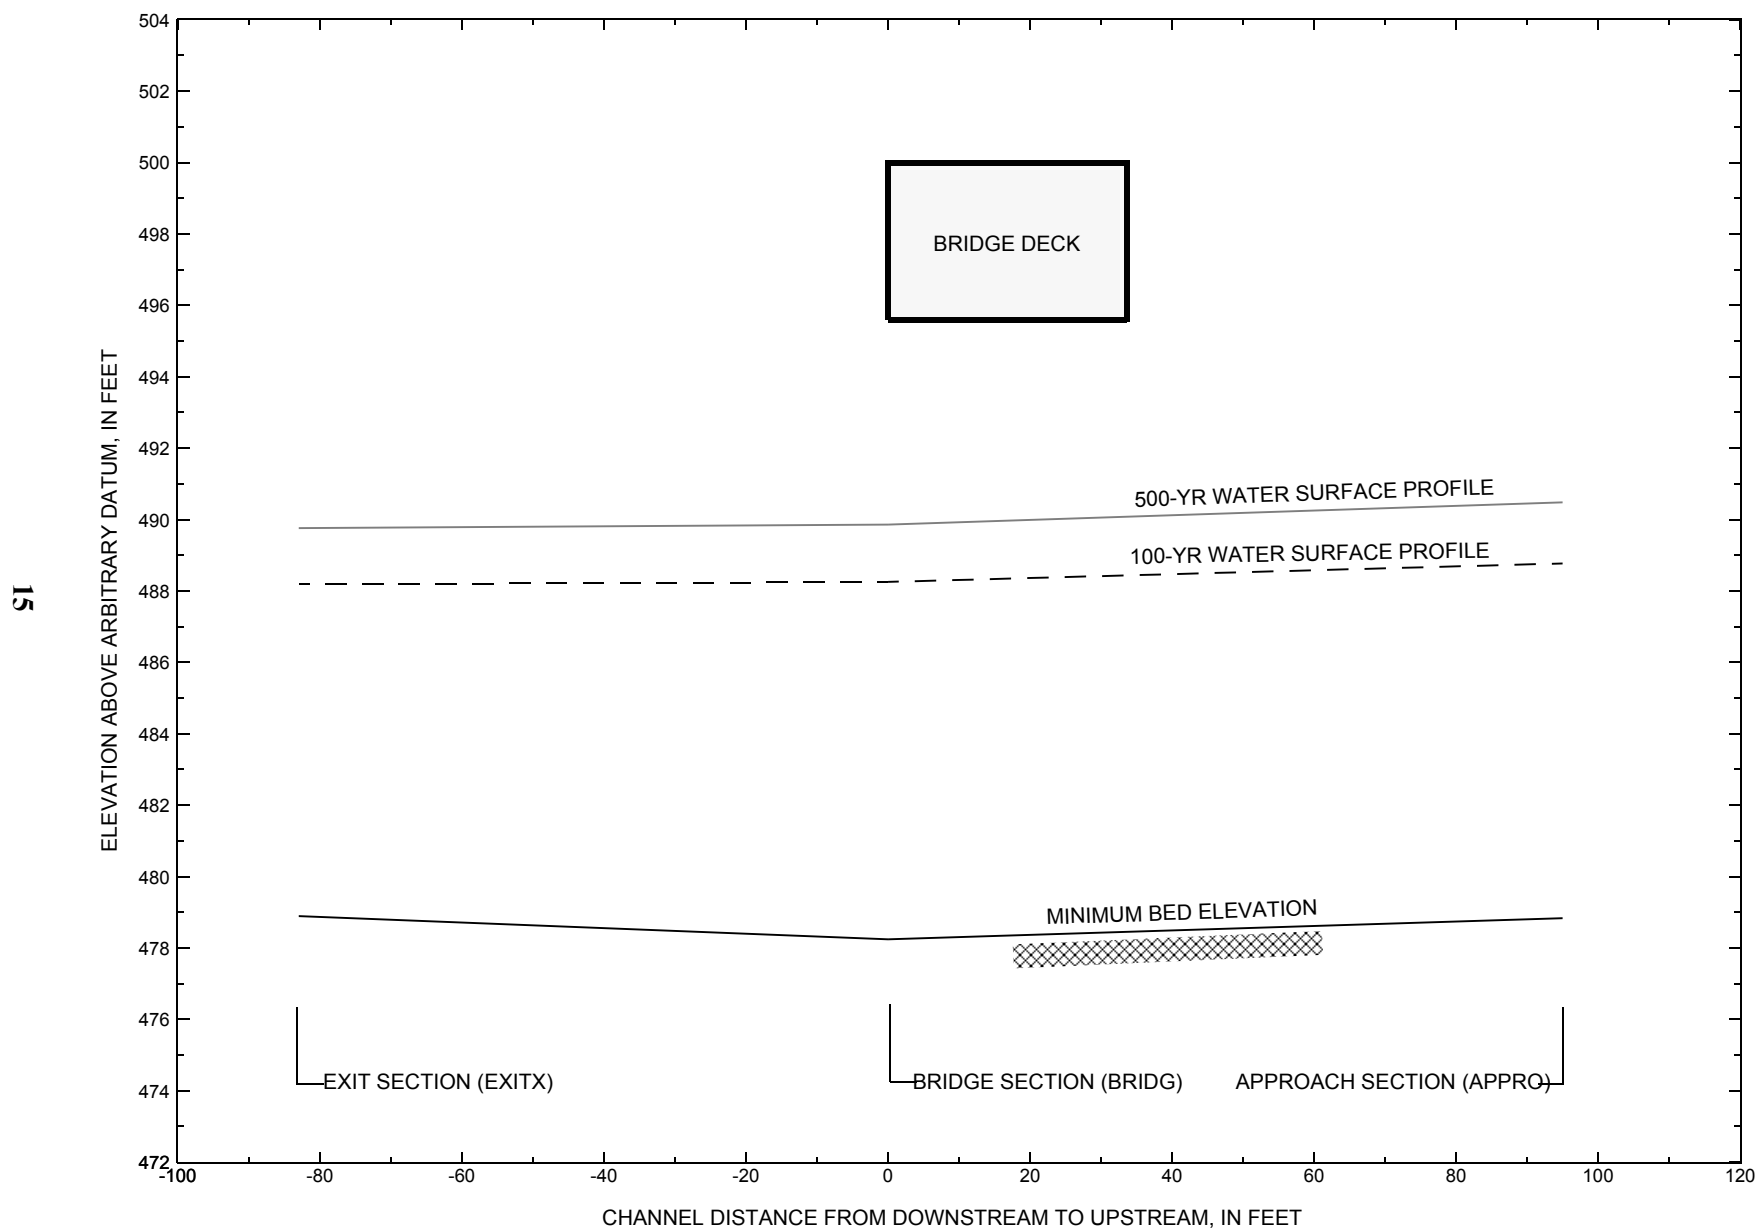
Figure 7. Water-surface profiles for the 100- and 500-yr discharges at structure MORRTH00020007 on Town Highway 2, crossing Ryder Brook, Morristown, Vermont.

Hydraulic analyses of the reach were done by use of the Federal Highway Administration's WSPRO step-backwater computer program (Shearman and others, 1986, and Shearman, 1990). The analyses reported herein reflect conditions existing at the site at the time of the study. Furthermore, in the development of the model it was necessary to assume no accumulation of debris or ice at the site. Results of the hydraulic model are presented in the Bridge Hydraulic Summary, Appendix B, and figure 7.

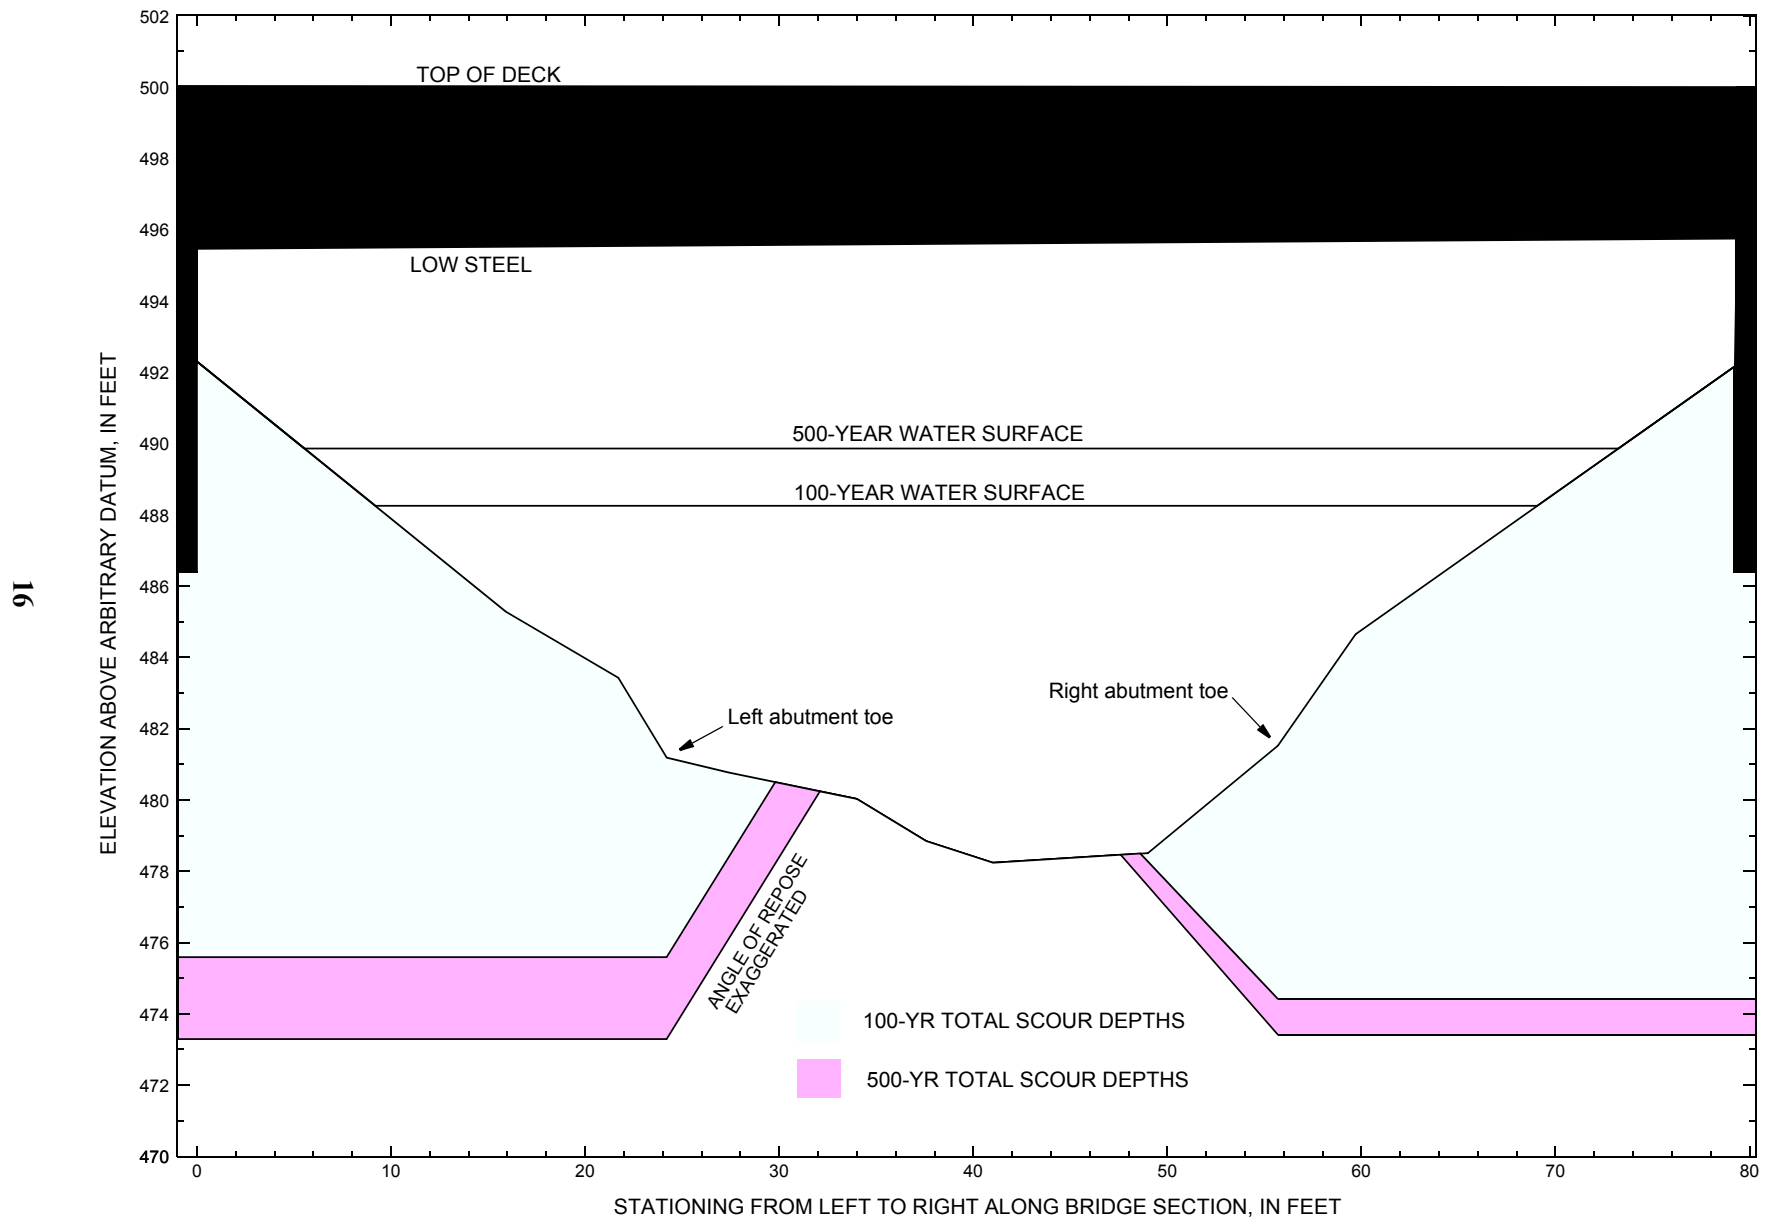
Figure 8. Scour elevations for the 100-yr and 500-yr discharges at structure MORRTH00020007 on Town Highway 2, crossing Ryder Brook, Morristown, Vermont.

Contraction scour predictions for all modelled flows at this site were zero. Abutment scour predictions ranged from 5.6 to 8.1 ft. The worst-case abutment scour occurred at the 500-year discharge. Additional information on scour depths and depths to armoring are included in the section titled “Scour Results”. Scoured-streambed elevations, based on the calculated scour depths, are presented in tables 1 and 2. A cross-section of the scour computed at the bridge is presented in figure 8. Scour depths were calculated assuming an infinite depth of erosive material and a homogeneous particle-size distribution. However, historical bridge records and field notes indicate the abutment footings may be set on bedrock.

Scour depths were computed using the general guidelines described in Hydraulic Engineering Circular 18 (Richardson and others, 1995). Scour depths were calculated assuming an infinite depth of erosive material and a homogeneous particle-size distribution. The results of the scour analysis are presented in tables 1 and 2 and a graph of the scour depths is presented in figure 8.

Because the influence of scour processes on the spill-through embankment material is uncertain, the scour depth at the vertical concrete abutment walls is unknown. Therefore, the total scour depths computed at the toe of the spill-through embankments were applied for the entire area of each embankment, as shown in figure 8.
