# LEVEL II SCOUR ANALYSIS FOR BRIDGE 22 (REDSVT01000022) on STATE ROUTE 100, crossing the WEST BRANCH DEERFIELD RIVER, READSBORO, VERMONT

U.S. Geological Survey  
Open-File Report 97-191

Prepared in cooperation with  
VERMONT AGENCY OF TRANSPORTATION  
and  
FEDERAL HIGHWAY ADMINISTRATION

By Erick M. Boehmler and Ronda L. Burns

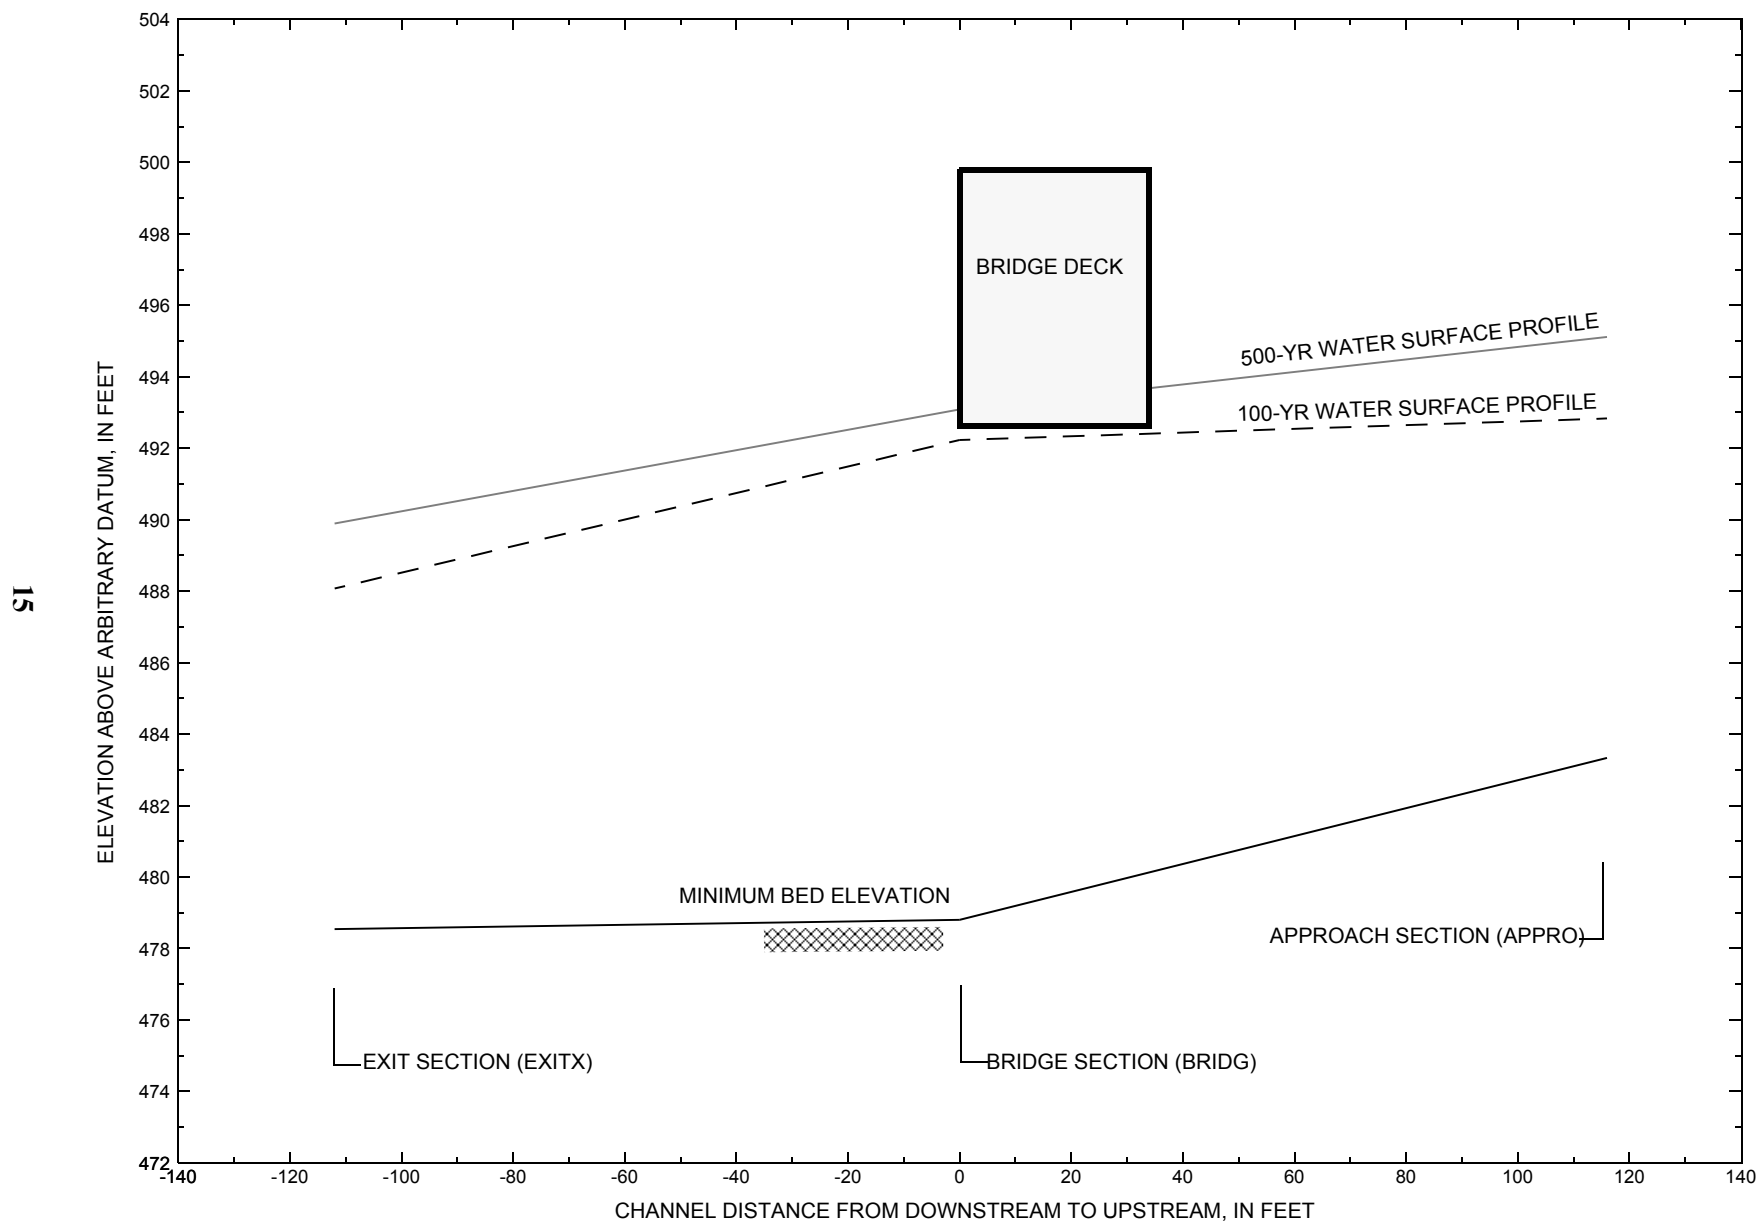
Figure 7. Water-surface profiles for the 100- and 500-yr discharges at structure REDSVT01000022 on State Route 100, crossing West Branch Deerfield River, Readsboro, Vermont.

*100-year discharge*      4,680 *ft<sup>3</sup>/s*  
*Water-surface elevation in bridge opening*      492.2 *ft*  
*Road overtopping?*      No      *Discharge over road*      -- *ft<sup>3</sup>/s*  
*Area of flow in bridge opening*      555 *ft<sup>2</sup>*  
*Average velocity in bridge opening*      8.4 *ft/s*  
*Maximum WSPRO tube velocity at bridge*      11.1 *ft/s*

*500-year discharge*      6,750 *ft<sup>3</sup>/s*  
*Water-surface elevation in bridge opening*      493.1 *ft*  
*Road overtopping?*      No      *Discharge over road*      -- *ft<sup>3</sup>/s*  
*Area of flow in bridge opening*      581 *ft<sup>2</sup>*  
*Average velocity in bridge opening*      11.6 *ft/s*  
*Maximum WSPRO tube velocity at bridge*      14.0 *ft/s*

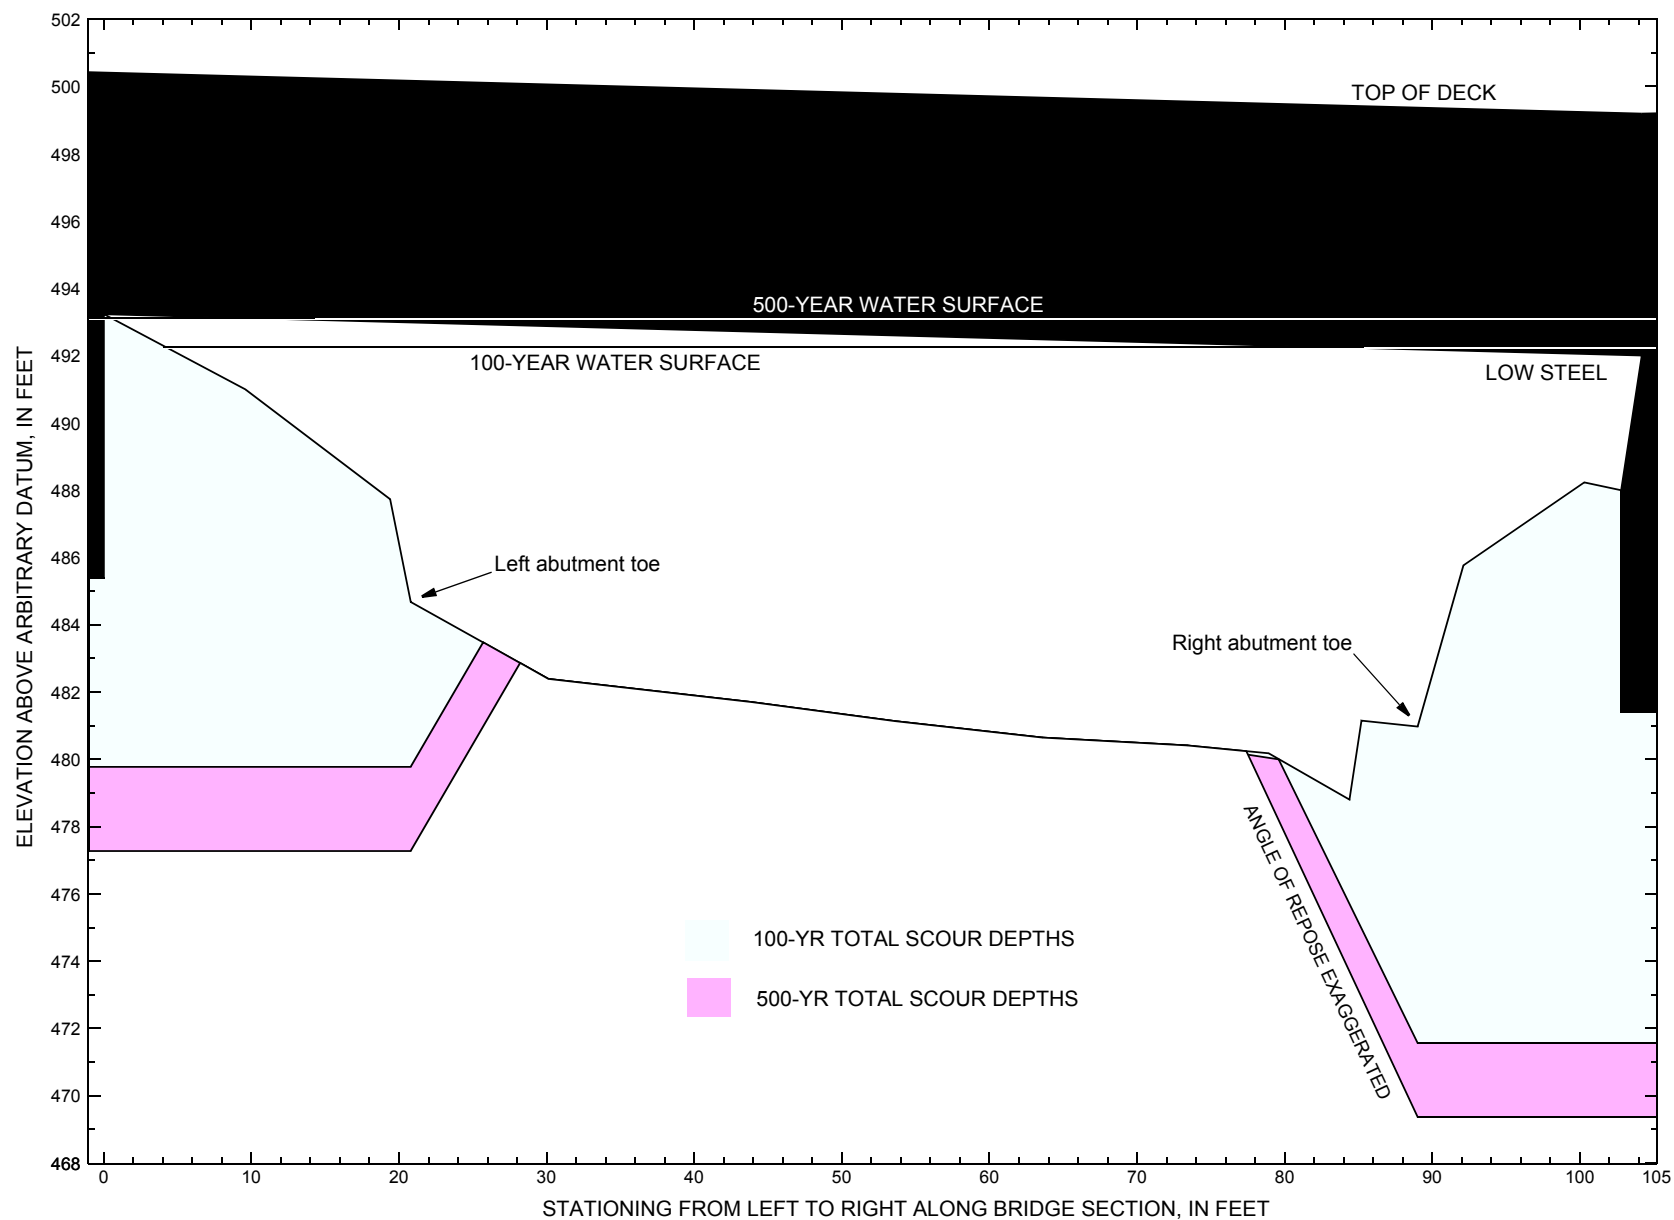
Figure 8. Scour elevations for the 100-yr and 500-yr discharges at structure REDSVT01000022 on State Route 100, crossing West Branch Deerfield River, Readsboro, Vermont.

There was no predicted contraction scour for any of the modelled flows. Abutment scour ranged from 4.9 to 11.6 ft. The worst-case abutment scour occurred at the right abutment for the 500-year discharge. However, historical information indicates the right abutment is in contact with bedrock at least in part. Additional information on scour depths and depths to armoring are included in the section titled “Scour Results”. Scoured-streambed elevations, based on the calculated scour depths, are presented in tables 1 and 2. A cross-section of the scour computed at the bridge is presented in figure 8. Scour depths were calculated assuming an infinite depth of erosive material and a homogeneous particle-size distribution.

Because the influence of scour processes on the spill-through embankment material is uncertain, the scour depth at the vertical concrete abutment walls is unknown. Therefore, the variables for the abutment scour equations applied were computed including the average width of the spill-through embankments. The total scour depths were applied for the entire spill-through embankment below the elevation at the toe of each embankment, as shown in figure 8.

Description	Station <sup>1</sup>	VTAOT Bridge seat elevation (feet)	Surveyed Bridge seat elevation <sup>2</sup> (feet)	Bottom of footing elevation <sup>2</sup> (feet)	Channel elevation at abutment/pier <sup>2</sup> (feet)	Contraction scour depth (feet)	Abutment scour depth (feet)	Pier scour depth (feet)	Depth of total scour (feet)	Elevation of scour <sup>2</sup> (feet)	Remaining footing/pile depth (feet)
100-yr. discharge is 4,680 cubic-feet per second											
Left abutment	0.0	1574.0	492.4	485.4	492.4	--	--	--	--	--	-5.6
Left abutment toe	20.8	--	--	--	484.7	0.0	4.9	--	4.9	479.8	--
Right abutment toe	89.0	--	--	--	481.0	0.0	9.4	--	9.4	471.6	--
Right abutment	104.2	1572.6	491.1	481.4	488.0	--	--	--	--	--	-9.8

Description	Station <sup>1</sup>	VTAOT Bridge seat elevation (feet)	Surveyed Bridge seat elevation <sup>2</sup> (feet)	Bottom of footing elevation <sup>2</sup> (feet)	Channel elevation at abutment/pier <sup>2</sup> (feet)	Contraction scour depth (feet)	Abutment scour depth (feet)	Pier scour depth (feet)	Depth of total scour (feet)	Elevation of scour <sup>2</sup> (feet)	Remaining footing/pile depth (feet)
500-yr. discharge is 6,750 cubic-feet per second											
Left abutment	0.0	1574.0	492.4	485.4	492.4	--	--	--	--	--	-8.1
Left abutment toe	20.8	--	--	--	484.7	0.0	7.4	--	7.4	477.3	--
Right abutment toe	89.0	--	--	--	481.0	0.0	11.6	--	11.6	469.4	--
Right abutment	104.2	1572.6	491.1	481.4	488.0	--	--	--	--	--	-12.0
