# LEVEL II SCOUR ANALYSIS FOR BRIDGE 80 (JAMAVT01000080) on STATE ROUTE 100, crossing the WEST RIVER, JAMAICA, VERMONT

U.S. Geological Survey  
Open-File Report 97-214

Prepared in cooperation with  
VERMONT AGENCY OF TRANSPORTATION  
and  
FEDERAL HIGHWAY ADMINISTRATION

By MICHAEL A. IVANOFF & JAMES R. DEGNAN

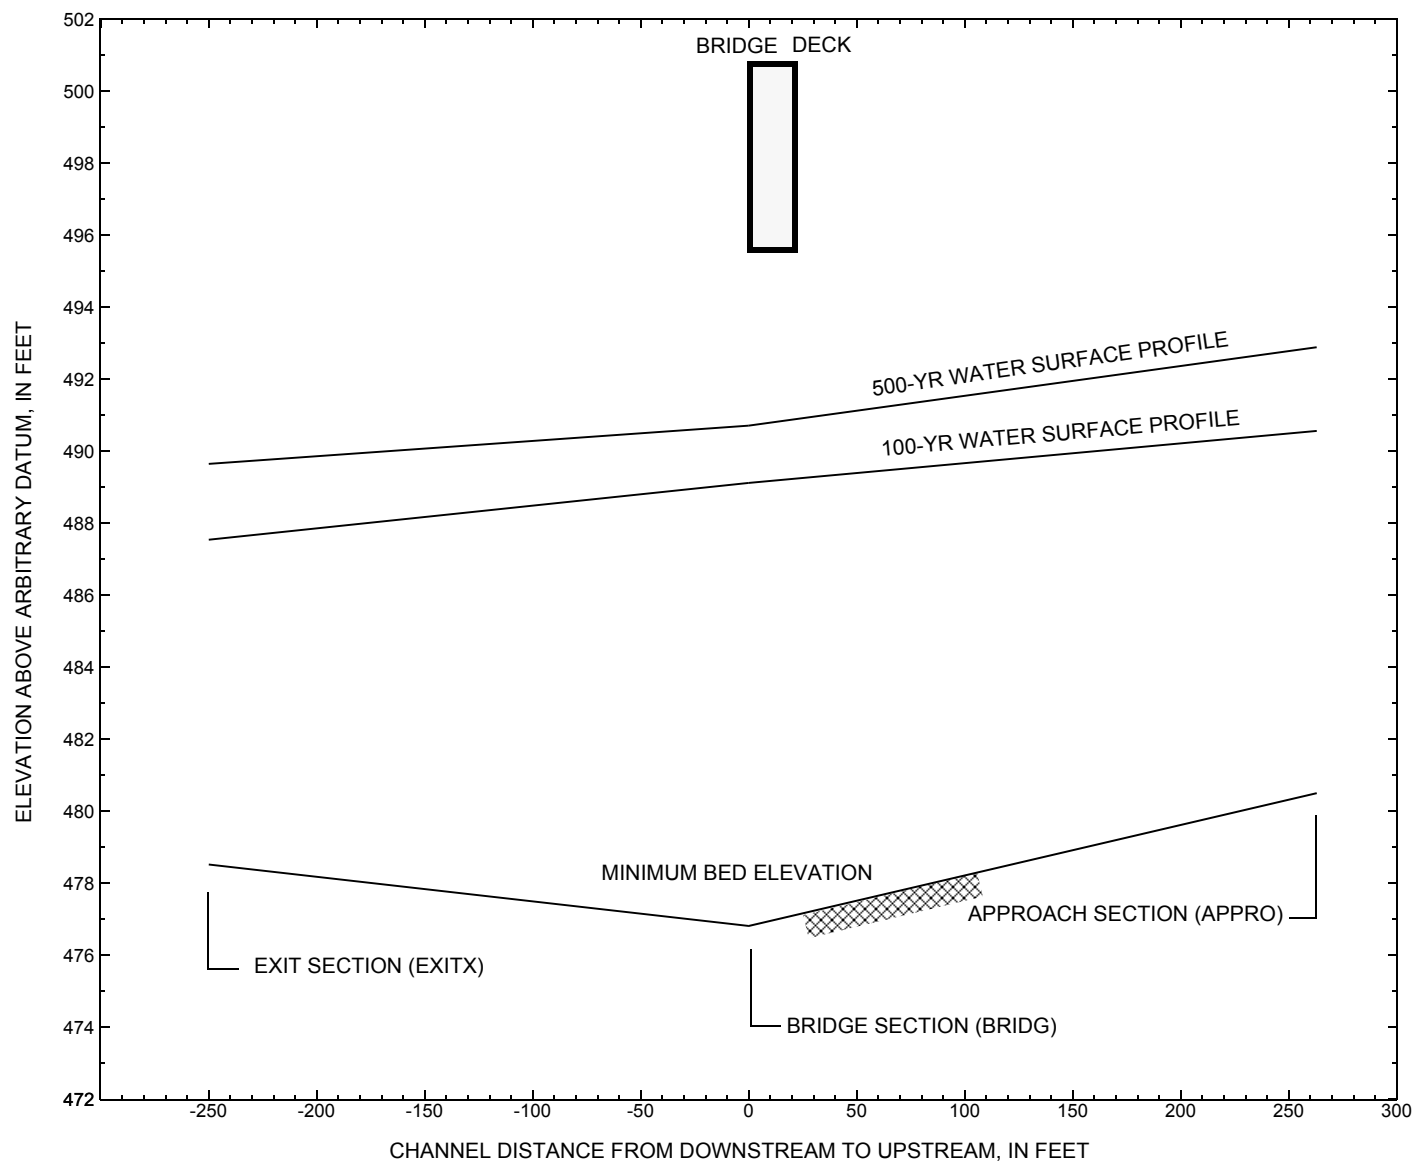
Figure 7. Water-surface profiles for the 100- and 500-yr discharges at structure JAMAVT01000080 on State Route 100, crossing the West River, Jamaica, Vermont.

*100-year discharge*      16,000 *ft<sup>3</sup>/s*  
*Water-surface elevation in bridge opening*      489.1 *ft*  
*Road overtopping?*      No      *Discharge over road*                 *ft<sup>3</sup>/s*  
*Area of flow in bridge opening*      1,974 *ft<sup>2</sup>*  
*Average velocity in bridge opening*      8.1 *ft/s*  
*Maximum WSPRO tube velocity at bridge*      9.6 *ft/s*

*500-year discharge*      25,800 *ft<sup>3</sup>/s*  
*Water-surface elevation in bridge opening*      490.7 *ft*  
*Road overtopping?*      No      *Discharge over road*                 *ft<sup>3</sup>/s*  
*Area of flow in bridge opening*      2,320 *ft<sup>2</sup>*  
*Average velocity in bridge opening*      11.1 *ft/s*  
*Maximum WSPRO tube velocity at bridge*      13.0 *ft/s*

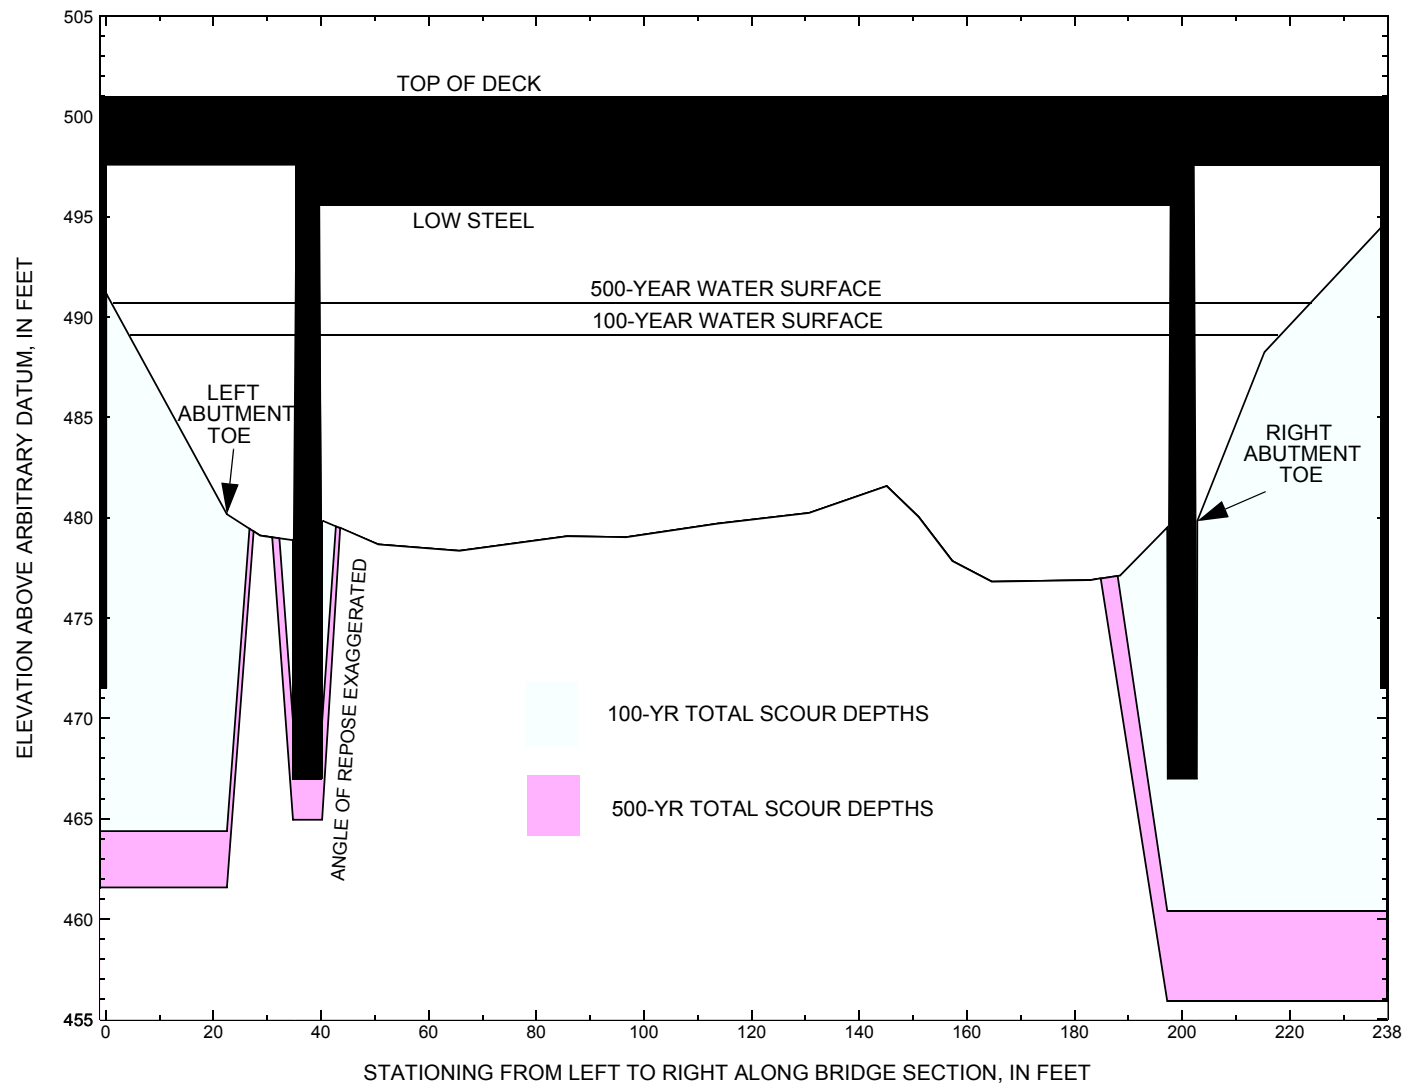
Figure 8. Scour elevations for the 100-yr and 500-yr discharges at structure JAMAVT01000080 on State Route 100, crossing the West River, Jamaica, Vermont.

A scour hole 3 ft deeper than the mean thalweg depth was observed along the streamward (right) side of the left pier during the Level I assessment. A scour hole 5 ft deeper than the mean thalweg depth was observed along the streamward (left) side of the right pier during the Level I assessment. The only scour protection measure at the site was type-2 stone fill (less than 36 inches diameter) along the left and right bank below the abutments forming a “spill-through” slope at each abutment. Additional details describing conditions at the site are included in the Level II Summary and Appendices D and E.

There was no computed contraction scour. Abutment scour ranged from 15.8 to 23.9 ft. The worst-case abutment scour occurred at the 500-year discharge. Pier scour ranged from 9.5 to 22.8 ft. The worst-case pier scour occurred at the 500-year discharge. Additional information on scour depths and depths to armoring are included in the section titled “Scour Results”. Scoured-streambed elevations, based on the calculated scour depths, are presented in tables 1 and 2. A cross-section of the scour computed at the bridge is presented in figure 8. Scour depths were calculated assuming an infinite depth of erosive material and a homogeneous particle-size distribution.

Because the influence of scour processes on the spill-through embankment material is uncertain, the scour depth at the vertical concrete abutment walls is unknown. Therefore, the total scour depths were applied for the entire spill-through embankment below the elevation at the toe of each embankment, as shown in figure 8. The right embankment scour depth was greater than the right pier scour depth and was extended under the pier.
