# LEVEL II SCOUR ANALYSIS FOR BRIDGE 8 (STAMVT01000008) on VERMONT HIGHWAY 100, crossing the NORTH BRANCH of the HOOSIC RIVER, STAMFORD, VERMONT

U.S. Geological Survey  
Open-File Report 97-215

Prepared in cooperation with  
VERMONT AGENCY OF TRANSPORTATION  
and  
FEDERAL HIGHWAY ADMINISTRATION

By MICHAEL A. IVANOFF

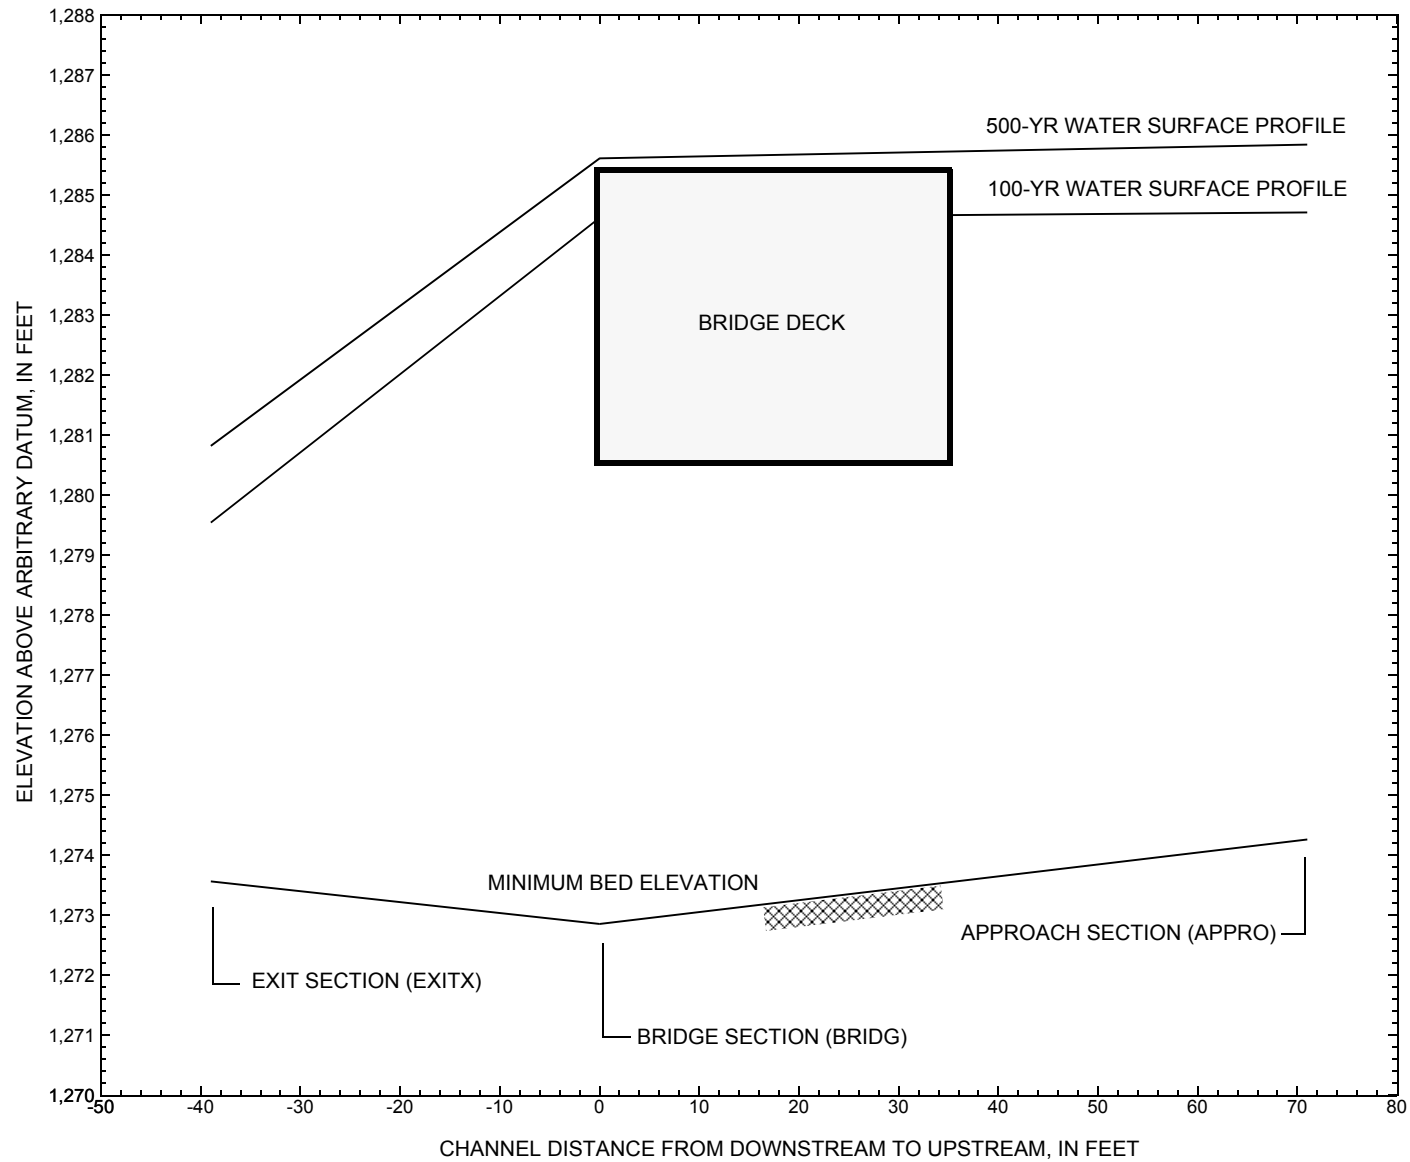
Figure 7. Water-surface profiles for the 100- and 500-yr discharges at structure STAMVT01000008 on Vermont Highway 100, crossing the North Branch of the Hoosic River, Stamford, Vermont.

*Water-surface elevation at Approach section with bridge*      1284.7  
*Water-surface elevation at Approach section without bridge*      1281.2  
*Amount of backwater caused by bridge*      3.5 *ft*

*Water-surface elevation at Approach section with bridge*      1285.9  
*Water-surface elevation at Approach section without bridge*      1282.8  
*Amount of backwater caused by bridge*      3.1 *ft*

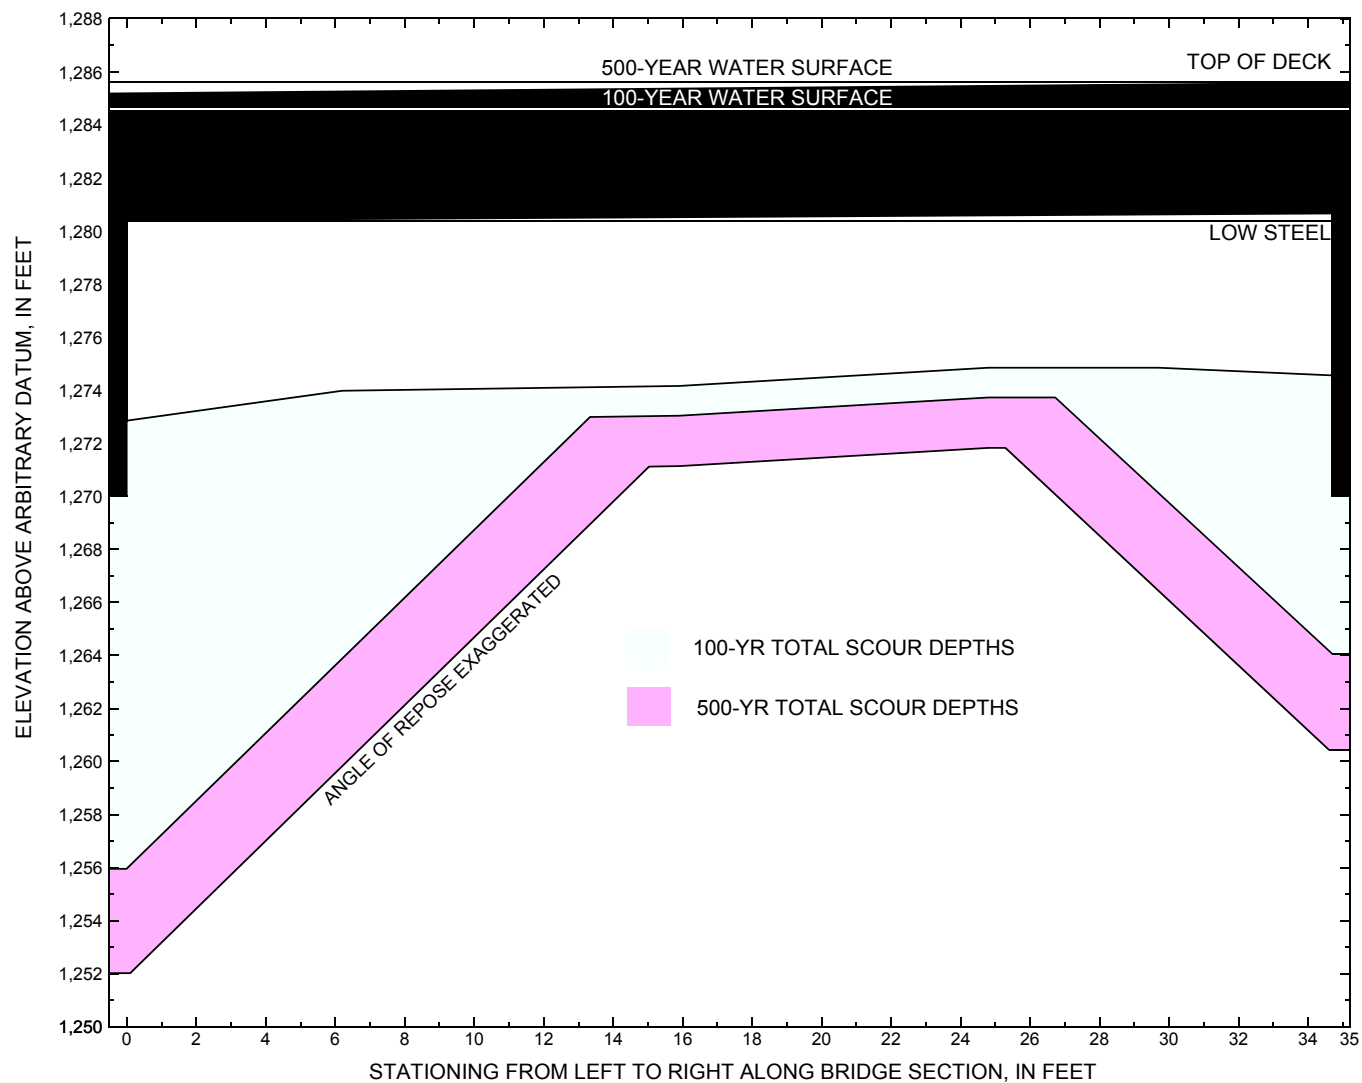
Figure 8. Scour elevations for the 100-yr and 500-yr discharges at structure STAMVT01000008 on Vermont Highway 100, crossing the North Branch of the Hoosic River, Stamford, Vermont.

The 100-year and incipient road-overflow discharges resulted in unsubmerged orifice flow. The 500-year discharge resulted in submerged orifice flow. Contraction scour at bridges with orifice flow is best estimated by use of the Chang pressure-flow scour equation (oral communication, J. Sterling Jones, October 4, 1996). Thus, contraction scour for all discharges was computed by use of the Chang equation (Richardson and others, 1995, p. 145-146). The results of Laursen's clear-water contraction scour equation (Richardson and others, 1995, p. 32, equation 20) for these events were also computed and can be found in appendix F. In this case, the 500-year discharge resulted in the worst case contraction scour with a scour depth of 3.0 ft.

Abutment scour was computed by use of the HIRE equation (Richardson and others, 1995, p. 49, equation 29) because the HIRE equation is recommended when the length to depth ratio of the embankment blocking flow exceeds 25. Variables for the HIRE equation include the Froude number of the flow approaching the embankments, the length of the embankment blocking flow, and the depth of flow approaching the embankment less any roadway overtopping.
