LEVEL II SCOUR ANALYSIS FOR BRIDGE 7 (CHESTH00030007) on TOWN HIGHWAY 3 (VT35), crossing the SOUTH BRANCH WILLIAMS RIVER, CHESTER, VERMONT

U.S. Geological Survey Open-File Report 97-362

The Town Highway 3 (VT 35) crossing of the South Branch Williams River is a 74-ft-long, two-lane bridge consisting of one 72-foot steel-beam span (Vermont Agency of Transportation, written communication, March 30, 1995). The bridge is supported by spill-through abutments. The channel is skewed approximately 5 degrees to the opening and the opening-skew-to-roadway is also 5 degrees.

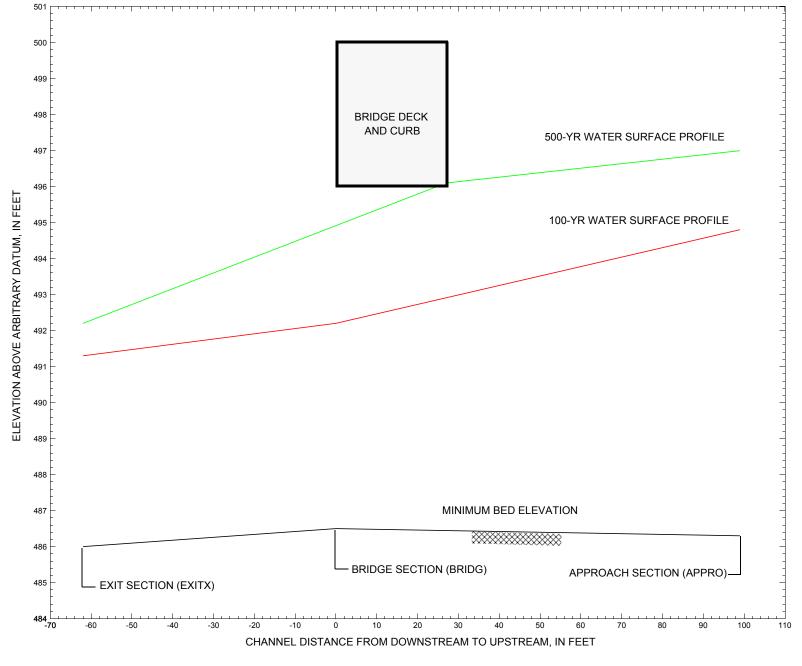
Figure 7. Water-surface profiles for the 100- and 500-yr discharges at structure CHESTH00030007 on Town Highway 3 (VT 35), crossing the South Branch Williams River, Chester, Vermont.

Hydraulic analyses of the reach were done by use of the Federal Highway Administration's WSPRO step-backwater computer program (Shearman and others, 1986, and Shearman, 1990). The analyses reported herein reflect conditions existing at the site at the time of the study. Furthermore, in the development of the model it was necessary to assume no accumulation of debris or ice at the site. Results of the hydraulic model are presented in the Bridge Hydraulic Summary, Appendix B, and figure 7.

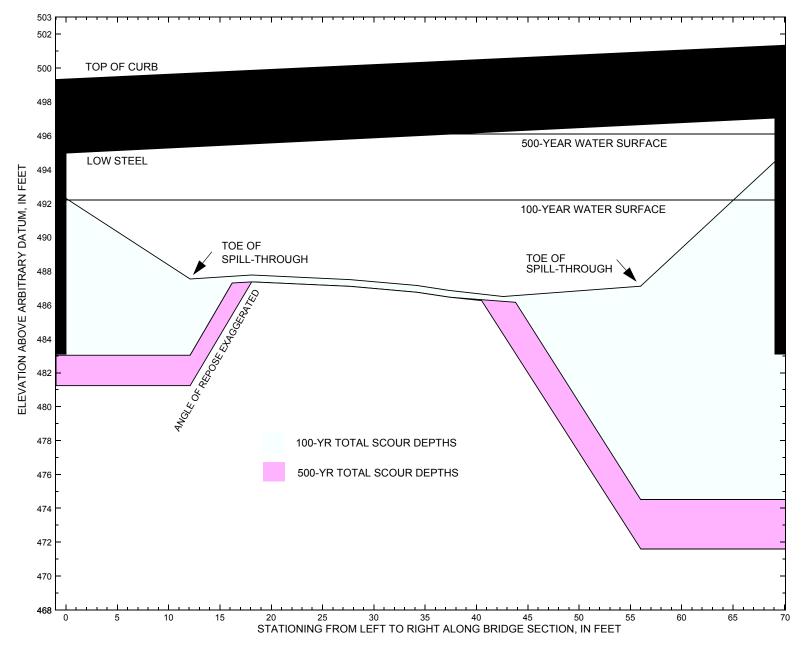
Figure 8. Scour elevations for the 100-yr and 500-yr discharges at structure CHESTH00030007 on Town Highway 3 (VT 35), crossing the South Branch Williams River, Chester, Vermont.

Contraction scour for all modelled flows ranged from 0.0 to 0.4 ft. The worst-case contraction scour occurred at the 100-year. Abutment scour ranged from 4.1 to 15.5 ft. The worst-case abutment scour occurred at the 500-year. Additional information on scour depths and depths to armoring are included in the section titled "Scour Results". Scoured-streambed elevations, based on the calculated scour depths, are presented in tables 1 and 2. A cross-section of the scour computed at the bridge is presented in figure 8. Scour depths were calculated assuming an infinite depth of erosive material and a homogeneous particle-size distribution.

Scour depths were computed using the general guidelines described in Hydraulic Engineering Circular 18 (Richardson and others, 1995). Scour depths were calculated assuming an infinite depth of erosive material and a homogeneous particle-size distribution. The results of the scour analysis are presented in tables 1 and 2 and a graph of the scour depths is presented in figure 8.
