# LEVEL II SCOUR ANALYSIS FOR BRIDGE 46 (CHESVT00110046) on STATE ROUTE 11, crossing the MIDDLE BRANCH WILLIAMS RIVER, CHESTER, VERMONT

U.S. Geological Survey  
Open-File Report 97-365

Prepared in cooperation with  
VERMONT AGENCY OF TRANSPORTATION  
and  
FEDERAL HIGHWAY ADMINISTRATION

By EMILY C. WILD

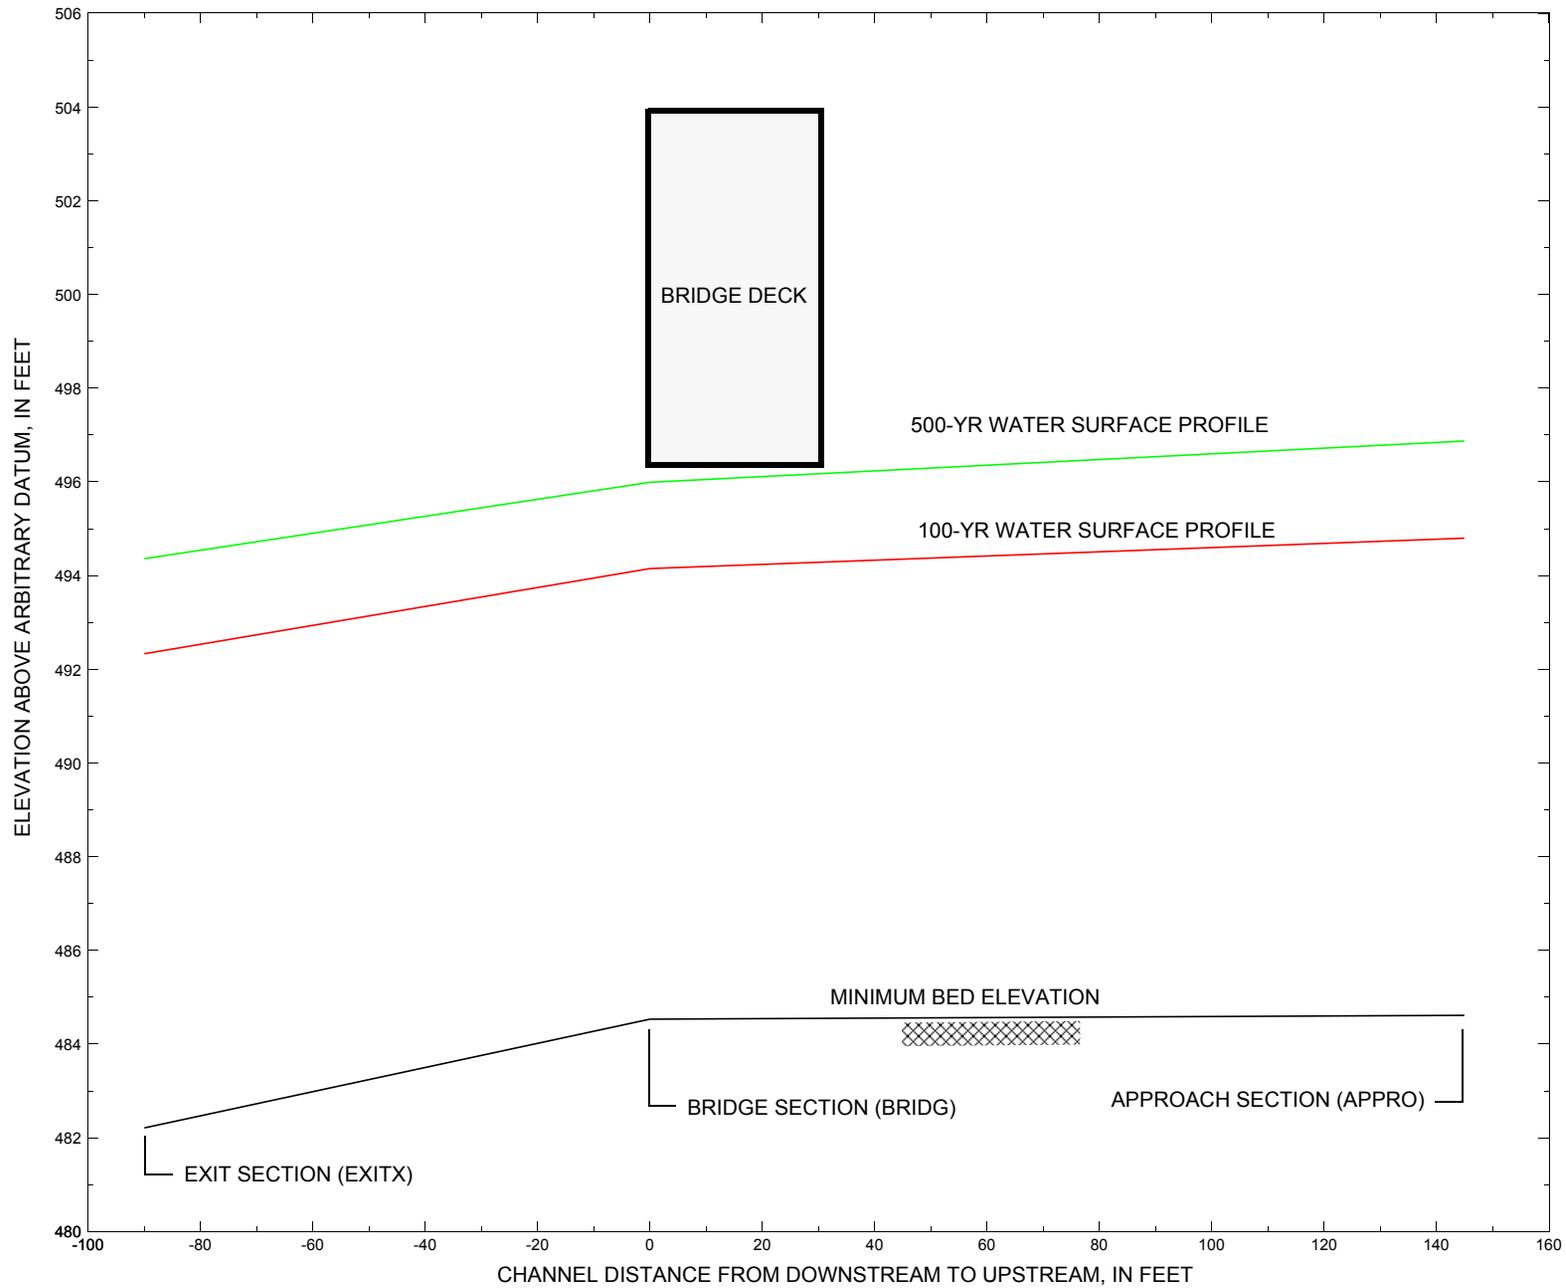
Figure 7. Water-surface profiles for the 100- and 500-yr discharges at structure CHESVT00110046 on Vermont 11, crossing the Middle Branch Williams River, Chester, Vermont.

Hydraulic analyses of the reach were done by use of the Federal Highway Administration's WSPRO step-backwater computer program (Shearman and others, 1986, and Shearman, 1990). The analyses reported herein reflect conditions existing at the site at the time of the study. Furthermore, in the development of the model it was necessary to assume no accumulation of debris or ice at the site. Results of the hydraulic model are presented in the Bridge Hydraulic Summary, Appendix B, and figure 7.

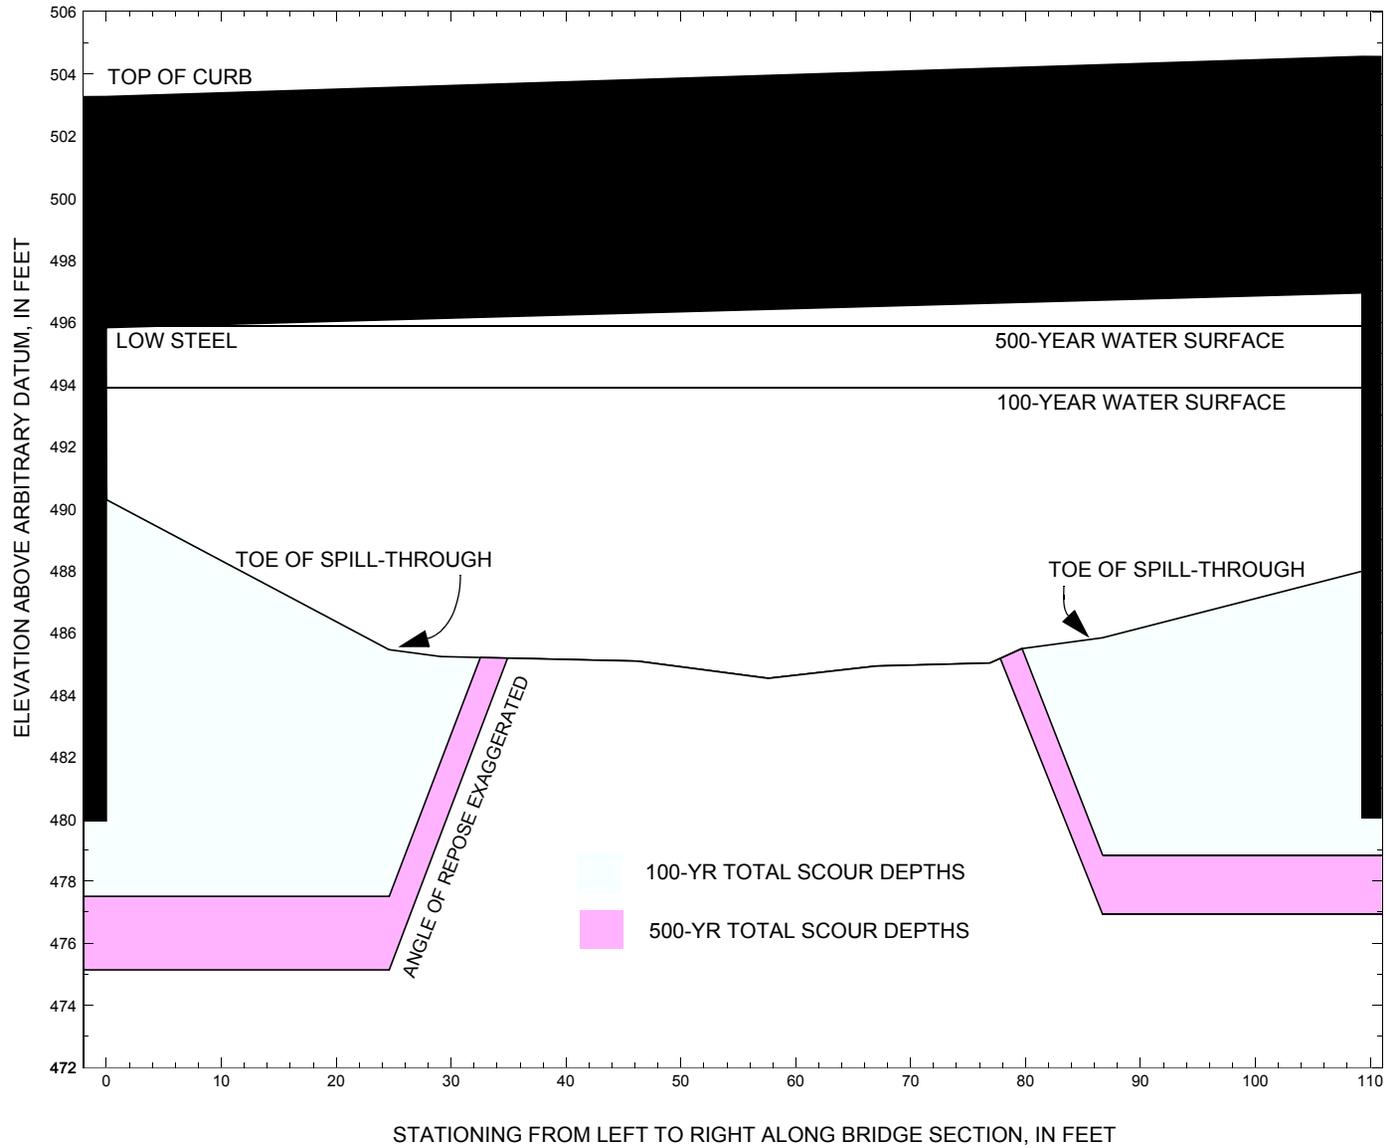
Figure 8. Scour elevations for the 100-yr and 500-yr discharges at structure CHESVT00110046 on Vermont 11, crossing the Middle Branch Williams River, Chester, Vermont.

There was no computed contraction scour for any modelled flows. Abutment scour ranged from 7.0 to 10.3 ft. The worst-case abutment scour occurred at the 500-year discharge. Additional information on scour depths and depths to armoring are included in the section titled "Scour Results". Scoured-streambed elevations, based on the calculated scour depths, are presented in tables 1 and 2. A cross-section of the scour computed at the bridge is presented in figure 8. Scour depths were calculated assuming an infinite depth of erosive material and a homogeneous particle-size distribution.

Because the influence of scour processes on the spill-through embankment material is uncertain, the scour depth at the vertical concrete abutment walls is unknown. Therefore, the total scour depths were applied for the entire spill-through embankment below the elevation at the toe of each embankment as shown in figure 8.
