LEVEL II SCOUR ANALYSIS FOR BRIDGE 25 (JAMATH00010025) on TOWN HIGHWAY 1, crossing BALL MOUNTAIN BROOK, JAMAICA, VERMONT

U.S. Geological Survey
Open-File Report 97-376

Prepared in cooperation with
VERMONT AGENCY OF TRANSPORTATION
and
FEDERAL HIGHWAY ADMINISTRATION

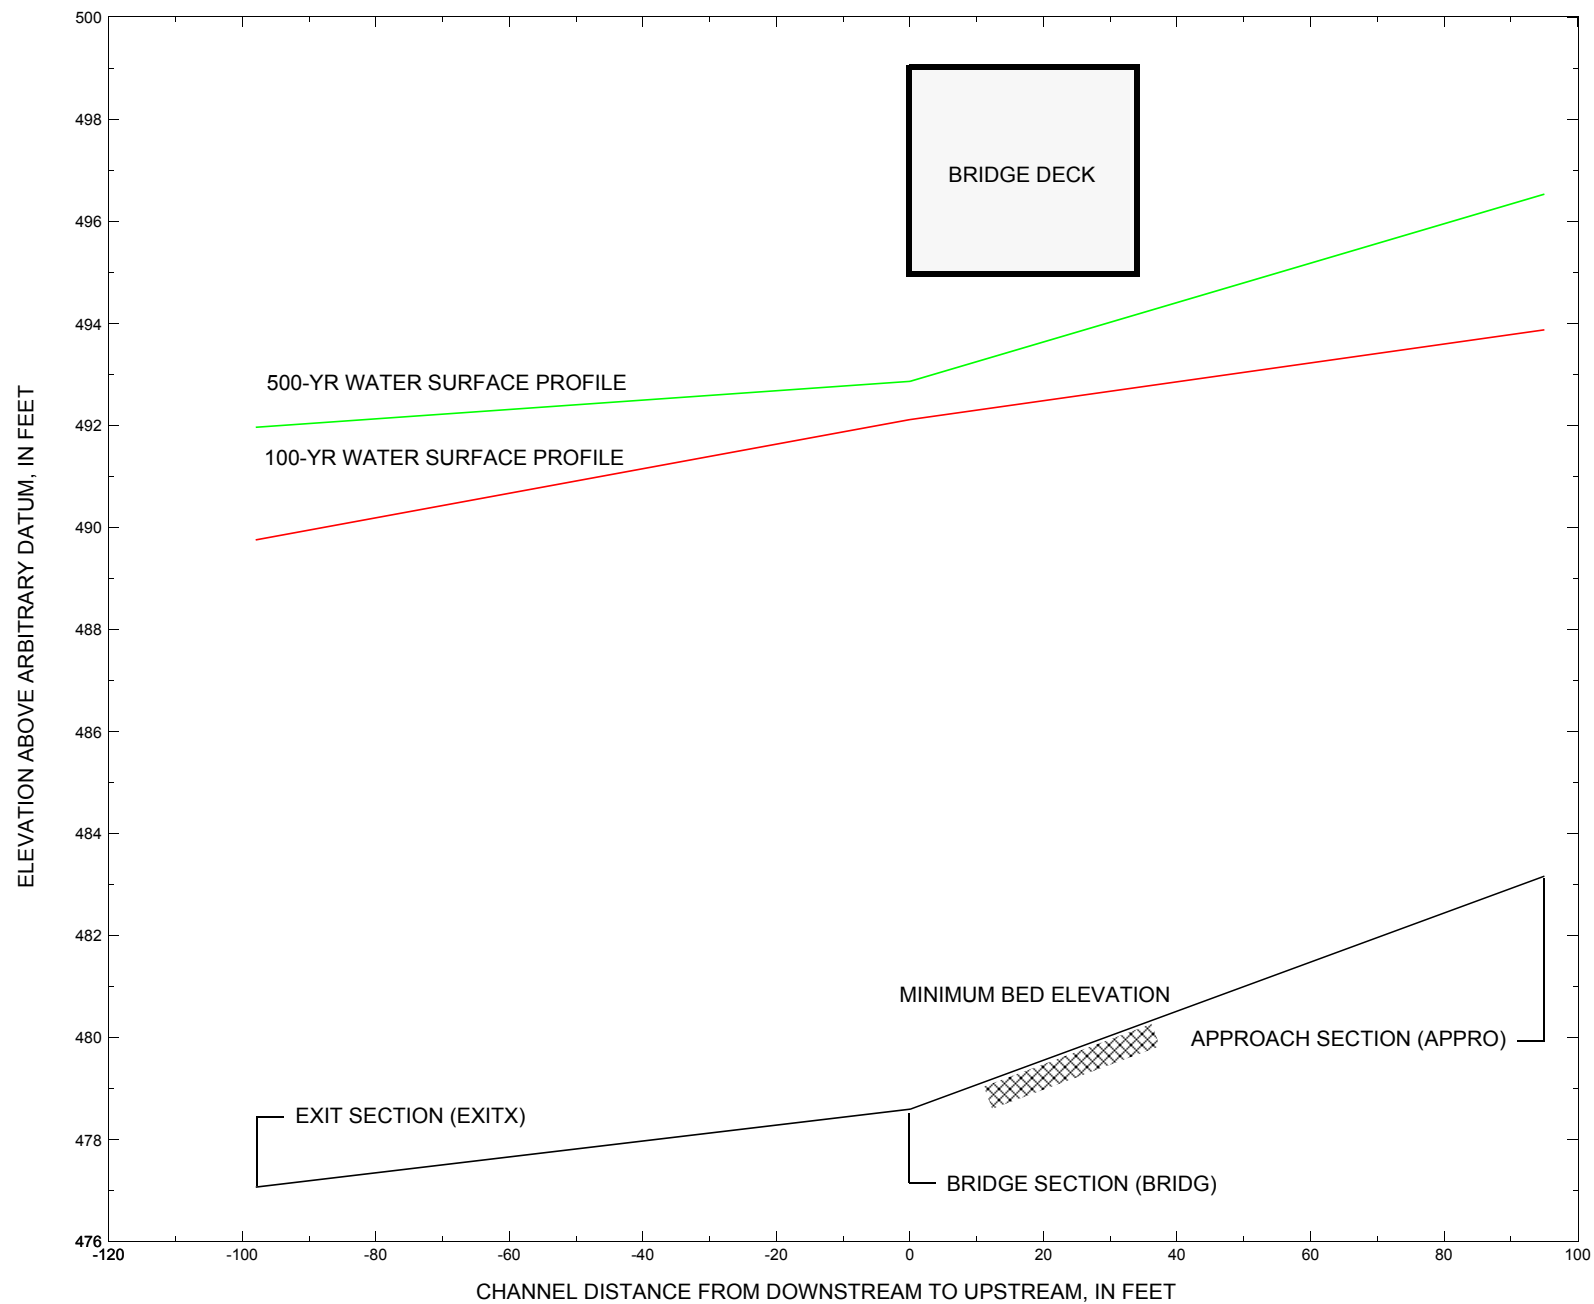
Figure 7. Water-surface profiles for the 100- and 500-yr discharges at structure JAMATH00010025 on Town Highway 1, crossing Ball Mountain Brook, Jamaica, Vermont.

100-year discharge 8,650 *ft³/s*
Water-surface elevation in bridge opening 492.1 *ft*
Road overtopping? N *Discharge over road* - *ft³/s*
Area of flow in bridge opening 675 *ft²*
Average velocity in bridge opening 12.8 *ft/s*
Maximum WSPRO tube velocity at bridge 15.8 *ft/s*

Water-surface elevation at Approach section with bridge 493.9
Water-surface elevation at Approach section without bridge 493.7
Amount of backwater caused by bridge 0.2 *ft*

500-year discharge 12,800 *ft³/s*
Water-surface elevation in bridge opening 492.9 *ft*
Road overtopping? N *Discharge over road* - *ft³/s*
Area of flow in bridge opening 722 *ft²*
Average velocity in bridge opening 17.7 *ft/s*
Maximum WSPRO tube velocity at bridge 22.0 *ft/s*

Water-surface elevation at Approach section with bridge 496.5
Water-surface elevation at Approach section without bridge 496.5
Amount of backwater caused by bridge 0.0 *ft*

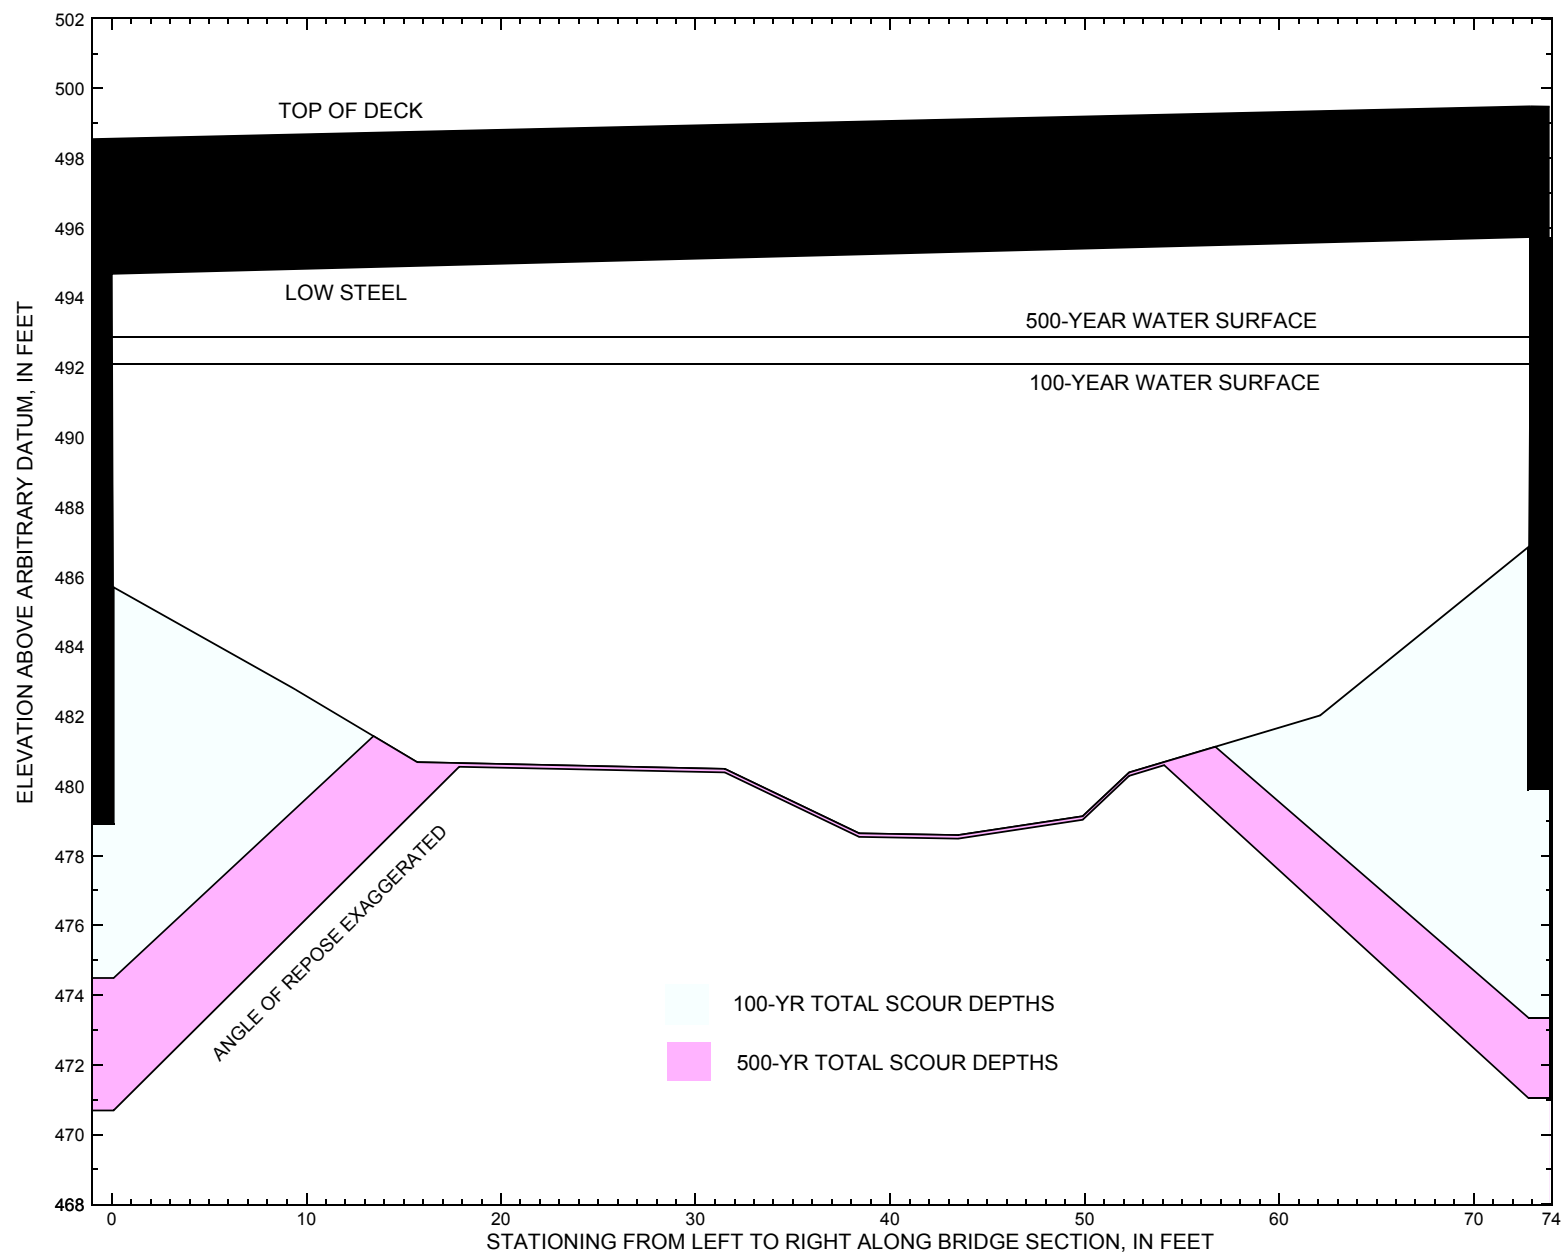
Figure 8. Scour elevations for the 100-yr and 500-yr discharges at structure JAMATH00010025 on Town Highway 1, crossing Ball Mountain Brook, Jamaica, Vermont.

Contraction scour only occurred at the 500-year discharge and was 0.1 ft. Abutment scour ranged from 11.2 to 15.7 ft. The worst-case abutment scour occurred at the 500-year discharge. Additional information on scour depths and depths to armoring are included in the section titled “Scour Results”. Scoured-streambed elevations, based on the calculated scour depths, are presented in tables 1 and 2. A cross-section of the scour computed at the bridge is presented in figure 8. Scour depths were calculated assuming an infinite depth of erosive material and a homogeneous particle-size distribution.

Abutment scour for both abutments was computed by use of the Froehlich equation (Richardson and others, 1995, p. 48, equation 28). Variables for the Froehlich equation include the Froude number of the flow approaching the embankments, the length of the embankment blocking flow, and the depth of flow approaching the embankment less any roadway overtopping. The left abutment scour may be limited by the bedrock noted on the left bank.

<i>100-yr discharge</i>	<i>500-yr discharge</i>	<i>Incipient overtopping discharge</i>
	<i>(D₅₀ in feet)</i>		
<i>Abutments:</i>	3.2	4.7	--
<i>Left abutment</i>	3.2	4.7	--
<i>Right abutment</i>	--	--	--
<i>Piers:</i>	--	--	--
<i>Pier 1</i>	--	--	--
<i>Pier 2</i>	--	--	--
