# LEVEL II SCOUR ANALYSIS FOR BRIDGE 23 (GLOVTH00410023) on TOWN HIGHWAY 41, crossing SHERBURNE BROOK, GLOVER, VERMONT

U.S. Geological Survey  
Open-File Report 97-388

Prepared in cooperation with  
VERMONT AGENCY OF TRANSPORTATION  
and  
FEDERAL HIGHWAY ADMINISTRATION

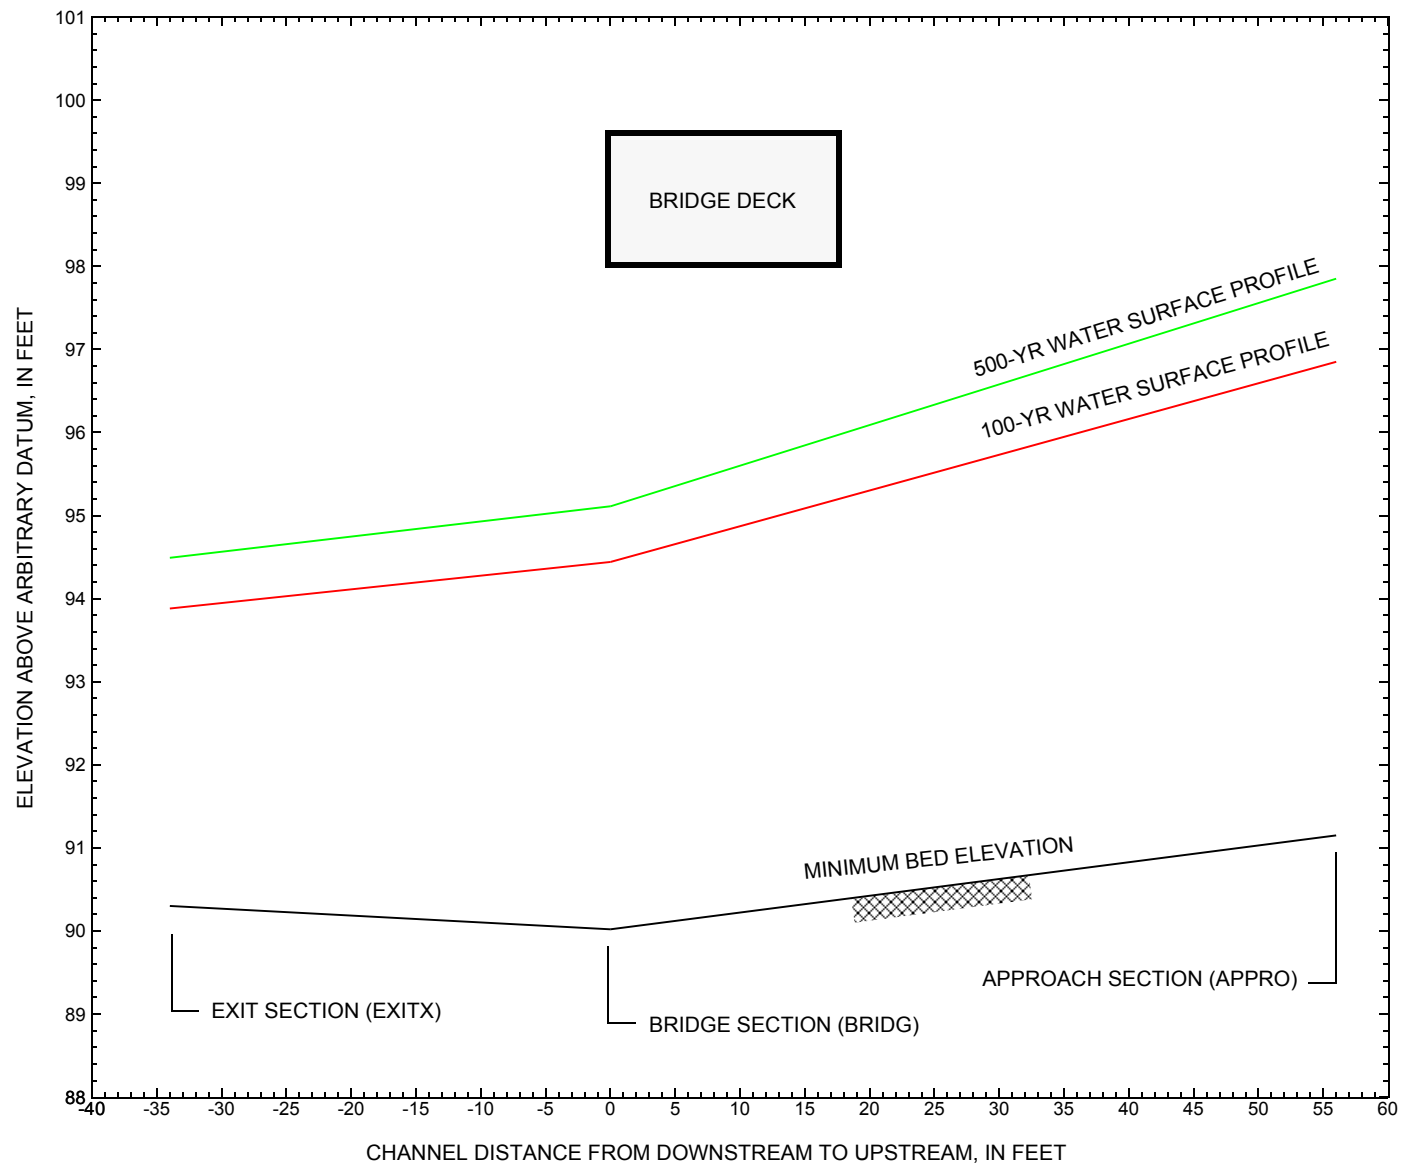
Figure 7. Water-surface profiles for the 100- and 500-yr discharges at structure GLOVTH00410023 on Town Highway 41, crossing Sherburne Brook, Glover, Vermont.

*100-year discharge*      515 *ft<sup>3</sup>/s*  
*Water-surface elevation in bridge opening*      94.4 *ft*  
*Road overtopping?*      N      *Discharge over road*      -- *ft<sup>3</sup>/s*  
*Area of flow in bridge opening*      53 *ft<sup>2</sup>*  
*Average velocity in bridge opening*      9.8 *ft/s*  
*Maximum WSPRO tube velocity at bridge*      12.4 *ft/s*

*500-year discharge*      700 *ft<sup>3</sup>/s*  
*Water-surface elevation in bridge opening*      95.1 *ft*  
*Road overtopping?*      N      *Discharge over road*      -- *ft<sup>3</sup>/s*  
*Area of flow in bridge opening*      64 *ft<sup>2</sup>*  
*Average velocity in bridge opening*      10.9 *ft/s*  
*Maximum WSPRO tube velocity at bridge*      13.7 *ft/s*

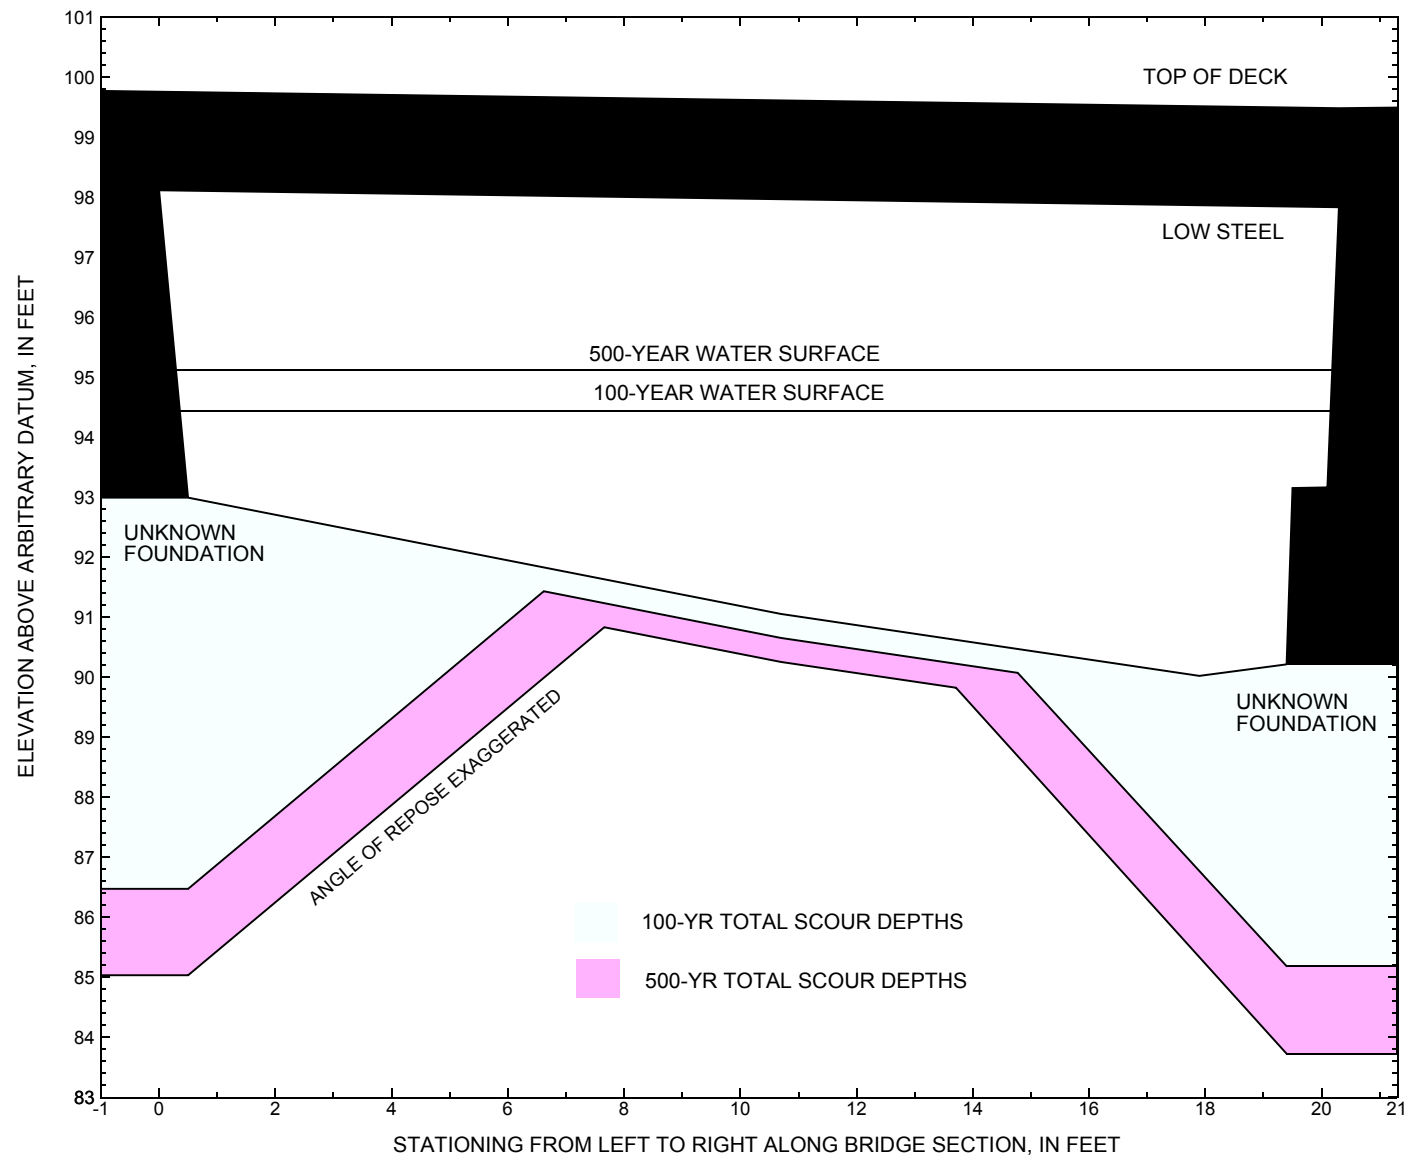
Figure 8. Scour elevations for the 100-yr and 500-yr discharges at structure GLOVTH00410023 on Town Highway 41, crossing Sherburne Brook, Glover, Vermont.

Contraction scour for all modelled flows ranged from 0.4 to 0.8 ft. The worst-case contraction scour occurred at the 500-year discharge. Abutment scour ranged from 4.6 to 7.2 ft. The worst-case abutment scour also occurred at the 500-year discharge. Additional information on scour depths and depths to armoring are included in the section titled “Scour Results”. Scoured-streambed elevations, based on the calculated scour depths, are presented in tables 1 and 2. A cross-section of the scour computed at the bridge is presented in figure 8. Scour depths were calculated assuming an infinite depth of erosive material and a homogeneous particle-size distribution.

Contraction scour was computed by use of the clear-water contraction scour equation (Richardson and others, 1995, p. 32, equation 20). Results are presented in figure 8 and tables 1 and 2. The streambed armoring depths computed suggest that armoring will not limit the depth of contraction scour.

Abutment scour was computed by use of the Froehlich equation (Richardson and others, 1995, p. 48, equation 28). Variables for the Froehlich equation include the Froude number of the flow approaching the embankments, the length of the embankment blocking flow, and the depth of flow approaching the embankment less any roadway overtopping.
