Landslides Triggered by the April 1997, Tropical Storms in Pohnpei, Federated States of Micronesia

Edwin L. Harp

William Z. Savage

U. S. Geological Survey Open-File Report 97-696 Denver, Colorado 80225 1997

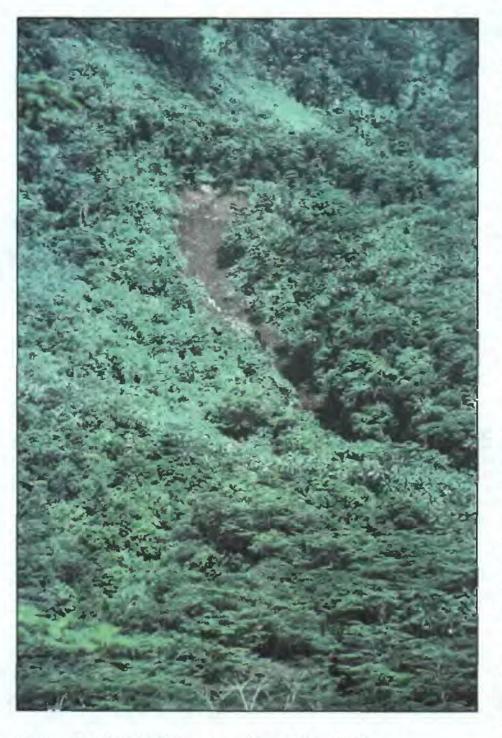
The initial failures appeared as spoon-shaped rotational slumps and slides with approximately planar failure surfaces (fig. 3). Subsequent to initial failure and movement, most of the soil and rock masses appeared to have undergone fluidization and became debris flows by additional mixing of debris

Figure 3. Typical "spoon shaped" rotational slumpldebris flow triggered the the April 20-21 tropical storm.

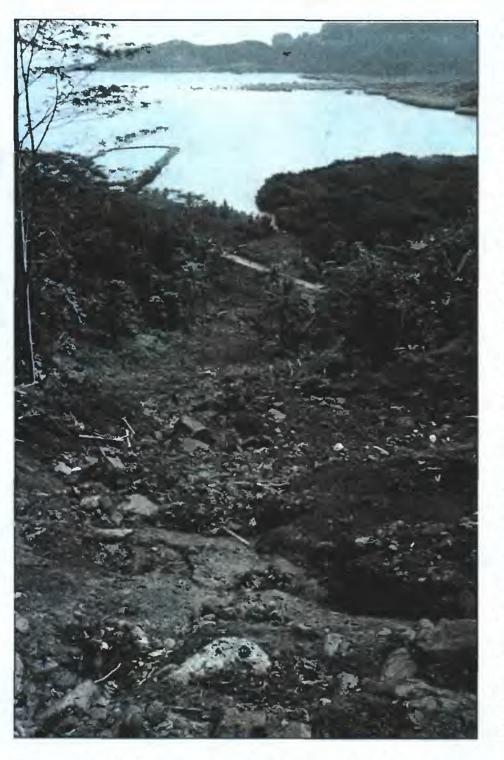
Coalescing debris flows at Oumoar and Iohl were responsible for all of the landslide-related fatalities that occurred on Pohnpei (fig. 2). There were 8 fatalities at Oumoar and 11 at Iohl. In both cases, the destructive flows began at, or about 10:30 p.m. on the night of April 20-21. Residents of Oumoar reported that there were repeated debris-flow episodes along the same path. Several survivors of the first flows that overran dwellings were caught in the paths of later flows as they attempted to rescue those caught in the first. At least three debris-flow episodes were involved in the destruction of the village of Oumoar where debris overran dwellings and swept wreckage and victims into the mangrove swamps that fringe the coast (fig. 4).

Figure 4. Photo from headscarp area of debris flow at Oumoar looking down the path of flow showing exposed bedrock and large clast size of debris remaining in flow path.

Near the headscarp at Oumoar, slopes were roughly 40° to the north and northeast, and bedding dips approximately 17° to the northeast. Soil depths ranged from a few centimeters to 1.5 m, and volumes of individual flows at Oumoar ranged from 2,000 to 7,000 m³. No fractures were observed upslope of the headscarps in the Oumoar area. None of the debris flows examined had well developed lateral levees along their flow paths, as is characteristic of most debris flows. This, and the well developed erosion channels through the landslide debris, suggest that large volumes of water issued from the landslide scarps after initial failure and that the debris flows had high water contents.

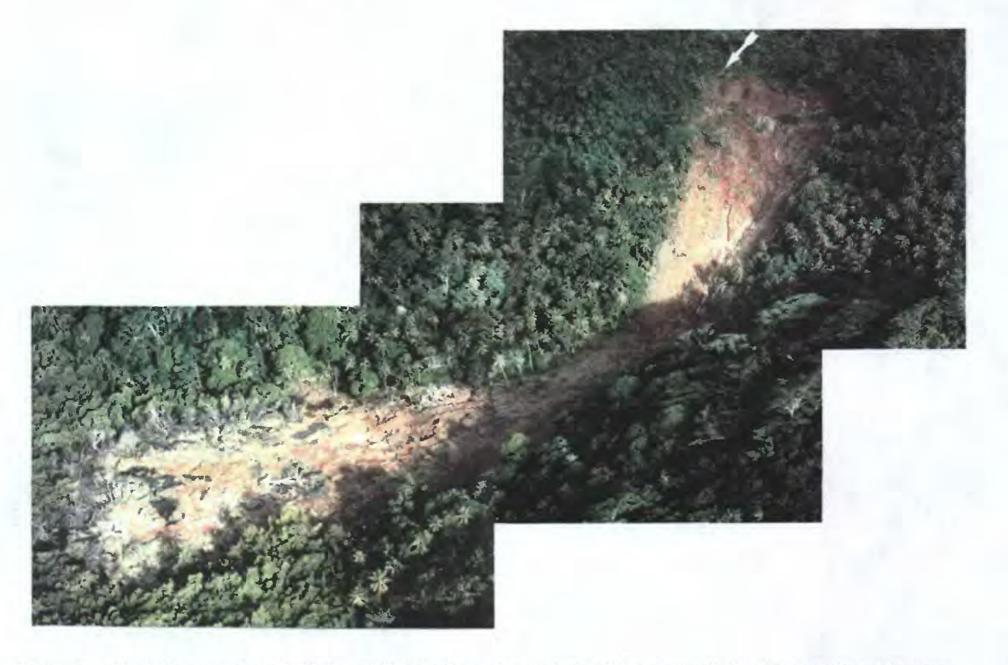
The landslide at Iohl was a rotational slump/debris flow approximately 200,000 m³ in volume. Its length from headscarp to its distal end is approximately 800 m. Several fractures existed just above the northeastern portion of its headscarp (as of June 1997; fig. 5) isolating several hundred cubic meters of material that may undergo movement in future high intensity rainfall. However, if this happens, it will provide only a minor amount of additional material to the existing landslide. Near the southwest portion of the headscarp, a block of several hundred cubic meters has moved downslope about 5 m from its original position on the slope (fig. 6).

Figure 5. Airphoto mosaic of Iohl slumpldebris flow. Arrow in headscarp area indicates position of extension fracture above headscarp. (Photo courtesty of Pohnpei Department of Justice)

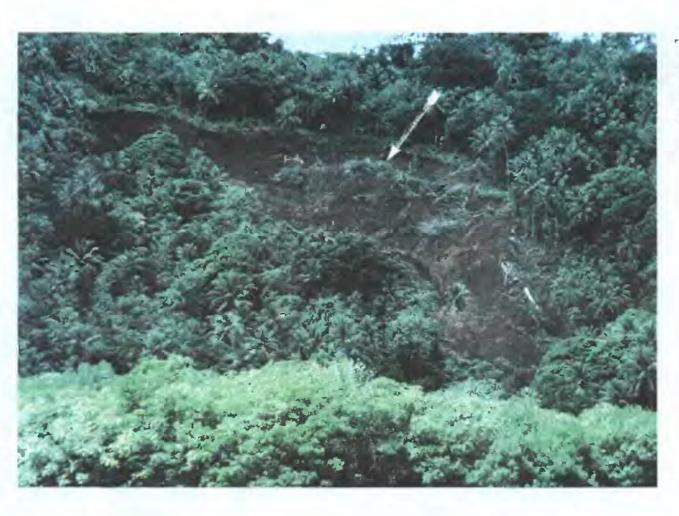
Figure 6. Headscarp area of Iohl landslide showing small slump mass remaining at right center of photo (arrow).

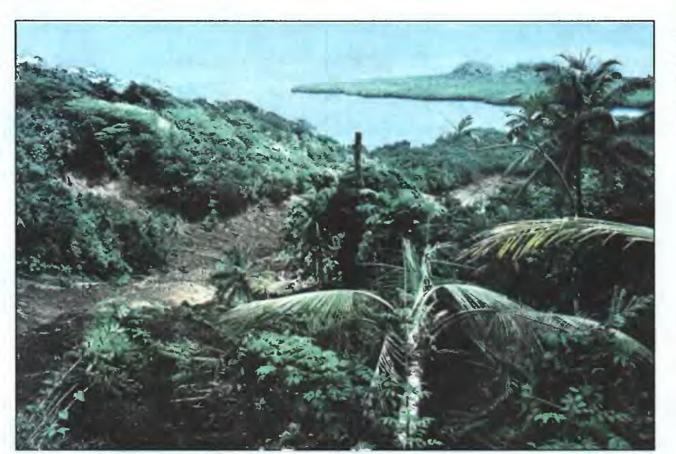
The headscarp of the landslide at Iohl faces northnorthwest. At about a third of the distance from the headscarp to the toe, the flow path turns from northwest to approximately due north (fig. 2; fig. 7). About halfway to its toe from the turn in the flowpath, another rotational slump/debris flow of about 10,000 m³ volume merges from the southwest. Fractures extending behind the headscarp of this landslide outline slump blocks of 500 to 1,000 m³ volume. These blocks should be considered unstable and may move in a future episode of intense rain.

Figure 7. Flow path of debris flow at Iohl showing the confluence of the major flow with a smaller rotational slump at the left of the photo.

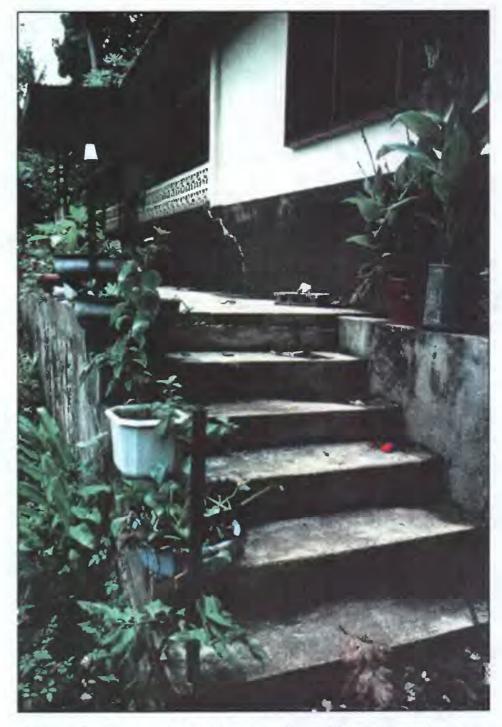
About 1 km southwest of the Iohl landslide, an incipient rotational slump occurred near the small village of Tamwarohi (fig. 2). Discontinuous arcuate fractures formed at the headscarp of the landslide indicate about 40 to 60 cm of downslope displacement and poorly define an incipient landslide about 100 m in width and about 120 m in length parallel to the slope. These fractures are within a weakly-cemented, medium-grained volcanic sandstone. The grains of the sandstone are friable and the "rock" easily broken apart by hand. A residence and a village meeting house located near the toe of the incipient landslide were damaged by cracks that propagated through the building foundations (fig. 8). The fractures in the left flank of the headscarp (looking downhill) crossed a streambed where water could easily travel to the slide surface. This incipient slump is likely to undergo additional movement during future rains and cause further damage to structures located in its path.

Figure 8. Fractures in foundation of house and steps resulting from movement on incipient rotational slump near Tamwarohi.

The incipient landslide in weakly cemented volcanic sandstone near the village of Tamwarohi will probably undergo additional movement during future storms. Fractures present on this slide are likely to intercept surface runoff and provide water to the basal surface of the failure, thus decreasing its stability. It is difficult to predict how much displacement is likely to occur. If displacement of several tens of meters occurs, an adjacent stream could be dammed, posing an additional hazard.
