# **GEOLOGIC HAZARDS AND RELATIVE SLOPE STABILITY OF THE INACTIVE PART OF THE SLUMGULLION LANDSLIDE, SOUTHWESTERN COLORADO**

## ***Open-File Report 97-706***

# Geologic Hazards and Relative Slope Stability of the Inactive Part of the Slumgullion Landslide, Southwestern Colorado

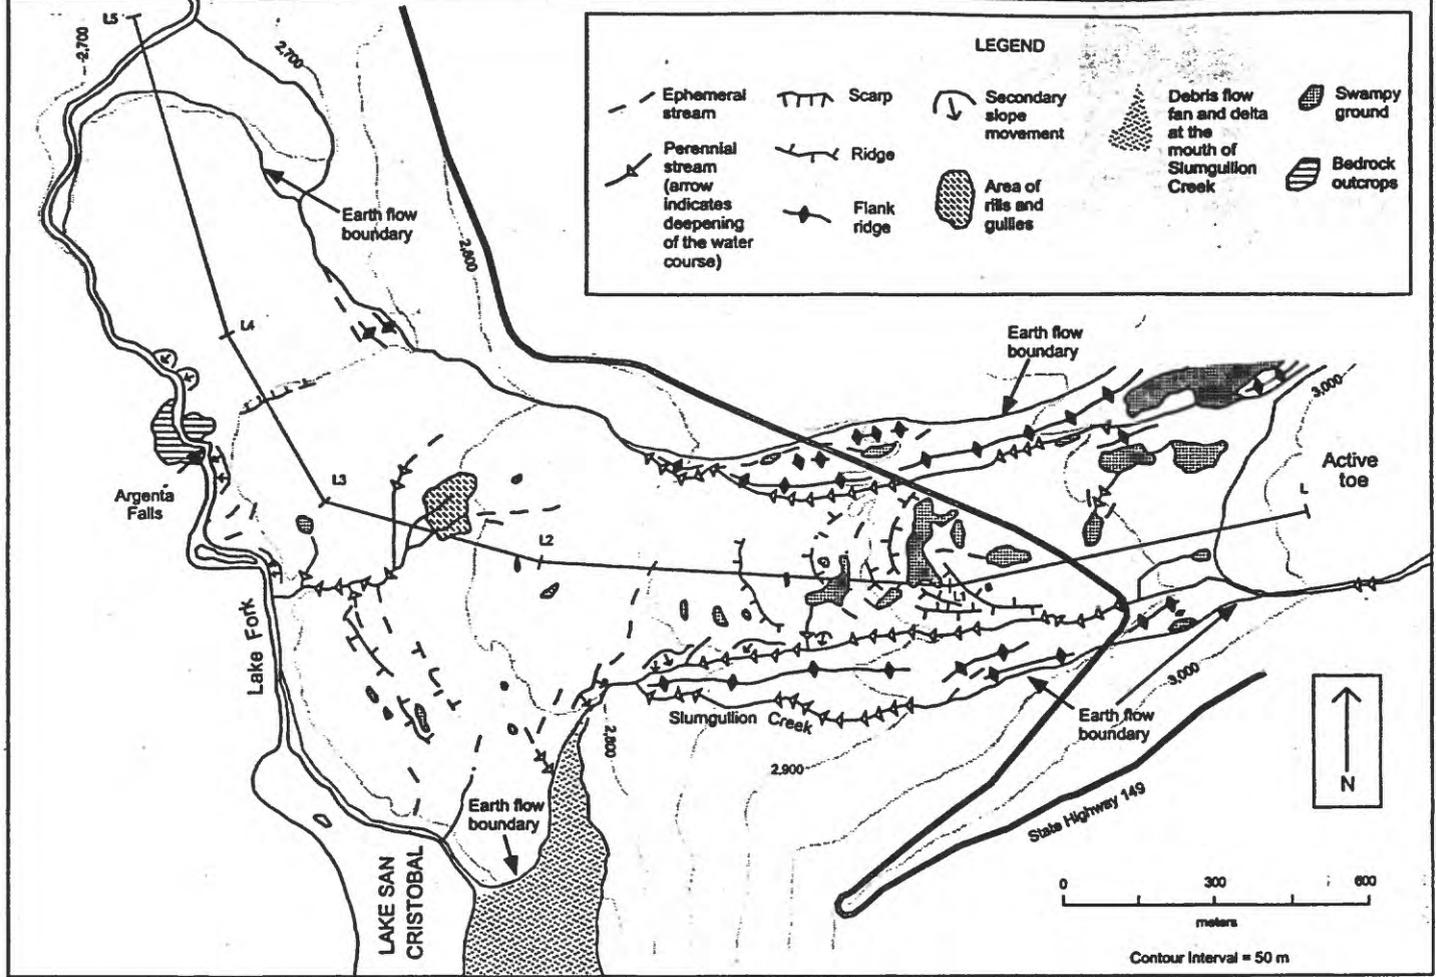
**FIGURE 2**—Geomorphological sketch of the middle-lower portion of the Slumgullion earth flow, from the active to the inactive toe. Trace of the longitudinal profile (fig. 3) is shown.

The hazard related to the presence of surface erosional areas at the inactive Slumgullion landslide is limited to a few sites, only the largest of which is shown in fig. 2. Surface erosion processes could increase the amount of sediment transported toward the main water courses during heavy rainstorms and in the snowmelt season; however, because of their location far away from occupied areas, they do not represent a serious hazard.

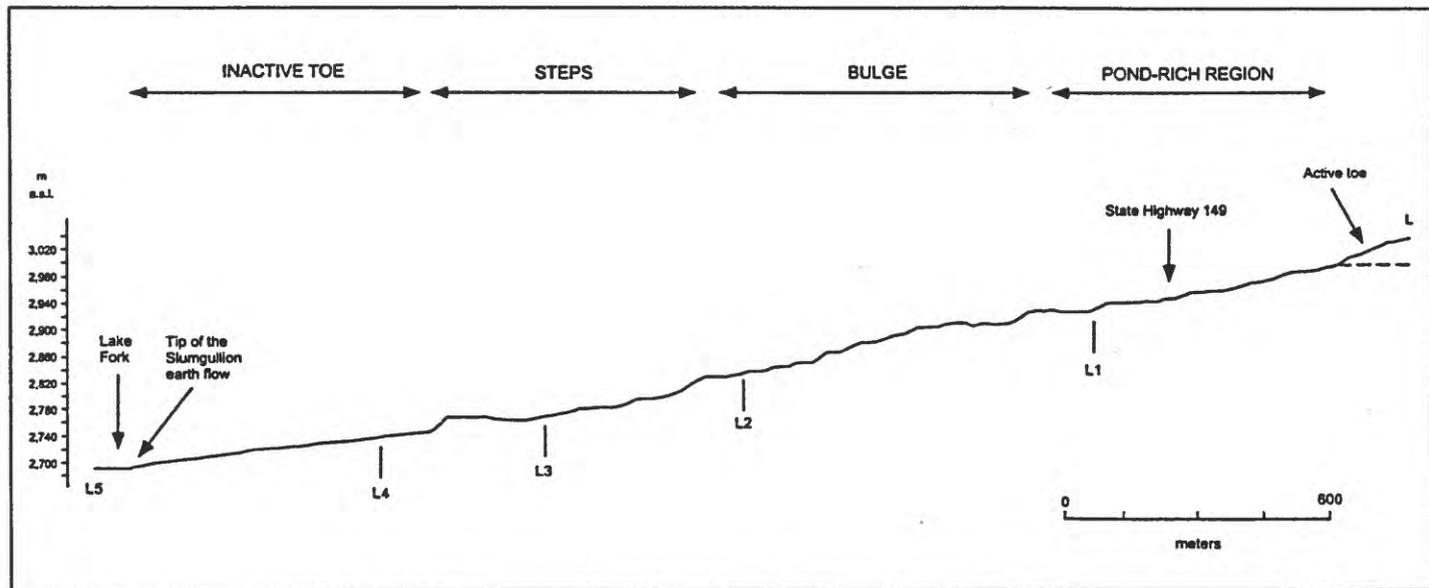
Four separate zones can be distinguished along the longitudinal profile, from the active to the inactive toe: 1) pond-rich region; 2) main bulge; 3) steps; 4) inactive toe (fig. 3).

**FIGURE 3**—Longitudinal profile of the middle-lower part of the inactive Slumgullion earth flow, starting from the toe of the active earth flow. Trace shown in fig. 2.

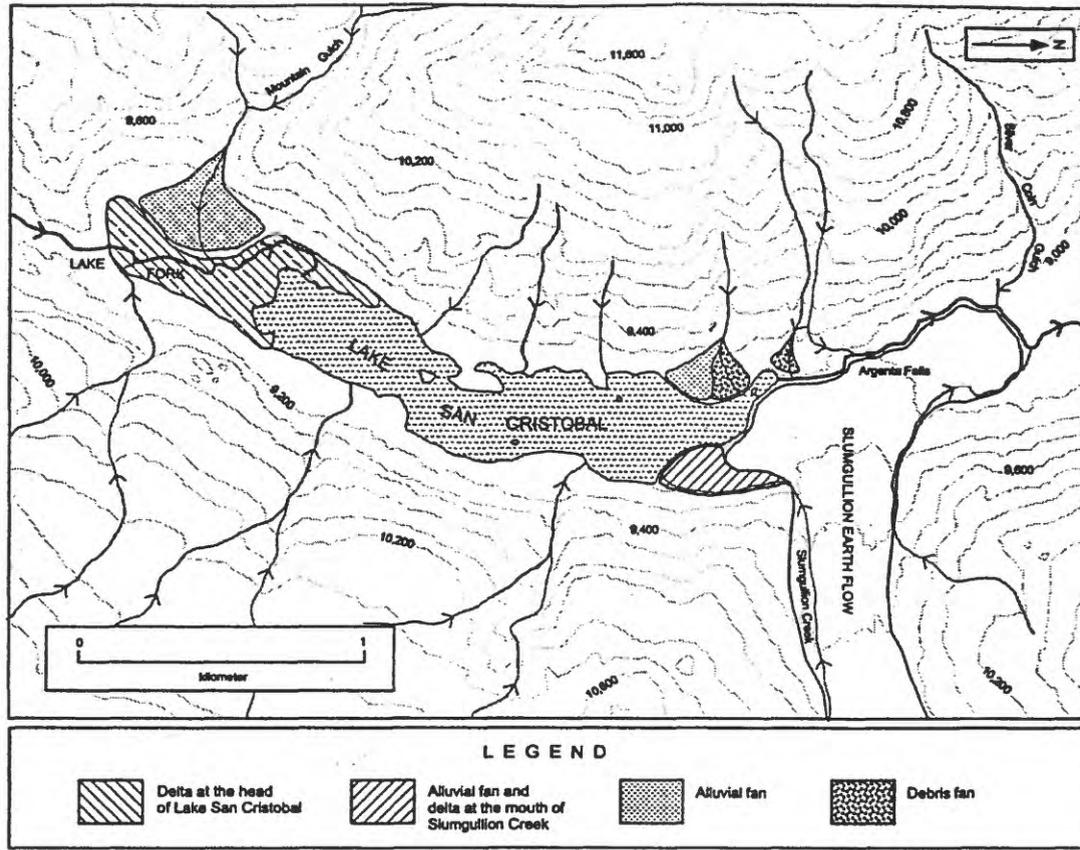
**FIGURE 4**—Map of Lake San Cristobal and surrounding areas. The two deltas, at the head of the lake and at the mouth of Slumgullion Creek, are also shown. Elevation in feet; contour interval 200 ft.

The original size of Lake San Cristobal has been progressively reduced by deposition of material occurring at two large deltas (table 2 and fig. 4): the first one, at the head of the lake, has a surface of about 400,000 m<sup>2</sup>, occupying, at present, more than one-quarter of the original lake basin (Schuster, 1996). The other delta, with an area of about 60,000 m<sup>2</sup> is located at the southeastern edge of the blockage, at the mouth of Slumgullion Creek. It is composed of material eroded from the surface of the earth flow. A description of the sedimentology of this delta, as well as of the related alluvial fan, is given in the section section on debris flows and flooding.

Debris-flow and flood events occur along Slumgullion Creek near Lake San Cristobal. There is a wide alluvial fan and delta built from successive distribution of debris-flow and flood materials at the mouth of Slumgullion Creek (fig. 4). In this section, we describe geomorphic and sedimentologic characters of both alluvial fan and delta, and then discuss the hazard related to debris-flow and flood processes.

Resort facilities located within the depositional area of debris-flow material, as well as along the banks of Slumgullion Creek, leads us to conclude that this area poses one of the most significant hazards related to the earthflow. The occurrence over the years of several debris-flow and flood events highlights the risk related to the presence of human habitation.

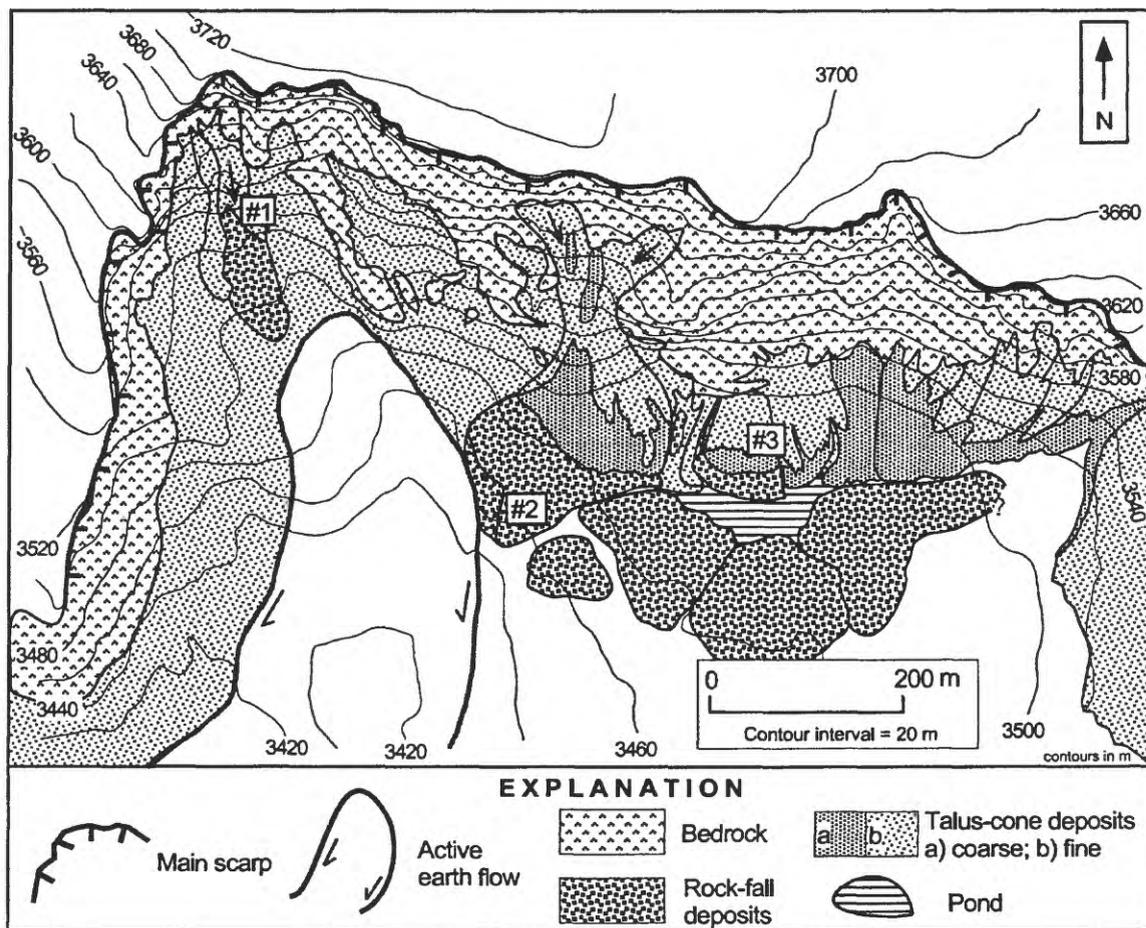
**FIGURE 5**—  
Geologic map of main scarp of the Slumgullion earth flow, showing the talus cones (#1, #2, and #3, as discussed in the text) fed by rock debris coming from the scarp, the rock-fall deposits, and the upper portion of the active earth flow.

Talus cones fed by both type of rocks, as the one labeled as # 2 in fig. 5, typically have fine-grained sediments in the upper part and boulders and cobbles at the toe. Coarse blocks and boulders at the toe are typically scattered and seldom touch each other. They are partly buried by smaller fragments that have accumulated at the toe by fluvial processes (see fig. 5 in Schuster and Smith, 1996). A few large boulders with the major axes oriented parallel to the slope are found at the apex of the cones and partly immersed within finer sediments.

Neither rock-fall deposits or talus accumulations directly add a surcharge load to the active Slumgullion landslide. The hazards related to rock-fall and talus processes are therefore mostly limited to the base of the head scarp. Nevertheless, there remains a possibility of involvement with currently moving material of the landslide through the occurrence of new rock-fall events from the western portion of the head scarp. A new surcharge on the existing deposits close to the active Slumgullion landslide (# 1 and # 2 in fig. 5) could promote further movement in the upper portion of the landslide.

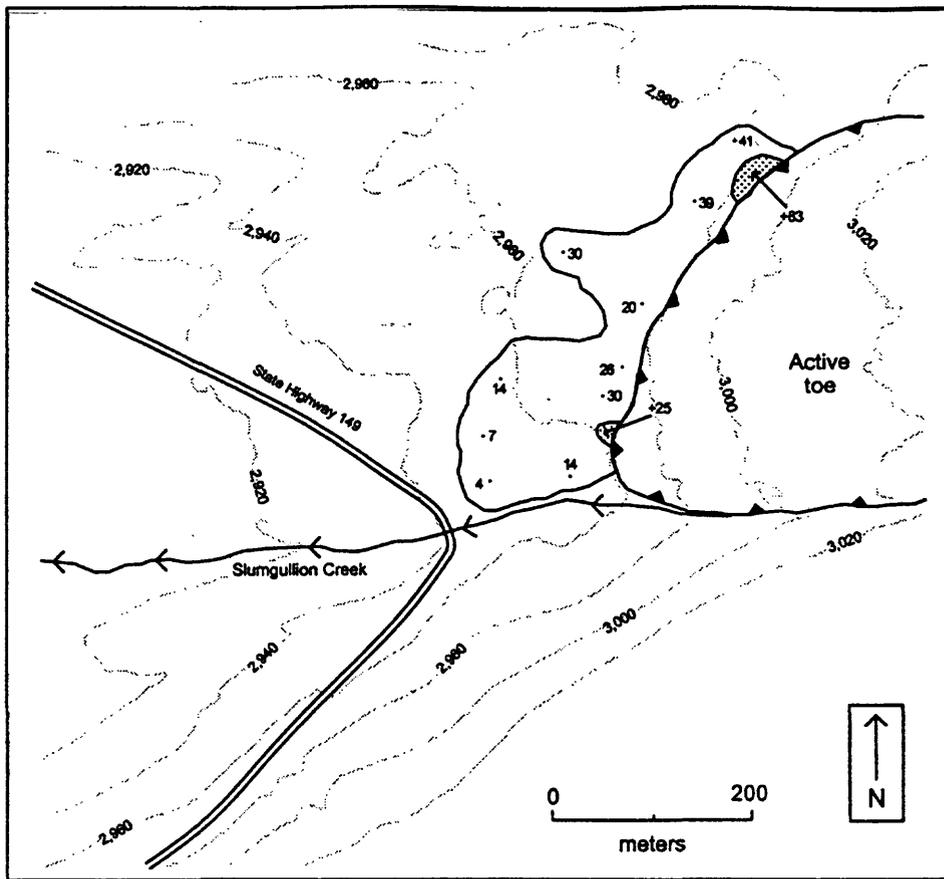
It is interesting to observe the interaction between the active and inactive portions of the Slumgullion landslide in the area downhill from the active toe. To determine if loading exerted by the currently moving material causes deformation of the inactive deposits, a party led by David J. Varnes began surveying this part of the landslide in 1991. The surveys so carried out to date indicate that the inactive part of the Slumgullion earth flow is responding to the load caused by the advancing toe, and is not as stable as previously assumed. The observed deformations are in the range from 20 to 80 mm (in a 2-year period of observation) near the active toe, and the amount of deformation decreases with distance from the toe (Varnes and others, 1996).

Deformation of this portion of the inactive Slumgullion landslide is further indicated by its hydrology. The area contains a large amount of surface water flowing off the active portion of the landslide. Drainage in this sector experiences diversions of streams, changes in surficial runoff patterns and changes in boundaries of the main ponds (W.Z. Savage, personal commun., 1997). From the hydrologic point of view, this area is comparable to most of the surface of the active earth flow, where the surficial drainage pattern changes abruptly in response to active movement of the landslide.

**FIGURE 6**—Area downhill from the active toe, showing the ground deformation of the inactive landslide deposits for the time period 1991-93 (simplified from Varnes and others, 1996).

Average values of ground deformation (in millimeters) are shown. With the exception of values +25 mm and +83 mm near the active toe, all other points have negative values, indicating ground subsidence.

State Highway 149, located near the currently deformed ground, is at long-term risk from the ground deformation downslope from the active toe. Despite the observed ground deformations, observations since 1991 have shown no sign of deformation on the highway. Assuming that the active toe keeps moving at the present rate (maximum value  $\approx 2.5$  m/year), the ground deformation will likely extend in the next 100 years to the area where State Highway 149 runs. Although the evidence is that there will be a diminishing trend in the movement of the active Slumgullion landslide (Parise and Moscardiello, 1997; Fleming and others, in press), it is however important to periodically survey the area downslope from the active toe, to detect any possible deformation of the highway.

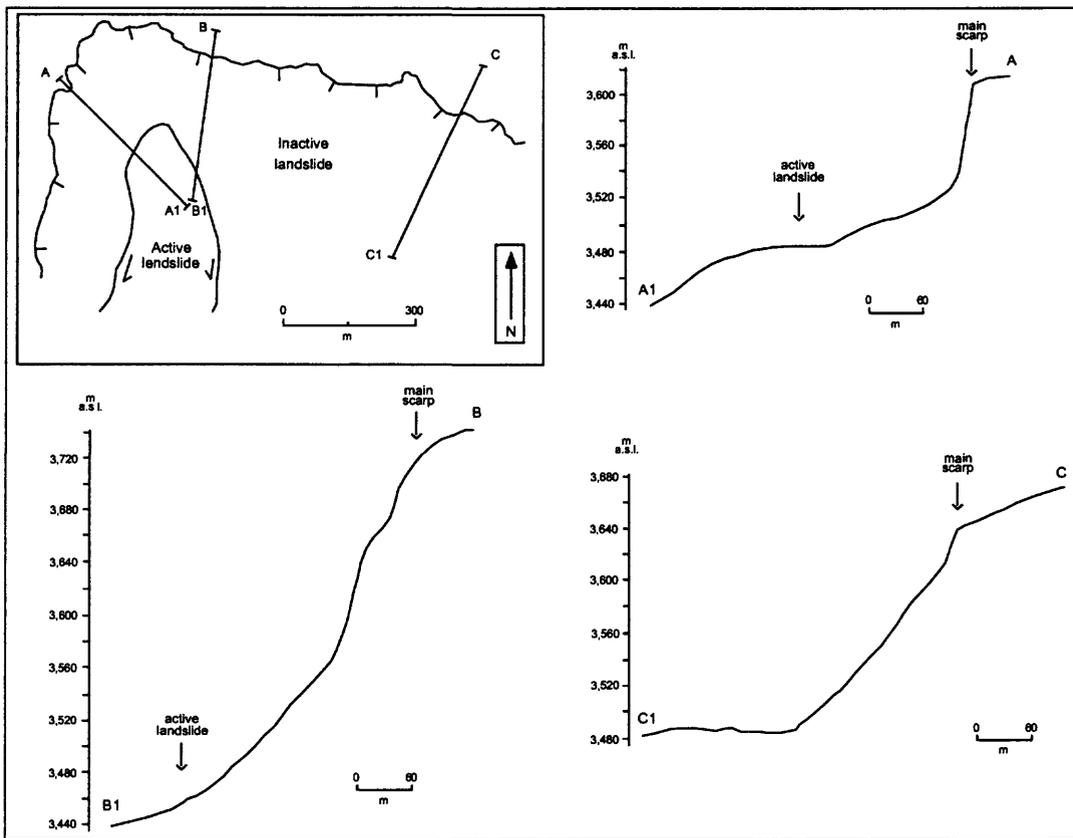
Rock-type is not uniform in the main scarp of the Slumgullion landslide: the western portion is characterized by slightly altered or unaltered rocks, while both eastern and southern parts are mainly very altered rocks, almost entirely transformed to clays. This difference is also visible in the scarp morphology, as shown in three profiles drawn across the main scarp (fig. 7). Profiles A-A1 and B-B1, at the western part of the scarp, are subvertical with very steep cliffs. On the other hand, profile C-C1, located at the eastern part of the main scarp, is considerably less steep.

**FIGURE 7**—Profiles at the main scarp of the inactive Slumgullion landslide. Inset map shows location.

As described in the section on rock-fall deposits, the possibility of future collapse seems more likely to happen in the western sector of the main scarp. A few cracks and other deformation features are recognizable uphill from the main scarp in its western portion. Such features are mostly limited to a narrow 20-m-wide band which follows the main scarp boundary. Evidence for a future collapse is limited to these deformation features. Observations at the base of the main scarp between 1989 and 1992 show that only a few small rockfalls occurred during this period (Schuster and Smith, 1996). Activity of the main scarp appears to be limited to sporadic and small-sized falls, and we speculate that a new catastrophic event, although not to be excluded in the long run, is not likely to happen in the short term.
