# LEVEL II SCOUR ANALYSIS FOR BRIDGE 16 (RIPTTH00110016) on TOWN HIGHWAY 11, crossing the MIDDLE BRANCH MIDDLEBURY RIVER, RIPTON, VERMONT

Open-File Report 97-751

By RONDA L. BURNS

**Structure Number** RIPTTH00110016      **Stream** Middle Branch Middlebury River  
**County** Addison      **Road** TH 11      **District** 5

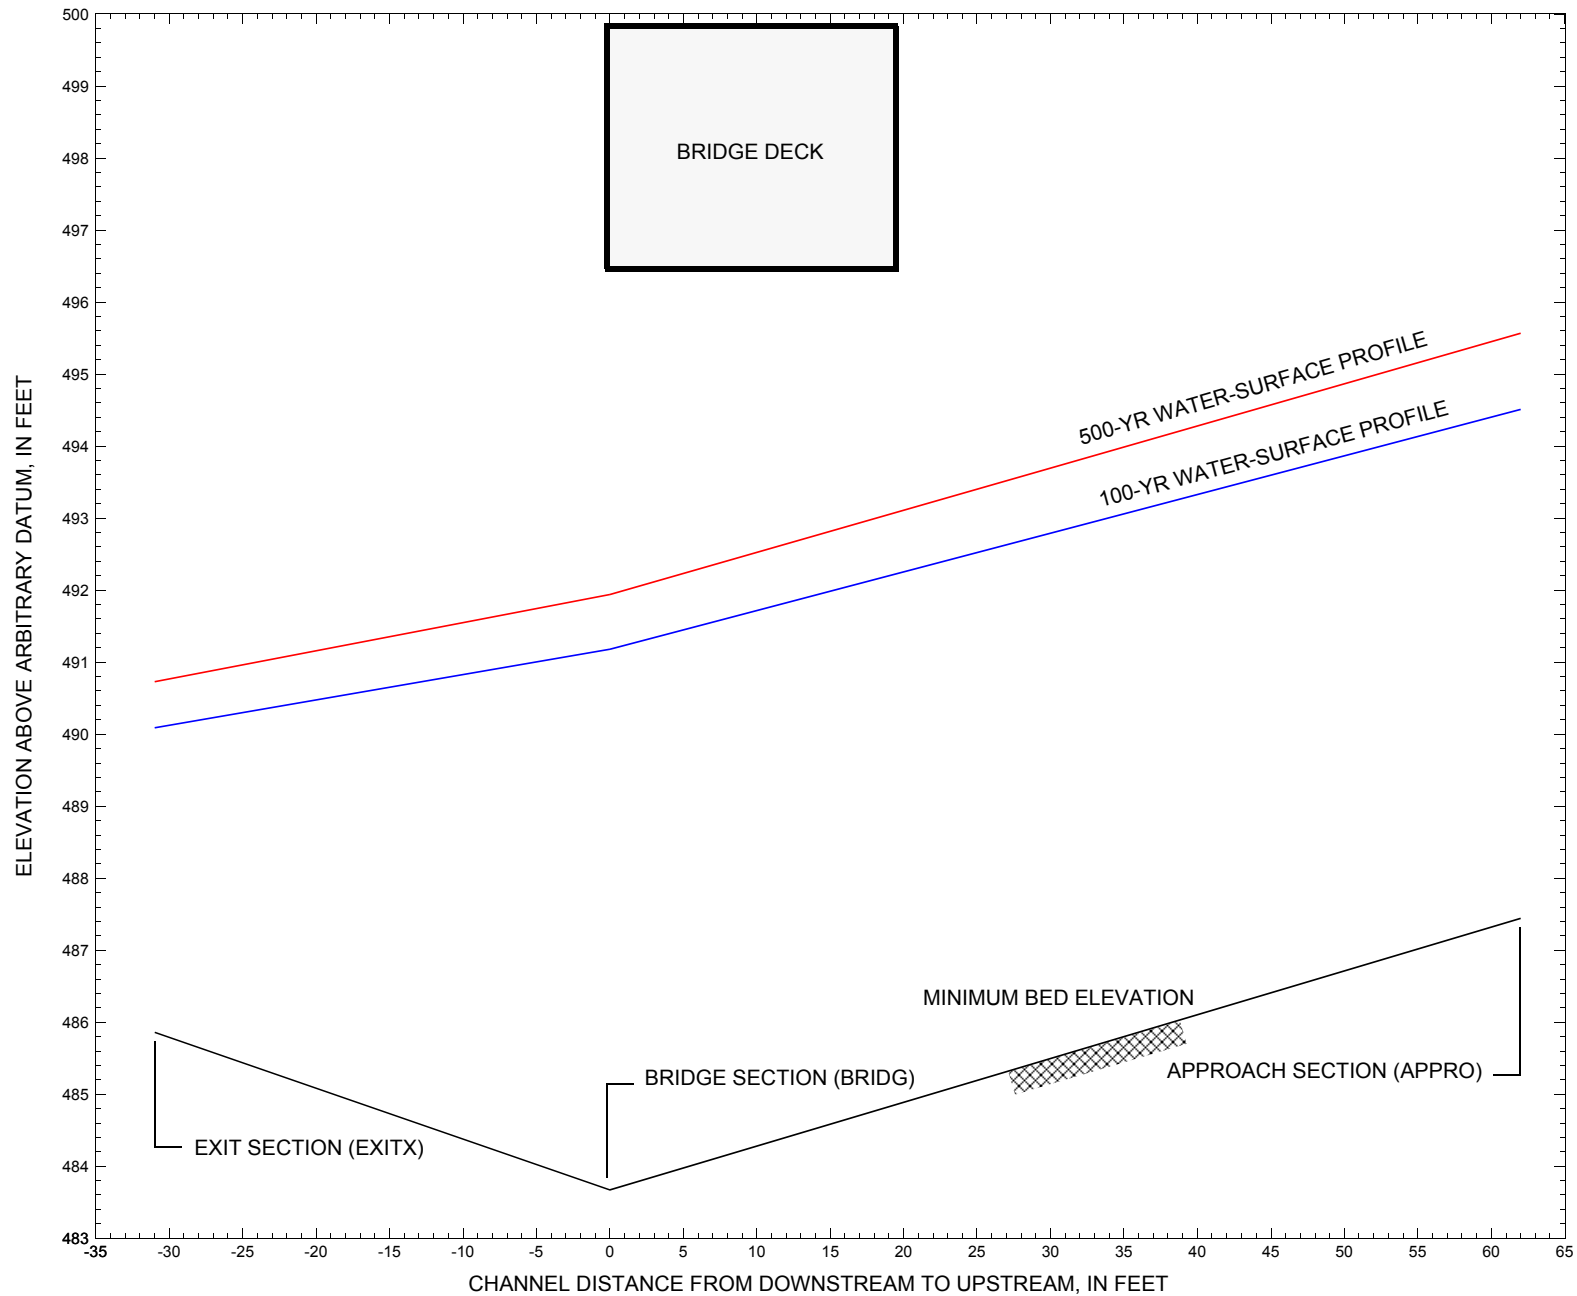
Figure 7. Water-surface profiles for the 100- and 500-yr discharges at structure RIPTTH00110016 on Town Highway 11, crossing the Middle Branch Middlebury River, Ripton, Vermont.

*Water-surface elevation at Approach section with bridge*      494.5  
*Water-surface elevation at Approach section without bridge*      492.5  
*Amount of backwater caused by bridge*      2.0 *ft*

*Water-surface elevation at Approach section with bridge*      495.6  
*Water-surface elevation at Approach section without bridge*      493.2  
*Amount of backwater caused by bridge*      2.4 *ft*

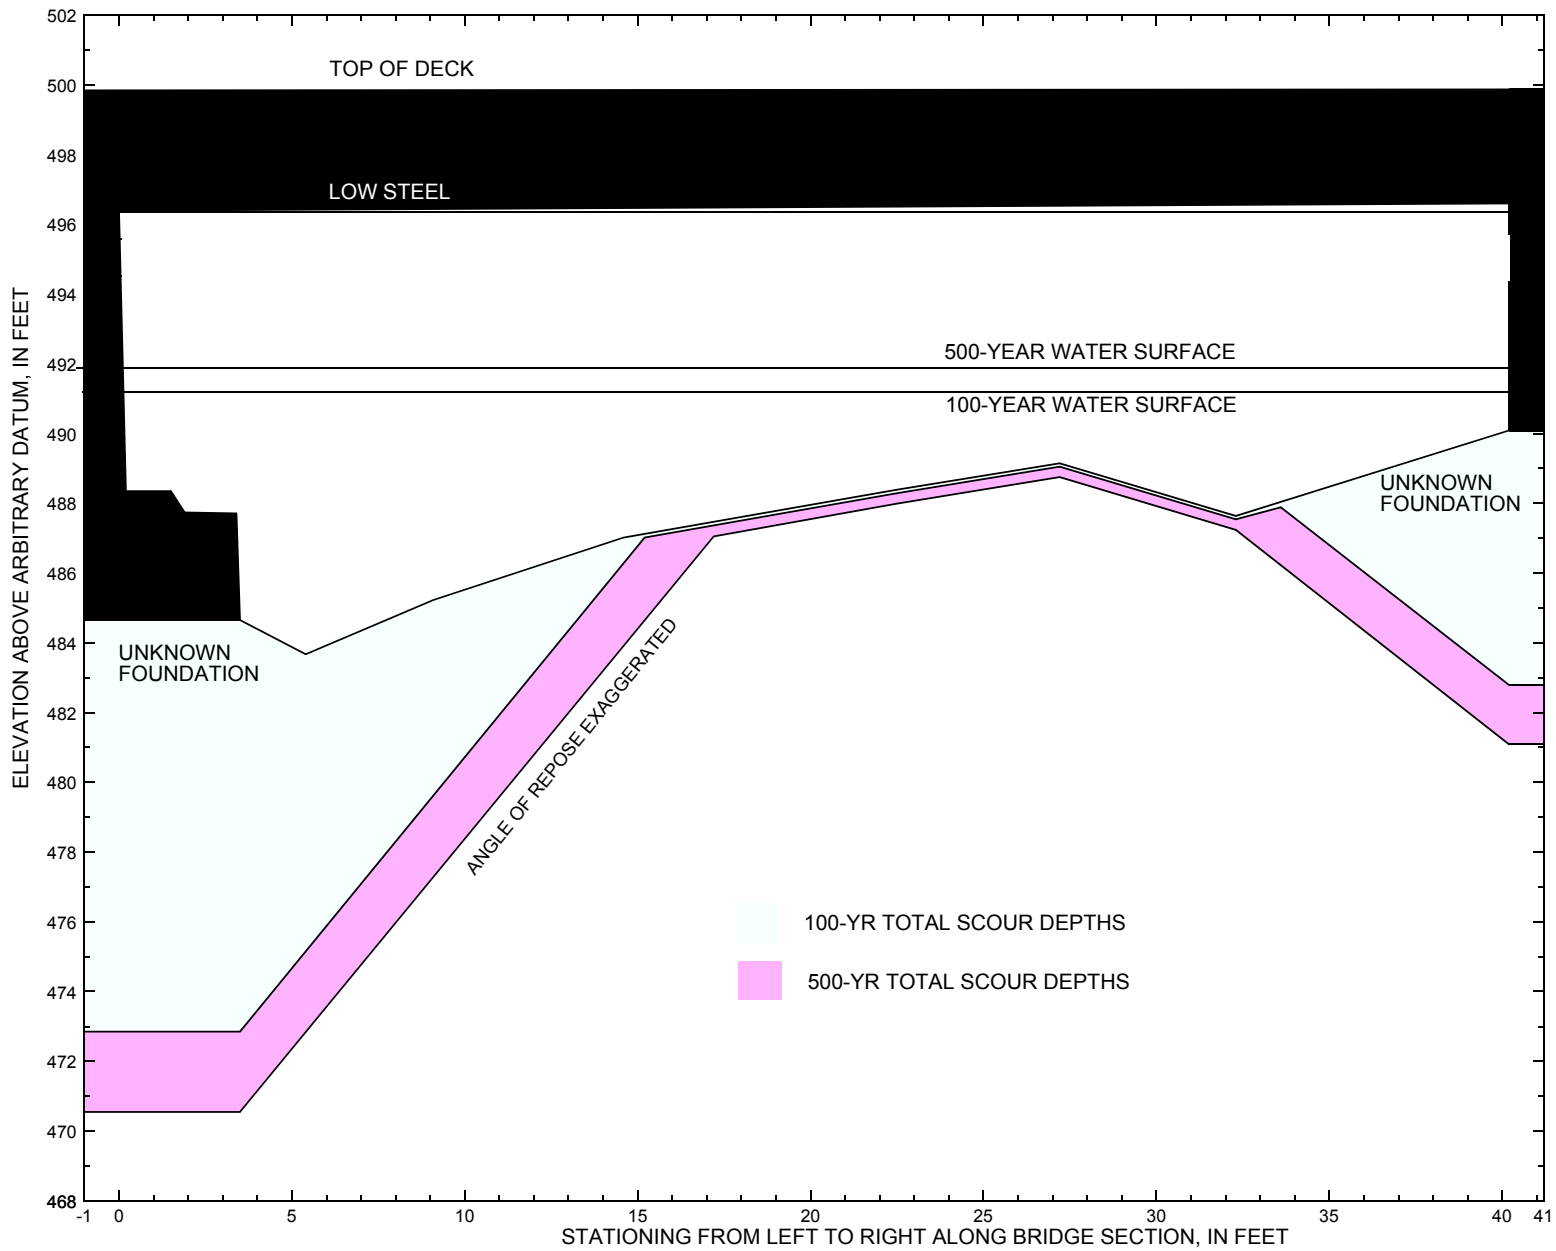
Figure 8. Scour elevations for the 100-yr and 500-yr discharges at structure RIPTTH00110016 on Town Highway 11, crossing the Middle Branch Middlebury River, Ripton, Vermont.

Contraction scour for all modelled flows ranged from 0.1 to 0.4 ft. The worst-case contraction scour occurred at the 500-year discharge. Abutment scour ranged from 7.2 to 8.6 ft along the right abutment and from 11.7 to 13.7 ft along the left abutment. The worst-case abutment scour occurred at the 500-year discharge. Additional information on scour depths and depths to armoring are included in the section titled "Scour Results". Scoured-streambed elevations, based on the calculated scour depths, are presented in tables 1 and 2. A cross-section of the scour computed at the bridge is presented in figure 8. Scour depths were calculated assuming an infinite depth of erosive material and a homogeneous particle-size distribution.

Description	Station <sup>1</sup>	VTAOT minimum low-chord elevation (feet)	Surveyed minimum low-chord elevation <sup>2</sup> (feet)	Bottom of footing/pile elevation <sup>2</sup> (feet)	Channel elevation at abutment/pier <sup>2</sup> (feet)	Contraction scour depth (feet)	Abutment scour depth (feet)	Pier scour depth (feet)	Depth of total scour (feet)	Elevation of scour <sup>2</sup> (feet)	Remaining footing/pile depth (feet)
100-yr. discharge is 1,400 cubic-feet per second											
Left abutment	0.0	--	496.4	--	484.7	0.1	11.7	--	11.8	472.9	--
Right abutment	40.2	--	496.6	--	490.1	0.1	7.2	--	7.3	482.8	--

Description	Station <sup>1</sup>	VTAOT minimum low-chord elevation (feet)	Surveyed minimum low-chord elevation <sup>2</sup> (feet)	Bottom of footing/pile elevation <sup>2</sup> (feet)	Channel elevation at abutment/pier <sup>2</sup> (feet)	Contraction scour depth (feet)	Abutment scour depth (feet)	Pier scour depth (feet)	Depth of total scour (feet)	Elevation of scour <sup>2</sup> (feet)	Remaining footing/pile depth (feet)
500-yr. discharge is 1,850 cubic-feet per second											
Left abutment	0.0	--	496.4	--	484.7	0.4	13.7	--	14.1	470.6	--
Right abutment	40.2	--	496.6	--	490.1	0.4	8.6	--	9.0	481.1	--

<i>100-yr discharge</i>	<i>500-yr discharge</i>	<i>Incipient overtopping discharge</i>
	<i>(D<sub>50</sub> in feet)</i>		
<i>Abutments:</i>	1.5	1.9	--
<i>Left abutment</i>	1.5	1.9	--
<i>Right abutment</i>	--	--	--
<i>Piers:</i>	--	--	--
<i>Pier 1</i>	--	--	--
<i>Pier 2</i>	--	--	--
