LEVEL II SCOUR ANALYSIS FOR  
BRIDGE 31 (JERITH00350031) on  
TOWN HIGHWAY 35, crossing  
MILL BROOK,  
JERICHO, VERMONT

Open-File Report 97-767

Prepared in cooperation with  
VERMONT AGENCY OF TRANSPORTATION  
and  
FEDERAL HIGHWAY ADMINISTRATION

By EMILY C. WILD

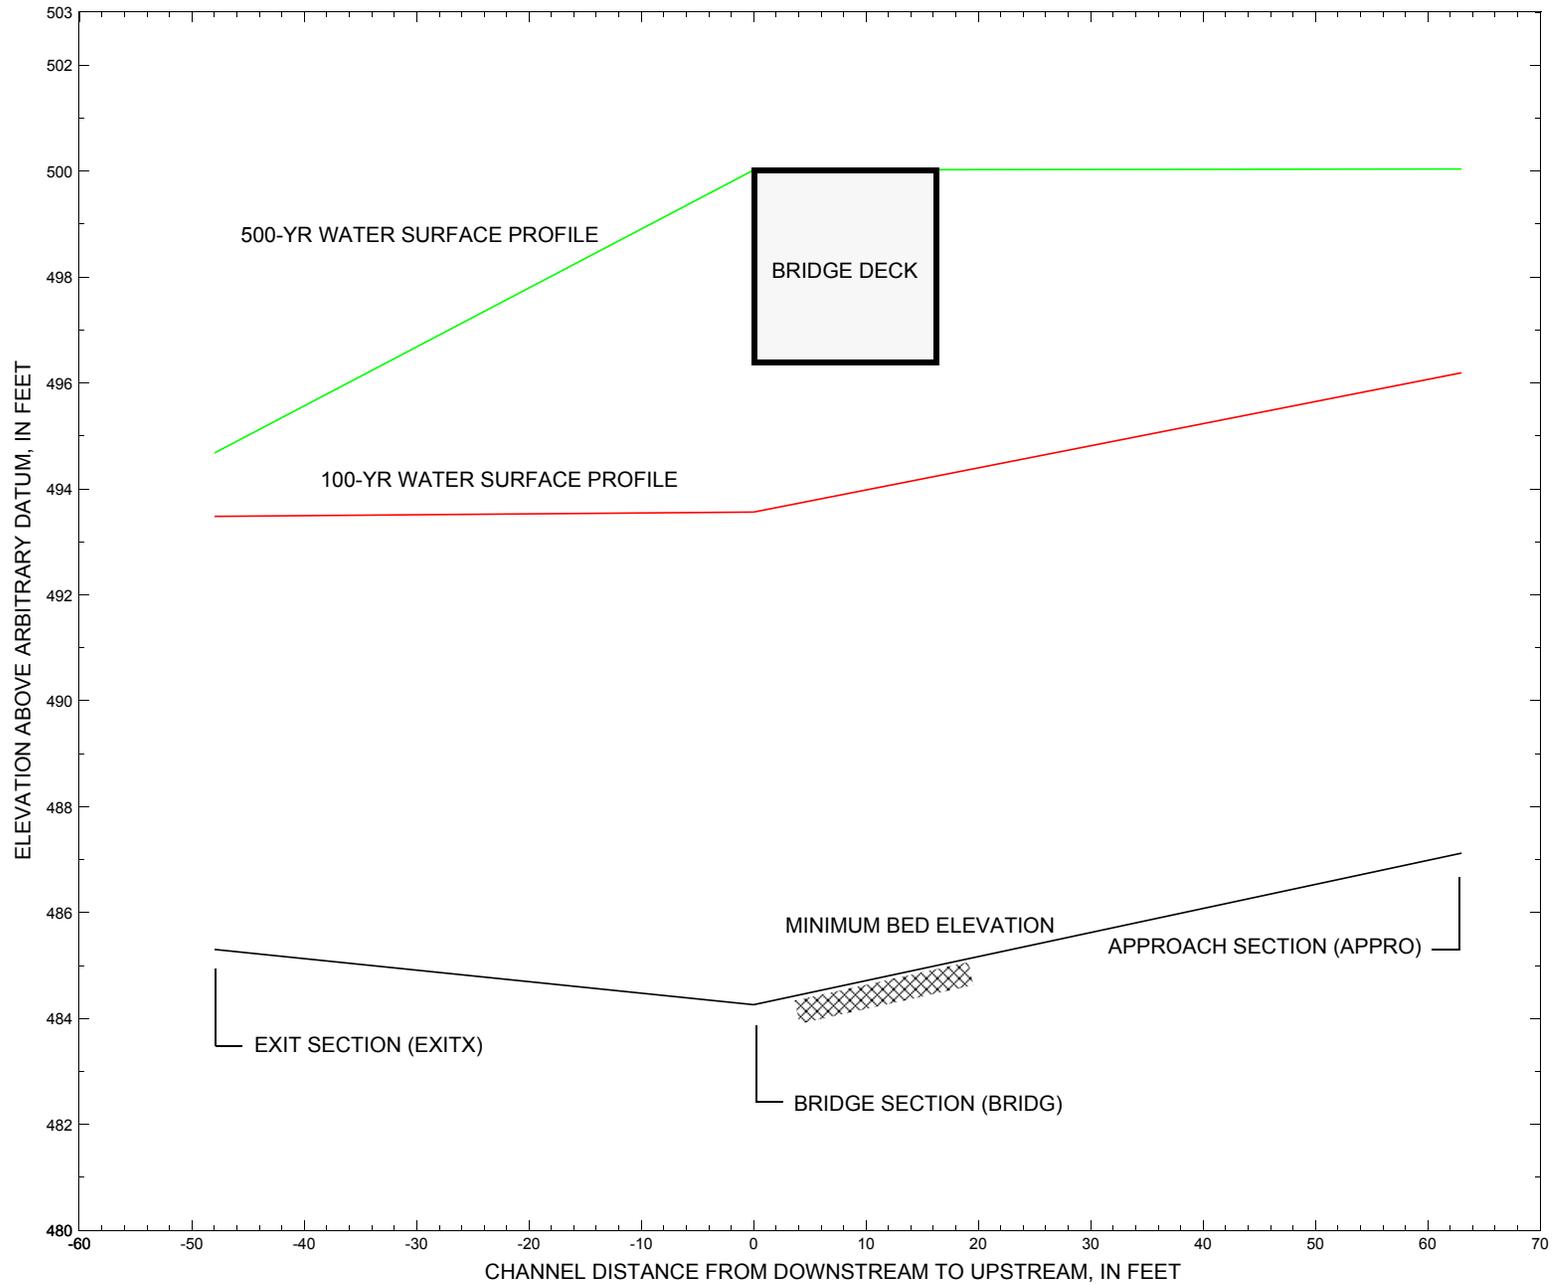
Figure 7. Water-surface profiles for the 100- and 500-yr discharges at structure JERITH00350031 on Town Highway 35, crossing Mill Brook, Jericho, Vermont.

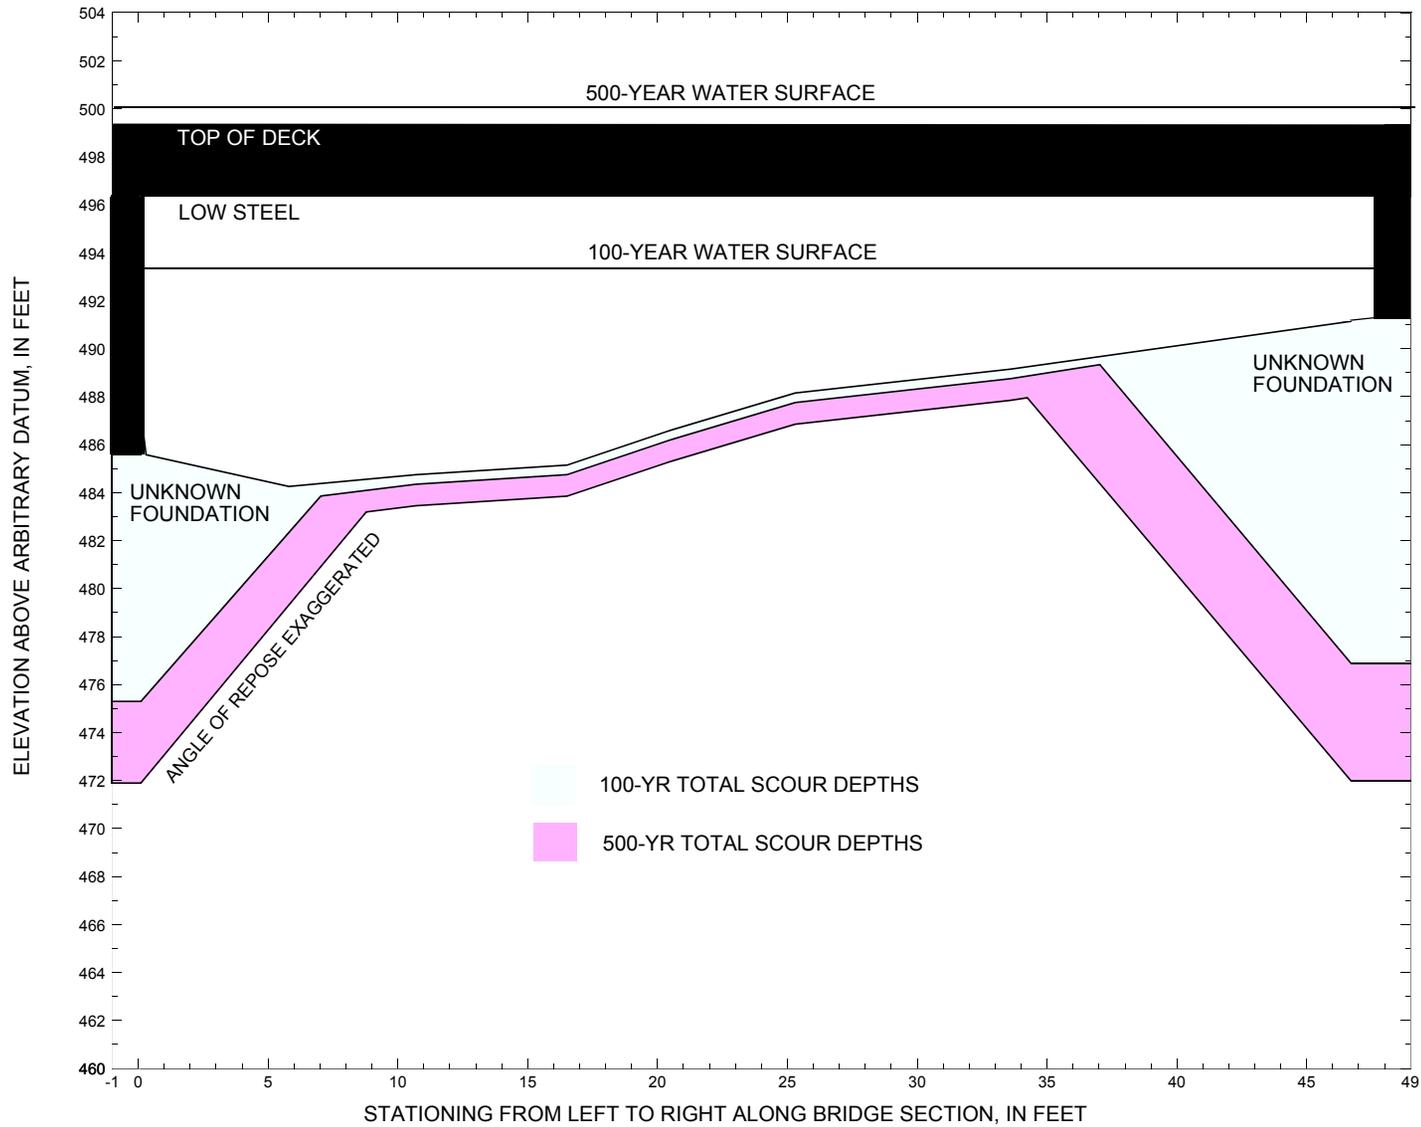
Contraction scour for all modelled flows ranged from 0.4 to 1.3 ft. The worst-case contraction scour occurred at the 500-year discharge. Left abutment scour ranged from 9.9 to 12.4 ft. Right abutment scour ranged from 13.8 to 17.8 ft. The worst-case abutment scour occurred at the 500-year discharge. Additional information on scour depths and depths to armoring are included in the section titled "Scour Results". Scoured-streambed elevations, based on the calculated scour depths, are presented in tables 1 and 2. A cross-section of the scour computed at the bridge is presented in figure 8. Scour depths were calculated assuming an infinite depth of erosive material and a homogeneous particle-size distribution.

Figure 8. Scour elevations for the 100-yr and 500-yr discharges at structure JERITH00350031 on Town Highway 35, crossing Mill Brook, Jericho, Vermont.
