# LEVEL II SCOUR ANALYSIS FOR BRIDGE 22 (WALDTH00180022) on TOWN HIGHWAY 18, crossing COLES BROOK, WALDEN, VERMONT

Open-File Report 97-768

By LORA K. STRIKER AND MICHAEL A. IVANOFF

U.S. Geological Survey  
Open-File Report 97-768

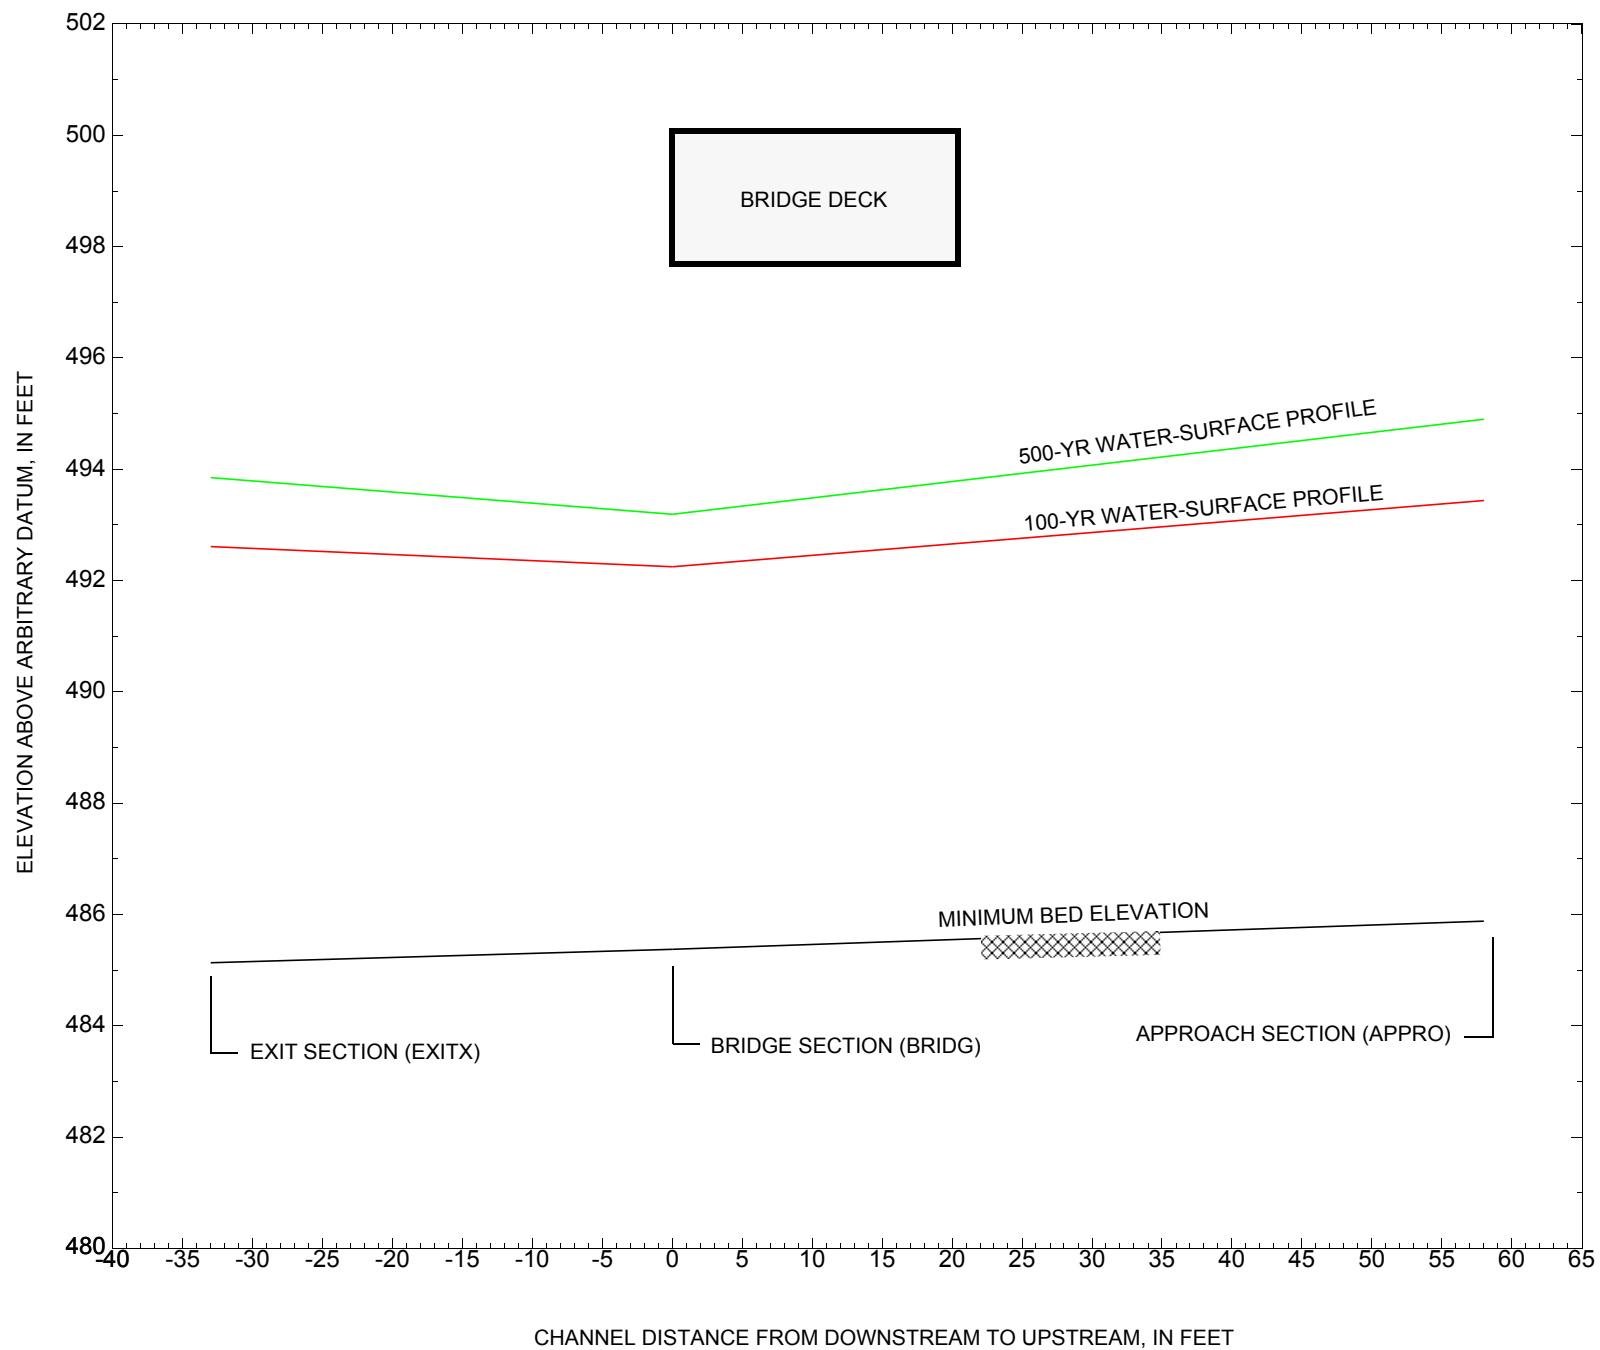
Figure 7. Water-surface profiles for the 100- and 500-year discharges at structure WALDTH00180022 on Town Highway 18, crossing Coles Brook, Walden, Vermont.

*100-year discharge*      2,190 *ft<sup>3</sup>/s*  
*Water-surface elevation in bridge opening*      492.3 *ft*  
*Road overtopping?*      N      *Discharge over road*      0 *ft<sup>3</sup>/s*  
*Area of flow in bridge opening*      240 *ft<sup>2</sup>*  
*Average velocity in bridge opening*      9.1 *ft/s*  
*Maximum WSPRO tube velocity at bridge*      10.8 *ft/s*

*500-year discharge*      3,100 *ft<sup>3</sup>/s*  
*Water-surface elevation in bridge opening*      493.2 *ft*  
*Road overtopping?*      N      *Discharge over road*      0 *ft<sup>3</sup>/s*  
*Area of flow in bridge opening*      278 *ft<sup>2</sup>*  
*Average velocity in bridge opening*      11.2 *ft/s*  
*Maximum WSPRO tube velocity at bridge*      13.4 *ft/s*

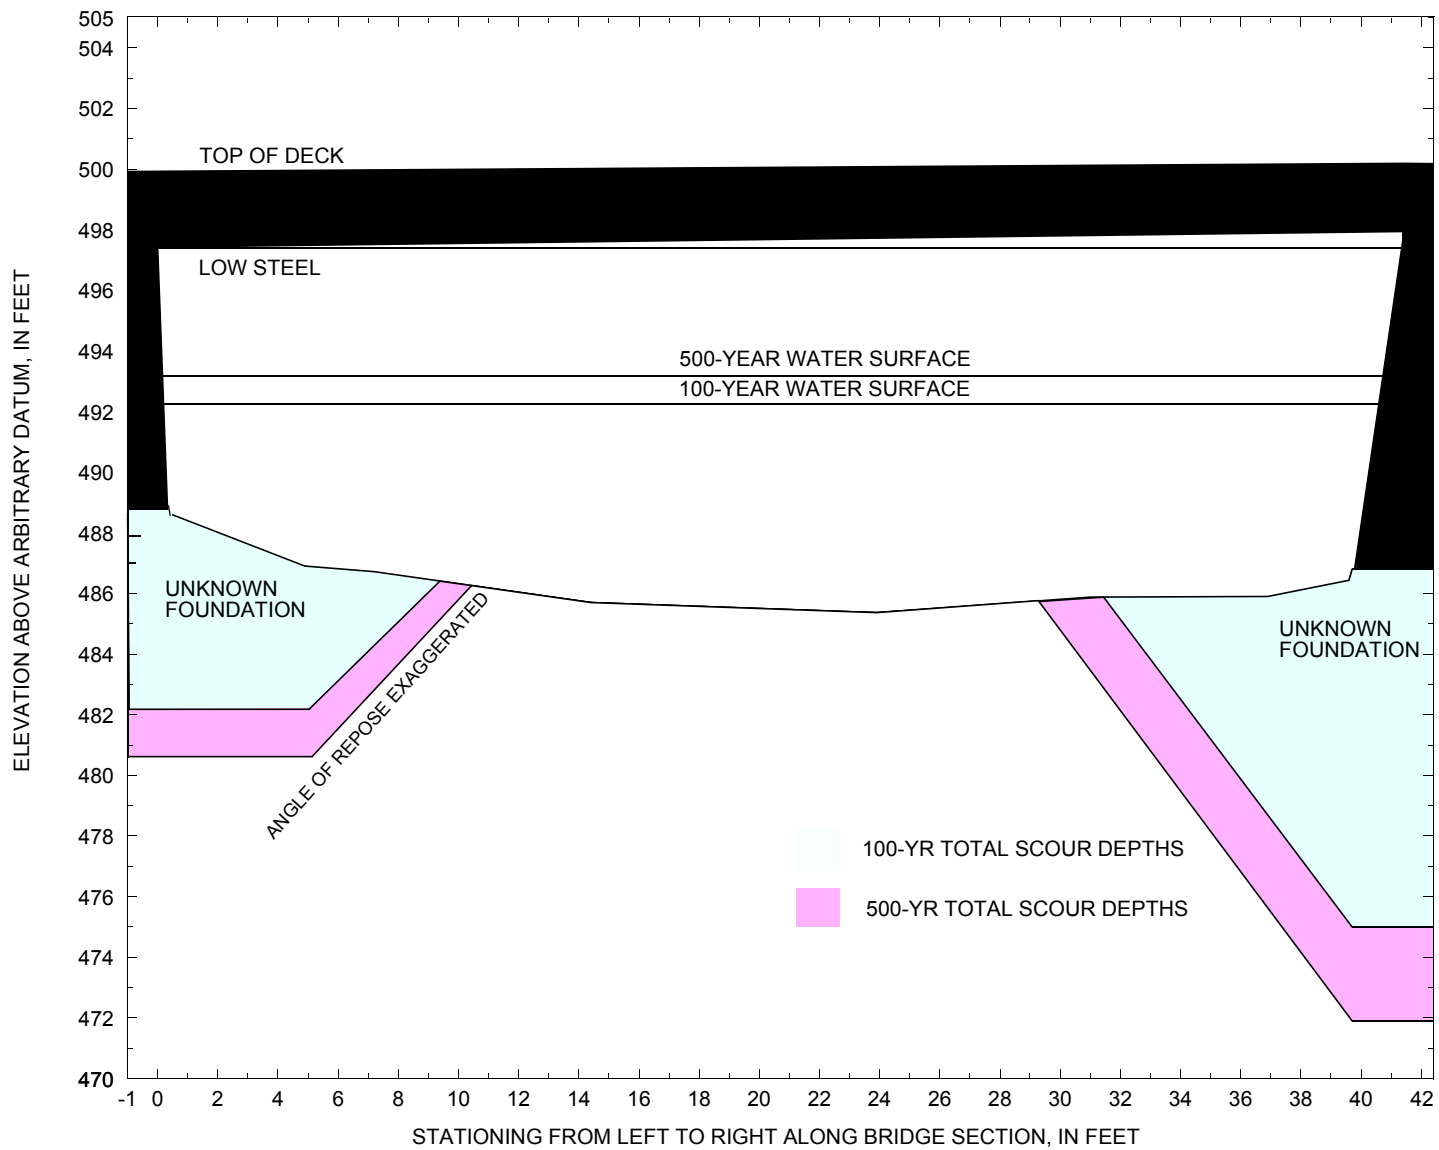
Figure 8. Scour elevations for the 100-year and 500-year discharges at structure WALDTH00180022 on Town Highway 18, crossing Coles Brook, Walden, Vermont.

Contraction scour for all modelled flows was 0.0 ft. Abutment scour ranged from 6.4 to 7.9 ft at the left abutment and from 11.8 to 14.9 ft at the right abutment. The worst-case abutment scour occurred at the 500-year discharge. Additional information on scour depths and depths to armoring are included in the section titled “Scour Results”. Scoured-streambed elevations, based on the calculated scour depths, are presented in tables 1 and 2. A cross-section of the scour computed at the bridge is presented in figure 8. Scour depths were calculated assuming an infinite depth of erosive material and a homogeneous particle-size distribution.

Scour depths were computed using the general guidelines described in Hydraulic Engineering Circular 18 (Richardson and others, 1995). Scour depths were calculated assuming an infinite depth of erosive material and a homogeneous particle-size distribution. The results of the scour analysis are presented in tables 1 and 2 and a graph of the scour depths is presented in figure 8.
