# LEVEL II SCOUR ANALYSIS FOR BRIDGE 5 (MORRTH00060005) on TOWN HIGHWAY 6, crossing BEDELL BROOK, MORRISTOWN, VERMONT

Open-File Report 97-793

By ERICK M. BOEHMLER and JAMES R. DEGNAN

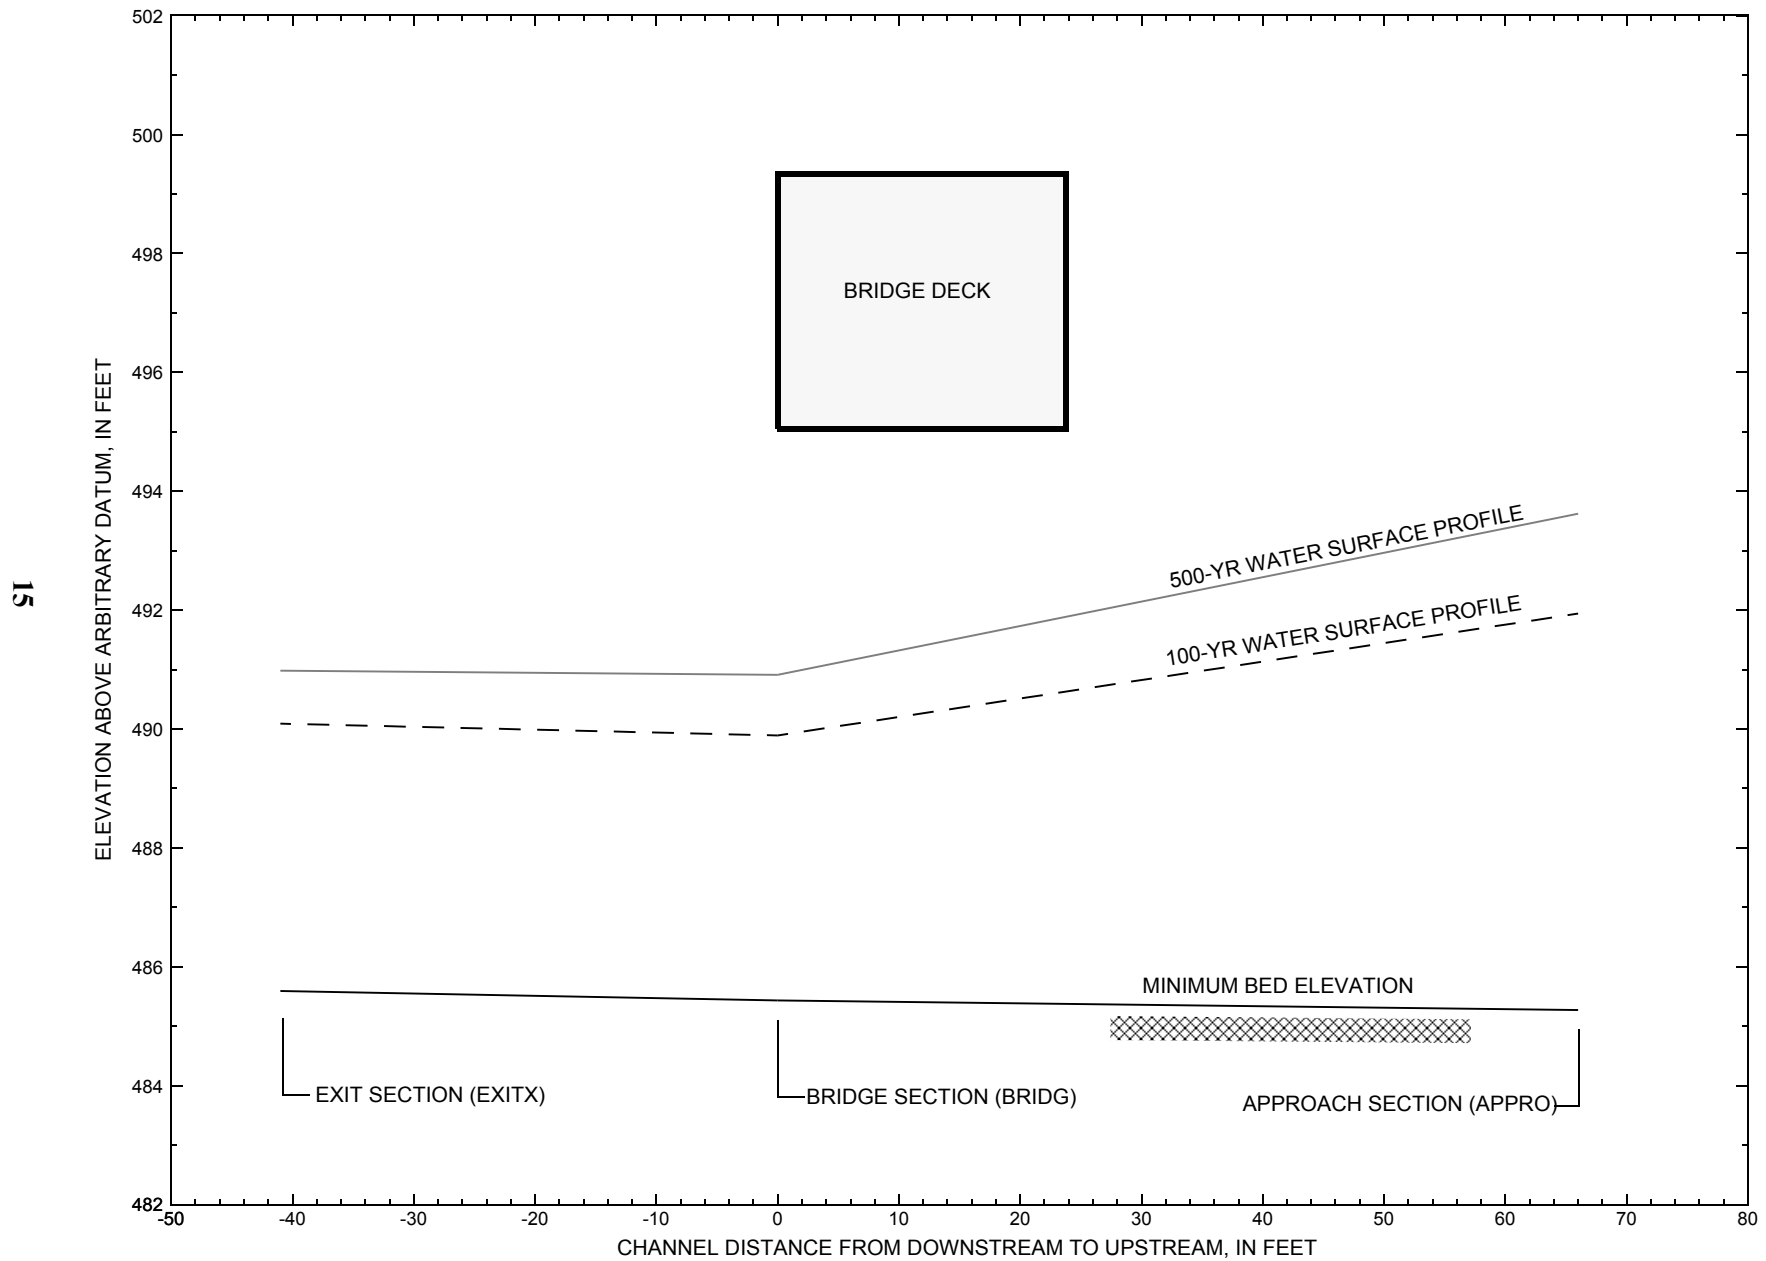
Figure 7. Water-surface profiles for the 100- and 500-yr discharges at structure MORRTH00060005 on Town Highway 6, crossing Bedell Brook, Morristown, Vermont.

Hydraulic analyses of the reach were done by use of the Federal Highway Administration's WSPRO step-backwater computer program (Shearman and others, 1986, and Shearman, 1990). The analyses reported herein reflect conditions existing at the site at the time of the study. Furthermore, in the development of the model it was necessary to assume no accumulation of debris or ice at the site. Results of the hydraulic model are presented in the Bridge Hydraulic Summary, Appendix B, and figure 7.

*100-year discharge*      1,400 *ft<sup>3</sup>/s*  
*Water-surface elevation in bridge opening*      489.9 *ft*  
*Road overtopping?*      No      *Discharge over road*      -- *ft<sup>3</sup>/s*  
*Area of flow in bridge opening*      135 *ft<sup>2</sup>*  
*Average velocity in bridge opening*      10.3 *ft/s*  
*Maximum WSPRO tube velocity at bridge*      12.1 *ft/s*

*500-year discharge*      2,100 *ft<sup>3</sup>/s*  
*Water-surface elevation in bridge opening*      490.9 *ft*  
*Road overtopping?*      No      *Discharge over road*      -- *ft<sup>3</sup>/s*  
*Area of flow in bridge opening*      176 *ft<sup>2</sup>*  
*Average velocity in bridge opening*      11.9 *ft/s*  
*Maximum WSPRO tube velocity at bridge*      14.0 *ft/s*

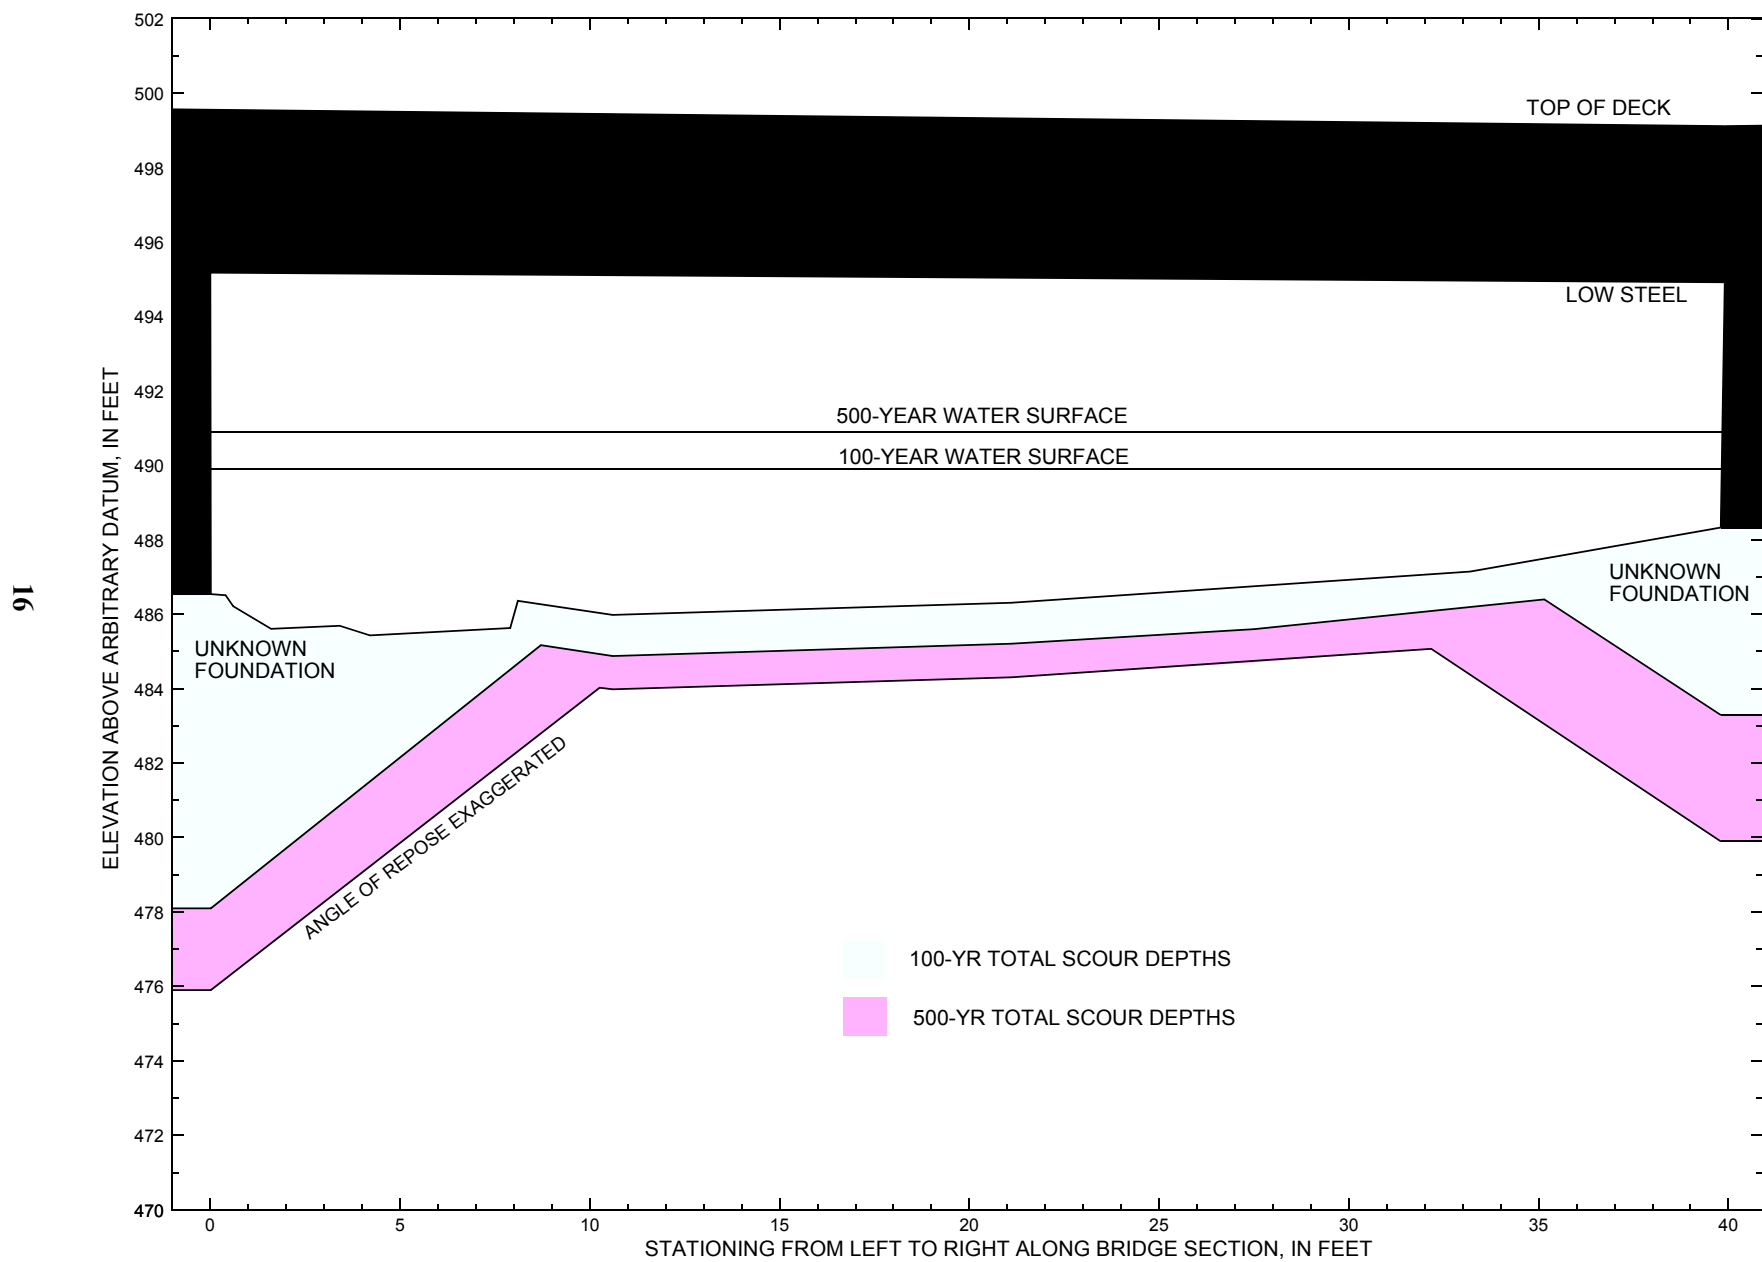
Figure 8. Scour elevations for the 100-yr and 500-yr discharges at structure MORRTH00060005 on Town Highway 6, crossing Bedell Brook, Morristown, Vermont.

Contraction scour for all modelled flows ranged from 1.1 to 2.0 feet. The worst-case contraction scour occurred at the 500-year discharge. Abutment scour ranged from 3.9 to 8.6 feet. The worst-case abutment scour occurred at the 500-year event. Additional information on scour depths and depths to armoring are included in the section titled “Scour Results”. Scoured-streambed elevations, based on the calculated scour depths, are presented in tables 1 and 2. A cross-section of the scour computed at the bridge is presented in figure 8. Scour depths were calculated assuming an infinite depth of erosive material and a homogeneous particle-size distribution.

Scour depths were computed using the general guidelines described in Hydraulic Engineering Circular 18 (Richardson and others, 1995). Scour depths were calculated assuming an infinite depth of erosive material and a homogeneous particle-size distribution. The results of the scour analysis are presented in tables 1 and 2 and a graph of the scour depths is presented in figure 8.

<i>Abutment scour</i>	7.3	8.6	--
<i>Left abutment</i>	3.9	6.4	--
<i>Right abutment</i>			
<i>Pier scour</i>	--	--	--
<i>Pier 1</i>	--	--	--
<i>Pier 2</i>	--	--	--
<i>Pier 3</i>	--	--	--

<i>100-yr discharge</i>	<i>500-yr discharge</i>	<i>Incipient overtopping discharge</i>
	<i>(D<sub>50</sub> in feet)</i>		
<i>Abutments:</i>	1.4	1.9	--
<i>Left abutment</i>	1.4	1.9	--
<i>Right abutment</i>	--	--	--
<i>Piers:</i>	--	--	--
<i>Pier 1</i>	--	--	--
<i>Pier 2</i>	--	--	--
